REPORT NO. NADC-77073-30

# REAL-TIME X-RAY INSPECTION OF COMPOSITE AIRCRAFT STRUCTURES

December 1978

FINAL REPORT  
AIRTASK No. OTR Rework  
Work Unit No. GA801

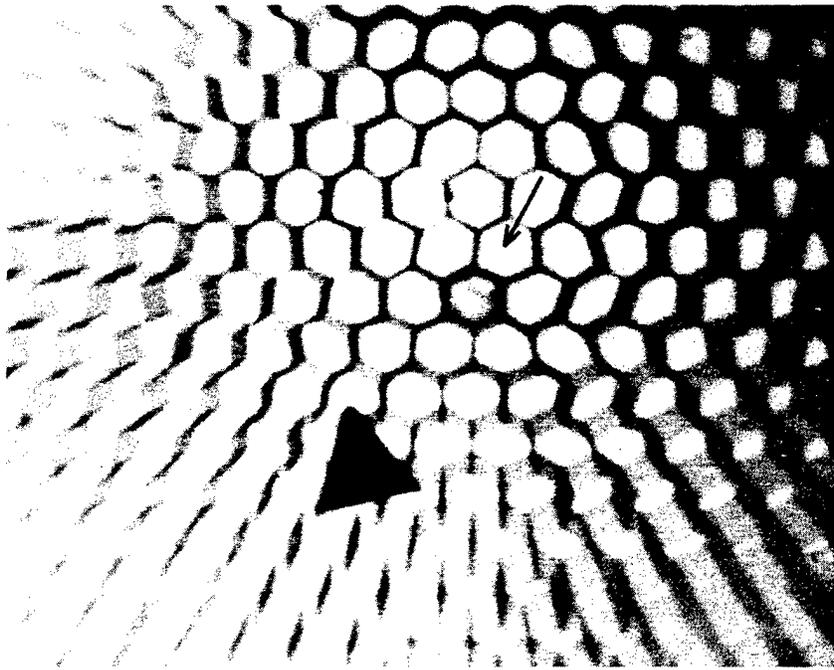
Another common type of composite defect listed on Table 6 is core damage. This can either occur during manufacturing or result from impact or ballistic damage. Figure 13 shows an RTR of a graphite/epoxy sample with a single damaged cell resulting from manufacturing. Another example, Fig. 14, is an RTR of a graphite/epoxy sample with the honeycomb core damaged by impact. These examples illustrate the sensitivity of RTR for detection of core damage even as minute as damage to a single cell.

Figure 13. RTR of a Graphite/Epoxy sample with aluminum honeycomb illustrating damage in a singular core (70kV, 5mA)

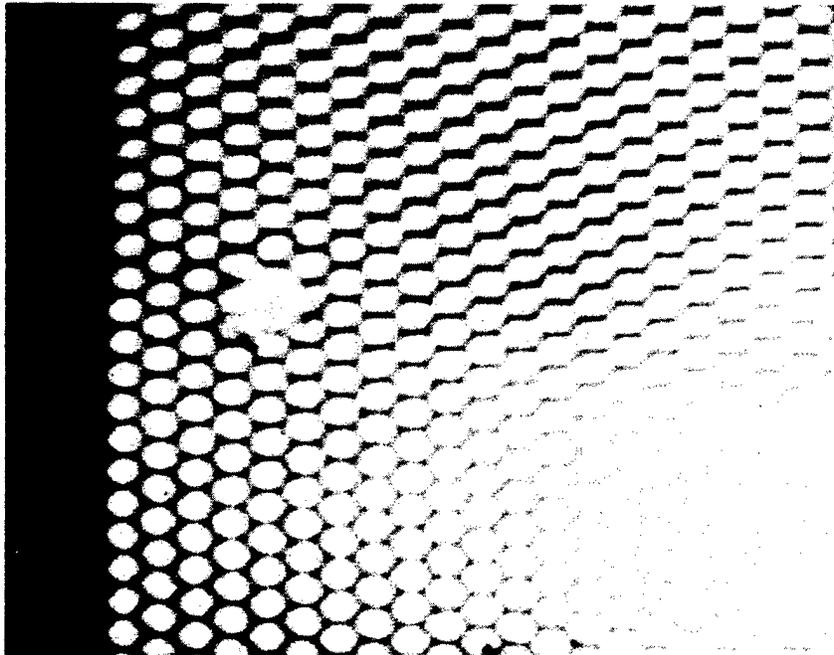
Figure 14. RTR of a Graphite/Epoxy Sample with Aluminum Honeycomb illustrating core damage (70kV, 5mA)

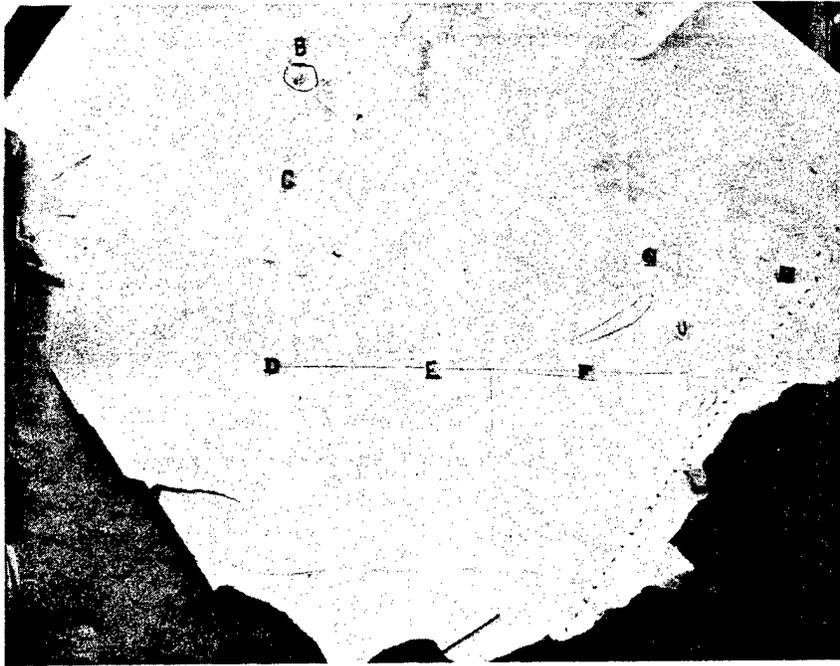
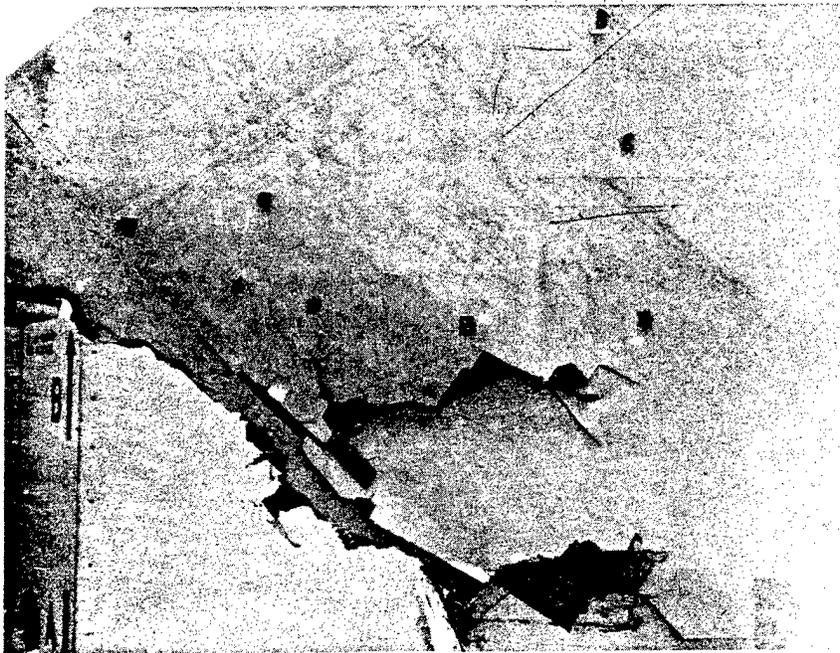
Figures 17 and 18 show the front (x-ray source side) and back (next to RTR screen) of a damaged F-14 stabilizer labelled with lead letters at different areas to identify the area during inspection. The photographs illustrate extensive damage at D, E and F, with no visible damage at C, H and U. Areas B and G contain small nicks that are visible on the surface.

Figure 17. Front Side of a damaged F-14 Boron/Epoxy horizontal stabilizer

Figure 18. Back side of the F-14 horizontal stabilizer

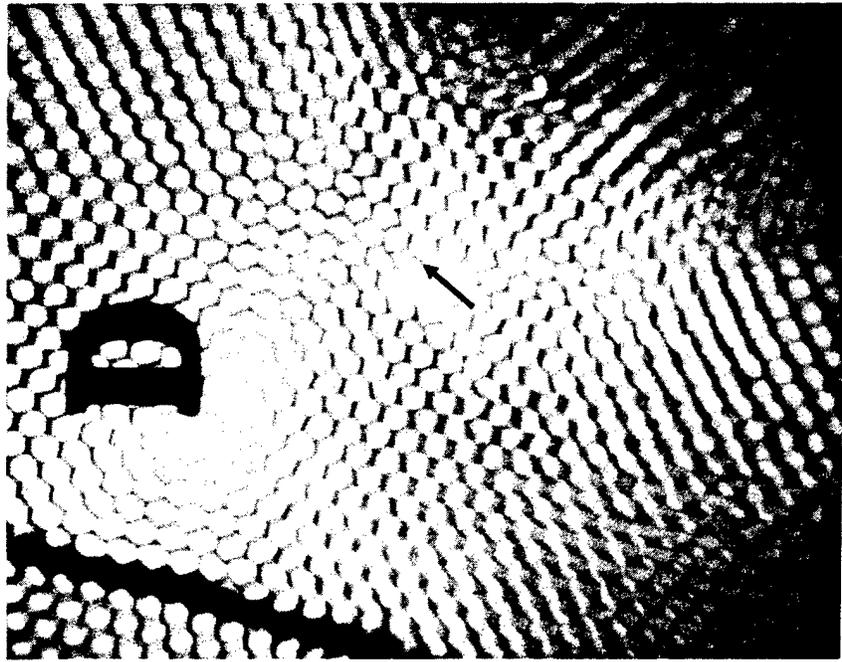
Figure 21. RTR of area D illustrating a large area of crushed honeycomb in the right corner. In addition a singular core indicates core damage similar to the type in Figure 13. (65kV, 4mA)

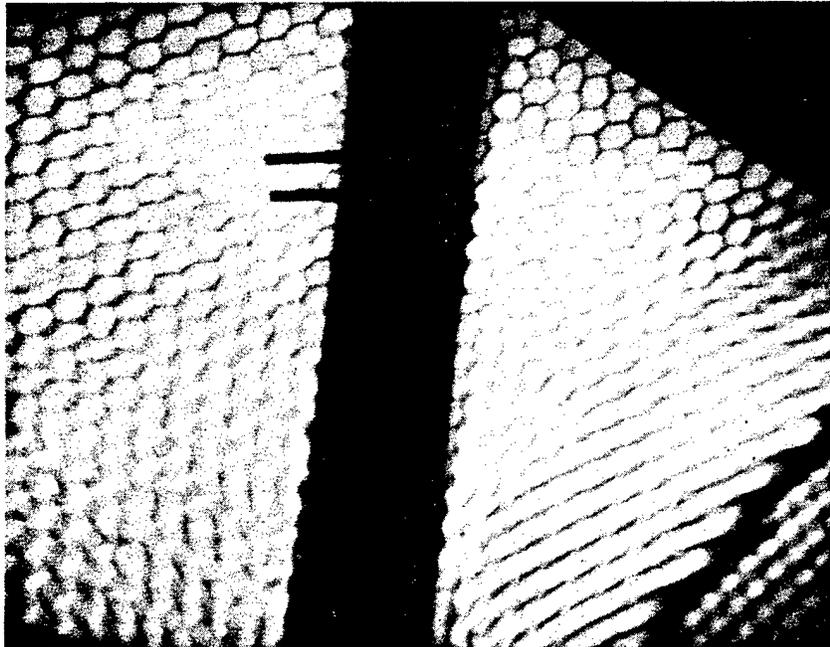
Figure 22. RTR of area U illustrating damage that is not visible on the surface (64kV, 4mA)

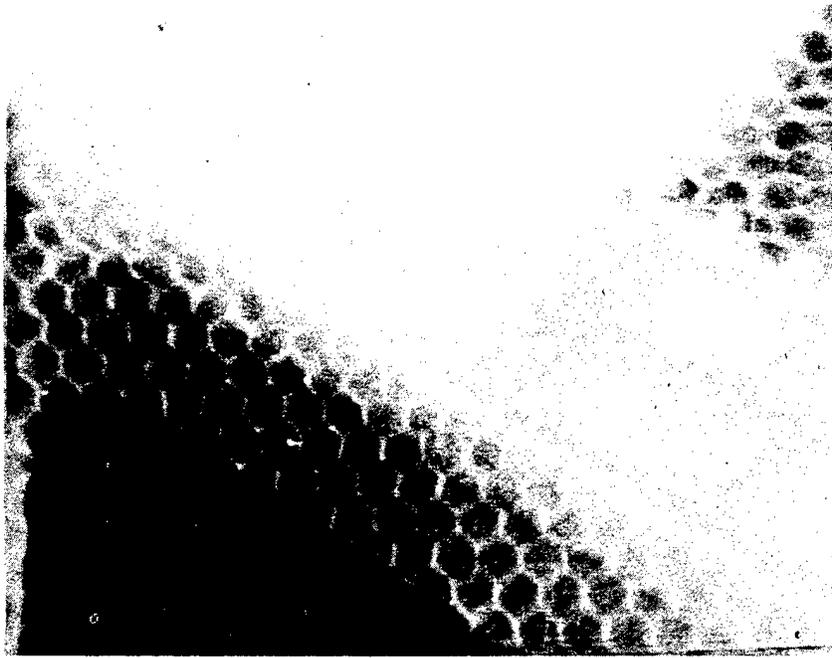
Figure 23. RTR of area H illustrating where the honeycomb is bonded to the aluminum honeycomb. The white areas indicate excessive adhesive (80kV, 4mA)

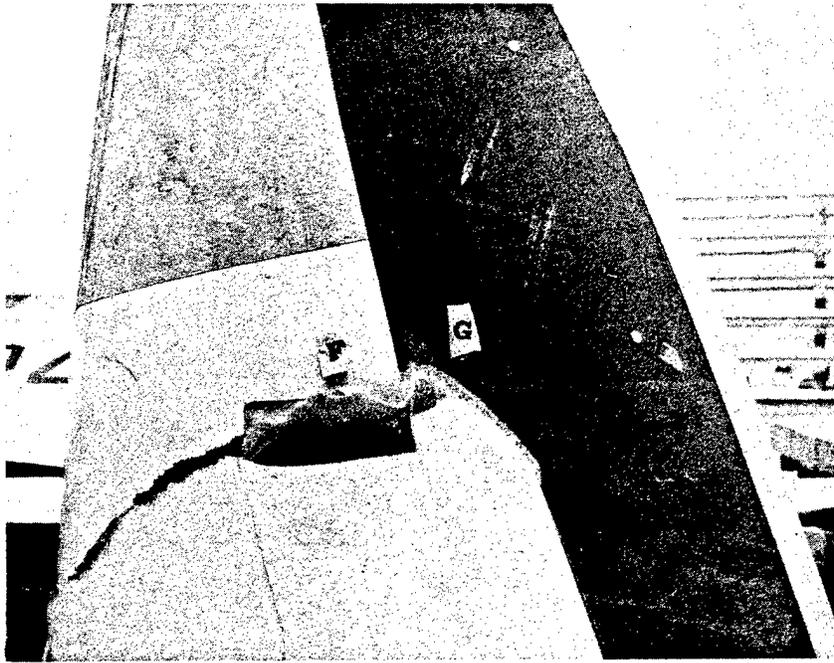
Figure 25. Damaged Fiberglass/Epoxy F-14 Radome containing a fiberglass honeycomb core

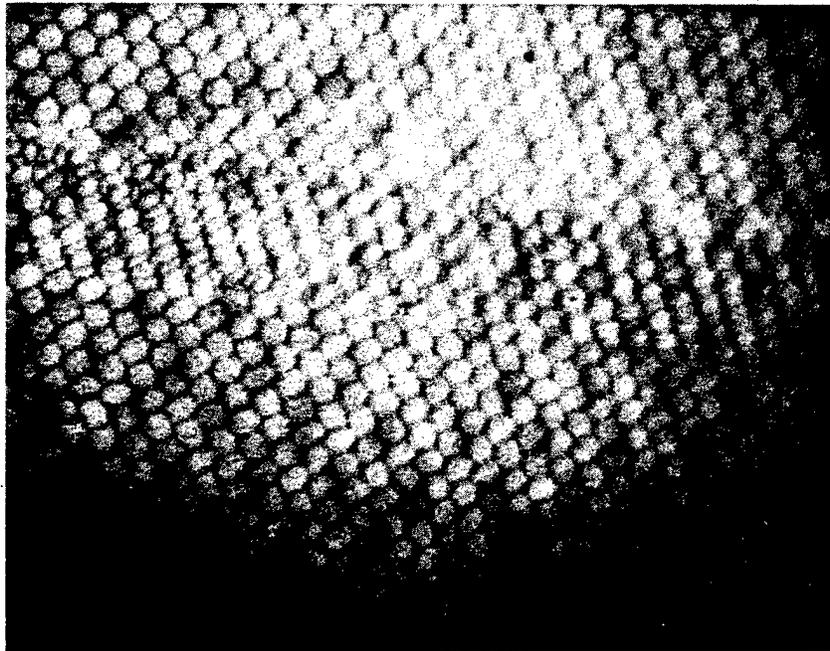
Figure 26. RTR of area F of the F-14 radome illustrating the cracks (white areas) and damaged honeycomb. The variations in the RTR indicate the porosity in the honeycomb. (60kV, 3.6mA)

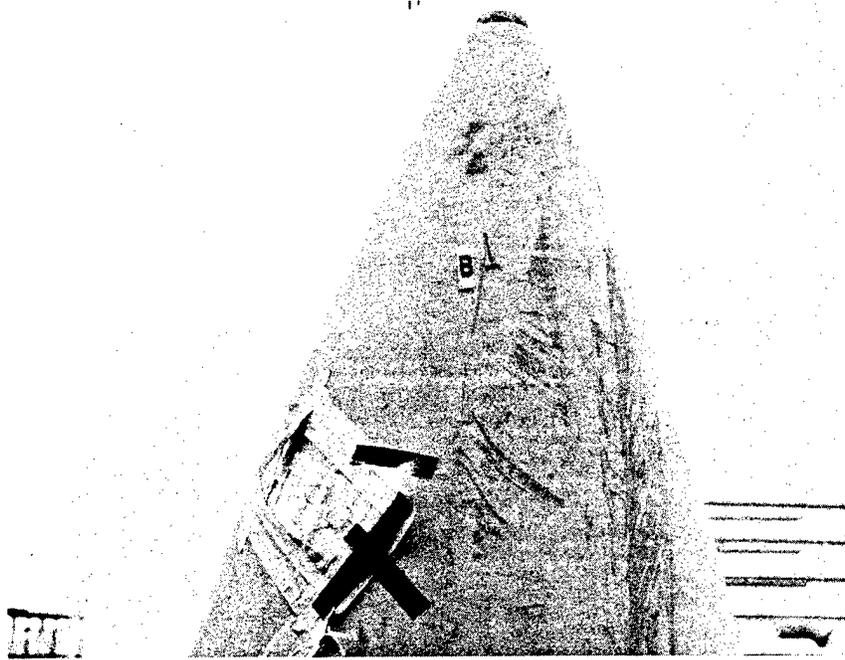
Figure 27. Damaged F-14 radome with a nick visible at area B

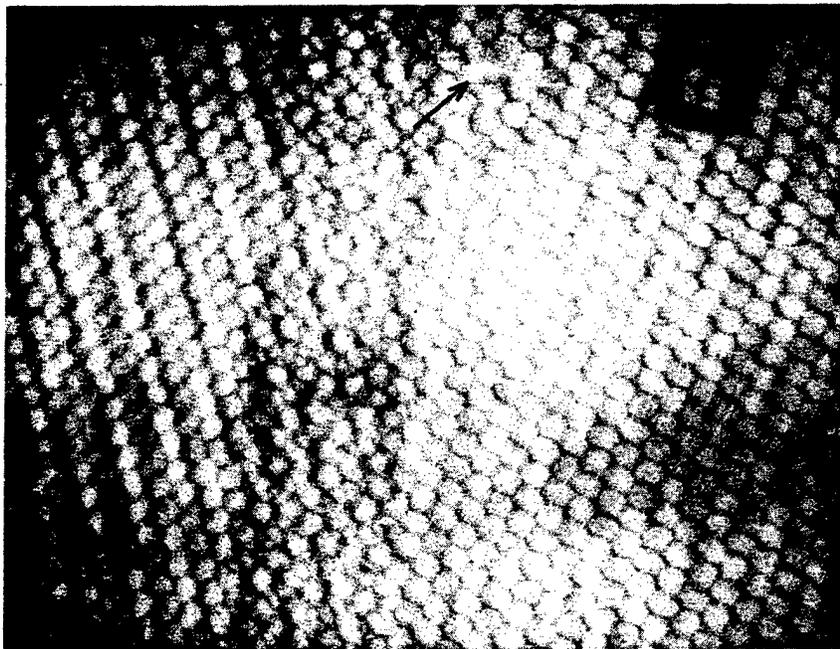
Figure 28. RTR of area B of F-14 radome illustrating the nick (60kV, 3.6mA)

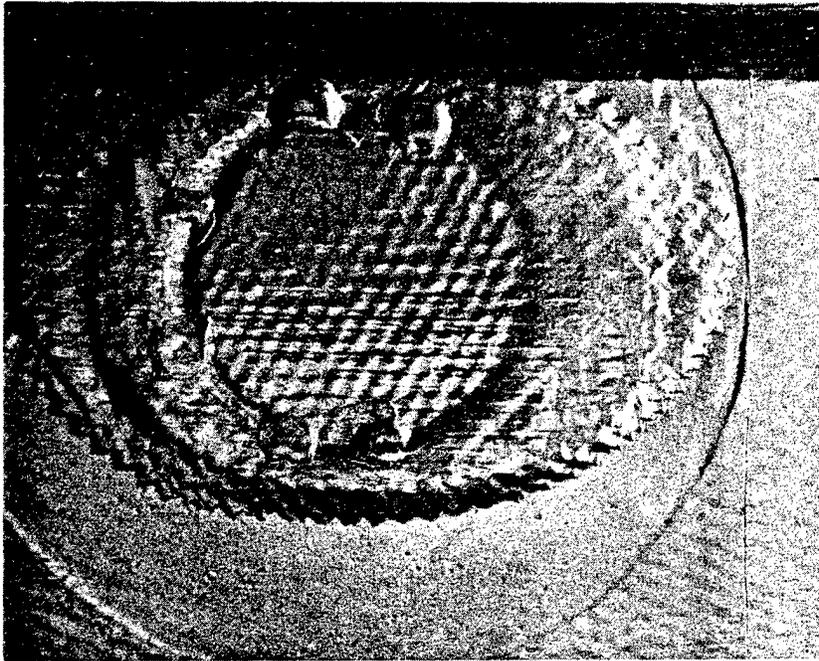
The last example inspected by direct RTR imaging was not for defects or damage, but repair verification. An S-3A spoiler recently repaired by the NARF, Alameda and NADC, Warminster was inspected at SAI to illustrate the feasibility of real-time radiography to image the repaired area and to inspect the splice of the core plug and also the core filter. Fig. 29 shows the repaired area of the graphite/epoxy S-3A spoiler. The RTR, Fig. 30, clearly illustrates the splice, plug, and filler. This radiograph illustrates another feature of the RTR system; the ability to electronically enlarge the image on the videomonitor. This was very advantageous when inspecting the splice and was shown to be superior to film radiographs, because of the ease of viewing the area. Therefore, utilization of RTR for this application would allow inspection to immediately verify the condition of the repair.

Figure 29. Repaired area of an S-3A graphite/epoxy spoiler

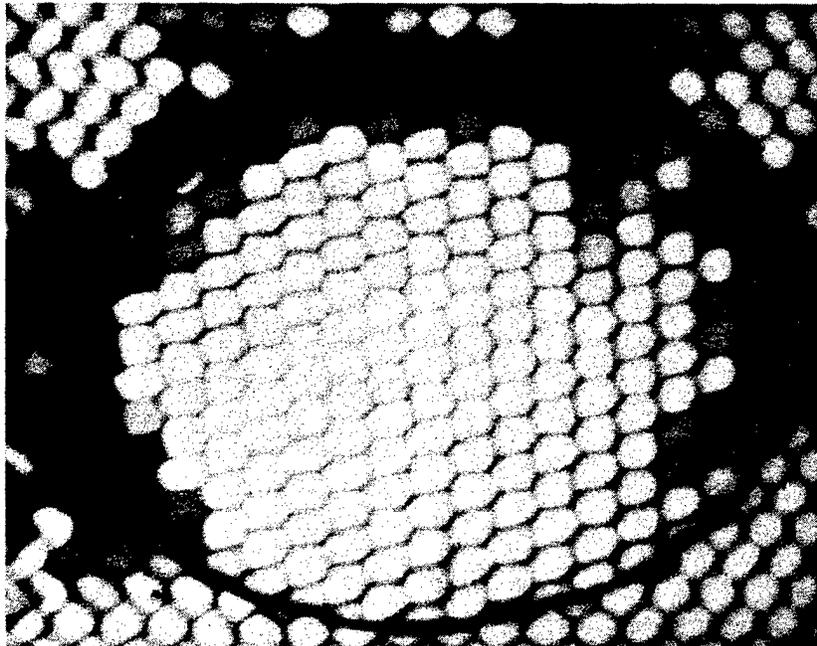
Figure 30. RTR of repaired area illustrating splice and filled core (70kV, 5mA)

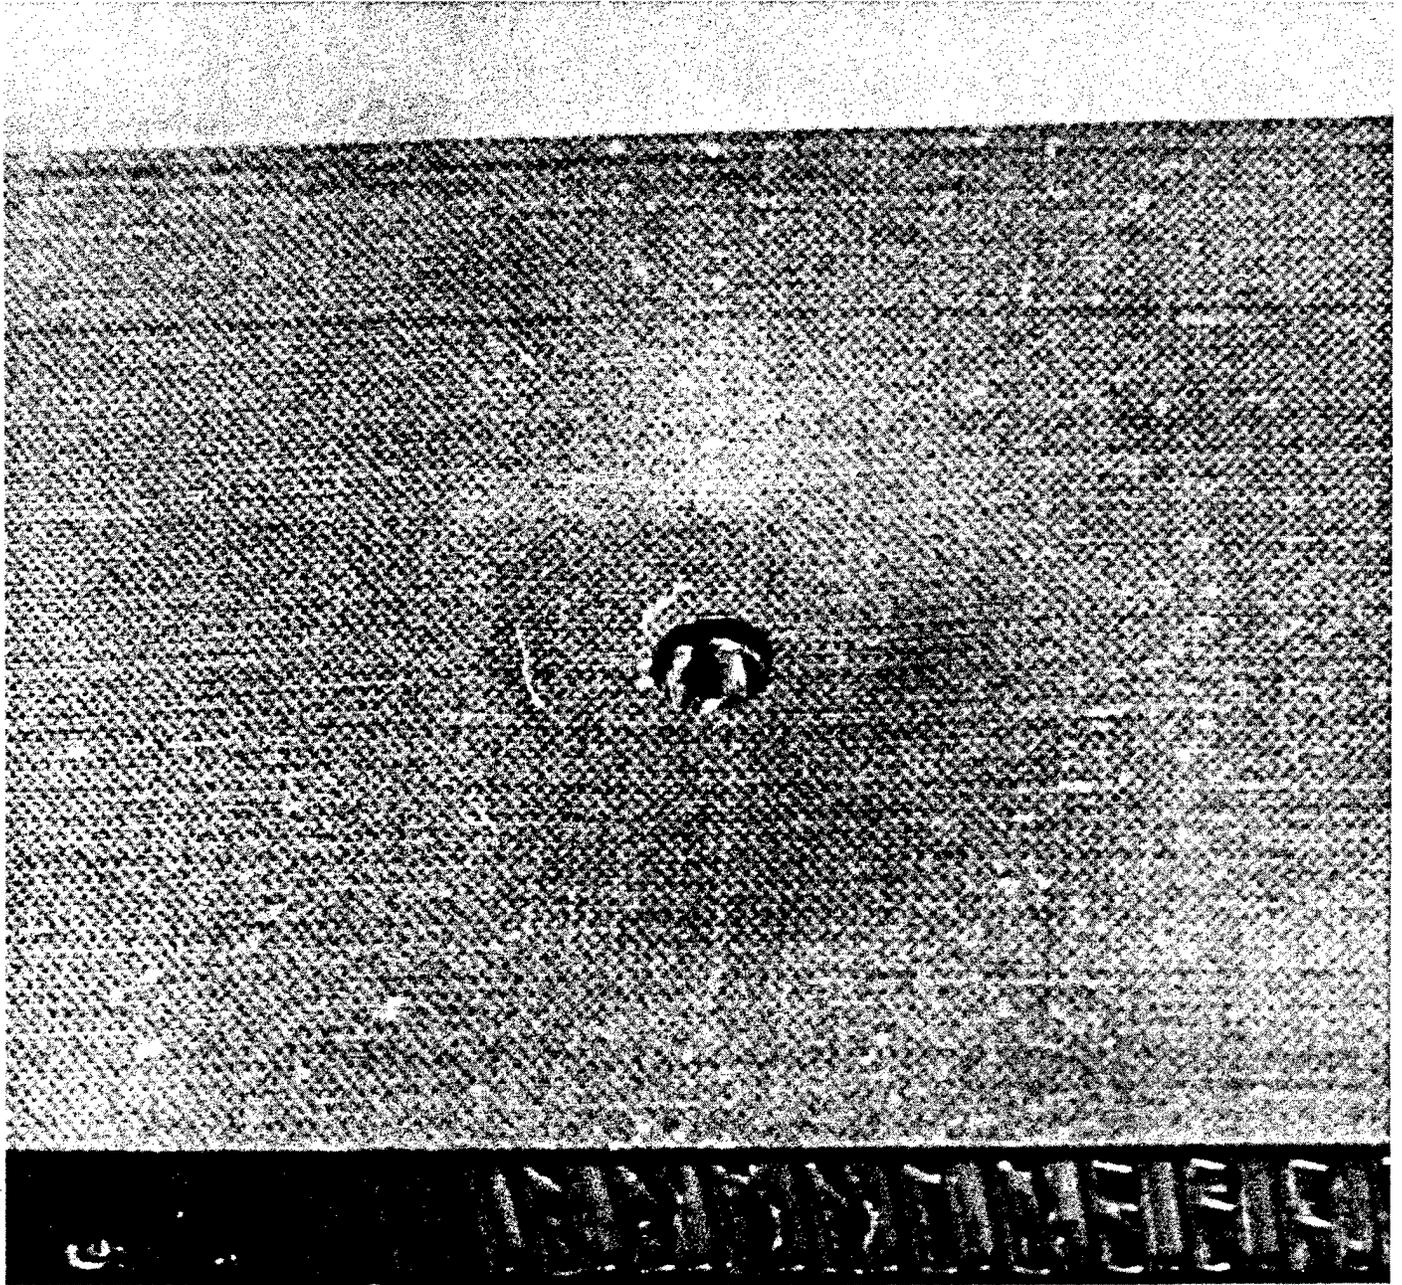
The first sample tested with the system is shown in Fig. 37. This is a graphite/epoxy sample with aluminum honeycomb that was hit with a hammer to produce debonds and delaminations. A 1/4 inch hole was then drilled and the penetrant was forced into the area. Figure 38, the RTR, shows where the liquid has flowed throughout the area illustrating debonds or delaminations. The next RTR, Fig. 39, shows an electronic video enlargement of the same area, showing areas where the liquid is not in the honeycomb, thus indicating that the liquid has flowed in between the graphite/epoxy layers.

Figure 37. Photograph of a section of a Graphite/Epoxy sample with aluminum honeycomb. It has been damaged by hitting the area with a hammer. A  $\frac{1}{4}$  inch hole has been drilled for the injector tip.

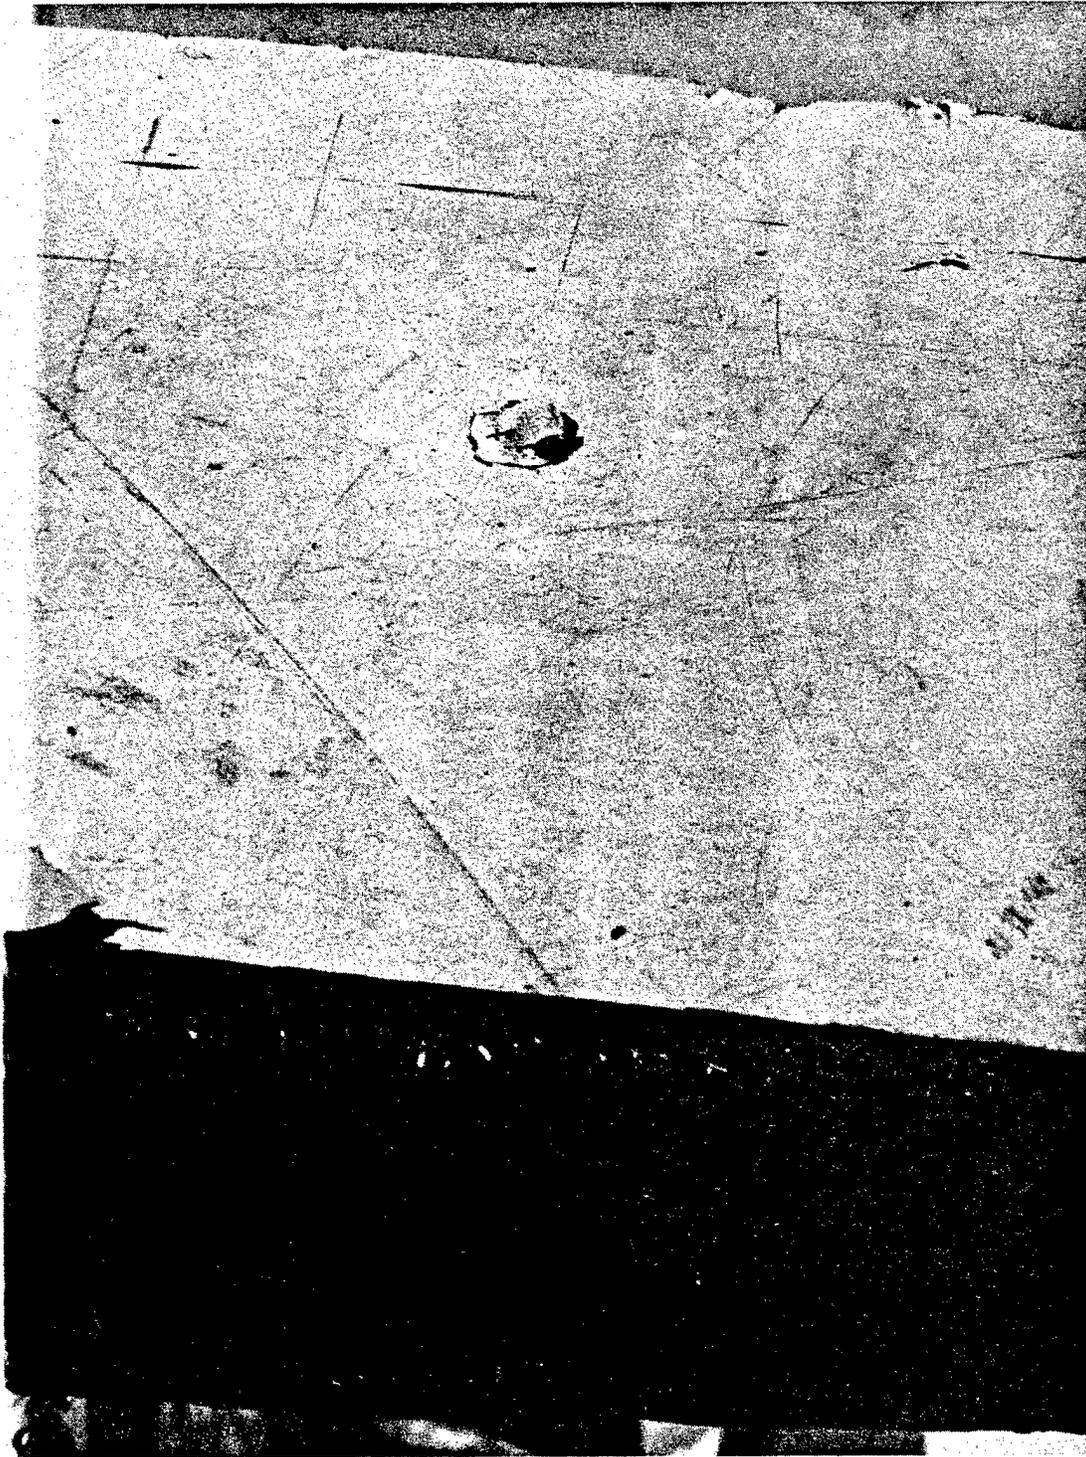
Another sample, a piece of an F-14 boron/epoxy horizontal stabilizer, Fig. 40 was hit with a hammer and injected with the penetrant to determine the extent of the damage. Figure 41 is an RTR of the area showing that there is no apparent physical damage to the structure. The light area in the radiograph is the 1/4 inch drilled hole. Figure 42, the RTR of the area with the penetrant, illustrates that the liquid has flowed throughout a much larger area than indicated by

Figure 40. Photograph of a small damaged area with a  $\frac{1}{4}$  inch drilled hole for the injector tip. This is a F-14 Boron/Epoxy horizontal stabilizer section.

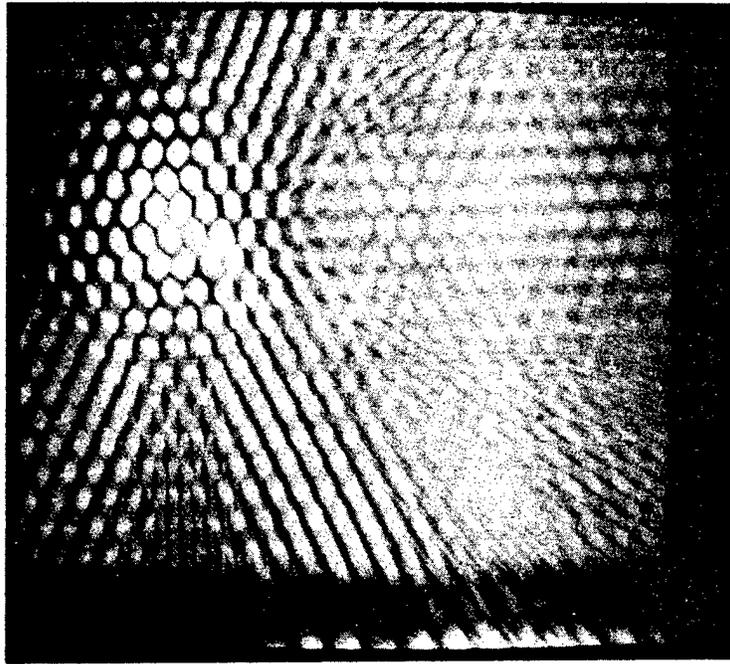
Figure 41. RTR of the damaged section, with no visible indication of damage. The light area is the  $\frac{1}{4}$  inch drilled hole (65kV, 5mA)
