Technical Report REMR-CS-53
April 1997

Repair, Evaluation, Maintenance, and Rehabilitation Research Program

Applications of Roller-Compacted Concrete in Rehabilitation and Replacement of Hydraulic Structures

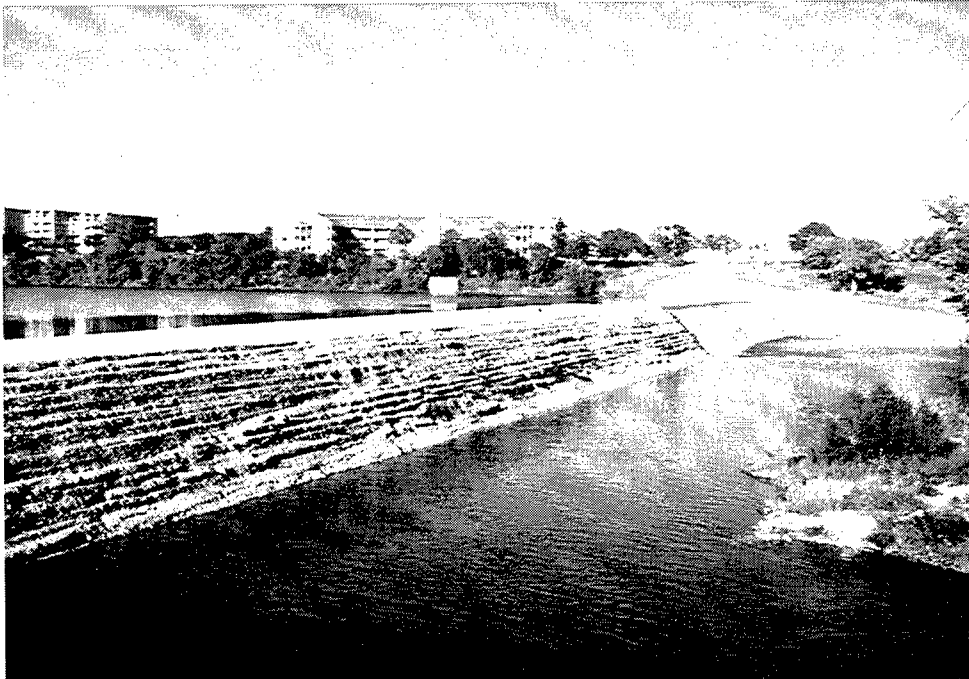
In October 1985, about a month following completion of RCC placement, a 279-mm (11-in.) rain caused a once-in-50-years flood. The new RCC gravity section was overtopped by 4.4 m (14.4 ft), and the emergency spillway by 4.1 m (13.4 ft). At its crest, the flood reached a flow of 3,540 cms (125,000 cfs) over the dam (*RCC Newsletter* 1986). Water flowed over the entire dam for about 5 days and over the service spillway for 3 weeks. An inspection of the dam following the flood revealed significant erosion in the uncompleted earthen abutments; however, damage to the RCC was limited to some minor surface spalling (Figure 11).

Figure 11. Condition of the RCC following overtopping, Kerrville Pounding Dam

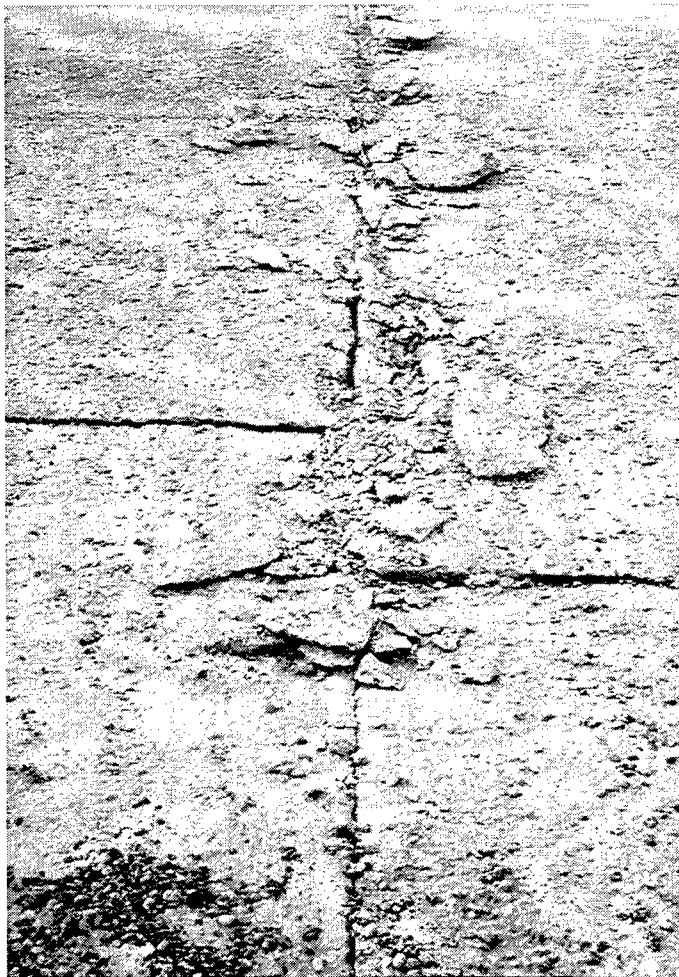
In general, depth of spalling was a maximum at a crack or joint and decreased to a featheredge within 0.3 to 0.6 m (1 to 2 ft) perpendicular to the crack or joint (Figure 16).

Figure 16. RCC spalling along a joint, Addicks Dam

Typically, spalling of this type is caused by excessive stress concentration resulting from debris lodged in the crack or joint or an improper joint. Spalls of this type usually start as delaminations.
