Technical Report CHL-97-5
March 1997

Monitoring Completed Navigation Projects Program

Burns Harbor, Indiana, Monitoring Study

Volume I: Overview of Approach and Results

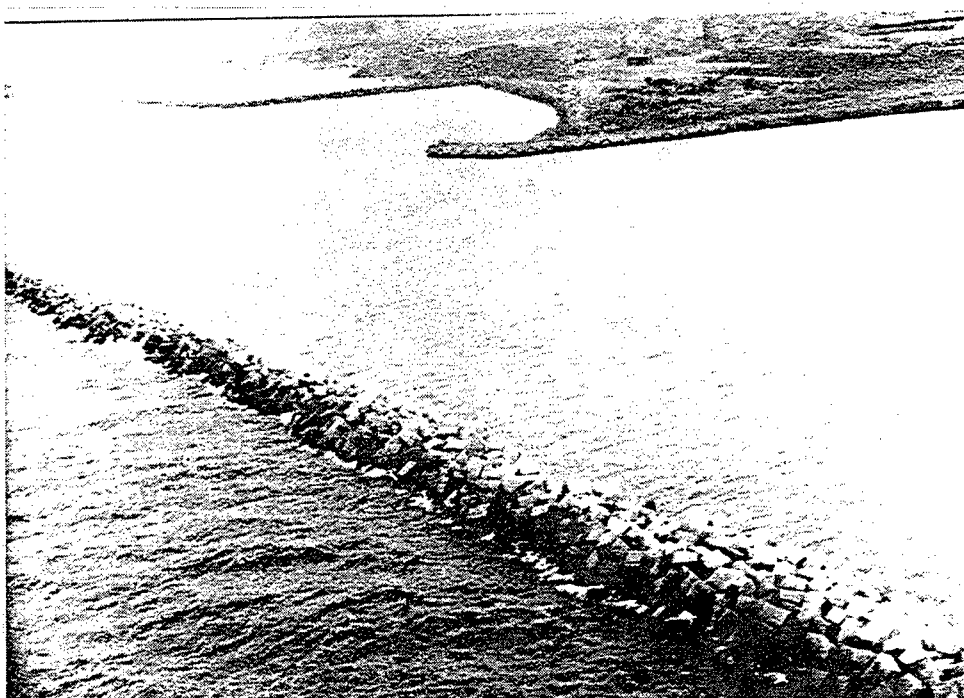
b. 1987 lakeside view

Figure 5. Views of armor layer

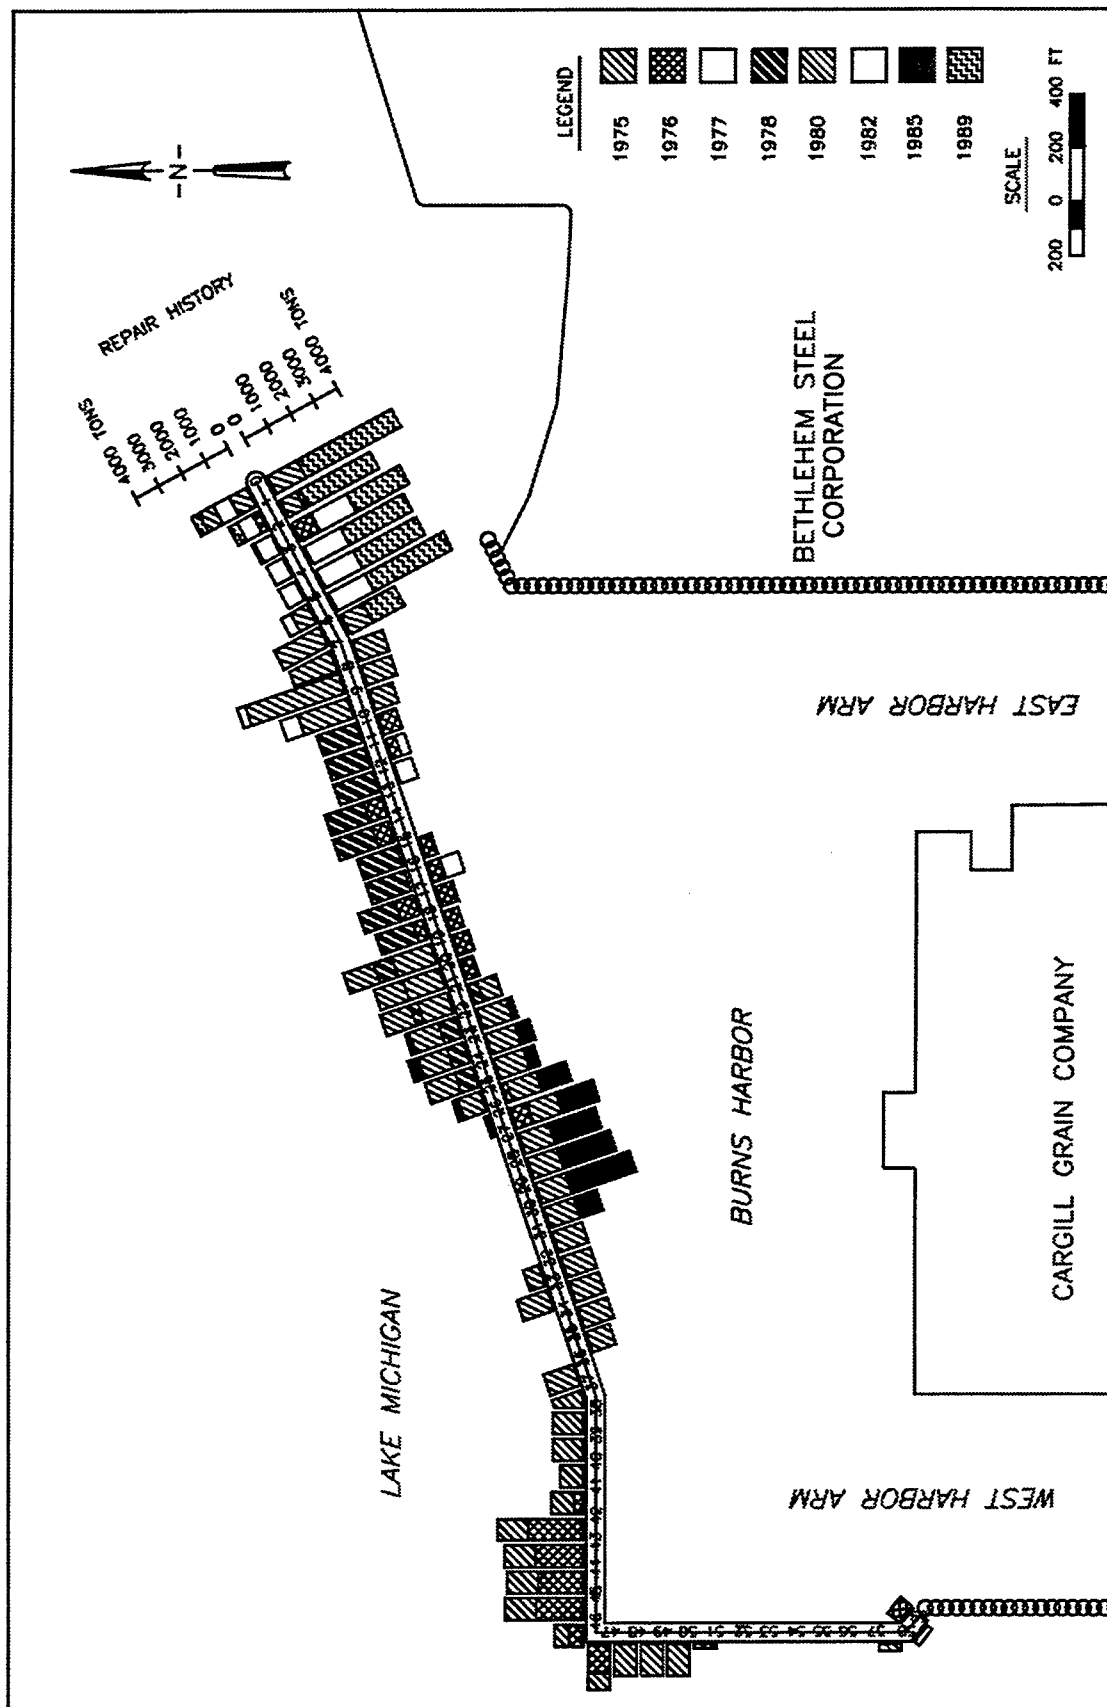
Figure 14. Breakwater repair history

Repairs of armor stone on both the lakeside and harborside were scheduled for the next 5 years, commencing in the summer of 1975. A report of inspection by the NCC District Geologist in July of 1975 declared the structure to be in better than expected condition, but the following summer, the IPC was repeating its request for repair work. A pattern of damage and repair continued through the 80's, with some sections receiving repeated maintenance. Figure 14 records the history of repairs by year, tonnage, and location. Amounts of repair stone placed each year and cumulatively are provided in Table 2; the total is 78 percent of the original armor amount. The maintenance stone placed on the breakwater, except for the 1989 repair, was limestone with a specific weight of 145 pcf. The 1989 repair utilized quartzite with a specific weight of 175 pcf. Figure 15 is a time line providing an overview of wave conditions (from WIS) and major events in the history of the structure.

Table 2 Annual and Cumulative Repair Stone Placed, Tons			
Year	Harborside	Lakeside	Total
1975	2,028	14,703	16,731
1976	6,463	10,555	17,018
1977	1,373	8,904	10,277
1978	0	14,345	14,345
1980	20,944	26,385	47,329
1982	6,957	0	6,957
1985	11,083	750	11,833
1989	19,477	1,150	20,627
Total	68,325	76,792	145,117

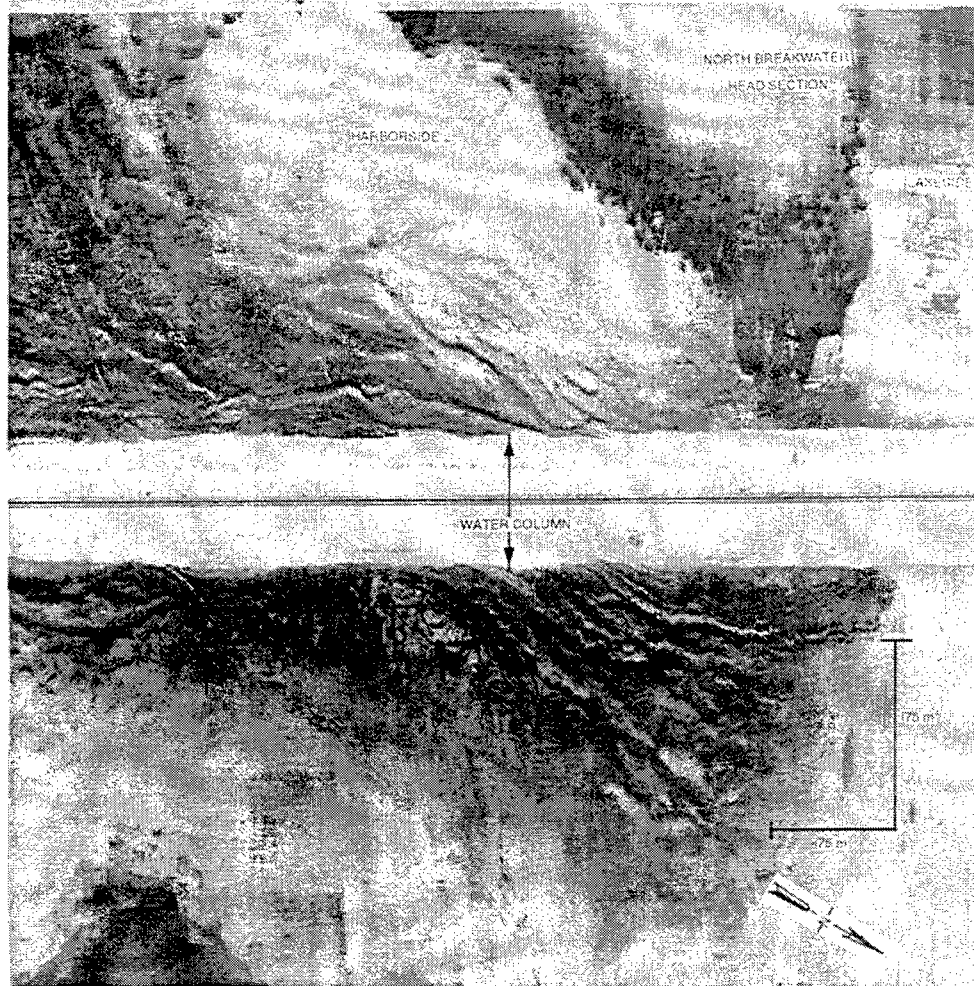
Figure 21. SSS record of scour features at harbor entrance

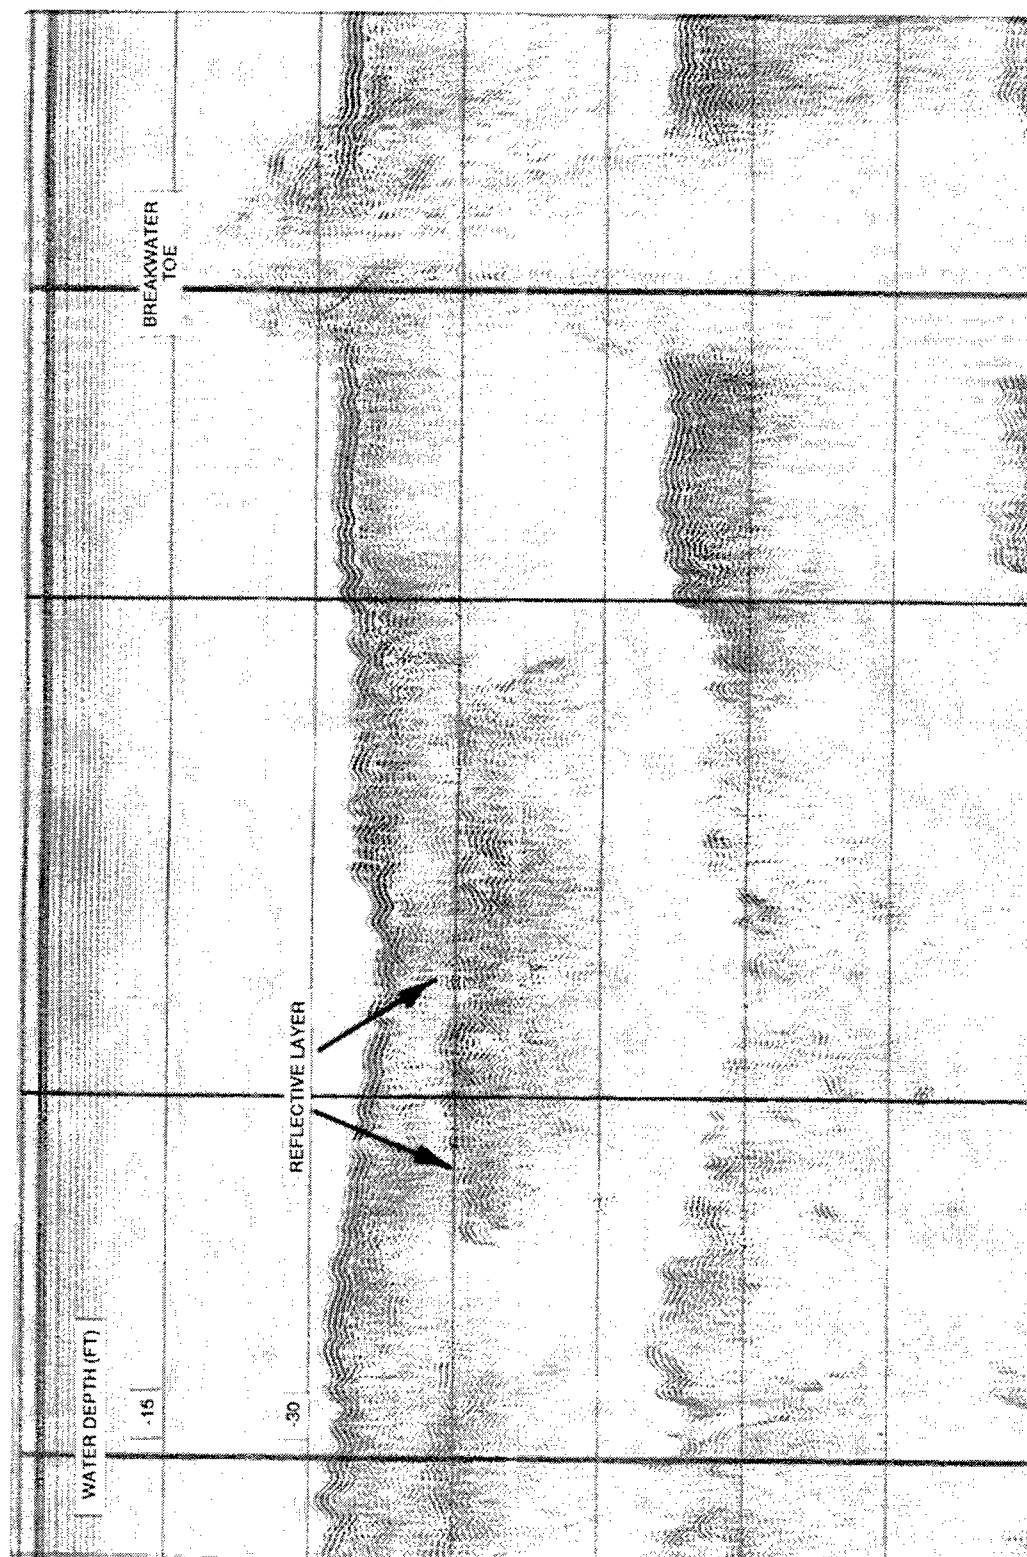
In contrast, line 6H (Figure 24), which traverses the entrance channel, indicates a harder layer 7-10 ft below the lake bottom, or at -45 ft. Approaching

the structure slope, some reflectors are visible below the upper mud layer, indicating stone projects further out than the visible toe at -32 ft.

Figure 24. Subbottom sonar sonogram, line 6H

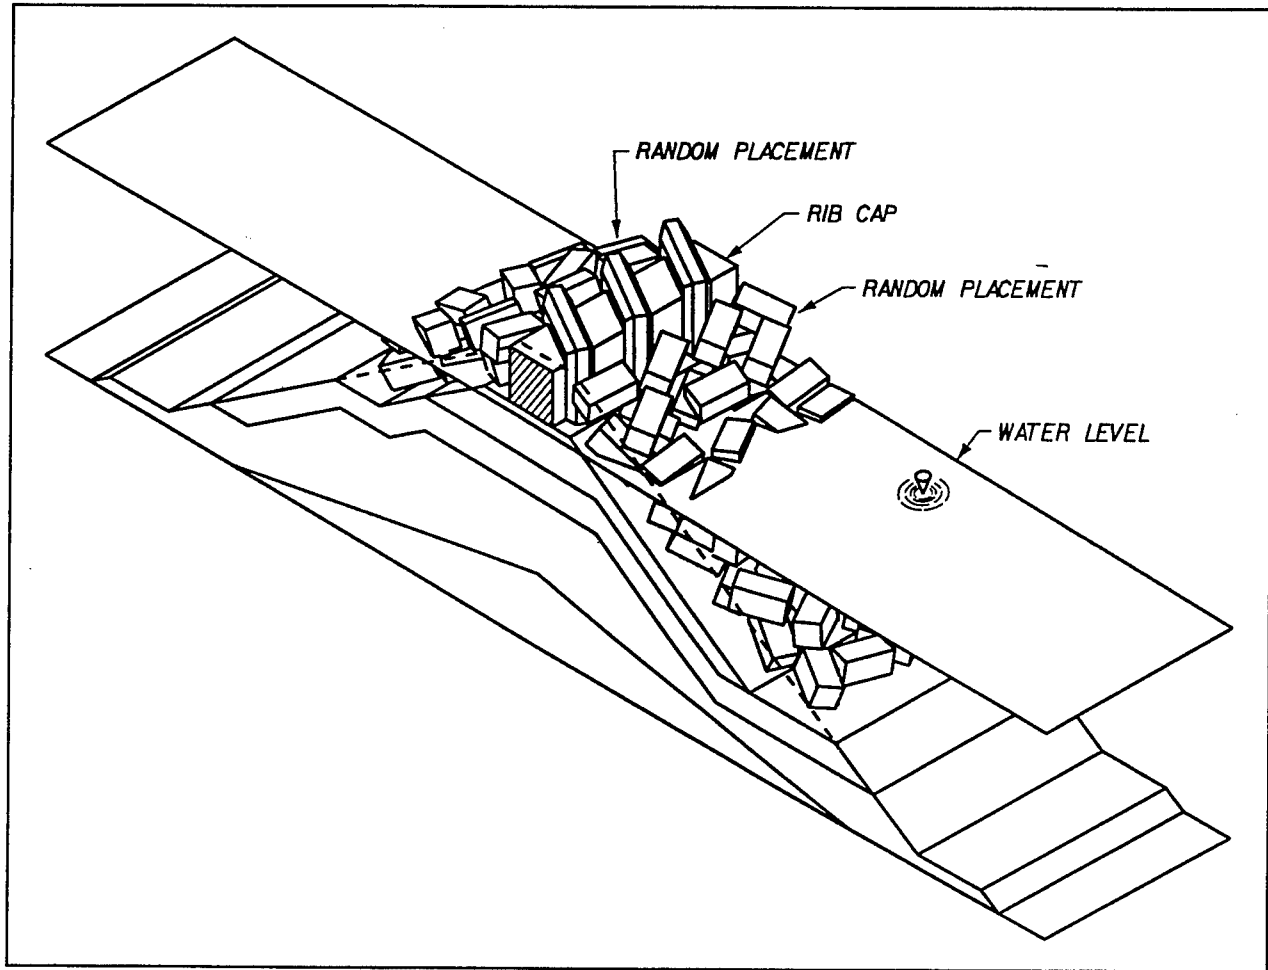
Figure 37. Illustration of rib cap

- b. Seal the structure. Some options are available to tighten the structure by sealing voids with grout or asphalt. The long-term durability of these options is not well-known. It is possible that the existing armor

could be repositioned to achieve lower porosity, but those options are effectively restricted to the subaerial portion of the structure because they cannot be practically accomplished below the waterline.
