# ENGINEERING TEST REPORT

ETR - 924

TITLE: Test Results of the RAH-66 Main Rotor Ballistically Damaged Flexbeam  
DATE: 4 August 1997  
A/C SERIES: RAH-66  
A/C MODEL: RAH-66 Prototype  
SYSTEM: Main Rotor  
CHARGE NO: CB571-300  
CONTRACT NO: DAAJ02-97-M-0001

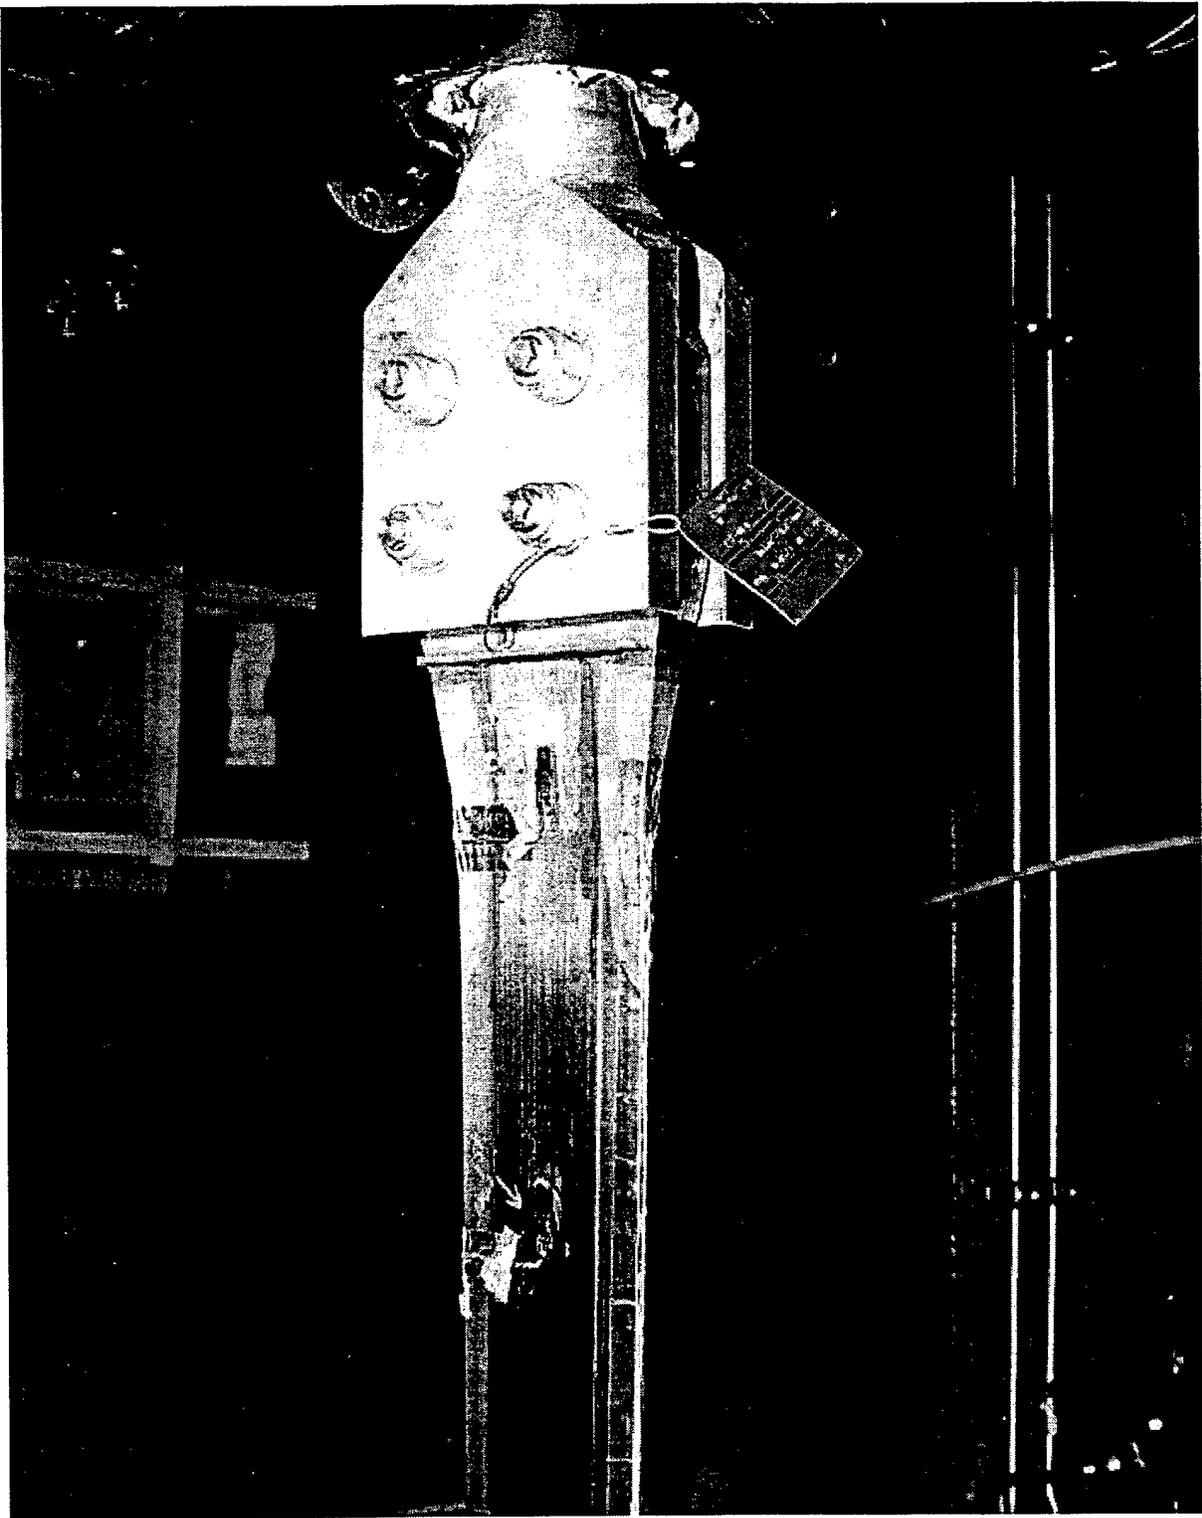
During the first test level, the crack propagated 7.5" outboard to a total length of 38". A second crack parallel to the first started and propagated 8.7" inboard and 34.4" outboard to a total length of 43.1"

Pictures of Ballistically Damaged Flexbeam  
after Completing First Load Level Testing
