**EB CURING OF VARTM FABRICATED MARITIME
COMPOSITE STRUCTURES**

Contract USZA22-97-P-0013
CDRL A002

September 19, 1997

DAMILIC Corporation
14670 Southlawn Lane
Rockville, MD 2085

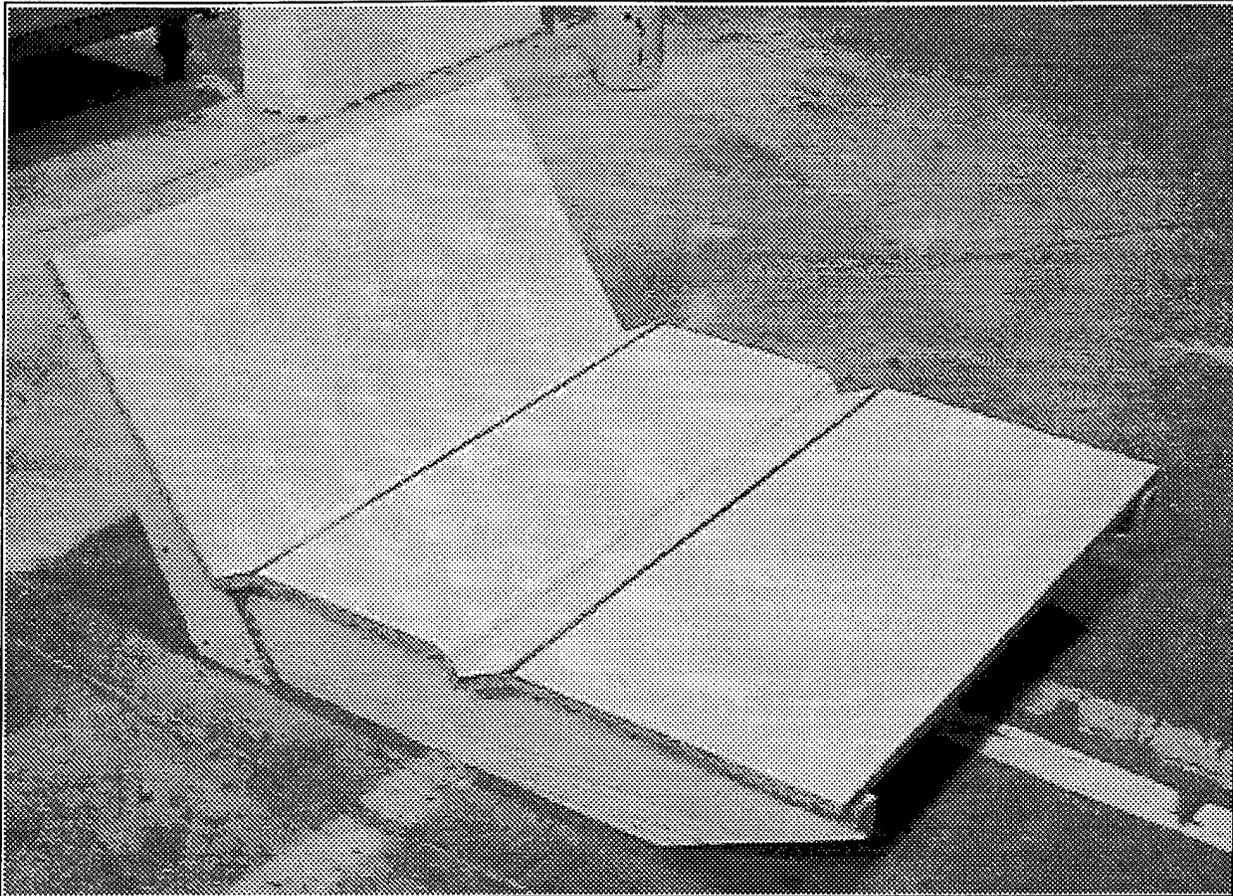
Because EB cures can be achieved at room temperature, no special consideration for high temperature operation was included in the tool design and construction. Unfortunately, the elevated temperature (ref. Figure 7), resulting from exothermic reaction during cure, exceeded the rated operating temperature of the epoxy fillet. This resulted in loss of vacuum during the EB cure, exacerbating the part's delaminations, and some local contamination of the hull outer surface with epoxy. This particular tool will require some minor rework for additional use. However, the use of a more appropriate epoxy would render this tool reusable for many production runs.

Figure 4: Tool was constructed of wood and Formica.

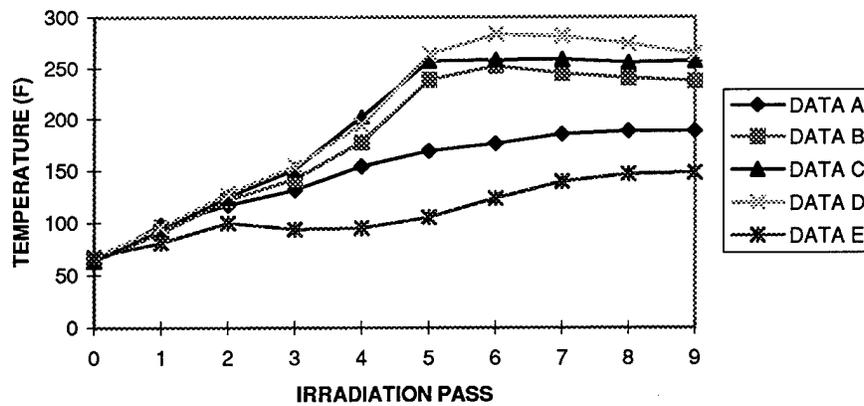
Figure 7: Temperature of thermocouples imbedded in part following each irradiation pass.

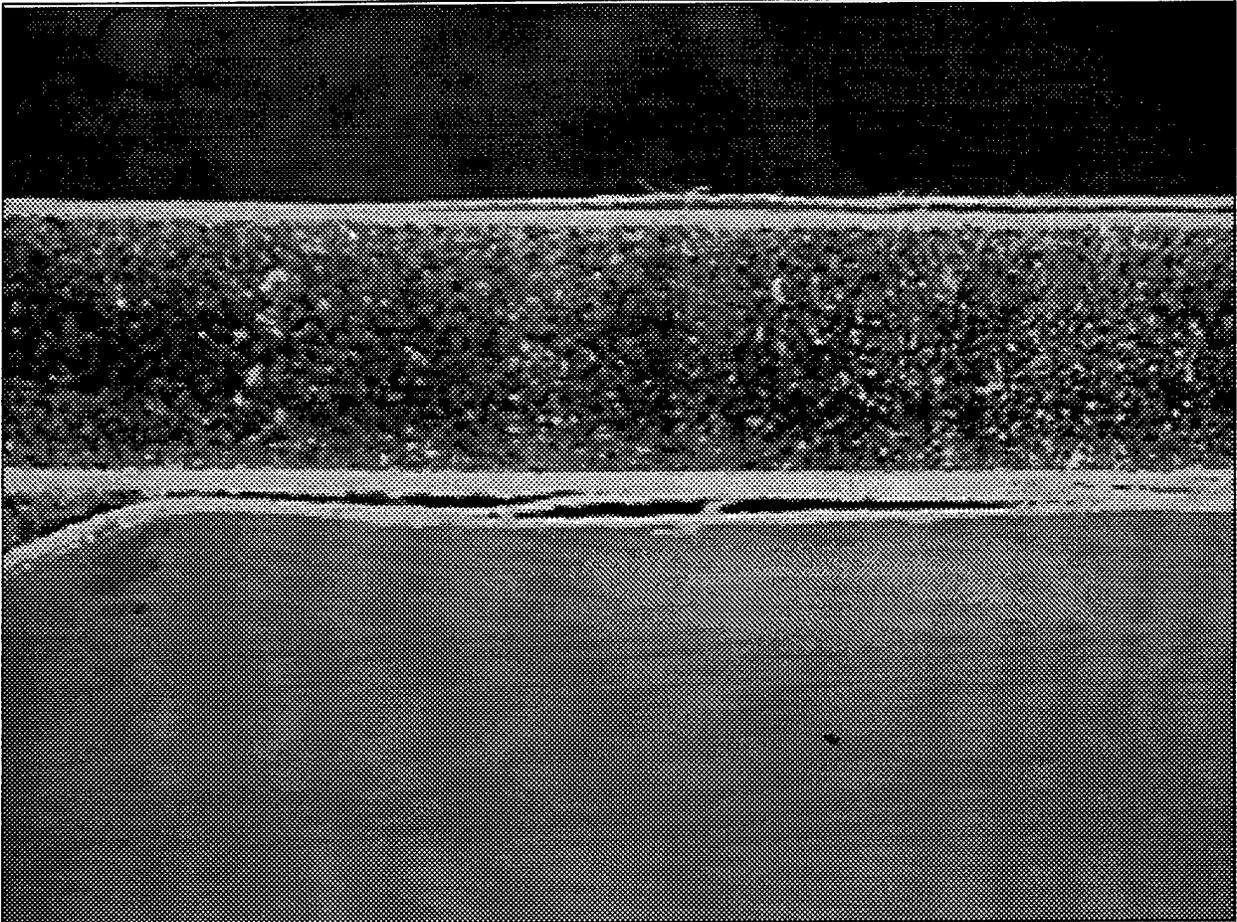
- 1) An elliptical area approximately 5" x 10" between the individual Kevlar fabric layers on the inside surface of the hull (i.e. the side with the longitudinal support structure) was observed immediately after removing the part from the tool. This is the upper delamination shown in Figure 9.

2) A 5" x 18" area roughly rectangular in shape between the hull plies and the strake over-plies (between spray strake and boat side). This is the lower delamination shown in Figure 9.

Figure 9: Both delamination and stains from the tooling were observed.

The cause of the delamination appeared to be a lack of proper wetting. Samples of fiber were removed for microscopic evaluation. Optical inspection was not more conclusive, so further magnification to 2000 X using a scanning electron microscope confirmed insufficient wetting in the region of delamination (Figure 10), while the sample from a region having no delamination exhibited complete coverage of the fibers with resin (Figure 11).

- 1) Thin gel coat gave the appearance of several scratches.
- 2) A variety of discolorations that are typical of EB curing were also observed, particularly in the foam core. However, there is no apparent change in color for the cosmetically important gel coat finish.
- 3) Regions of radius formed by the tooling have epoxy on the gel coat surface as described on page 7 (see Figure 9).

Although the final EB cured part did exhibit several flaws, they appear to be unrelated to the EB process. In fact, our evaluation of the delaminations and the general imperfections strongly indicate that minor refinement of the resin lay-up and infusion process would remove all of the observed problems. Further, it is believed that simple modification of the resin formulation could result in a reduction of dose, a reduction of the styrene content, and an improvement in the performance properties of the matrix.

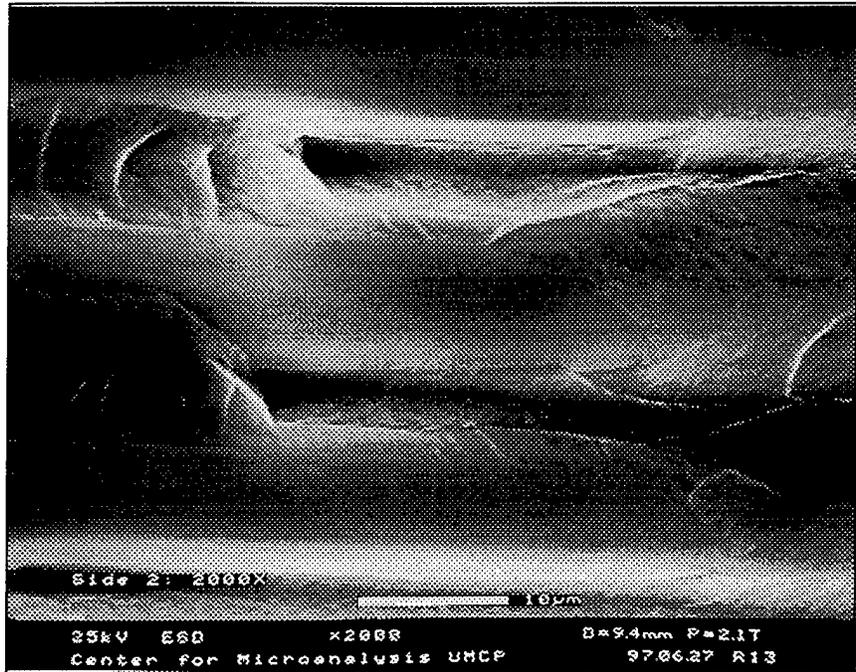
Figure 10: Fibers in region of delamination show lack of resin coverage.

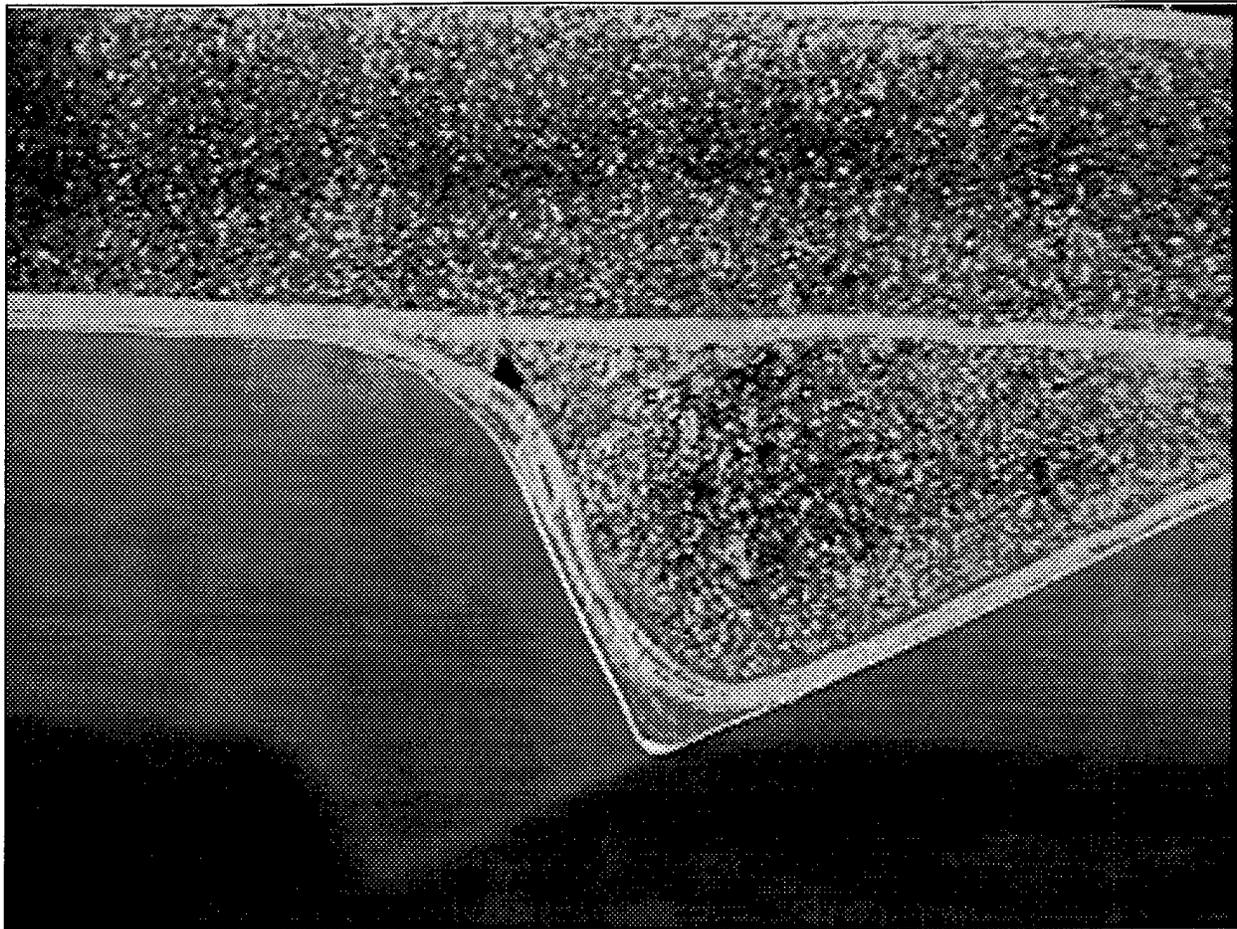
In addition to the regions of delamination, there are voids between the foam core and adjacent plies at the strake (see example in Figure 12) and longitudinal support. All regions with voids and delamination appear to be resin starved.

Figure 12: Void in the spray strake
