Technical Report CHL-97-17
August 1997

Periodic Inspection of Humboldt Bay Jetties, Eureka, California

Report 1 Base Conditions

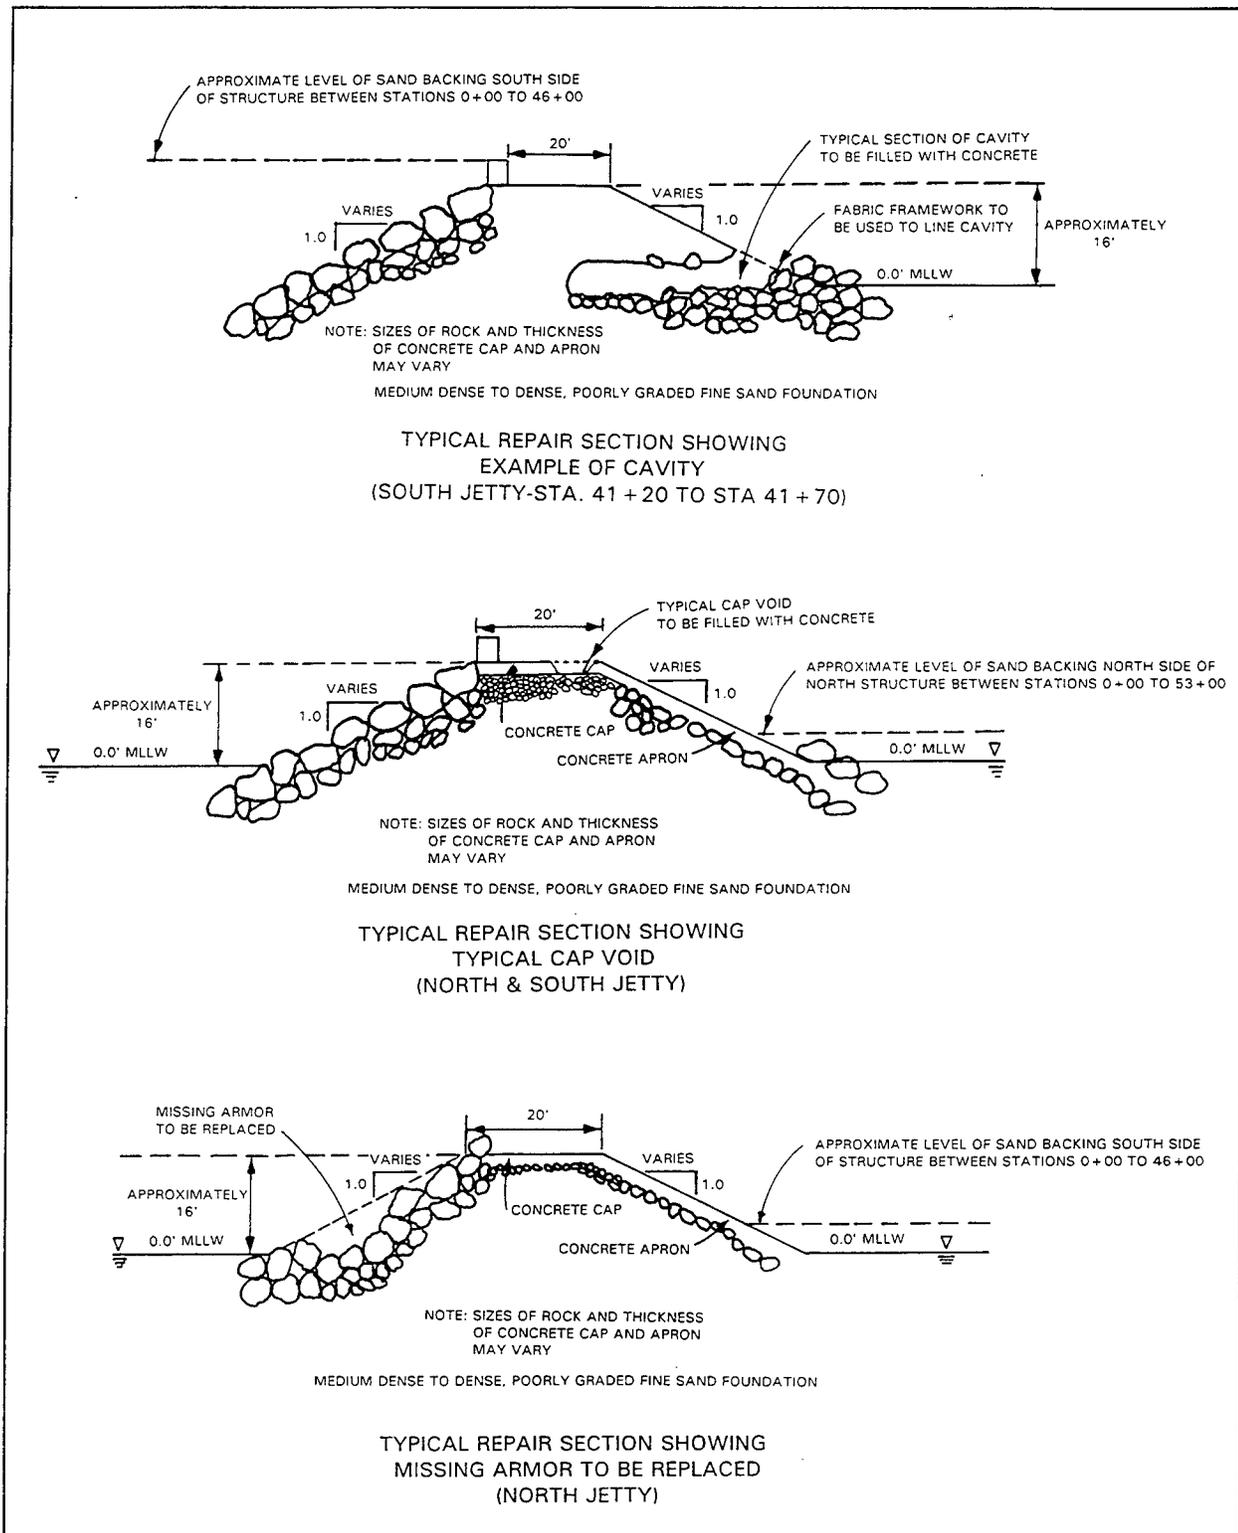
In 1988, substantial repair work was done on both of the jetties. Repairs involved the use of approximately 181,440 kg (2,000 tons) of stone for slope repair and 765 cu m (91,000 cu yd) of concrete for the filling of voids in the structure (USAED, San Francisco 1988). Figure 5 shows typical repairs made in 1988, and Figure 6 provides a plan view of Humboldt Bay, the jetty structures, and the navigation channels as of December 1994.

Figure 5. Typical repairs made to jetties in 1988

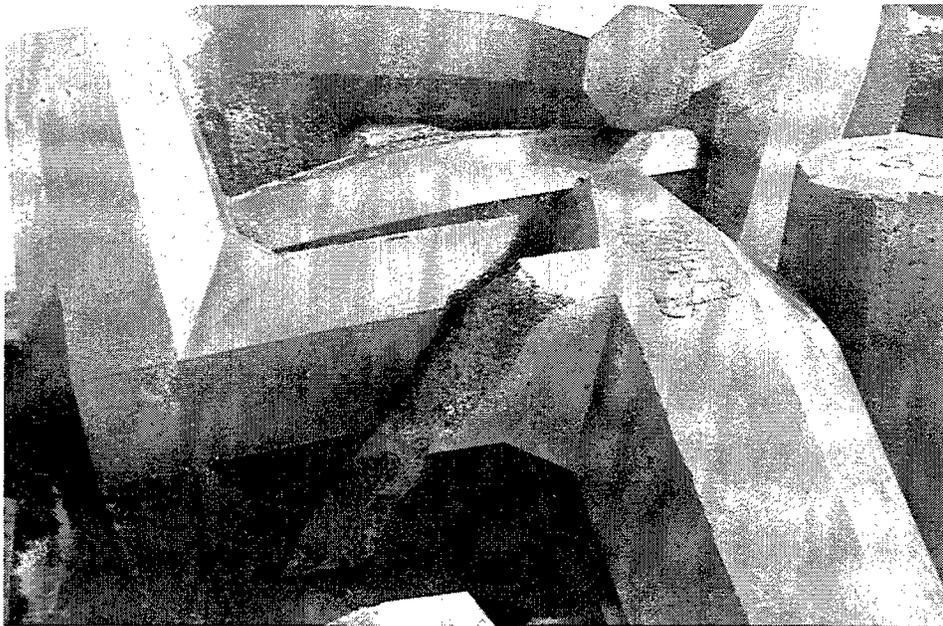
Figure 17. Dolos with angled, mid-shank break

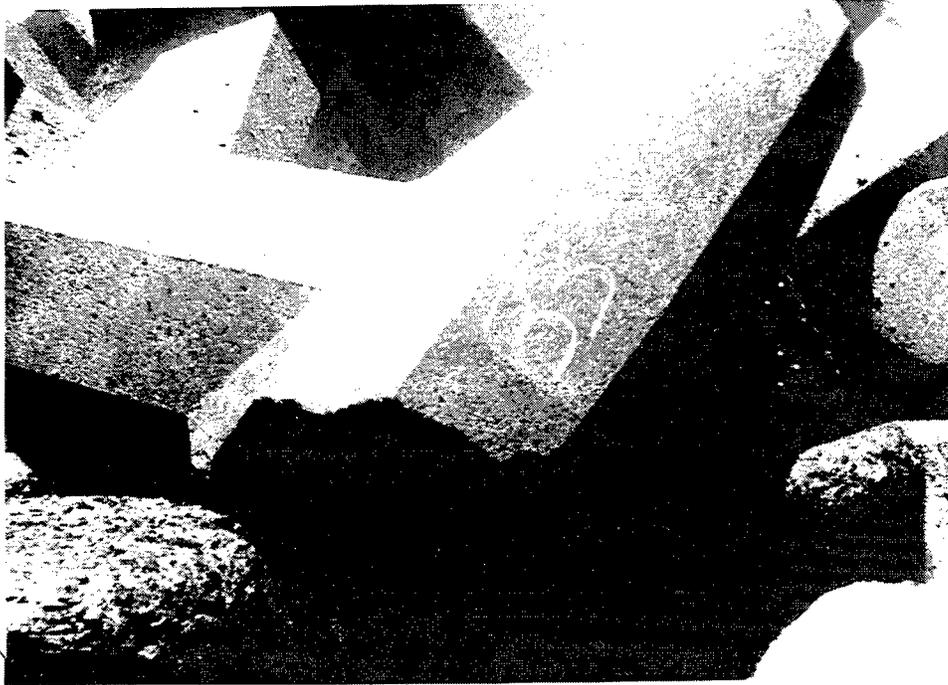
Figure 19. Dolos with straight fluke-shank break

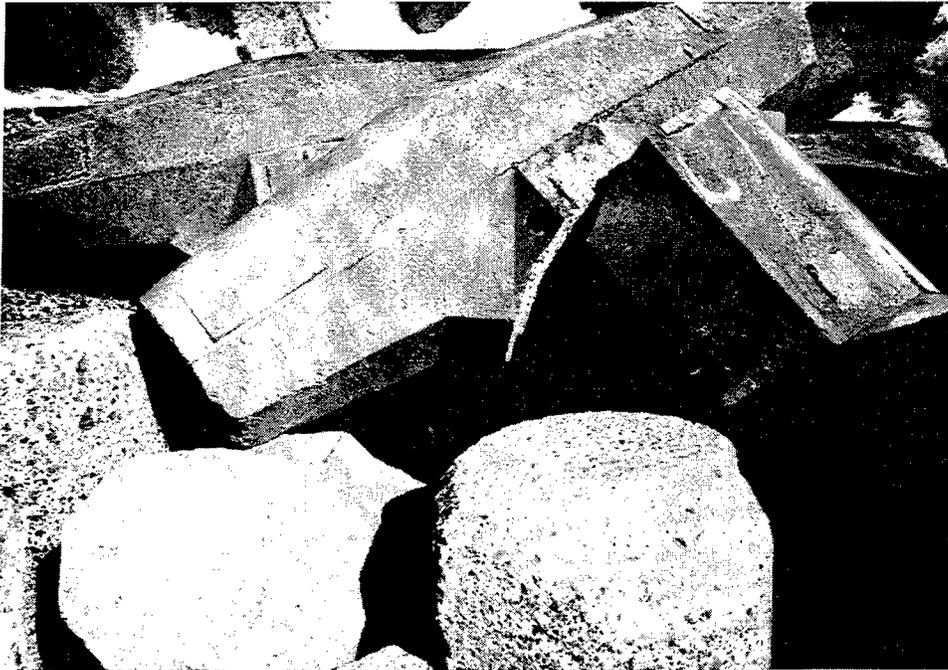
Figure 20. Dolos with straight, shank-fluke break

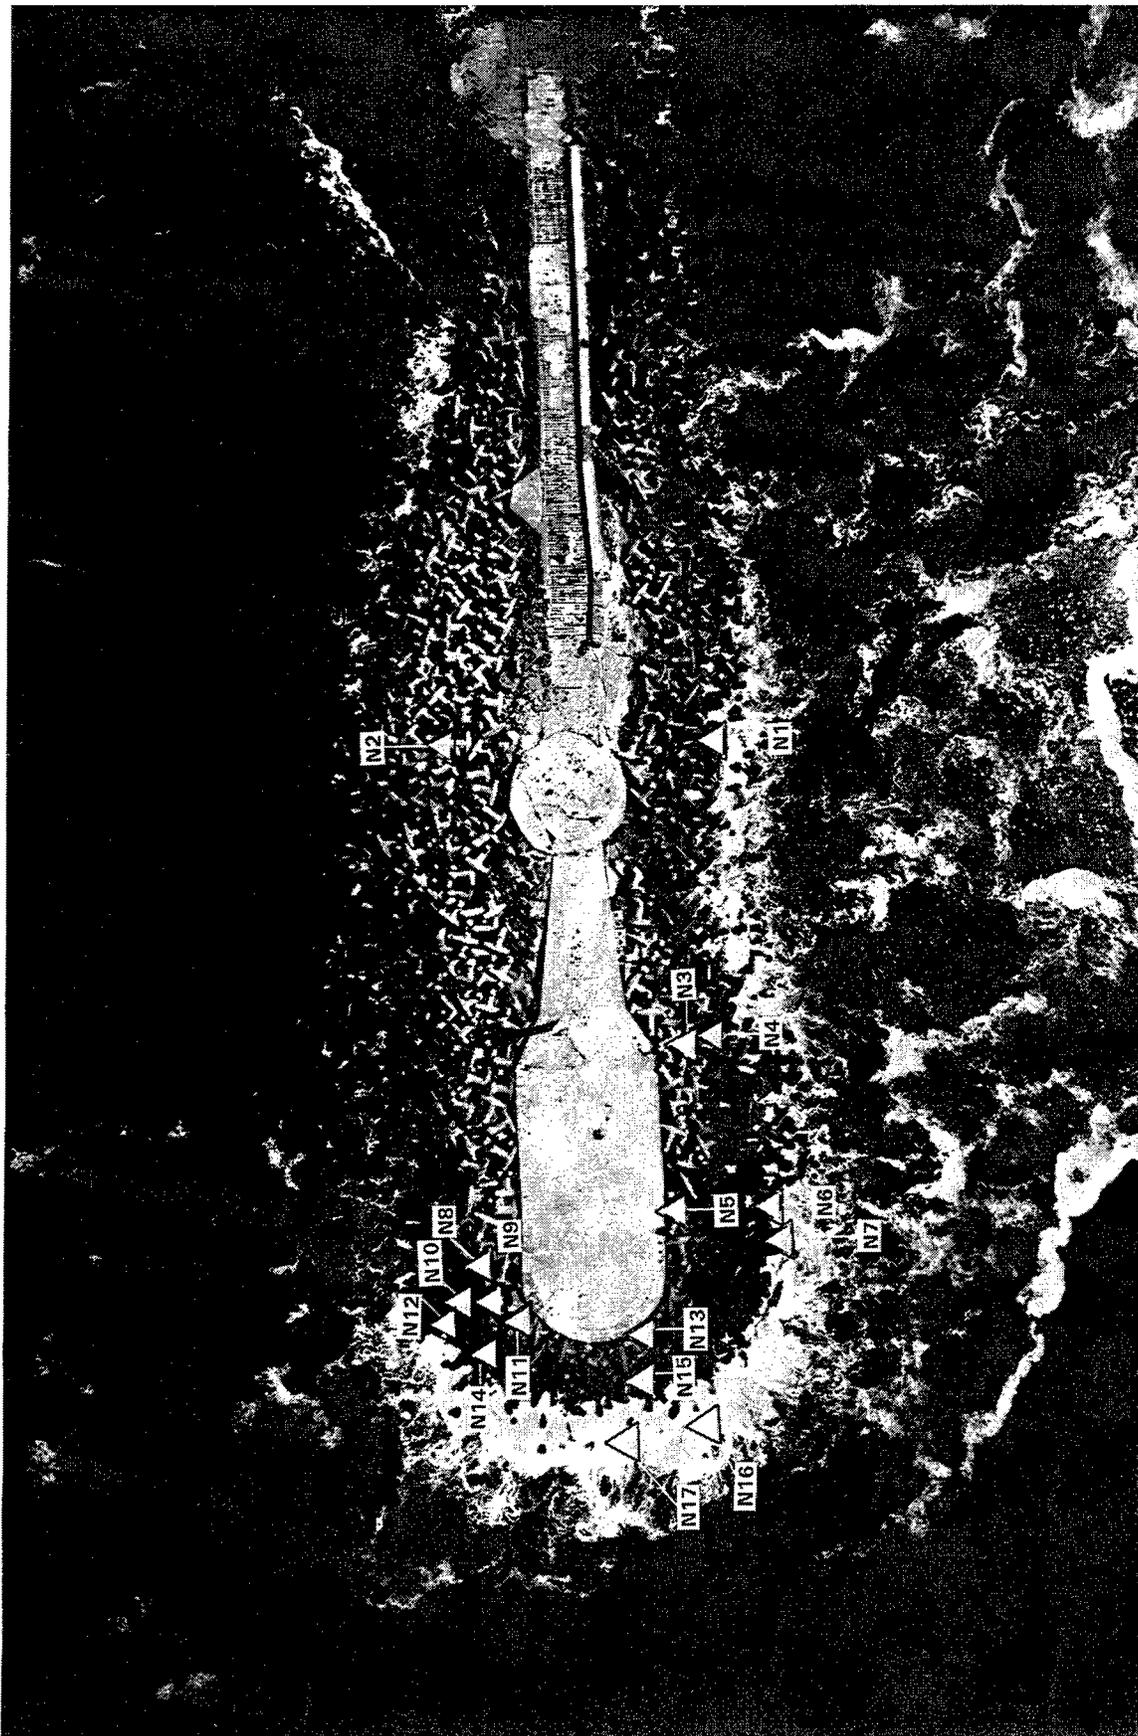
Approximate locations of the broken/cracked dolos armor units are shown in Figures 21 and 22, respectively, for the north and south jetties; and detailed data obtained during the broken armor unit inventory are shown in Table 4. Armor unit numbers identified in Figures 21 and 22 correspond to those listed in Table 4. As shown on the figures, broken units are concentrated along the seaward ends of the jetties. Eighty-eight percent of the broken units on the north jetty and seventy-one percent of those on the south jetty are located around the monolithic structures at the jetty heads. In addition, more broken dolosse were observed on the south sides of the structures than on the north. If the approximate center lines of the jetties are projected seaward along the axes of the structures, 59 percent of the broken units on the north jetty and 65 percent of those on the south jetty are located on the southern side of the jetties. With regard to distance downslope from the jetty caps, most the broken dolosse appear to be located in the active wave zone. Detailed data obtained during the broken armor unit survey will allow for an accurate indication of new breaks when the structure is revisited at some point in the future.

Figure 21. Approximate locations of broken/cracked dolos armor units on the north jetty

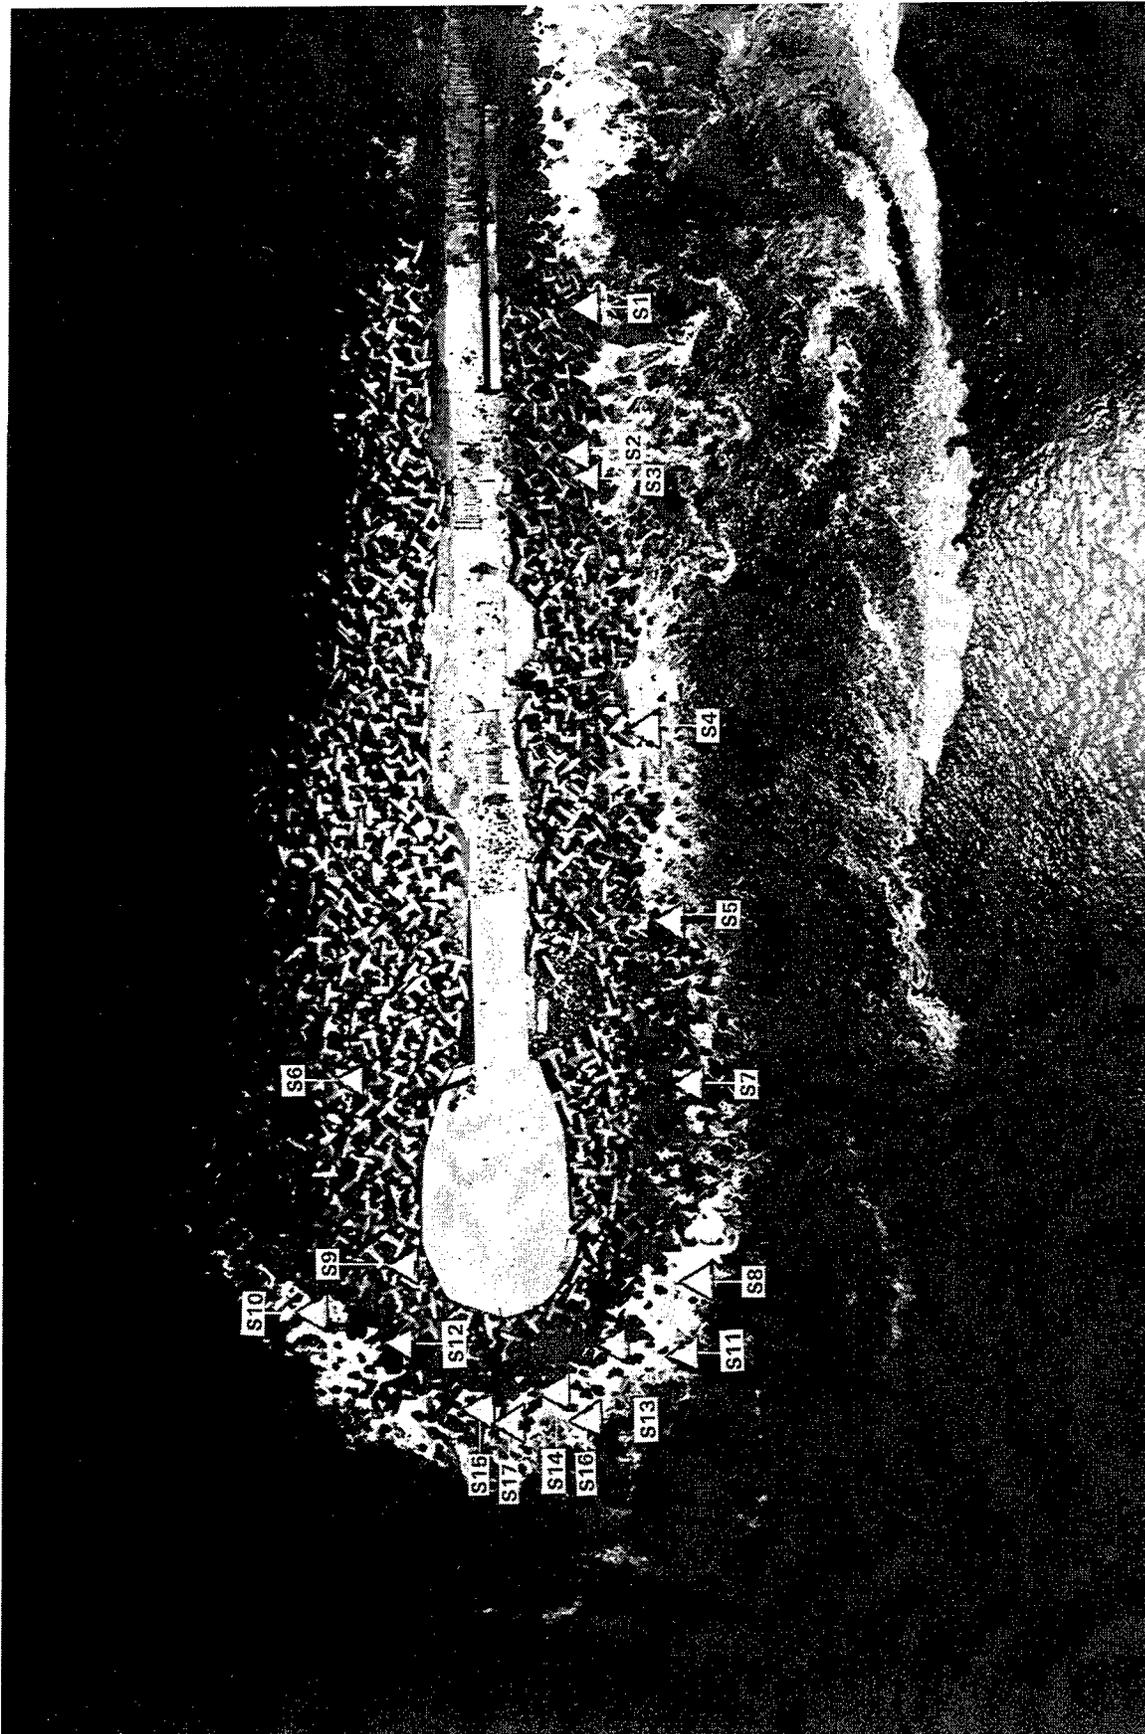
Figure 22. Approximate locations of broken/cracked dolos armor units on the south jetty
