Technical Report SL-97-9  
September 1997

# Durability of Posttensioned Concrete After 33 Years of Marine Exposure

by *Morris Schupack, Schupack Suarez Engineers, Inc.*  
*Edward F. O'Neil, WES*

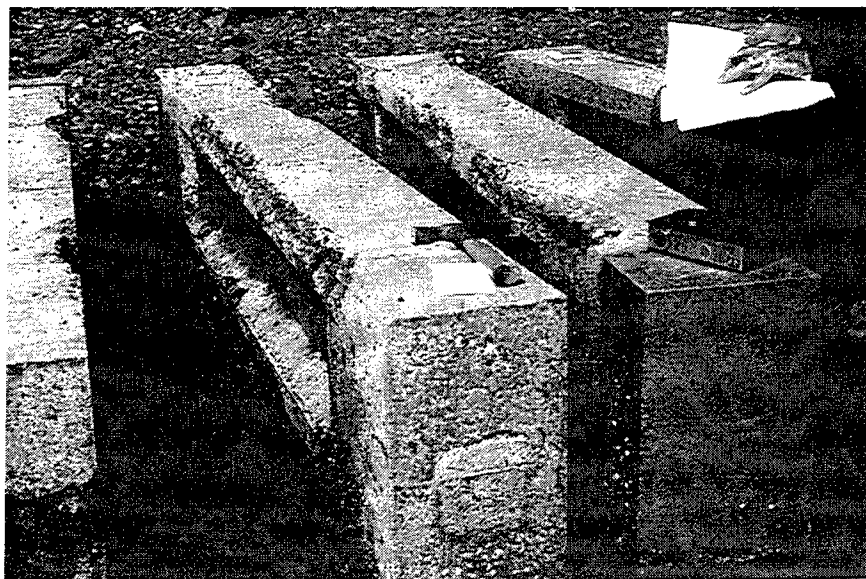
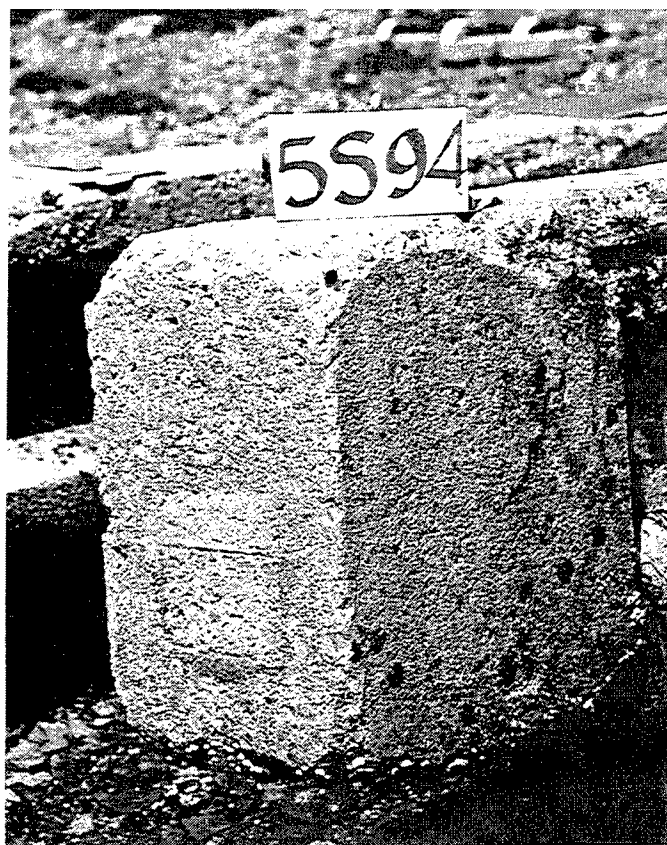
**FIG. 6**

Beam 5 - Seaward end - 1972

Beam 5 - Seaward end - 1994

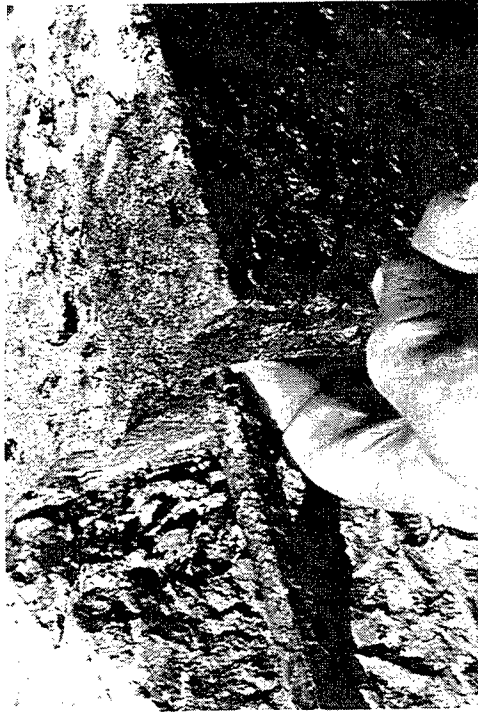
The only complete wasting of reinforcing steel that has occurred are those that were contiguous to and in epoxy-resin concrete. Figure 7G through 7L and 8B through 8G shows similar performance. The rebars penetrating the epoxy were destroyed to an unknown depth into the end cap and the bar adjacent to the epoxy-resin concrete interface also was completely corroded and had spalled the concrete off. The reason for this type of complete dissolution of the reinforcing steel is not fully understood. A possible explanation for this is the far superior electrical isolation of the epoxy concrete compared to the portland-cement concrete and the consequent large cathode-small anode corrosion cell. It is also possible that once the interface between the epoxy resin and the concrete suffered concrete deterioration, the reinforcing steel progressively corroded inward toward the body of the epoxy resin. A further study of some of the remaining beams may reveal the reasons for this more aggressive corrosion and the progression of the rebar corrosion into the epoxy-resin concrete.

Beam 12- Landward end - 1980  
Rebar corrosion into epoxy end protection  
Fig. 7-2G

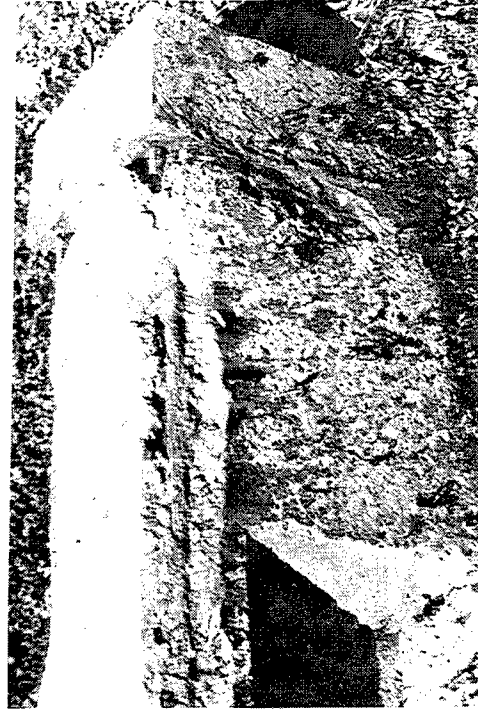
Beam 12 - Landward end - 1980  
Edge spalling and rebar corrosion  
Fig. 7-2H

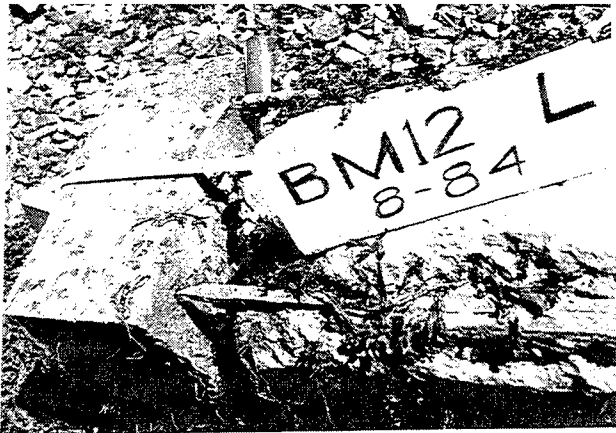
Beam 12 - Landward end - 1984  
Corrosion of rebar  
Fig. 7-3I

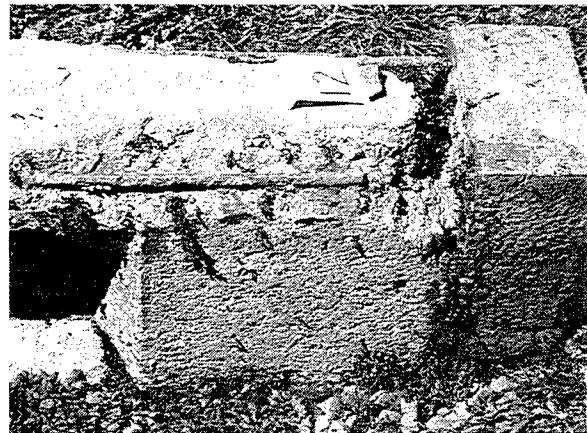
Beam 12 - 1988  
Epoxy end cap and rebar corrosion  
Fig. 7-3J

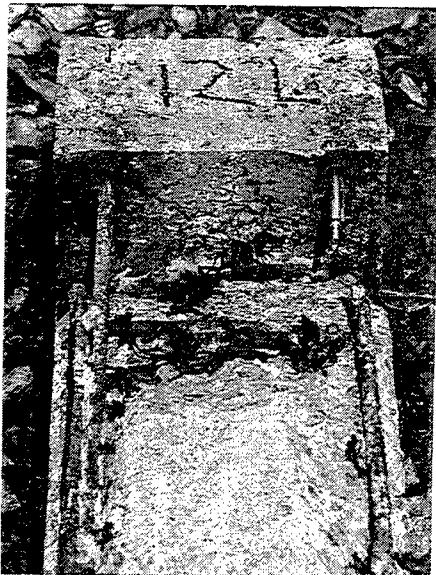
Fig. 7-3K

Beam 12 - Landward end - 1994  
Concrete and rebar deterioration

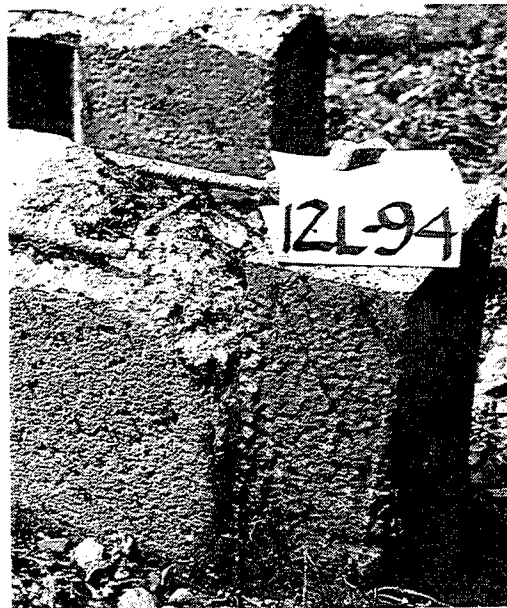
Fig. 7-3L

Beam 12 - Landward end - 1994  
Concrete and rebar deterioration

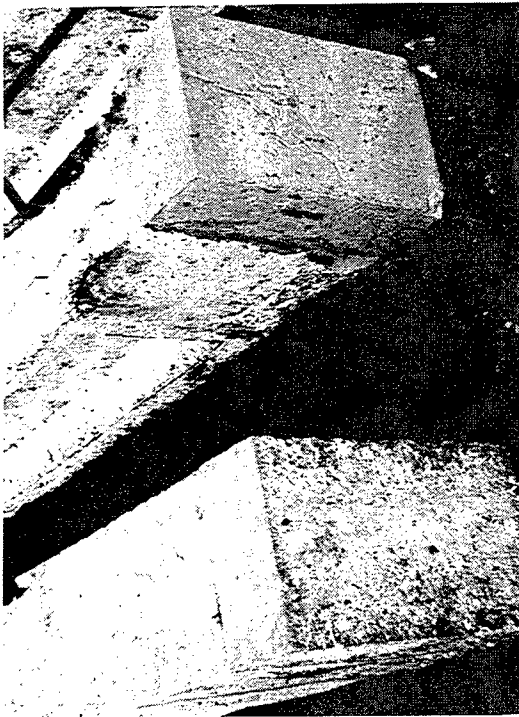
Beam 16 - Seaward end - 1972  
Rebar corrosion  
Fig. 8-1A

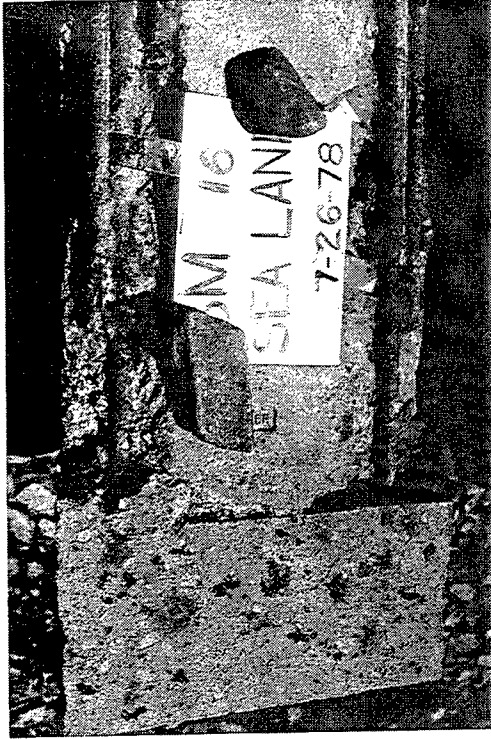
Beam 16 - Seaward end - 1978  
Progressive corrosion & spalling  
Fig. 8-1B

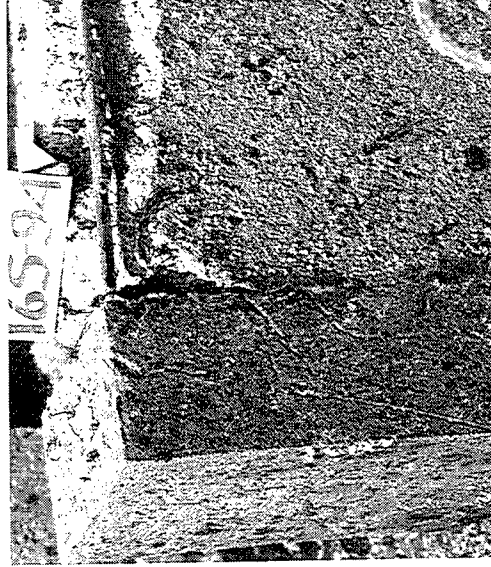
Beam 16 - Seaward end - 1994  
Interface failure  
Fig. 8-1D

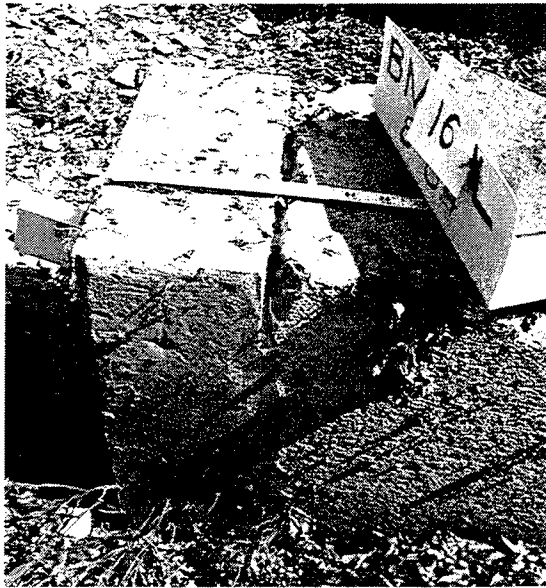
Beam 16 - Landward end - 1984  
Concrete interface breakdown  
Fig. 8-2E

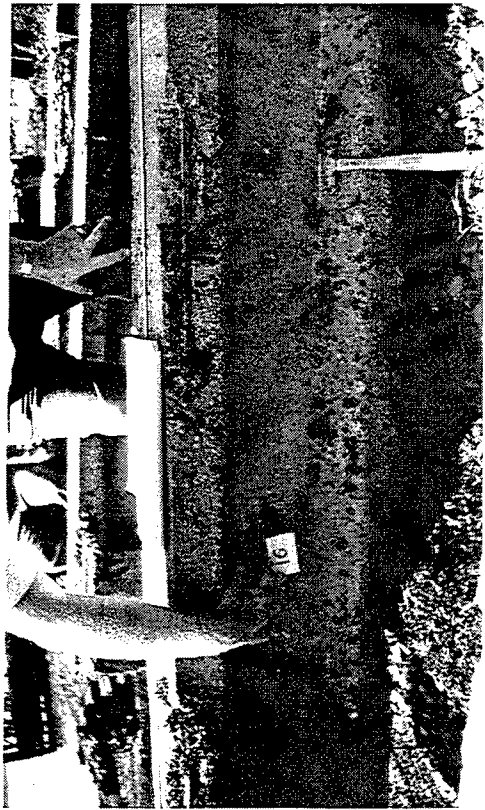
Beam 16 - 1984  
First indication of stirrup corrosion  
Fig. 8-3I

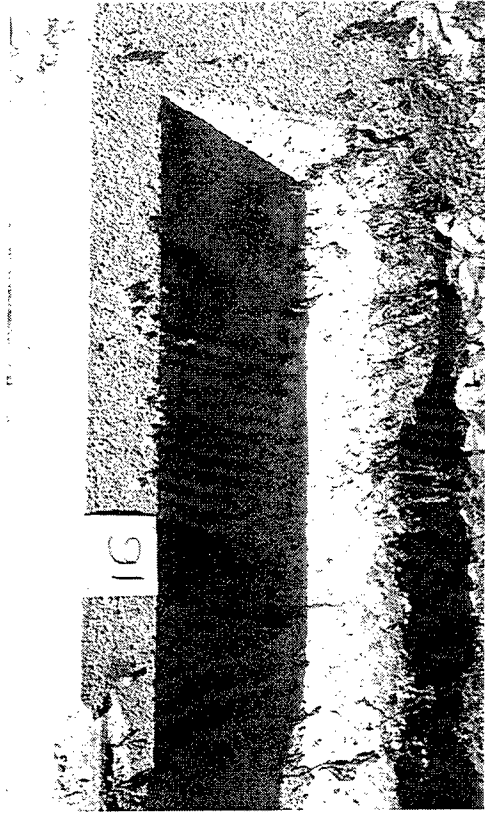
Beam 16 - 1988  
Stirrup corrosion has not progressed  
Fig. 8-3J

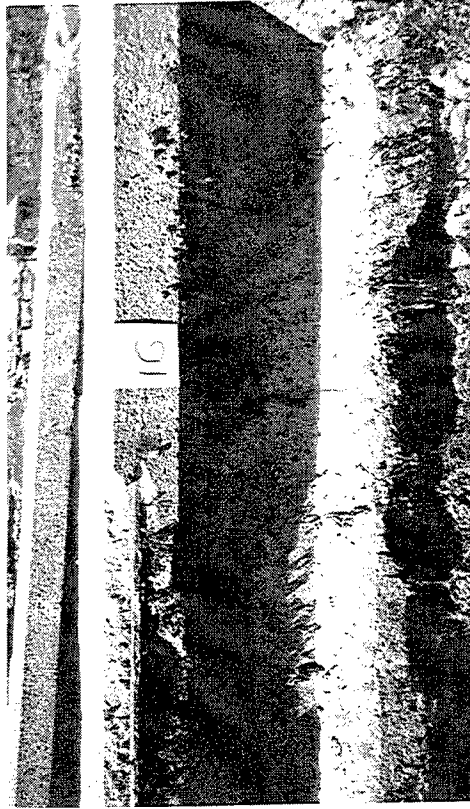
Beam 16 - 1990  
Stirrup corrosion  
Fig. 8-3K

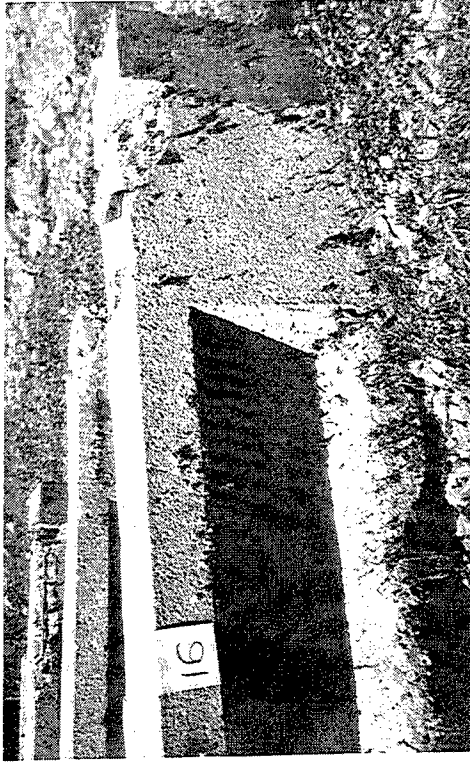
Beam 16 - 1994  
Stirrup corrosion  
Fig. 8-3L

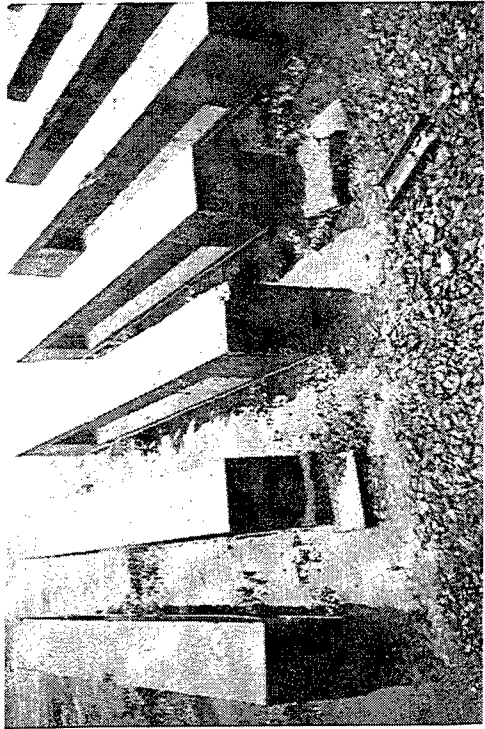
The corrosion of the reinforcing steel occurred randomly and is generally associated with locations where there was 3/4 in. (19 mm) or less concrete cover. The progression of rebar corrosion can be seen in Fig. 9, photo history of Beam 17, which was autopsied in 1983. The consequence of rebar corrosion, spalling of the surrounding concrete is shown in Fig. 9B, C, D, and F. The cage of reinforcement removed after autopsy of this particular beam is shown in Fig. 9G. Note that the extent of the corrosion is limited in the twenty two year exposure. In most cases where reinforcing bars are exposed by spalling of the surrounding concrete, the intensity of corrosion, even after 33 years of exposure, was not great. In most cases the bar deformations were still evident in 1994. This may be because of the relatively cold temperatures at Treat Island.

Beam 17 - Landward end - 1972  
End protection failed  
Fig. 9-1A

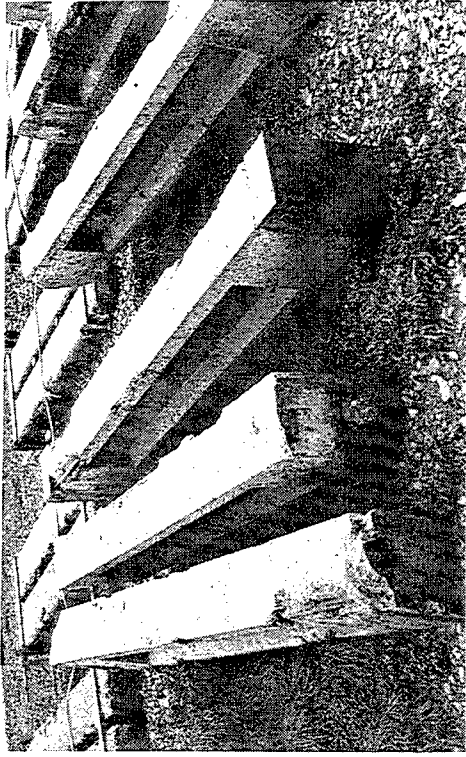
Beam 17 - Landward end - 1976  
Edge spall  
Fig. 9-1R

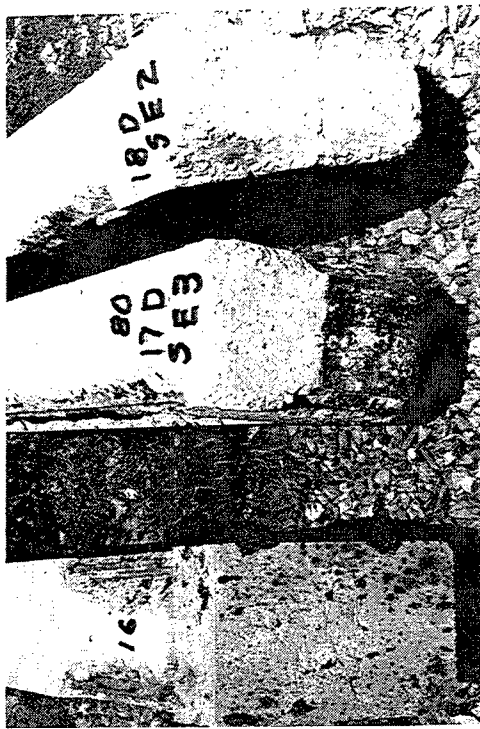
Beam 17 - Seaward end - 1980  
Failed 1963  
Fig. 9-1C

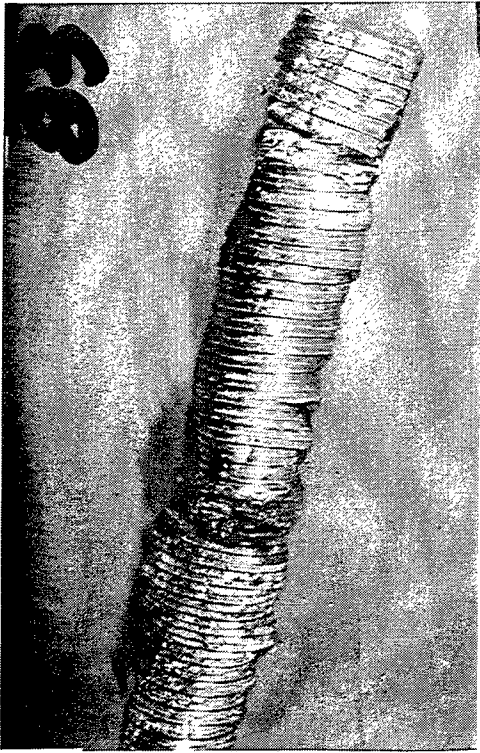
Beam 17 - Outside - 1984  
Post-tensioning conduit corrosion  
Fig. 9-3I

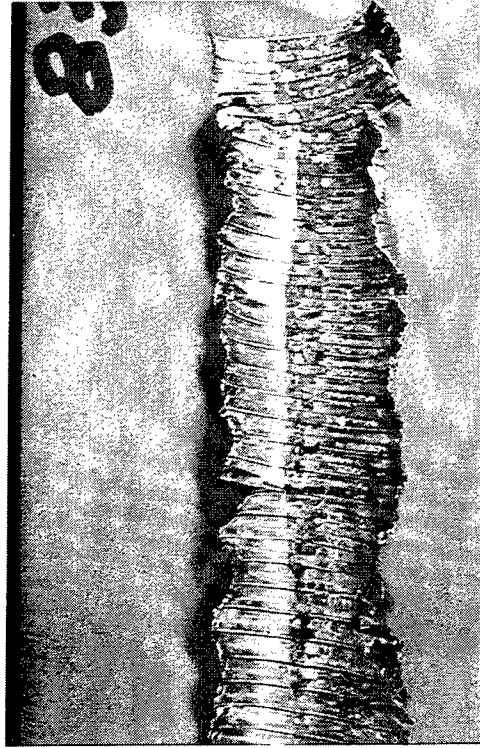
Beam 17 - Inside - 1984  
Post-tensioning conduit corrosion  
Fig. 9-3J

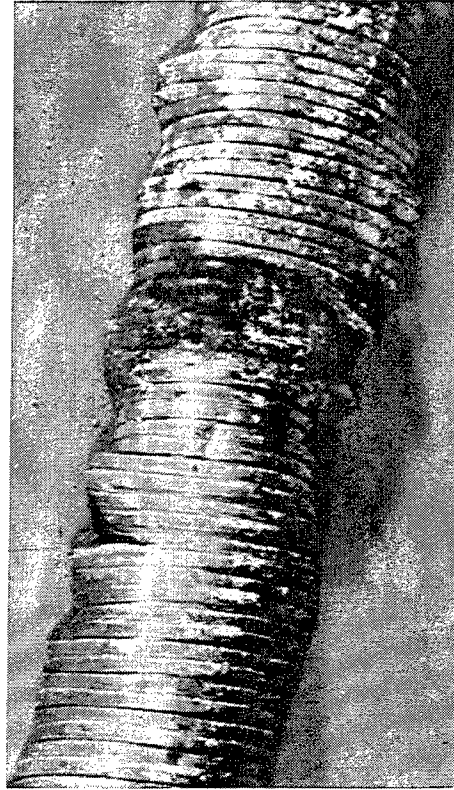
Fig. 9-3K

Beam 17 - Post-tensioning conduit corrosion - 1984

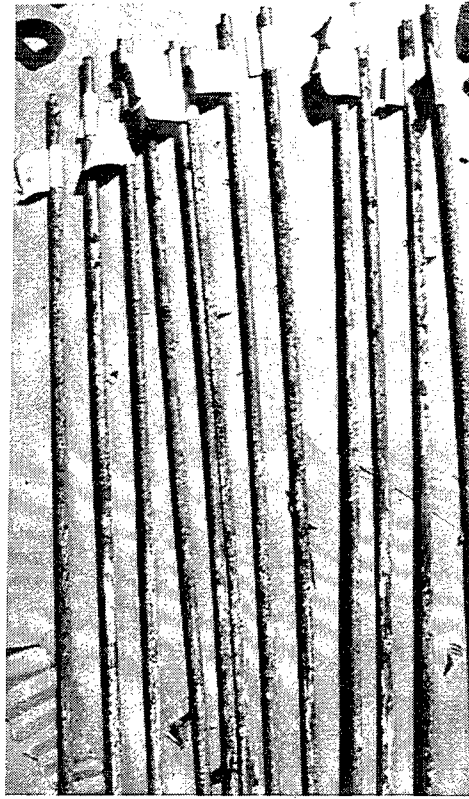
Fig. 9-3L

Beam 17 - Prestressing wire corrosion - 1984

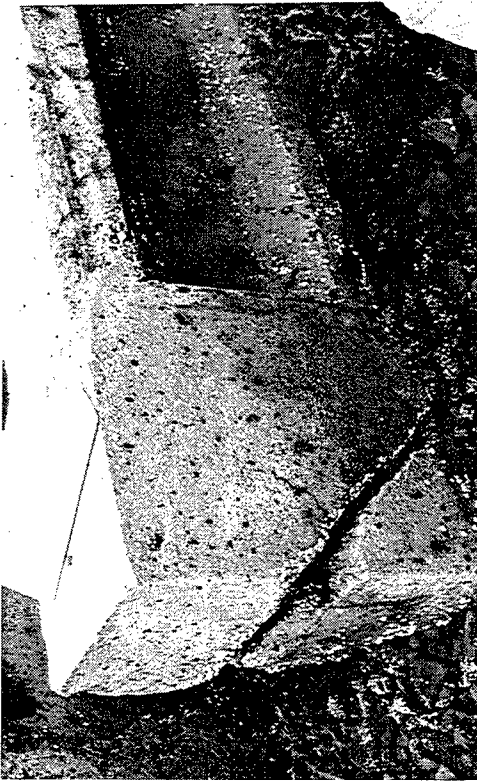
a) One failed in 1972, autopsied in 1983 (Fig. 10-1A).

Beam 4 - Seaward end - 1982  
Failed flush epoxy anchorage protection  
Fig. 10-1A

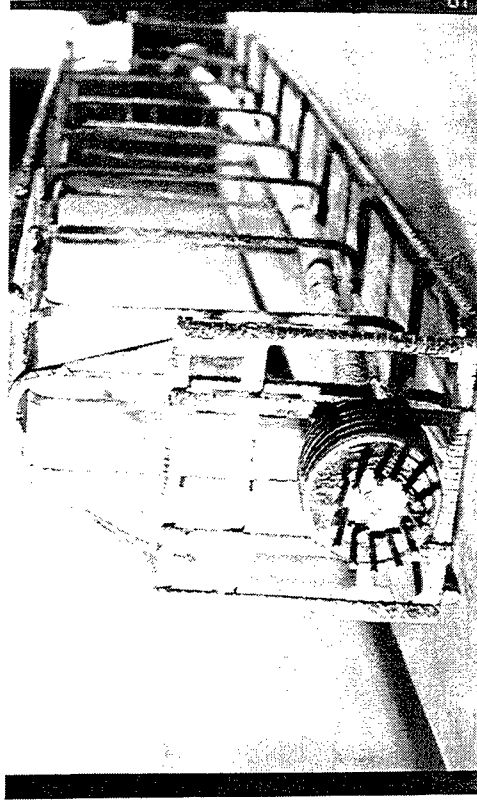
Beam 4, land end, had an epoxy-resin concrete exterior protection. It was in good condition in 1983 when it was autopsied. Figure 10-1B shows the Freyssinet anchorage after removal of the epoxy-resin concrete.

Beam 10 - Autopsy - 1983  
Anchor and reinforcement cage  
Fig. 10-1B

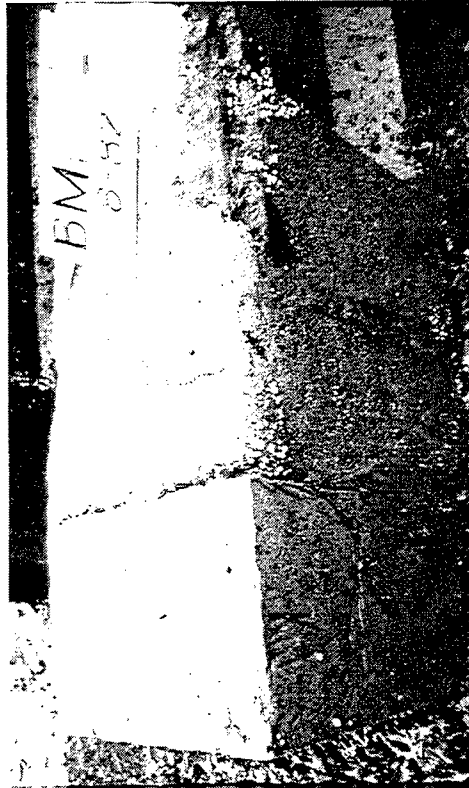
Beam 4 - Landward end - 1982  
Epoxy external end protection  
Fig. 10-1C

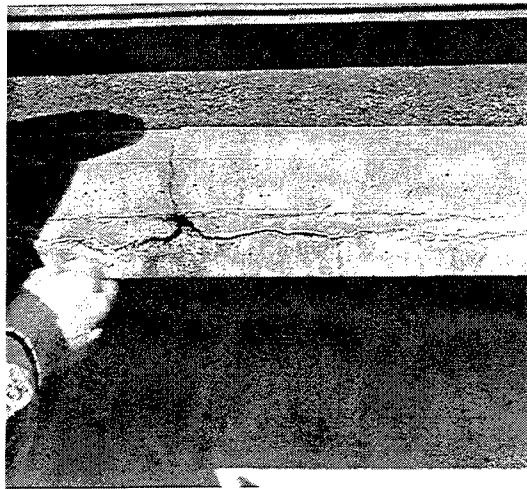
Fig. 12-B Concrete railroad platform with epoxy mortar curb showing concrete deterioration.

Horizontal crack in concrete with some indication of degraded concrete

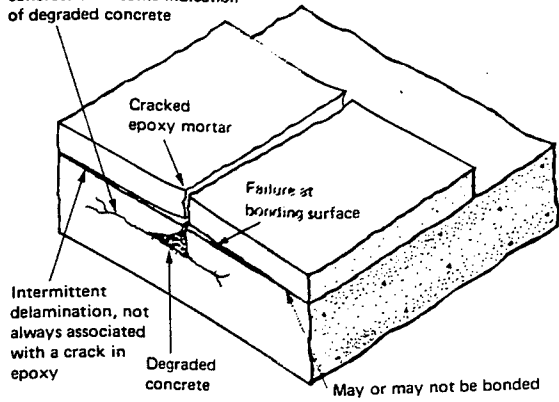
Fig. 12-A

Condition of the same concrete and epoxy mortar after several years (Ref. 10)

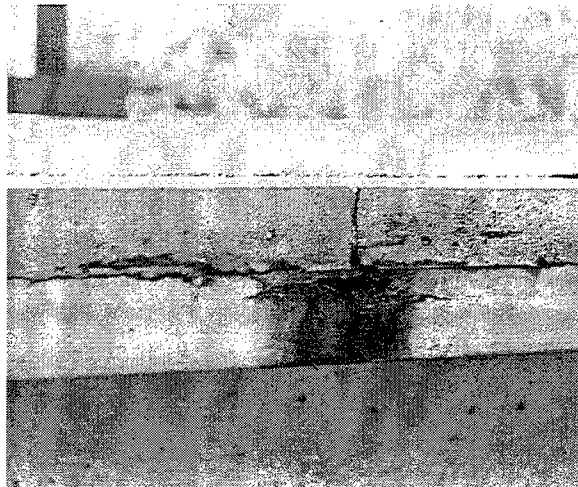
Fig. 12-C Concrete railroad platform with epoxy mortar curb showing concrete deterioration.

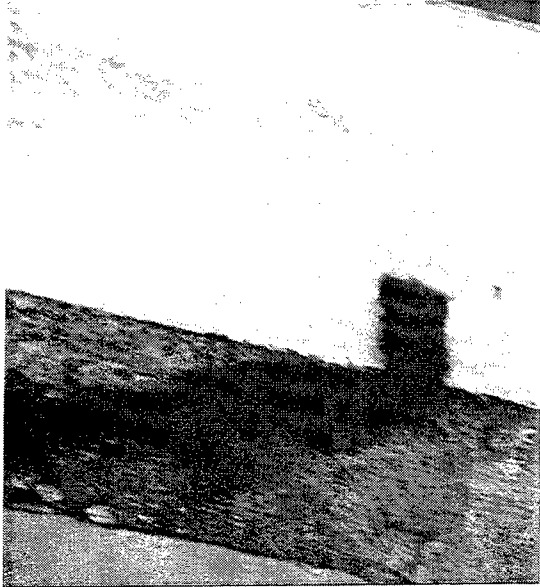
FIG. 13-A

NONE BONDED - MORTAR PERMITTED  
WATER ACCESS TO TENDON ANCHOR  
WITH RESULTING CORROSION

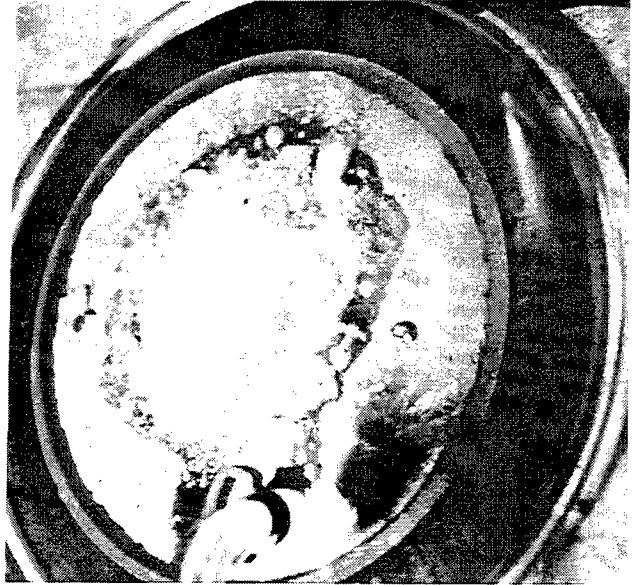
FIG. 13-B

POROUS MORTAR USED IN POCKET  
DETECTED BY A BUBBLE VACUUM  
TEST
