DOT/FAA/AR-96/21

# Composite Failure Analysis Handbook Update 1

WL-TR-93-4004

August 1997

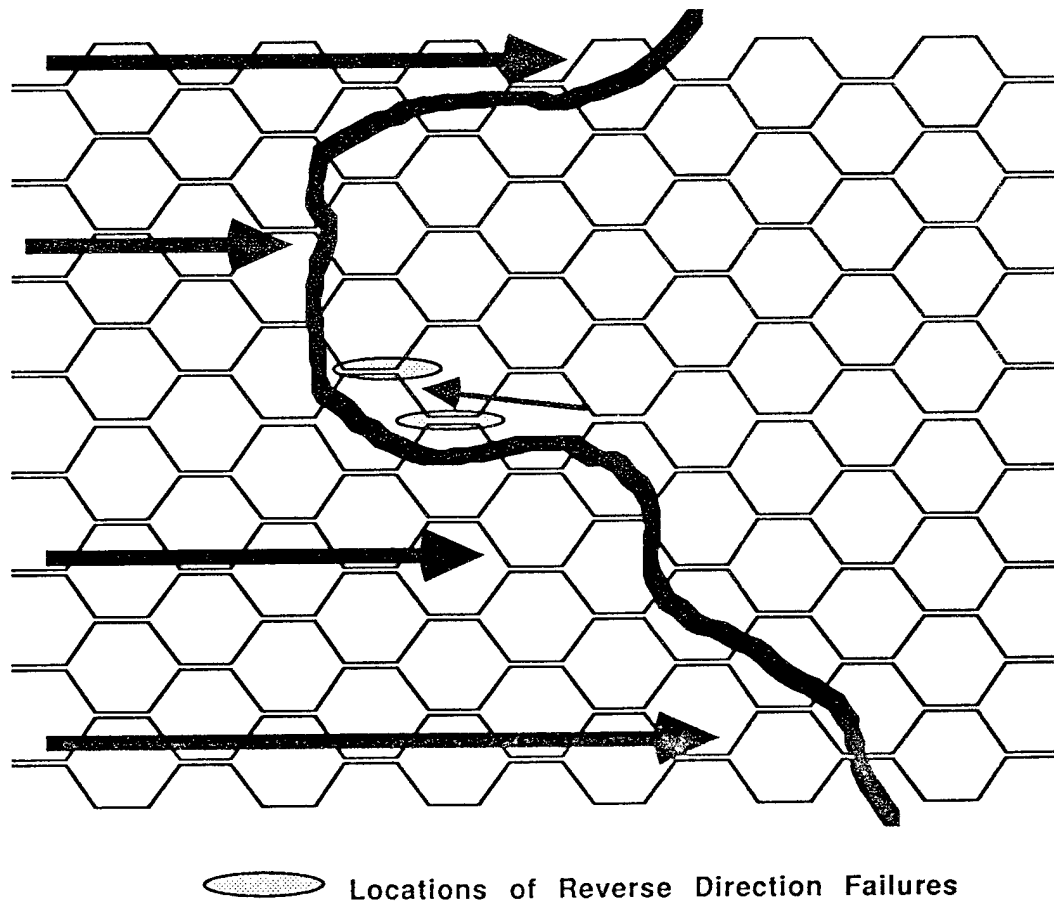
The illustration on the left shows "Wallner" lines indicating the failure initiated at the apex of the upper arm of the meniscus. It then propagated across the joint and caused a conchoidal fracture in the trailing meniscus. The illustration on the right shows the same type of event but with a Wallner line failure pattern at the trailing meniscus.

Figure 3.8-5. The Failure Front Doesn't Travel as a Straight Line and May, for Short Distances, Change Direction

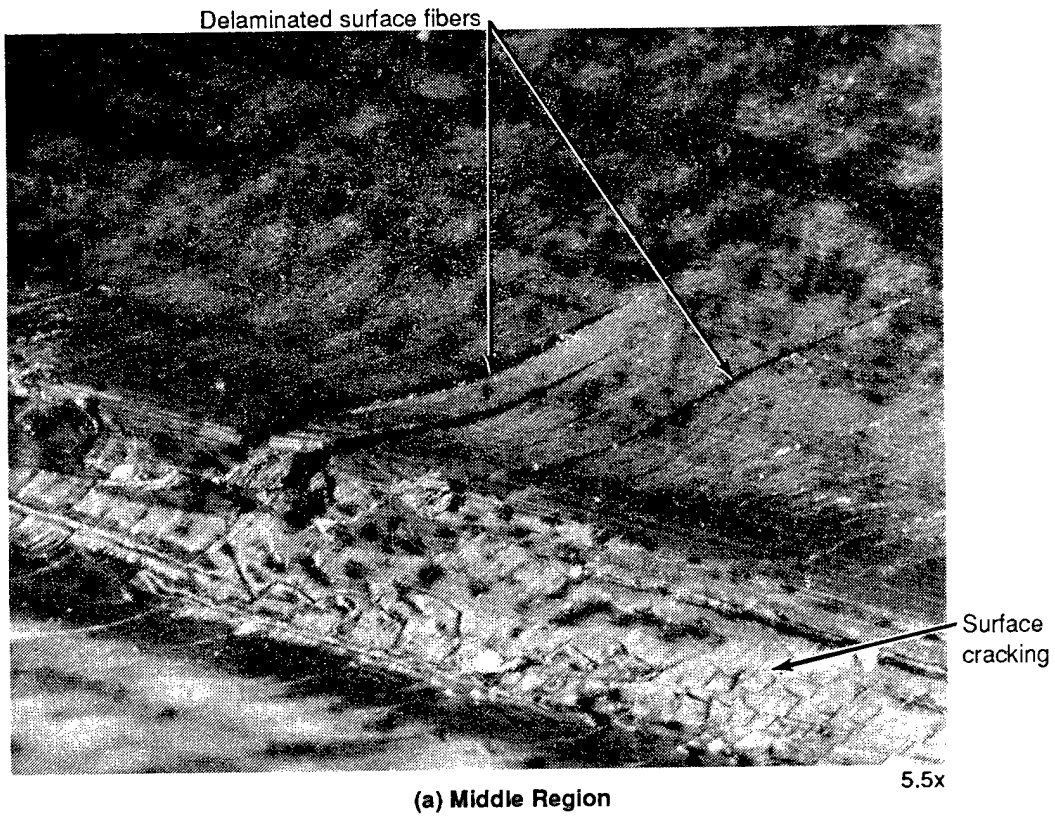
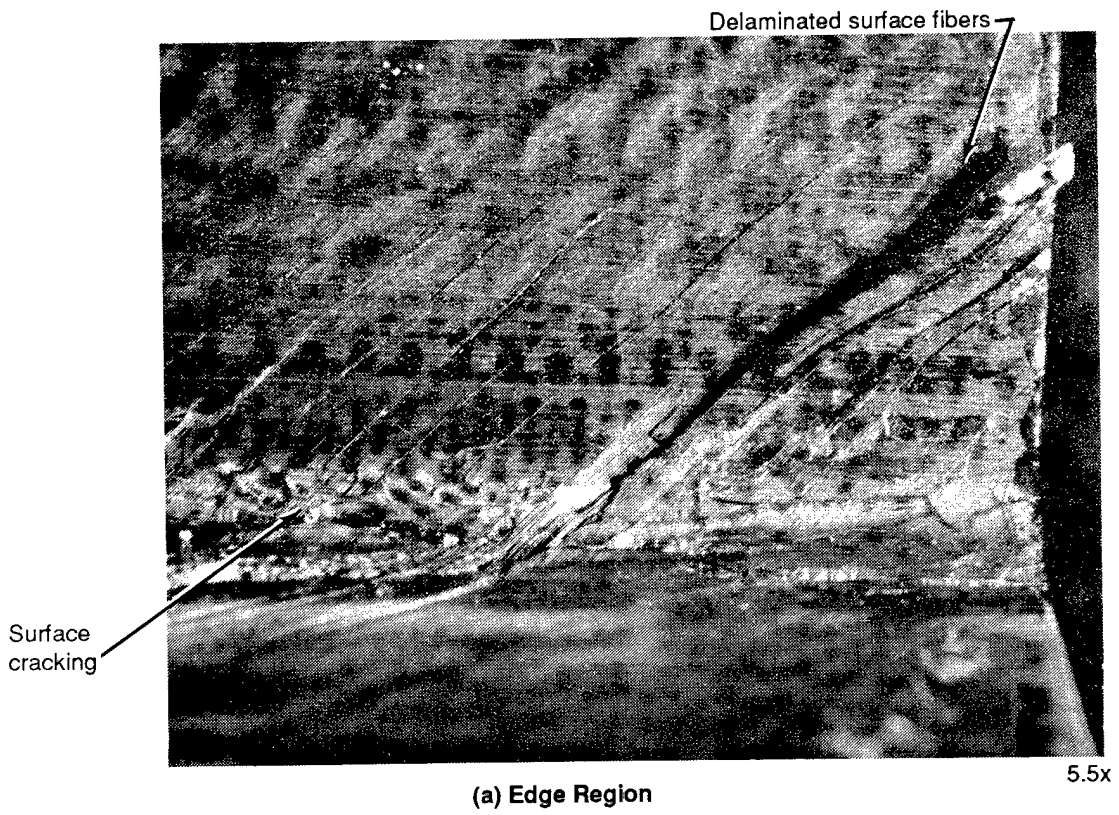
Figure 4. Micrographs Showing Regions of Surface Fibers Delamination and Cracking Along the Middle and Edges of the Inner Radius

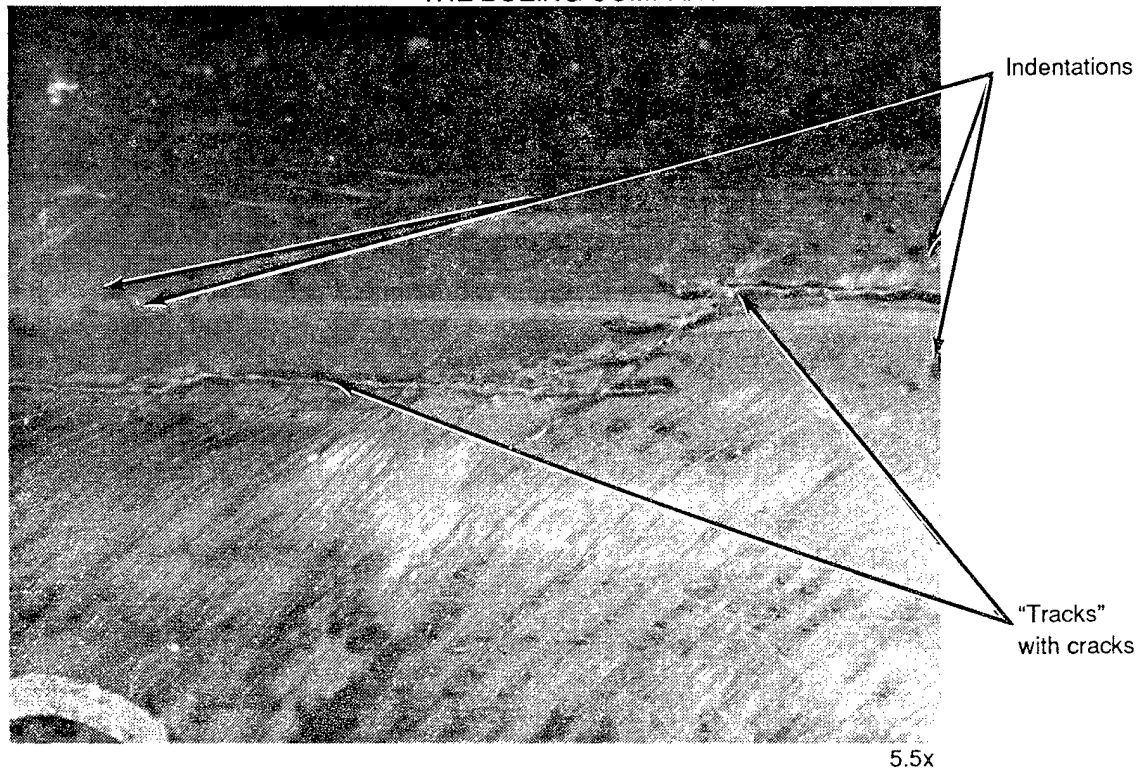
Figure 5. Micrograph of the Indentations and "Tracks" Along the Inner Radius

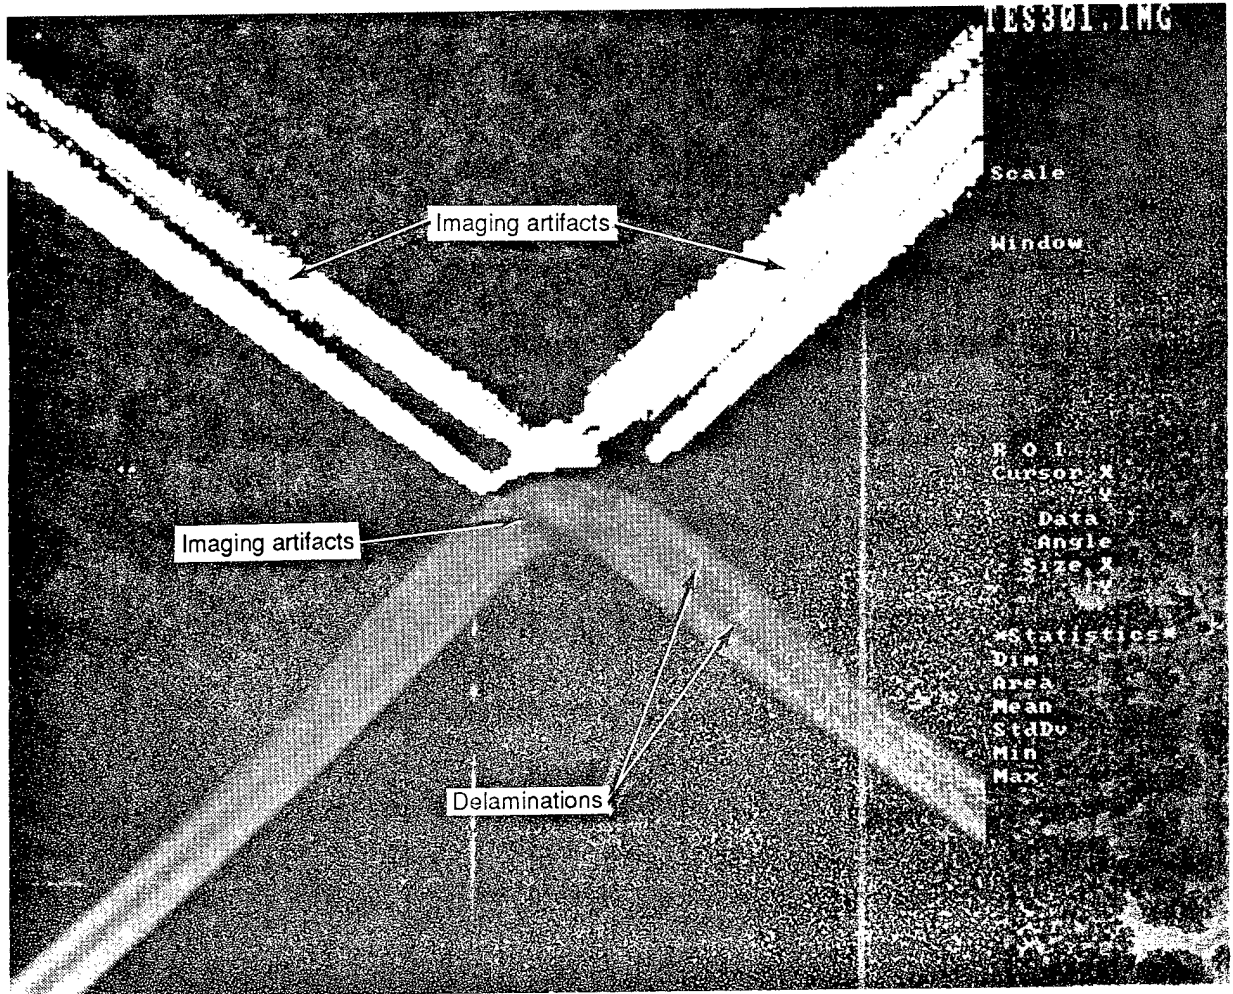
The part was subsequently dried in an oven at 90°F for 30 minutes before another set of scans was performed. This time the edges were sealed, the surface of the part was sprayed with a lacquer, and the fastener holes were plugged (fig 9). The part was then rescanned which revealed that it was almost completely delaminated (fig. 10). The grip areas were not delaminated as observed in the pulse-echo analysis.

Figure 6. CT Image Showing the Imaging Artifacts and Some of the Actual Delaminations

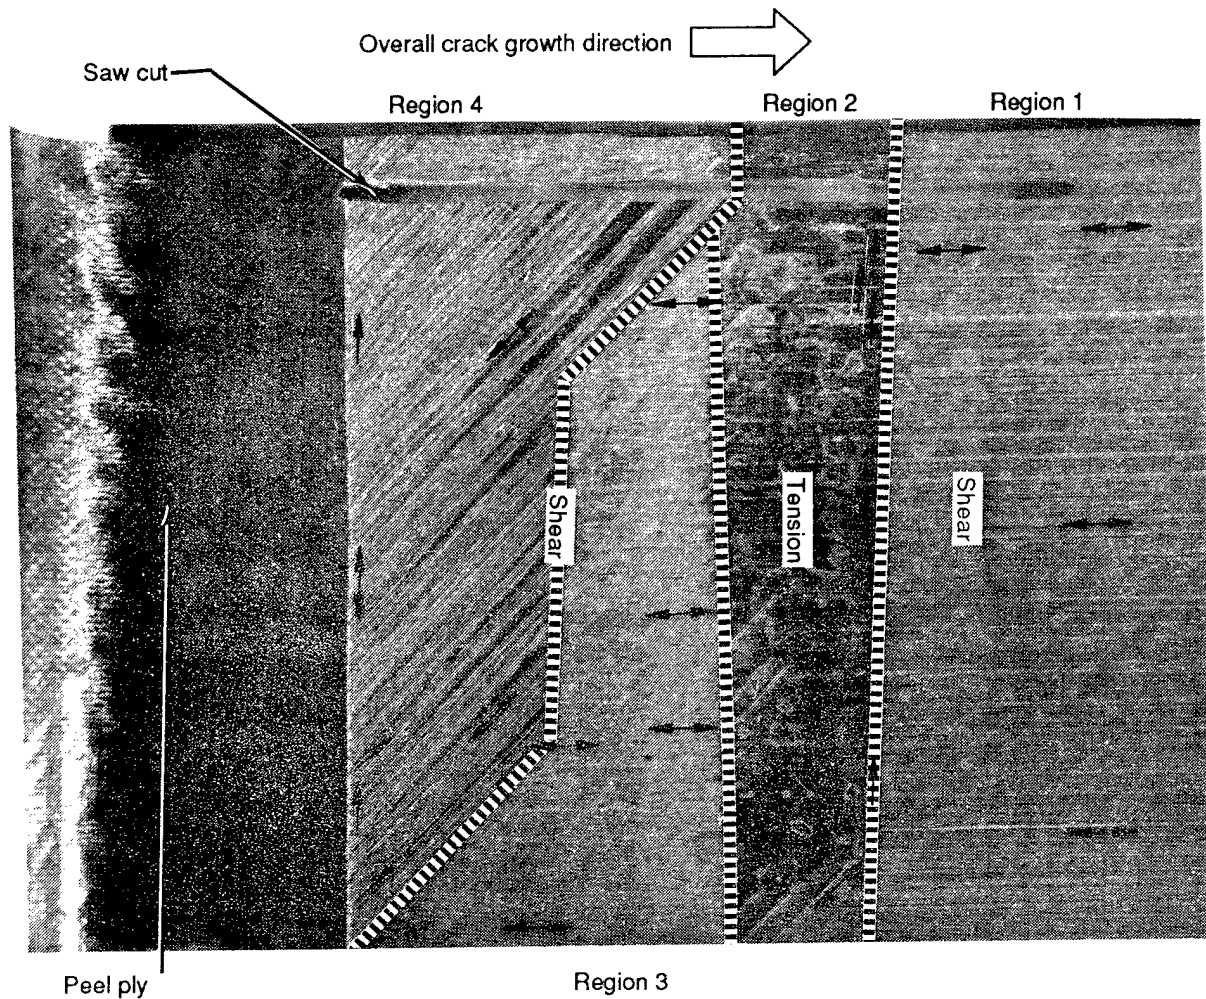
Initially, the component was gripped at the edges of the flanges using the fastener holes. As loading began, one edge was pulled away from the other edge which induced an initial shear loading condition inside the component at the edge of the peel ply. The presence of the peel ply in the center (where the maximum shear stress occurred) provided a high stress concentration region which allowed the cracks to initiate. As the edges were pulled further apart, the cracks continued to propagate by shear.

Note: Four regions are identified, exhibiting two different fracture modes:

- Region 1: Mode II (shear)
- Region 2: Mode I (tension)
- Region 3: Mode II (shear) 0-degree fibers
- Region 4: Mode II (shear) 45-degree fibers

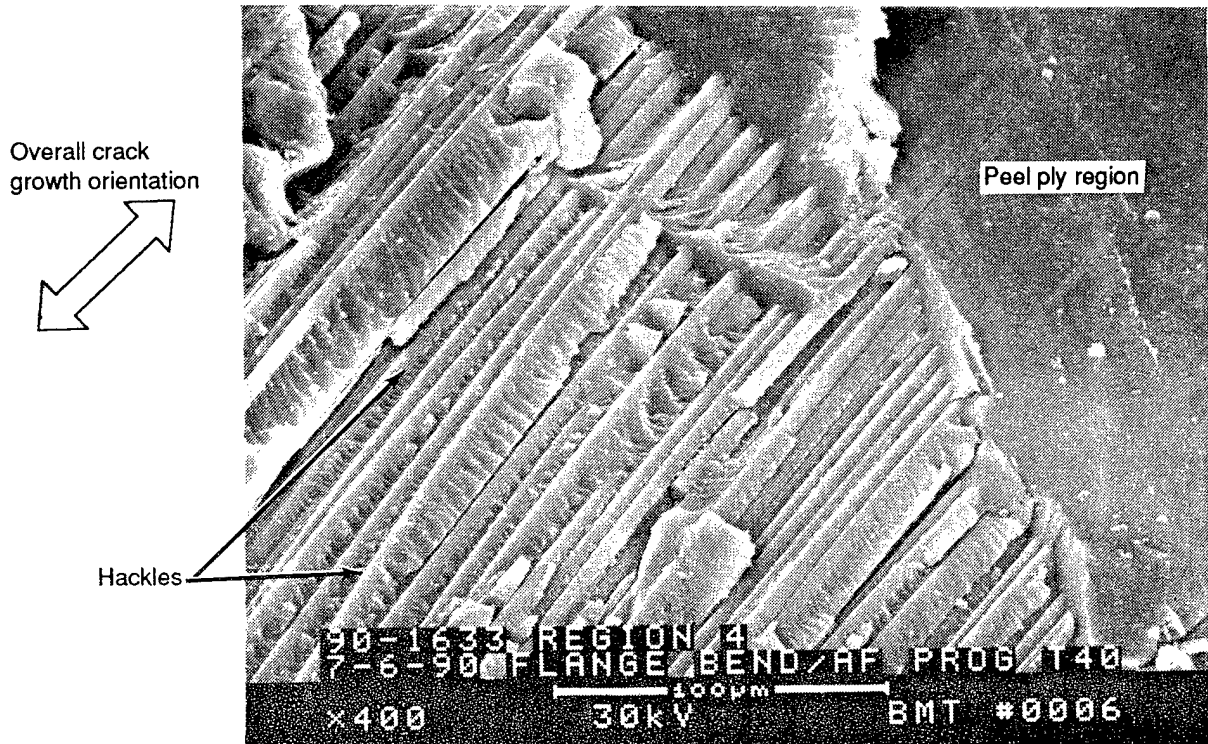
Figure 14. SEM Micrograph of a Mode II-Type (Shear) Fracture Surface in Region 4 Adjacent to the Peel Ply

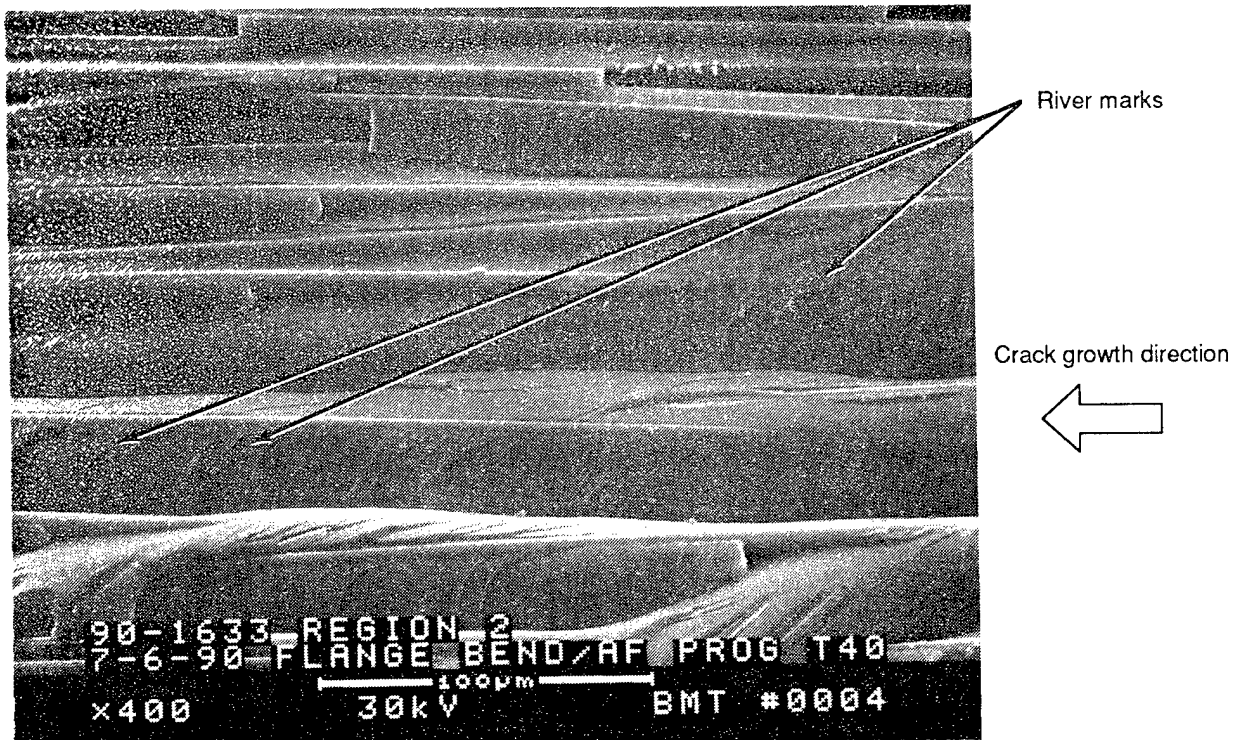
Figure 15. SEM Micrograph of a Mode I-Type (Tension) Fracture Surface in Region 2

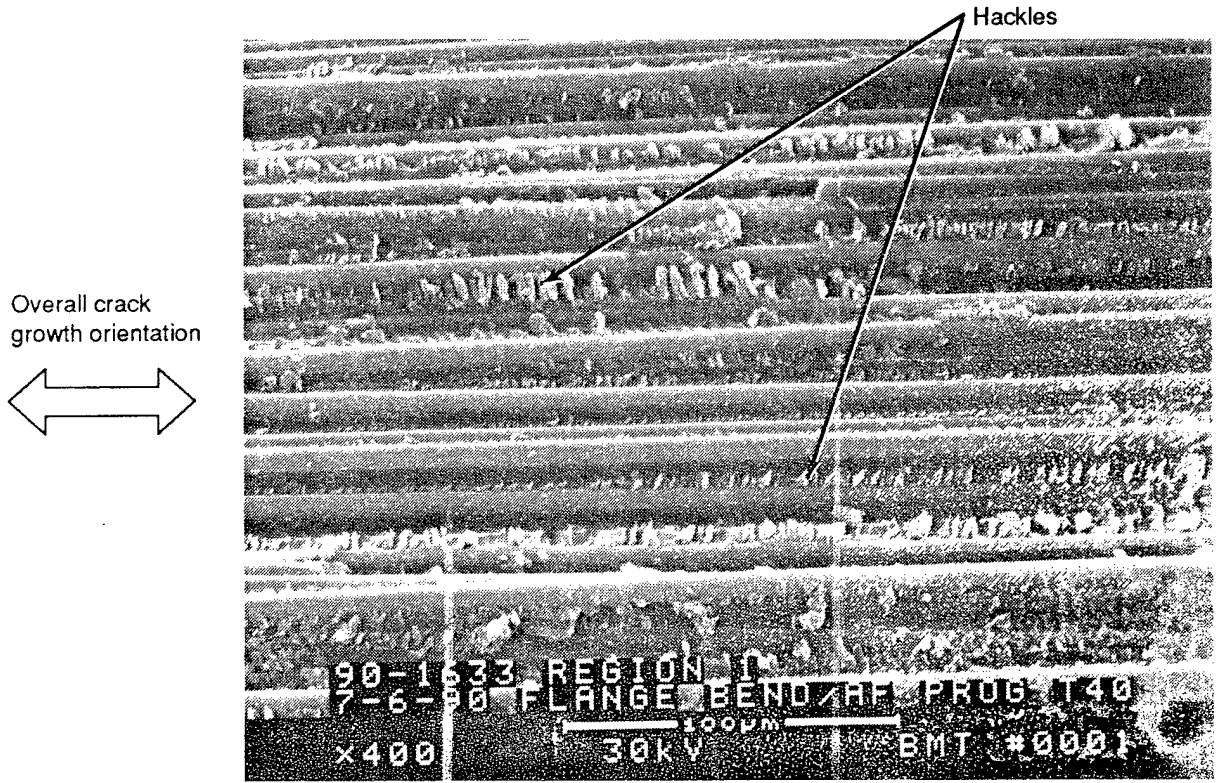
Figure 16. SEM Micrograph of a Mode II-Type (Shear) Fracture Surface in Region 1

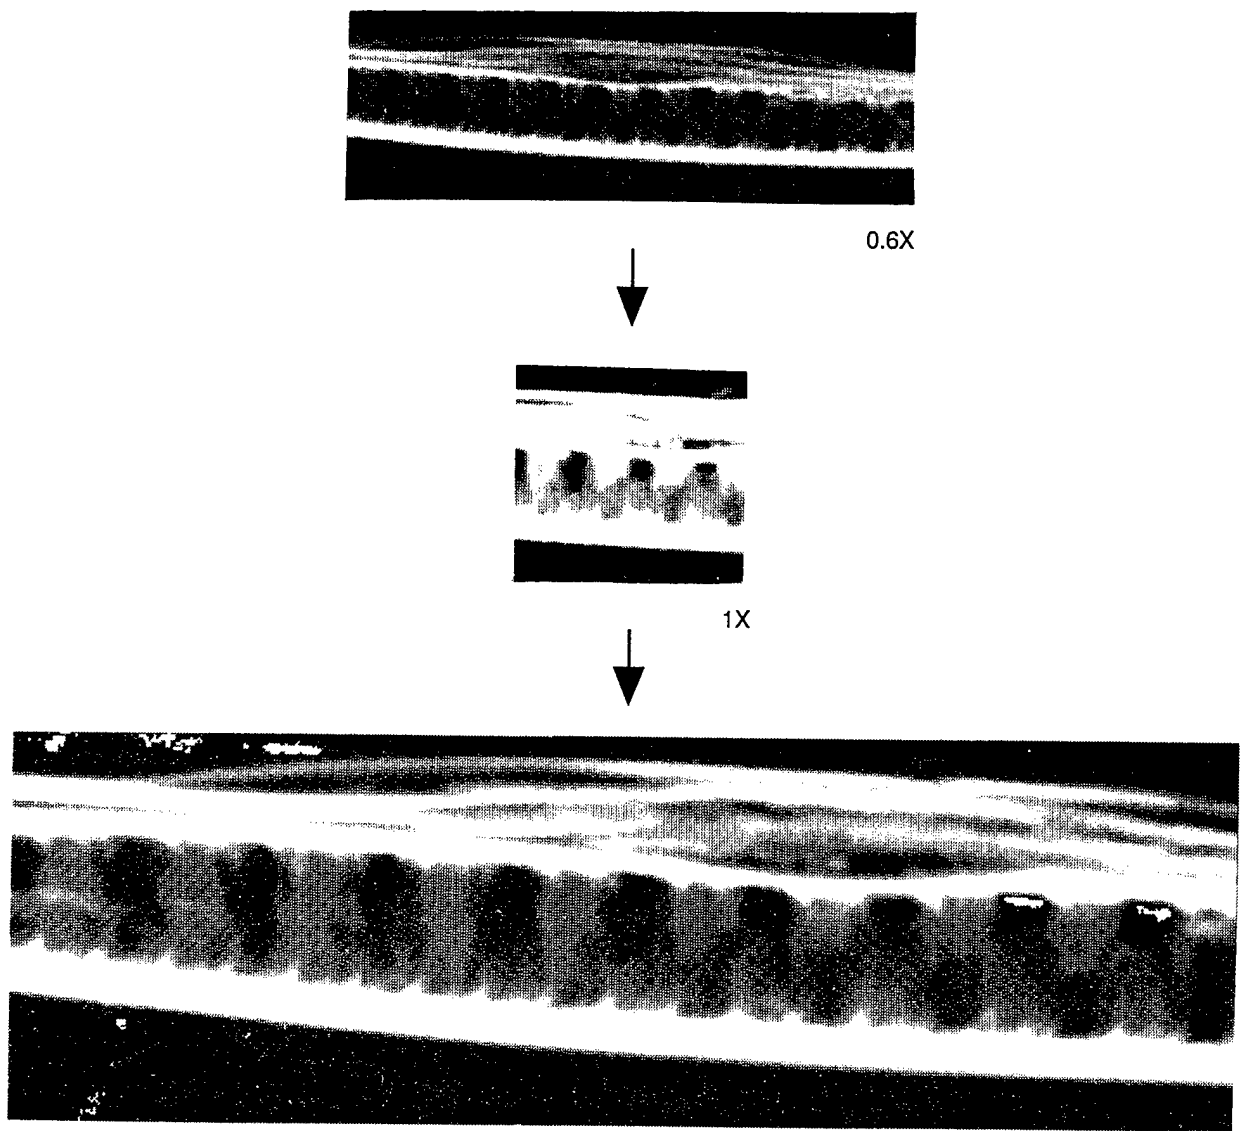
Figures 8 through 11 through show the various images of the slices through the component. The longitudinal slices 1, 2, & 3 show the damage present in the honeycomb regions in the center of the component. The front half of the panel appears to have been crushed by a macroscopic shearing of the upper front half of the facesheet. The back half exhibited little if no damage. However near the bulge, the core appeared to be crushed in the short transverse direction. There was no evidence showing any longitudinal buckling trends to either end (from one end to the other). This transverse damage was located all along the back half of the component.

Figure 8. CT Images of the Transverse Scan Through the Delaminated Zone

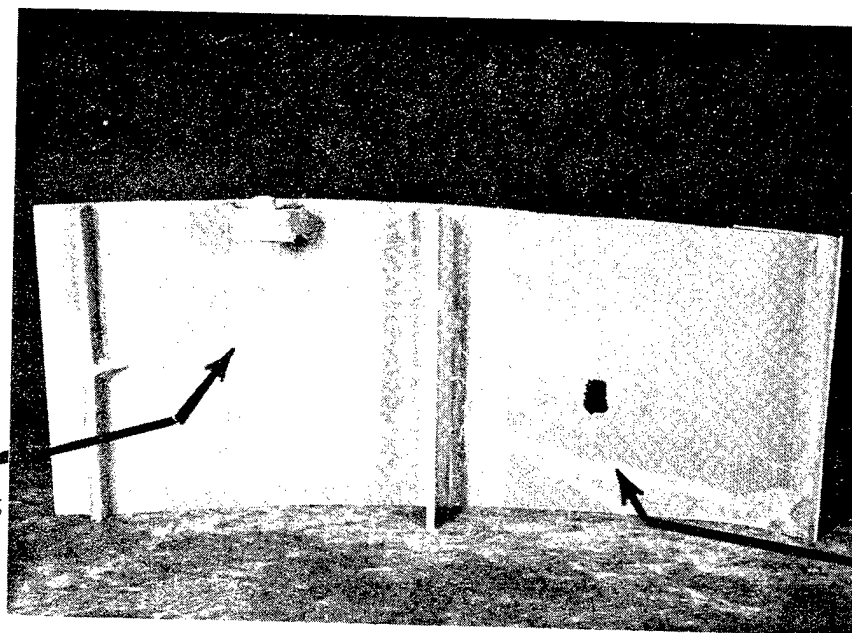
small delaminated  
region corresponding  
to the crack on the  
outer surface

large delaminated  
region corresponding  
to a sanded region  
on the outer surface

*Figure 3. Photograph of the Inner Surface of the Upper Wing Surface*

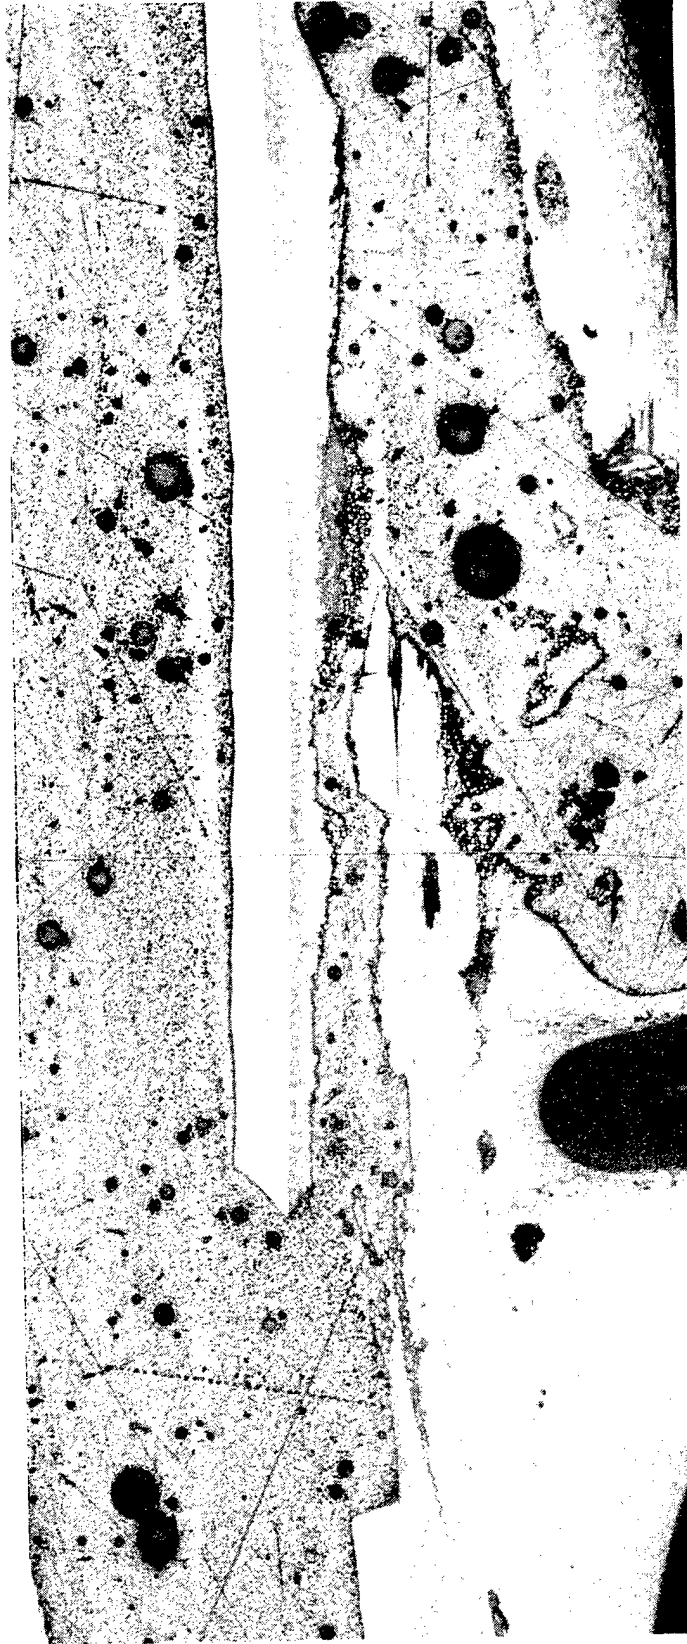
Figure 10. Cross Section through a Crack in the Upper Wing Skin

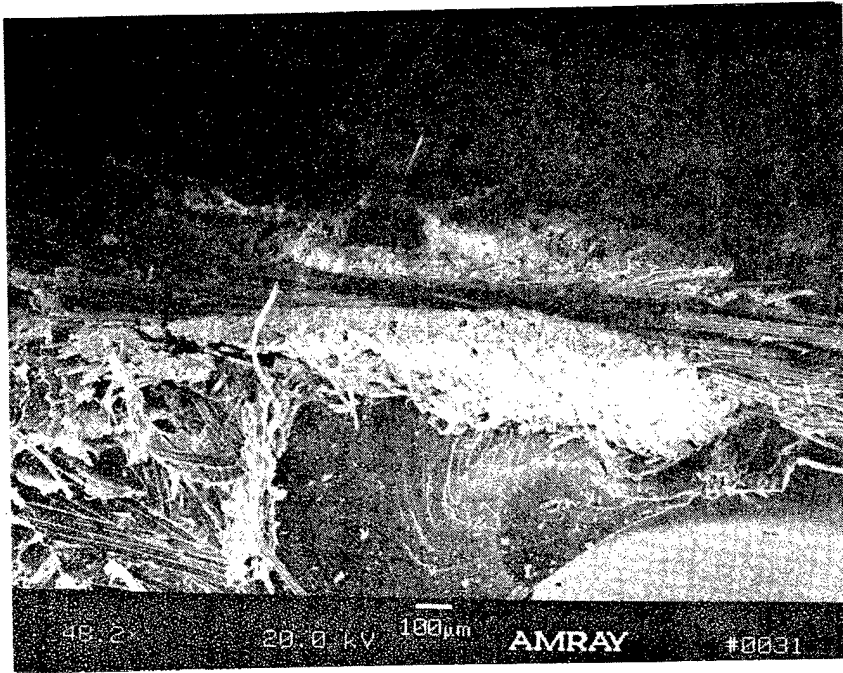
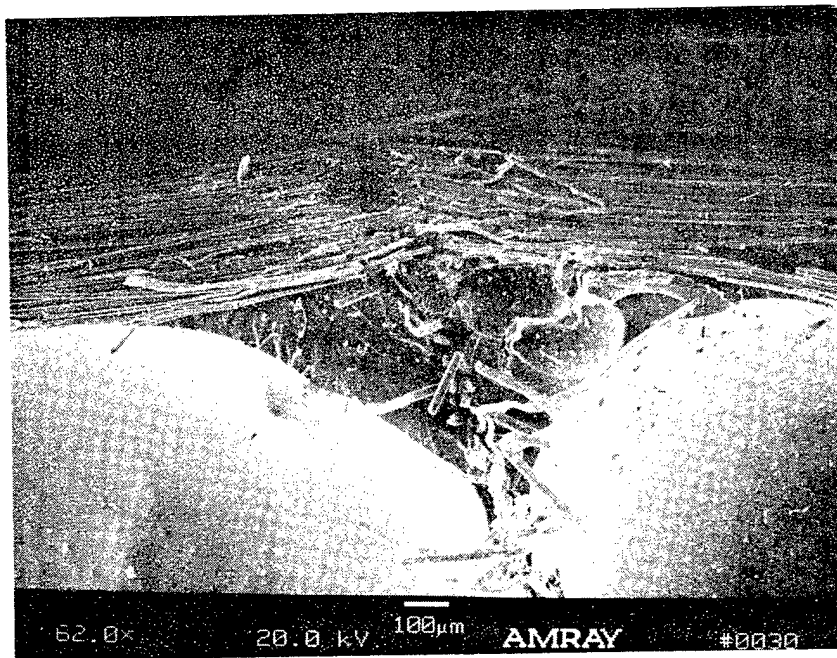
Figure 12. SEM Photographs of the Crack Surfaces

feature on the both the fibers parallel and perpendicular to the crack were the hackles indicating a mode II (shear) loading.
