TECHNICAL REPORT ARCCB-TR-97021

**HYDROGEN CRACKING DURING SERVICE OF
HIGH STRENGTH STEEL CANNON COMPONENTS**

**J. H. UNDERWOOD
E. TROIANO
G. N. VIGILANTE
A. A. KAPUSTA
S. TAUSCHER**

SEPTEMBER 1997

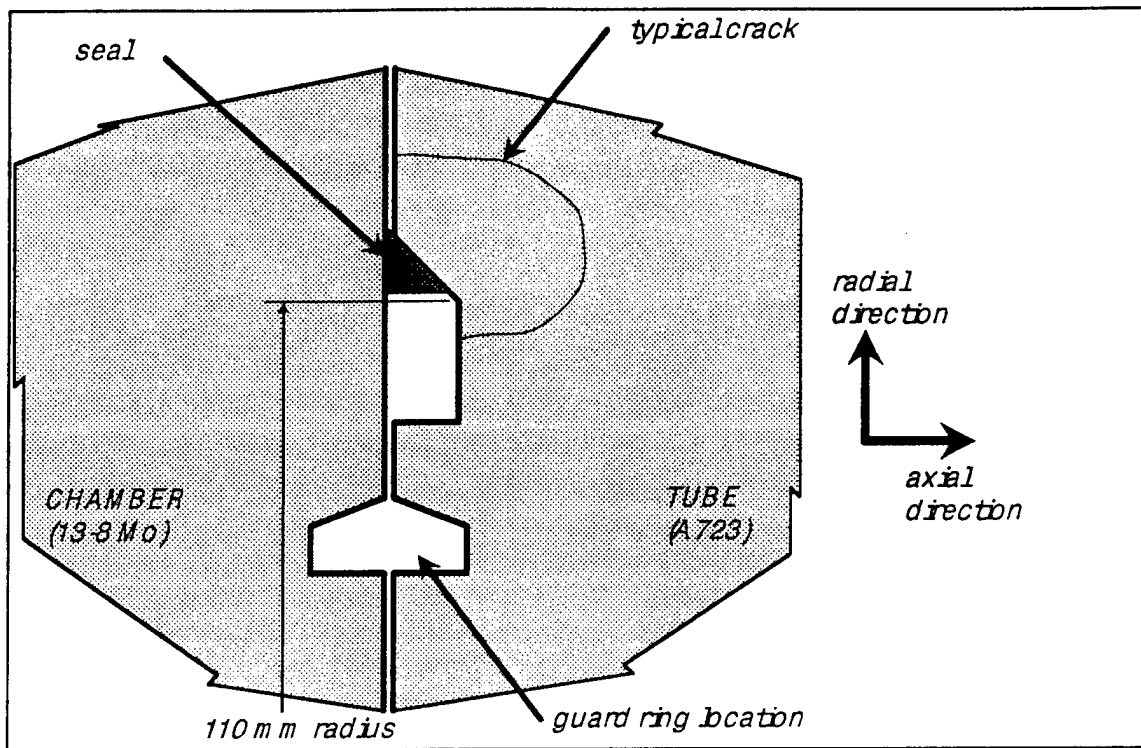
FIG. 2 - Sketch of Seal Location #1 and Cracking Observed

Cracking in the prototype cannon with the seal at location #1 was suspected due to a small pressure leak that was observed during the fifth firing cycle. The typical crack size and location sketched in Figure 2 show a 21-mm (surface length) crack that provided a pressure path around the seal and thus accounted for the observed leak. Two other cracks were observed at other angular positions of the seal, a 19-mm surface length crack at a position 185° away from the 21-mm crack, and a 6-mm surface length crack 111° away from the 21-mm crack. The angular positions are significant because the two largest cracks were within a few degrees of alignment with the two 180°-spaced vent holes in the guard ring, and the 6-mm crack was closely aligned with a plugged test hole in the guard ring contact surface of the tube. The presence of the plugged hole could have affected the contact surface and allowed passage of combustion products at this location. Thus, each of the three positions of cracking was closely aligned with angular positions of known (guard ring vent holes) or suspected (plugged hole) sources of propellant combustion products. This is strong evidence that the source of the environment that contributed to the cracking was the combustion products. Regarding initiation of the three cracks, each of the three cracks included the internal corner of the seal pocket adjacent to the seal. This corner is a likely origin of cracking. As shown in Figure 2, the larger two cracks extended farther from the corner toward the outer radius of the tube rather than toward the inner radius; this can be

explained in terms of the residual stresses in the cannon tube, discussed in the next section. The 6-mm crack was nearly centered on the internal seal pocket corner, thus indicating that this seal pocket corner was the origin of the cracks.

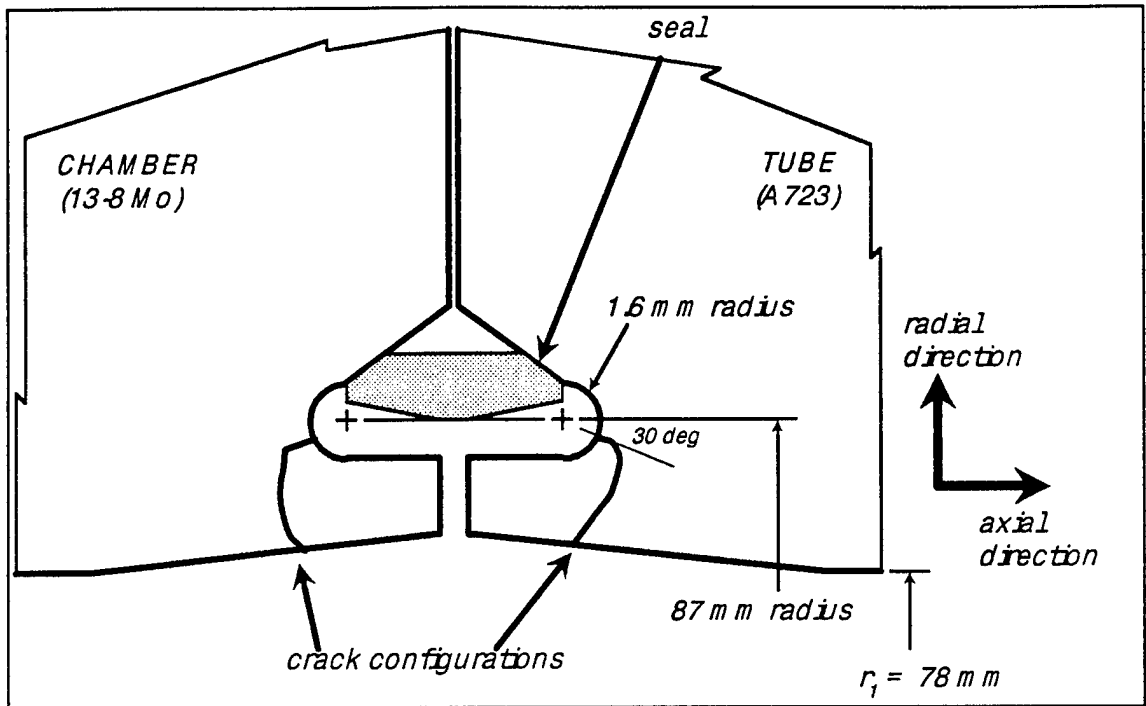
FIG. 3 - Sketch of Seal Location #2 and Cracking Observed

Cracking in the prototype cannon with the seal at location #2 was found to be quite extensive when the cannon was disassembled after thirty firing cycles. Nearly identical crack configurations were observed in both the chamber and tube sections of the cannon, initiating from a location in the seal pocket about 30° from the axial direction in each section; see Figure 3. The cracks extended through to the inner radius surface and extended about 50 mm in the circumferential direction in each section. The similar location, size, and orientation of rapid cracking in components of different material is quite remarkable. The similar cracking suggests that a significant load was applied about equally at locations close to the seal pocket radius of both the chamber and tube, thereby overwhelming the expected differences in cracking resistance of the two materials. Referring again to Figure 3, the seal contact load that is applied to the seal surfaces of the chamber and tube meets this criterion of a significant local load being applied to both cannon sections. The question of whether or not seal contact loads can result in tension stresses in the seal pocket radius will be addressed later, in relation to the finite element results.

Results of the finite element analysis are given in Figures 8 and 9, which show contour plots of the radial direction stresses in the area of the seal pocket. Recall from Figure 3 that the location #2 cracking in both components started within 30° of normal to the radial direction. Figure 8 shows the radial stress distribution resulting from the 156 MPa end load. The maximum radial tensile stress in the seal pocket radius is 12 MPa at an angle of 29° from the radial direction, compared with 30° from the radial direction for the observed cracks in Figure 3. Note that most stresses in the area of the seal pocket are compressive and that the $\sigma = 0$ contour approximates the direction of the observed cracks shown in Figure 3. Figure 9 shows the radial stress distribution resulting from the 3023 MPa seal contact load. The maximum radial tensile stress in the seal pocket radius is 233 MPa at an angle of 14° from the radial direction. As with Figure 8, most stresses in the area of the seal pocket are compressive and the $\sigma = 0$ contour approximates the direction of the observed cracks. It is clear from these results that stresses from both end loads and from seal contact loads can account for the initiation location and the growth directions of the observed cracking, and that the seal contact loads have the more significant quantitative effect on cracking. Next, these results will be used to calculate the approximate value of applied stress intensity factor, for comparison with the measured crack growth rate versus applied K data presented earlier.

The cause of cracking at location #2 of both the A723 tube and the 13-8 Mo chamber sections of a prototype cannon, given the presence of hydrogen-laden propellant products and susceptible high strength steels, was the sustained tensile stresses arising from assembly preloads required to maintain pressure seals between cannon components. The seal contact load produced a sustained tensile stress in the seal pocket radius near the location of the observed cracking. The end load between the tube and chamber produced a small addition to the sustained tensile stress at the observed cracking location. Firing pressure loads may have contributed to the initiation of cracking and are believed to be the predominate cause of continued growth of the cracks.

A reduced level of sustained tensile stress near pressure seals in these cannon components can be accomplished by design changes that reduce stress concentrations near the seal contact area. An increased seal pocket radius and a machining process with smaller inherent defect size would reduce the sustained stresses. A small further reduction in sustained stress can be accomplished by increasing the separation distance between the seal pocket area and areas of end load between cannon components.

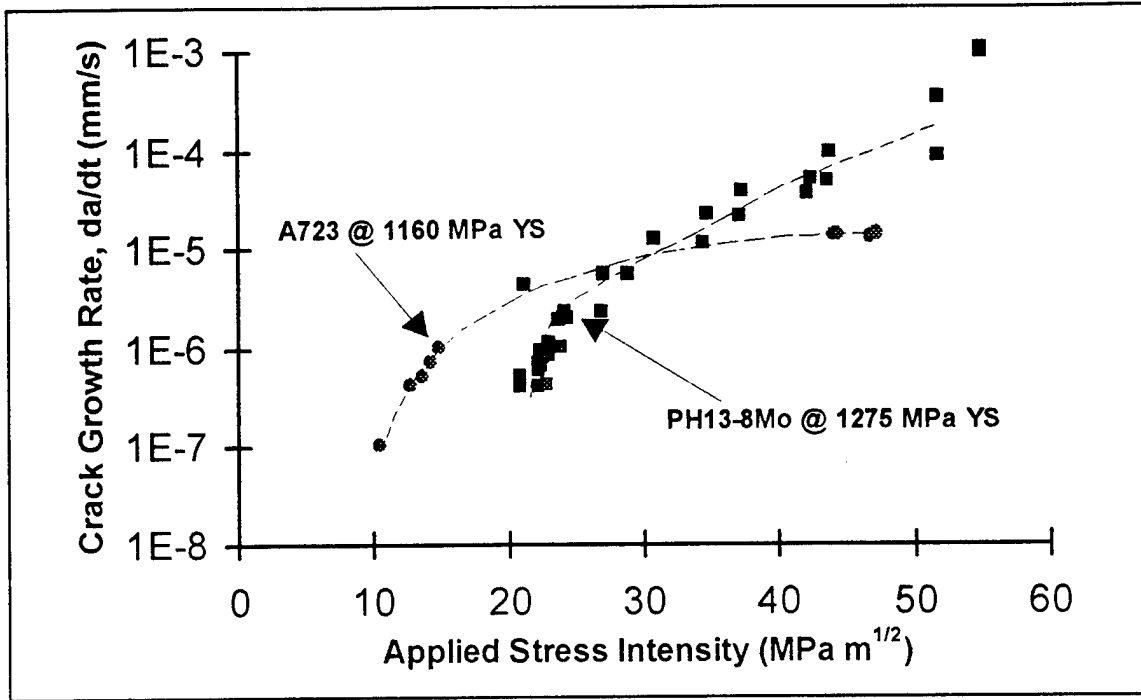
FIG. 5 - Hydrogen Cracking for Two Steels; 3000 hours in Electrolytic Cell

Laboratory hydrogen cracking tests (ref 3) have been performed in response to the earlier environmental cracking incident (ref 1) and to the cracking under discussion here. Results from the prior work with direct application to the discussions here are shown in Figure 5. Bolt-loaded compact specimens were machined from the tube and chamber sections described here and tested in an electrolytic cell containing a 3.5 percent aqueous NaCl solution containing As_2O_3 poison and using a current density of 40 ma/cm^2 . Additional information on the tests is in Reference 3. Crack growth rate from a five-point moving average varies over four orders of magnitude for the two materials. A larger increase in da/dt with increasing applied K was noted for the 13-8 Mo steel, compared with A723. The two materials had about the same da/dt of 10^{-5} mm/s at an applied K of $30 \text{ MPa m}^{1/2}$. Since there was a similar amount of observed cracking at location #2 for the chamber and tube cannon sections, it will be interesting to see if this value of $30 \text{ MPa m}^{1/2}$ is consistent with the calculation of applied K based on finite element results, described later.

The value of applied K determined above, 34.7 MPa $m^{1/2}$, compared with the growth data in Figure 5, can account for the cracking observed at location #2 in both the A723 steel tube and the 13-8 Mo steel chamber. Of course, the value of applied K depends on the assumption of a 0.1-mm deep, 0.02-mm radius defect, but these values are believed to be representative of typical manufacturing methods. Recent work (ref 8) in fatigue initiation with cannon components supports this belief.
