Underground Water Distribution System Fort Belvoir, Virginia

Leak Detection Survey

CONTRACT #DACA01-94-D-0034
SYSTEMS CORP PROJECT #94013.09

August 1, 1995

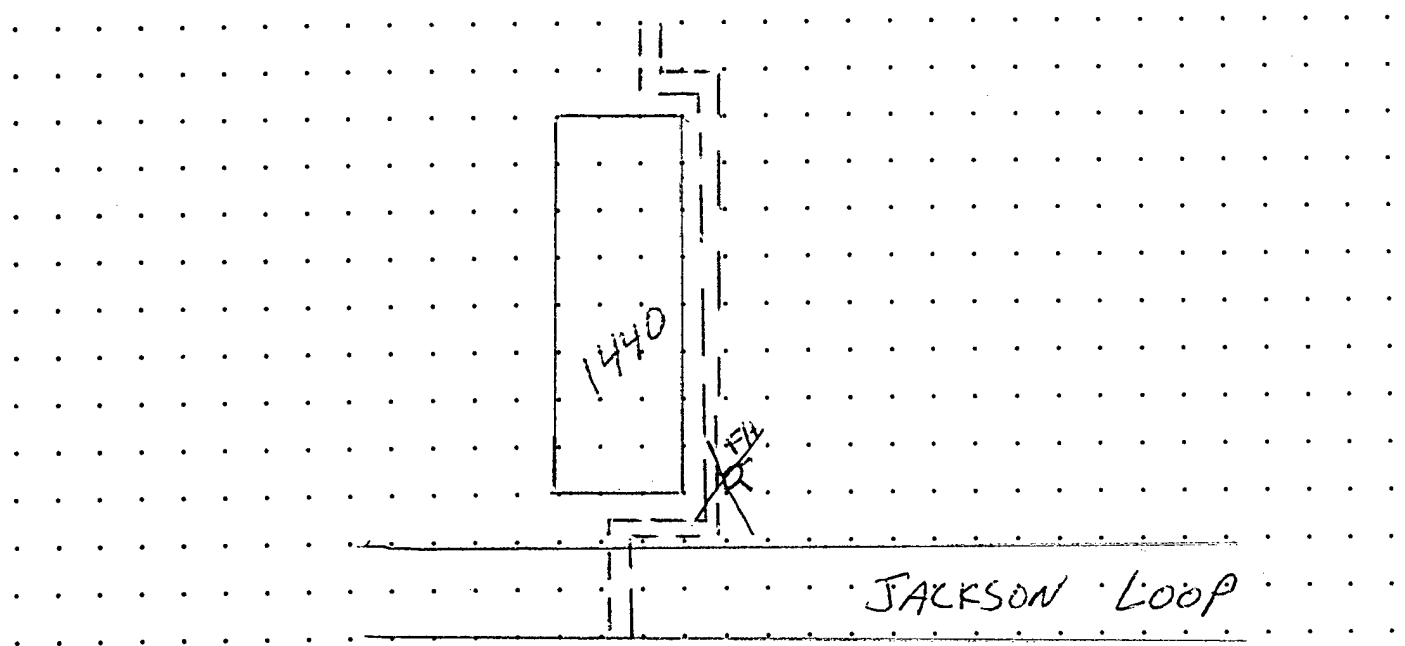
| <u>3 gpm</u> |

FINE hydrant in front of south side of #1440 off Jackson Loop leaking

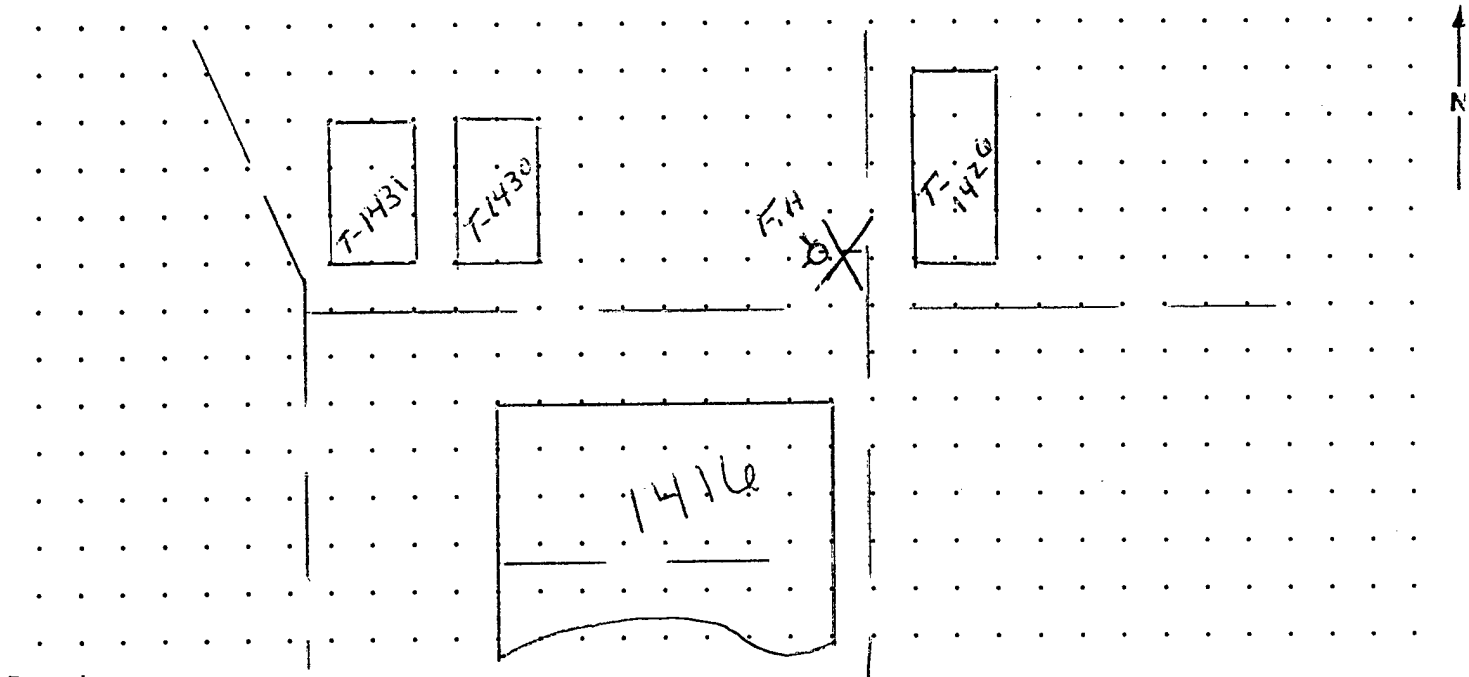
2 gpm

Fire hydrant at west side of Building T-1426
LEAKING

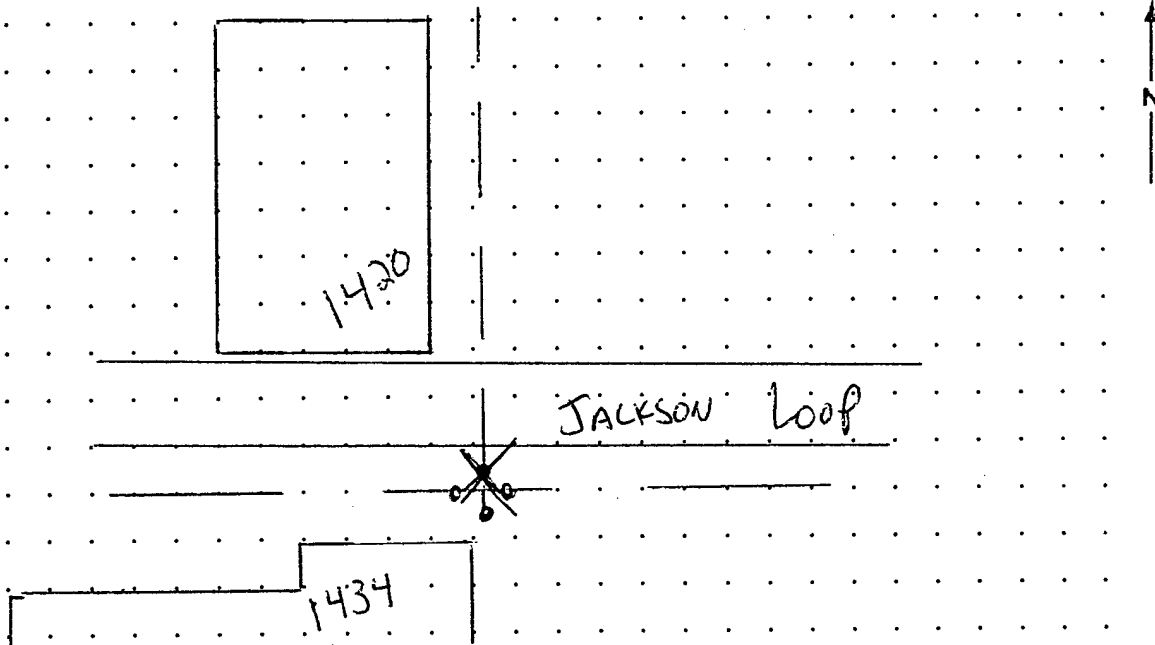
| <u>4 gpm</u> |

VALVE CONTROLLING FLOW NORTH ON 8" LINE
RUNNING ALONG EAST SIDE OF BUILDING 1420 LEAKING. VALVE
IS OFF SOUTH SIDE OF JACKSON LOOP AT NORTHEAST CORNER
of BUILDING #1434

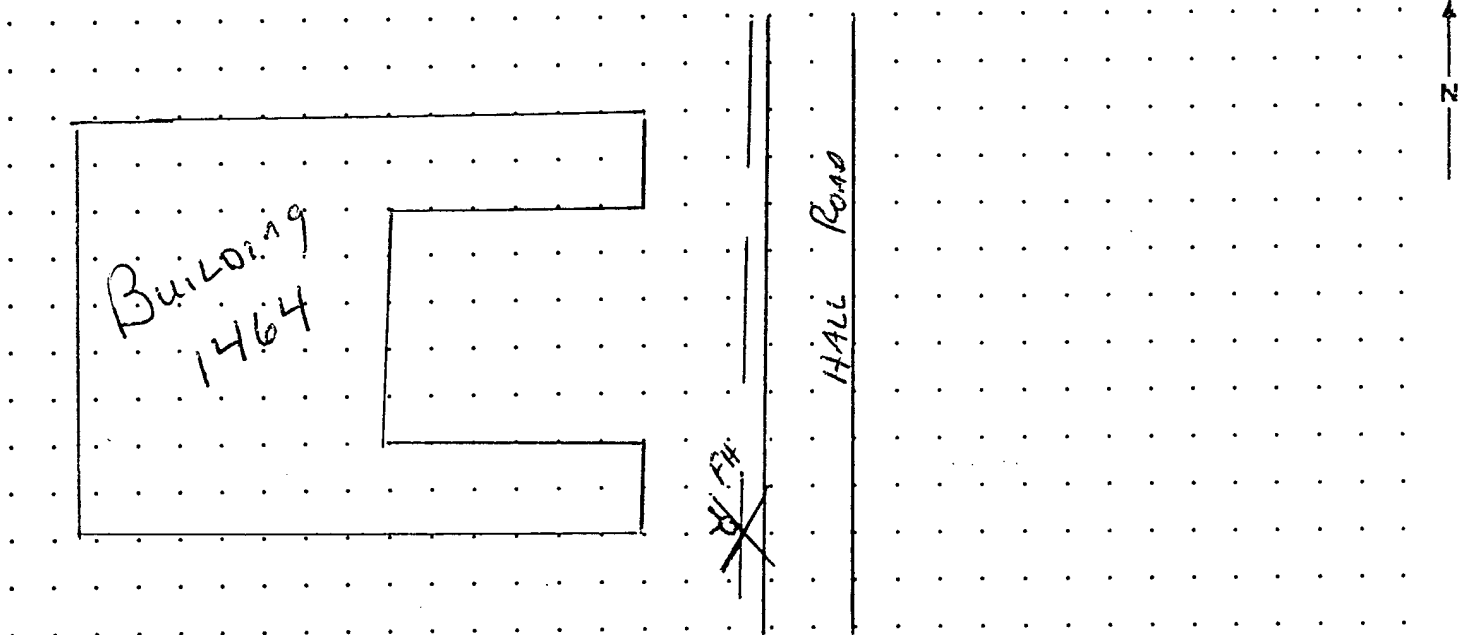
FINE hydrant on EAST SIDE of Building # 1464
Along HALL Road leaking

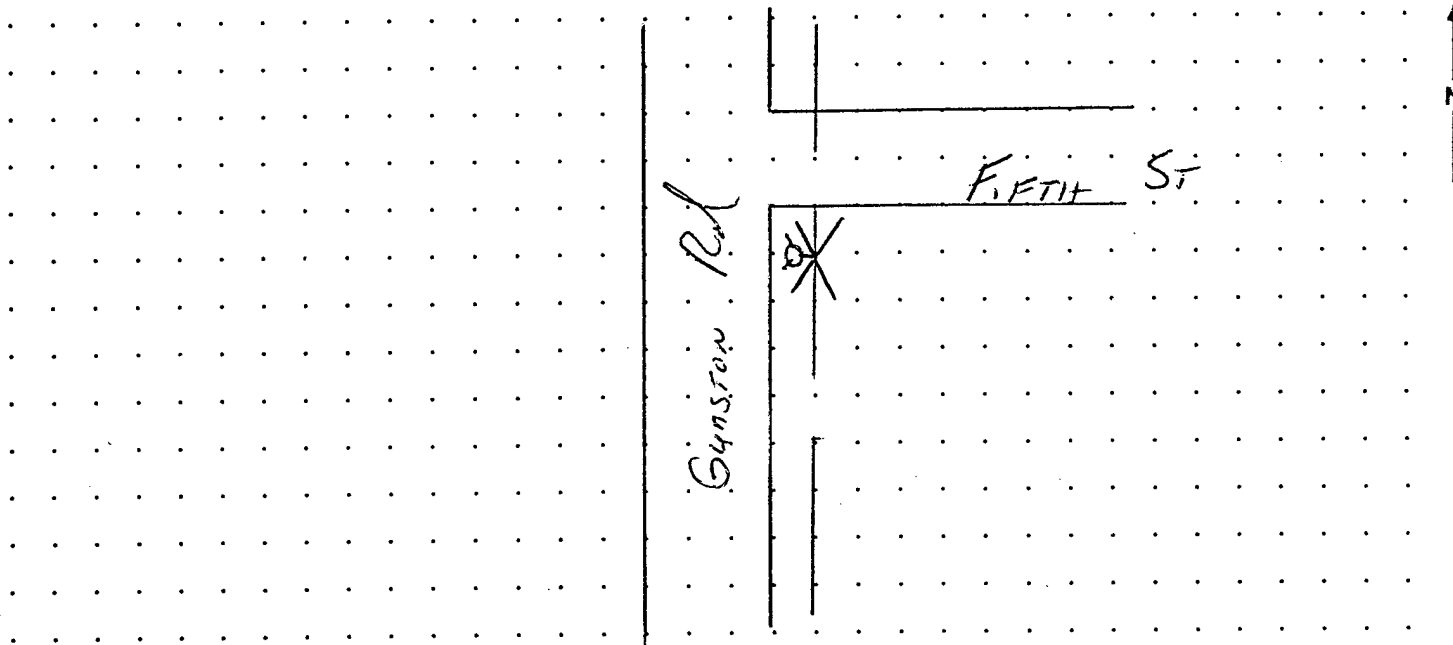
Fire hydrant at intersection of Gunston Rd & Fifth St leaking

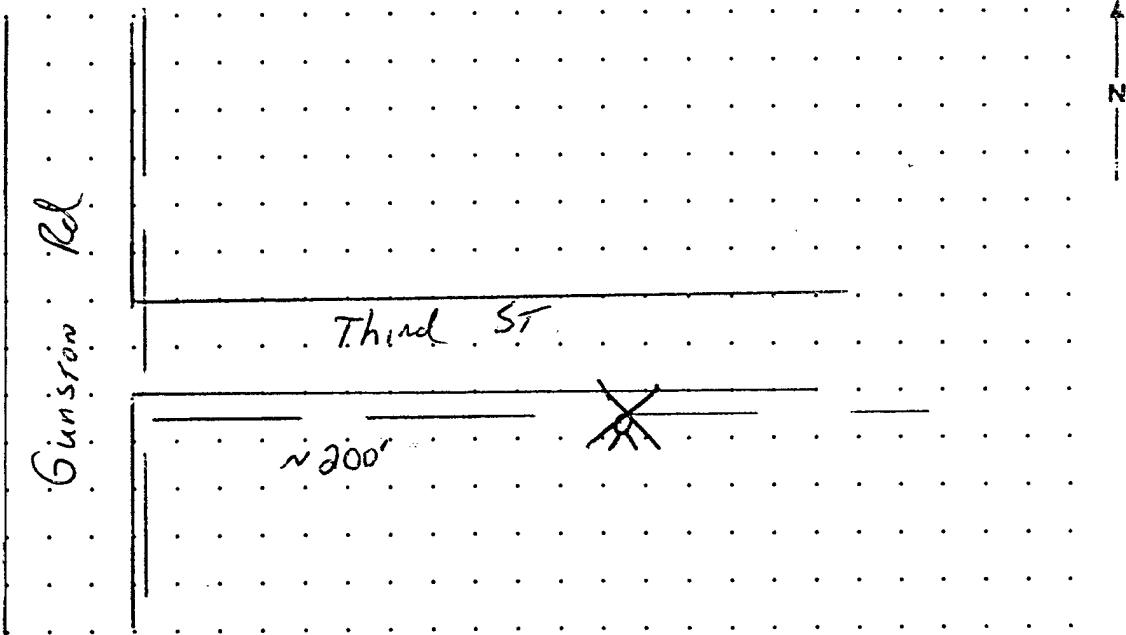
MAP- H-8

4 gpm

Remarks Fire hydrant on Third St approx 200 FEET EAST of INT of Third St + Gunston Rd LEAKING

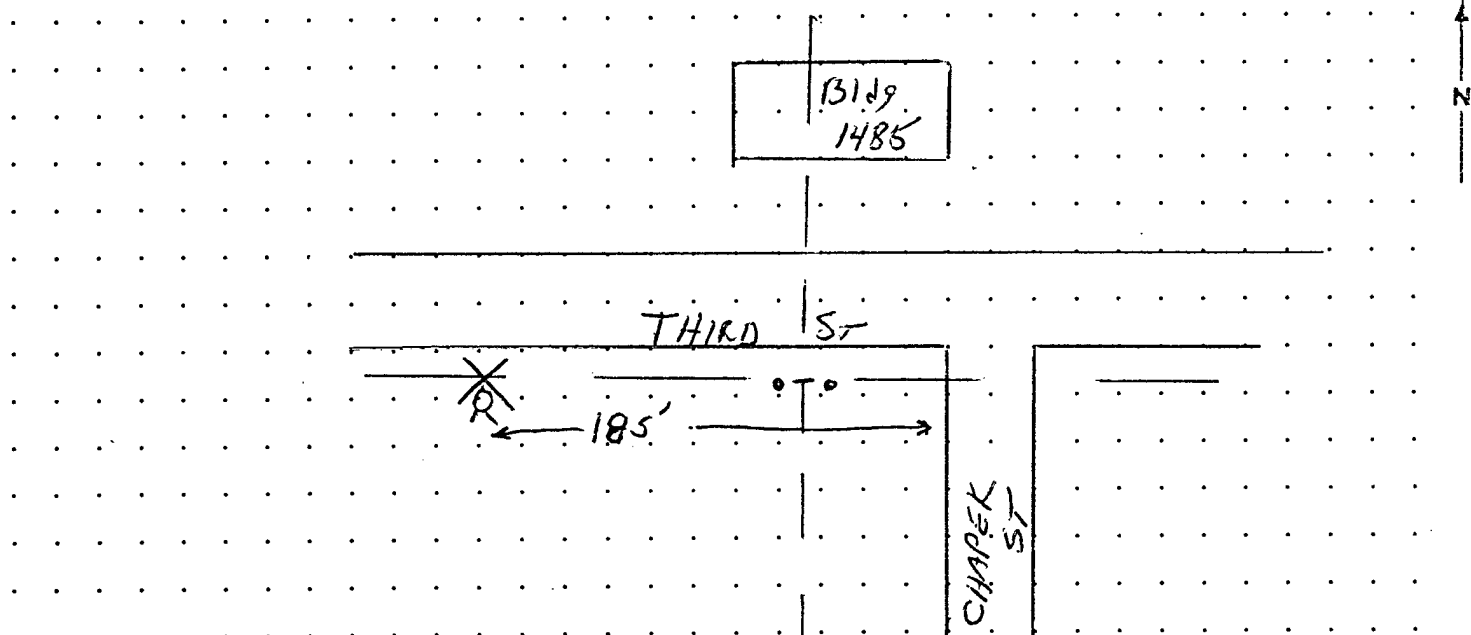
MAP H-8

| <u>4 gpm</u> |

Remarks Fire hydrant on Third St approx 185' west of Int of Third St & CHAPEK ST LEAKING

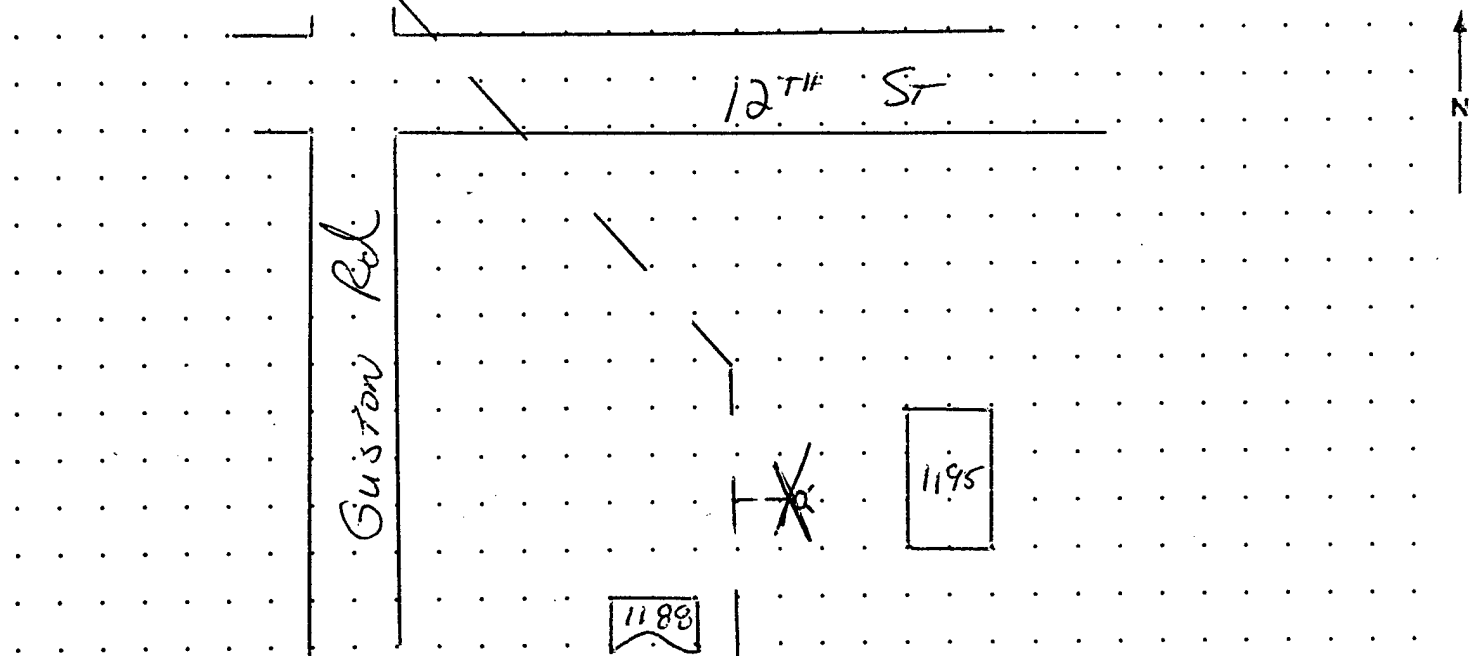
| <u>1 gpm</u> |

Fire hydrant in grass in front of Building #1195 leaking

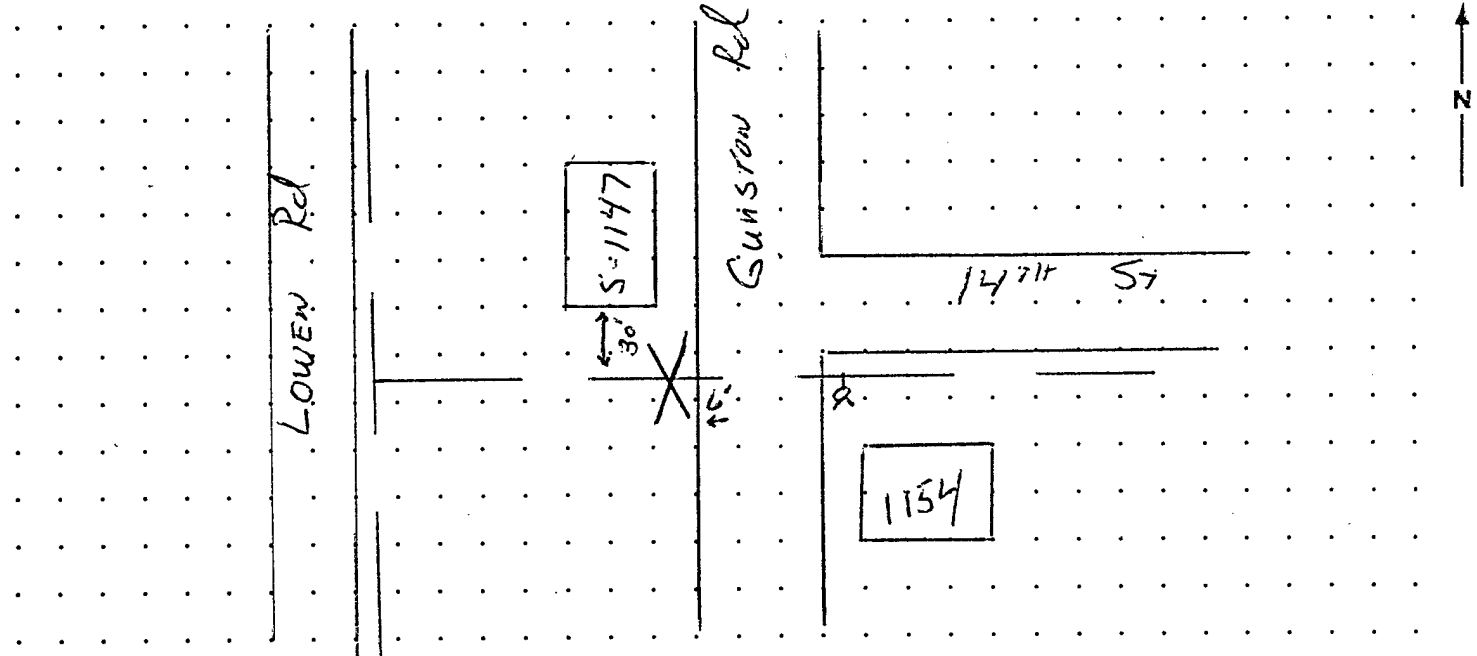
MAP J-8

| INDICATION OF LEAK | LEAKAGE DETECTED AT: | LEAK APPEARS TO BE ON: | COVER |
|---|--|---|--|
| ESTIMATION OF LEAKAGE: <u>10 gpm</u> | See Remarks | | |

Remarks LEAK on 8" MAIN off 12" MAIN. LEAK IS
Behind CURBLINE south of Building # S-1147. LEAK
is approx 30' south of south Building Wall of # S-1147
and approx 10' west of west curb line of Gunston Rd
across Road from int. of Gunston Rd + 147th St

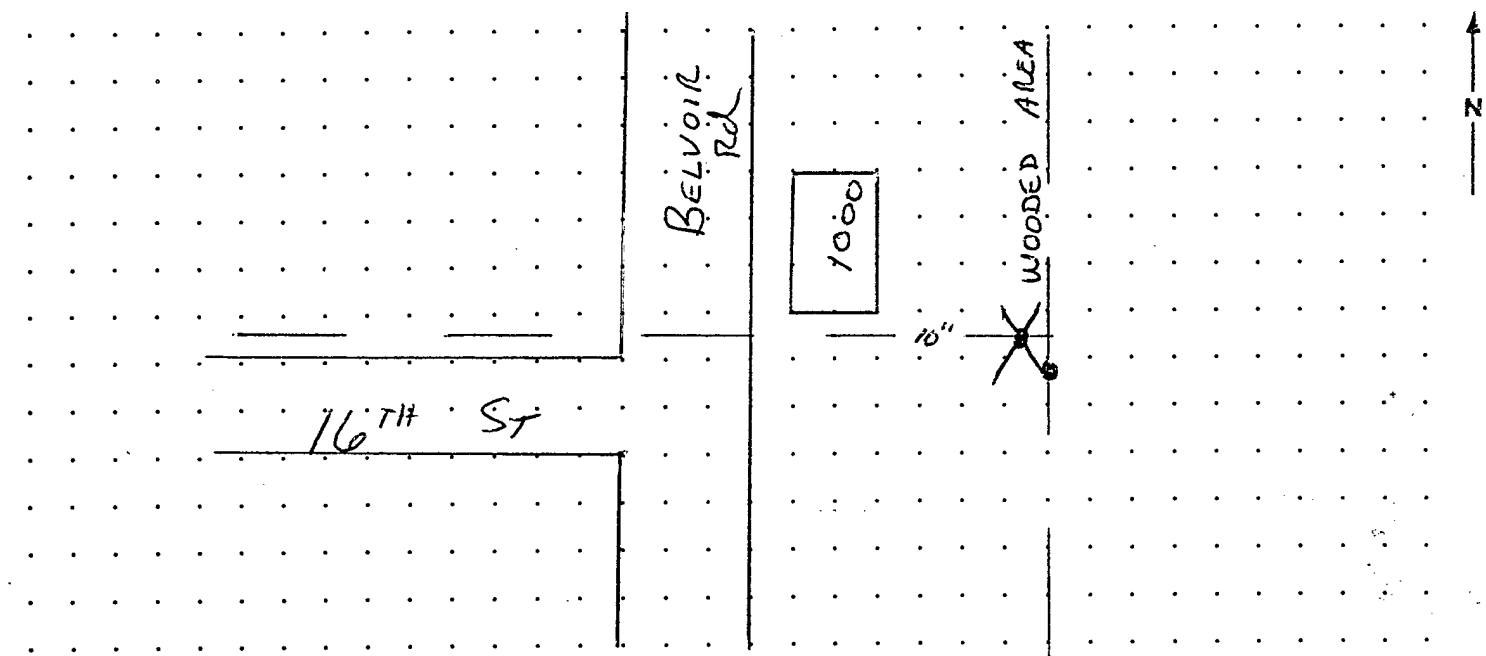
MAP J-9

| <u>3 gpm</u> |

Remarks LEAK APPEARS to be on MAIN, AT OR NEAR
VALUE (possible flange) on water line running WEST along
side of Building #1000. LEAK & VALVES ARE IN WOODED AREA
Behind Building #1000.

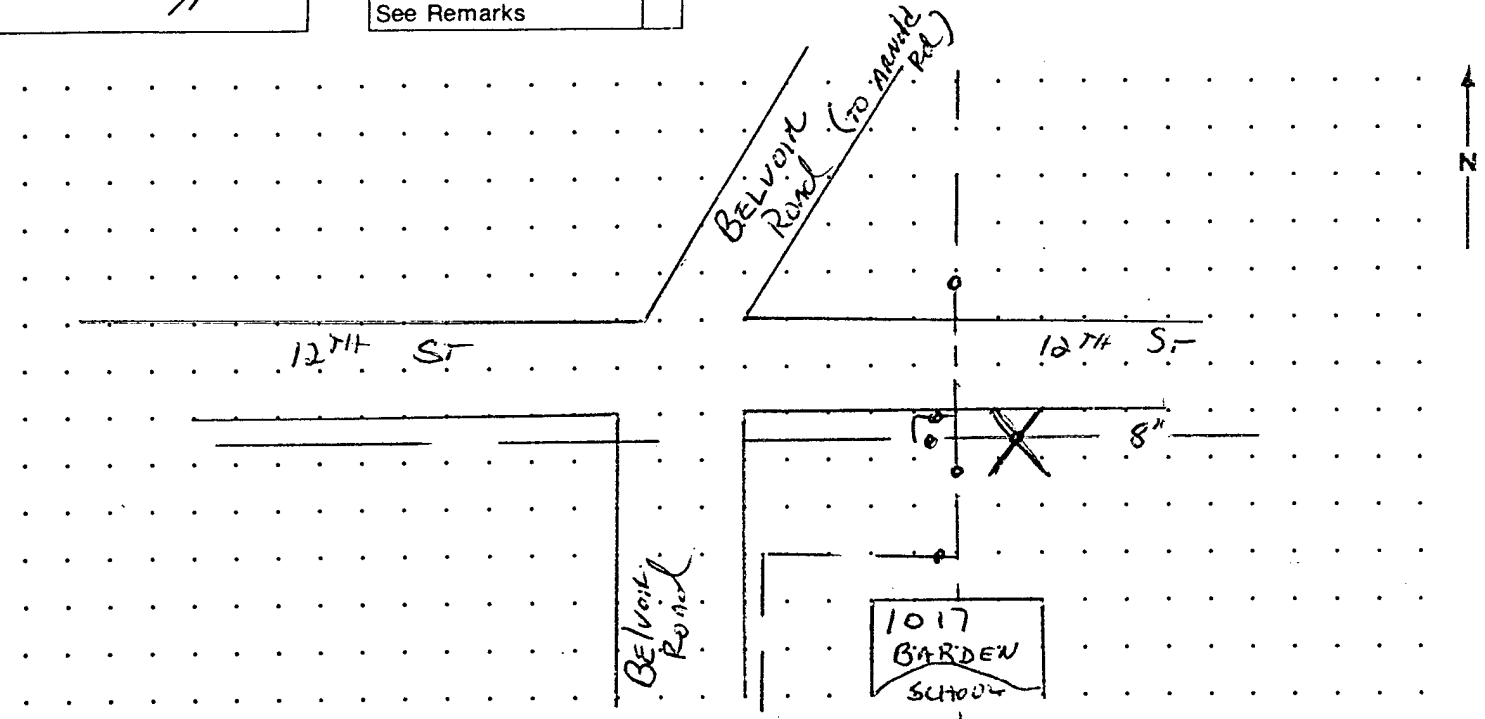
MAY J-9

2 gpm

Remarks 8" valve controlling flow EAST on 12th ST
from valve group along 12th ST in front of # 1017
(BARDEN School); leaking - WATER SURFACING

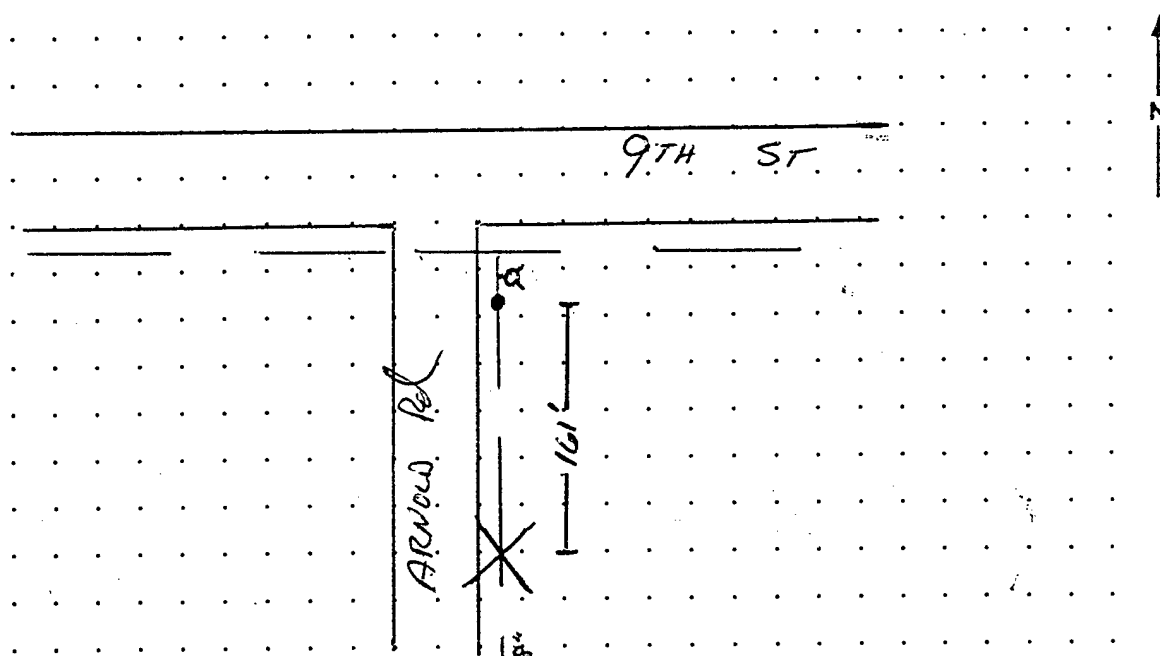
MAP I-8

| <u>10 gpm</u> |

Remarks LEAK APPEARS TO BE 8" MAIN ALONG EAST
SHOULDER OF ARNOLD ST 161' SOUTH OF MAIN VALVE
ON ARNOLD RD AT INT OF ARNOLD RD + 9TH ST

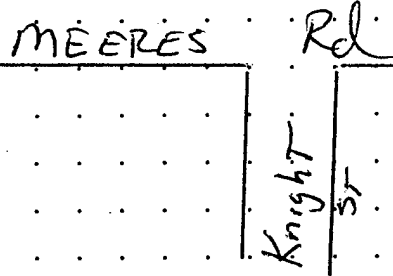
| <u>1 gpm</u> |

LEAK ON 2" TAP FOR AIR RELEASE VALVE ON 16" IN MANHOLE IN FRONT OF #1741 MEERES RD (CHENEY School)

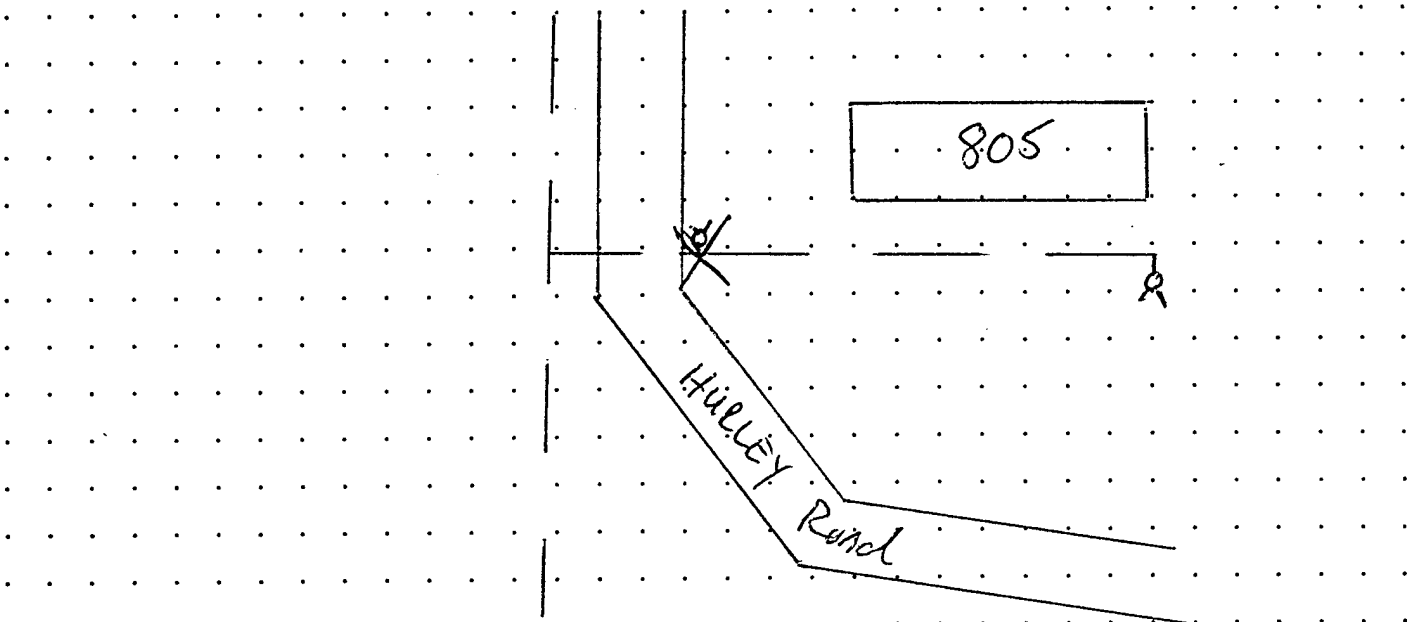
MAP - J-9

3 gpm

Remarks Fire hydrant on Hurley Road NEAR WEST SIDE OF Building # 805 LEAKING

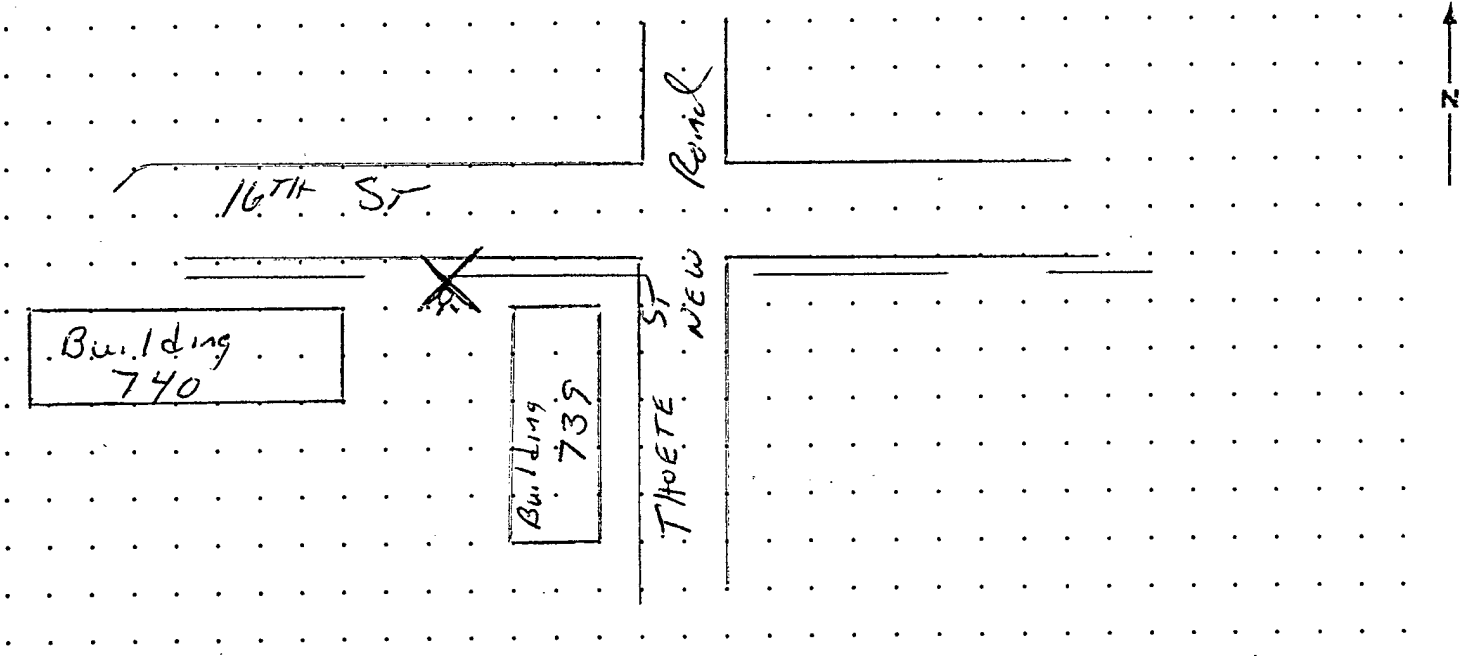
MAP K-8

ESTIMATION OF LEAKAGE:
25 gpm

Remarks LEAK APPEARS TO BE AT FIRE hydrant, possibly had
LATERAL AT FIRE hyd on 16TH ST Between Buildings # 739
& 740

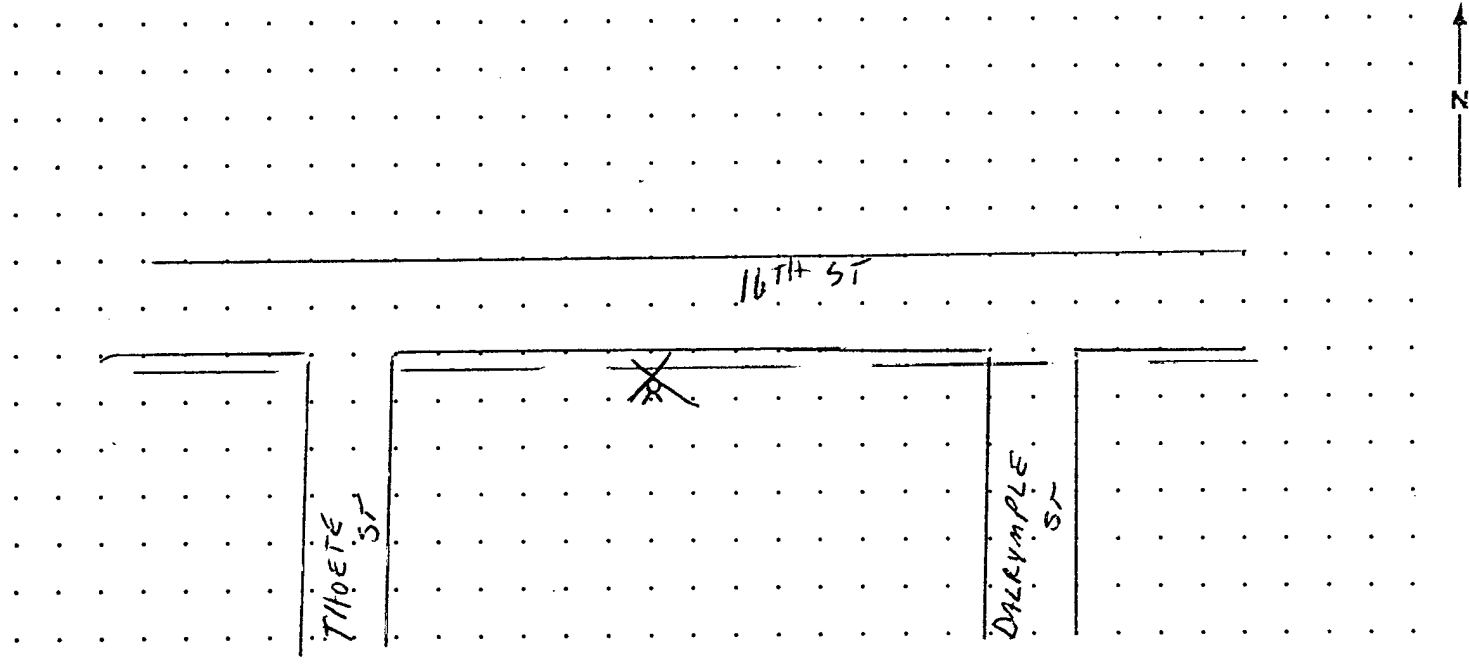
1 gpm

Fine hydrant on 16TH ST Between Dalrymple ST & THOETE ST LEAKING

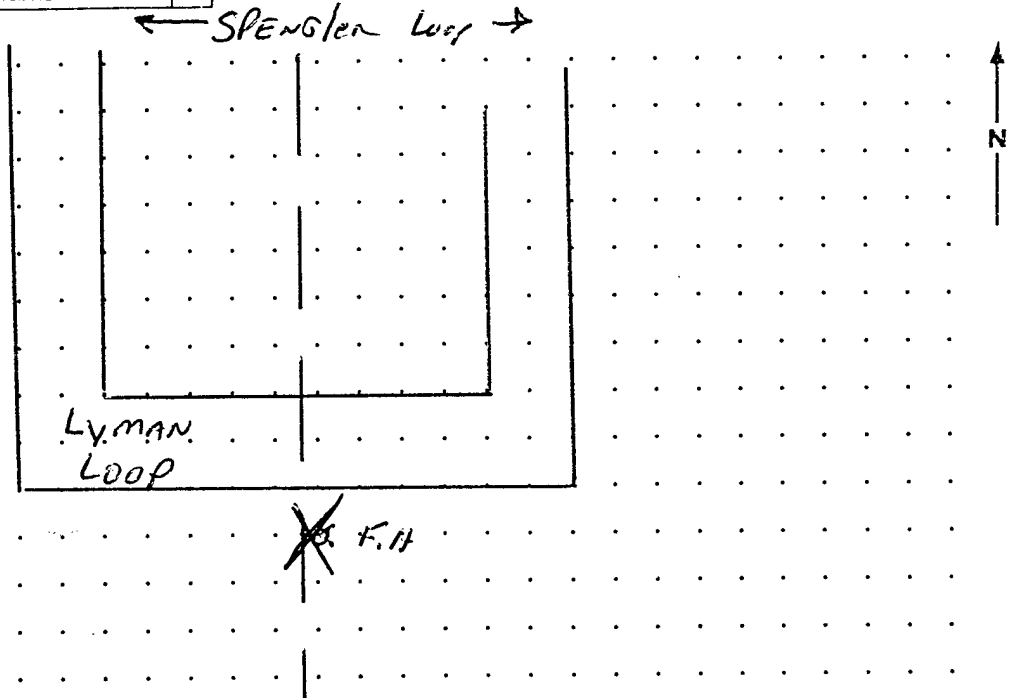
ESTIMATION OF LEAKAGE:
15 gpm

Remarks Fire hydrant Body at FINE hydrant on back side of Lyman Loop cracked - Fire hydrant has 1 1/2" crack in Body

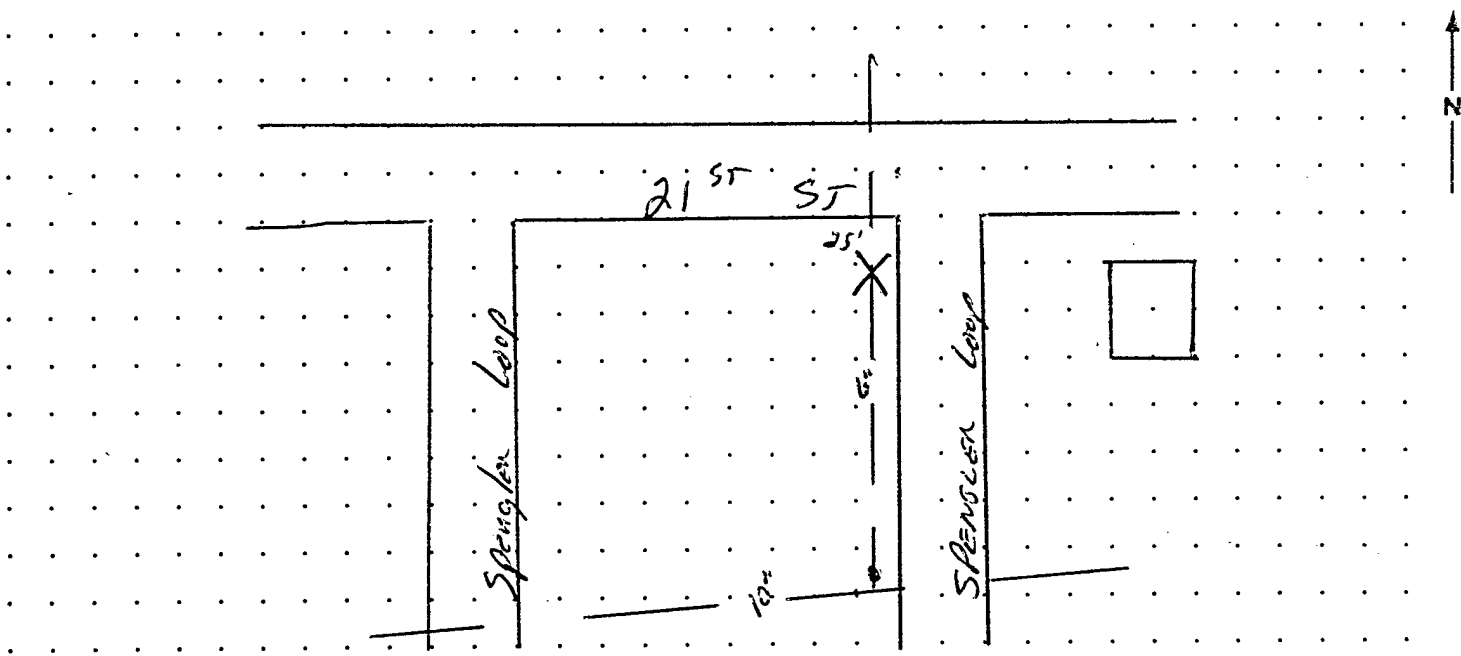
5 gpm

LEAK on 6" MAIN Running on west side of
Spengler loop AT 21ST ST - LEAK SURFACING - LEAK
IS N 25' off 21ST ST INTO SOIL

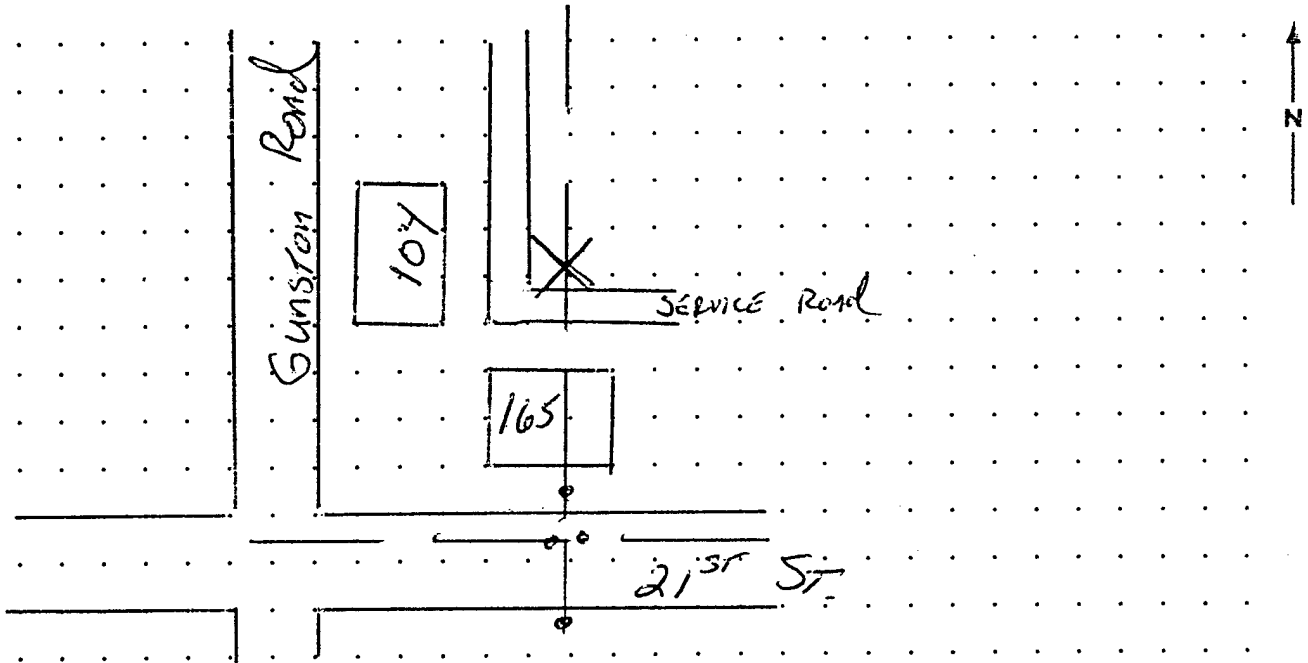
MAP-K-9

| <u>20 gpm</u> |

Remarks LEAK APPEARS TO BE ON MAIN ALONG NORTH SIDE OF SERVICE ROAD BEHIND #165 21ST ST

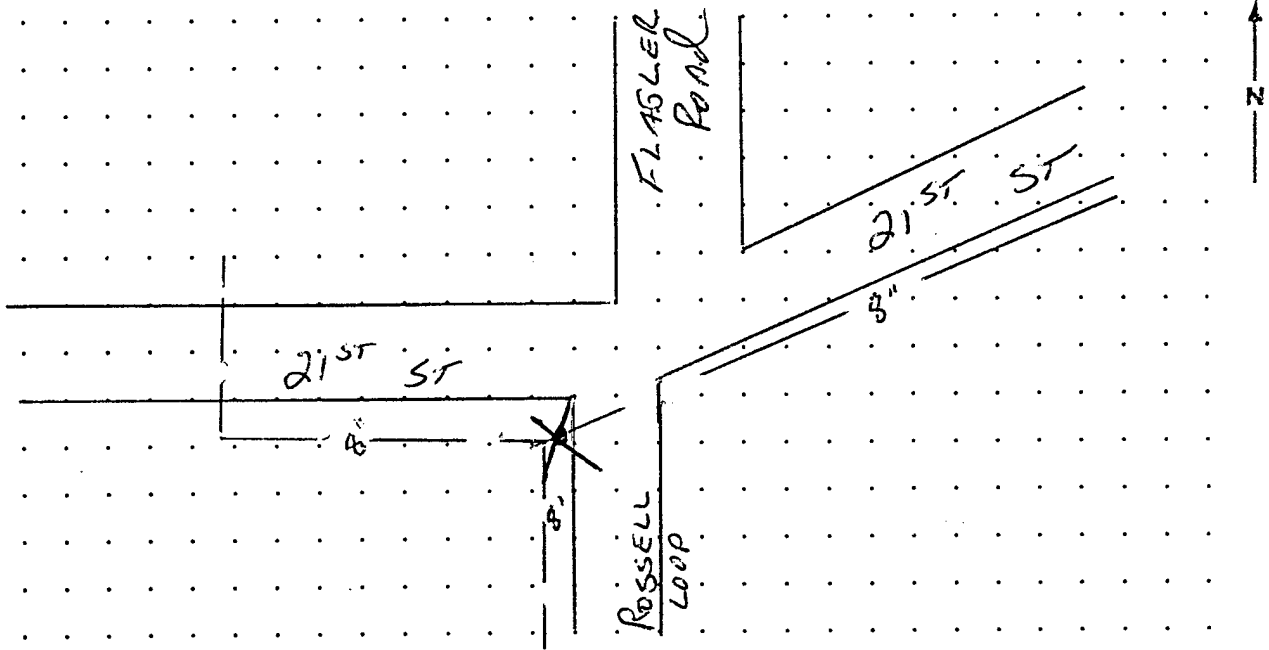
| <u>2 gpm</u> |

8" MAIN VALVE AT SE. CORNER OF INT OF Rossell Loop & 21ST ST STREET LEAKING. WATER SURFACING

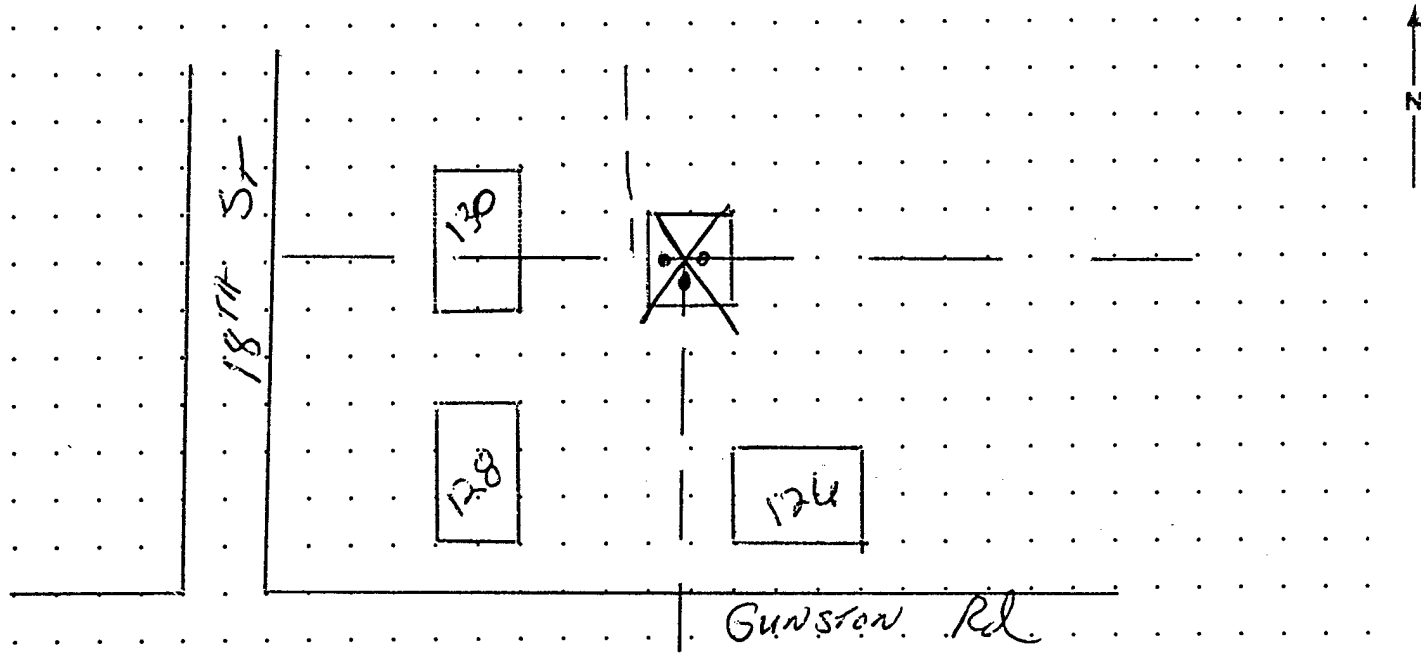
ESTIMATION OF LEAKAGE:
3 gpm

Remarks LEAK APPEARS TO BE ON VALVE IN VALVE PIT AT REAR OF #130 18TH ST. PIT IS FULL OF WATER SO EXACTLY WHICH VALVE IS LEAKING CANNOT BE DETERMINED

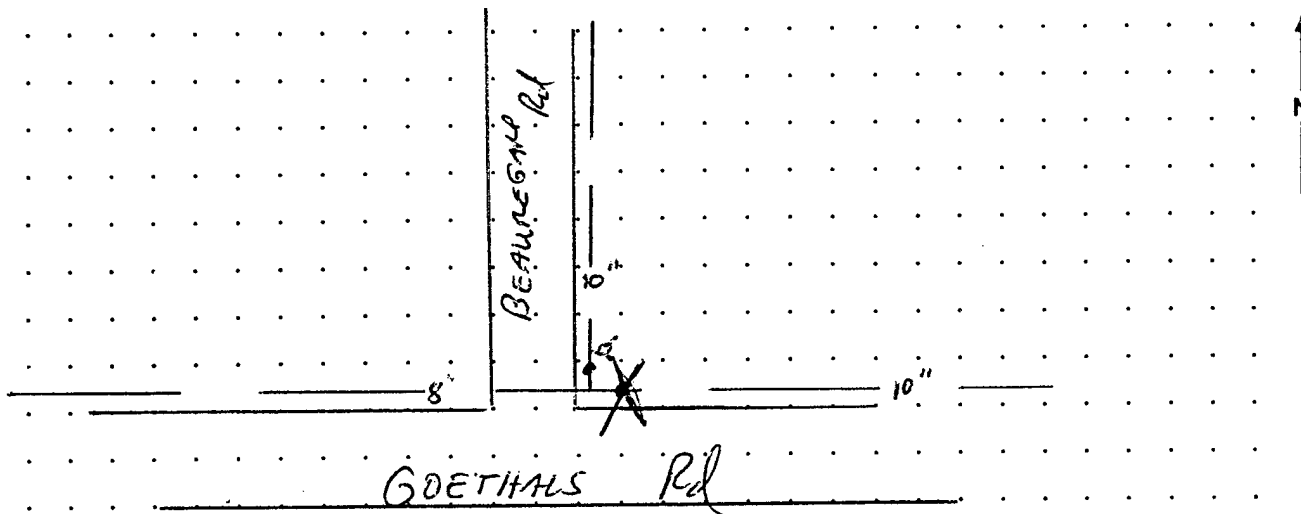
| <u>1 gpm</u> |

10" MAIN VALVE controlling water flow EAST ON GOETHALS Road FROM INT WITH BEAUREGARD Rd LEAKING

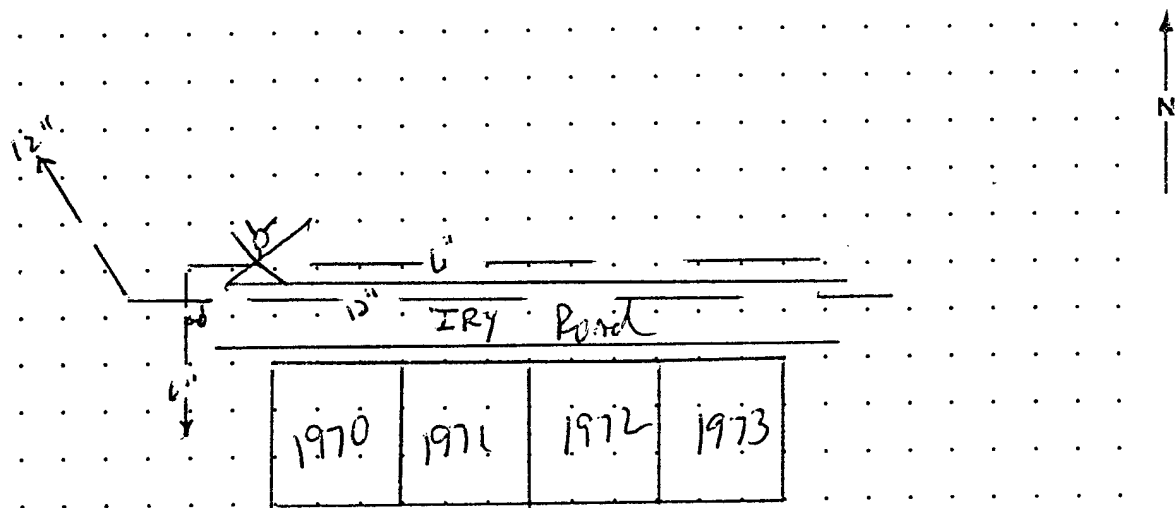
ESTIMATION OF LEAKAGE:
3.9 gpm

Remarks Fire hydrant AT REAR of #1970 IRY Road
LEAKING
A POSSIBLE SECOND LEAK HERE - maybe 12" x 6"
BEHIND TIE IN. TOO MUCH MUD, WATER & CAT TAILS.
NEED TO LOCATE EXACT SOURCE of surfacing
water

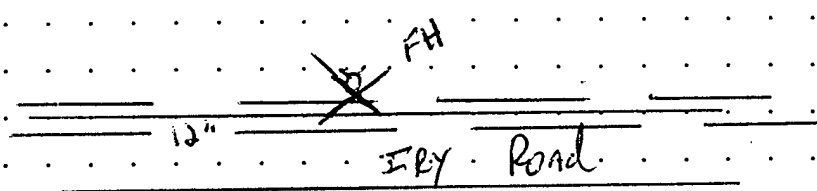
Fire hydrant across ERY Road from Building #1972
leaking

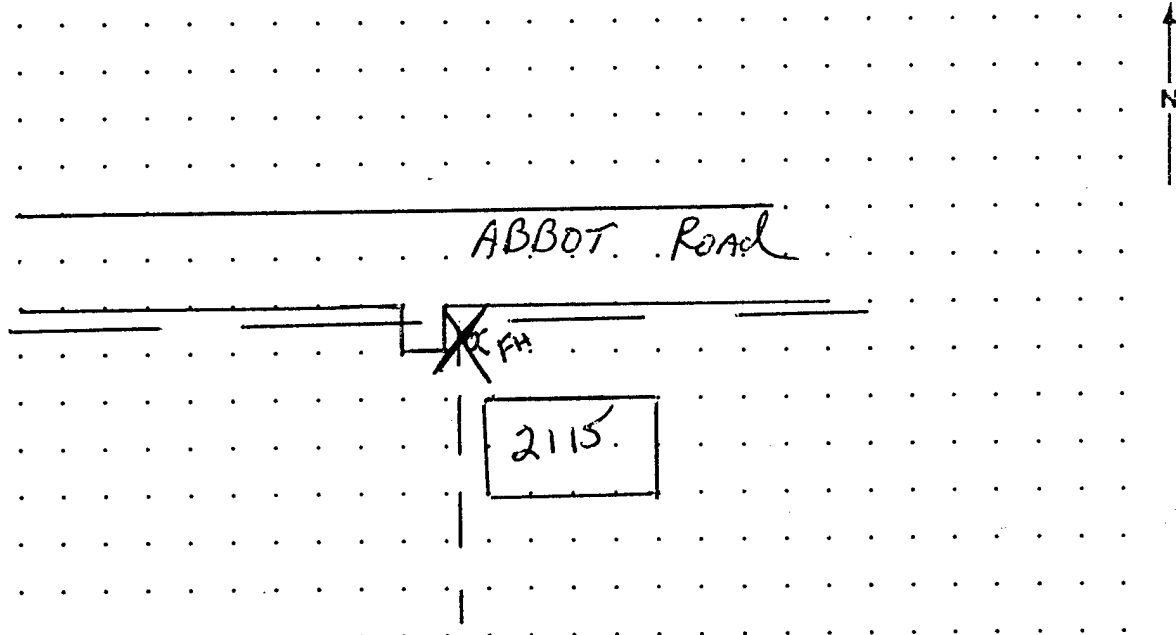
MAP G-7

1 gpm

Remarks Fine hydrants AT N.W corner of Building # 2115 (NORTH HEALTH CLINIC) ON ABBOT ROAD LEAKING

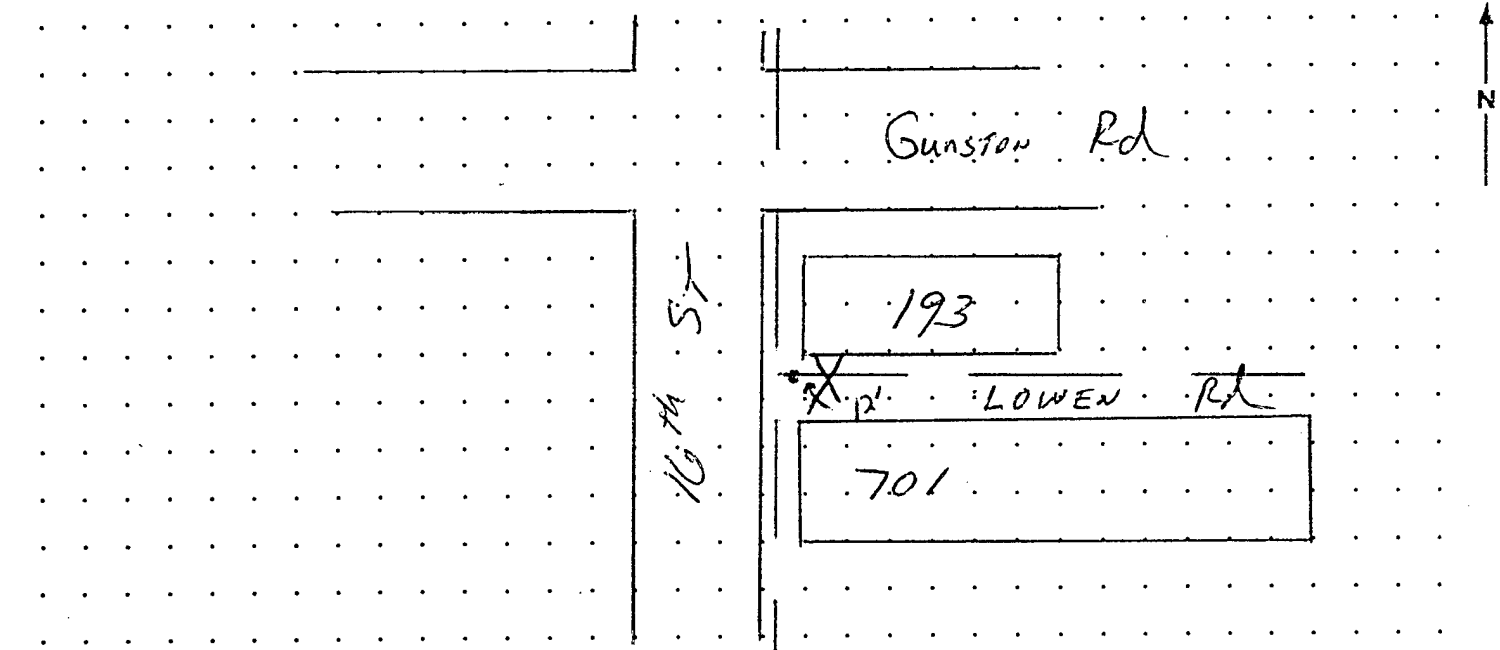
| <u>10 gpm</u> |

Remarks LEAK APPEARS to be on 6" MAIN RUNNING EAST FROM 16th ST Between Buildings # 193 & 701. LEAK IS APPROX 12' EAST OF 6" MAIN VALVE AT INT OF 16th ST & Access Road Between Buildings (LOWEN Rd) 193 & 701

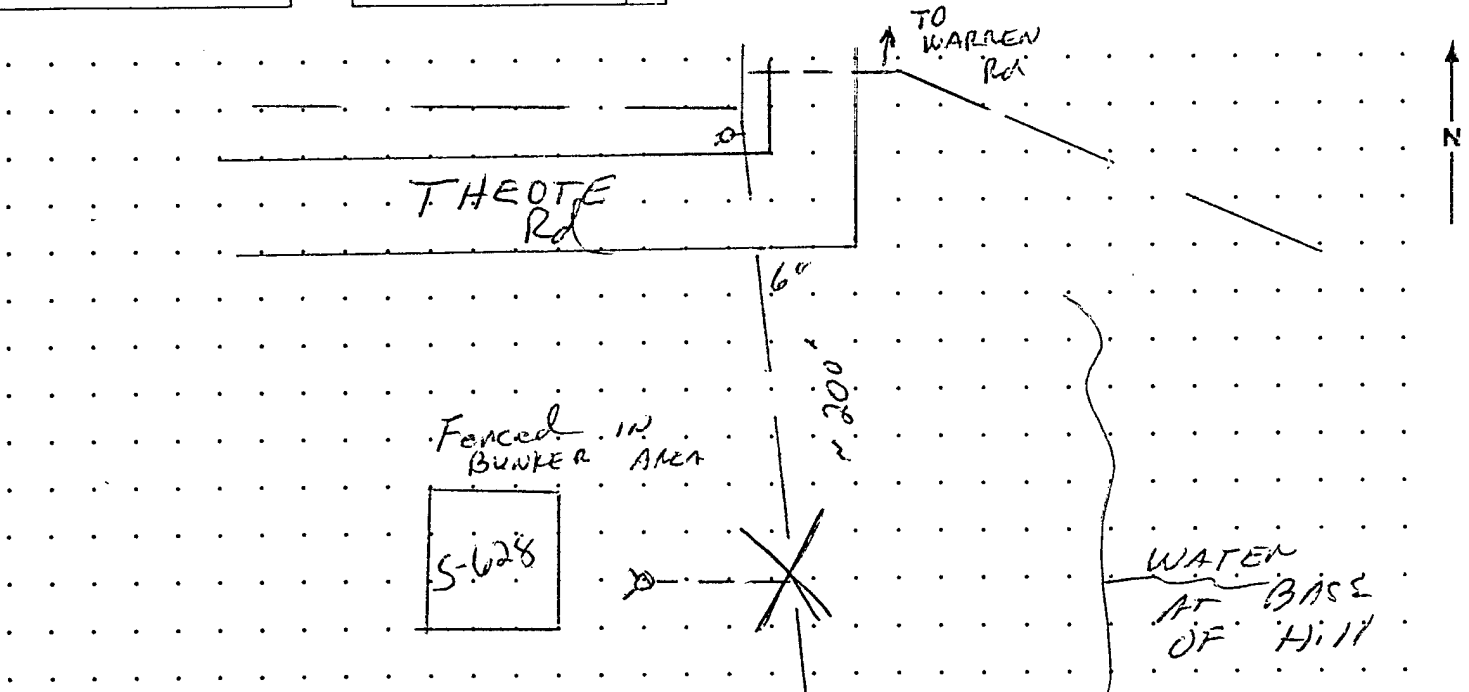
| <u>100 gpm</u> |

LEAK APPEARS to be on 6" MAIN IN
right of way off of THEOTE ROAD. LEAK IS IN
AREA of FIRE hydrant "T" NEAR BUILDING S-628
