Underground Water Distribution System Fort Belvoir, Virginia

Leak Detection Survey

CONTRACT #DACA01-94-D-0034
SYSTEMS CORP PROJECT #94013.09

August 1, 1995

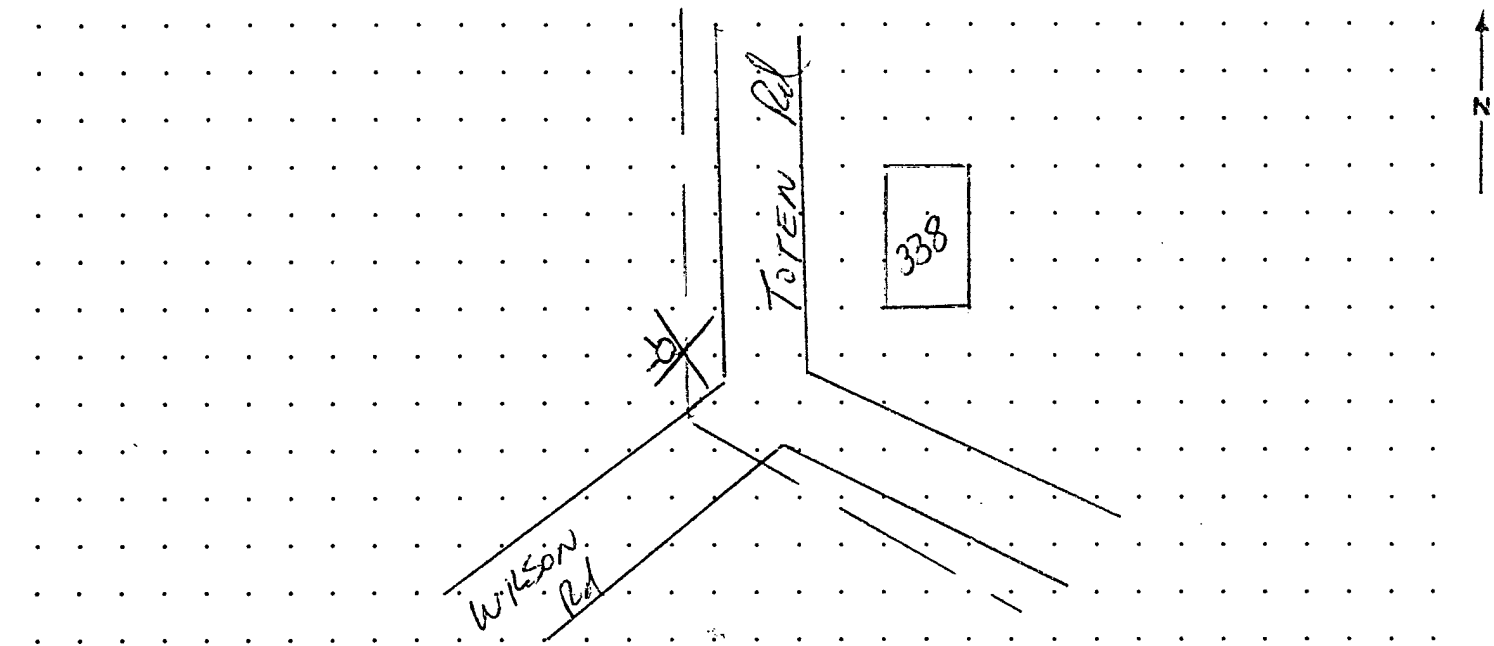
MAR 11-9

Remarks Fire Hydrant across TOTTEN Road from BUILDING #338 LEAKING

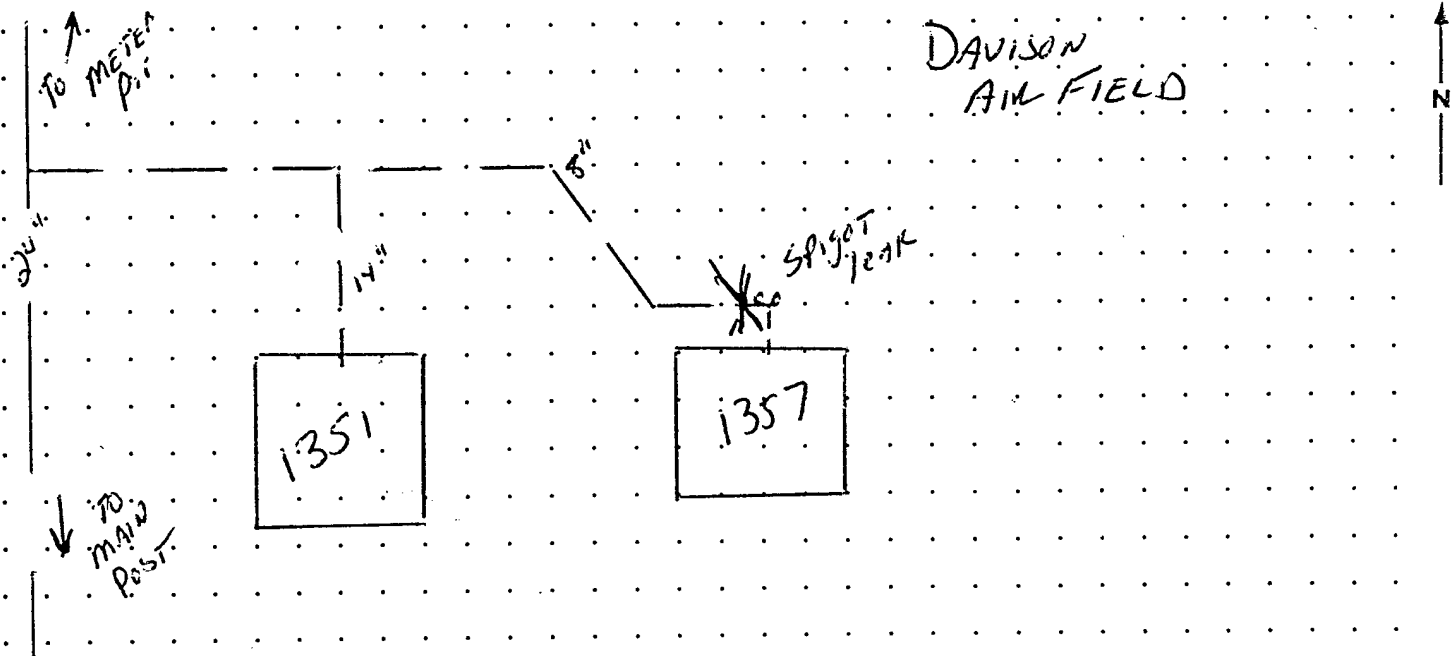
6-5

| <u>1 gpm</u> |

Remarks OUTSIDE YARD SPIGOT LEAKING AT BASE
WATER SURFACING

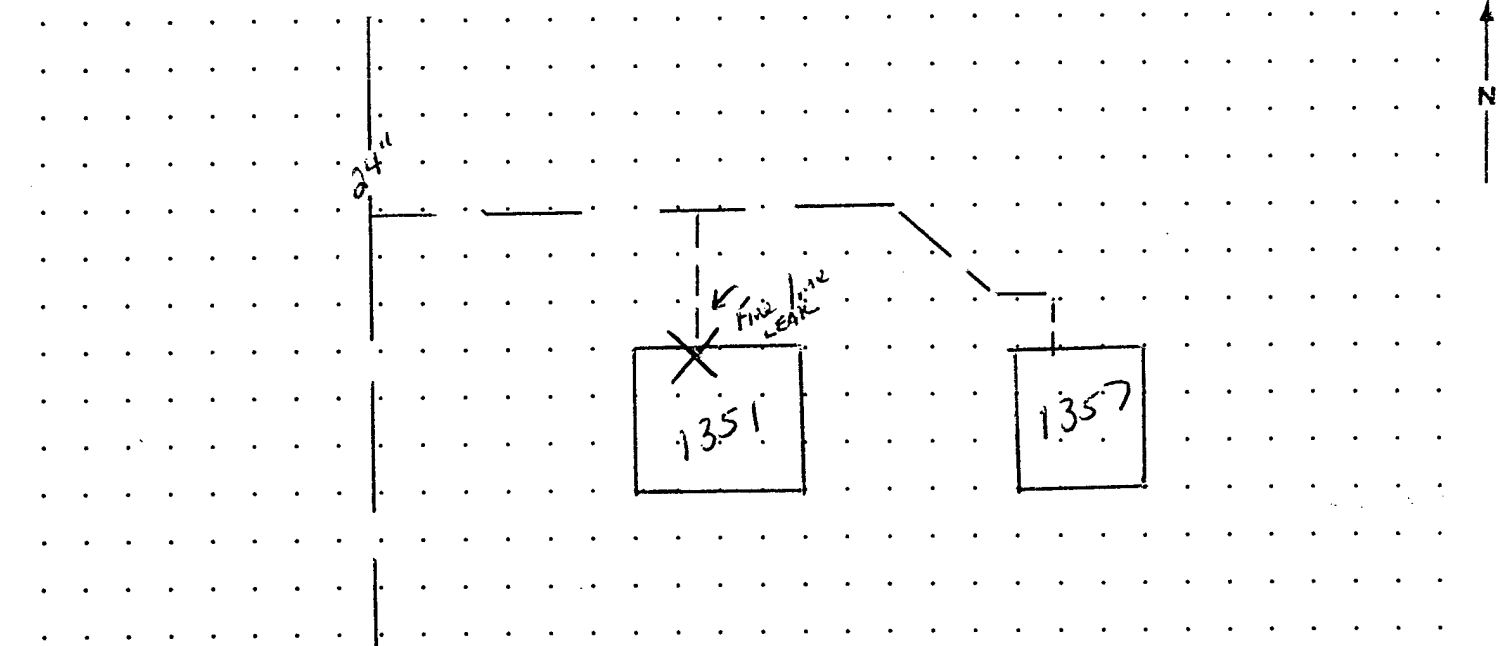
MAP 6-5

Remarks Check VALVE on sprinkler line in Building # 1351 leaking through drain line, water coming out DRAIN LINE OUTSIDE BUILDING
