ARMY RESEARCH LABORATORY

Examination of BSU-86/B Setscrews

ARL-MR-379

NOVEMBER 1997

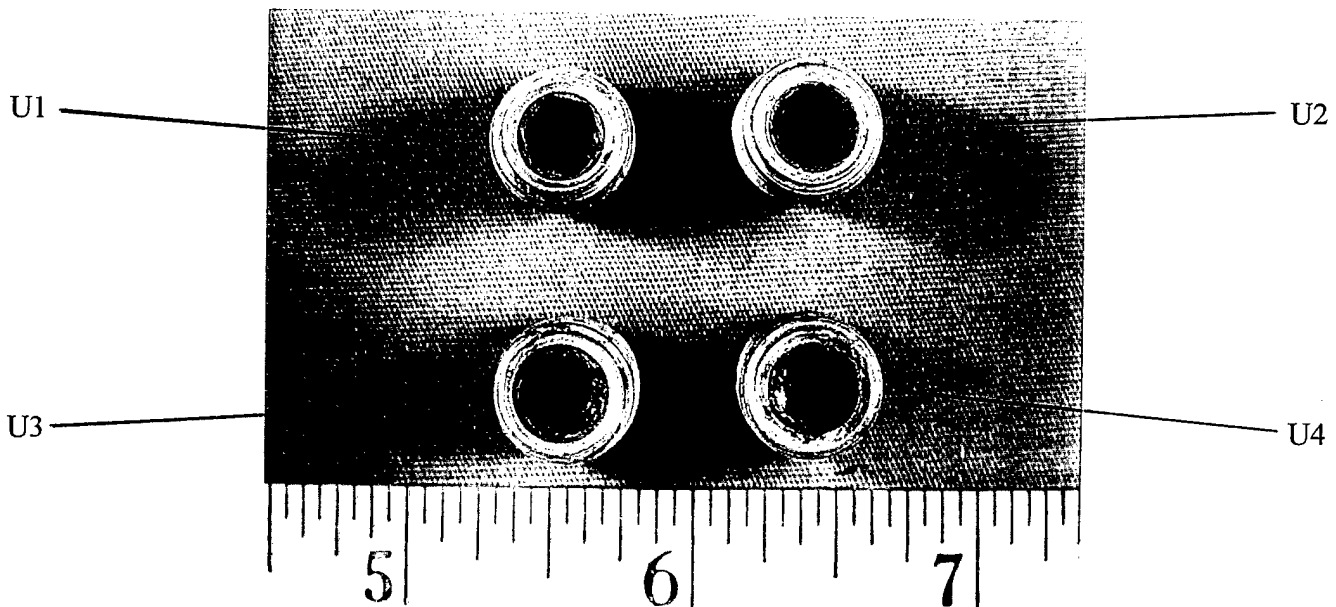
Figure 1. Photograph of the Four Used Setscrews in the As-Received Condition. (U1 represents the setscrew with the most intact socket, while U4 represents the setscrew with the worst stripped socket.)

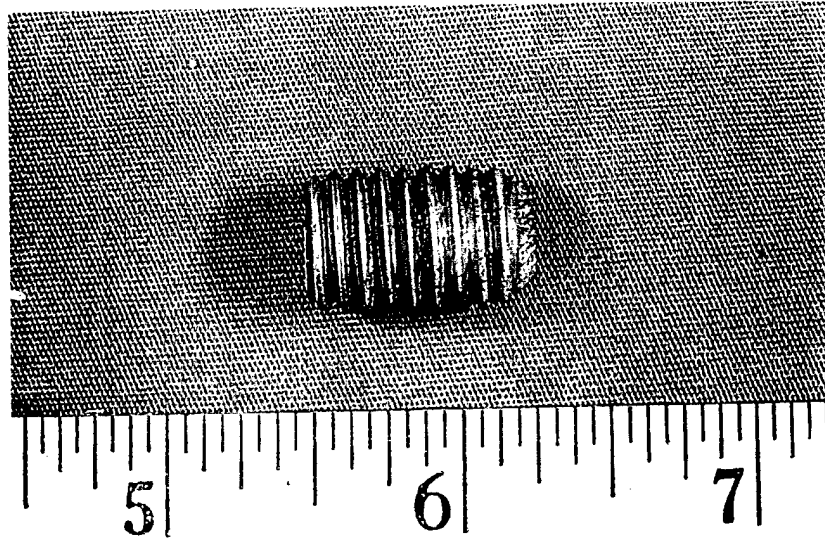
Figure 2. Representative Used Setscrew in the As-Received Condition.

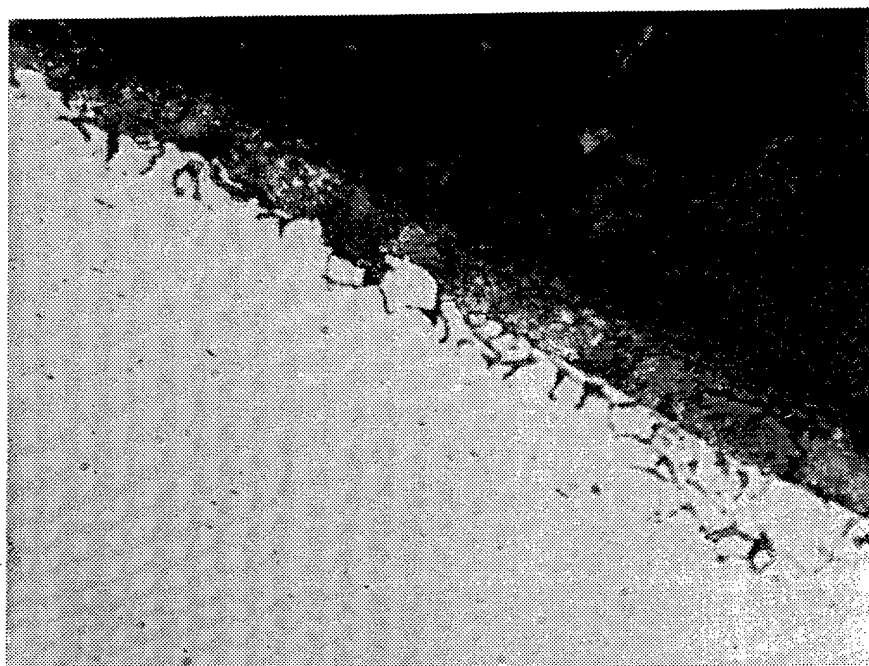
Metallography was used to confirm the presence of decarburization along the periphery of the setscrews. The setscrews that were sectioned and mounted for microhardness testing were subsequently metallographically prepared. The samples were first examined in the as-polished condition. The samples were relatively clean and exhibited no appreciable inherent material defects. Some surface laps were noted in the roots of some threads, as shown in Figure 6. This particular lap was found in a thread root of setscrew N1. Along the surface of the samples, areas of microcracking were also noted. These cracks were filled with cadmium, which indicated that they were present before the plating operation. The amount of cracking varied from setscrew to setscrew, as well as from thread root to thread tip. This cracking was not noted along the socket surfaces. The cracking along a thread flank of the U1 setscrew is shown in Figure 7, which represented the worst case

scenario. This cracking was heavier than that noted along the flank of the U4 setscrew (see Figure 8). Table 5 summarizes the extent of the cracking noted. No comparison could be drawn between the used versus the new setscrews; however, the heaviest areas of microcracking correlated to the regions of heaviest decarburization.

Figure 7. Microcracking Noted Along a Thread Flank of Setscrew U1 (magnification 1000x).

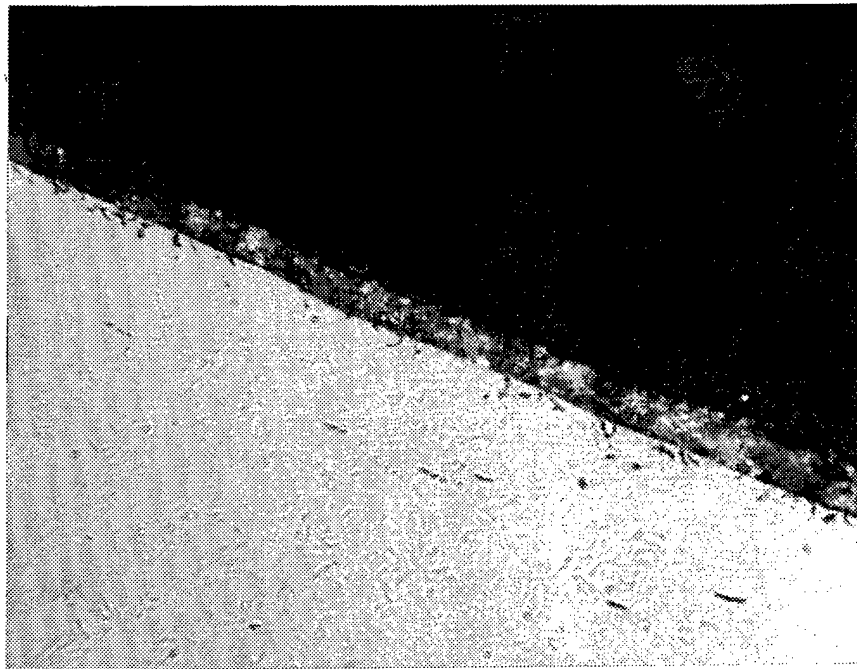
Figure 8. Microcracking Noted Along a Thread Flank of Setscrew U4 (magnification 1000x).

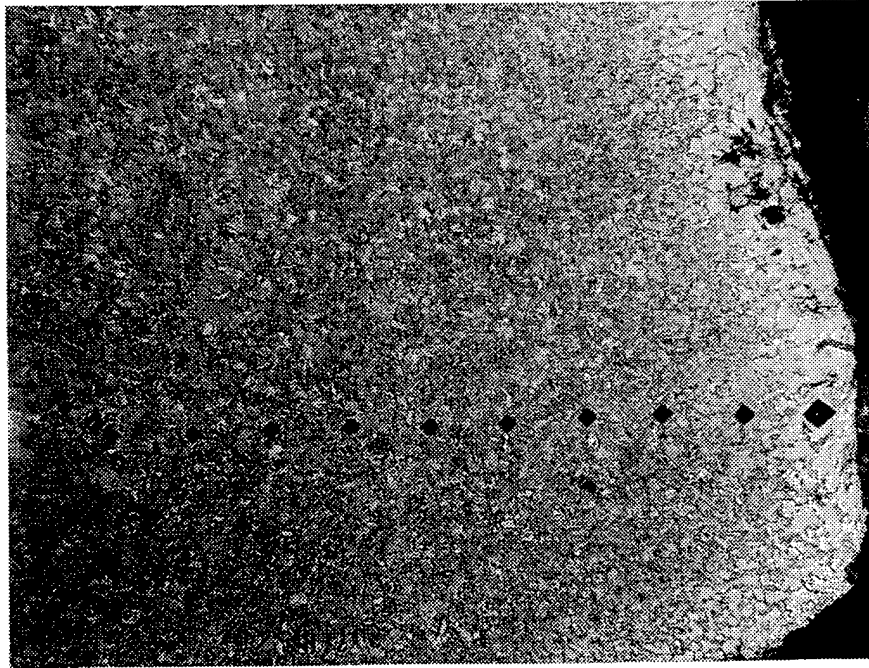
Figures 9 through 12 show the Vickers microhardness profiles taken from the thread tips of U1, U4, N1, and N2, respectively. Note that the setscrews with the heaviest amount of cracking (see Table 5) also exhibited the lowest surface hardness (see microhardness results) and the heaviest amount of surface decarburization (see Figures 9 and 12). Figure 13 shows a magnified view of the hardness indents at the tip of the thread of U1. Note that the indent located within the decarburized layer (white layer) is larger than the other indents. This shows that the decarburized layer is much softer than the transition zone and core. Figure 14 shows the decarburized layer at the thread tip of N2. Figures 15 through 18 show the hardness indents at surface of the socket for U1, U4, N1, and N2, respectively. Note the decarburization on U1 (see Figure 15) and N2 (see Figure 18).

Figure 9. Vickers Microhardness Profile Along the Tip of a Thread From Setscrew U1. (Note the layer of decarburization along the tip of the thread; magnification 200x.)

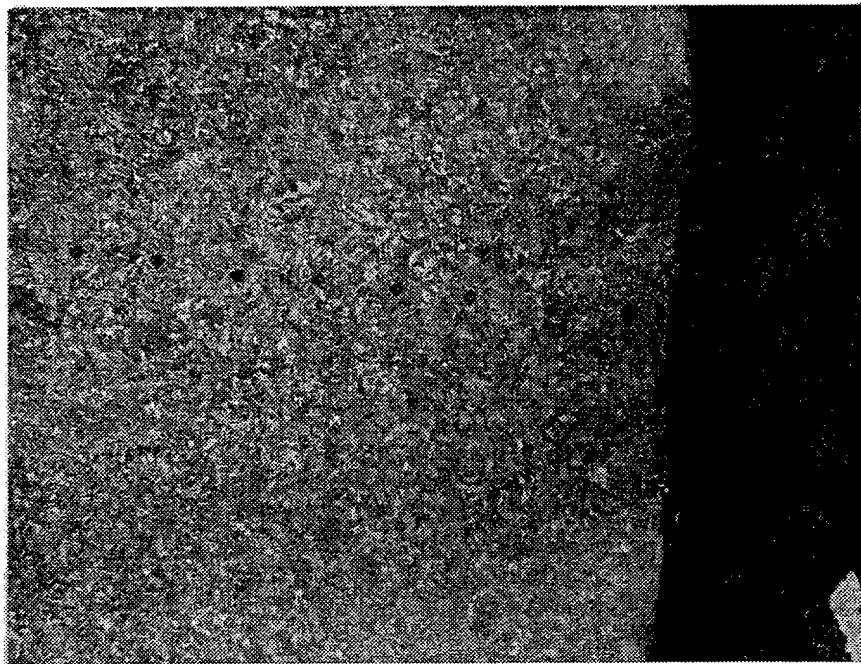
Figure 10. Vickers Microhardness Profile Along the Tip of a Thread From Setscrew U4 (magnification 200x).

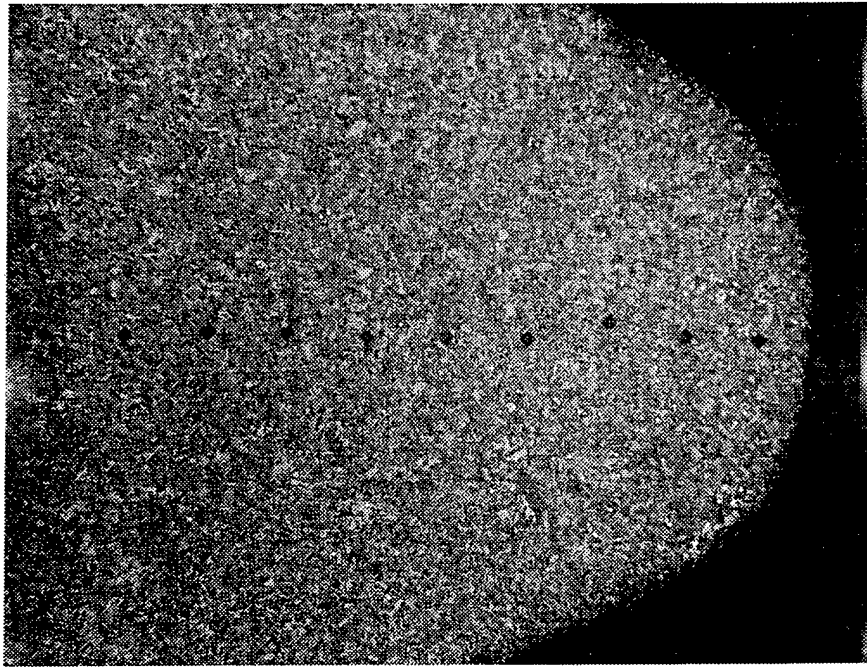
Figure 11. Vickers Microhardness Profile Along the Tip of a Thread From Setscrew N1 (magnification 200x).

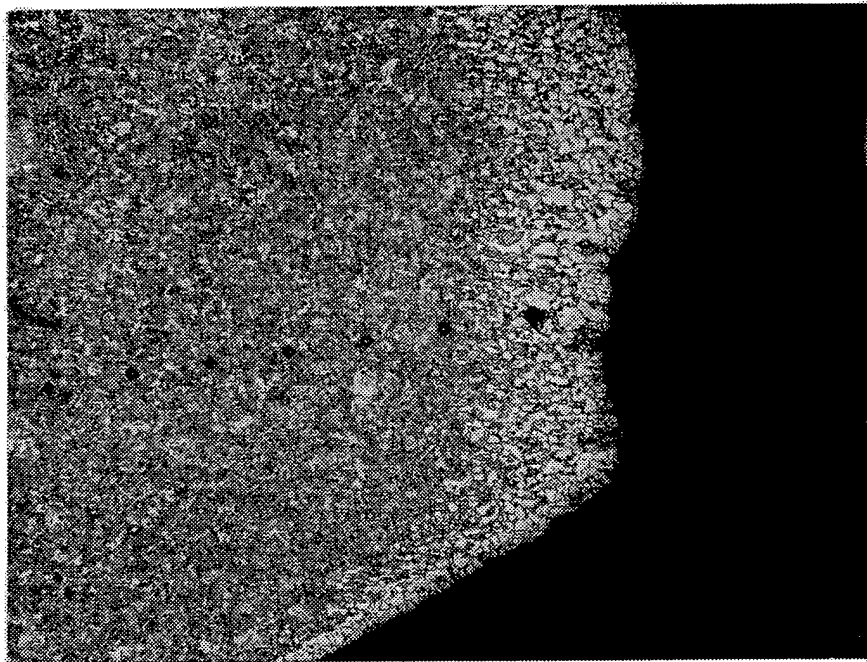
Figure 12. Vickers Microhardness Profile Along the Tip of a Thread From Setscrew N2. (Note the layer of decarburization along the tip of the thread; magnification 200x.)

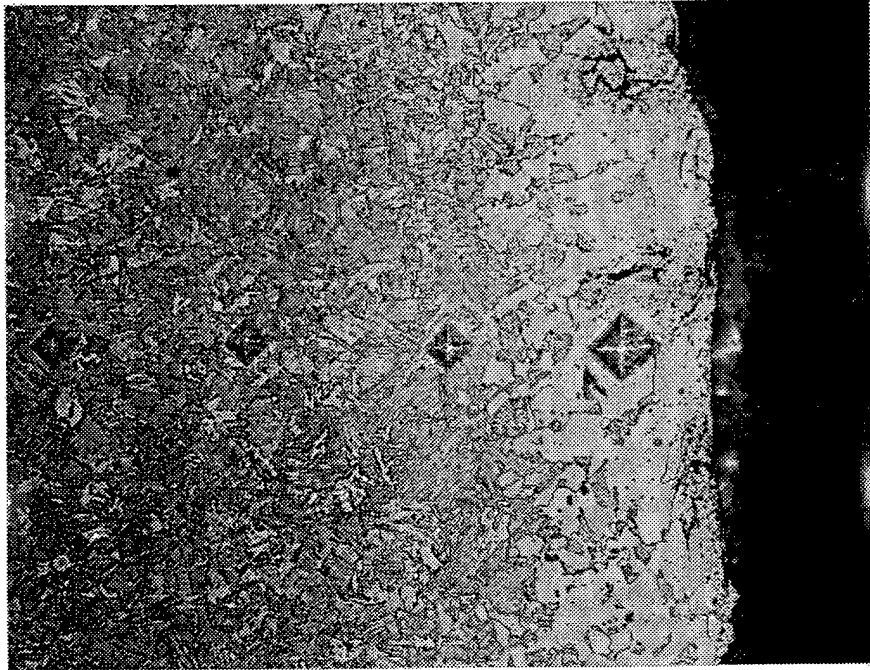
Figure 13. Vickers Microhardness Profile Along the Tip of a Thread From Setscrew U1 at Higher Magnification. (Note the larger indent within the decarburized layer indicating a softer material; magnification 500x.)

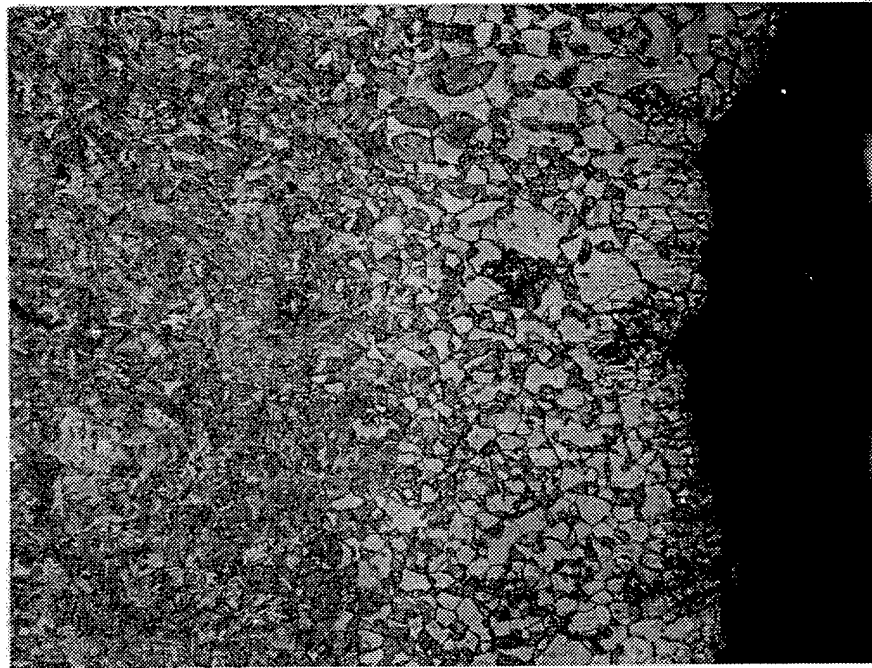
Figure 14. Vickers Microhardness Profile Along the Tip of a Thread From Setscrew N2 at Higher Magnification. (Note the larger indent within the decarburized layer indicating a softer material; magnification 500x.)

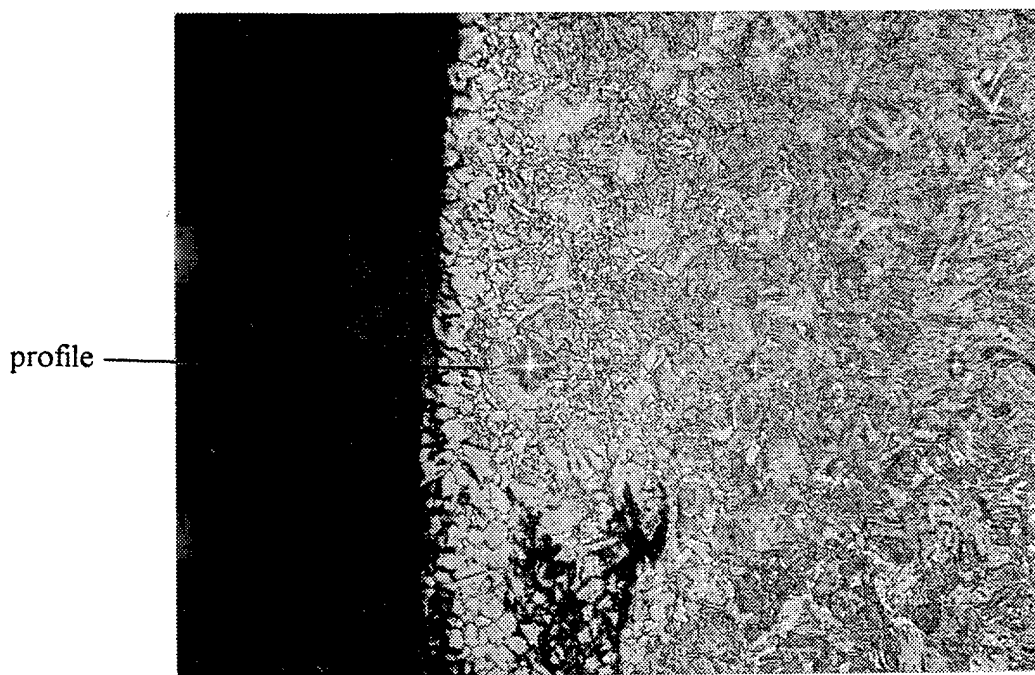
Figure 15. Vickers Microhardness Profile Along the Socket of Setscrew U1. (Note the larger indent within the decarburized layer indicating a softer material; magnification 500x.)

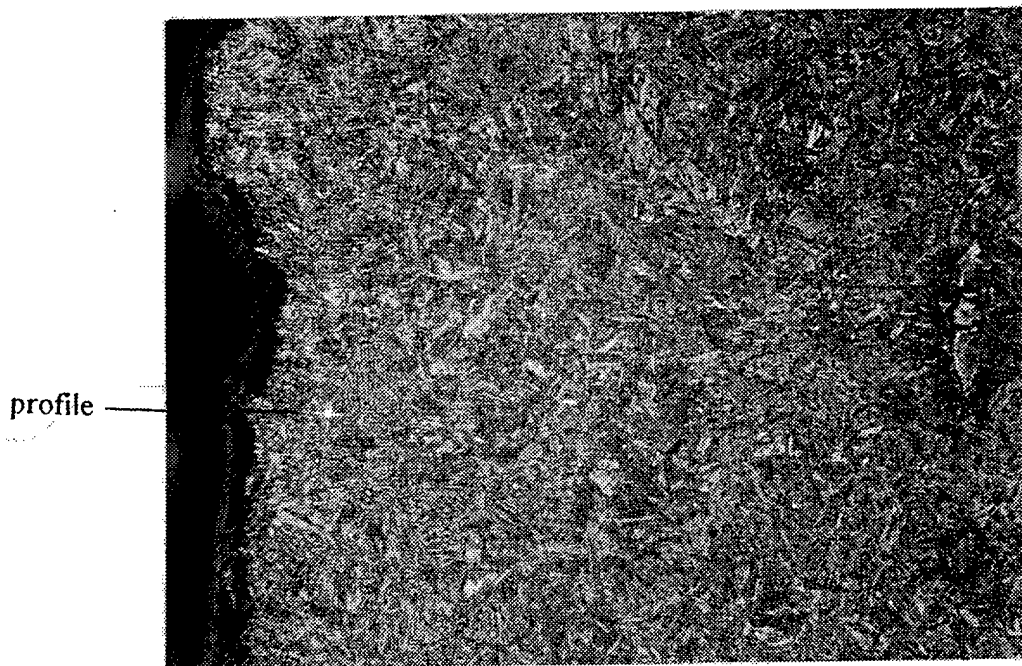
Figure 16. Vickers Microhardness Profile Along the Socket of Setscrew U4. (No decarburization was present on the socket surface; magnification 500x.)

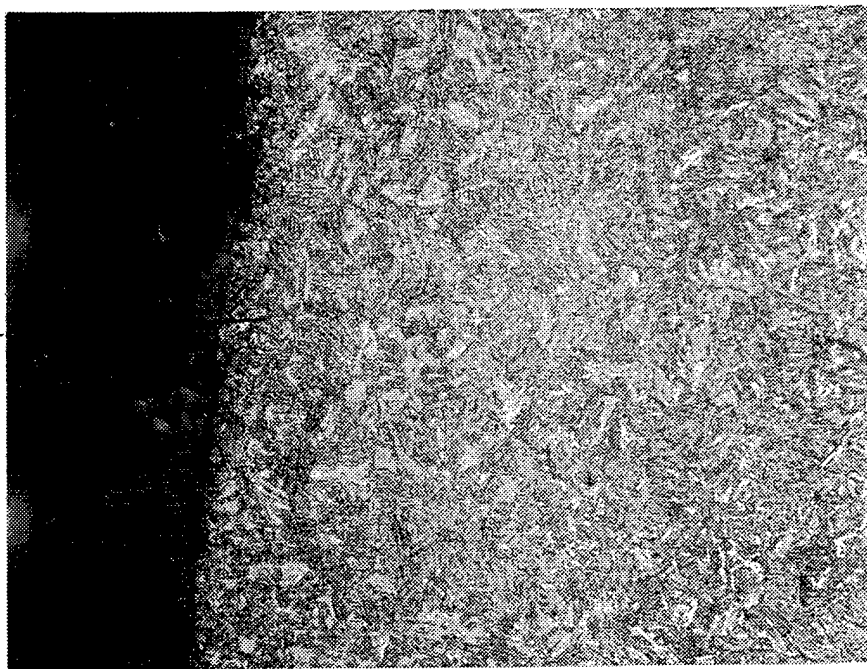
Figure 17. Vickers Microhardness Profile Along the Socket of Setscrew N1. (No decarburization was present on the socket surface; magnification 500x.)

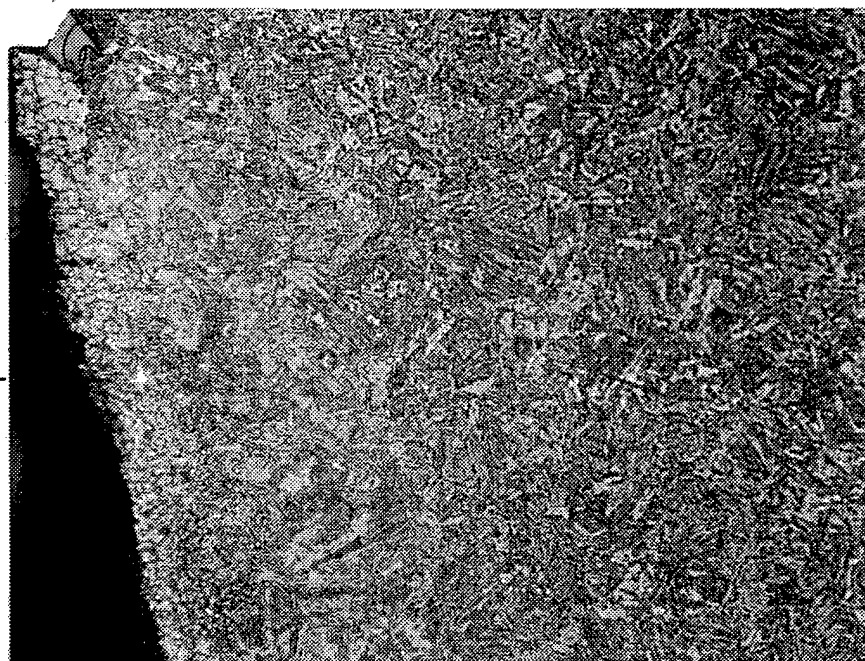
Figure 18. Vickers Microhardness Profile Along the Socket of Setscrew N2. (Note the larger indent within the decarburized layer indicating a softer material; magnification 500x.)
