**The Performance of Low-Rise Open Span Heavy Steel
Structures In Extreme Winds**

Joe R. Charlton, B.S., P.E.

A REPORT

CIVIL ENGINEERING

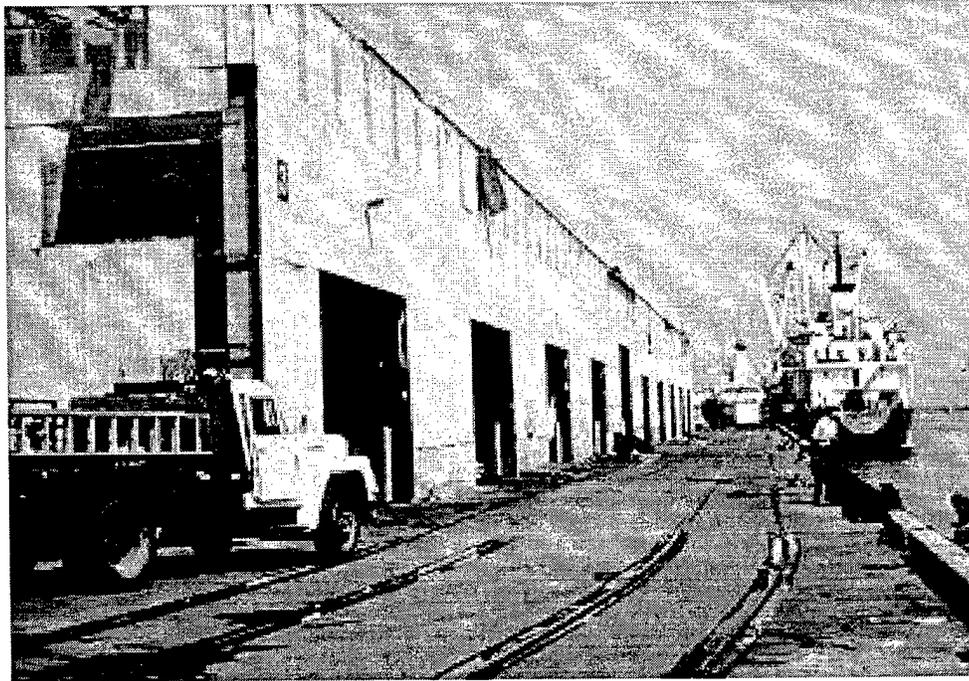
Figure 4.1 South Exterior Elevation of Building 3

This warehouse building sustained no significant structural damage, as can be seen in Figures 4.1, 4.2, and 4.3. The only damage noted was the failure of several large overhead doors and the removal of some of the corrugated metal roof and wall panels.

The probable cause of the roof and wall panel failure was the prior failure of the large overhead doors located on the side of the building running parallel to the railroad tracks, as seen in Figure 4.1. These overhead doors failed due to positive pressure

generated by wind blowing normal to the surface of the doors. Once the two overhead doors failed, the internal pressure inside the building increased and the roof panels and siding were torn from the structure due to the combined internal and external pressure.

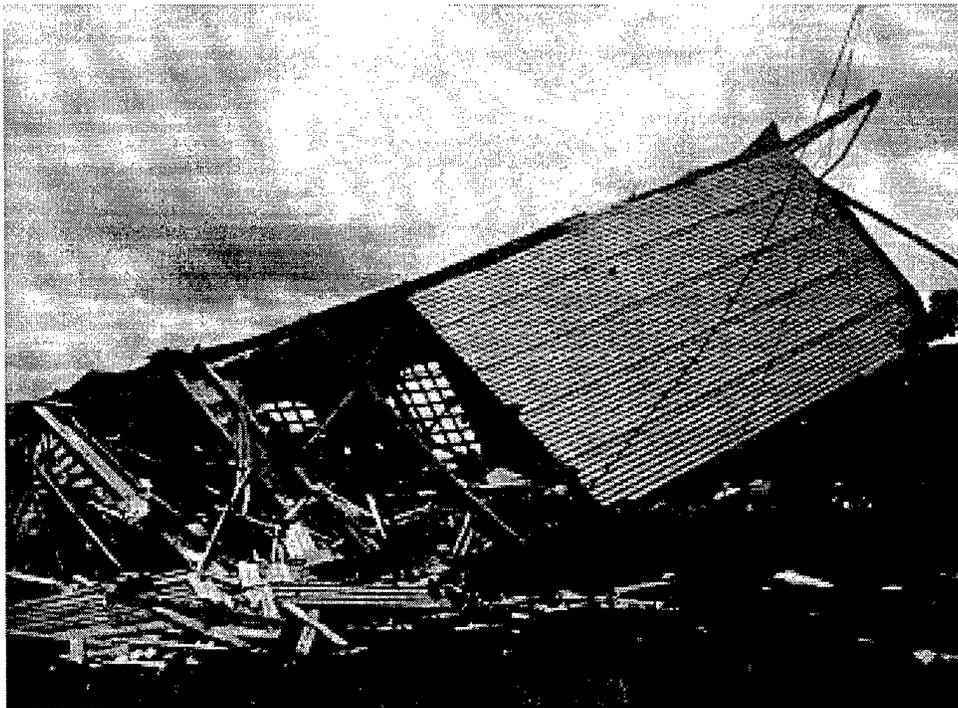
Figure 4.8 Failure of Parachute Tower

As seen in Figure 4.8, the parachute drying tower was totally destroyed by the Altus tornado. The failure of the tower was caused by excessive wind loads on the windward and leeward walls. These wind loads were sufficient to cause the anchor bolts on the southeast and northeast columns to fail in tension. Once the anchor bolts failed, the overturning moment generated by the easterly wind caused the building to rotate about the other two columns and collapse. A close up of the anchor bolt failure can be seen in Figure 4.9 and a close up of the column base plate in Figure 4.10. Figure 4.10 shows definitively that the base plate did not fail.

Using this approach, the overturning moment, M_o , was found to be 45.9q ft*kips, where q is the wind pressure on the structure. Equating the righting moment, M_r , and the overturning moment, M_o , and solving for q, the wind pressure was determined to be approximately 48.0 psf. The minimum wind velocity to cause failure is then calculated using the equation, $V = \sqrt{q/.00256}$. Using this equation the minimum failure wind velocity was found to be 136 mph.

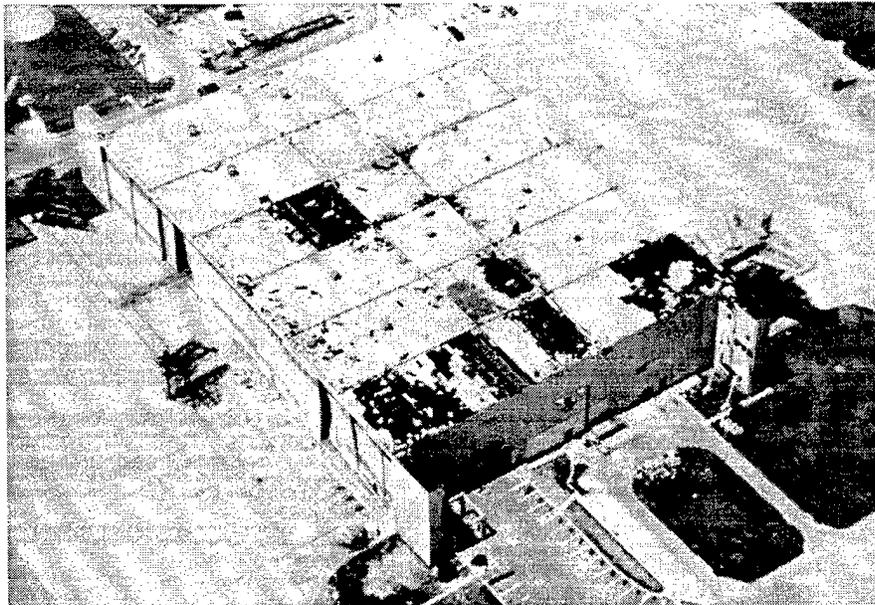
Figure 4.12 Aerial View of Damage to Building 285

Overall, the hangar performed well when subjected to these severe winds. The exterior corrugated asbestos siding performed well and experienced only localized failure. There were no failures noted in the heavy “C” channel wall girts or the roof trusses supporting the corrugated siding and the roof decking, respectively. No failures were noted on the main structural elements. The only damage to this building was the removal of a portion of the roofing material and the roof decking, structural damage to two rail mounted hangar door sections, and the removal of exterior corrugated siding along the door pockets. The damage to the hangar is shown in Figures 4.12 through 4.17.

The majority of the damage to the roof covering seen in Figure 4.12 is along the edges of the roof line. This damage is consistent with the higher suction pressures that are typically experienced at the leading edges of a structure with a flat roof. One other factor that may have precipitated the damage to the roof membrane is the partial failure of

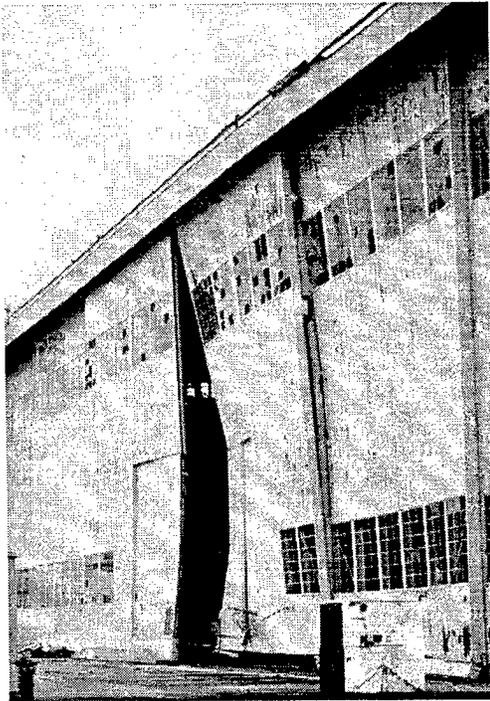
Figure 4.13 Elevation of the North Side of Bldg 285

The partial failure of two sections of the hangar door, as seen in Figures 4.13, 4.14, and 4.15 was caused by wind acting normal to the door surface and weakness in the free edges of the door sections. Because of the secondary openings in the door sections, they did not have a continuous member along their free edge. This lack of a continuous member weakened the structural framing and the lighter secondary framing was unable to transfer the loads into the upper header and the lower rail seen in Figure 4.15. This failure was most likely not due to either a design or a construction deficiency but was simply an area of the structure that had little redundancy.

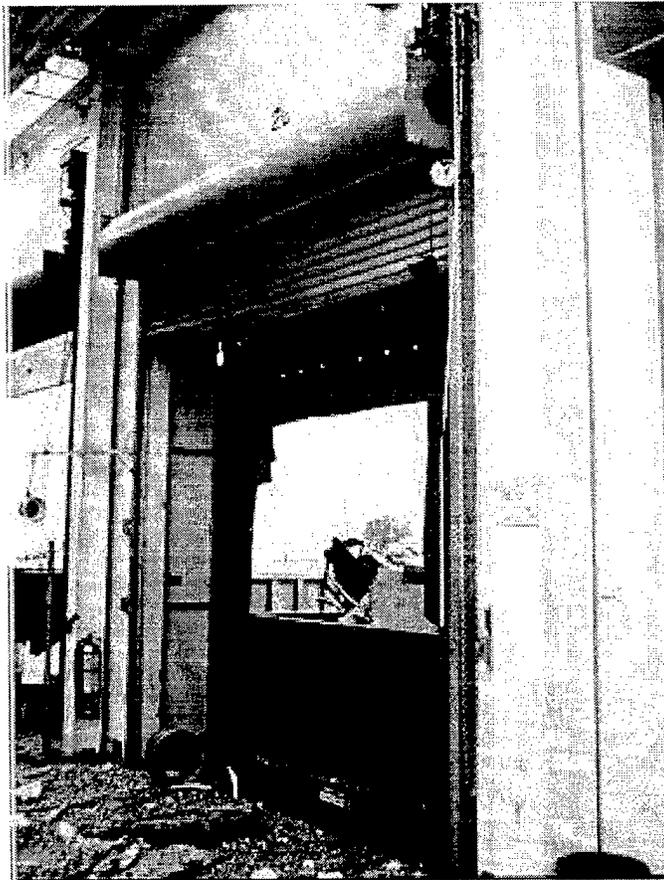
Figure 4.19 Undamaged Overhead Door

The main structural system performed well and sustained very little damage as did the large overhead doors, shown in Figure 4.19. The only damage to the main structural system was a horizontal crack in the CMU shear wall. The other element damaged was the corrugated steel roof decking. Approximately 80% of the corrugated steel roof deck was torn from the building. The damage mentioned can be seen in 4.20 and 4.21.

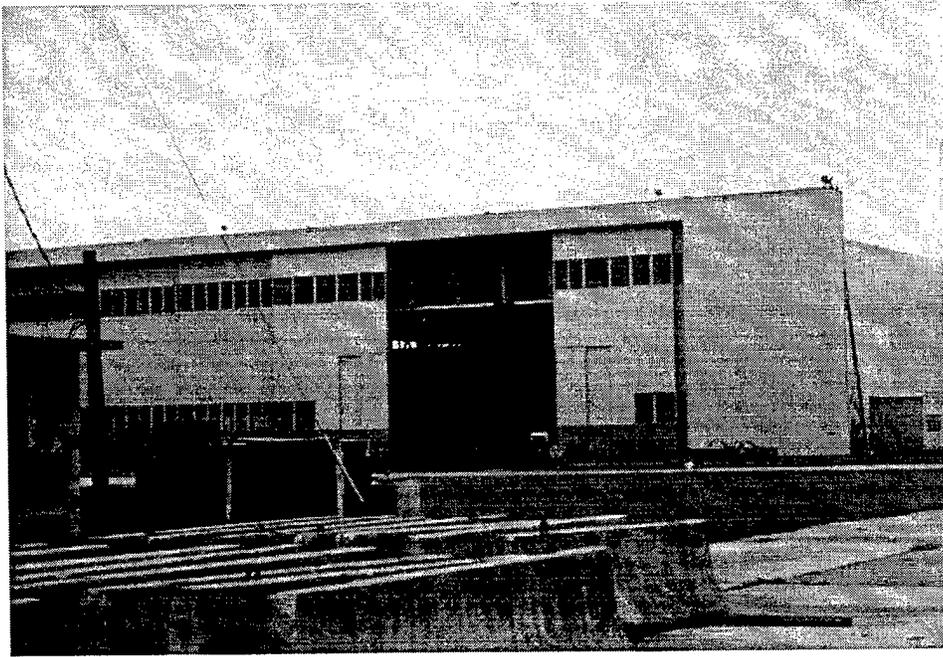
Figure 4.22 Exterior Elevation of Large Hangar

The only visible damage to this hangar is damage to the roof covering and decking. All of the structural members performed as designed, as did the corrugated metal siding. All of the windows in the structure remained intact, as did the hangar doors. These observations of the extent of the damage generally agree with the assessment by McDonald and Smith, 1990. The extent of the damage can be seen in Figures 4.22 and 4.23.

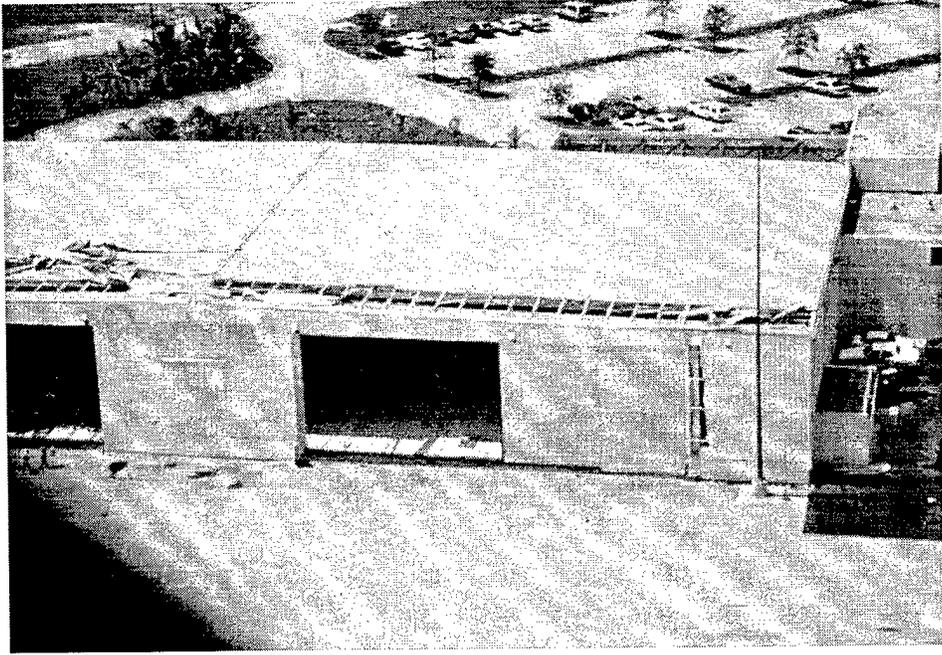
Figure 4.25 Elevation of Beechcraft Hangar

The main component that was damaged on all three hangars was the roof decking. The corrugated siding on the front of the Beechcraft hangar also received minor damage at the door pocket, see Figure 4.25.
