# Investigation of Concrete from I-20 Near Monroe, Louisiana

Miscellaneous Paper SL-98-1  
January 1998

Final report

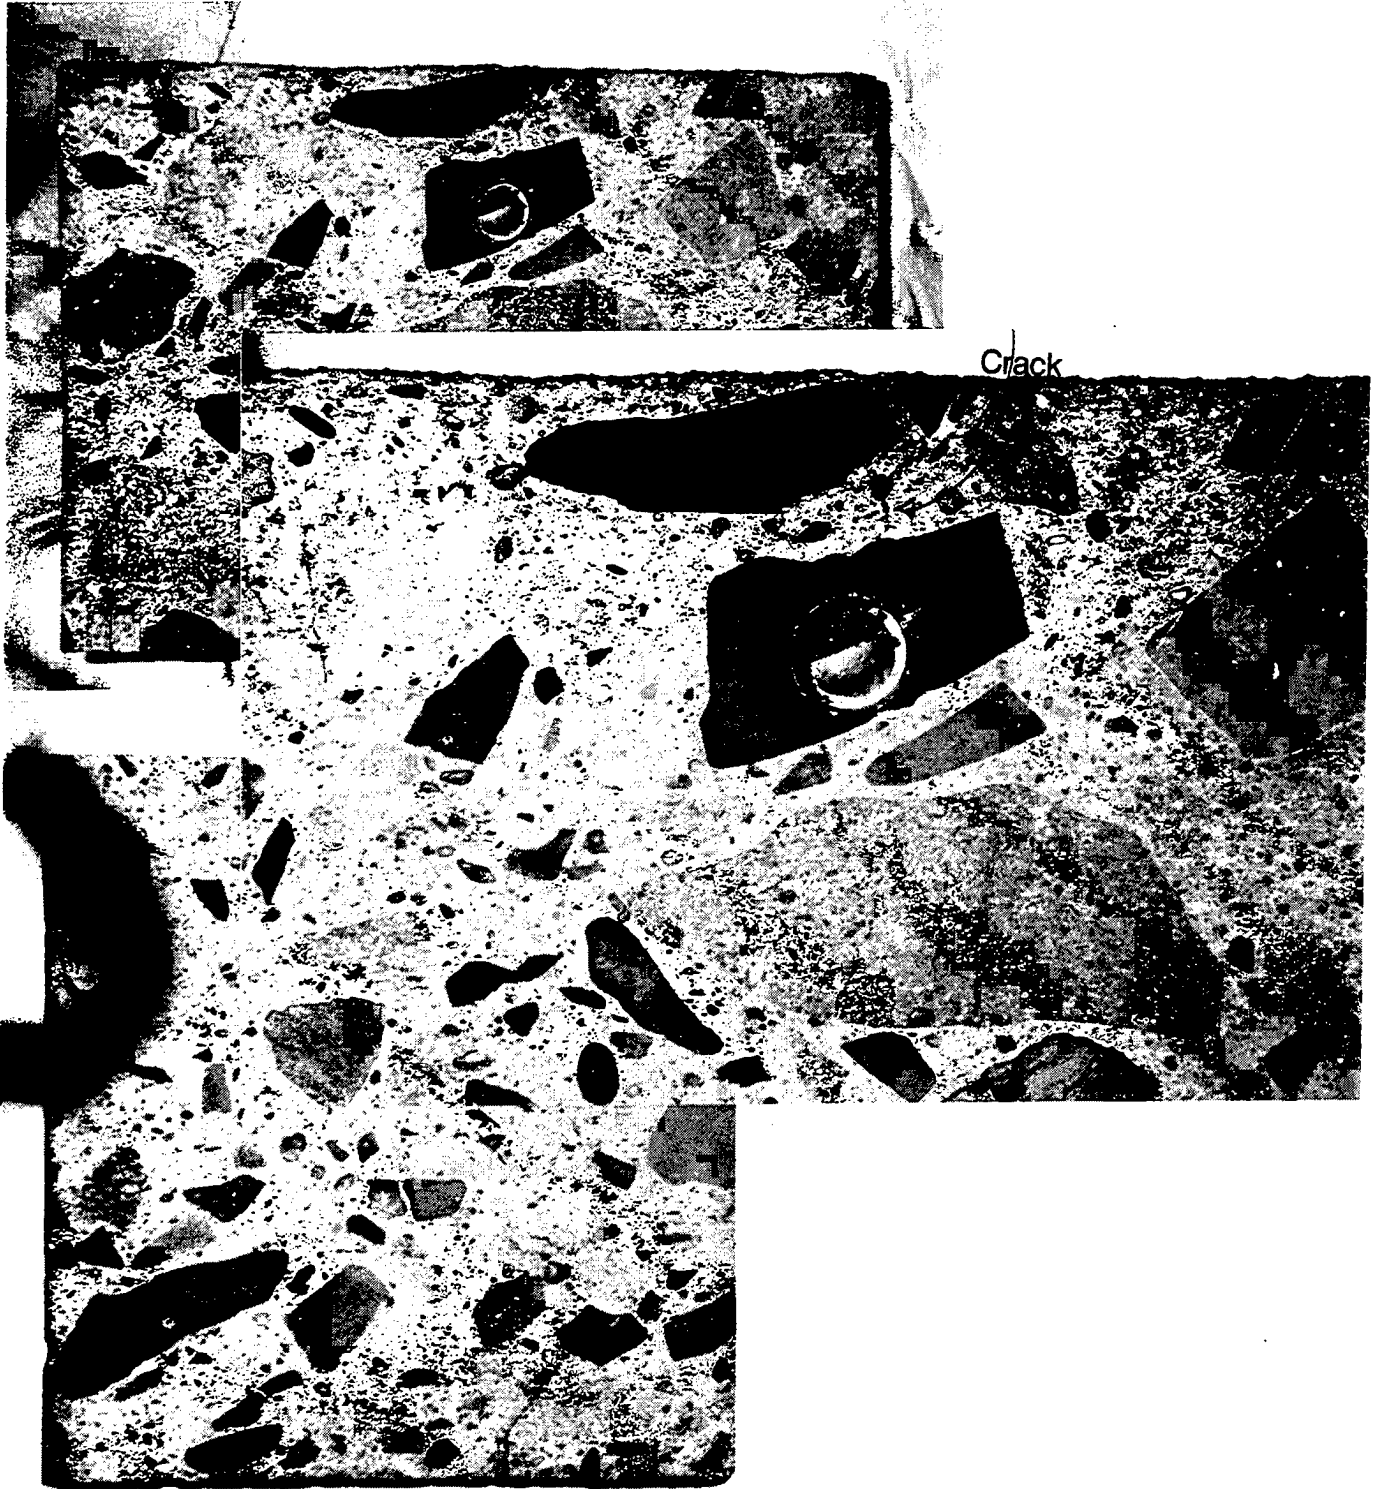
- a. 950623 - This core was cut along its entire length to expose the interior concrete. A near-surface vertical crack was associated with subsurface dark-gray coarse-aggregate particles with prominent reaction rims. These particles showed some interior cracks. X-ray diffraction examination of one particle indicated that the particle was composed of a fine-grained dolomitic limestone containing some quartz and clay, as shown in Figure 16. Some interior, randomly oriented incipient cracks were also observed associated with dark-gray coarse-aggregate particles with reaction rims, as illustrated in Figure A1, Appendix A. These cracks were located in the lower portion of the core.

Figure A1. Sample 950623 shows reactive particles 1 and 2 near top surface associated with cracks. The top and bottom samples are 6 in. (152 mm) left to right

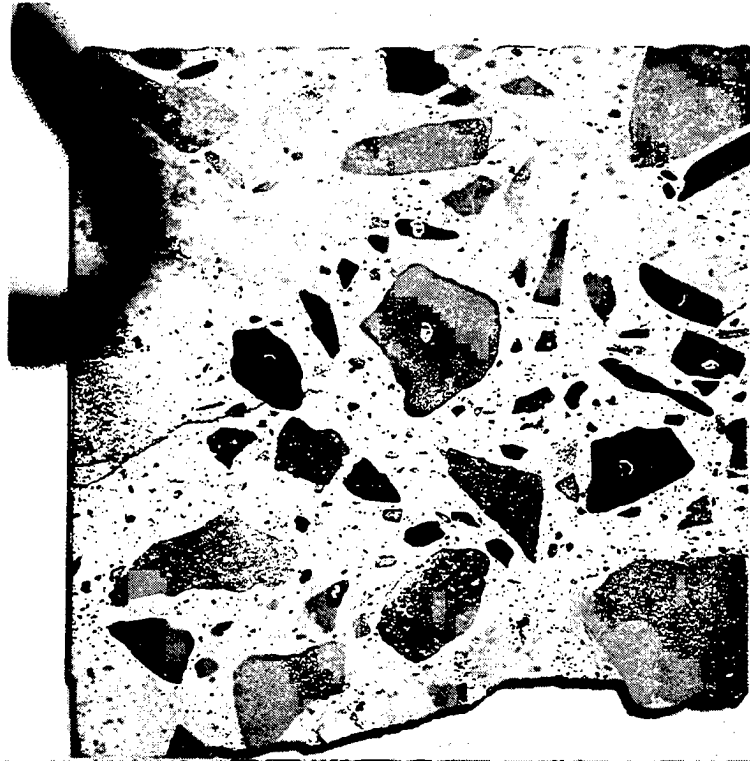
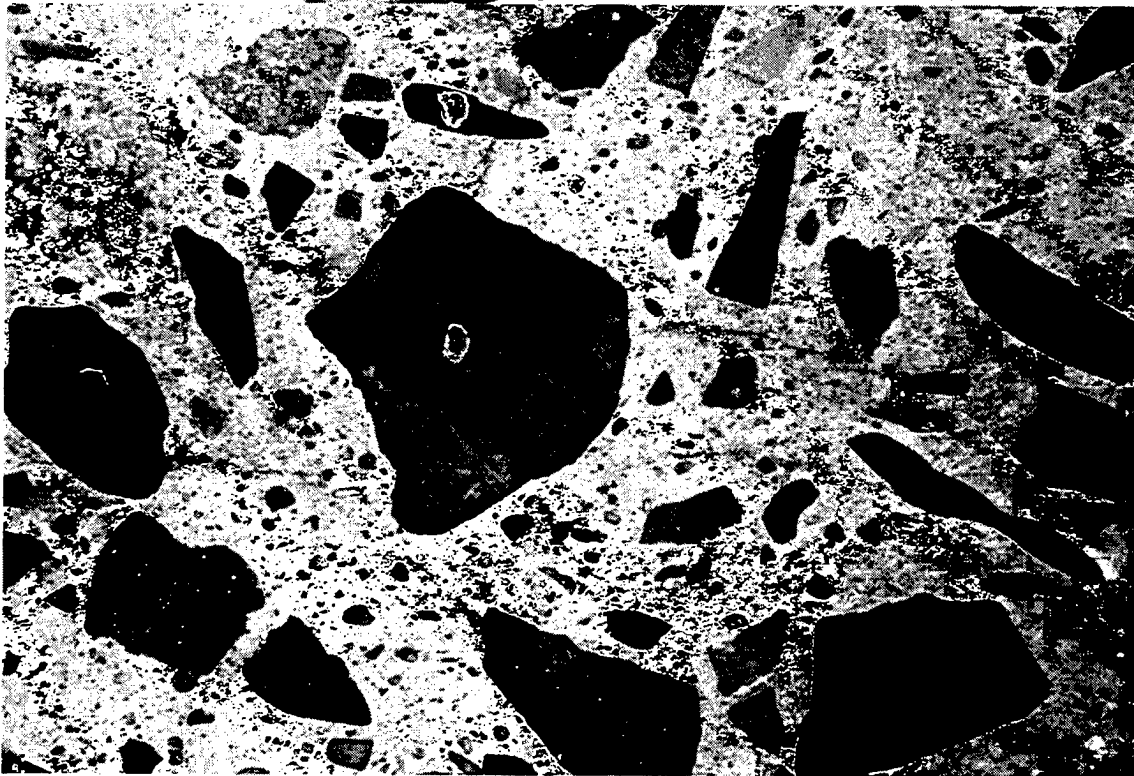
- b. 950625 - Vertical cracks from the surface intersected dark-gray coarse-aggregate particles as well as horizontal intermittent fractures, as shown in Figure A2, Appendix A. All fractures could be traced to dark-gray coarse-aggregate particles with dark reaction rims either partially or entirely rimming the particle. No cracking was associated with similar smaller dark coarse-aggregate particles. Cracks in some particles were continuous into the paste while other cracks in the aggregate particles showed no such continuation. The paste was hard and intact.

Figure A2. Sample 950623 shows a random crack pattern with cracks propagating from central reactive coarse aggregate. Other reactive aggregate particles are also present. Top sample is 6 in. (152 mm) left to right

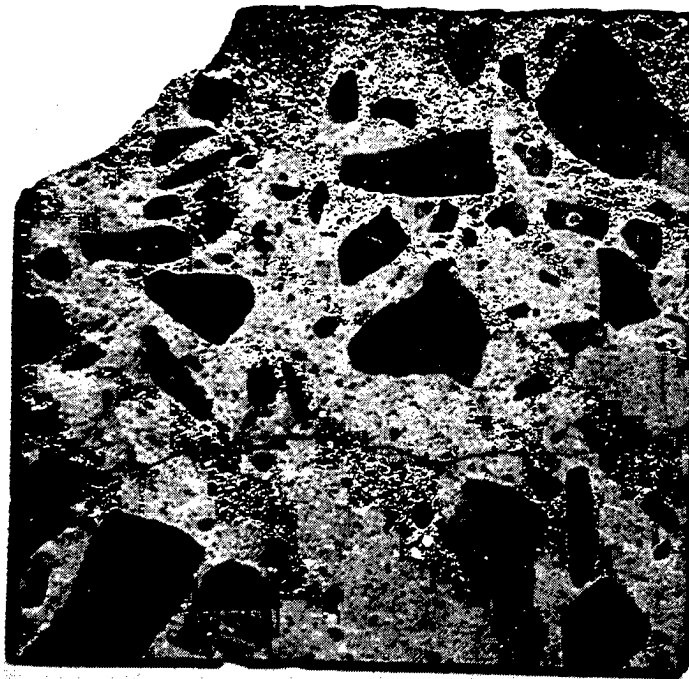
- c. 950626 - This concrete sustained localized damage. A single horizontal crack and some hairline fracturing were observed on a cut section on one side of the slab (Figure A3a, Appendix A). On the reverse side, heavy fracturing of the concrete associated with dark-gray coarse-aggregate particles was observed. Minor cracking at the bottom of the core associated with cracked dark-gray coarse aggregate is illustrated in Figure A3a, Appendix A. Examination of a thin section containing coarse-aggregate particles showed a linear opening along oriented features. The cracks contained no observed reaction products.

Figure A3a. Sample 950626 shows some interior cracking in the concrete and a few small reactive particles with reaction rims. The sample is 6 in. (152 mm) left to right

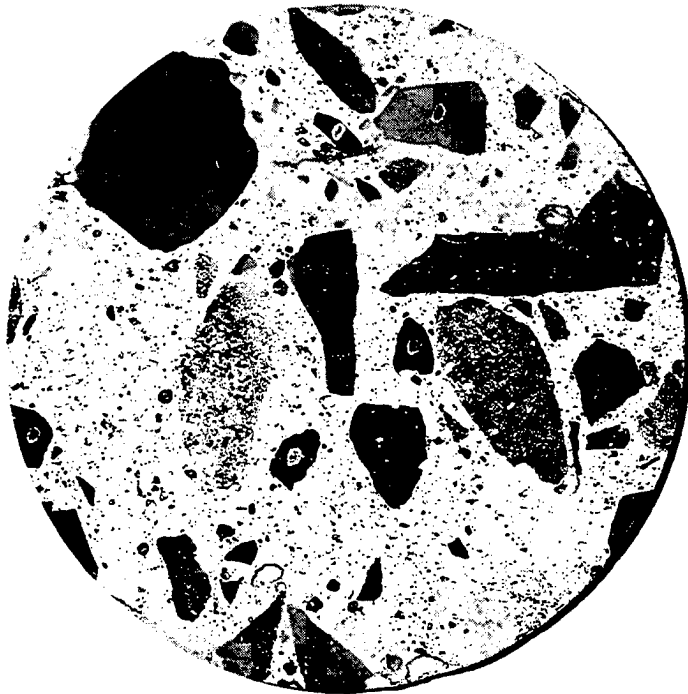
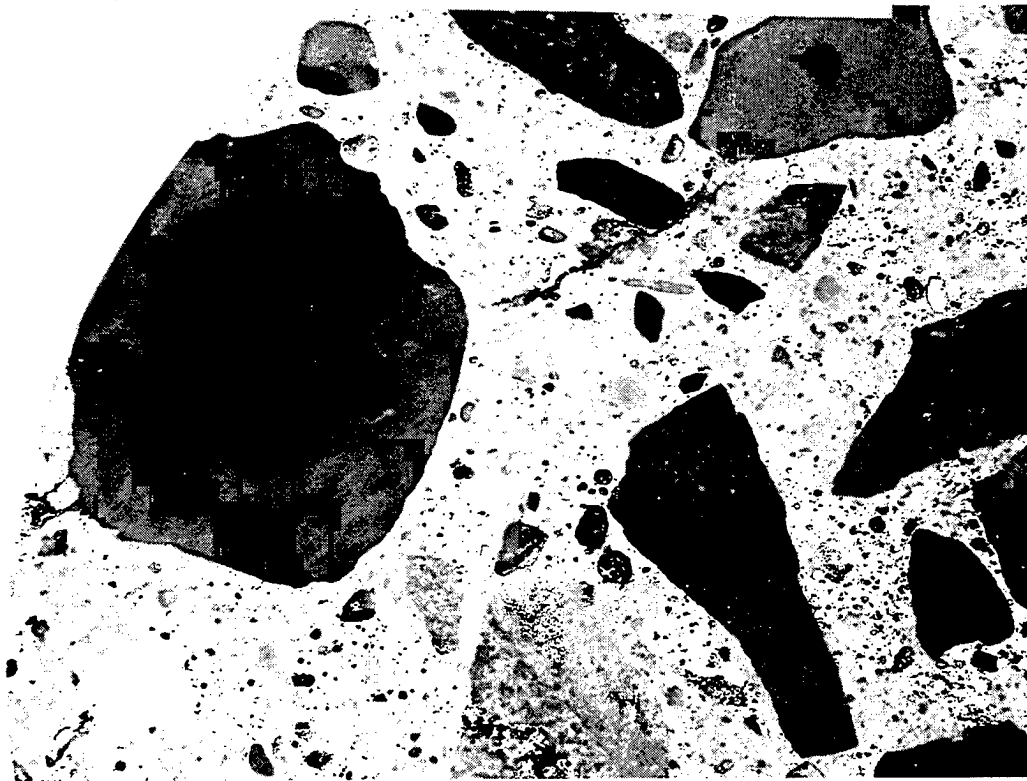
Figure A3b. Sample 950626 shows reactive aggregate particles at bottom of core. The sample is 6 in. (152 mm) left to right

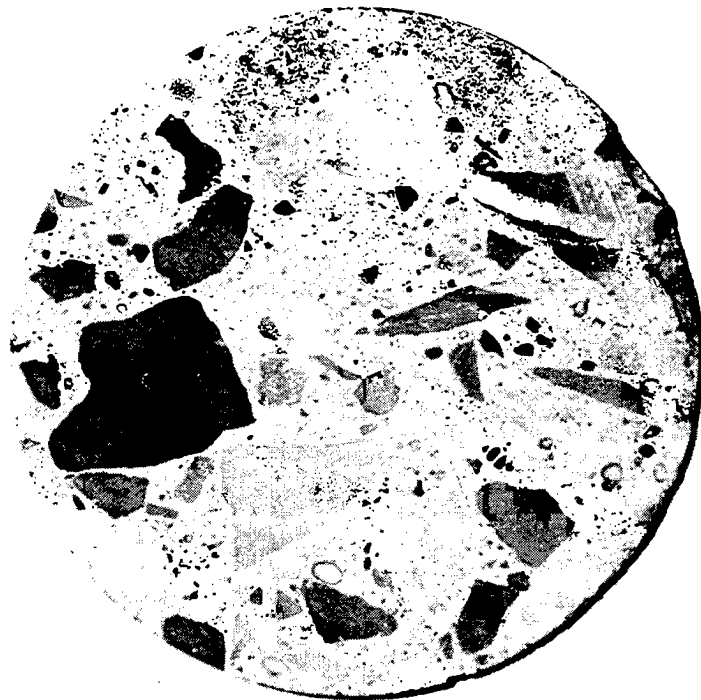
Figure A4. Sample 950627 shows no cracks. The sample is 6 in. (152 mm) left to right

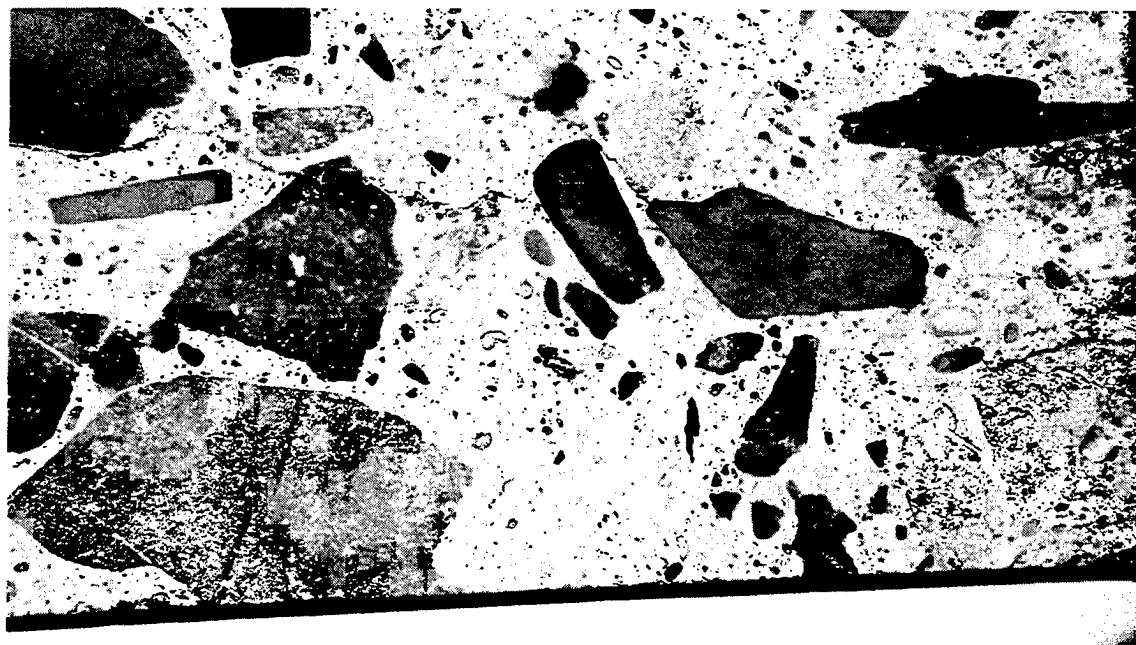
- e. 950628 - The concrete contained numerous cracks throughout the length of the core. The cracks were vertical, horizontal, and diagonal going through, as well as around, coarse-aggregate particles, as shown in Figures A5a and A5b, Appendix A. There were numerous

Figure A5a. Sample 950628 shows severe cracking in near surface concrete. Epoxy resin fills the cracks. Top sample is 6 in. (152 mm) left to right

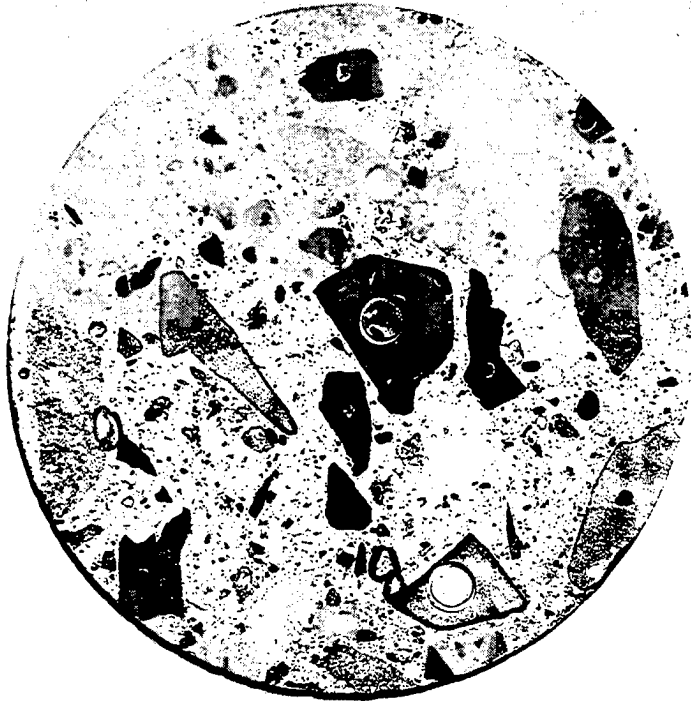
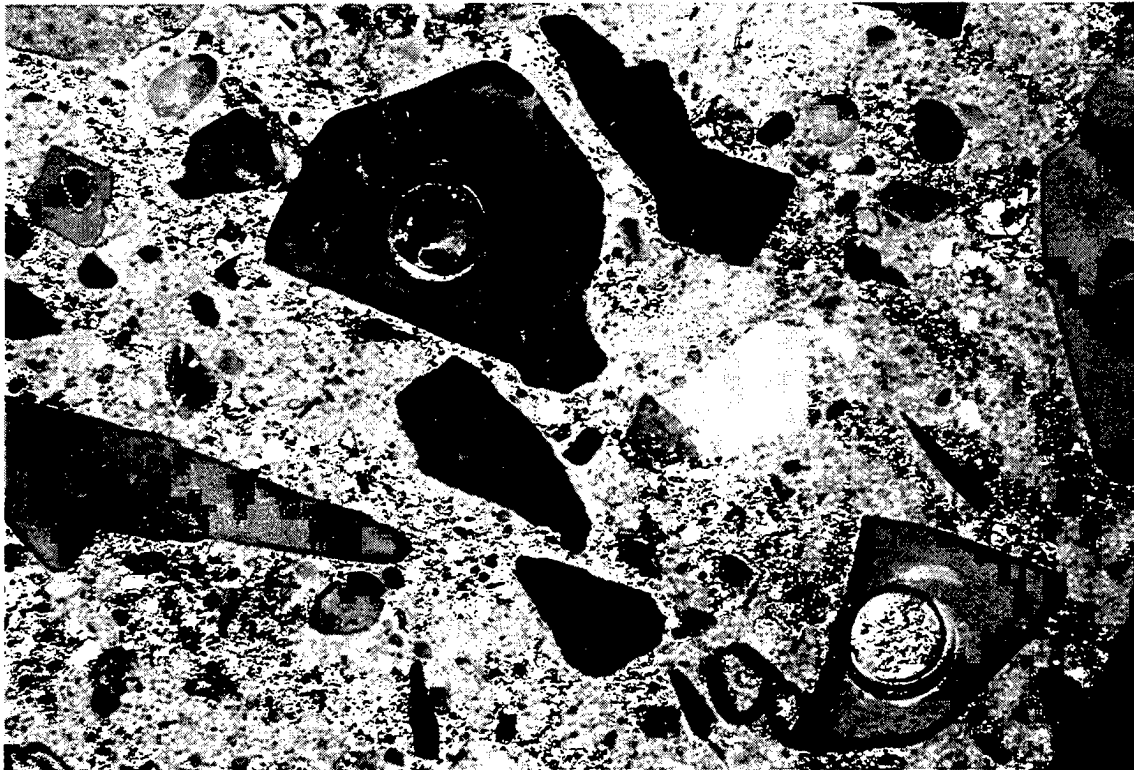
- f.* 950620 - The core was cracked throughout its length. The cracks were randomly oriented. There were numerous dark-gray limestone coarse-aggregate particles with dark reaction rims. The rims exhibited radial cracks that extended into the paste. Aggregate particles with these rims were dolomitic limestone containing quartz and clay. X-ray diffraction patterns are presented in Figures 18 and 19. Figure A6, Appendix A, shows the appearance of these aggregate particles.

Figure A6. Sample 950620 shows aggregate reaction at the base of the core. Cracks are visible along the reaction rim. Top sample is 6 in. (152 mm) left to right

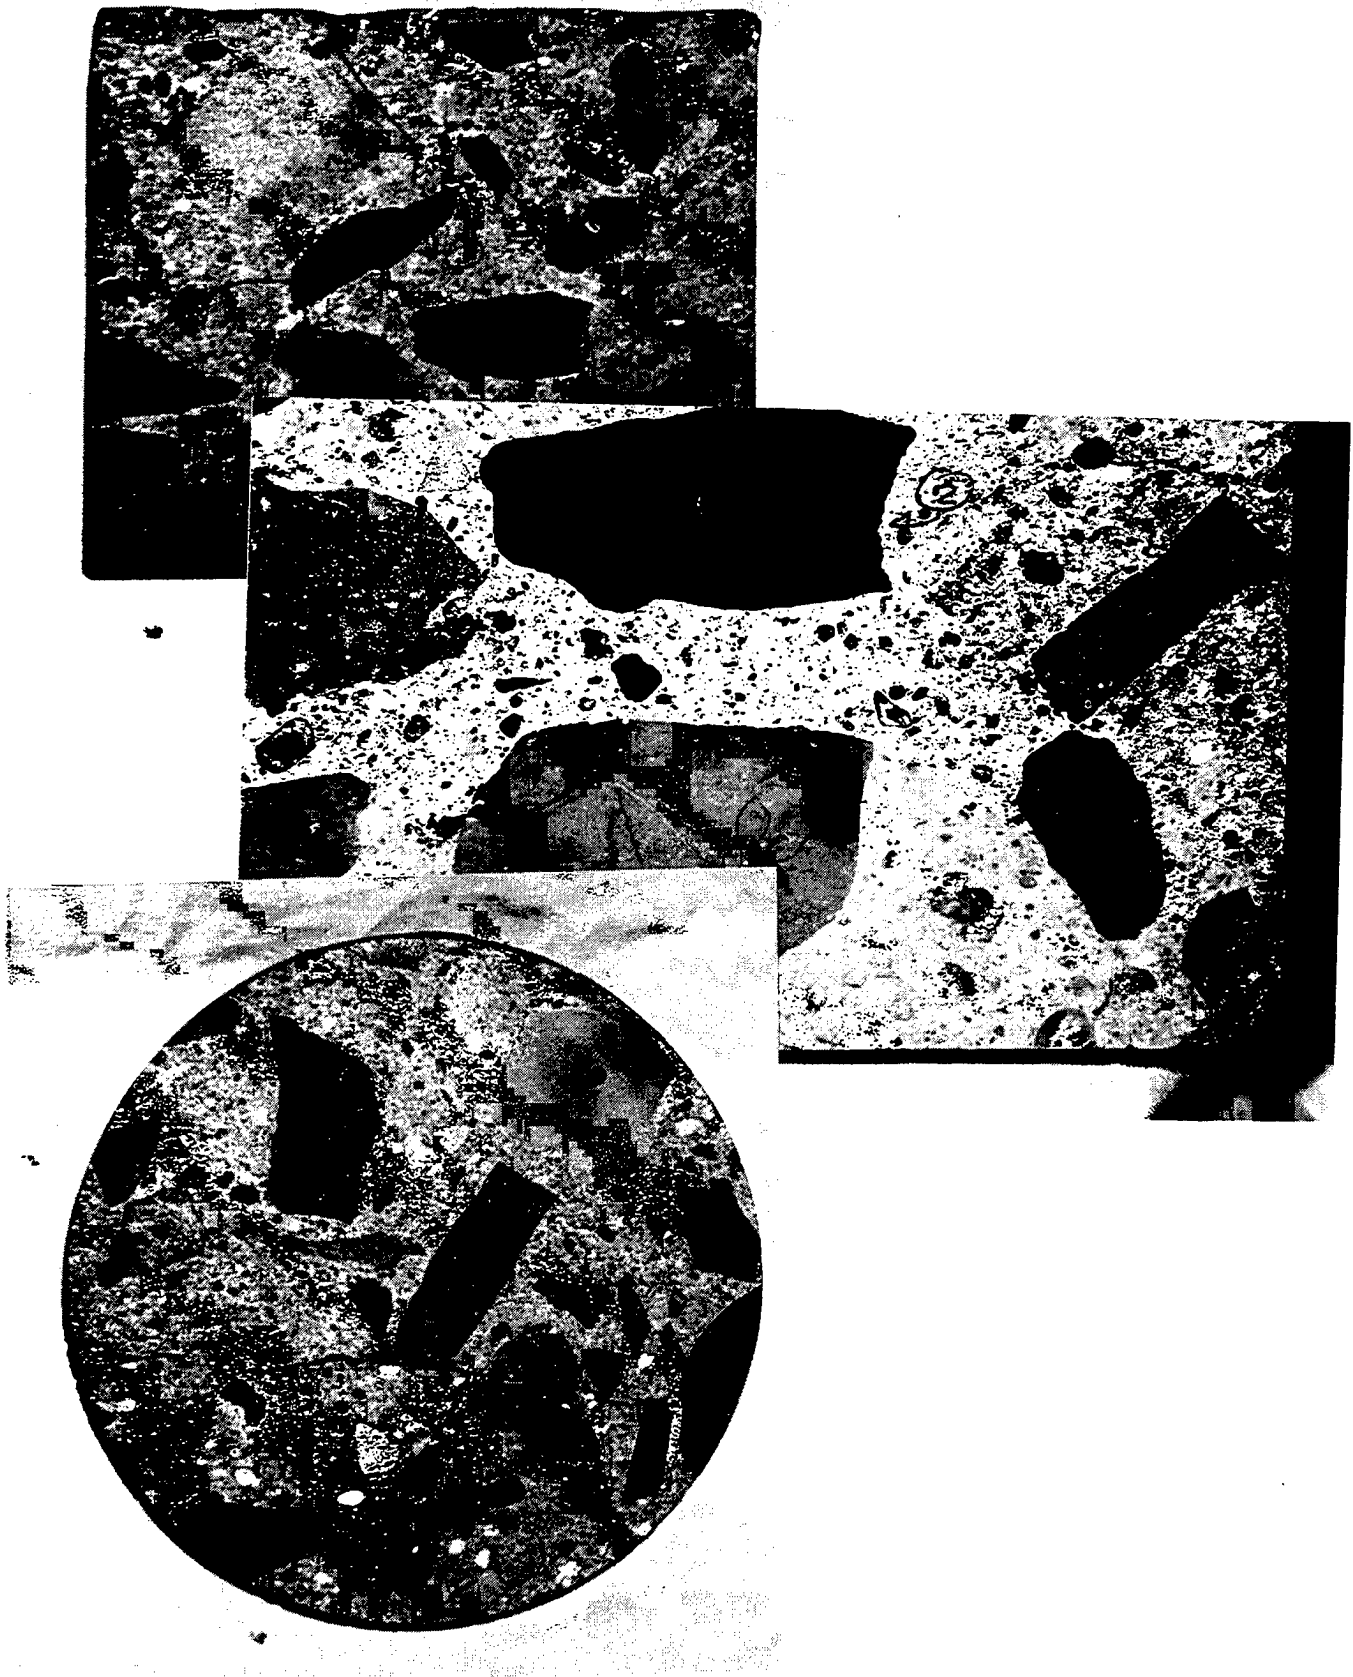
- g.* 950619 - The core was cracked throughout its length. Cracking in the near-surface concrete was more severe as vertical, horizontal, and diagonal cracks were common and associated with dark-gray limestone coarse-aggregate particles (Figure A7, Appendix A). Thin sections of two coarse-aggregate particles were prepared. Particle #A was a light-colored fine-grained limestone consisting of a fine-grained matrix and rhombohedral dolomite crystals. No cracks associated with this particle were observed. Particle #B was a dark-gray fine-grained limestone with a rim around it and was associated with cracking. No difference could be observed between the material in the rim and the interior of the particle. Fine quartz grains were embedded in a calcite matrix.

Figure A7. Sample 950619 shows random crack pattern with cracks propagating from two central reactive coarse-aggregate particles and cracking in bottom end of sample. Top and bottom samples are 6 in. (152 mm) left to right

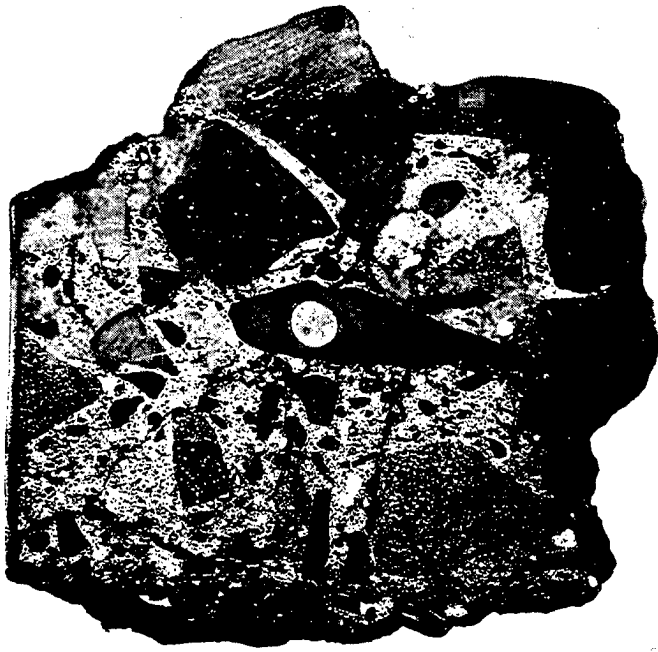
- h.* 950617 - This sample consisted of rubble. The core had broken into fragments during the coring process. One large piece was impregnated using an epoxy resin and then cut open for examination. The concrete was highly fractured (Figure A8, Appendix A). There were numerous dark-gray limestone coarse-aggregate particles. Cracks were mostly associated with the larger coarse-aggregate particles. The associated dark-gray coarse-aggregate particles were dolomitic limestone containing some quartz as well as illite (clay-mica). An X-ray diffraction chart showing the relative abundance of the calcite and dolomite is presented in Figure 20.

Figure A8. Sample 950617 shows a reactive aggregate particle and cracking of rim zone. Diameter core boring is 11 mm

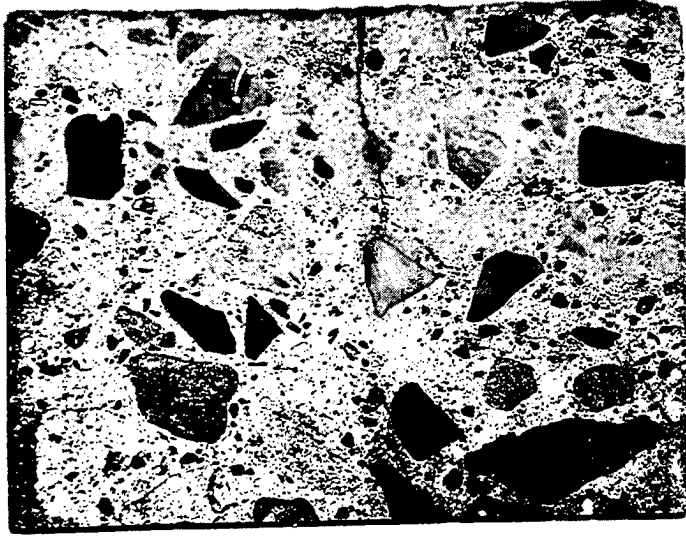
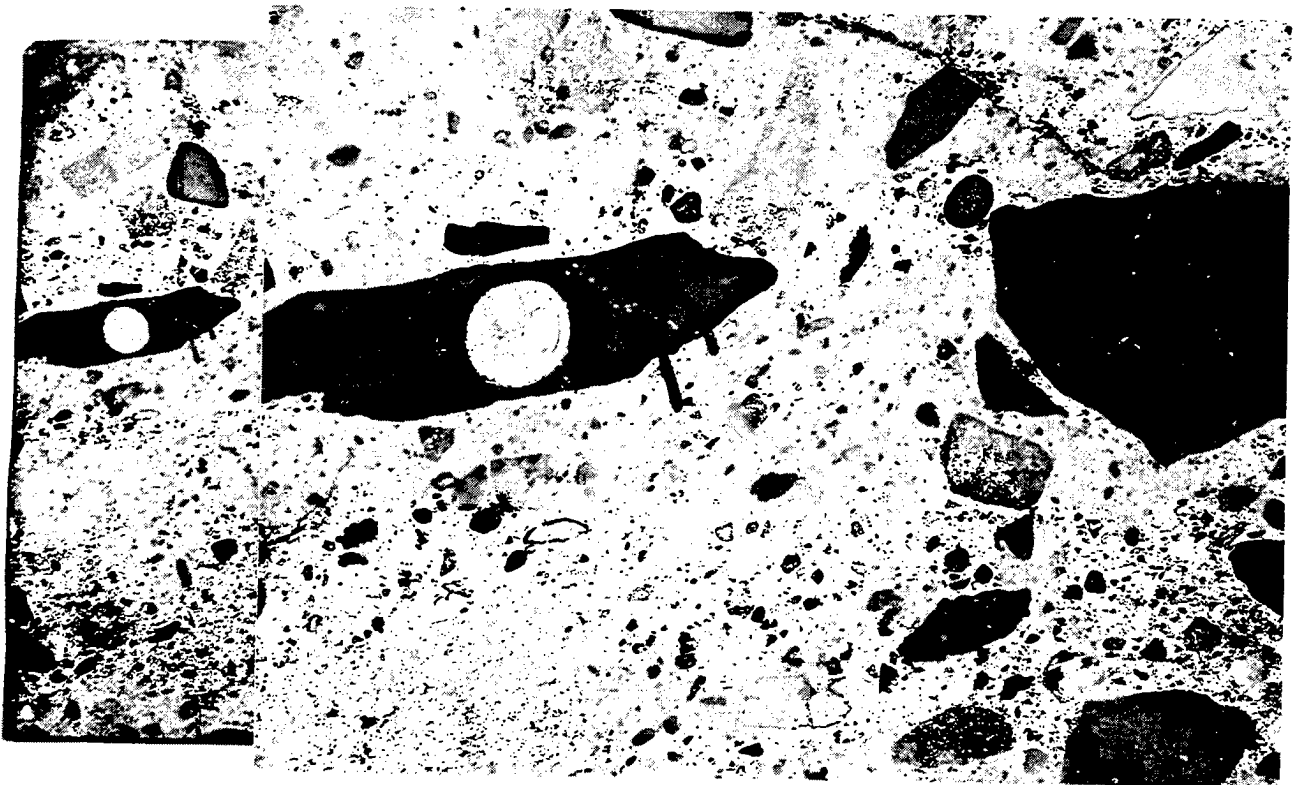
- j.* 950616 - The surface cracking was light. However, the interior concrete showed an extensive crack system. A vertical crack extended several inches into the interior concrete going through coarse-aggregate particles as well as around them. The vertical cracks intersected horizontal and diagonal cracks (Figures A9a and A9b, Appendix A). The majority of the cracks were associated with cracked dark-gray fine-grained limestone coarse-aggregate particles. Two particles examined by X-ray diffraction were dolomitic limestone with acid-insoluble materials consisting of quartz and clays. Figures 21 and 22 illustrate the relative abundance of the carbonate phases.

Figure A9a. Sample 950616 shows a central vertical near-surface crack and some incipient cracks associated with aggregate particle A. Samples on left are 6 in. (152 mm) left to right

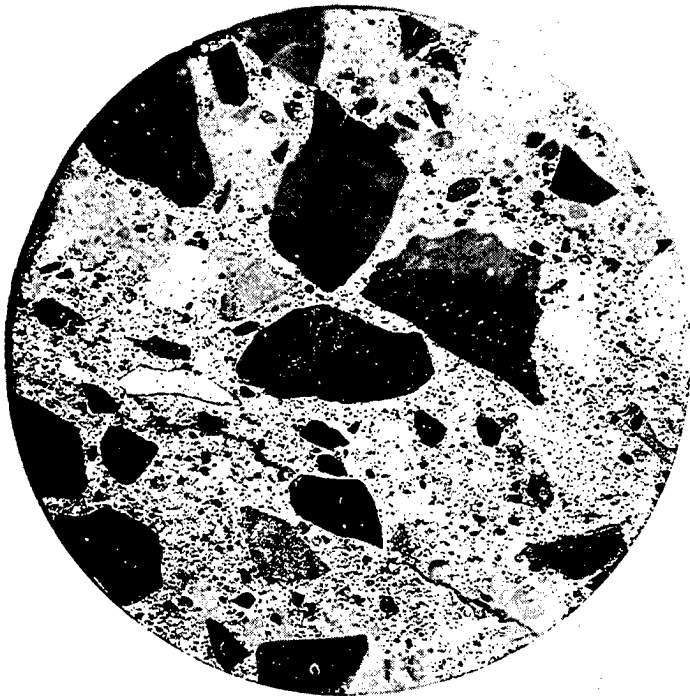
Figure A9b. Sample 950616 shows bottom of core and crack associated with reactive aggregate particle. Top sample is 6 in. (152 mm) left to right

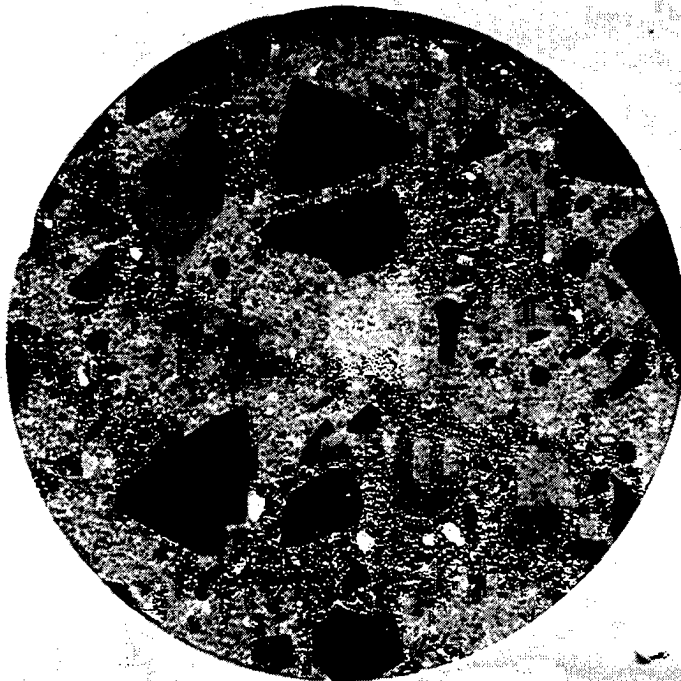
- k.* 950622 - This sample was intact with no visible cracks. The coarse aggregate was light colored and did not contain any reaction rims (Figure A10, Appendix A). A single hairline crack at the bottom of the core, shown in Figure A10, Appendix A, was observed and seems unrelated to dark-gray coarse aggregate.

Figure A10. Sample 950622 shows intact concrete with mostly light-colored aggregate particles. Bottom slice of core contains hairline crack. Both samples are 6 in. (152 mm) left to right

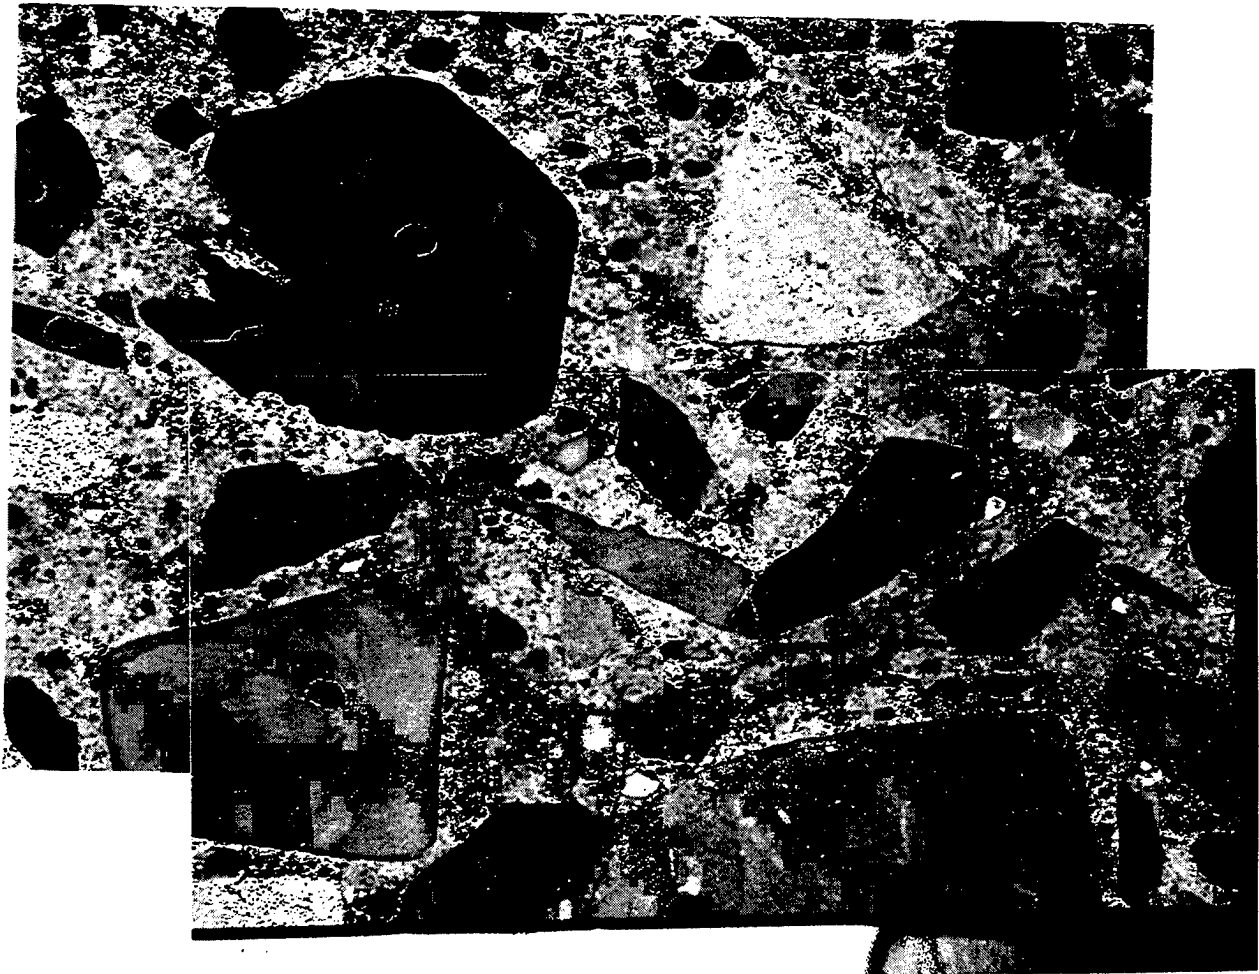
- l.* 950618 - This concrete was heavily cracked. Vertical, horizontal, and diagonal cracks were abundant throughout the length of core. The cracking was associated with a large dark-gray limestone coarse-aggregate particle (Figure A11, Appendix A). Fractures were observed in the central portion of the aggregate particle as well as in the rim area of the particle. A specimen of this aggregate particle was cored along the paste-to-aggregate interface and prepared for examination as a ground section. The specimen was impregnated using an epoxy resin to reinforce the sample and minimize possible additional cracking in the preparation process. The specimen showed the propagation of cracks through the interface zone. The cracks were not confined to the interface zone of the aggregate particle as they propagated into the interior of the aggregate particle. The interior portion of the aggregate particle was also cracked. High-resolution elemental analysis using the scanning electron microscope (SEM) and energy dispersive X-ray (EDX) showed no migration of elements in this particular aggregate particle, as illustrated in Figure 27.

Figure A11. Sample 950618 shows random crack pattern with cracks propagating from central reactive coarse-aggregate particle. Other reactive particles are also evident. Top sample is 6 in. (152 mm) left to right

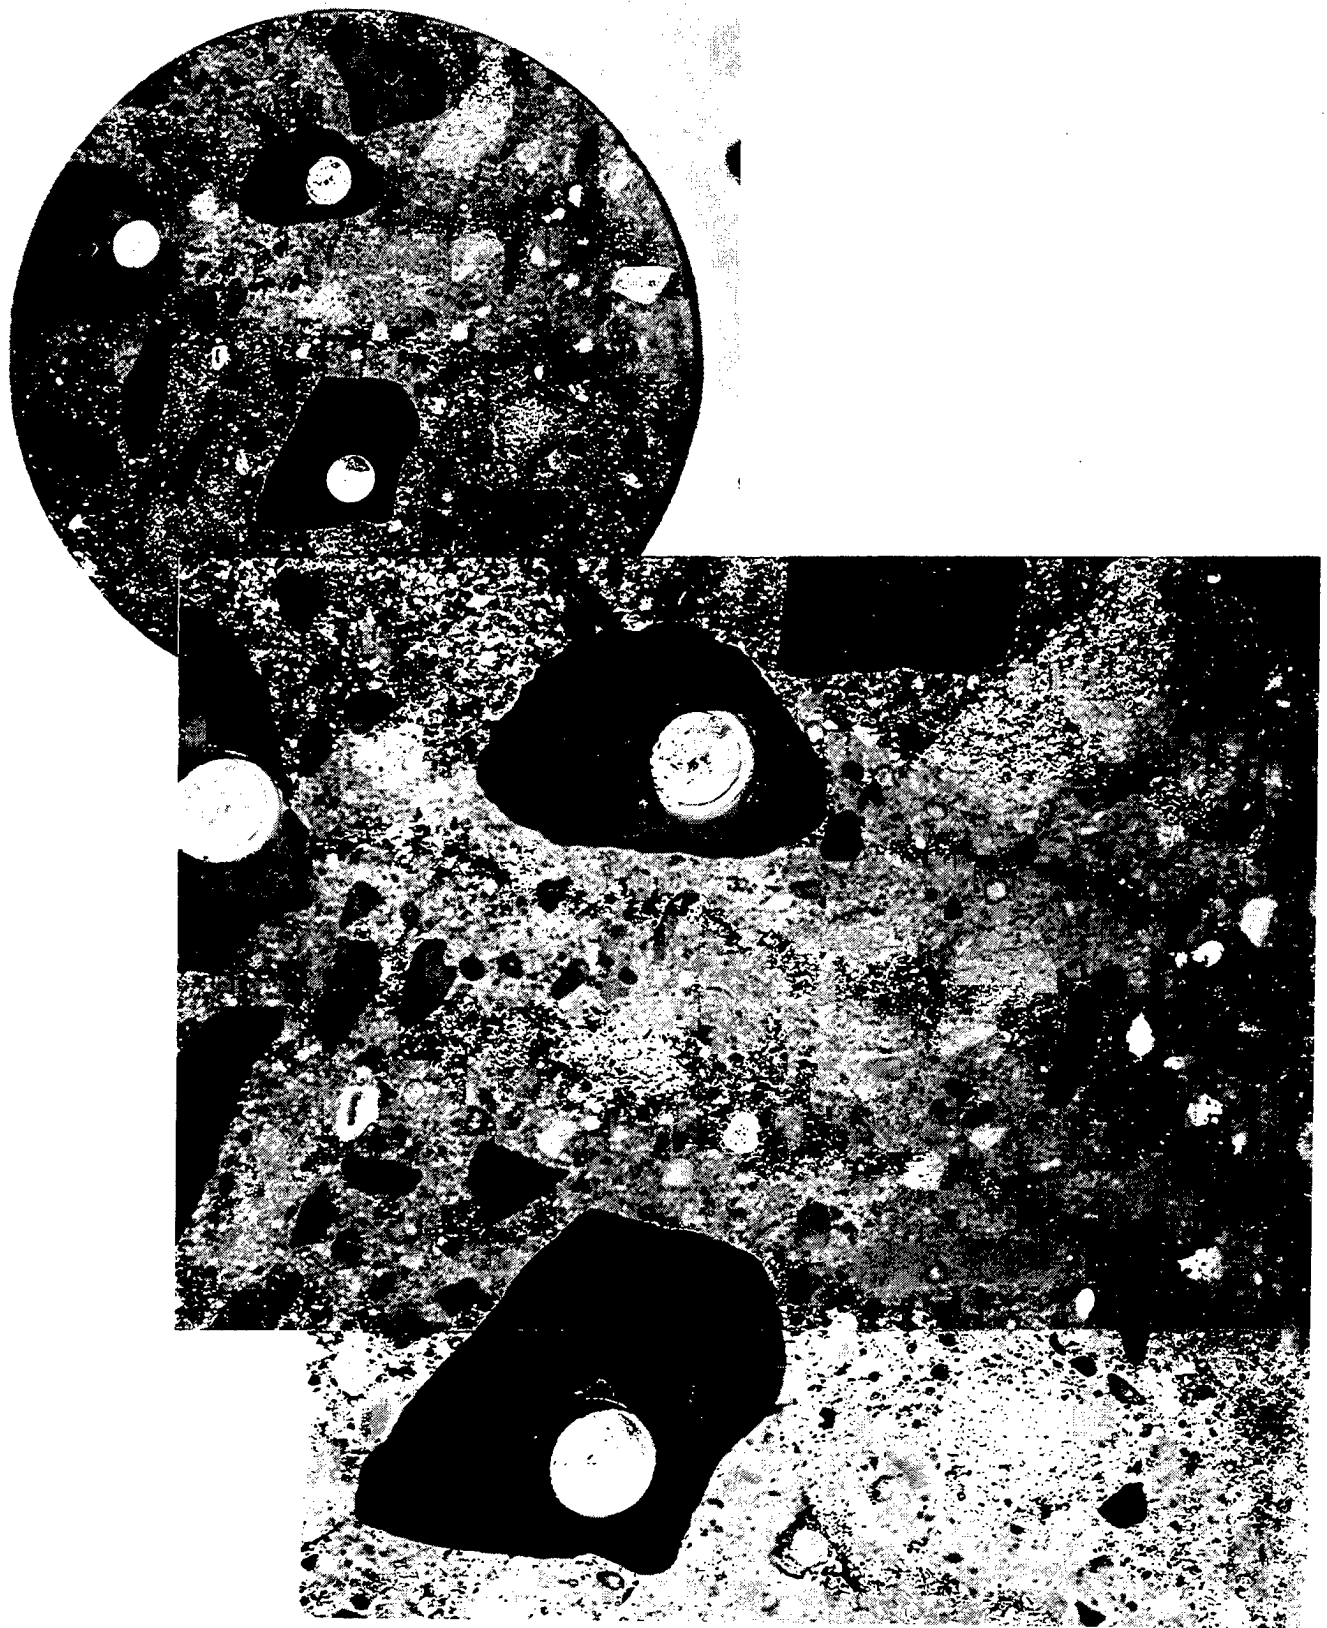
with a prominent reaction rim (Figure A12, Appendix A) (particle #C) was a fine-grained dolomitic limestone also containing insoluble material including clays and quartz (Figure 25). A thin section of a near-surface dark-gray fine-grained impure limestone coarse-aggregate particle showed a rim on this aggregate and micro cracks in the rim propagating into the paste. Etching of coarse-aggregate particle using dilute hydrochloric acid showed no relief in the rim area; i.e., the rim was neither more nor less acid soluble than the unaltered rock.

Figure A12. Sample 960621 shows aggregate particles A, B, and C. A is non-expansive, B is non-expansive, and C is expansive. Top sample is 6 in. (152 mm) left to right

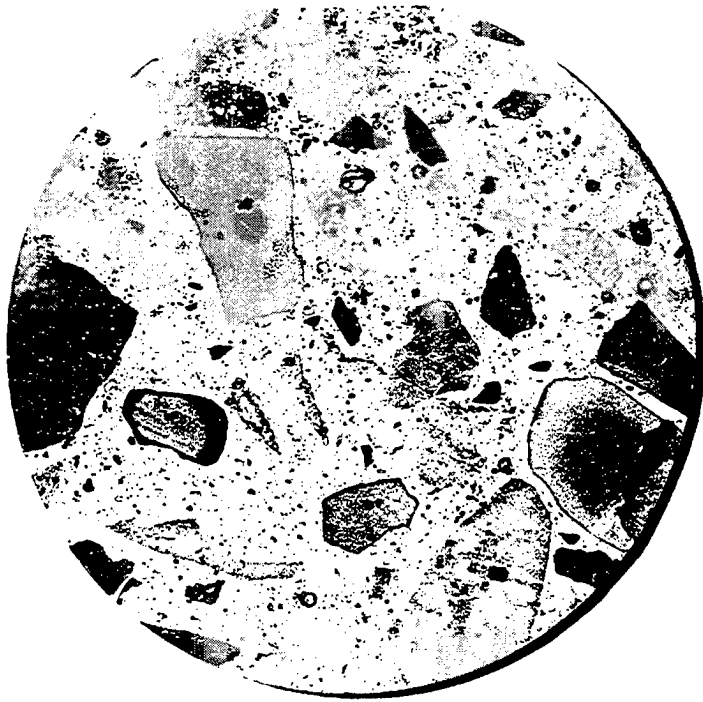
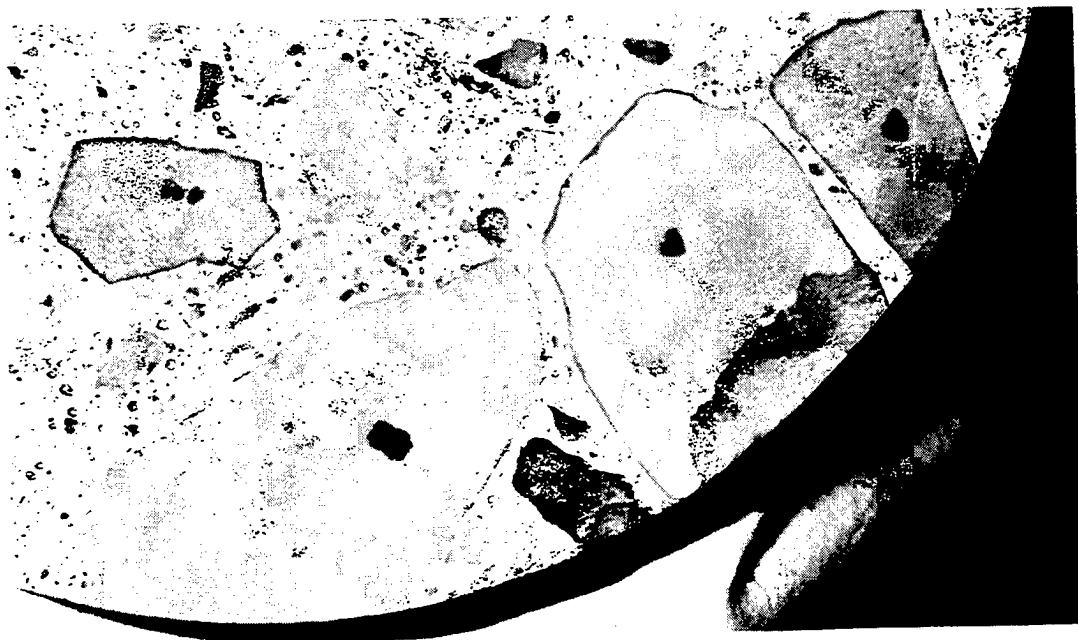
Figure A13. Sample 950615 shows some non-expansive reactive aggregate particles. Top sample is 6 in. (152 mm) left to right
