AIRCRAFT ACCIDENT REPORT

UNCONTAINED ENGINE FAILURE
DELTA AIR LINES FLIGHT 1288
MCDONNELL DOUGLAS MD-88, N927DA
PENSACOLA, FLORIDA
JULY 6, 1996

**Adopted: January 13, 1998
Notation 6725C**

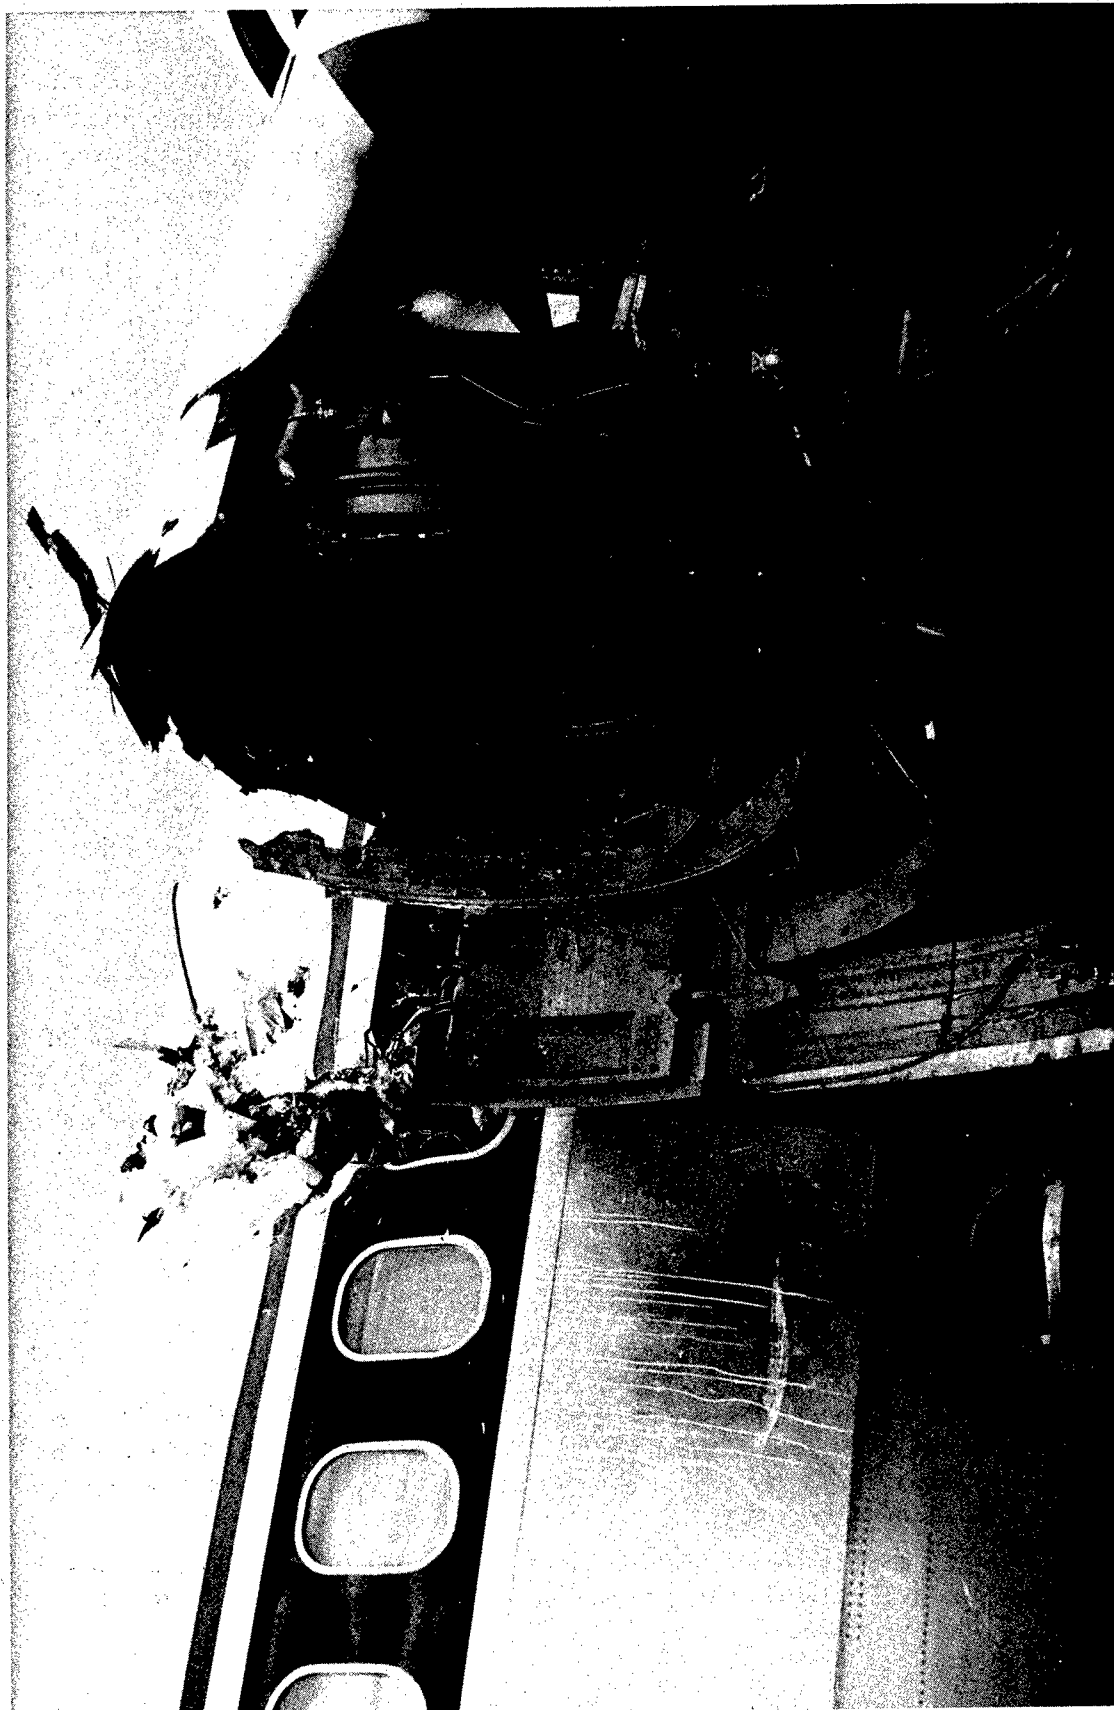
Figure 1.—Damaged area of airplane near No. 1 engine.

The aft left fuselage and interior of the airplane in the vicinity of the No. 1 engine were substantially damaged by debris from the engine (see figure 1). A total of 16 holes, punctures, or tears were documented on the left fuselage skin. Several large holes and tears were

The cabin interior was substantially damaged near seat row 37, next to the left engine. Debris from the left engine's fan hub and fan blades had penetrated the left cabin wall and overhead bin vertically from the lower left passenger window through the overhead bin and ceiling panel. Engine fan components had also pierced the side and ceiling of the right cabin wall.

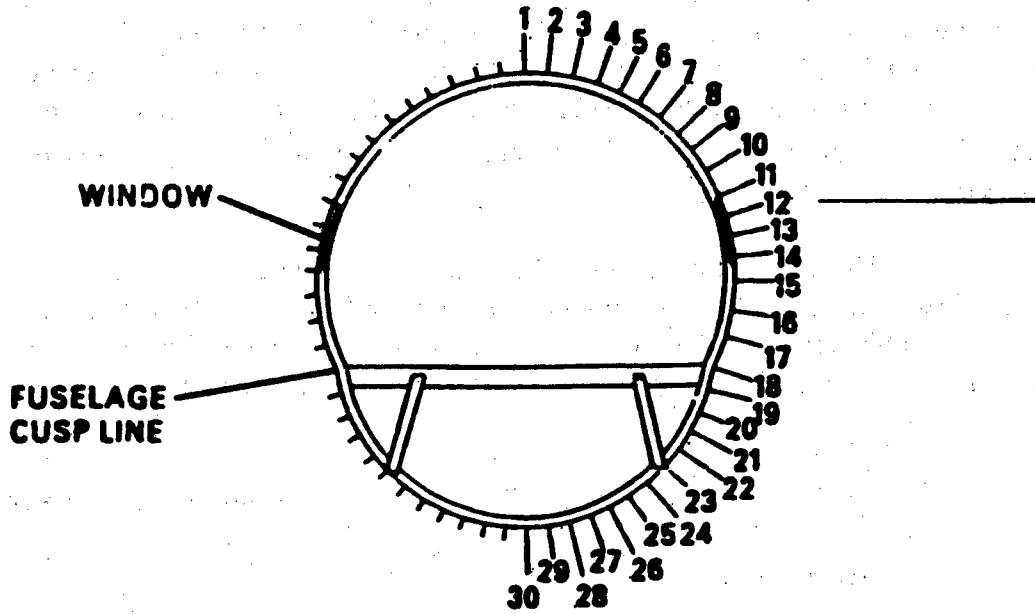
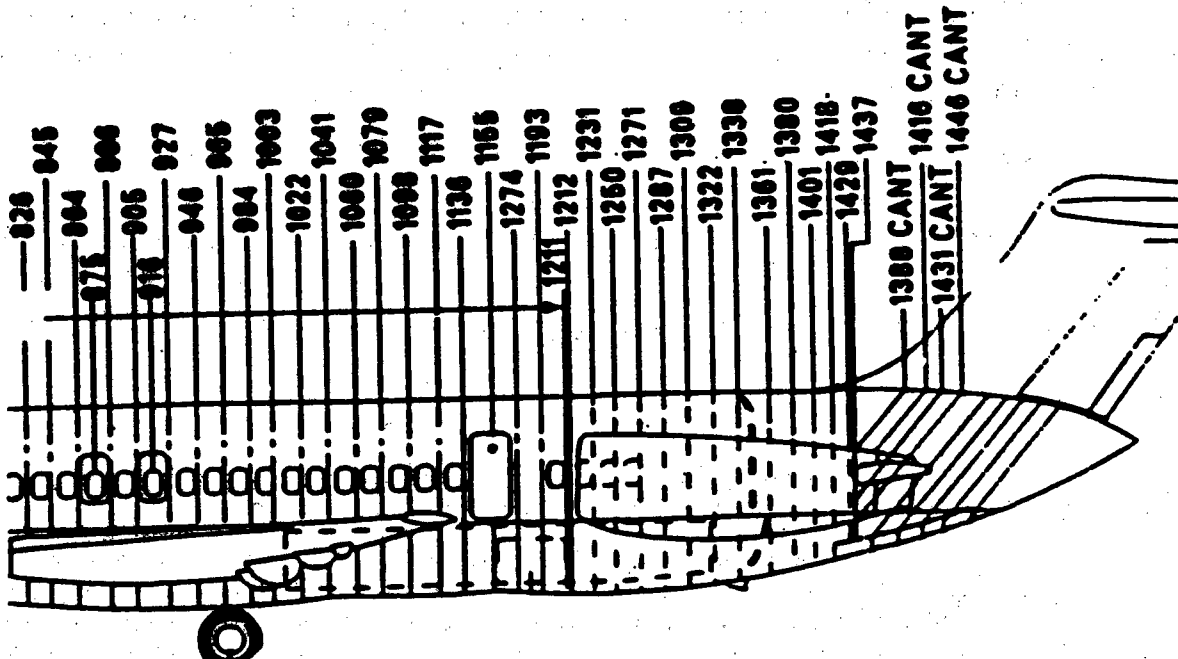
Figure 2.—Fuselage station and longeron identifications.

found between fuselage stations (FS) 1250 and FS 1282 (adjacent to row 37) and from the top of the window to longeron 2 (see figure 2).¹² Seven exit holes, punctures, and tears were documented on the right fuselage skin between FS 1228 and 1271 (just forward of row 37). Most of the wires in the wire bundle located along longeron 4 (on the right side of the fuselage) were severed near FS 1250. Of the 154 wires in the bundle, 146 had been severed. Four of the severed wires were channel differential protection wires that compared incoming and outgoing current for the right generator.¹³ No evidence of penetrations existed below the floor level on either side of the fuselage.

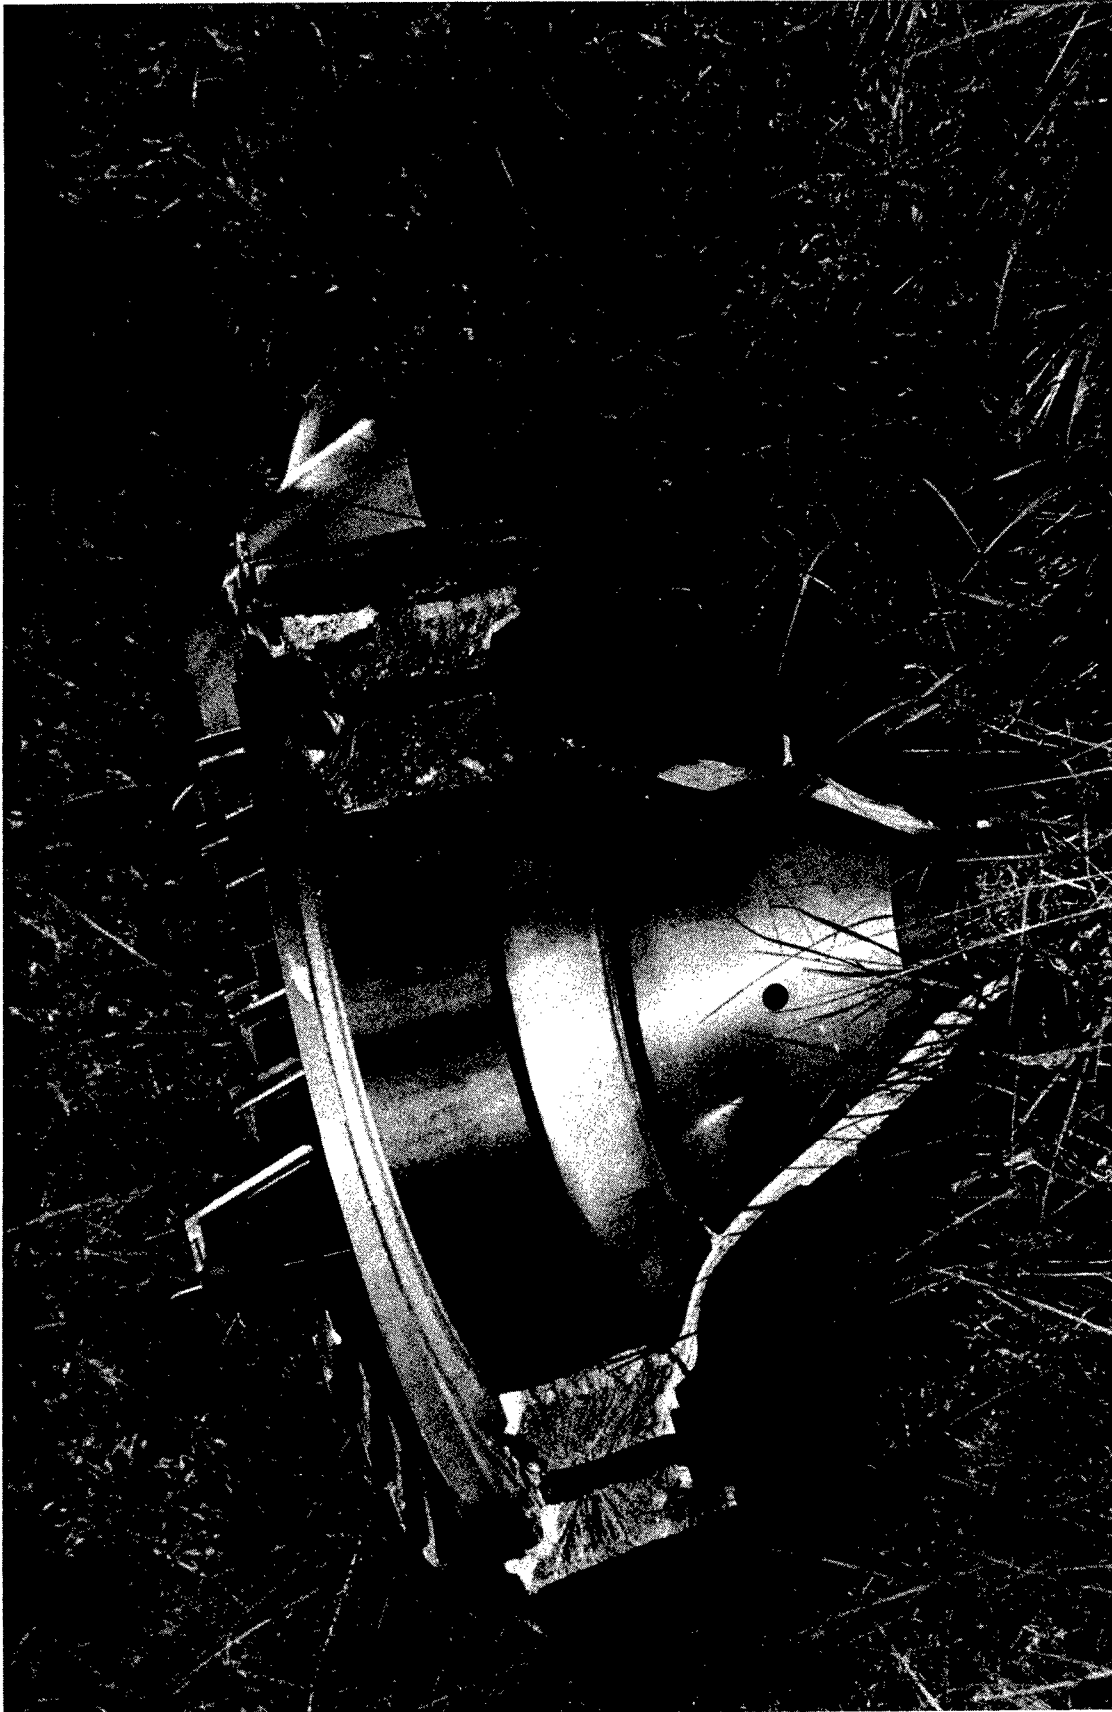
Figure 6.—Two-thirds of hub rim and adjoining conical section.

The fan hub fractured through a tierod hole and blade slot. There were two fan blade roots still in place on the small rim segment and 13 blade roots on the larger rim segment. Three of the 13 blades were full length and bent counterclockwise as viewed from aft looking

forward (ALF).³⁰ A smaller fracture surface was found at the forward section of the conical hub oriented at right angles to the hub axis and extending 360° around the part circumference. The hub rim's fracture surfaces were examined at the accident site by a Safety Board metallurgist and were found to have evidence of fatigue cracking.

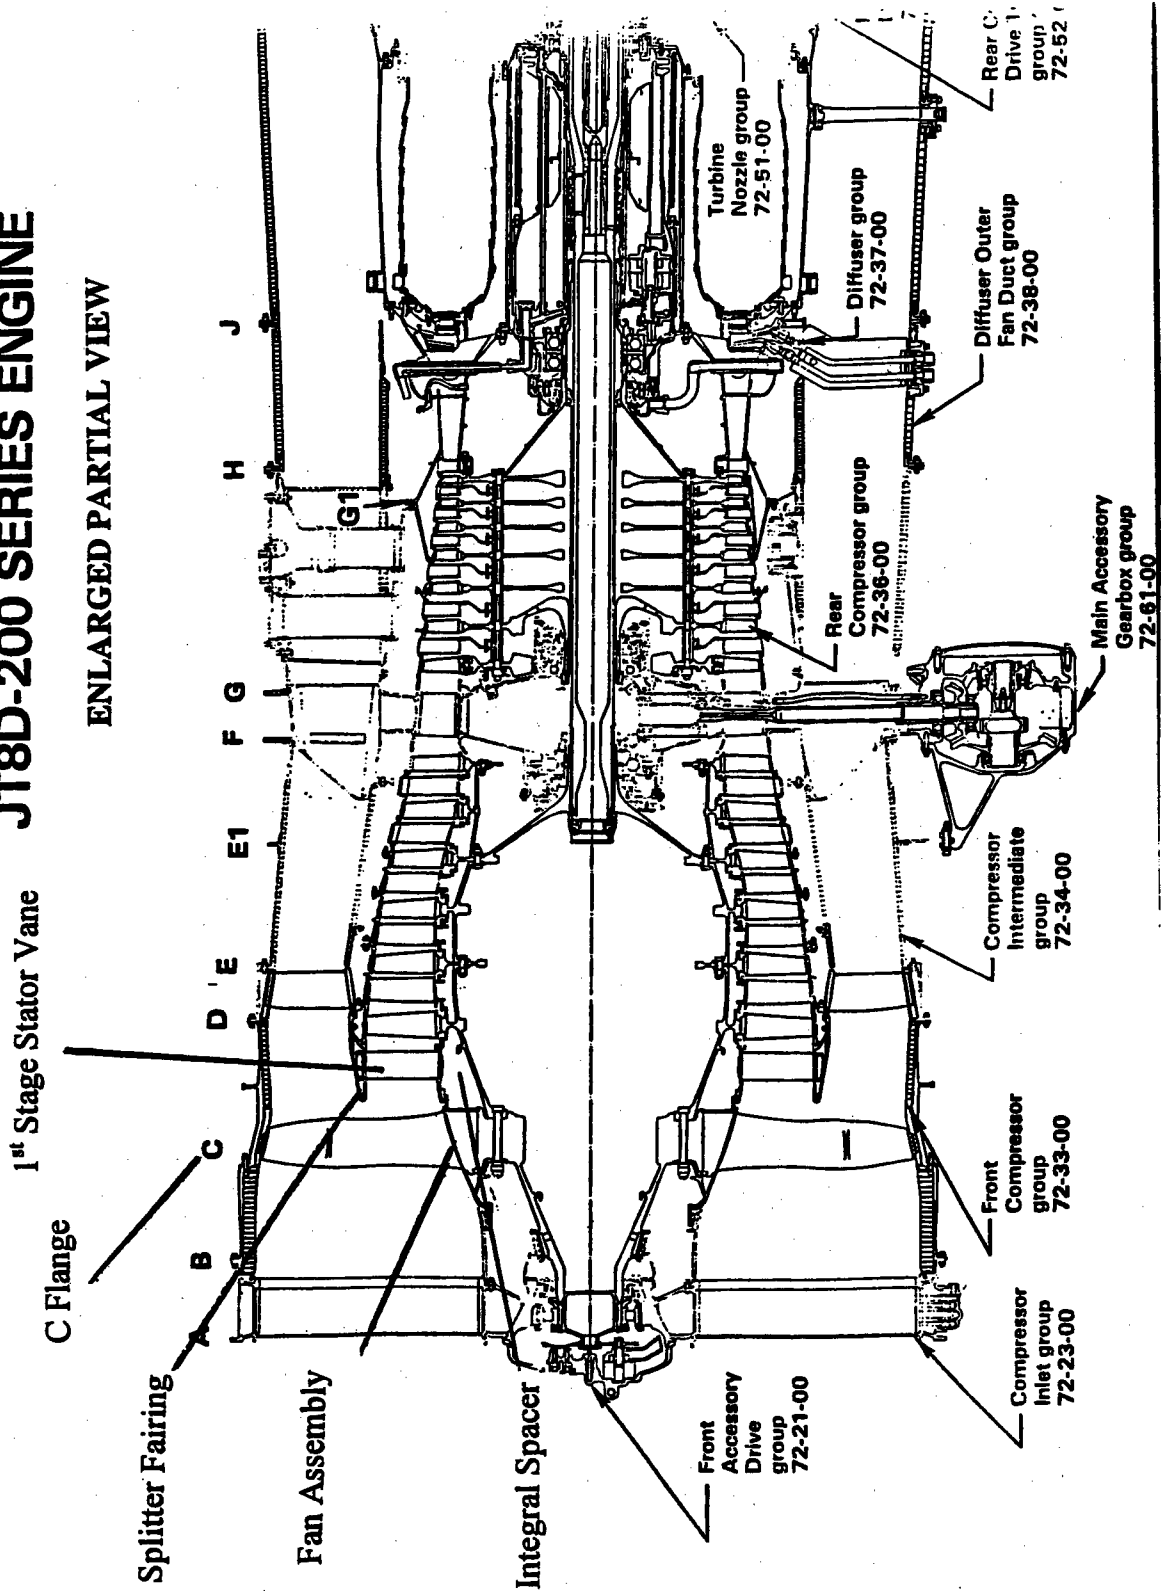
Figure 7.—Enlarged, partial view of outer engine case of JT8D-200 series engine.

The outer engine case separated at the C flange (see figure 7).³¹ Forward of the C flange, the case remained attached to the cowl. The case was torn and fragmented in two areas (centered at the 1 o'clock and 7 o'clock positions) between the C and D flanges. The 1 o'clock position was missing a segment from the 12:30 to 2 o'clock positions. The case was intact but had been torn loose from the D flange between the 2 o'clock and 3 o'clock positions. A 14-inch circumferential part of the fan rear case was found on the runway 61 feet to the right of the centerline and 441 feet from the runway threshold. Acoustic honeycomb in the fan case area was ripped, torn, or missing in many places. The splitter fairing³² (see figure 7) was missing from the 1 o'clock to the 7 o'clock position. A torn piece of the splitter remained attached at the 5 o'clock position. Twelve first-stage stator vanes³³ were present on the remaining splitter fairing. The inner diameter ends of the vanes were separated from the inner shroud and bent in the direction of rotation.

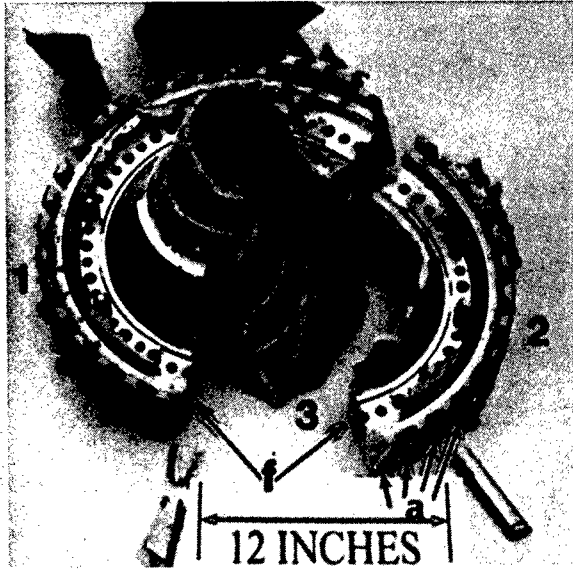
Figure 9a.—Fractured fan hub.

The fractured components of the accident fan hub were examined in the Safety Board's materials laboratory. The fan hub had fractured radially in two places (see figure 9a). One of the radial fractures contained a fatigue crack that originated at two locations on the inboard side of a tierod hole (see figure 9b). The two origins were located within the tierod hole at distances of 0.307 inch and 0.553 inch from the aft edge of the hole. Fatigue fracture features extended a maximum of about 1.5 inches radially inboard (towards the center of the engine) from the origins (see figure 9c). Outside of the fatigue region, the fracture features were consistent with an overstress separation.

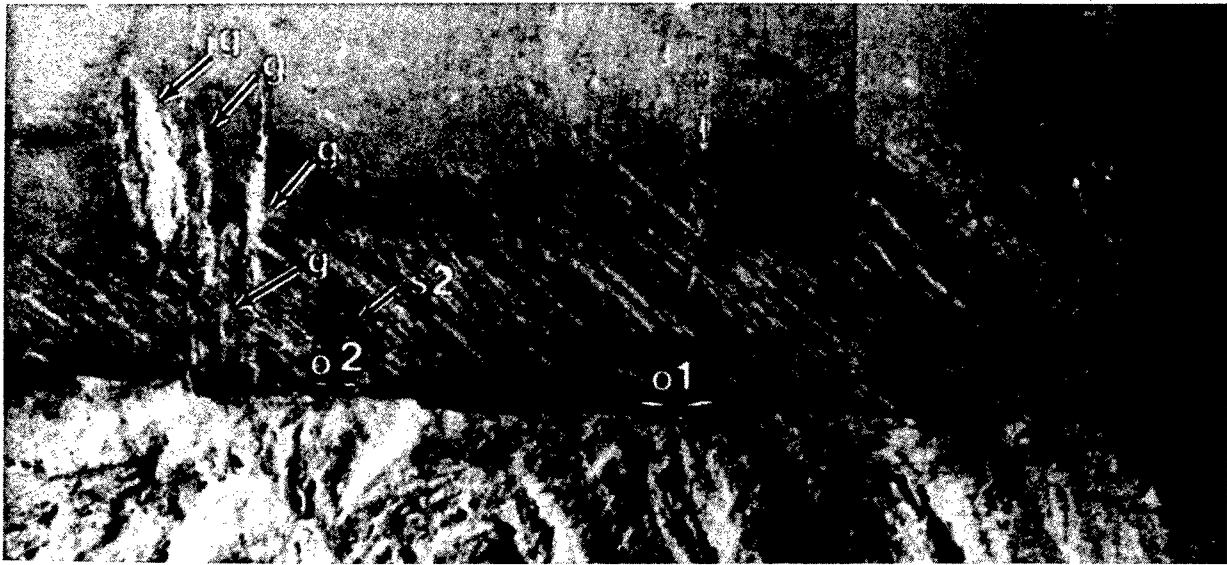
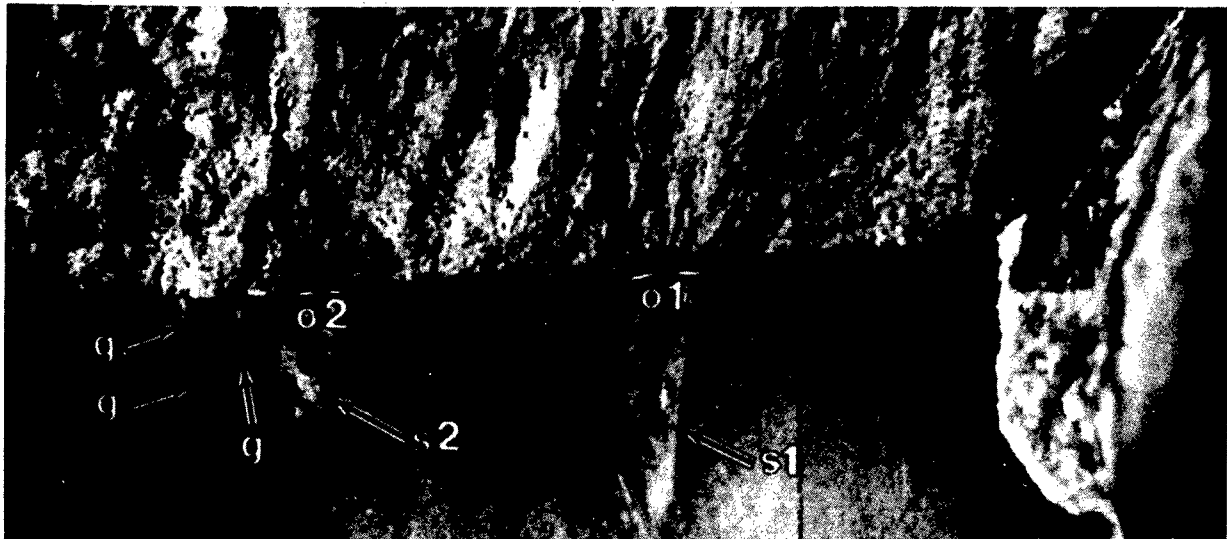
Figure 9c.—Magnified view of fatigue fracture features.

About 12,887 fatigue striations were found in the fatigue fracture region, roughly equivalent to the number of the hub's flight cycles. A portion of the fatigue fracture surface adjacent to the origin area was discolored slightly darker than other parts of the fatigue region. This discolored fracture region extended about 0.7 inch radially inboard from the origin area. At the aft face of the hub, the fracture discoloration extended about 0.46 inch inboard from the hole. Along the hole wall, this discoloration extended about 0.90 inch forward from the aft inboard corner of the hole. The number of striations in the discolored part of the fracture was approximately the same as the number of flight cycles recorded for the hub at the last FPI performed by Delta.
