DOT/FAA/AR-98/22

FAA T53-L-13L Turbine Fragment Containment Test

June 1998

Final Report

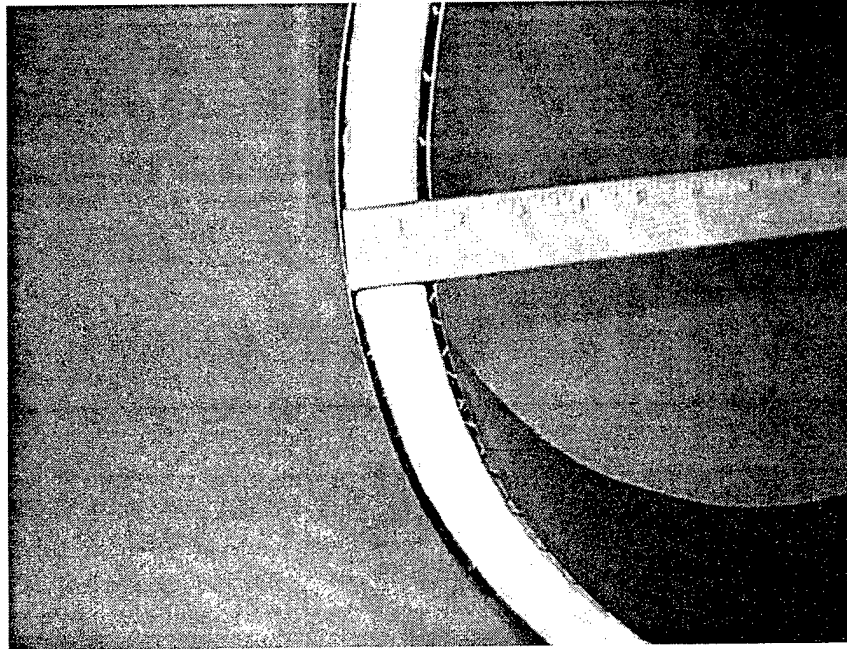
FIGURE 1. CONTAINMENT RING SECTION

The containment ring was developed and fabricated by Pepin Associates Inc. The ring was fabricated with a 0.014-inch titanium inner and outer sleeve. One-inch-thick Kevlar 29 ballistic fabric made up the primary structure of the containment ring. The ring was strengthened with titanium rods which were inserted through the fabric and laser welded to the inner and outer sleeves (figure 1). The ring weighed approximately 25 lbs. The containment ring was installed on the test engine and loosely connected to the engine case. The ring was centered on the second stage power turbine.

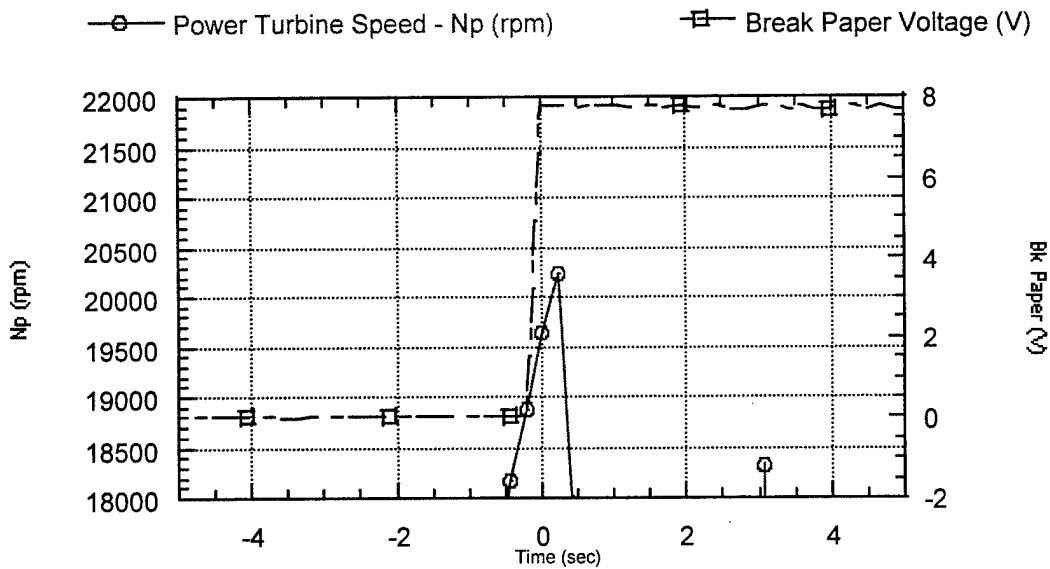
FIGURE 5. POWER TURBINE SPEED AND BREAK PAPER VOLTAGE VERSUS TIME TEST DATA

The test was completed as planned. The cameras were triggered as Np passed through 14,000 rpm. The disk released at 19,629 rpm. Test data are provided in figures 5 through 7. The disk ruptured into three nearly equal sections that were contained by the containment ring. The outer titanium shell split due to the tensile load resulting from the disk fragments pulling the Kevlar into a triangular shape. All three disk fragments penetrated the engine combustor case. The fuel lines located between the containment ring and combustor case were penetrated, resulting in a small fire. Secondary blade fragments exited the engine exhaust nozzle and a few fragments

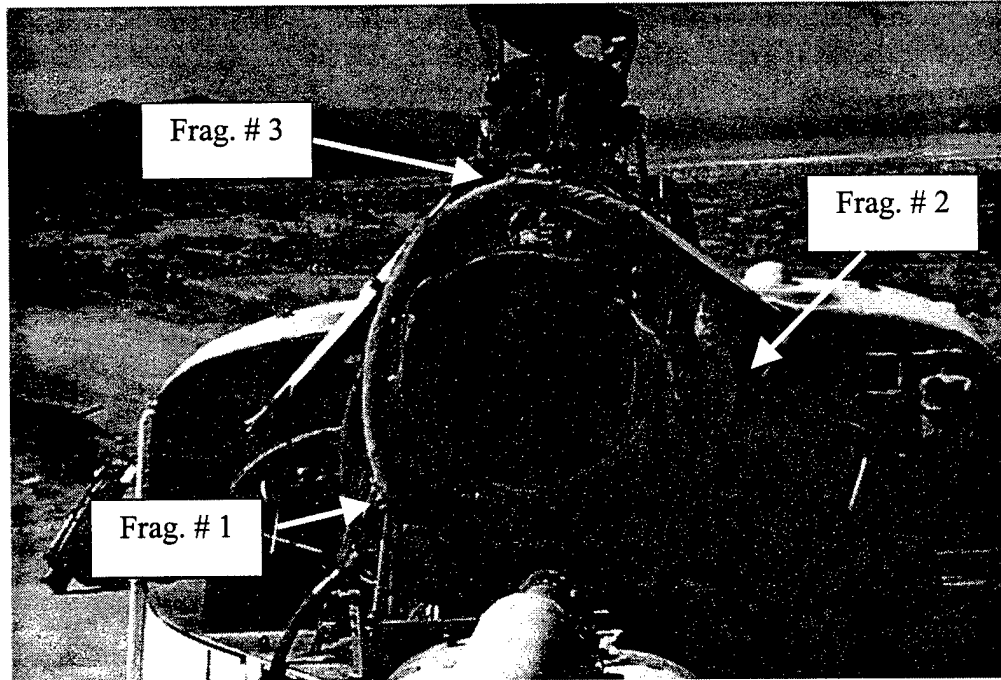
Figure 8. Posttest Engine

appeared to exit through the holes created by the disk fragments. These fragments were low-energy releases. Post event pictures are provided in figures 8 through 11.

The engine stayed within its mounts, with little apparent duress caused from the disk fragment energy being absorbed. The only noticeable sign of high vibration or loading was a broken throttle linkage.

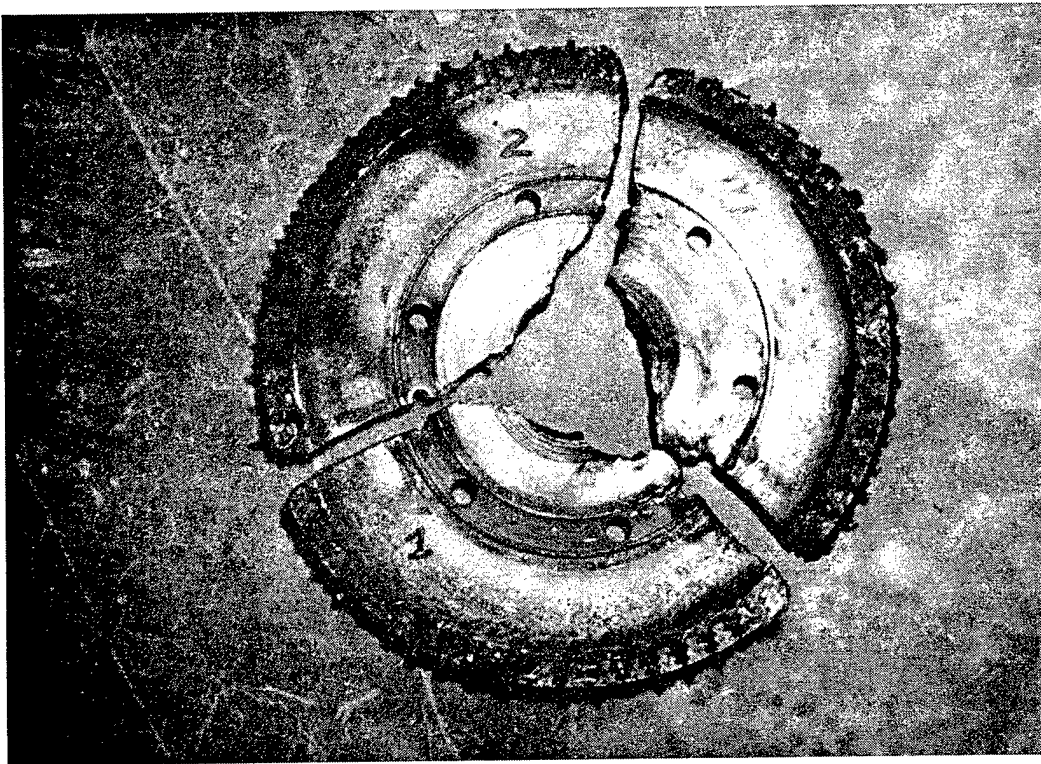
FIGURE 11. DISK FRAGMENTS

The disk fragments were recovered and weighed (table 1). The original weight of 10.8 lbs included blades which were broken off during impact. Approximately 2.65 lbs of debris was released.

Disk Fragment Number	Fragment Weight After Burst (lbs)
1	2.66
2	2.70
3	2.79
Total Large Disk Fragments	8.15

All three fragments penetrated through the combustor case and were embedded inside the containment ring. Minimum interactions between the immediate engine components and fragments were observed.
