Modelling of the HMAS Westralia Fire

DSTO-TR-0698

MODELLING OF THE HMAS WESTRALIA FIRE

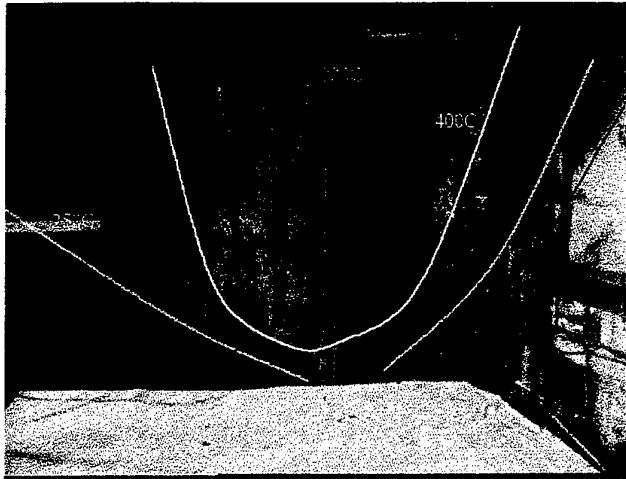
An estimate of the temperatures experienced by this bulkhead derived from observation of the damage to the paint and fittings on this bulkhead are shown in Figure 3. Similar estimates of the maximum temperatures experienced at the top of the port escape ladder are shown in Figure 4.

Figure 3. The wall adjacent to the starboard engine is shown together with approximate fire isotherm values from observed damage. Notice the two light fittings. The light fitting on the left has experienced temperatures near 250°C and the polycarbonate diffuser has melted and flowed away. The fitting on the right has experienced temperature in excess of 400°C and this has resulted in the destruction of the aluminium support as well as the burning of the polycarbonate diffuser.

The 150°C line is the lowest level at which the paint is observed to blister. The 250°C line is the lowest level at which the paint is discoloured. The 450°C line is the line at which the paint is completely burnt. The 800°C line is an estimate beyond which no paint residue remains. Some of these estimates are time dependent and could be out by 20%.

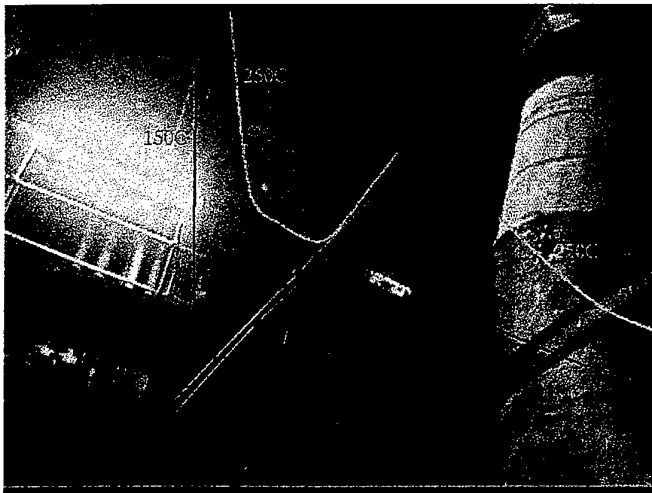
Figure 4. The port side bulkhead looking towards the port escape ladder from the 1st platform. Approximate isotherms values are shown.

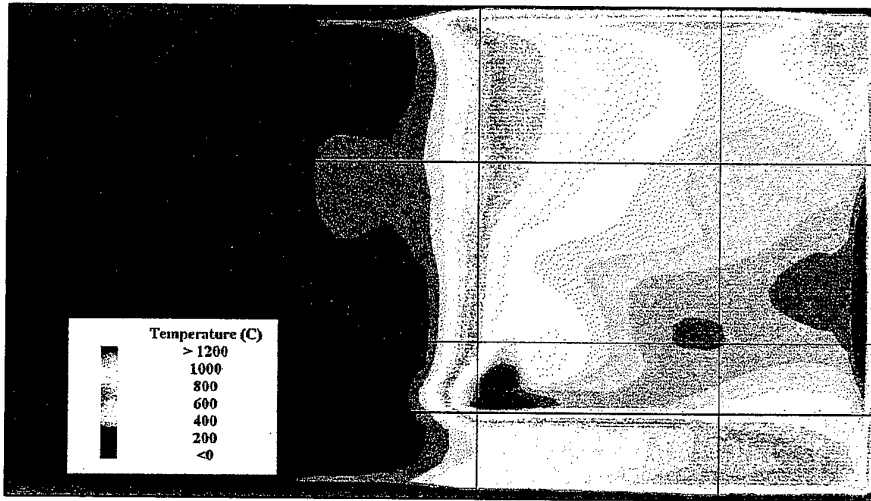
The temperature distribution under the MCR is of interest since this is where significant damage was done to the cabelling and the 3 tonne lifting rail directly above the fire source. Very high temperatures are indicated in the region of the cables ($>1200^{\circ}\text{C}$) and in the area above the cargo pumps. The temperature distribution predicted for a horizontal plane 0.5 m below the MCR floor is shown in Figure 8. The

Figure 8. The temperature distribution is shown, viewed from above, 0.5 metres below the MCR 1 minute into the event. A fireball is predicted to have spread across the whole of the underside of the MCR. The hottest spot is directly above the fire source. The wall adjacent to the starboard engine can be seen to effectively to block the heat getting to the machinery behind it.

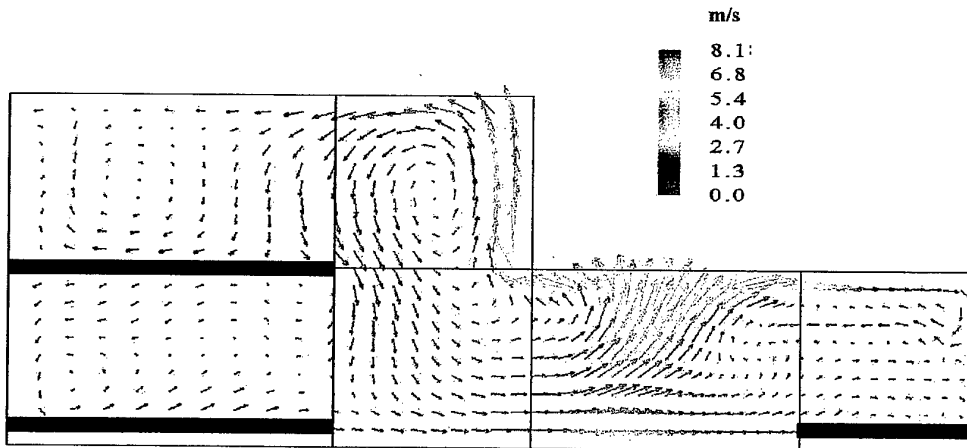
Figure 9. The bulk airflow of the compartment is depicted 1 minute into the incident for a aft-forward vertical section through the fire source. The main area of concern is the flow above the cargo pumps where hot gases are directed down onto the top of the motors.

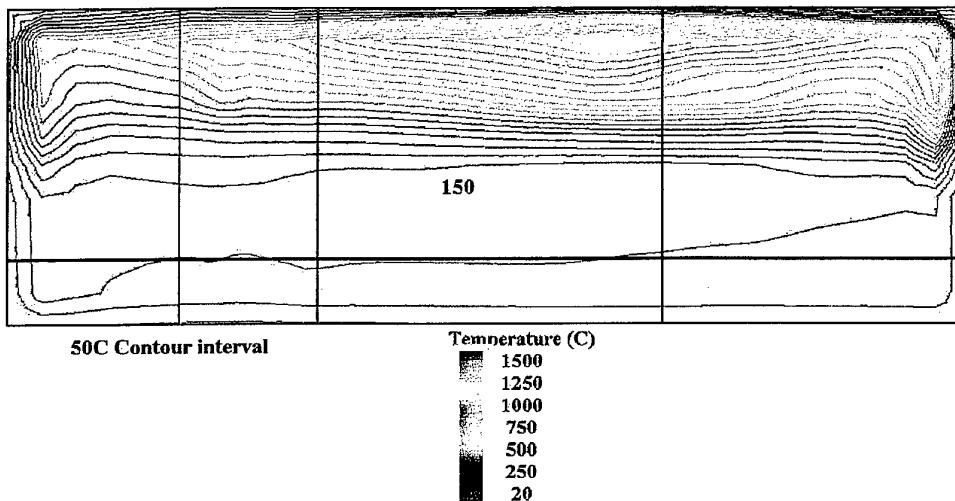
The exposure of the cargo pumps to high temperatures is of concern to the cost of repairs to the vessel. The predicted temperature contours is shown in Figure 10 for a section across the compartment through the location of the cargo pumps.

The 150 C isotherm is labeled and is significant as at this height the adhesive label was obtained from cargo pump number 3. A contour interval of 50°C was used in drawing the figure.

Figure 10. The isotherm predictions are shown, 1 minute into the incident, for a section through the cargo pumps area. The view is toward aft. Temperatures as high as 500C are predicted of the air at the tops of the pumps. The 150°C contour corresponds to the position of an adhesive label attached to the pump. An examination of a sample of this label suggests an exposure to a temperature of approximately 140°C.

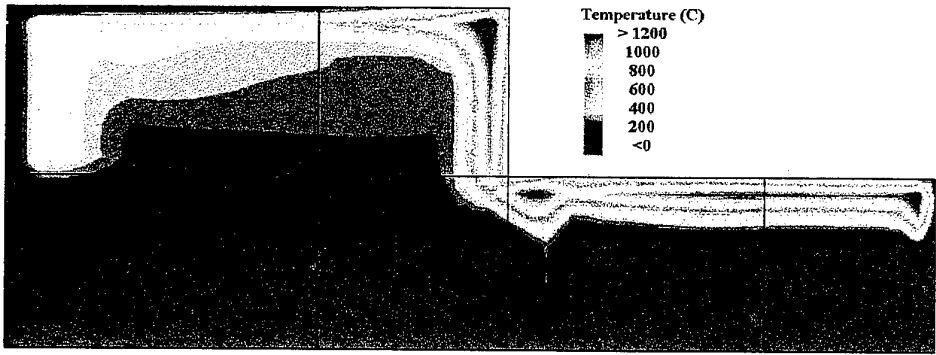
Figure 11 shows the predicted temperature distribution of the fire incident after 1 minute. The figure shows an aft to forward section through the origin of the fire. The bottom of the picture corresponds to the top of the starboard engine.

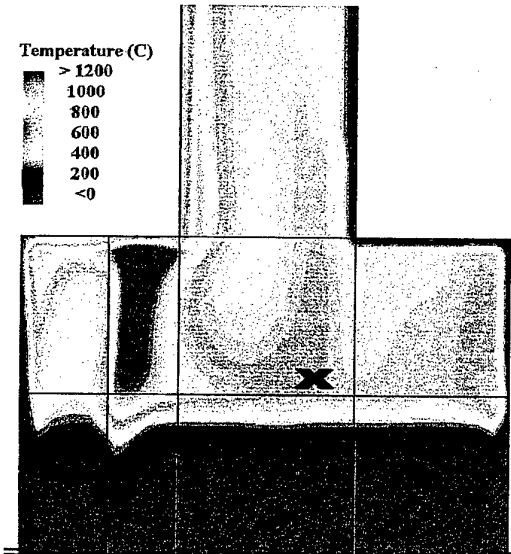
The model temperature predictions for the section just aft of the MCR looking aft are shown in Figure 12. The hot plume spilt from under the MCR can be seen to rise up the starboard side. Predicted temperatures of approximately 500 to 600°C would be experienced at the MCR level near the starboard escape ladder (marked with an X). This is consistent with the damage to the aluminium walkway, which softened and buckled during the incident. The top of the port escape ladder (marked with an X) also was predicted to be exposed to temperatures of 300 to 400°C, again consistent with the damage observed (paint blistered and burnt, light fitting difusers melted and signs damaged).

Figure 12. Temperature distribution 1 minute into the event for a cut across the compartment aft of the MCR looking aft. High temperatures of the order of 400°C are predicted to exist at the top of the port ladder (marked with an X).

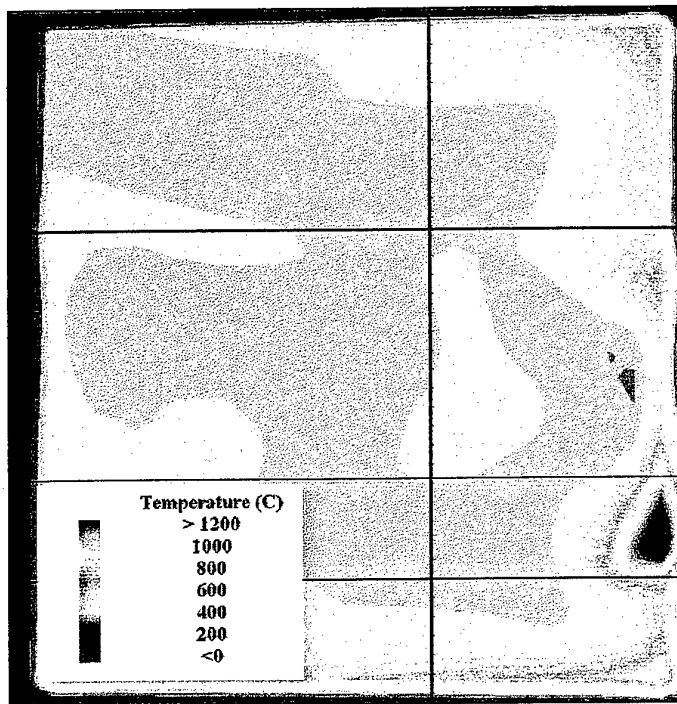
The firefighting team, from the level of the fridge flat, attempted re-entry into the engine compartment. This level refers to the top platform at the aft end of the compartment. The platform can be seen in Figure 2 just above the boiler. The predicted temperatures on the fridge flat level, depicted in Figure 13, one minute into the incident indicate that there is significant heating across the whole of this area. Temperatures are predicted to be near 350°C. The predicted temperature four minutes into the event is shown in Figure 14. Temperatures are predicted to have fallen to 100°C. At four minutes, this is still too hot for an attempted reentry [9]. The observed damage at the fridge flat level is again consistent with the predicted temperature history (light fittings melted and little damage to paint work)

Figure 13. The temperature distribution one-minute into the fire incident at the level of the fridge flat.

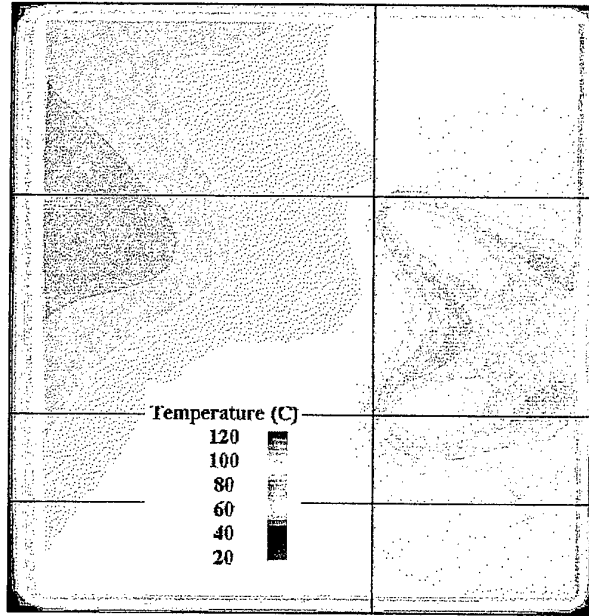
Figure 14. The temperature distribution is depicted 4 minutes into the fire incident at the level of the fridge flat. The residual temperatures at the aft end of the compartment, where the fire fighters attempted to re-enter the compartment, is still near 100°C and too hot for a reentry.

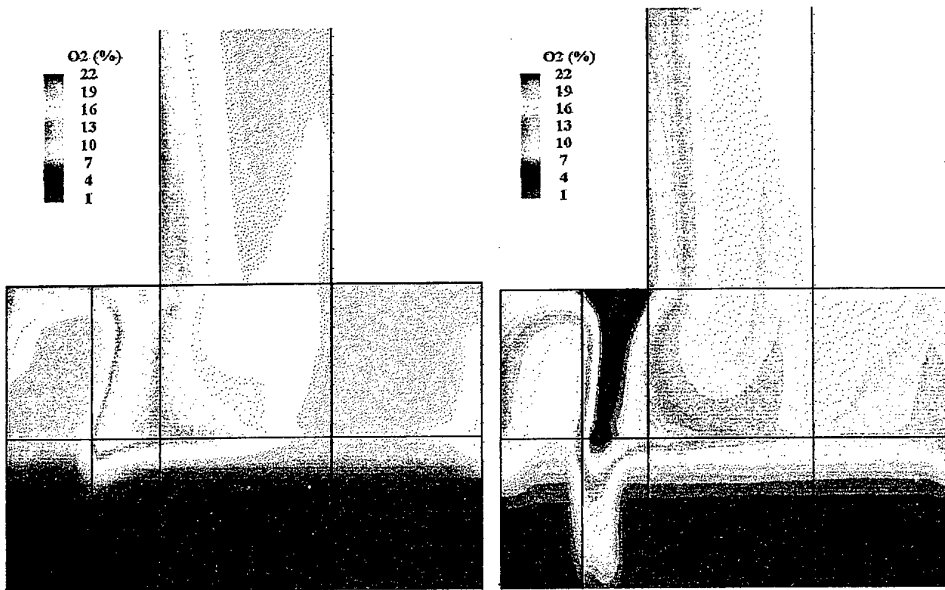
The oxygen content of the compartment is shown in Figure 15 for a section across the compartment just aft of the MCR looking aft at 30 and 60 seconds into the fire. The starboard side shows the depleted air associated with the fire plume rising rapidly up the starboard side of the stack. The port side shows a depleted oxygen level within a minute as smoke fills the whole compartment. The carbon dioxide level in the model, shown in Figure 16, has filled the compartment with levels of up to 10% CO₂ down below the MCR within a minute. The CO₂ distribution matches the oxygen loss distribution well indicating that in the model fire the fire was well ventilated.

Figure 15. Calculated oxygen content 0.5 minute and 1 minute into the fire incident. A cut across the compartment aft of the MCR is shown looking aft. The bottom of the picture corresponds to the level at the top of the engines. The horizontal line in the middle of the picture is at the level of the MCR. Low concentrations of oxygen are predicted at the top of the escape ladder

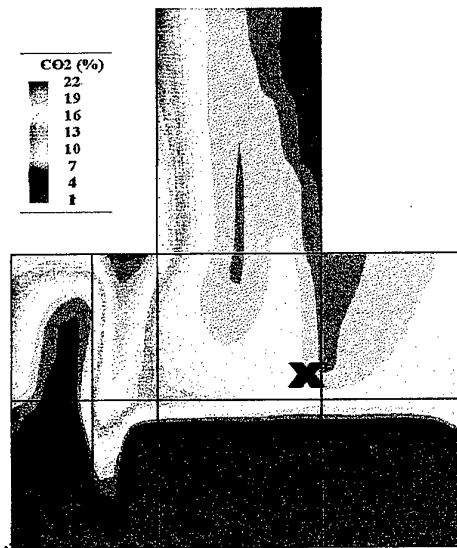
Figure 16 Calculated carbon dioxide levels 1 minute into the fire incident. A cut across the compartment aft of the MCR is shown looking aft with the same geometry as in Figure 15. High concentrations of CO₂ are predicted at the top of the port escape ladder at the level of the MCR, (marked with an X).
