National Transportation Safety Board

Safety Recommendation

Date: January 15, 1998

In reply refer to: A-98-1 and -2

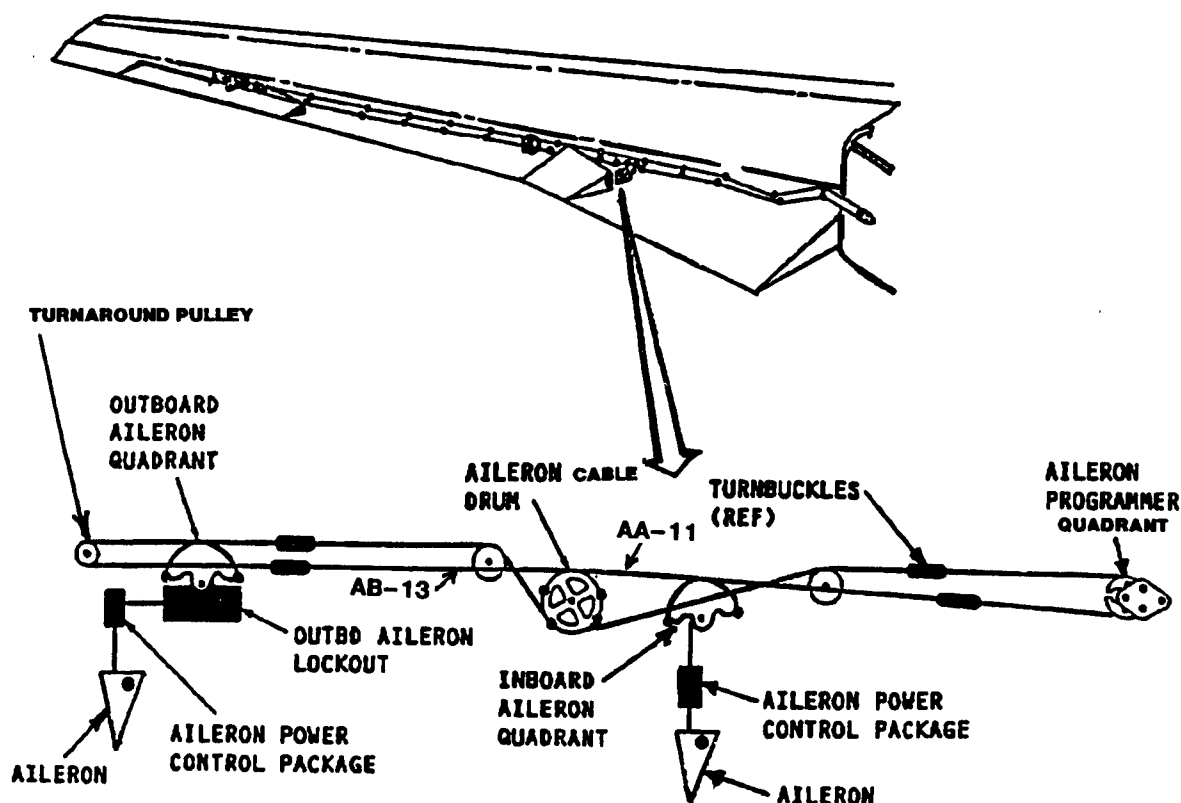
Figure 1. Aileron Wing Control Cable System.

Each wing has two AA and two AB aileron cable assemblies (see Figure 1.), one inboard and one outboard. The inboard AA cable run connects the aileron programmer quadrant to the aileron cable drum, and the inboard AB cable run connects the same quadrant to the inboard aileron PCU quadrant. The outboard AA cable run connects the aileron cable drum to the outboard aileron quadrant, and the outboard AB cable run connects the drum to the same quadrant via a turnaround pulley. The aileron cable drum, which is located at wing station (WS) 776.98, is a four-slotted pulley with a guide pin and is used to provide a complete (closed) cable loop to the inboard aileron even if the outboard segment is lost because of malfunction. The guide pin's purpose is to ensure that all four cables remain in the correct pulley slots at all times.

Further investigation by BASI revealed that the two aileron control cable decals¹ on the aileron cable drum's inboard and outboard mounting brackets at WS767 and WS780 were installed incorrectly. The decal for WS767 was fitted at WS780 and vice versa. BASI also found that a similar 747 aircraft, S/N 23028, production line number 584, had the aileron cable replaced because of excessive wear, and the cable was frayed down to one remaining strand. This aircraft also had the two aileron control cable decals on the aileron cable drum's inboard and outboard mounting brackets at WS767 and WS780 fitted incorrectly and interchanged. Because of the decals' transposition, the Safety Board requested a U.S. operator to randomly inspect its 747 airplane aileron control systems for the aileron cable drum decal identification at WS767 and WS780. An inspection on November 24, 1997, of one 747-251, S/N 21707, production line number 378, revealed similar decal transposition on the right WS767 and WS780.

The BASI investigation concluded that the Brisbane incident was caused by misrouting of cables on the aileron cable drum at WS776.98 and that transposition of the aileron control cable decals on the aileron cable drum at WS767 and WS780 has the potential to cause misalignment of the aileron control cables during installation. The Safety Board is concerned that airplanes with mispositioned aileron cable installation decals may be susceptible to aileron cable failures in flight, which could jeopardize flight safety. The Safety Board believes that the Federal Aviation Administration should issue an airworthiness directive to require operators of 747s, produced before production line number 1130, to conduct a one-time inspection of the aileron control system to ensure correct routing of aileron control cables on the aileron cable drum located at WS776.98 and correct installation of aileron cable decals at WS767 and WS780 at the earliest possible inspection interval.

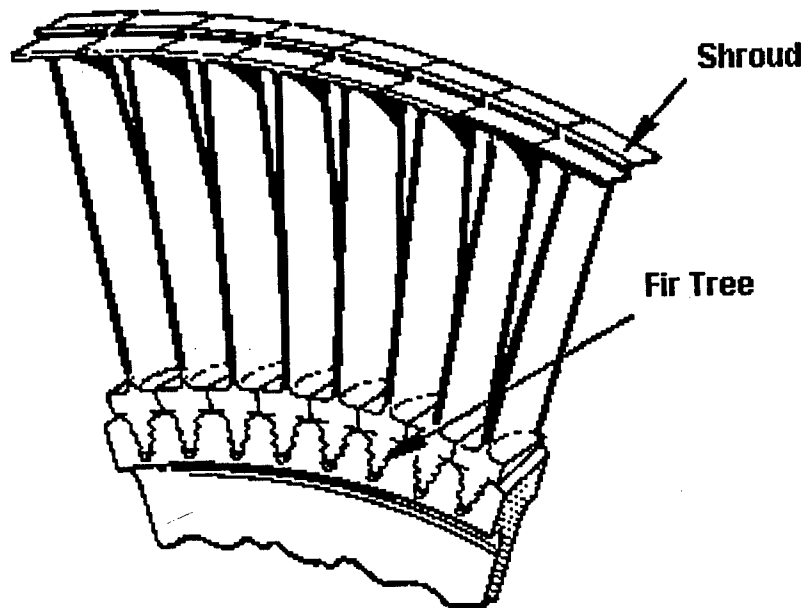
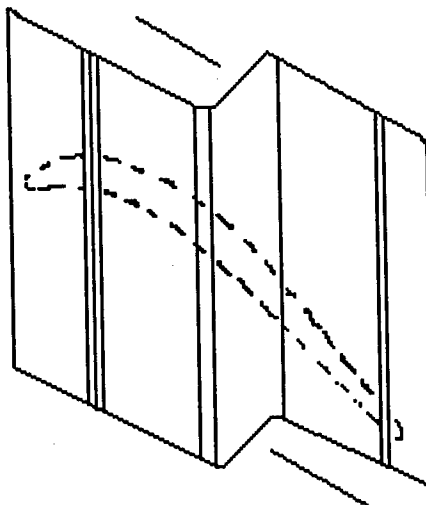
Shroud Notch (contact area)

origin area. Examination of the 4th stage LPT blade shroud notches³ that were recovered from the exhaust case revealed evidence of extreme notch wear estimated at 0.030 to 0.050 inch in depth.

The JT8D LPT blade design incorporates a blade tip shroud for structural support and vibration dampening. The blade shrouds interlock to provide stiffness so that they function as a single ring to reduce blade flexing caused by thermal, aerodynamic and centrifugal loads. The shroud notches (contact areas) are coated with PWA 694, which is a cobalt alloy that is a hard temperature and wear resistant material, to help reduce wearing. Worn shroud notch surfaces reduce blade damping and drop the blades' resonance frequency into the engine operating range. This increases the vibratory stresses to levels that can initiate fatigue cracking.

According to P&W, the JT8D-200 series engine has experienced 180 3rd and 4th stage LPT blade failures resulting from two different failure modes. The first is excessively worn LPT blade notches that can result in HCF fractures occurring at the root of the 3rd and 4th stage blades. P&W indicated that approximately 95 percent of all 3rd and 4th stage blade failures are the result of

Determine the effectiveness of inspection techniques used to measure the amount of shroud wear on installed 3rd and 4th stage low pressure turbine blades on Pratt & Whitney JT8D-200 series turbofan engines, and mandate inspection techniques determined to be most effective based on an interval derived from failure and operational data. (A-98-8)

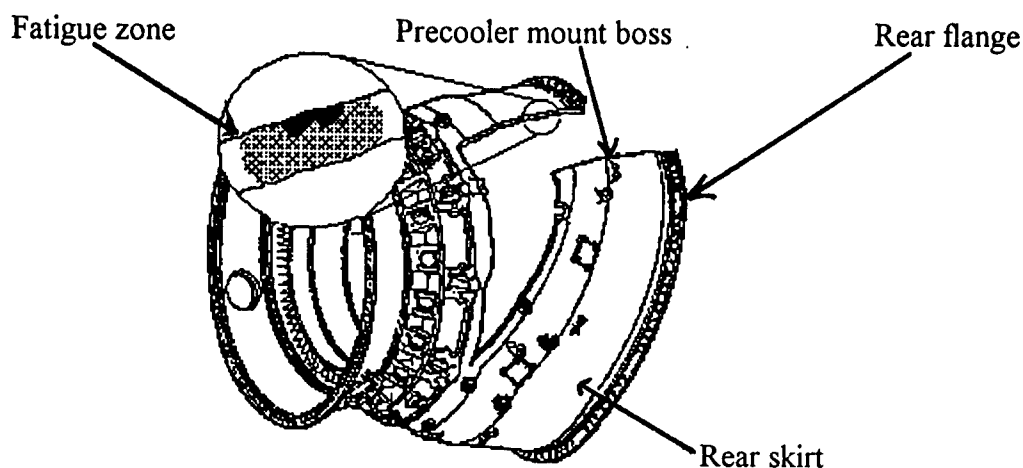
Figure 1: Ruptured diffuser case

A section of the diffuser case rear skirt (see figure 1) was examined at the Safety Board's materials laboratory in Washington, D.C. Examination of the fracture surface, approximately 10 ½ inches from the rear flange, adjacent to the upper precoolers mount boss, revealed a 5-inch long discolored high cycle fatigue³ (HCF) zone with about 90,000 striations. The fatigue initiated at a crack that looked like two thumbnail-shaped, gray-colored areas, which were approximately 0.040-inch wide by 0.010-inch deep. High levels of delta phase precipitate⁴ were discovered in the thumbnail-shaped origin areas. Individual 0.0005 to 0.0008-inch deep toolmarks or scratches were found on the outer case wall extending the length of the origin area. Numerous additional toolmarks were found on the exterior surface of the rear skirt. The toolmarks were formed when the exterior surface of the case was machined (blended) during manufacture. The diffuser case had accumulated 9,342 total flight cycles⁵ since new.

A metallurgical analysis of the fracture surface indicated that the thumbnail-shaped cracks had initiated at the base of the toolmarks because of a combination of high residual stresses and low-cycle fatigue⁶ (LCF). The crack then propagated in HCF, as evidenced by the very small striation spacing found in the majority of the 5-inch long fatigue zone, after which the crack progressed to failure in tensile overload.

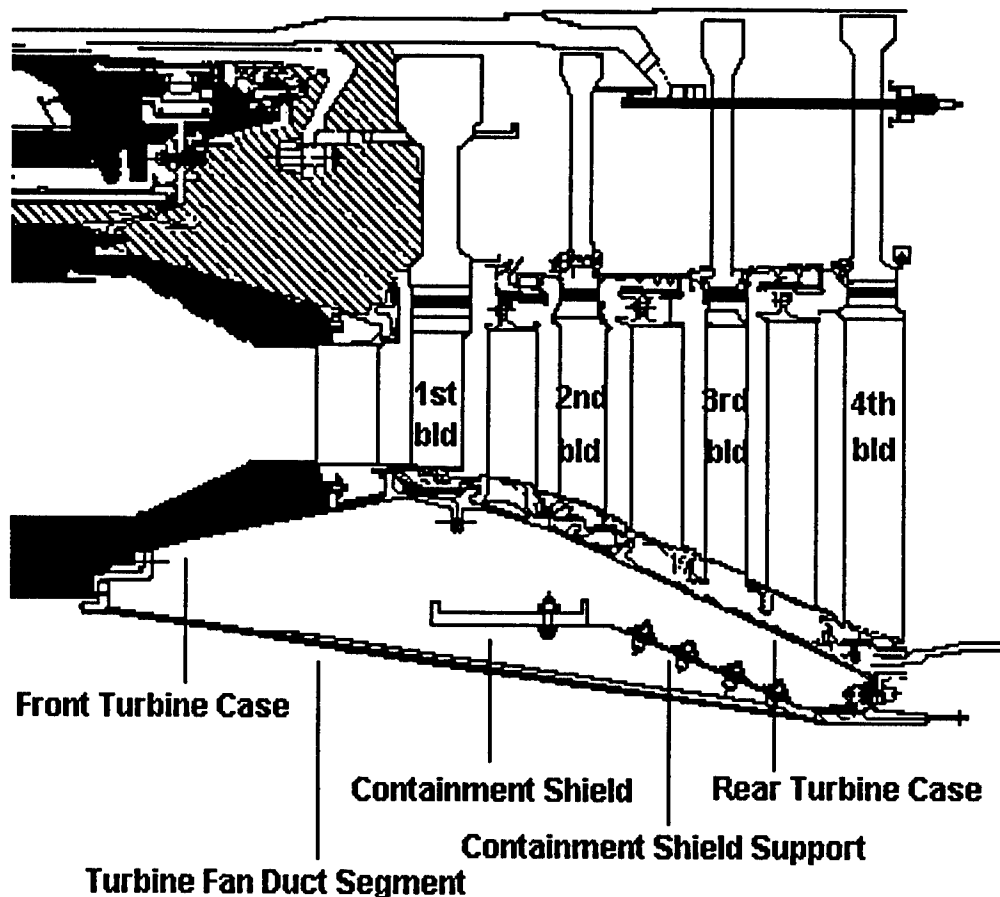
Figure 1 Containment Shield Configuration

applicable to all JT8D-209, -217, -217A, -217C, and -219 turbofan engines. The containment shield is a clam shell design consisting of two half-shields joined by clevis plates and supported by a cantilevered shield support attached to the HPT rear flange. Considerable impact damage (engine debris) was observed on the inner diameter (ID) of the containment shield; however, the shield remained intact. The impact of turbine material on the lower shield shifted it outward and aft from its normal installed position, buckling its support. First-stage turbine blades and 2nd-stage turbine vanes had exited the engine through the openings between the HPT and LPT case flanges and deflected off the containment shield ID while exiting the engine and before striking the airframe.

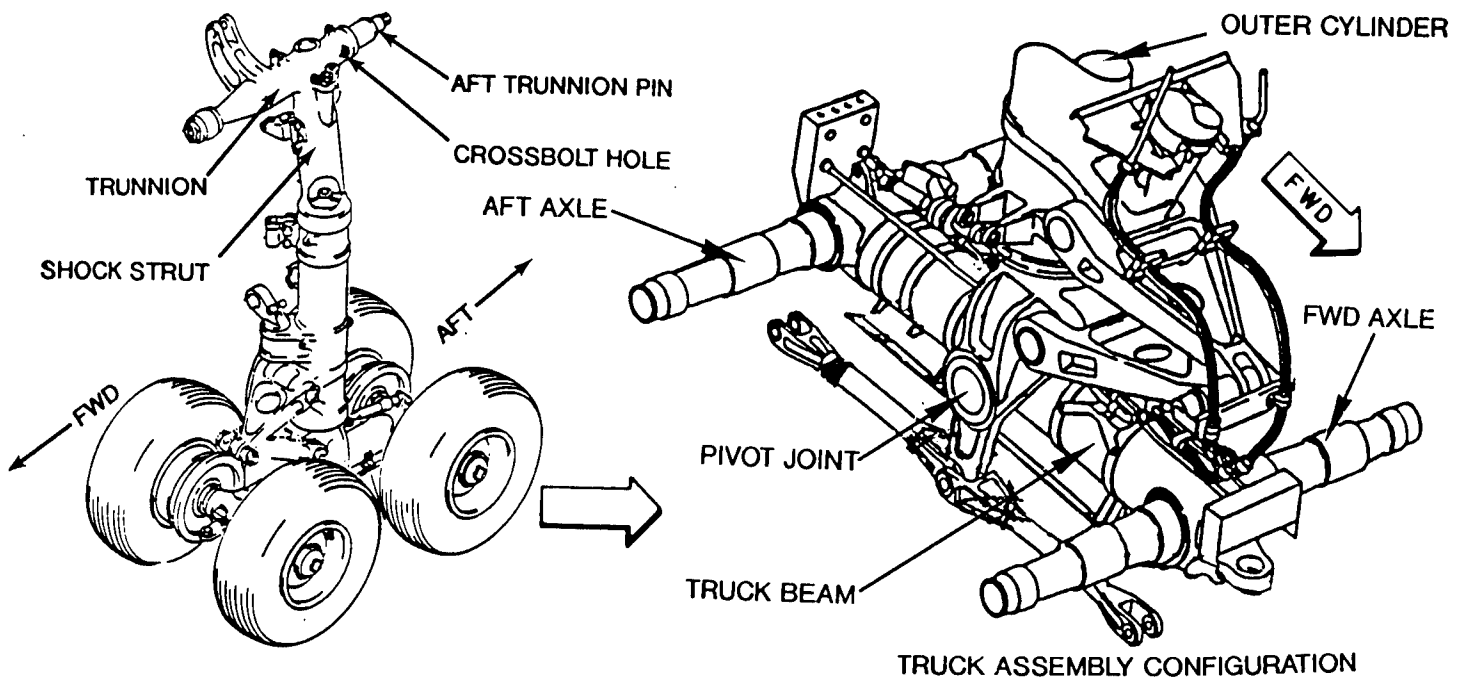
Figure 1. Boeing 757 Main Landing Gear Assembly

The 757 MLG is a conventional, four-wheel, dual-tandem landing gear that has a metering pin orifice shock strut (see figure 1). The gear has four support points: the forward trunnion, the aft trunnion, the drag brace, and the side strut. The shock strut outer cylinder of the MLG assembly transfers operational loads from the truck assembly to the four support points. The assembly consists of a truck beam, axles, wheels and tires, brake rods, and a protective shield. The truck beam is the primary supporting member of the truck assembly. It pivots on the lower end of the shock strut outer cylinder.

The truck beam is a hollow cylinder made from 4340M steel. The inner surface has three primary means of corrosion protection: cadmium-titanium electroplating; Boeing Material Specification BMS10-11 type 1 primer; and MIL-C-11796 Class 1 corrosion-inhibiting compound (CIC), also called Cosmoline. This CIC is applied in a hot liquid form and coats the inner surface of the truck beam with a uniform layer. Any moisture in the truck beam is drained through an opening at the aft end of the cylindrical truck beam section by gravity during truck tilt during takeoff.

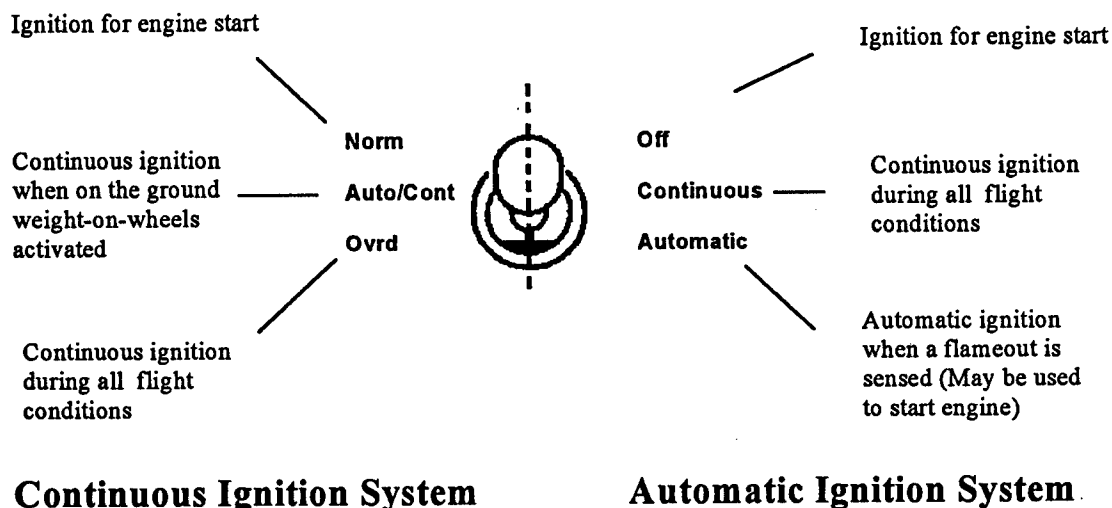
Figure 1. Typical Ignition Switch Position Labeling in TPE331-powered Airplanes

not truly automatic because the pilot must first select an ignition mode using a manually selectable three-position switch. Flameouts can be detected by the decay in certain engine parameters, such as engine revolutions per minute or torque. The automatic ignition system can relight the engine without pilot action or awareness of any engine or airplane performance changes if the ignition mode switch is in the automatic position.
