MARINE ACCIDENT REPORT

RAMMING OF THE
POPLAR STREET BRIDGE
BY THE TOWBOAT M/V CITY OF GREENVILLE
AND ITS FOUR-BARGE TOW
ST. LOUIS, MISSOURI
APRIL 2, 1983

NTSB/MAR-83/10

1. Report No. NTSB/MAR-83/10	2. Government Accession No. PB83-916410	3. Recipient's Catalog No. <i>PB 83 916410</i>	
4. Title and Subtitle Marine Accident Report -- Ramming of the Poplar Street Bridge by the Towboat M/V CITY OF GREENVILLE and Its Four-Barge Tow, St. Louis, Missouri, April 2, 1983		5. Report Date November 29, 1983

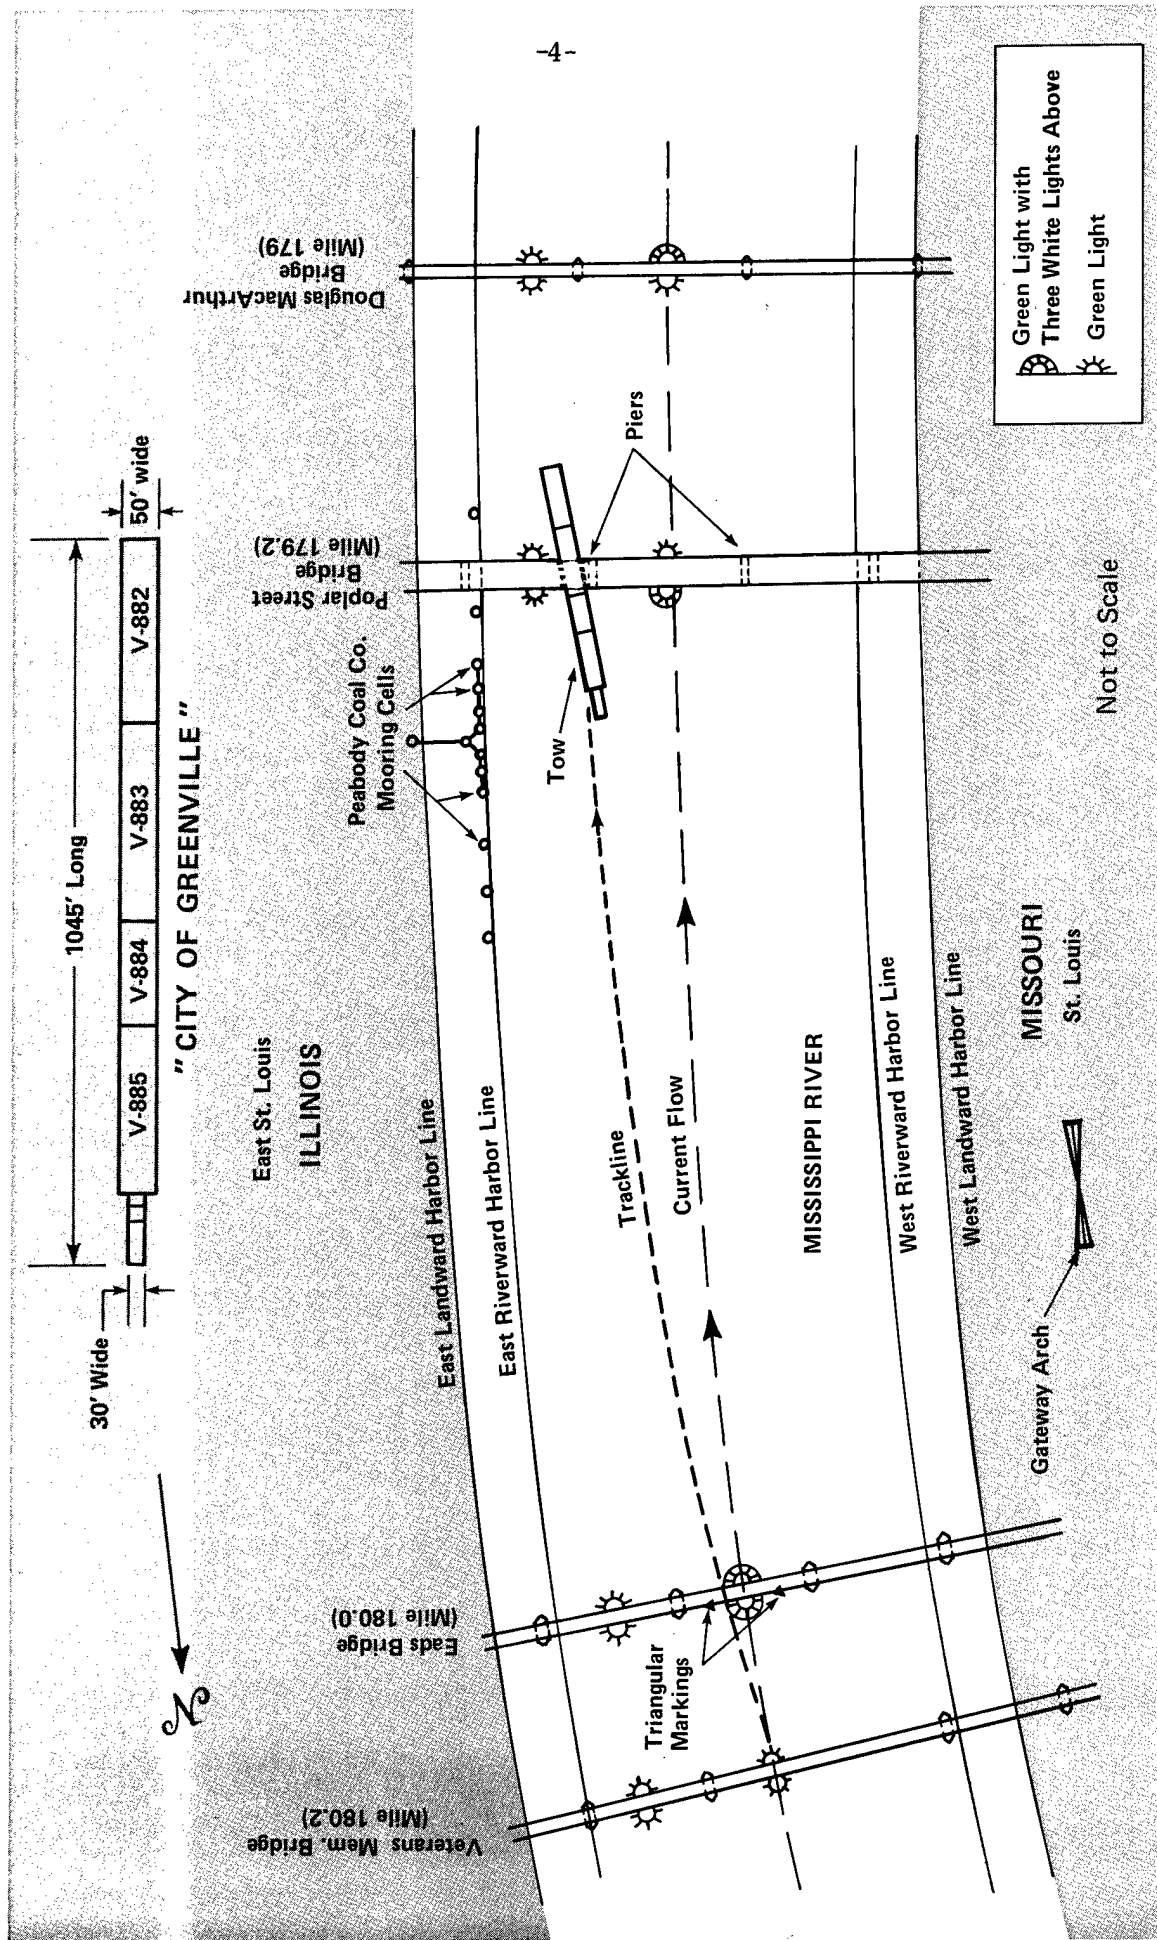
As the tow passed under the closely spaced Veterans and Eads Bridges (see figure 1), the operator recognized that a crosscurrent was setting the tow to the left. At some point the operator applied some amount of left rudder in an attempt to move the stern to the right to prevent the pilothouse or upper parts of the deckhouse of the towboat from striking the left side of the center arch of the Eads Bridge. This application of left rudder moved the stern to the right, causing the head of the tow to move to the left toward the Illinois side of the river. The steersman stated that, as the towboat passed under the Eads Bridge, the towboat was very close to the triangular-shaped mark which indicated the extreme left edge of the usable span of the bridge's center arch. 5/ (See figure 1.)

Figure 1.--Approximate trackline of the CITY OF GREENVILLE.

of the left side span. At this time the operator turned on the searchlight and illuminated the pier. This was his first use of the searchlight in navigating through the St. Louis harbor area. By the time the head of the tow entered the left side span, it was apparent that the starboard side of the tow might strike the bridge pier, and the operator applied right rudder in an attempt to move the stern of the tow to the left and away from the pier. This maneuver was not successful, however, and the starboard side of the tow, at about the point where the second and third barges were coupled, struck the right bridge pier of the left side span at about 2320. (See figure 1.)

The straight course that the operator steered toward the left side span of the Poplar Street Bridge resulted in a diagonal trackline across the river from a position near the center of the river toward a point on the left side of the river. The tow was, in fact, crabbing ^{16/} since it was cutting across the current of the river. As the tow proceeded downriver, it would have been necessary to bring the head of the tow to the left in order to continue to head toward the green lights of the side span, thus increasing the tow's angle to the current. The operator probably failed to recognize that the tow was crabbing, since he initially believed that he was steering for the main span in the center of the river. It is possible that the progress of the tow also could have been affected by the occurrence of a crosscurrent from the Illinois side of the river at some point below the Eads Bridge and above the Poplar Street Bridge. A crosscurrent would have required the operator to compensate by steering further to the left, which would account for a portion of the tow's relatively steep angle toward the Illinois shore at the time of impact.
