**US Army Corps
of Engineers**
Waterways Experiment
Station

Inspections of previously monitored coastal structures / by Robert R. Bottin, Jr., Larry R. Tolliver ; prepared for U.S. Army Corps of Engineers.

60 p. : ill. ; 28 cm. — (Technical report ; CHL-99-3)

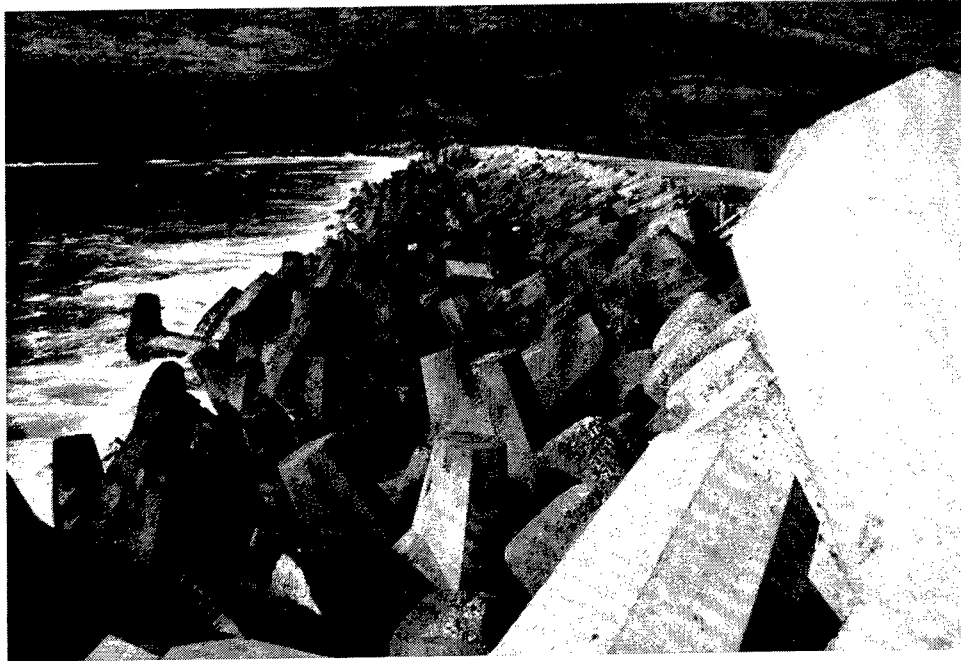
The breakwater (Figure 3) was inspected on 22 July 1998. The inspection indicated that most of the armor units were in similar positions as recorded during the 1995 survey based on detailed photogrammetric maps of the structure. Numerous broken armor units were observed, but were validated as those documented in the 1995 survey. Fragments of some of the broken armor units were still in the same locations as observed in 1995. It was noted that the older 16,150-kg (17.8-ton) tribars are showing major surface spalling of concrete (Figure 4), but this is not felt to put the structure in any danger of instability. Overall the structure is in good condition.

Figure 3. Sea side of Nawiliwili Harbor breakwater

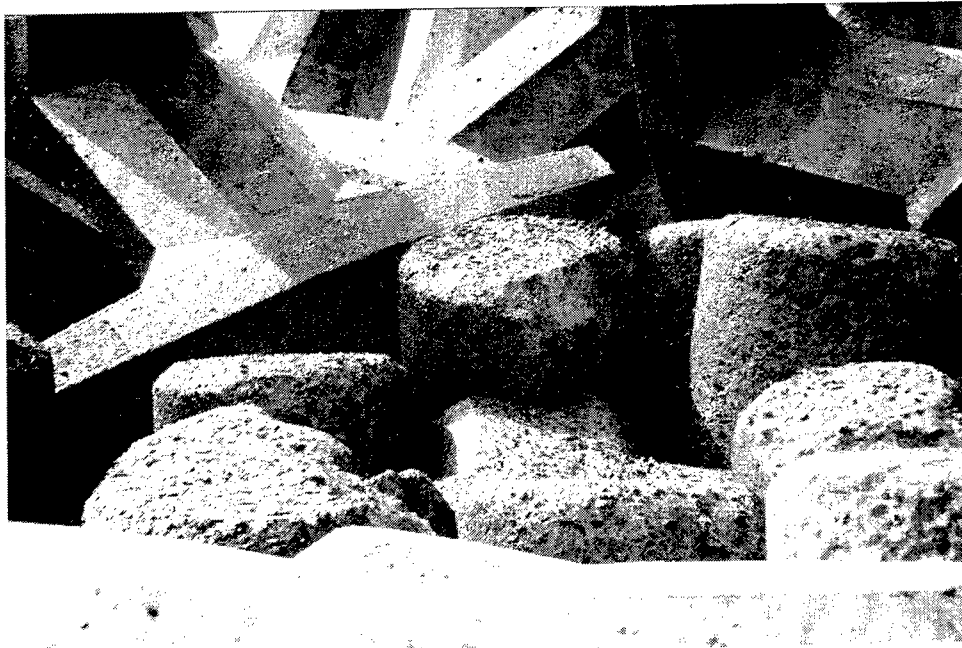
Figure 4. Surface spalling of tribars on Nawiliwili breakwater

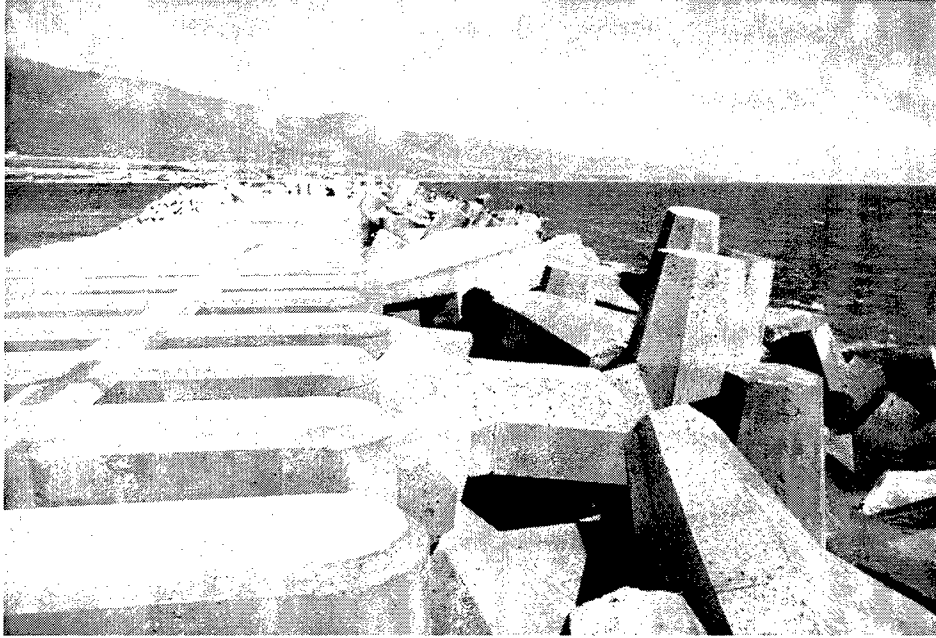
The Kahului Harbor breakwaters were inspected on 21 July 1998. The inspection, as close as could be observed visually, indicated that most of the armor unit positions were similar to those obtained during the 1993 survey. Views of the structures are shown in Figures 6 and 7. On the east breakwater it appeared that two 31,750-kg (35-ton) tribars had flipped and slid downslope slightly on the sea side of the structure at approximately sta 10+50. Additional breakage of some of the 5,445-kg (6-ton) dolosse

Figure 6. Kahului east breakwater

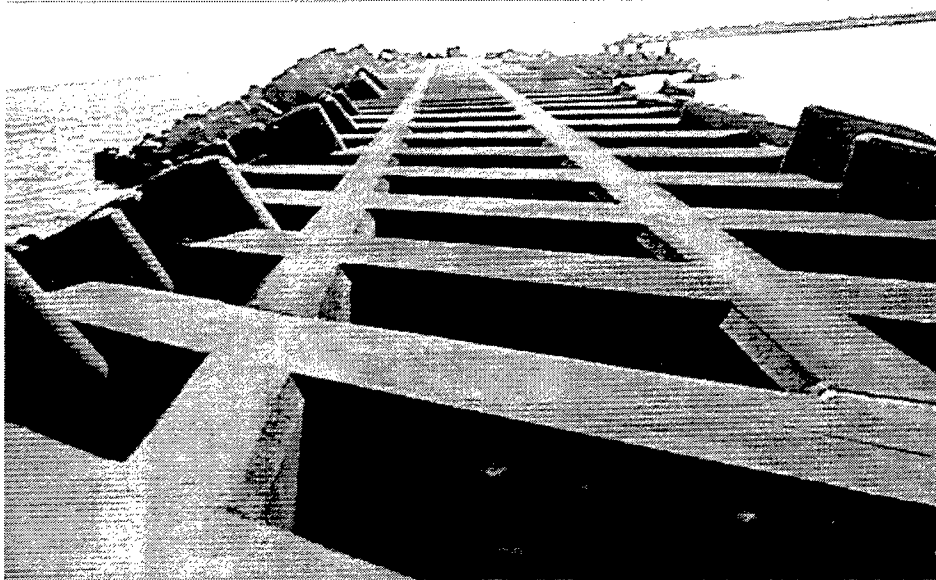
Figure 7. Kahului west breakwater

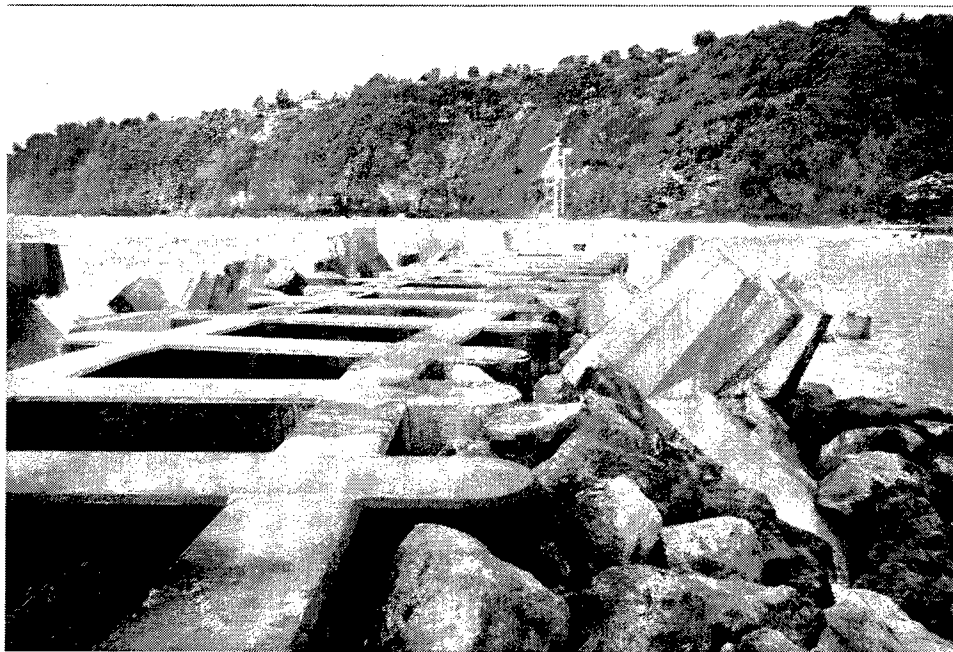
The Laupahoehoe breakwater (Figure 10) was inspected 22 July 1998. The inspection indicated that the armor units were in the same positions

Figure 10. Laupahoehoe breakwater

as documented in the 1993 survey. No broken armor units were observed, and the structure is considered to be in excellent condition.

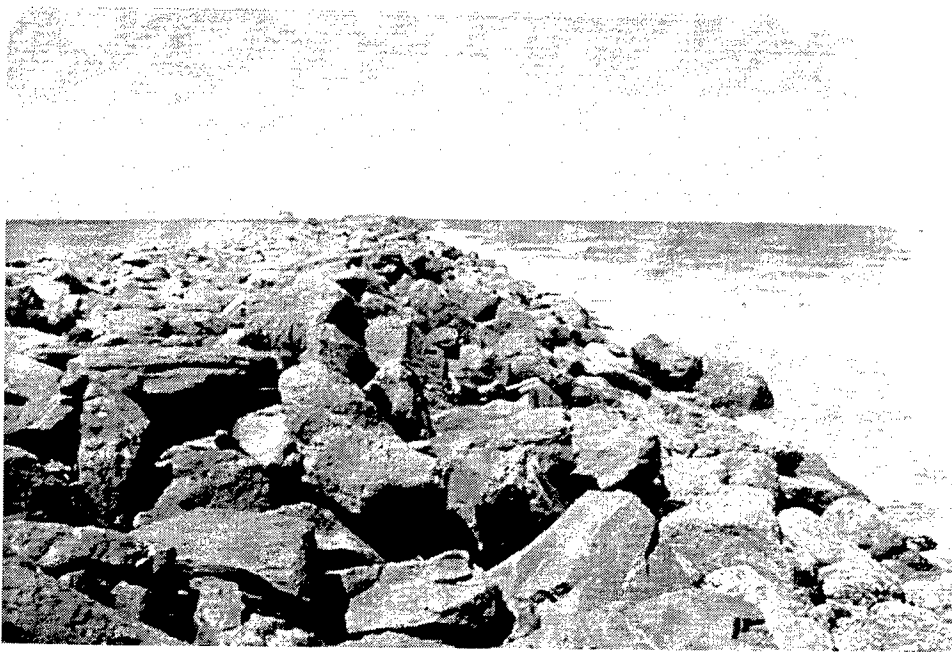
An inspection of the north jetty (Figure 12) on 24 June 1997 revealed that the head of the structure no longer existed. Comparisons to photogrammetric data obtained in May 1993 indicated that approximately 50 m (165 ft) of the north jetty head was no longer above water, and stone had apparently been removed to below the water level by wave action. When the notch area was not visible, measurements from known locations on the structure were made to confirm this finding. Remnants of some of the jetty could be seen seaward of the structure in wave troughs as they passed. Above-water stone around the head was not uniform (Figure 13). Other observations of the structure revealed some low areas in the crest and some voids on the sea side of the jetty. At a location approximately 305 m (1,000 ft) shoreward of the jetty head (the head location of 24 June 1997), low areas in the crest existed over about a 30.5-m (100-ft) span.

Figure 12. Yaquina Bay north jetty

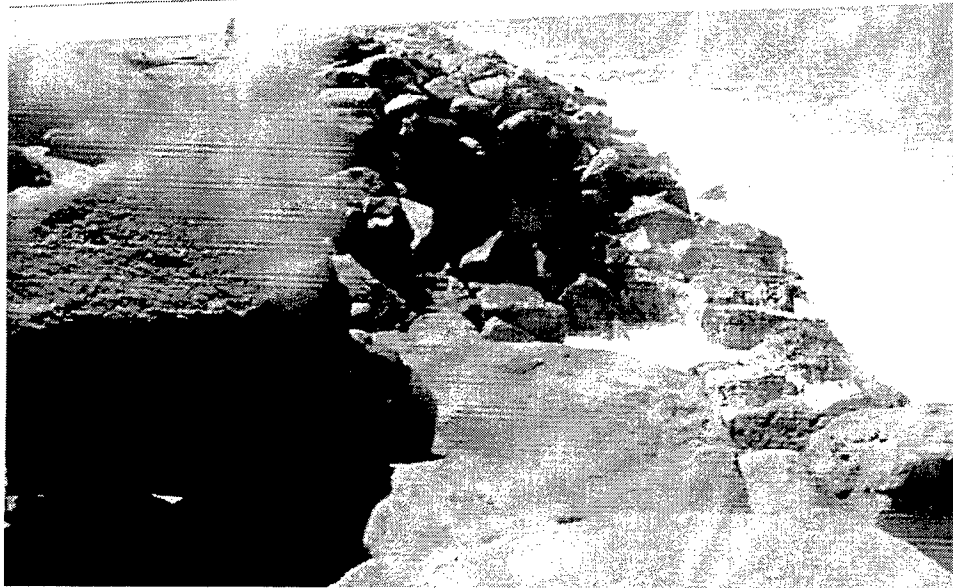
Figure 15. Void on seaward side of Yaquina north jetty observed about 650 m (2,125 ft) from head

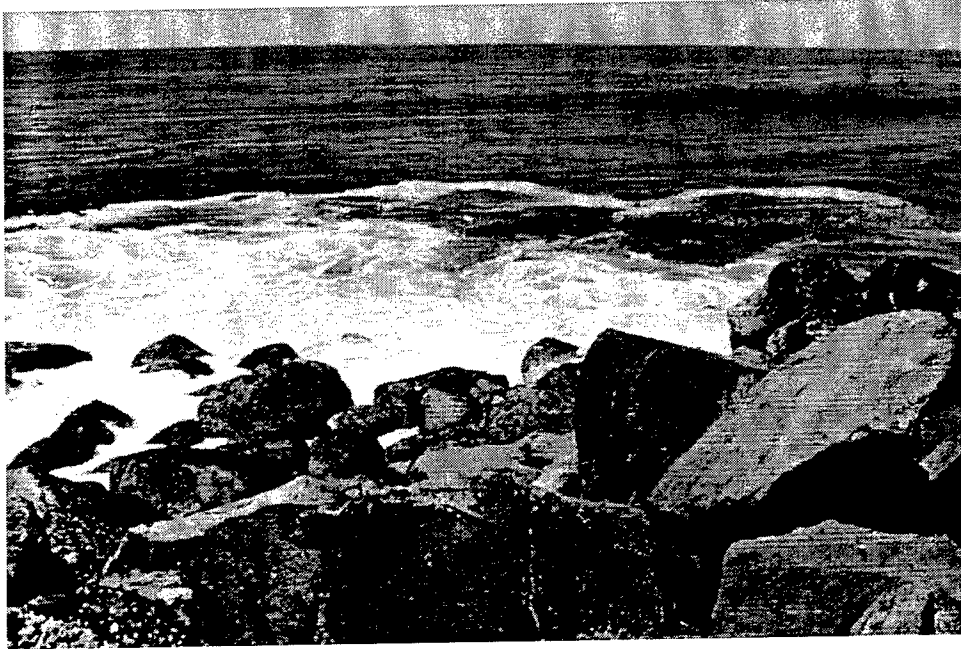
Figure 19. Head of Siuslaw River south jetty spur

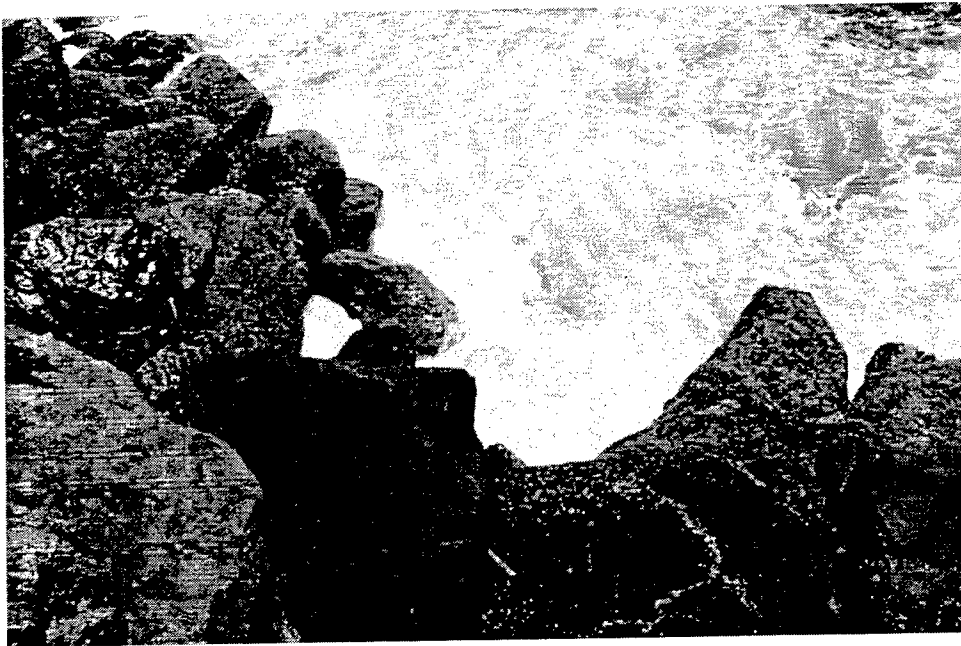
Figure 20. Void in south jetty spur at Siuslaw

slopes of the south jetty system were in good condition, with the exception of the jetty head and the jetty spur head as previously discussed.

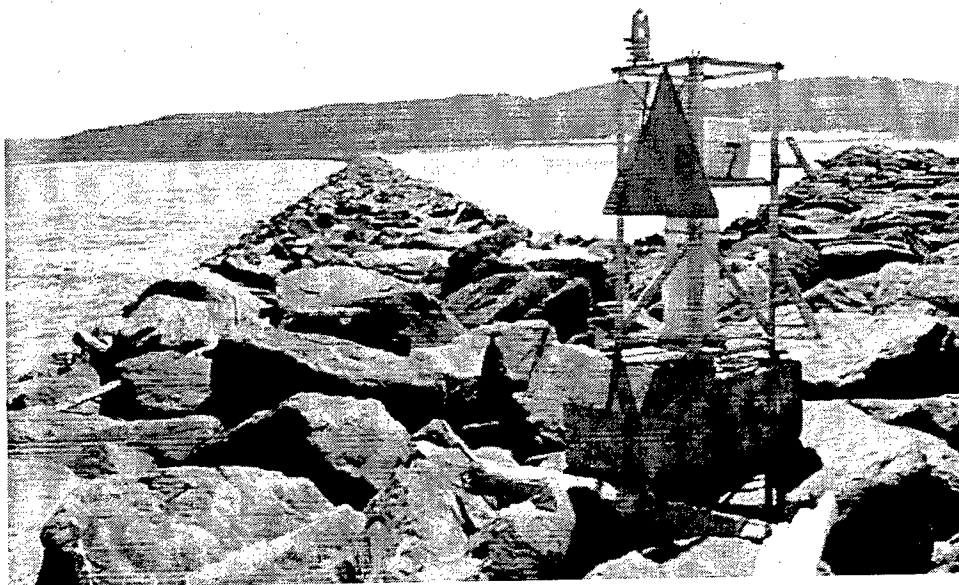
The training jetty and south jetty were inspected on 25 June 1997. Inspection of the training jetty revealed that the 1980 extension was in very good condition (Figure 22). Its cross section appeared to be uniform along its length, and very few of the armor stones had cracked. The shoreward portion of the structure (1951 construction) had some areas that appeared to be damaged on the shore side. This was prevalent immediately landward of the shoreline where stone from the back side of the jetty was scattered (Figure 23). The channel-side face of this portion of the training jetty was in good condition. Inspection of the south jetty revealed a

Figure 22. View of Umpqua River training jetty (left structure) looking shoreward

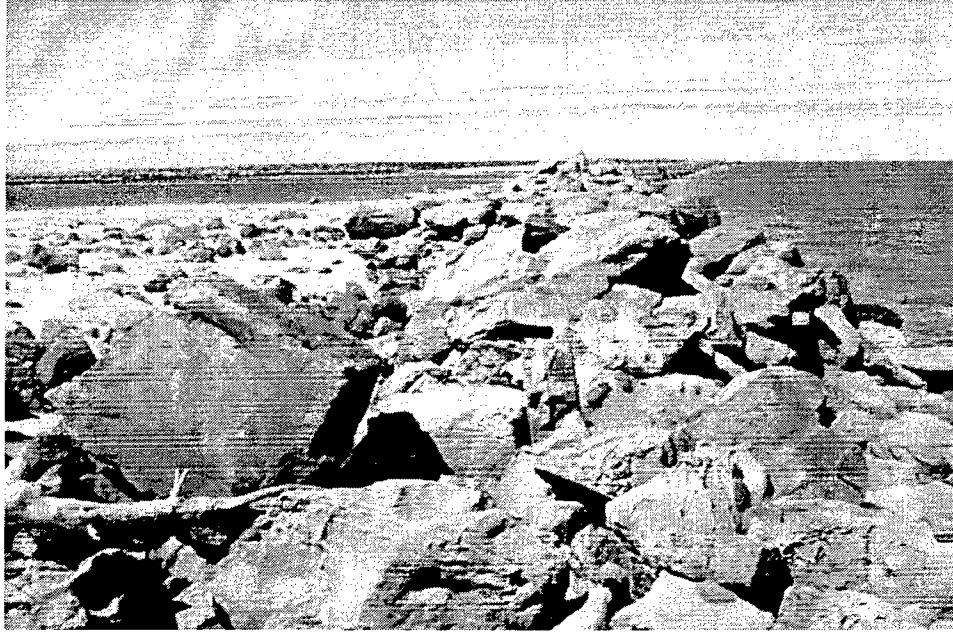
Figure 23. Scattered armor stone on shore side of Umpqua training jetty

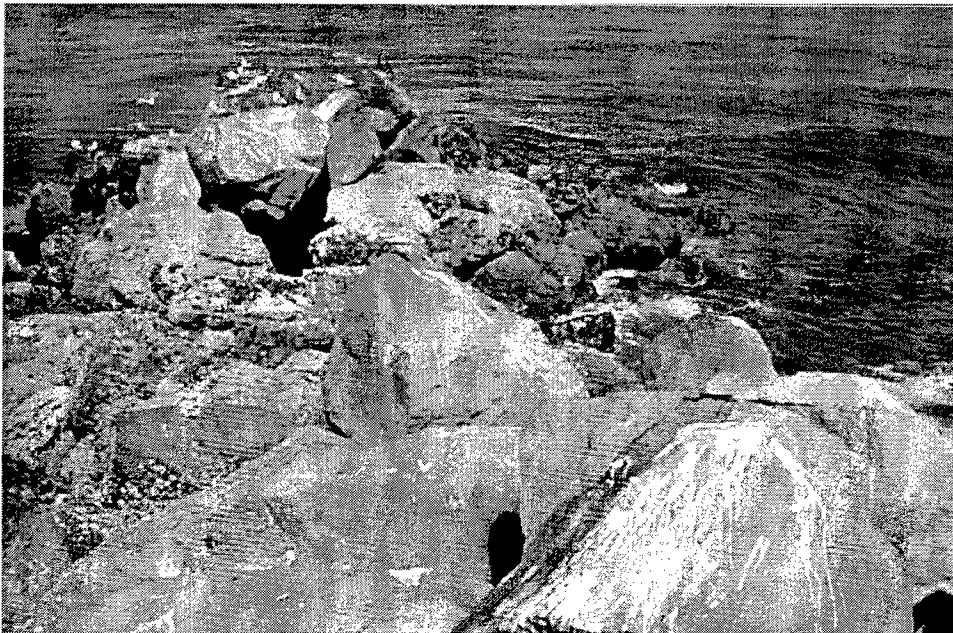
breach at its head. The breach did not extend below the water level, but extended through the jetty (Figure 24). In addition, just shoreward of the breach, a large void existed on the sea side of the structure (Figure 25). The trunk of the south jetty was in good condition.

Figure 24. Breach at head of Umpqua River south jetty

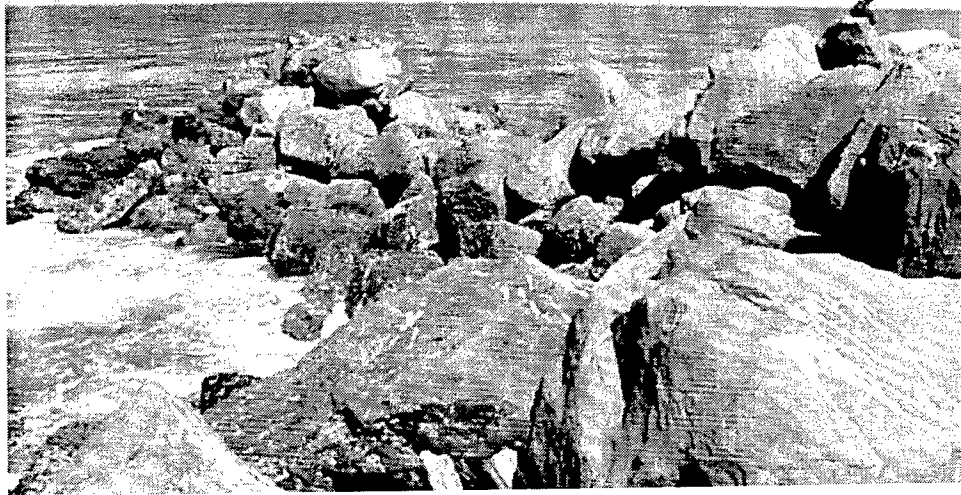
Figure 25. Breach and void at head of south jetty at Umpqua River

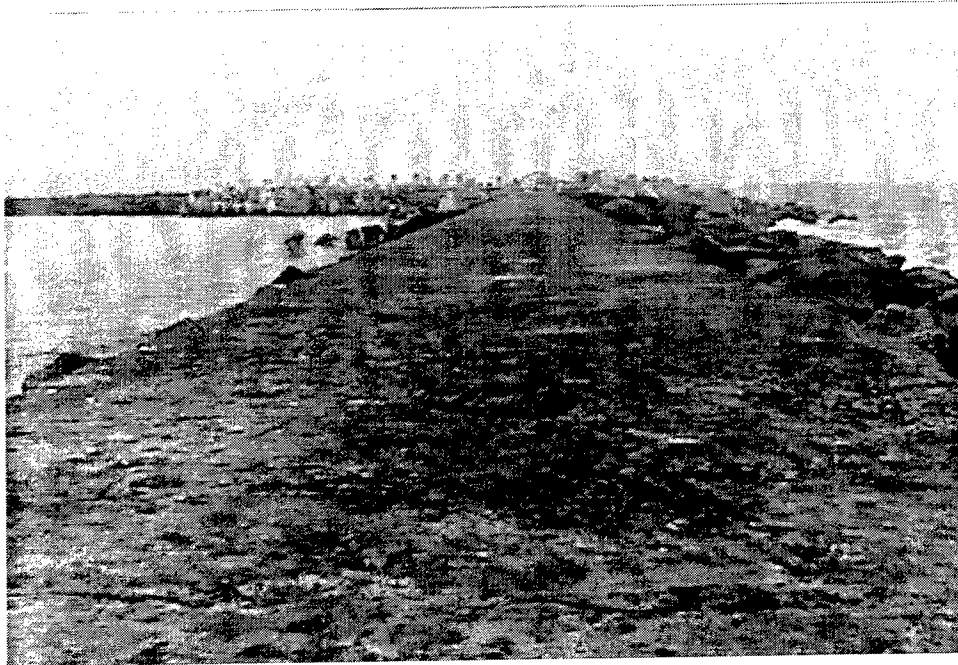
The Crescent City Harbor breakwater (Figure 27) was inspected on 15 September 1998. The inspection indicated that most of the armor unit positions were similar to those shown in the 1993 photography as close as could be observed visually. It appeared that only a couple of the 38,100-kg (42-ton) units had changed positions slightly along the waterline at the outer portion of the main stem. Figure 28 shows some of these units at the head of the main stem of the breakwater. Numerous broken armor units were observed, but were validated as being broken in the 1993 survey. Overall the structure is in good condition.

Figure 27. Crescent City Harbor breakwater

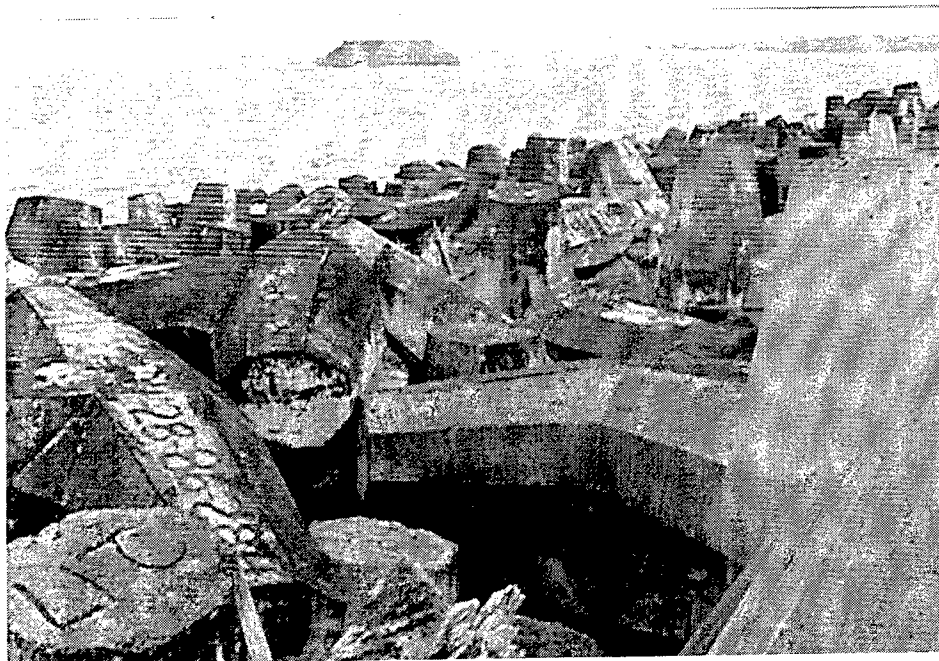
Figure 28. View of 38,100-kg (42-ton) dolosse on the sea-side slope of the main stem of the Crescent City breakwater

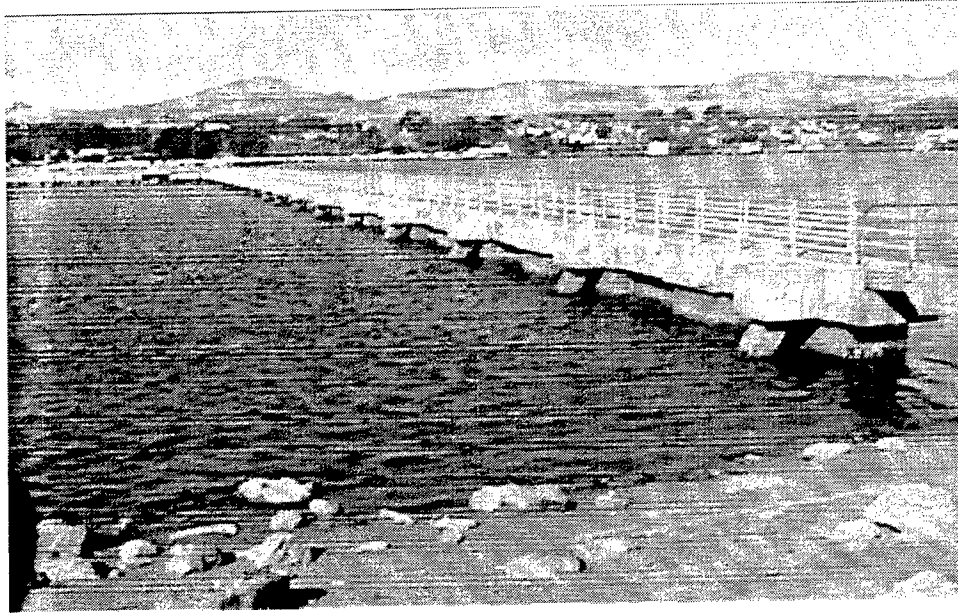
The Spud Point Marina breakwater (Figure 30) was inspected on 16 September 1998. The assessment revealed no evidence of misalignment, movement, spalling, or subsidence of the structure. The hairline cracks across the top of the breakwater cap noted in the earlier surveys did not appear to have widened (Figure 31). Additional hairline cracks were observed, particularly on the vertical sides of the cap. Some of these cracks

Figure 30. View of marina side of shoreward leg of Spud Point breakwater

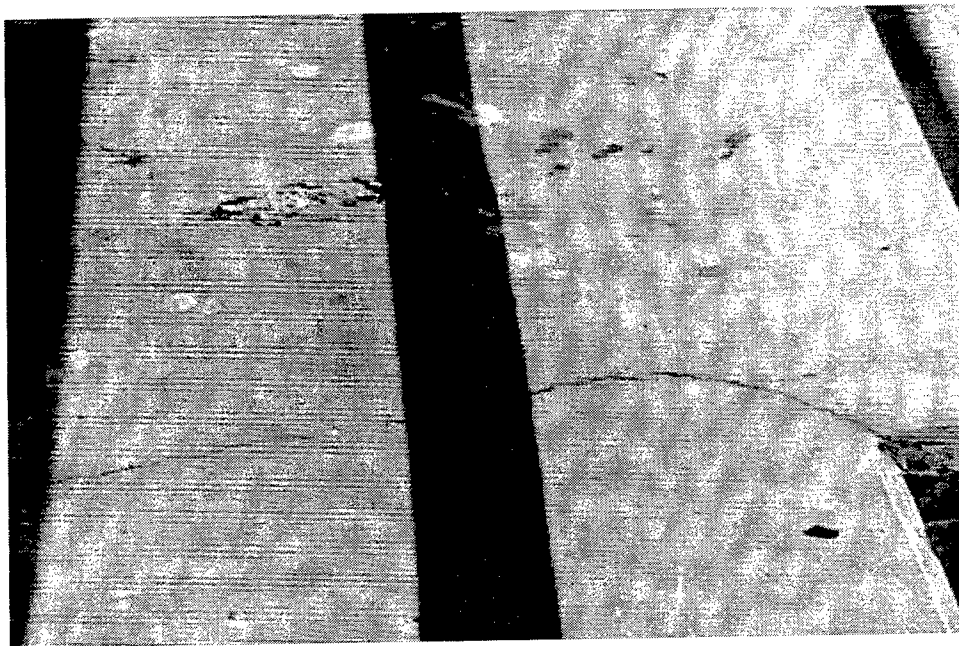
Figure 31. Hairline crack across cap of Spud Point Marina breakwater

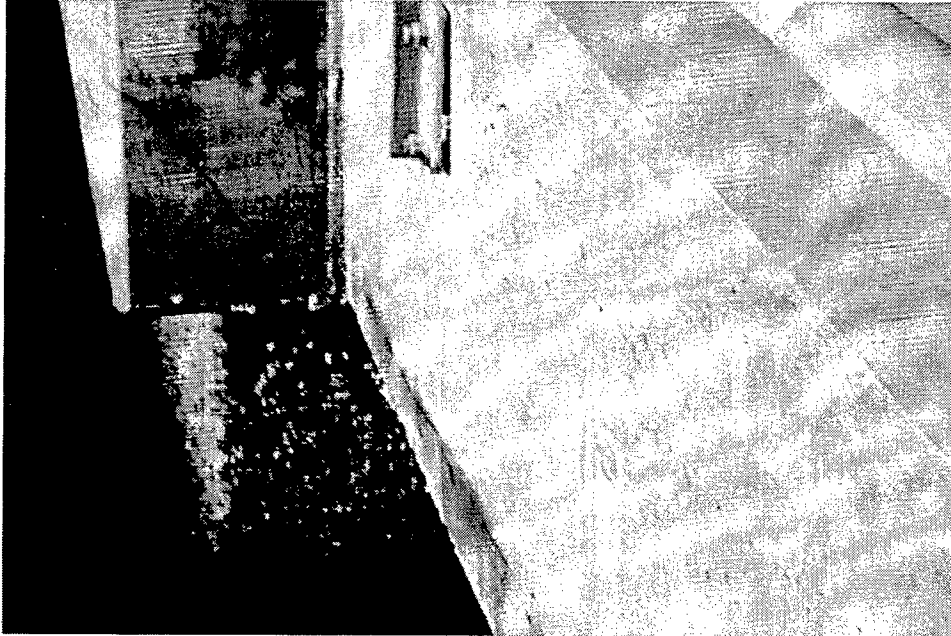
were vertical, but the majority were horizontal cracks formed about 152 mm (6 in.) above the bottom edge (Figure 32). Stains on the concrete along some of these hairline cracks indicated that some of the rebar is rusting in these areas. Cracks along the baffled sections and batter

Figure 32. Example of cracks noted in vertical portions of concrete cap at Spud Point Marina breakwater

piles were not visible due to the buildup of barnacles on the structures. There is no evidence that the hairline cracks in the breakwater cap are threatening the integrity of the structures. Overall, the structure appears to be in very good to excellent condition.

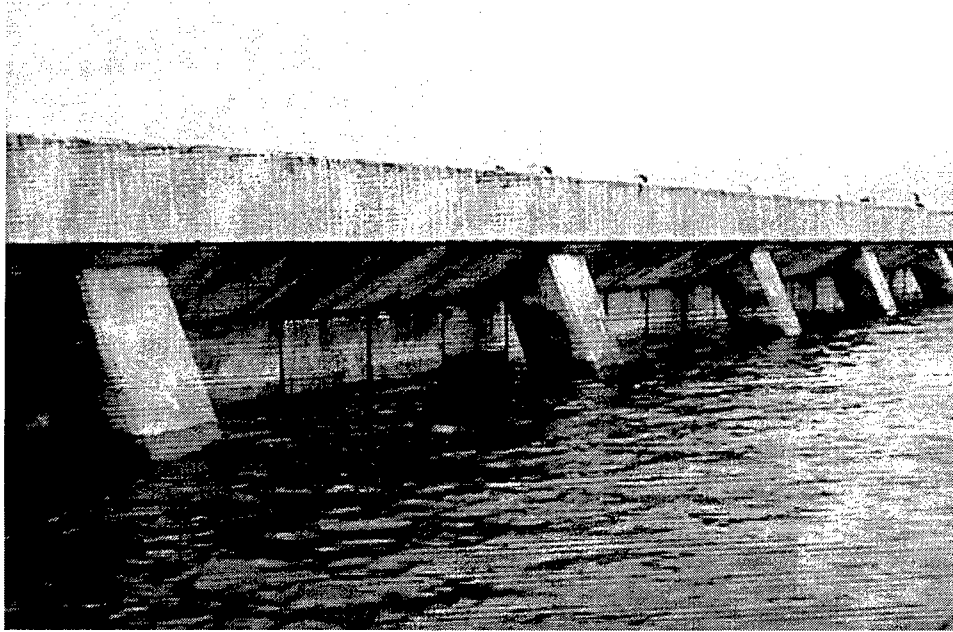
The Fisherman's Wharf breakwaters were inspected on 17 September 1998. Visual assessment of the structures was conducted by running a boat along the sides of the breakwaters and walking the main breakwater cap. A portion of the main detached breakwater is shown in Figure 34. The inspection revealed no deterioration or apparent settlement of the breakwaters. Numerous areas along the concrete piles between the main breakwater cap and the waterline were spalled (Figure 35). These areas are not threatening the structural integrity or function of the structure. The overall condition of the breakwaters was very good to excellent.

Figure 34. Portion of detached breakwater at Fisherman's Wharf Harbor

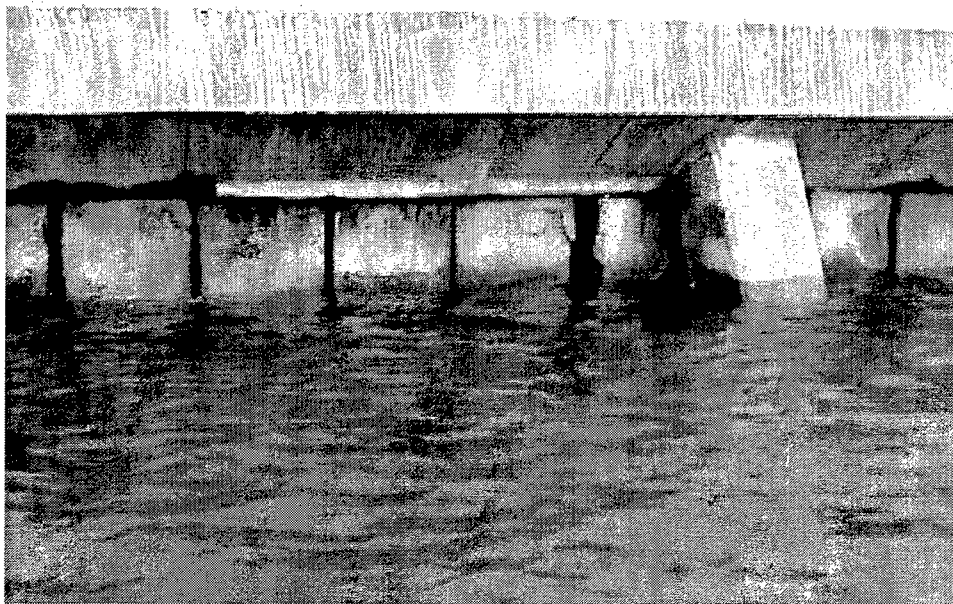
Figure 35. Spalling of concrete piles between the breakwater cap and the water surface at Fisherman's Wharf Harbor

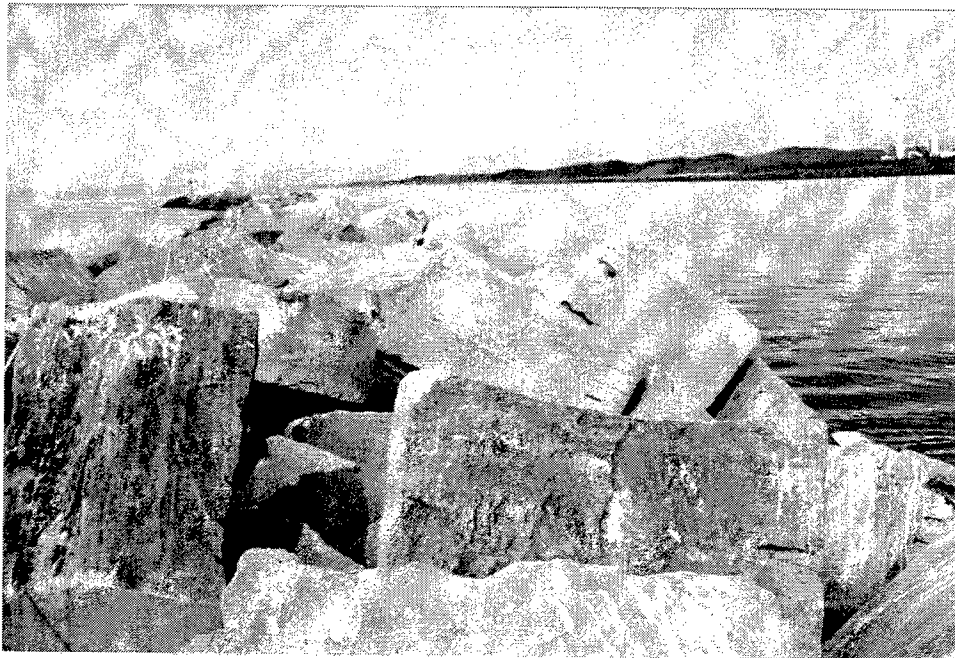
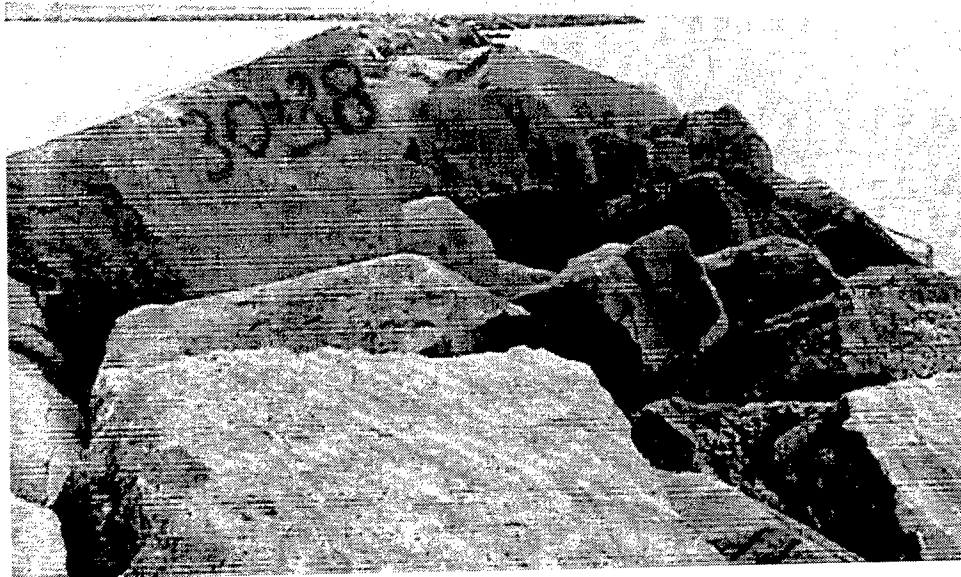
The Burns Harbor north breakwater (Figures 37 and 38) was inspected on 17 June 1998. The elevation of the breakwater was compared to topography data obtained previously during the photogrammetric analysis. Sections of the structure in which it appeared that low areas existed since the last inspection are shown in the following tabulation.

Figure 37. Burns Harbor breakwater looking east

Figure 38. Burns Harbor breakwater looking west

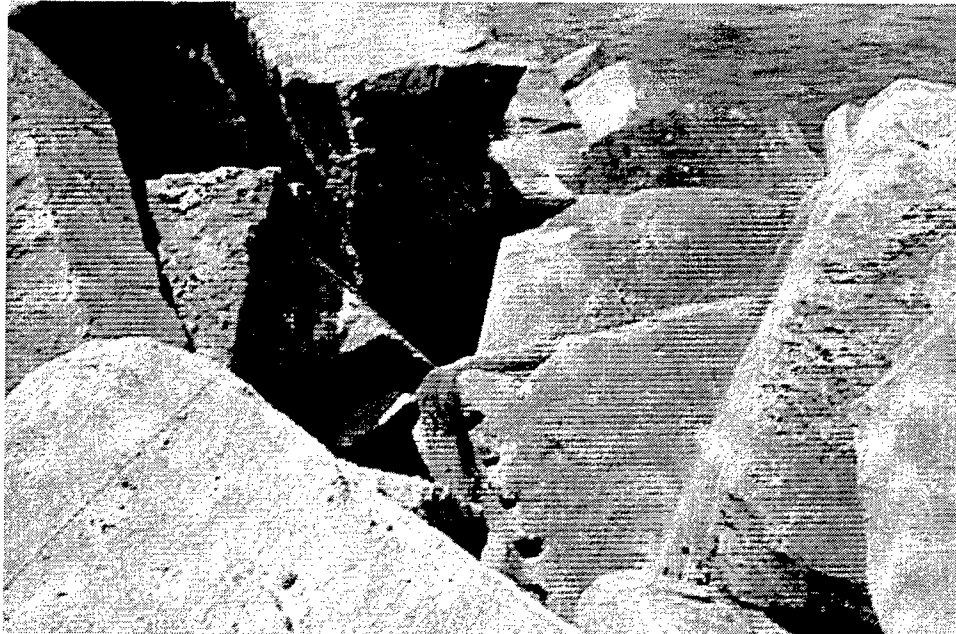
The inspection also indicated several voids in the breakwater. Figures 39 and 40 depict typical voids in the Burns Harbor structure. It appeared that continued deterioration of the breakwater had occurred since the last inspection.

Figure 39. Void on lakeward crest of Burns Harbor breakwater

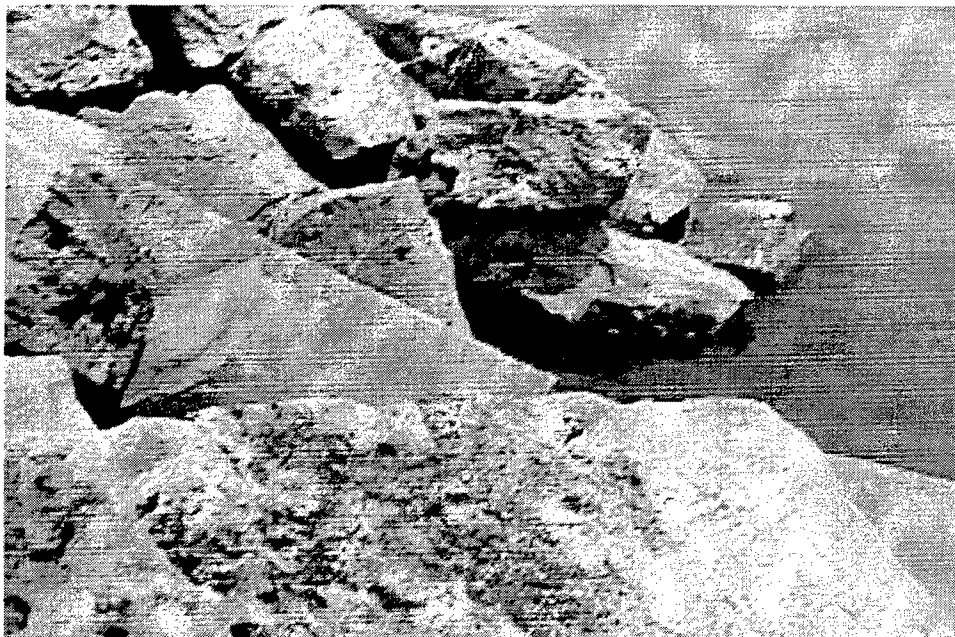
Figure 40. Typical void in harbor side of Burns Harbor breakwater

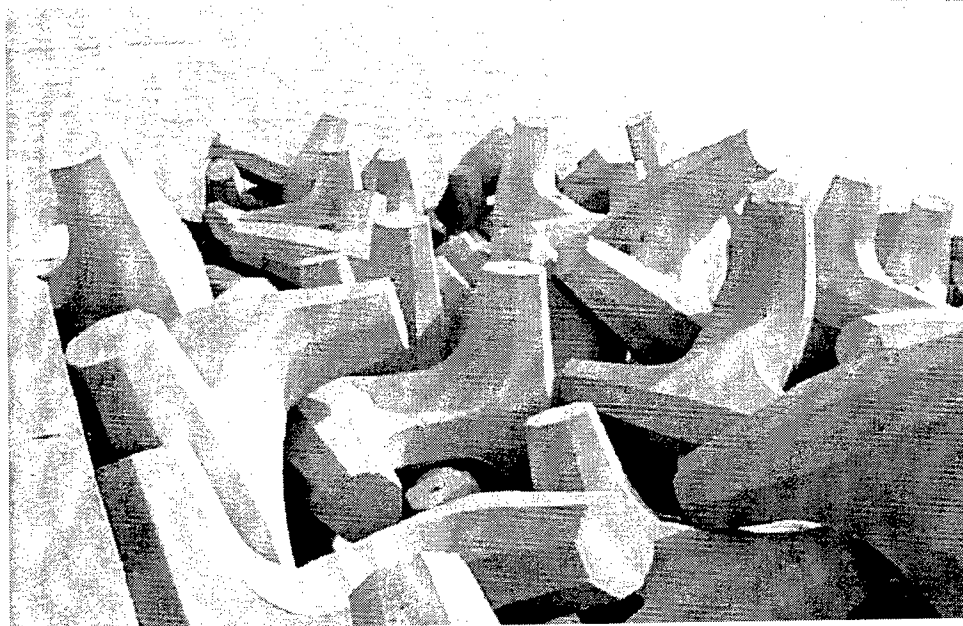
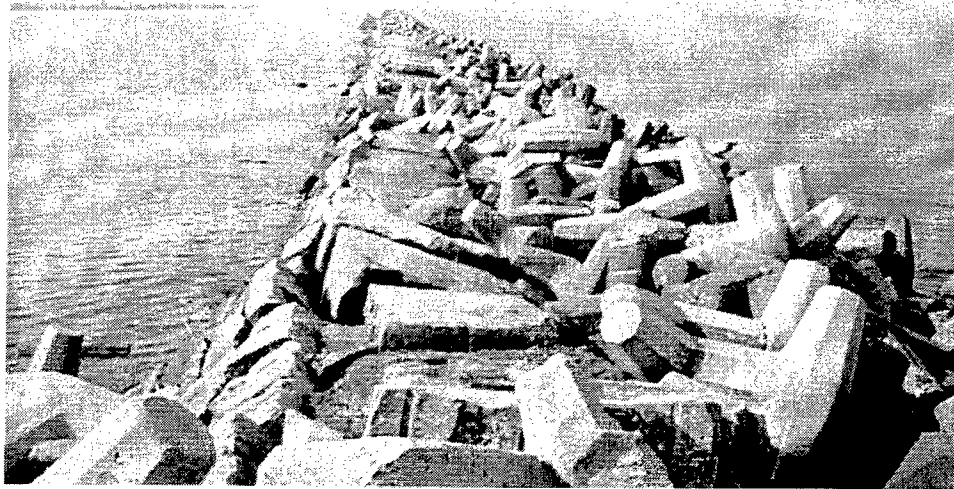
The Cleveland Harbor east breakwater (Figures 42 and 43) was inspected on 7 October 1997. The inspection revealed that the structure has changed little since the 1993 survey. Comparison of armor unit positions

Figure 42. View of 3,628-kg (4-ton) dolosse at head of Cleveland Harbor east breakwater

Figure 43. View of 1,814-kg (2-ton) dolosse along trunk of Cleveland Harbor east breakwater

with detailed, rectified aerial photography, in general, revealed that most of the armor units were in the same position as in 1993. Even fragments of broken dolosse were in the same positions based on the aerial photographs. Apparent armor unit movement was observed at only one location along the structure. At sta 262+55 one dolos had moved downslope slightly and an adjacent dolos had flipped upslope. It was also noted that some new 3,628-kg (4-ton) dolosse had been placed between sta 253+50 and 254+00 since 1993. The structure is in fair to good condition and appears to be functioning well.

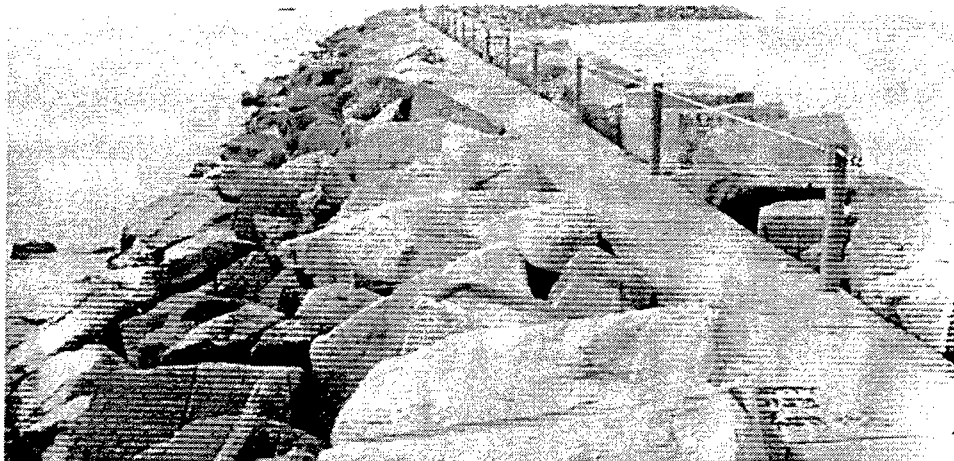
An inspection of the Cattaraugus Creek Harbor south breakwater (Figure 45) on 8 October 1997 revealed voids in the armor stone layer at two locations on the lake side of the breakwater along the curved portion (sta 15+00 and sta 16+50). The void at sta 16+50 is shown in Figure 46. An additional void was observed on the head of the structure (Figure 47), which resulted in a steep slope. During the inspection several broken stones were observed sporadically along the structures; however, overall the structure appears to be in good condition. The north breakwater was inaccessible and not inspected. It is protected by the curved south structure.

Figure 45. Cattaraugus Creek south breakwater looking lakeward

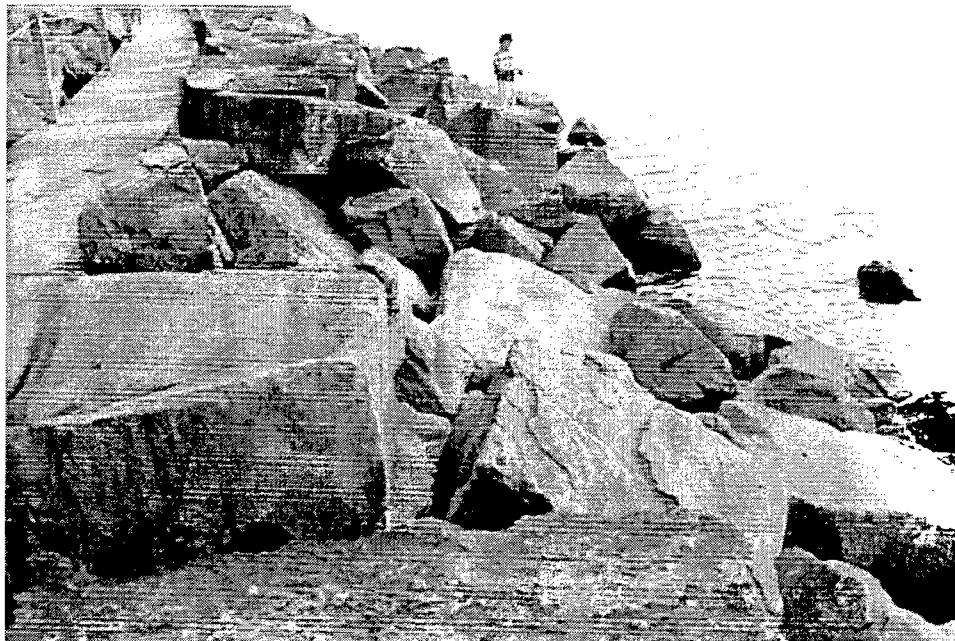
Figure 46. Void along trunk (sta 16+50) of Cattaraugus Creek south breakwater

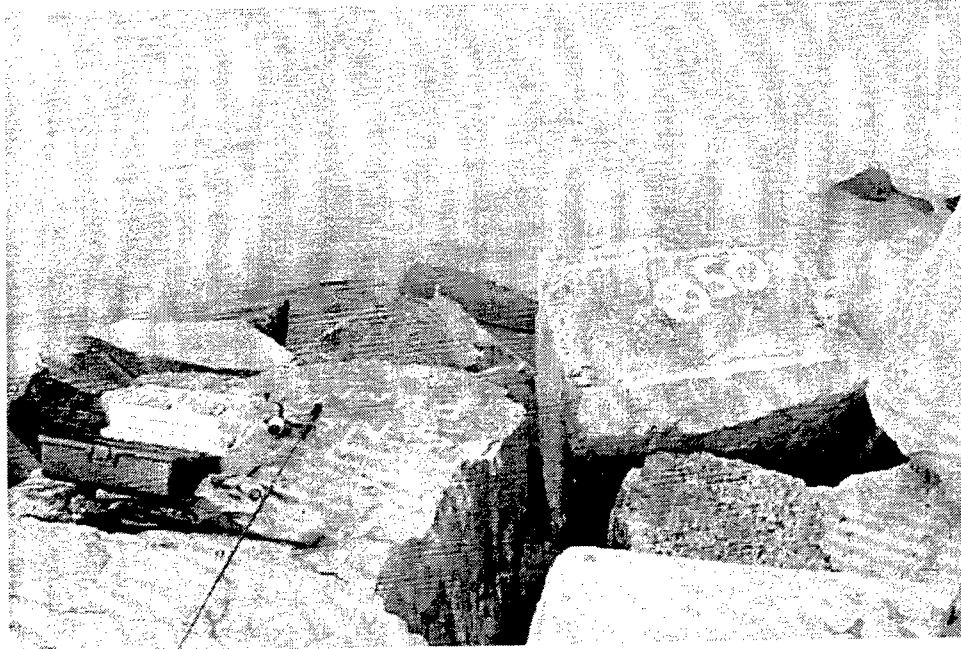
Figure 47. Void and steep slope at head of Cattaraugus Creek south breakwater

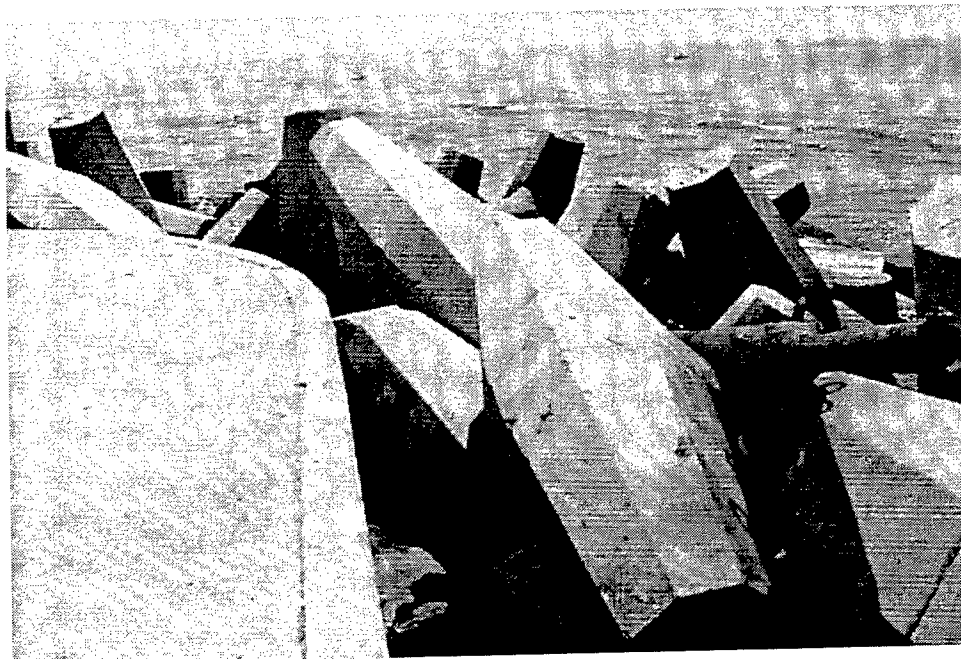
The Manasquan Inlet jetties were inspected on 10 June 1997. The 14,515-kg (16-ton) dolos armor units are shown in Figure 49. Visual comparisons of armor unit positions on the north jetty to 1994 photomaps revealed that several units had moved slightly. Horizontal movement appeared to range from 0.15 to 0.6 m (0.5 to 2 ft). In addition, it appeared that the downslope portions of most of these units had slightly lost

Figure 49. 14,515-kg (16-ton) dolos armor units on Manasquan Inlet jetties

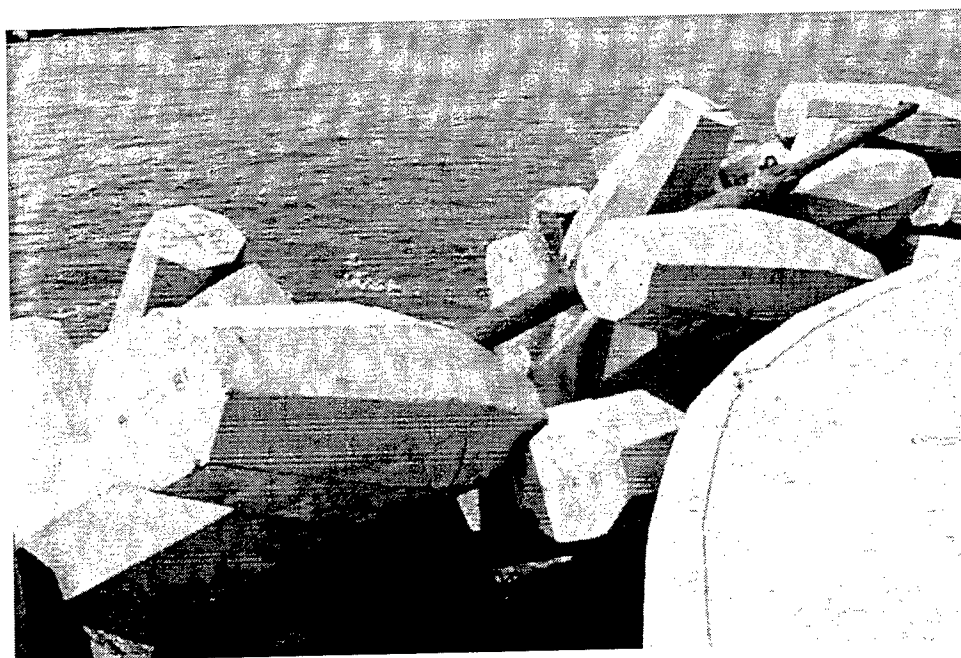
elevation. Seven of these units were adjacent to the void area (Figure 50) on the south side of the jetty head, which had been identified in the 1994 survey. The void area also appeared slightly larger than in 1994. Two armor units on the north side of the structure and four on the seaward tip of

Figure 50. Void area on south side of Manasquan Inlet north jetty head

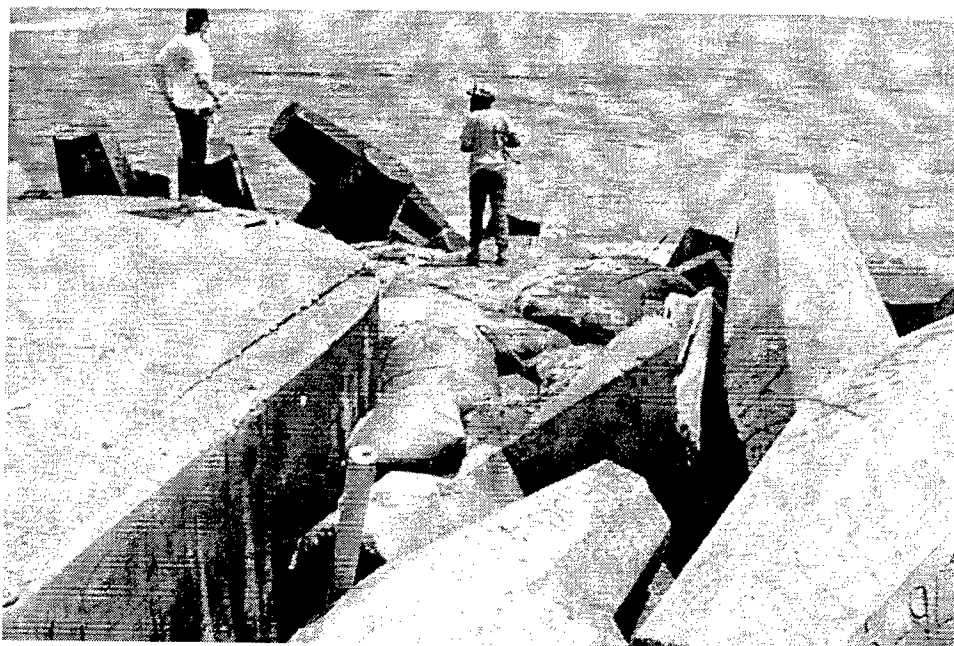
Figure 51. Emergency repair work (grout-filled bags) at head of Manasquan Inlet south jetty

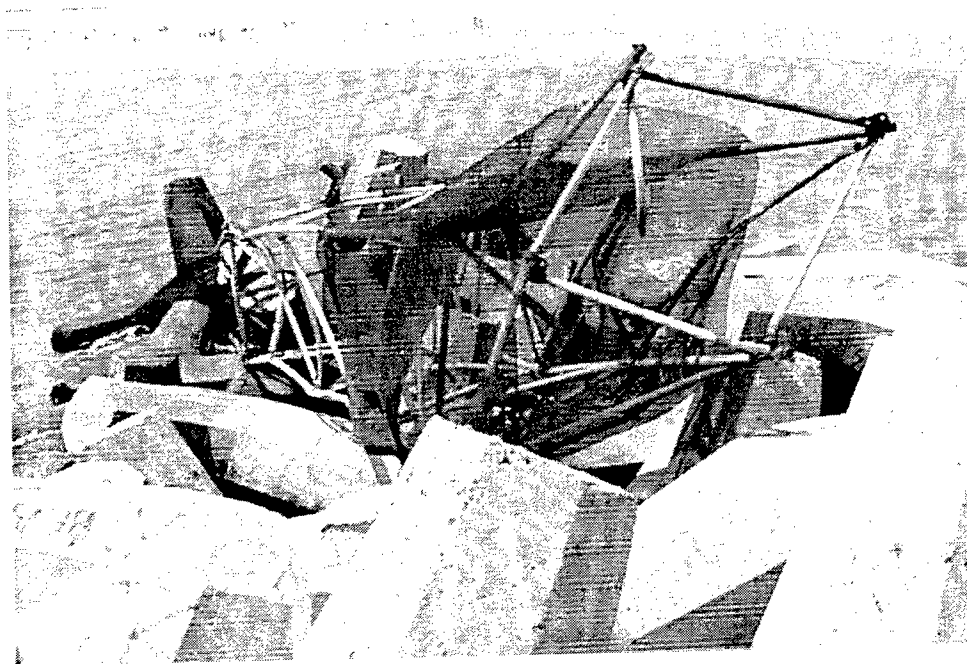
Figure 52. Lighthouse base washed into Manasquan Inlet south jetty as a result of 1995 storm
