**US Army Corps
of Engineers**
Waterways Experiment
Station

Inspections of previously monitored coastal structures / by Robert R. Bottin, Jr., Larry R. Tolliver ; prepared for U.S. Army Corps of Engineers.

60 p. : ill. ; 28 cm. — (Technical report ; CHL-99-3)

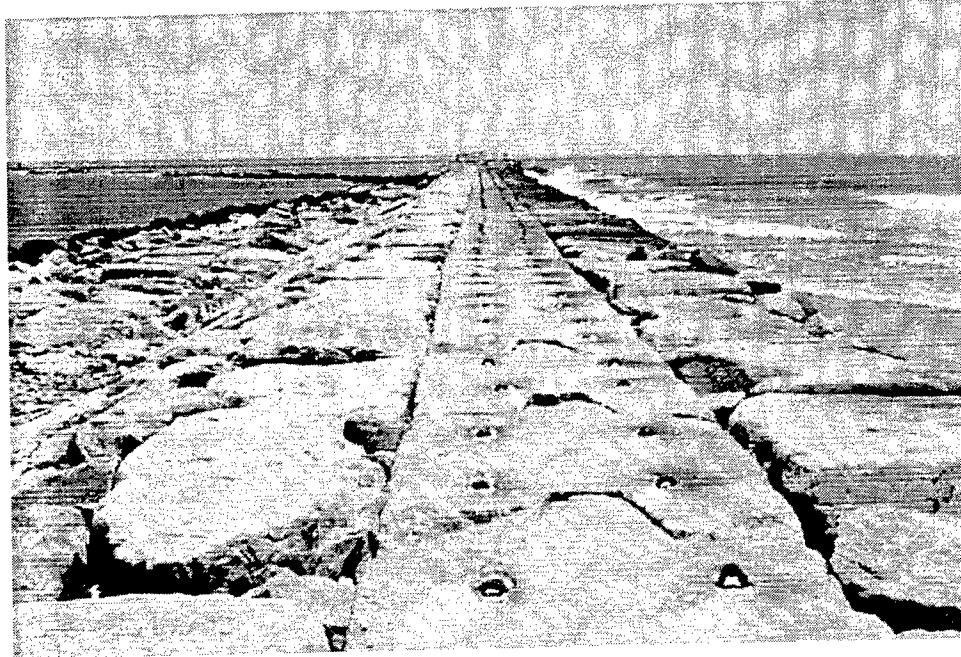
Figure 54. Rehabilitated south jetty trunk at Ocean City Inlet

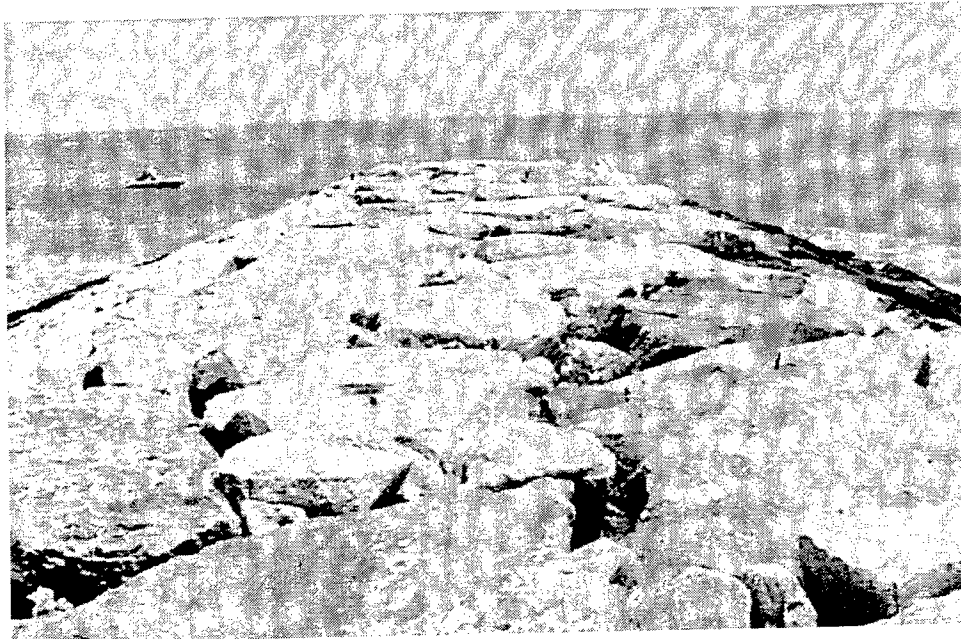
Figure 55. Head portion of south jetty rehabilitation at Ocean City Inlet

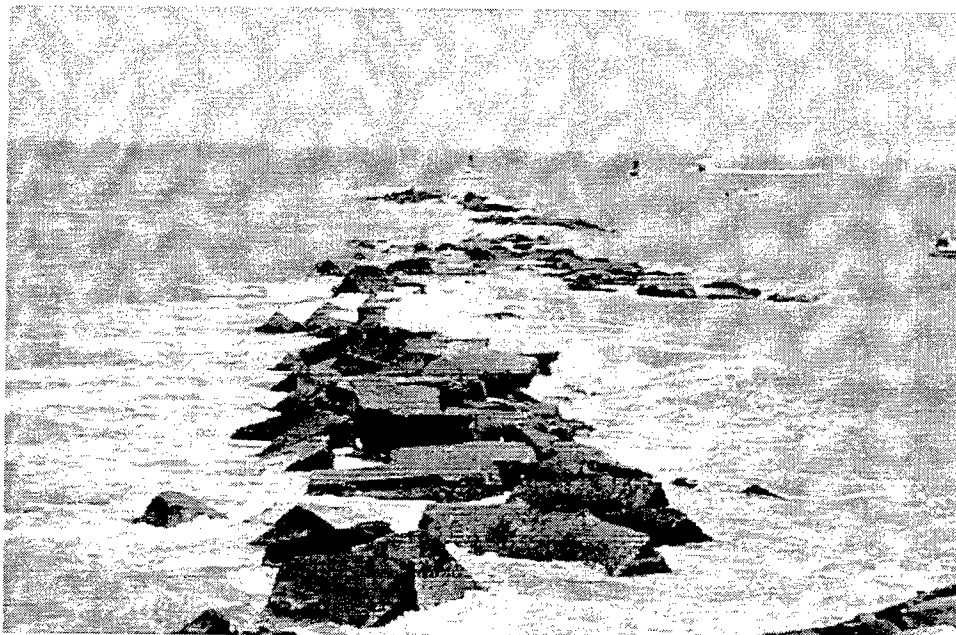
Figure 57. Seaward section of existing south jetty at Ocean City Inlet (beyond sta 13+00)
