C-5 A FUSELAGE STRESS ANALYSIS

Report No. TR-92-7

June 1992

Operated for the Flight Dynamics Directorate by CSA Engineering, Inc.

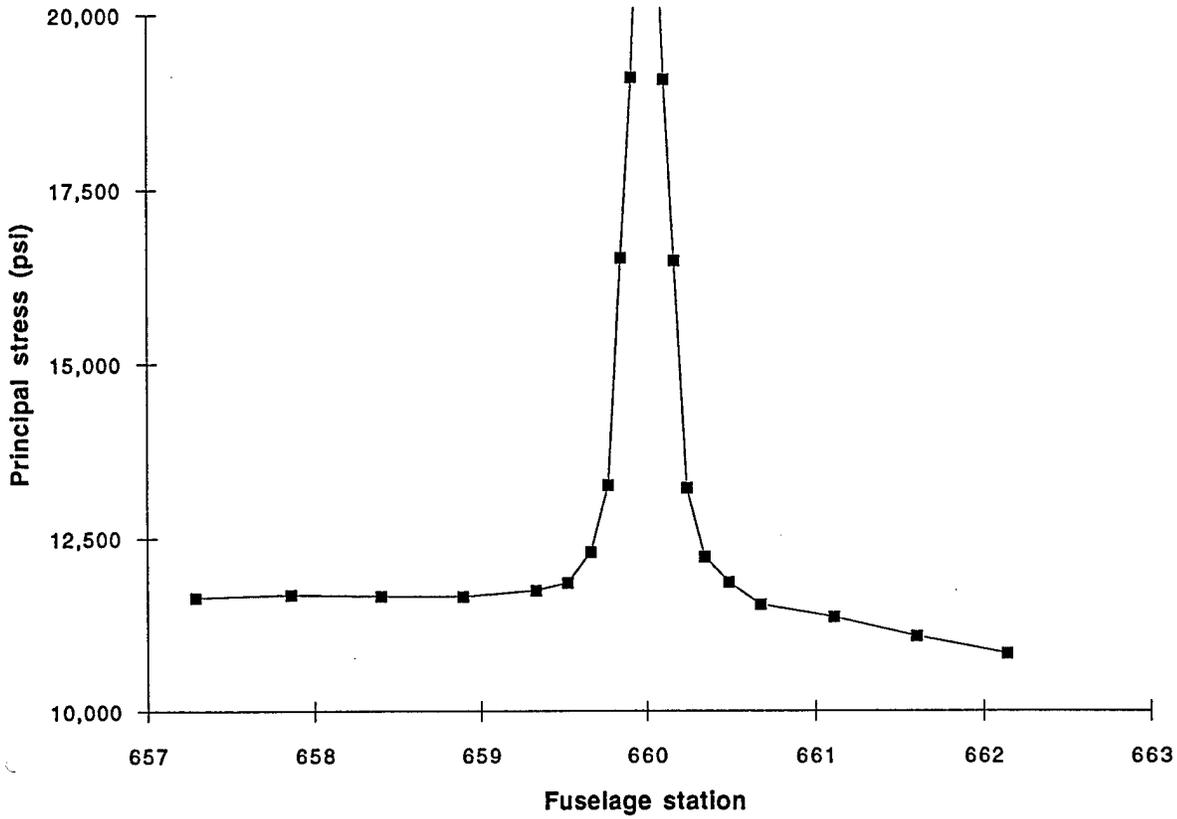
Internal pressure: The results from the baseline static stress analysis with only uniform internal pressure were as expected. In particular, the stress level in the fuselage skin panel in the hoop or circumferential direction remote from the fastener hole ranged from 10,000 to 12,000 psi. The theoretical value of the hoop stress in a thin-walled cylinder of 143" radius and 0.068" thickness when subjected to uniform radial pressure of 8.3 psi is 17,454 psi. Evidently, the frames and titanium doublers are picking up significant amount of load. The theoretical value of the meridional stress for an equivalent thin-walled cylinder is 8,727 psi; in the fuselage skin remote from the hole, meridional stresses ranged from 6,500 to 7,500 psi; the rest, apparently, is carried by the stringers. The major principal stress near the fastener hole was 19,100 psi, a jump of 75% from the stress observed in the areas remote to the fastener hole. Figure 2 shows a plot of the maximum principal stress along WL 295 near a typical fastener, which in this case was modeled at FS660.

Internal pressure with cargo load: When the cargo load is present, the major principal stress near the fastener hole increases from 19,100 psi to 19,860 psi and the location of the point where the maximum occurs shifts by 30 degrees from the horizontal. Additionally, as expected, the stresses in the fuselage skin near the cargo floor are high. Overall, the presence of cargo load influences the WL295 stresses only

Figure 2: Maximum principal stress along WL 295 near a typical fastener at FS660 marginally.

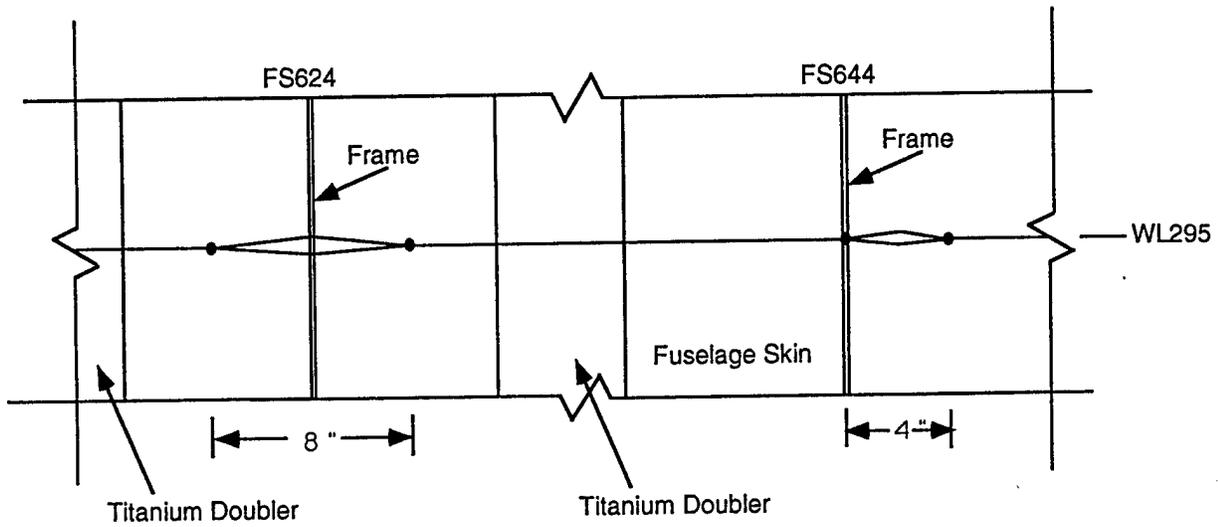
Figure 3 shows the crack pattern along WL295 that was used to assess the effects of typical cracks on frames. Specifically, three cracks were modeled: one 8" crack along WL295 centered at FS624 was modeled to determine its effect on the frame at FS624; one 4" crack was modeled from FS644 to FS648 to obtain its effects on the FS644 frame; and one 0.14" crack was modeled at the fastener hole to determine the stresses in the fuselage skin ahead of the crack when a crack initiates and propagates from the fastener hole along WL295.

Internal pressure: For the internal pressure load only, the principal stress ahead of the crack near the fastener hole was 15,770 psi; the stress at the same location for the baseline analysis was 13,210 psi, a jump of 20%. Also, the maximum principal stress at the fore edge of the fastener hole increased from 19,100 psi to 20,430 psi. Table 2 shows the forces in the frames under various conditions. Note that an 8" crack causes the bending moment in the FS624 frame at WL295 to increase from 7,503 in-lb to 15,713 in-lb, or 109%. The axial force increases from 5,350 lb to 8,092 lb, or 51%. The 4" crack near the frame at FS644 increases the bending moment by 57% and the axial force by 11%.

Figure 3: Cracks at WL 295; first crack pattern

Internal pressure with cargo load: The maximum principal stress at the fore edge of the fastener hole, for this load case, rose from 20,380 psi to 21,530 psi; the principal stress at the aft edge dropped from 19,860 psi to 15,490, however. Table 2 shows the forces in the frames when the cargo load is present. The presence of an 8" crack caused the bending moment in the FS624 frame at WL295 to increase from 4,893 in-lb to 12,417 in-lb, an increase of 154%. The axial force increased from 5,618 lb to 8,200 lb, an increase of 46%. The forces in the FS644 frame did not change significantly, however.

So far, it appears that no simple solution exists for the correction of the skin cracking problem. Although most of the cracks occur along WL 295, it appears prudent to develop a repair that applies to all cracks or to develop a set of repairs covering all cracks. The current repair involves putting titanium doublers on both sides of the cracks. The drawback of this repair is that it requires more holes be made in the skin, thus creating the potential for more crack sites. Other possible repairs include unloading WL 295 fasteners by designing a new structure for supporting the external fairing and routing the loads down to the next lower stringer. Also, the cracks occurring at other stringers could be eliminated by putting doublers on the opposite side of the skin. These repairs will not address the corrosion damage that already exists in these areas. Another repair that addresses all of the concerns is a

Boron Epoxy patch. The current fasteners should be replaced with flush countersunk fasteners to remove some of the existing corrosion and provide a flat surface to bond a multiple layer Boron Epoxy patch. Such a patch will reduce the stresses at the crack tip and carry the load across the crack. Also, the patch would inhibit further crack growth, as well as crack growth from existing corrosion pits. Furthermore, since no new holes are required, new potential crack initiation sites would not be created. It appears that seven layers of Boron are needed in multiple directions to carry the hoop tension and longitudinal stresses from pressurization. An extension of the FEA work to investigate the Boron Epoxy repair is recommended.

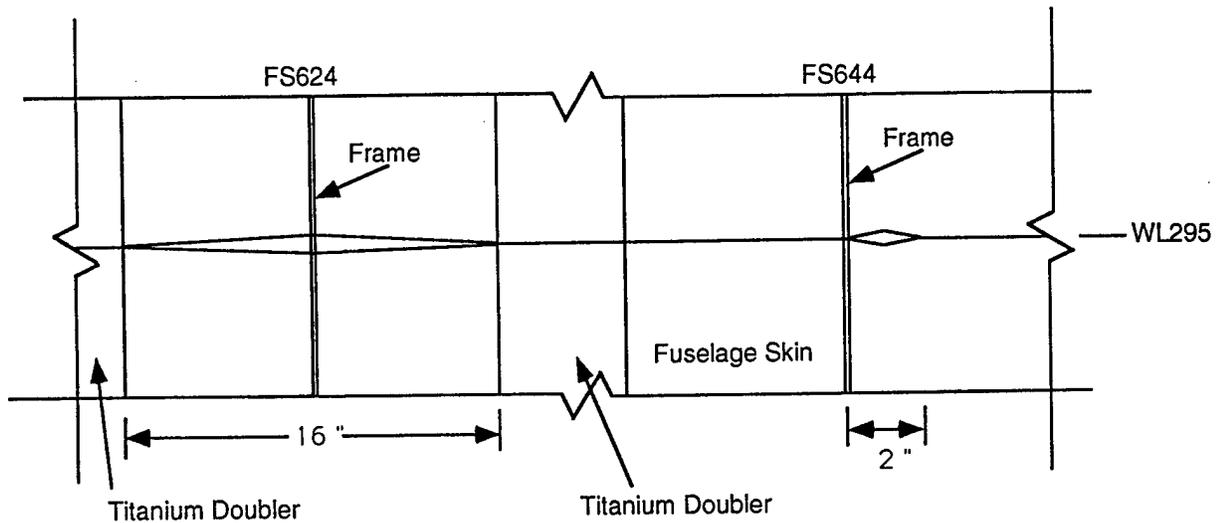
Figure 4: Cracks at WL 295; second crack pattern

Figure 4 shows the cracks along WL295 that were modeled to assess the effects of typical cracks on frames. Specifically, three cracks were modeled: one 16" crack along WL295 centered at FS624 was modeled to determine its effect on the frame at FS624; a 2" crack was modeled from FS644 to FS646 to obtain its effects on the frame at FS644; and one 0.15" crack was modeled at the fastener hole to determine the stresses in the fuselage skin ahead of the crack when a crack initiates and propagates from the fastener hole at an angle making 45 degrees with WL295.

Internal pressure: For the internal pressure load only, the maximum principal stress along WL295 rose from 19,110 psi to 19,700 psi; the stresses at the aft end of the hole along WL295 dropped from 19,080 psi to 16,130 psi. Table 3 shows the forces in the frames under various conditions. Note that a 16" crack increases the bending moment in the FS624 frame at WL295 from 7,503 in-lb to 22,777 in-lb, or 204%. The axial force increases from 5,350 lb to 10,599 lb, or 98%. The 2" crack near the frame at FS644 increases the bending moment by 25% and the axial force by 5%.

Internal pressure with cargo load: The maximum principal stress at the fore edge of the fastener hole, for this load case, rose from 20,380 psi to 20,540 psi; the principal stress at the aft edge dropped from 19,860 psi to 19,180, however. Table 3 shows the forces in the frames when the cargo load is present. A 16" crack caused the bending moment in the FS624 frame at WL295 to increase from 4,893 in-lb to

19,396 in-lb, or 296%. The axial force increased from 5,618 lb to 10,688 lb, or 90%. The forces in the FS644 frame did not change significantly, however.
