Embrittlement of a Platinum-Iridium Screen

10 January 1999

G. L. STECKEL and N. MARQUEZ
Mechanics and Materials Technology Center
Technology Operations

6. AUTHOR(S) G. L. Steckel and N. Marquez					
7. PERFORMING ORGANIZATION NAME(S) AND ADDRESS(ES) The Aerospace Corporation Technology Operations El Segundo, CA 90245-4691				8. PERFORMING ORGANIZATION REPORT NUMBER TR-99(8565)-2

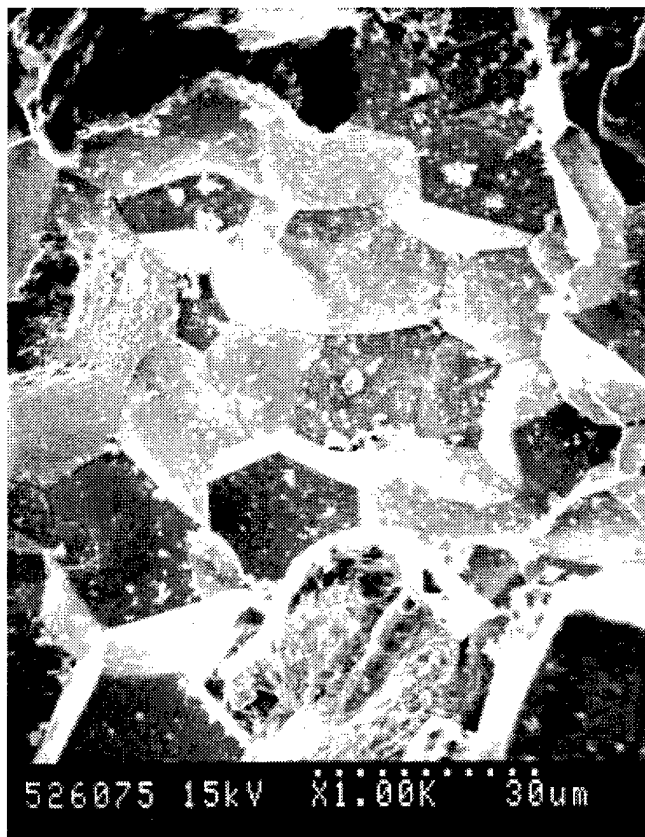
There was approximately a two-month delay between discovery of the wire fragments and the eventual disassembly of the motor discussed above. Thus, a preliminary failure analysis was performed on the wire fragments retrieved from the nozzle bag. Initially, scanning electron microscopy (SEM) utilizing energy dispersive X-rays (EDX) for chemical analyses was performed. SEM revealed the brittle intergranular nature of the fracture surfaces as shown in Figure 3. It is also apparent from

Figure 3 that the grain size of the Pt-Ir wire was unusually large. The ASTM grain size was approximately No. 7, which corresponds to an average grain diameter of 32 μm . It was also determined that the fractures consistently occurred at mesh bend points on the wires as shown in Figure 4. EDX indicated that the wire composition was approximately 88wt% Pt and 12wt% Ir. The only other element detected on the wire fractures or outer wire surfaces was aluminum. The presence of Al was attributed to catalyst particles that consist of Ir on an Al_2O_3 carrier. Catalyst particles can be seen on the fracture surface in Figure 3. No potentially embrittling contaminants were identified on the wire fracture surfaces.

Figure 3. SEM micrograph of fracture surface of Pt-Ir wire fragment. Particles on surface are from the Ir/ Al_2O_3 catalyst.

The micrograph in Figure 3 is from the SEM analysis of the wire fragments. The MMTc SEM/EDX results were completely consistent with those performed by the contractor. EDX was performed at several areas on fracture surfaces on two wire fragments such as that shown in Figure 3. In all cases, the only elements identified were Pt, Ir, Al, and O. No evidence of Si was detected. However, it should be noted that the Si K_{α} X-ray peak is located at an energy of 1.739 keV while the Pt and Ir M_{α} peaks are located at 2.048 keV and 1.977 keV, respectively. Thus, low concentrations of Si would be difficult to detect due to overlapping with the strong Pt and Ir peaks. Furthermore, EDX is not an effective technique for detection of thin layers of contaminants on material surfaces.

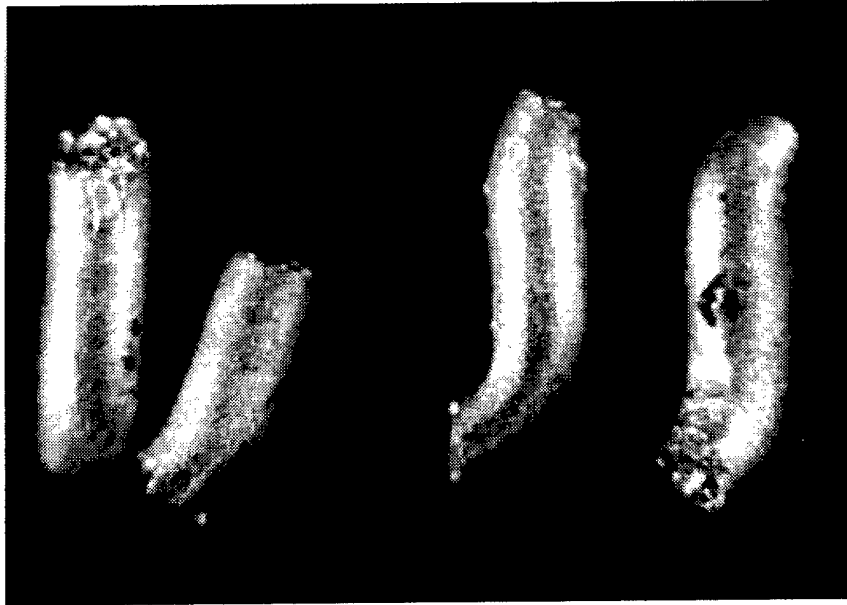
Figure 4. Photograph of four Pt-Ir wire fragments.

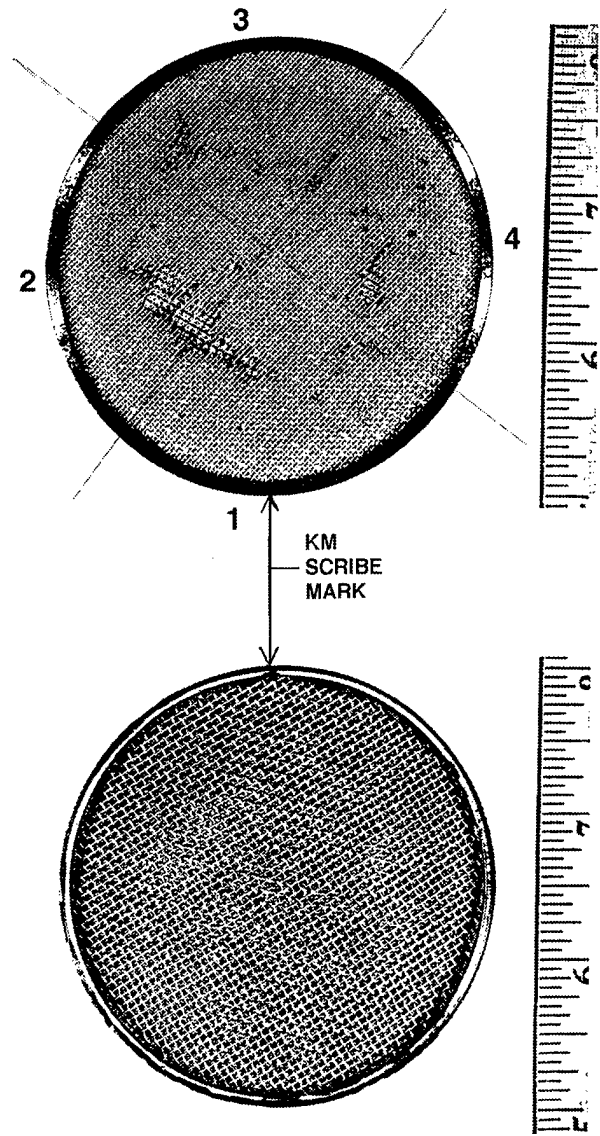
After the motor was disassembled, additional material from the mid-retainer/screen assembly was provided to MMTC for evaluation. Photographs of the front and rear surfaces of the mid-retainer/screen assembly are shown in Figure 5. The top photograph shows a circular pattern of damage to the first 40 x 40 screen due to embrittlement of the 0.010-in.-diam wires. The lower photograph shows that the 18 x 18 mesh of 0.017-in.-diam wires was undamaged. The contractor sectioned the mid-retainer/screen assembly into quadrants by cutting along the lines shown in the upper photograph and sent Quadrant No. 2 to MMTC for evaluation.

Figure 5. Photograph of up stream (top) and down stream (bottom) sides of mid-retainer/screen assembly. Top photograph shows location of cuts for sectioning into quadrants.

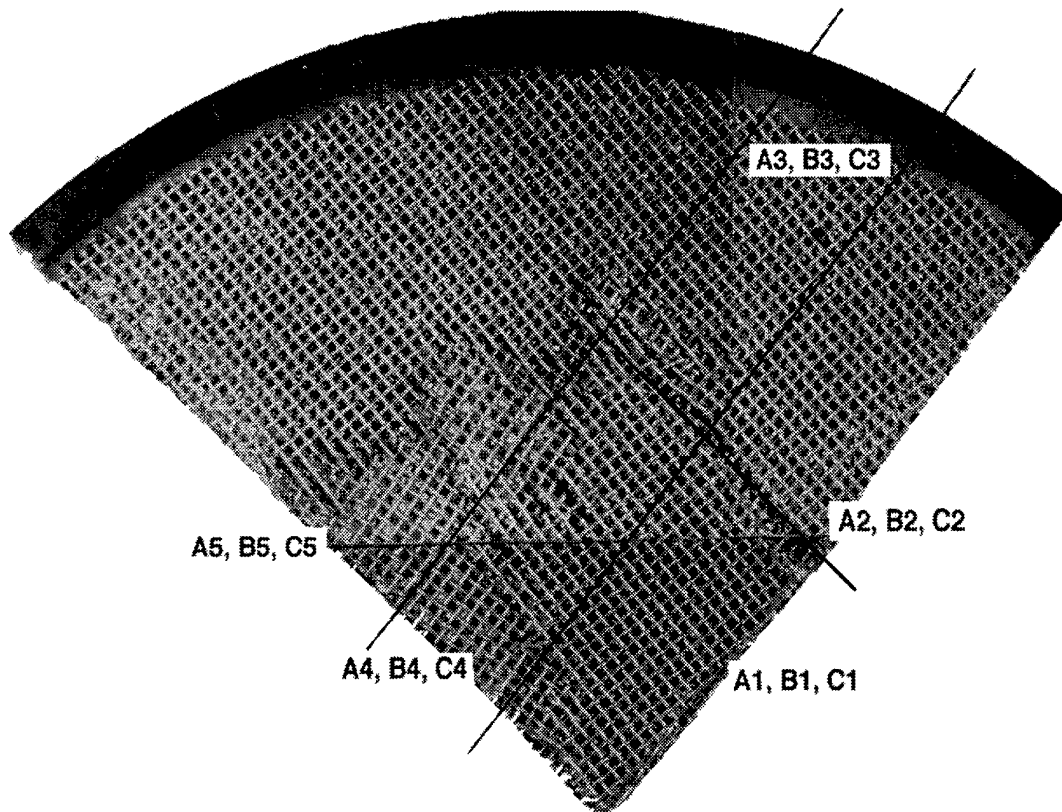
The photograph in Figure 6 shows the damaged areas on Quadrant No. 2 and the cutting pattern for removing smaller samples for various evaluations and experiments. For the purpose of convenient sample identification, the top, brittle screen was identified as Mesh A, the middle screen as Mesh B, and the lower, coarse screen as Mesh C. Initially, the entire quadrant was evaluated using SEM/EDX to document fracture features and conduct preliminary chemical analyses of the wire surfaces and fracture surfaces. The quadrant was then sectioned as shown in Figure 6 using a low-speed diamond saw with deionized water as a lubricant. Samples A1, A2, and B1 were mounted and polished for performing SIMS analyses on wire cross sections. These samples were selected to allow comparisons between areas on Mesh A with and without brittle failures (A1 and A2, respectively) and to compare the damaged Mesh A with the apparently undamaged Mesh B. Samples A3, B3, and C3 were used for SIMS analyses of the wire surfaces. The intent of these analyses was not only to compare the surface chemistry for the three screens, but to also make comparisons between the "high points" (tensile side) of the wires at crossovers in the weave to the "saddle points" (compressive side) where the crossing wires contact one another. The high points can easily be contaminated during handling of the screens, whereas the saddle points are somewhat protected from contamination.

Figure 6. Photograph of Quadrant No. 2 from Mid-Retainer/Screen Assembly. The Screens Were Sectioned into Samples and Identified as Shown. Mesh A = Top, Embrittled Screen, Mesh B = Middle Screen, and Mesh C = Bottom Screen.

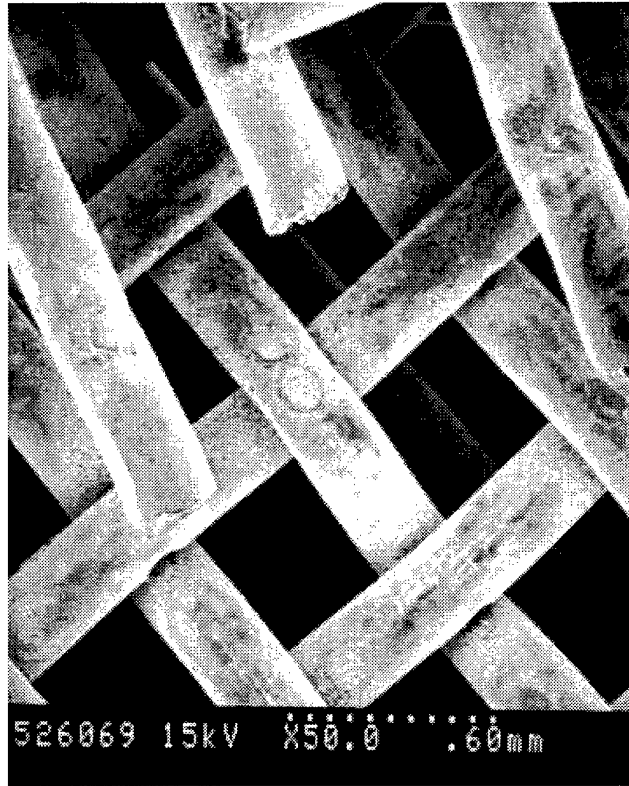
Figure 8. SEM micrograph of damaged area on mid-retainer/screen assembly.

Figure 8 also shows that the wires underwent considerable deformation at the crossover points of the weave. The wire in the upper right corner of the figure appears to be slightly kinked within the saddle point of the crossover. This was a common observation. Figure 10a shows a higher magnification of a kinked saddle point. The saddle points were characterized by a reduced density of catalyst particles and considerable etching of the grain boundaries. Thermal etching of grain boundaries commonly occurs during high-temperature vacuum annealing (brazing operation), but may also occur in high-temperature reducing environments (motor firing). A higher-magnification view in Figure 10b demonstrates that in some areas, grains were completely dislodged. Other saddle points showed complete dissolution of the grain boundaries (Figure 11a), the development of voids at the grain boundaries (Figure 11b), or possible surface melting (Figure 11b). These observations are probably indicative of the embrittlement process and are contributors to the apparent partial fusion between crossing wires.

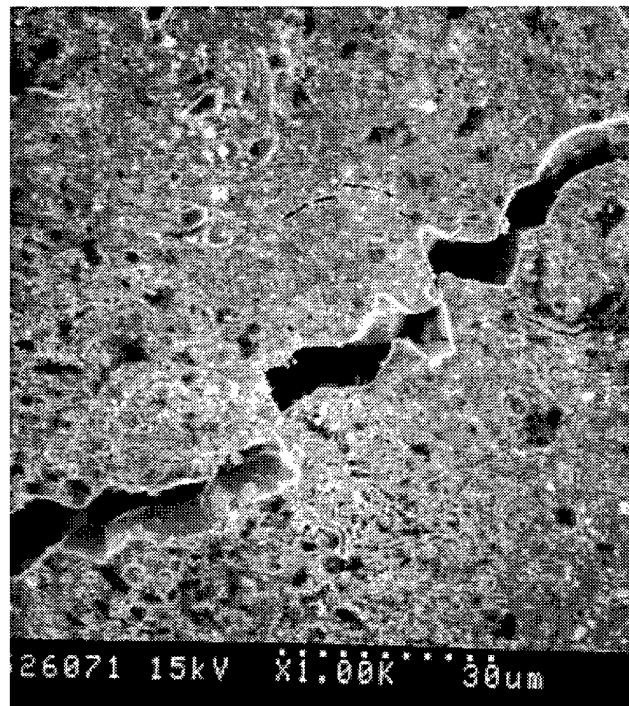
Figure 9. SEM micrograph of cracked Pt-Ir wire on Mesh A.

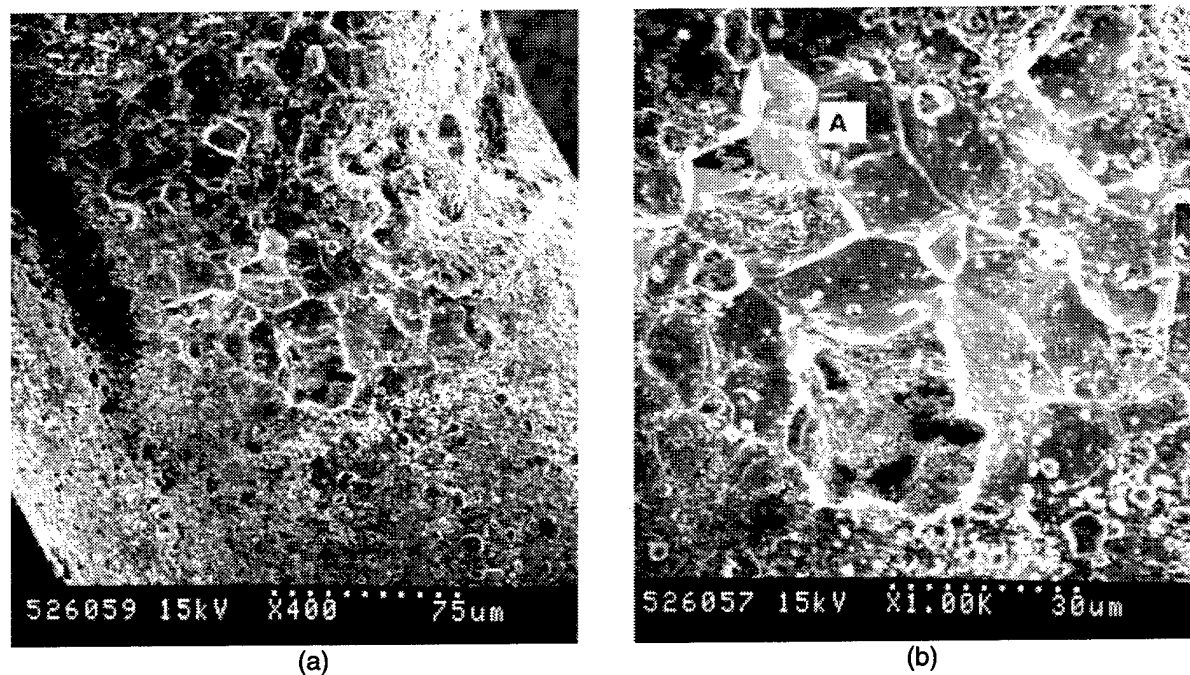
The saddle points shown in Figures 10 and 11 are from areas on Mesh A in which the saddle points were exposed when the crossing wire fractured. In order to view the saddle points on Meshes B and C, it was necessary to extract the crossing wire. Figure 12 shows a saddle point on Mesh C, which has the appearance of a ductile fracture surface. This fracture surface is direct evidence that the crossing wires were fused together. Figure 12 is typical of all saddle points (4 or 5) examined in the SEM for Mesh C. A larger number of saddle points was examined on Mesh B. Most of the Mesh B saddle points had the ductile fracture surface characteristic of the separation of fused wires over part of the crossover area and the "free surface" features shown in Figures 10 and 11 over the remainder of the area.

Figure 10. SEM micrographs of a saddle point of a crossover point on Mesh A. The higher-magnification micrograph (b) shows dislodged grains at point A.

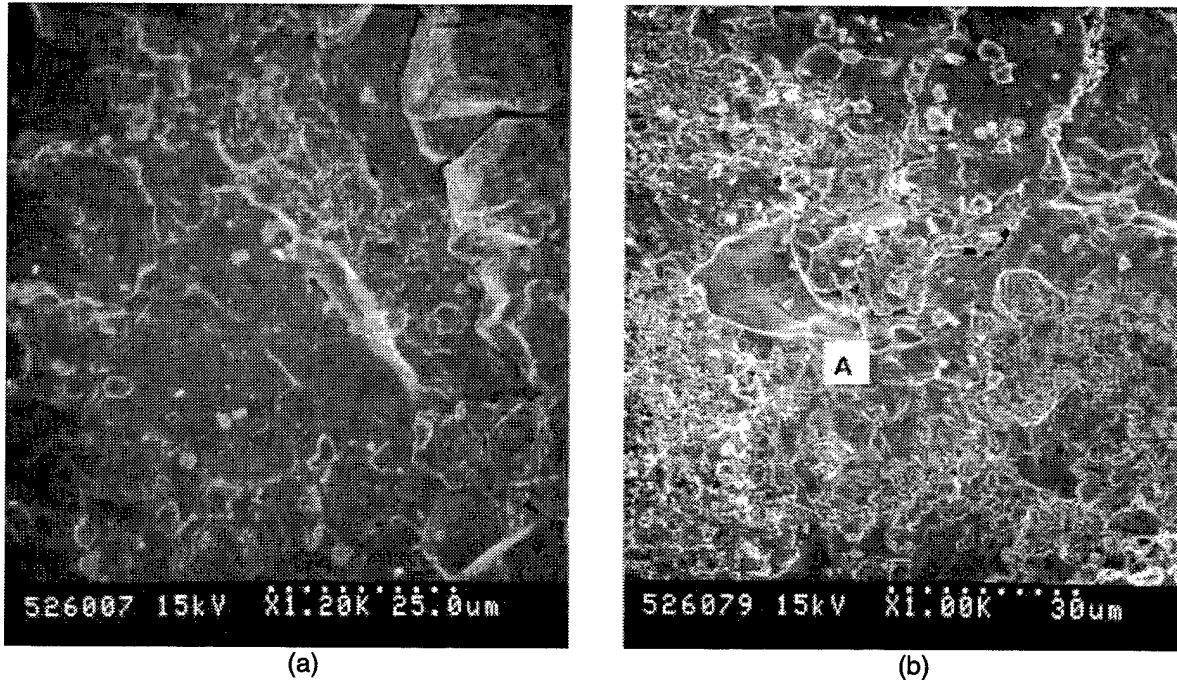
Figure 11. SEM micrographs of two saddle points at crossover points on Mesh A. Extensive grain boundary dissolution is shown in (a). Grain boundary voids along with possible melting at location A are shown in (b).

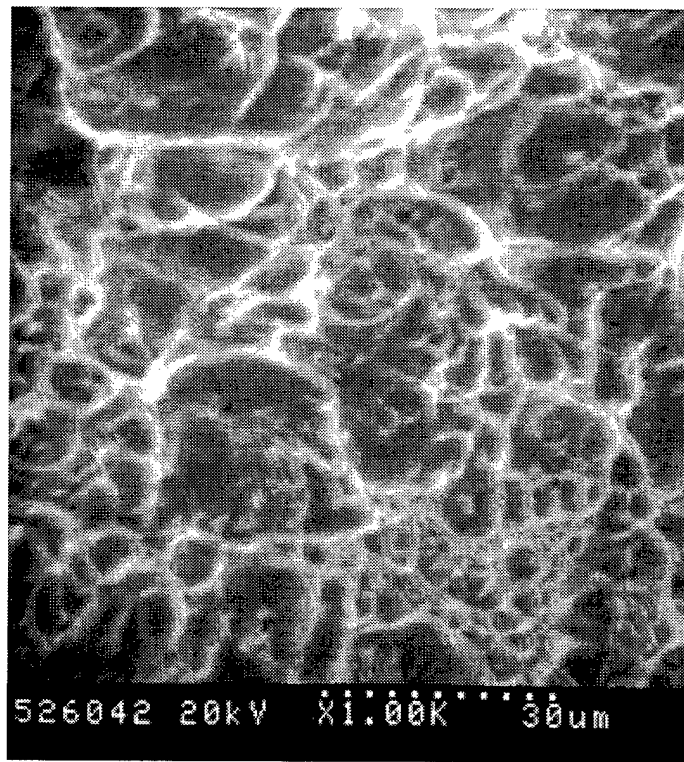
Figure 12. SEM micrograph of a saddle point of a crossover point on Mesh C.

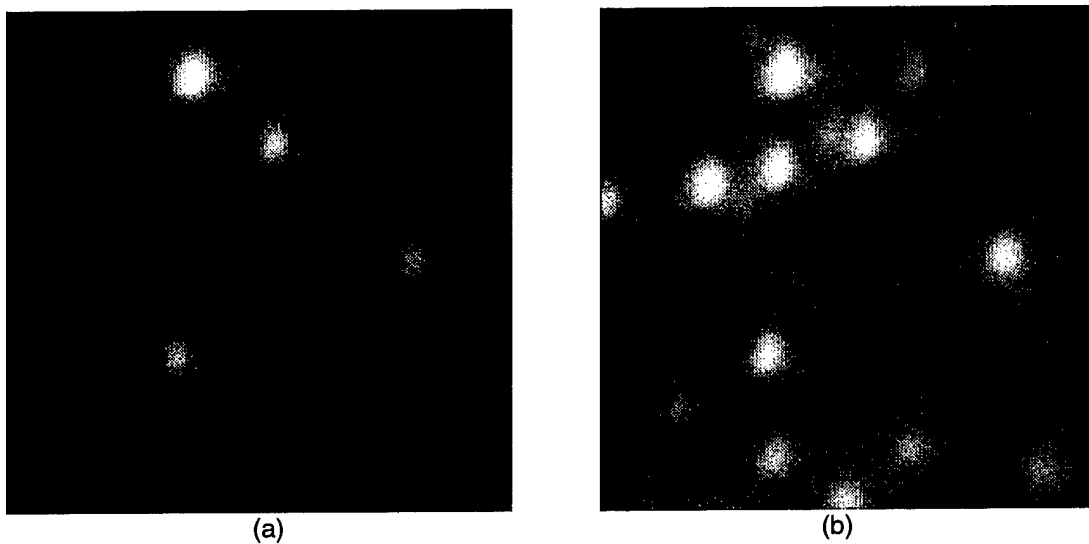
counts is indicated in parentheses for each element or compound. Spectral data are presented for two separate areas on Sample Nos. A1 and A2, and for one area on all other samples. Similar elemental spectra were obtained for the wire fragment, the two areas on Sample Nos. A1 and A2, and the one area on Sample No. B1. The primary impurities were Cr, Rh, Al, In, Si, and Ca. Rh was not included in Table 2 or Figure 13 since the presence of Rh is expected and is of no concern. Indium was the most surprising impurity and appeared to be present in significant levels, although not at concentrations sufficient to be detected by SEM/EDX. Cr, Rh, Si, and Ca were all detected in the bulk chemical analysis (Table 1), while Al was not detected, and In was not checked for in the bulk analysis. Elemental mapping indicated that the Cr, Rh, Al, and In were distributed uniformly throughout the cross section. The Ca and Si were associated with one another and appeared to be present as distinct particles, as shown by the elemental maps in Figure 14 for Sample No. A2, Area B.

Figure 14. Silicon (a) and calcium (b) Maps of analysis Area B on cross section of Sample No. A2. Bright spots indicate presence of Si or Ca.

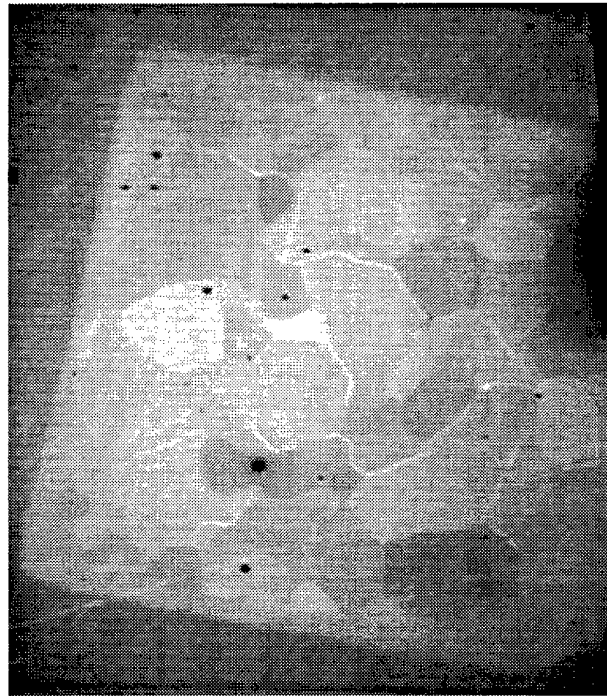
Figure 15. SEM Micrograph of Area B on Sample No. A2 following SIMS analysis. EDX analysis indicated that dark spots are Ca-Si-O particles.

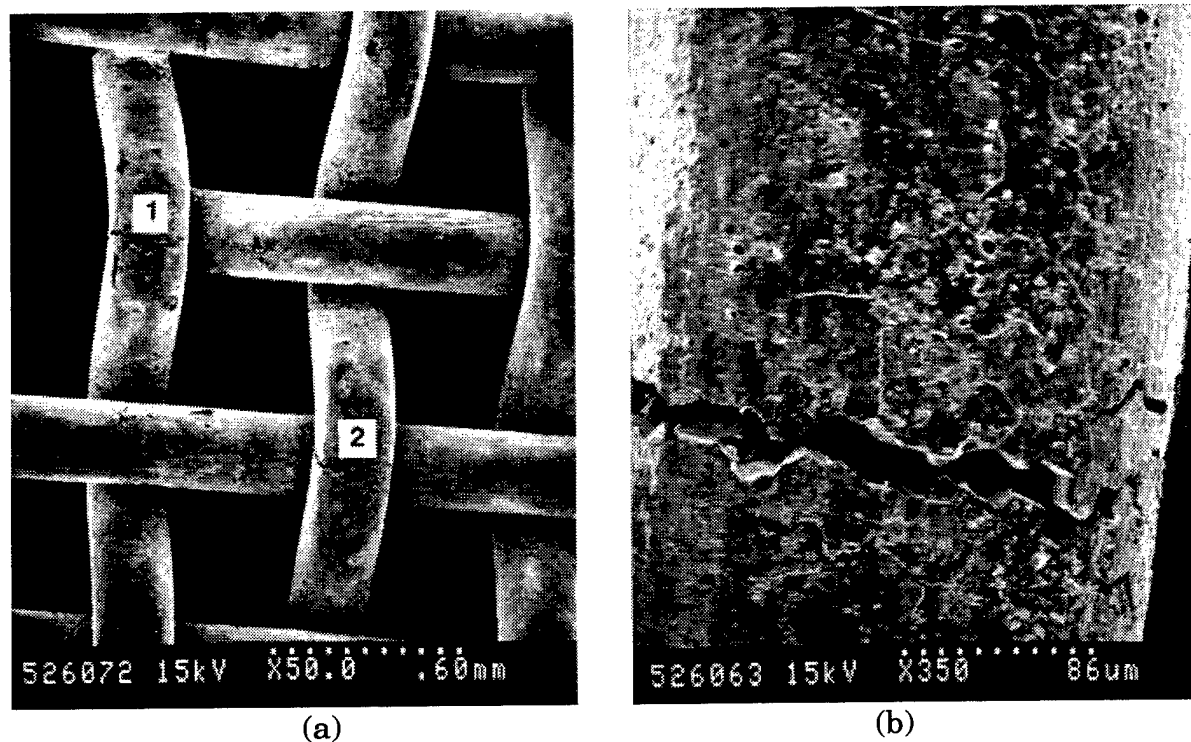
Sample Nos. A3, B3, and C3 were examined in the SEM following the SIMS analyses. Figure 18a shows Areas 1 and 2 from the SIMS analyses on Sample No. A3, and Figure 18b shows a higher-magnification view of Area 2. A comparison of Figure 18b with Figure 9 shows that the 90-min ion sputtering during the SIMS analysis cleaned a significant fraction of the catalyst particles from the wire surface and also etched the grain boundaries. Extensive EDX over the etched area did not reveal any elements other than Pt, Ir, Al, and O. Thus, although the Mn/Pt and Ga/Pt secondary-ion count ratios after sputtering were very high on Area 2 (Figure 16), the actual concentrations of Ga and Mn were too low to be detected by EDX.

Figure 18. SEM micrographs of Sample No. A3 following SIMS analysis. Micrograph (a) shows Areas 1 & 2 adjacent to cracks. Micrograph (b) is higher-magnification view of Area 2.

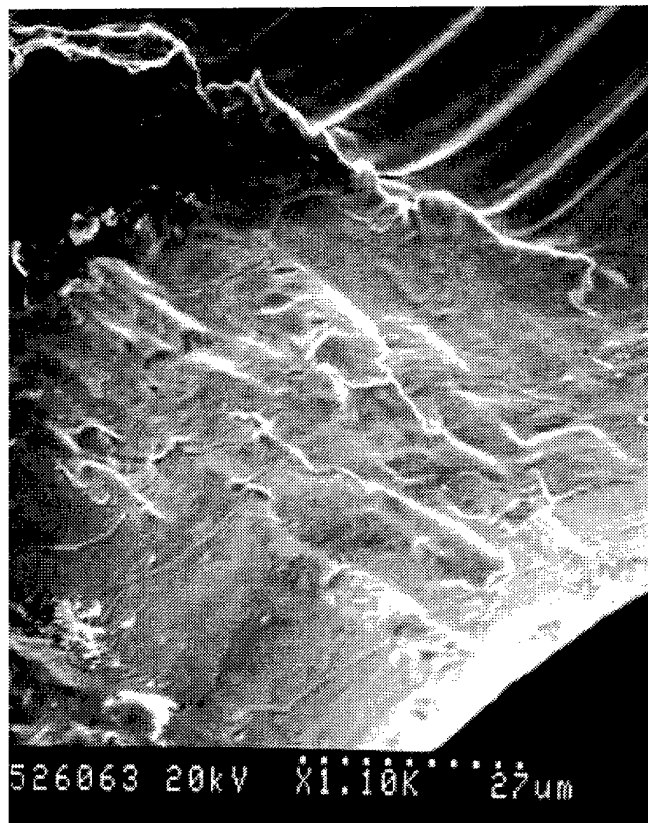
The Kaiser Marquardt Pt-Ir screens designated Lot Nos. 1 and 2 that were subjected to the braze simulation heat treatment were submitted to MMTTC for evaluation. The primary goal was to determine whether these screens exhibited the partial fusion at weave crossover points that were observed for the screens from REM S/N KM004. Lot No. 1 was heat treated at 1150°C (2100°F) for 2 h to simulate the braze operation. Lot No. 2 was subjected to this heat treatment twice. Wires were extracted from both screens under a stereo microscope at a magnification of 20x. For both heat-treated lots, the wires were very easily extracted with no indications of fusion between wires. Figure 19 shows that the wires were subjected to substantial deformation at the crossover points, not unlike the deformation experienced by the wires in the S/N KM004 screens. However, the wires in the Lot No. 1 and 2 screens showed no evidence of the dislodged grains, dissolution of grain boundaries, voids at the grain boundaries, or fusion between wires seen on the embrittled wires.

Figure 19. SEM micrograph of a saddle point of a crossover point on Kaiser Marquardt Lot No. 2 screen following heat treatment simulating brazing.
