Flightfax

ARMY AVIATION
RISK-MANAGEMENT
INFORMATION

APRIL 1999 ♦ VOL 27 ♦ NO 4

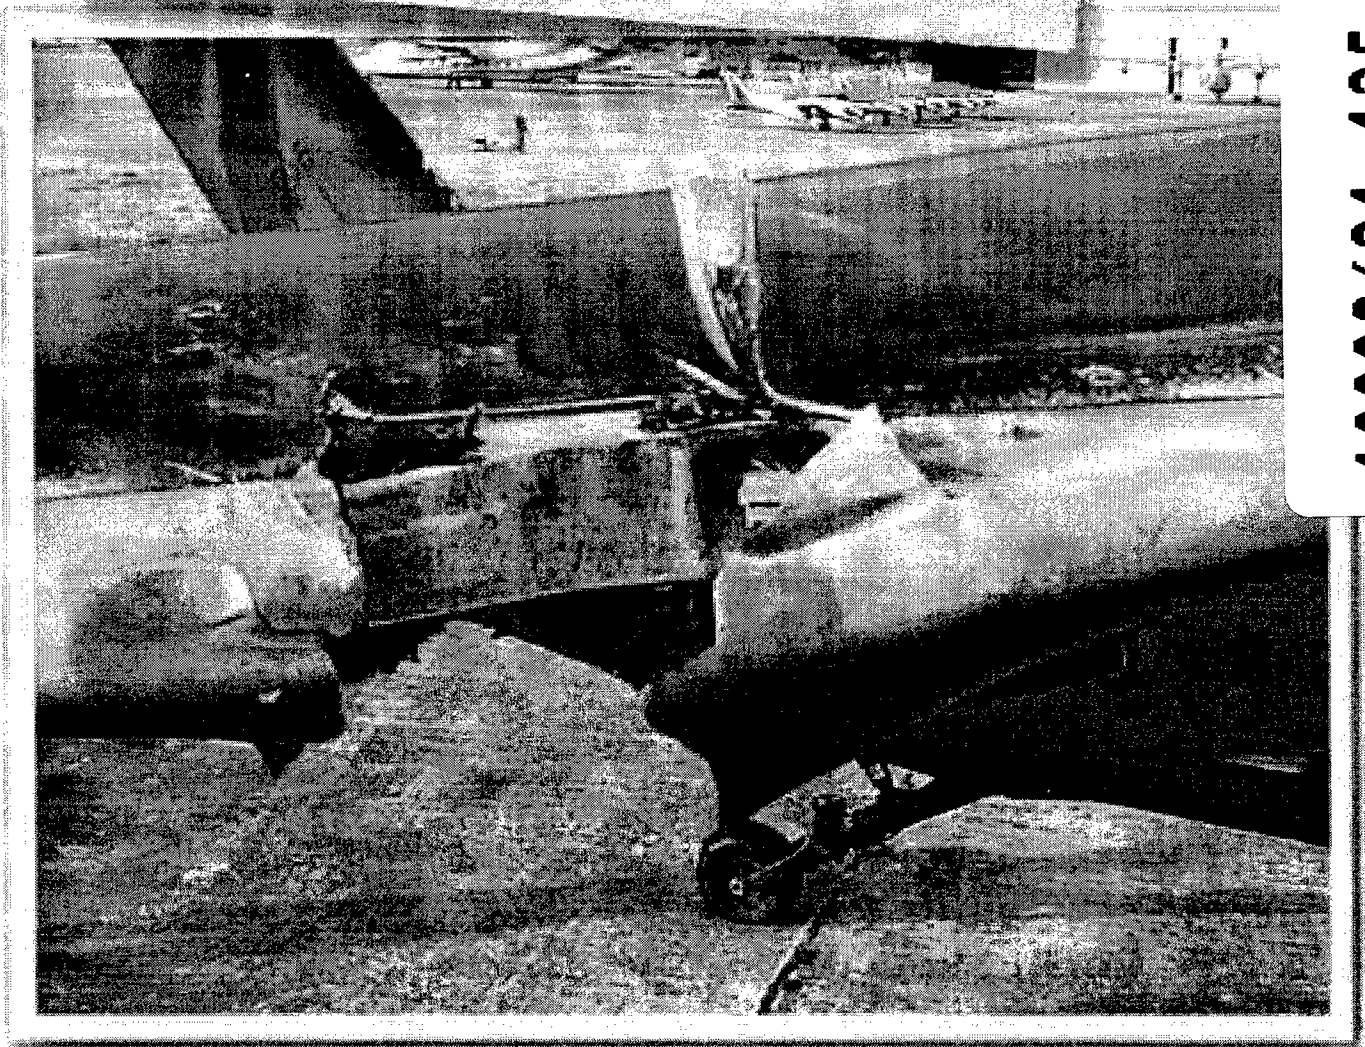
Black Hawk vs. buzzard: it could have been ugly

This UH-60 was in the traffic pattern at 700 feet agl and 115 knots when its rotor blade met with a buzzard. The crew had entered a right descending turn in an attempt to miss 5 or 6 birds in the flight path. One bird, however, followed the aircraft into the

turn. The strike was a little like hitting a ripe tomato with a ball bat and sprayed bird over the entire aircraft. When the crew righted the aircraft, they were pointed toward the runway on a modified final at about ½-mile. With no landing area available below, they

Damage was limited to the blade. And to the bird.
