TECHNICAL REPORT ARCCB-TR-99010

**ANALYSIS OF A PISTON EXPERIENCING
ENVIRONMENTALLY-ASSISTED CRACKING
AS A RESULT OF COMPRESSIVE OVERLOADING**

JUNE 1999

**US ARMY ARMAMENT RESEARCH,
DEVELOPMENT AND ENGINEERING CENTER
CLOSE COMBAT ARMAMENTS CENTER
BENÉT LABORATORIES
WATERVLIET, N.Y. 12189-4050**

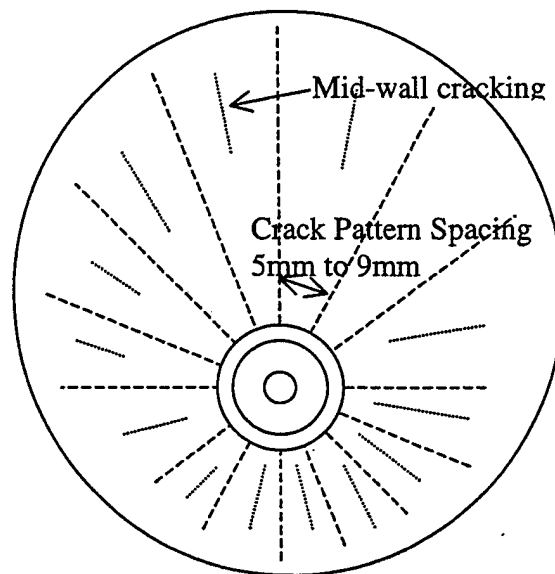
In August 1997, testing was conducted of a piston utilized in the seal of a closed-ended pressure vessel. Testing included 100 loading cycles, at pressures ranging from 69 MPa to 414 MPa. Upon completion of the test, the component was disassembled, cleaned, and inspected. Although no pressure losses were observed during the test, it was noticed that cracking of the Maraging 200 steel piston had occurred (Figure 1). Cracking was not observed during testing because cleaning of the system was strictly forbidden. The cracking pattern emanated in a radial fashion around the piston, yet none of the cracks broke through the thickness of the piston. Cracks ranged in length from barely noticeable, to approximately 20-mm in length. Cracking was also observed at many locations approximately half the distance between the center of the piston and the outside diameter. In some cases, cracks that started in the center of the piston appeared to "link up" with the cracks that started at the midpoint between the center and the outside diameter. There was also a characteristic ripple where the cracked surfaces protruded upward, producing an uneven texture on the top surface of the piston. The crack pattern appeared relatively evenly spaced, with a crack spacing of approximately 5-mm to 9-mm.

Figure 1. Radial cracking pattern on piston face.

Ultrasonic inspection of the piston indicated that most of the cracks ranged in depth from approximately 1.0-mm to 1.5-mm, with the maximum depth of each crack occurring at the center of the piston. Magnetic particle inspection of the piston revealed that none of the cracks extended to the outside diameter of the piston. Inspection of the top surface revealed a "dishing" effect. The top surface of the piston was 0.05-mm higher on the outside diameter than in the center. The backside of the piston was also plastically deformed and dished. The center of the piston was 0.025-mm higher than the outside edge of the back of the piston.

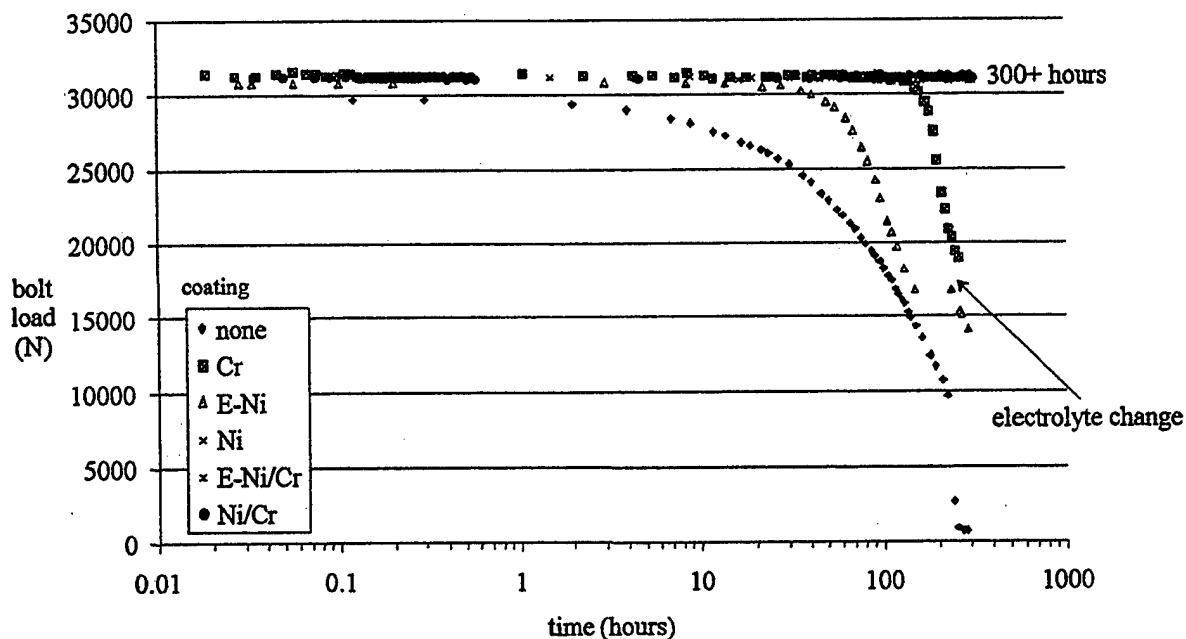
Figure 4 clearly highlights the resistance that each of the coatings provides to the Maraging 200 base material. We can see that the Maraging 200 material with no coating provided approximately one hour incubation time, followed by a decreasing load as monitored by the instrumented bolt. After approximately 250 hours of exposure, the cracking had reached an apparent threshold value, and no further decrease in load was observed. The specimen with the electroless nickel (E-Ni) protective coating provided approximately 30 hours of protection, and rapid cracking of the underlying base material resulted. In this test, after approximately 150 hours of exposure, the cracking appeared to arrest. Cracking immediately resumed after the electrolyte was changed. We believe that the electrolyte had become depleted, or because the electrolyte is hygroscopic, it may have absorbed enough moisture to severely compromise the pH of the acid. The specimen that was protected with the chromium coating (Cr) provided approximately 150 hours of protection, and was followed by rapid cracking of the base material. The specimens protected with the electroplated nickel (Ni), electroplated nickel and chromium (Ni/Cr), and electroless nickel and chromium (E-Ni/Cr) all withstood the 300 hours of exposure with no degradation of the base material.

Figure 4. Environmental cracking resistance of Maraging 200.

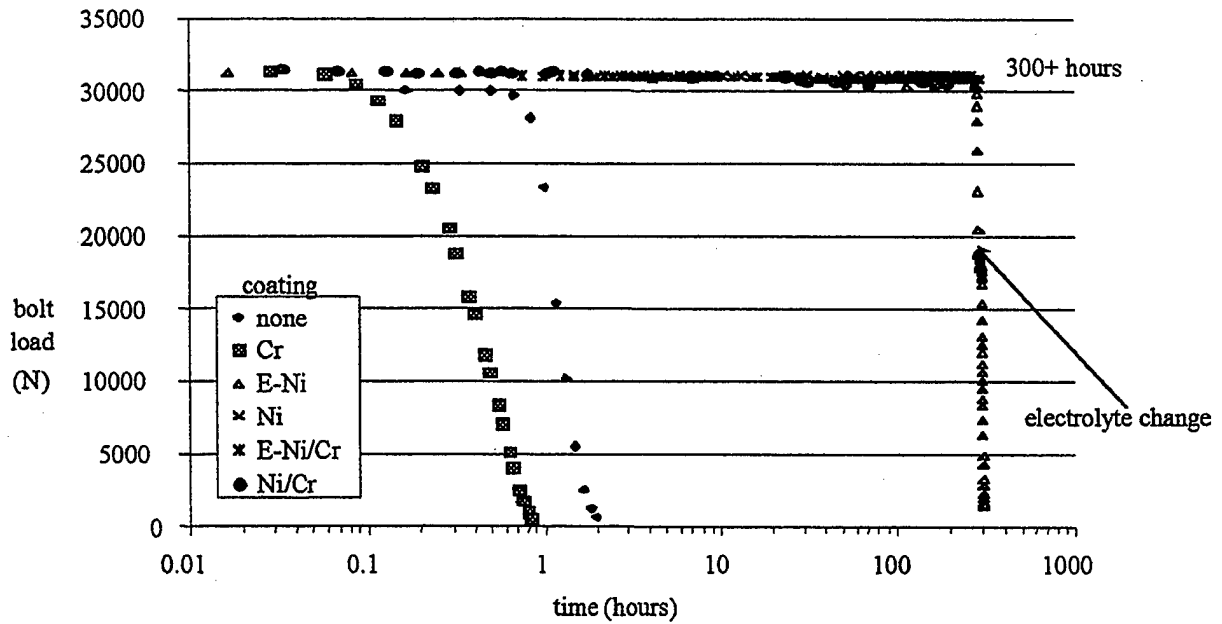
Figure 5 shows results of the tests on the 1300 MPa A723 steel. The first thing to note is that the A723 steel with no protective coating provided less than one hour of incubation time, and cracking had proceeded to the threshold in less than two hours. The chromium coated specimen provided approximately 0.1 hour of incubation time and had proceeded to the threshold in less than one hour. We believe this is a direct result of microcracking, which is often observed in chromium plating. This microcracking acts as crack initiation sites and rapidly accelerates the incubation time. The specimen coated with electroless nickel provided approximately 280 hours of incubation time, at which time the specimen began shedding load. At approximately 290 hours of exposure, the cracking arrested and an electrolyte change was performed. Cracking immediately resumed and at 300 hours, the specimen had attained the threshold. The specimens with electroplated nickel, electroplated nickel and chromium, and electroless nickel and chromium attained the 300 hours of exposure with no cracking and no shedding of load.

Figure 5. Environmental cracking resistance of A723 steel.
