PB99-910401  
NTSB/AAR-99/01  
DCA94MA076

## AIRCRAFT ACCIDENT REPORT

UNCONTROLLED DESCENT AND COLLISION WITH TERRAIN  
USAIR FLIGHT 427  
BOEING 737-300, N513AU  
NEAR ALIQUIPPA, PENNSYLVANIA  
SEPTEMBER 8, 1994

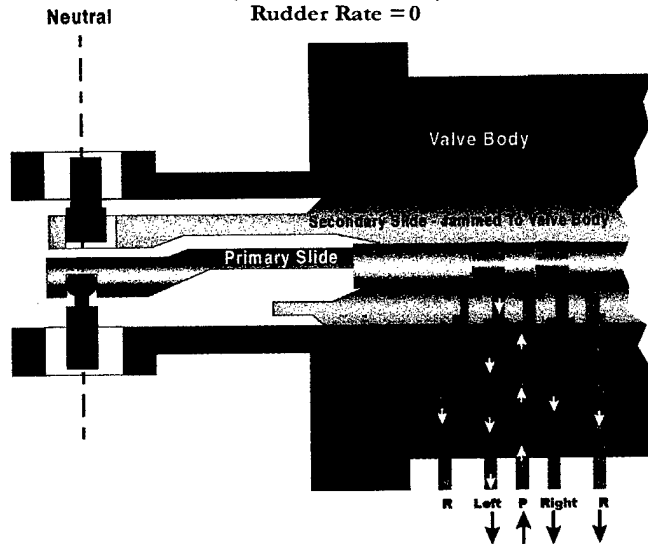
**Intended Operation:  
Secondary Slide Jammed Full Open, Primary Slide Opposing  
(Full Cross Flow)  
Rudder Rate = 0**

**Figure 16.** PCU servo valve intended operation with the secondary slide jammed to the servo valve housing and primary slide opposing.

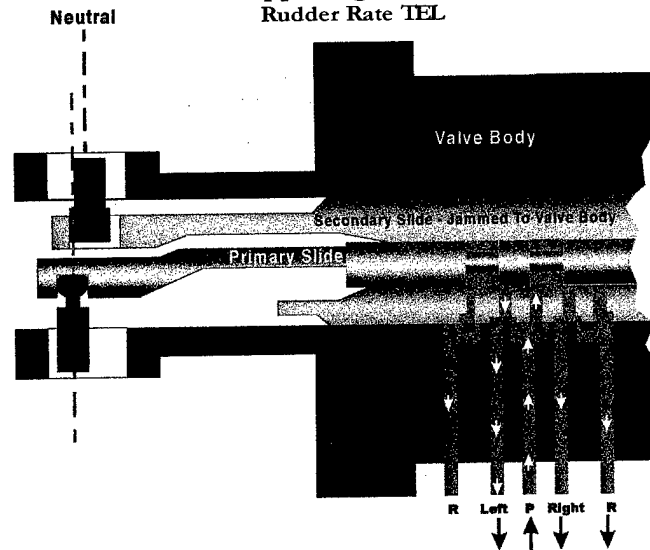
**Newly Discovered Failure Effect:  
Secondary Slide Jammed Full Open, Primary Slide Over-Stroke  
In Opposing Direction  
Rudder Rate TEL**

**Figure 17.** PCU servo valve with the secondary slide jammed to the servo valve housing and the primary slide in the overtravel condition.

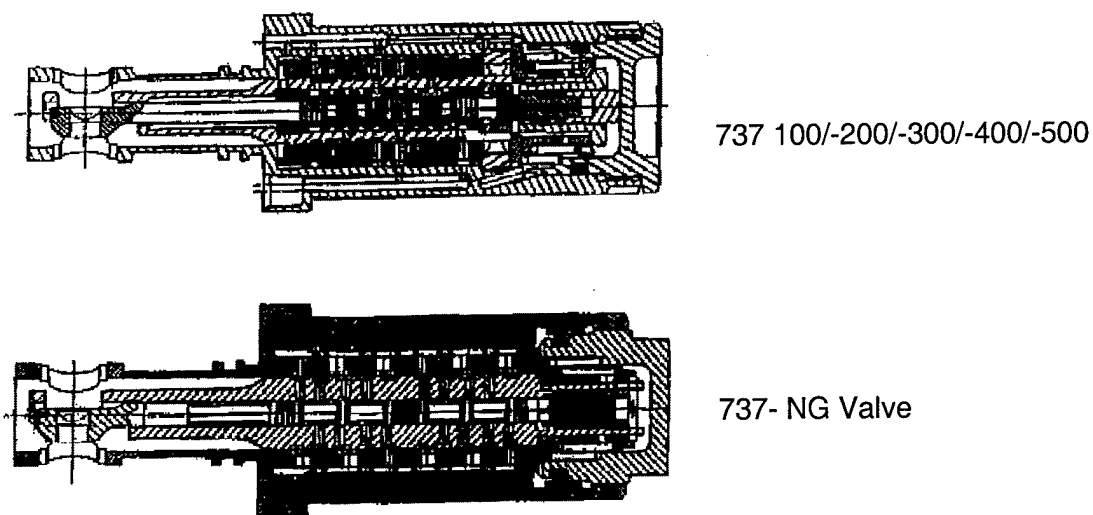
single piece rather than built up by a group of smaller parts. Figure 31 shows the 1998 redesigned servo valve for both the earlier 737 series airplanes and the 737-NG airplanes.

**Figure 31.** Parker's 1998 redesigned servo valve for 737 airplanes.
