155-mm Howitzer Malfunction Investigation: A Laboratory Study of the Igniter Train Operation

ARL-TR-2106

November 1999

Army Research Laboratory

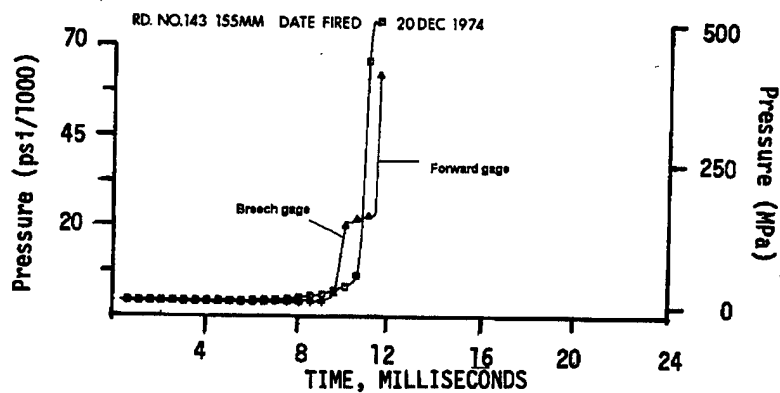
- Round 142: Hangfire, 10 s (minimum, not measured); muzzle velocity, 857 m/s (2,812 ft/s) and 61 m/s (200 ft/s) higher than a normal cold round; mean chamber pressure, 379 MPa (55,000 psi) and ~ 110 MPa (16,000 psi) higher than a normal cold round.
- Round 143: Hangfire, 5.8 s (measured); erratic pressure vs. time trace with a chamber pressure in excess of 793 MPa (115,000 psi) causing a breechblow and extensive damage to the XM199E5 cannon tube. The pressure vs. time history for this round is shown in Figure 2.

Figure 2. Pressure-Time Trace of Breechblow Round Fired at APG With XM203E1 Charge Conditioned to -54° C in XM198 Howitzer.

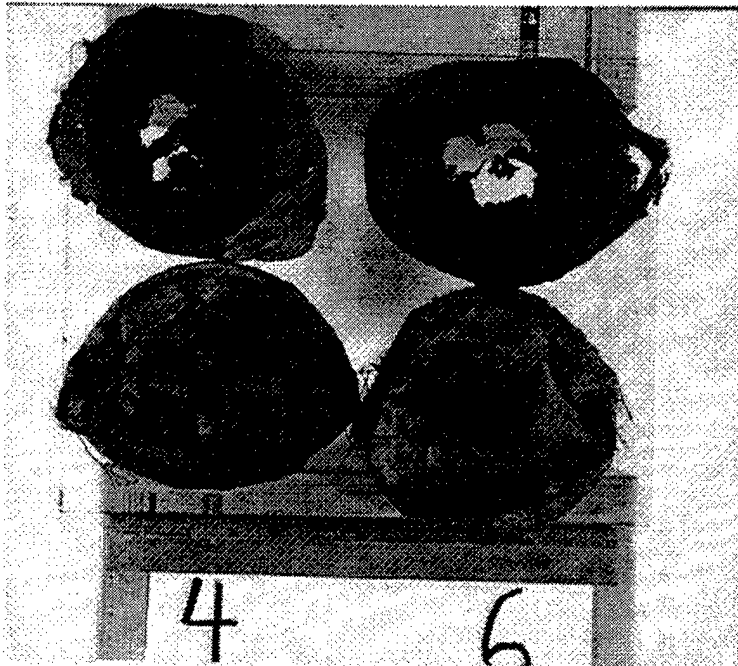
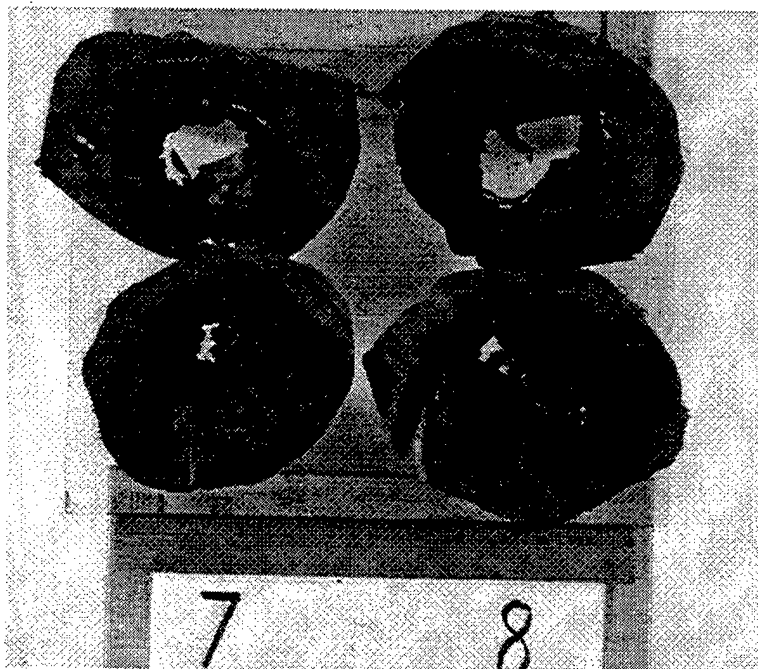
3.1.4 Run 6. Runs 4 (-54°C) and 6 ($+12^{\circ}\text{C}$) post-firing photos are shown in Figure 7(a). It is seen that there are no significant differences between the low-temperature and ambient firings. Results in Table 1 indicate that the time to peak pressure is slightly longer for the cold runs (54 ms) than for the ambient runs (35 ms). However, no events with delays in the range of seconds were observed. Pressure-time traces are shown in Figures 8 (Gauge 1) and 9 (Gauge 3).

3.1.6 Run 8. Results were very similar to that of Run 5, which used the 203 material at -54°C . The post-firing photo of base pad and propellant bag of Runs 7 and 8 are shown in Figure 7(b).

Figure 7. Post-Firing Photographs of Bass Pad (Top) and Propellant Bag (Bottom). 28 g (1 oz) of Black Powder Used in Base Pad; (a) 203, (b) 123.

Again, no significant difference is seen due to the conditioning temperature. Close observation of Figure 7 shows, however, that there are some differences in cloth penetration between the 123 (viscose-rayon impregnated resin) and the 203 (polyester-viscose rayon). The 123 cloth (Figure 7[b]) is more subject to ignition damage than the 203 cloth. In fact, no penetration of the propellant bag is observed in Figure 7(a), whereas there are several holes in the propellant bag in Figure 7(b). Apparently, this difference in cloth had no substantial effect on the operation of the black powder, but it did inhibit the damaging effect of primer black powder output on the propellant bag. Pressure-time traces are shown in Figures 13 (Gauge 1) and 14 (Gauge 3).

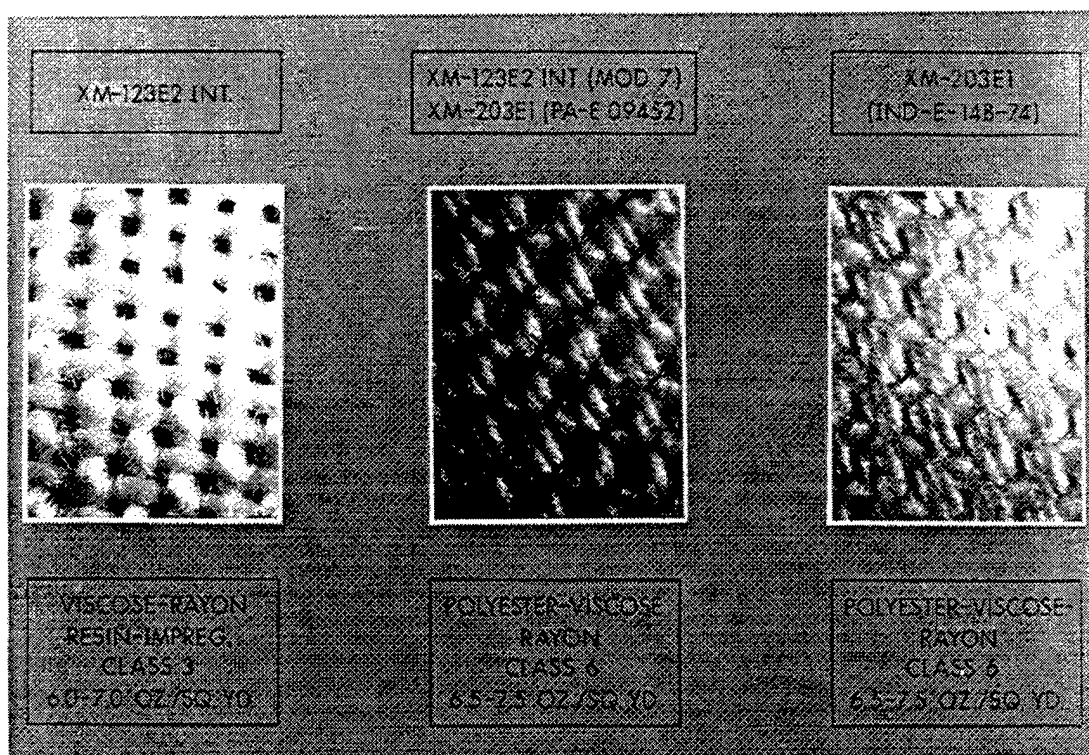
In referring to Figure 43, it can be seen that there is a substantial difference in cloth porosity between the cloth used in the 123 charge and the cloth used in the 203 charge. Only the inner base pad cloth is shown. Figure 7 shows the residue of the base pad (top) and propellant bag (bottom) after firing of an abbreviated charge, as in Figure 4. The base pad contained 28 g (1 oz) of black powder, there was no snake, and an inert central core tube was used.

Figure 43. Inner Lining of Base Pad Cloths Used in 123 Interim (Left) and 203 (Right). The XM123E2 Interim (Mod 7) Cloth Is Not Discussed in This Report.

It is seen that the penetration of and damage to the propellant bag is substantially greater for the 123 system than the 203 system. Apparently, the heavier cloth with a finer weave inhibits the transfer of energy into the propellant bed. The pressure-time curves of two different base pads (Figures 5 and 13) do not show any substantial difference, which indicates that the overall energy output is not altered and only the transfer of energy to the propellant is affected by the cloth.
