**US Army Corps
of Engineers**

CERL Technical Report 99/66
August 1999

Technical Assistance To Supplement Installation of Low NO_x Boilers at the Pentagon Heating and Refrigeration Plant

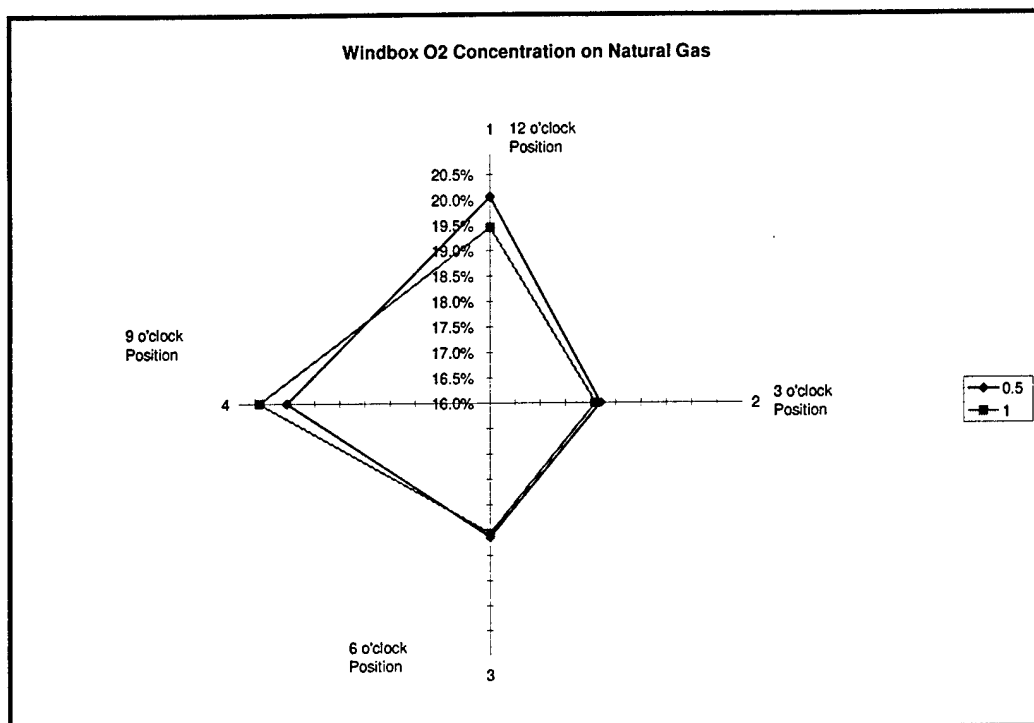
Figure 8. Windbox oxygen concentration on natural gas.

On oil with a properly operating oil gun, the flame front was uniform and well shaped at 50 percent load and higher. At loads below 50 percent, the flame was brighter near the top half and colder in the bottom half. This was probably due to the higher oxygen content in the air at the top of the burner and less turbulent conditions.

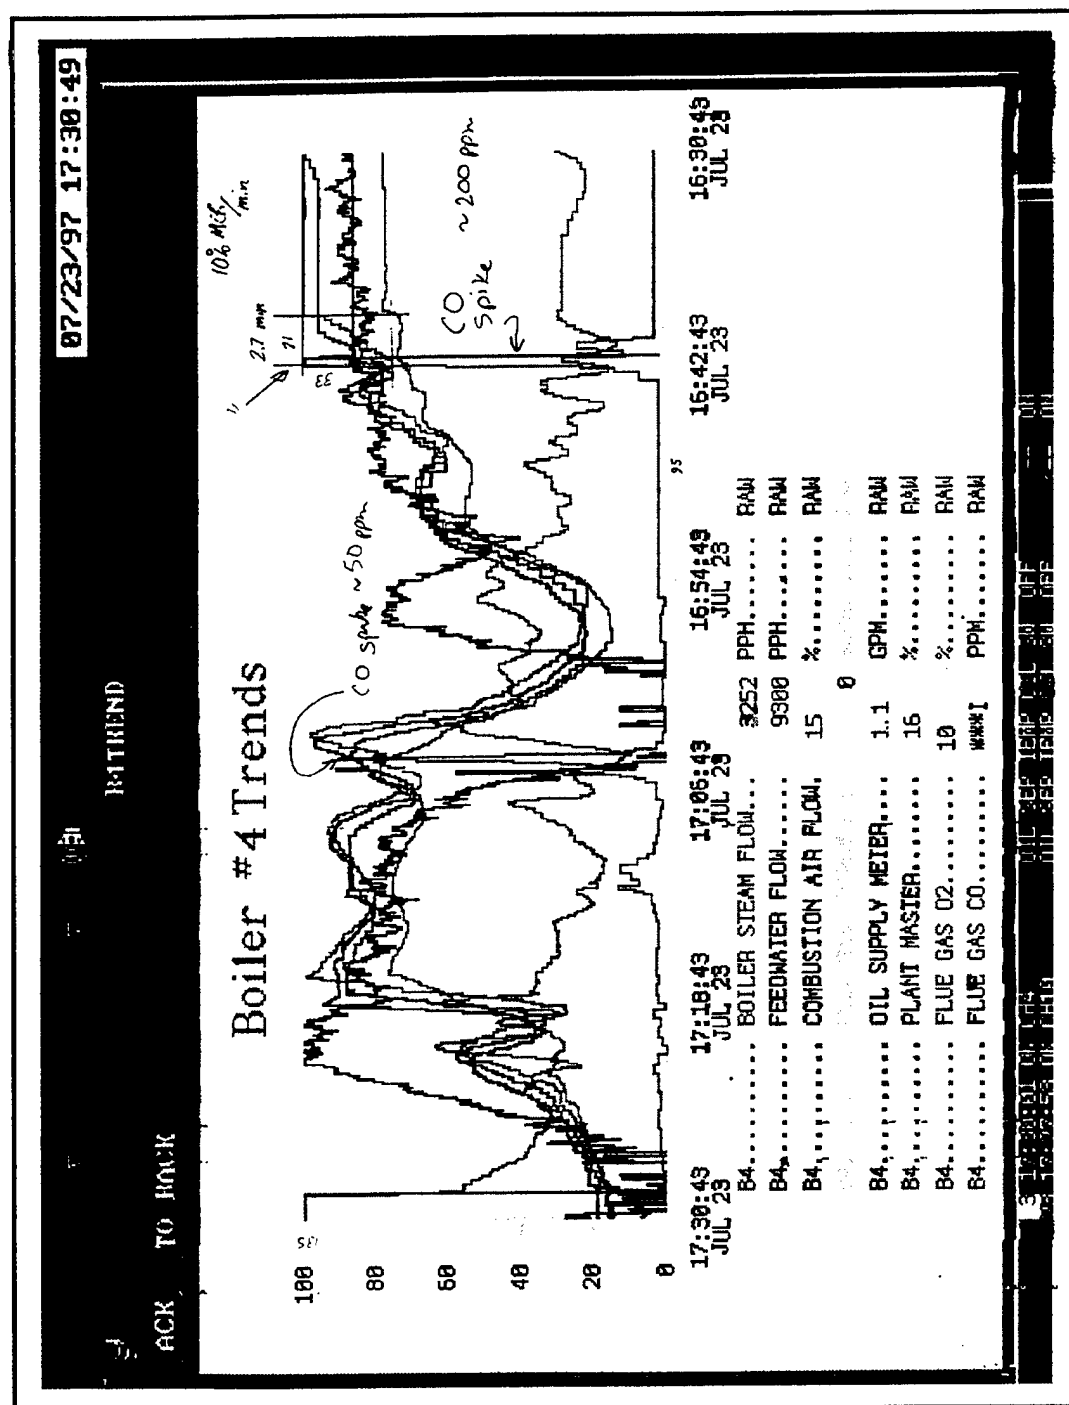
Figure 9. DCS printout showing boiler No. 4 trends.

The PRO letter also states that "unexpected carbon monoxide excursions were witnessed 7-9 May 1997 which were possibly due to DCS communications failure." When operating above the turndown limit of 6 to 1, the burners performed satisfactorily. On 23 July 1997, when changing the steam load manually at very high rates (greater than 10 percent Max Continuous Rating [MCR] per minute), there were two CO excursions above 50 PPM when near full load followed by dropping load quickly. (Figure 9 shows the DCS printout.) It was not clear to the team why the excursions occurred under these abnormal operating conditions. Although the load change was abnormal, a parallel metered control system should have been able to handle that change. The control system did respond to the excursion appropriately and increased air to quickly reduce the CO levels. The fuel train may need closer examination to precisely identify the cause of the CO excursion. The control system characteristic curve may need adjustment. For an unknown reason at 16:40 on 23 July, the controls let the fuel valve remain fully open for 30 to 60 seconds after the airflow was being reduced. It appears that the control system ruled that the airflow was so excessive that the fuel did not need to be reduced until the airflow signal had dropped significantly. One factor may be that the fuel oil supply pressure was increased slightly to try to reach full load. The burner did perform safely under normal load transients. However, if the current airflow-metering scheme is used, the team has recommended that the control system characteristic curve be inspected and recalculated.

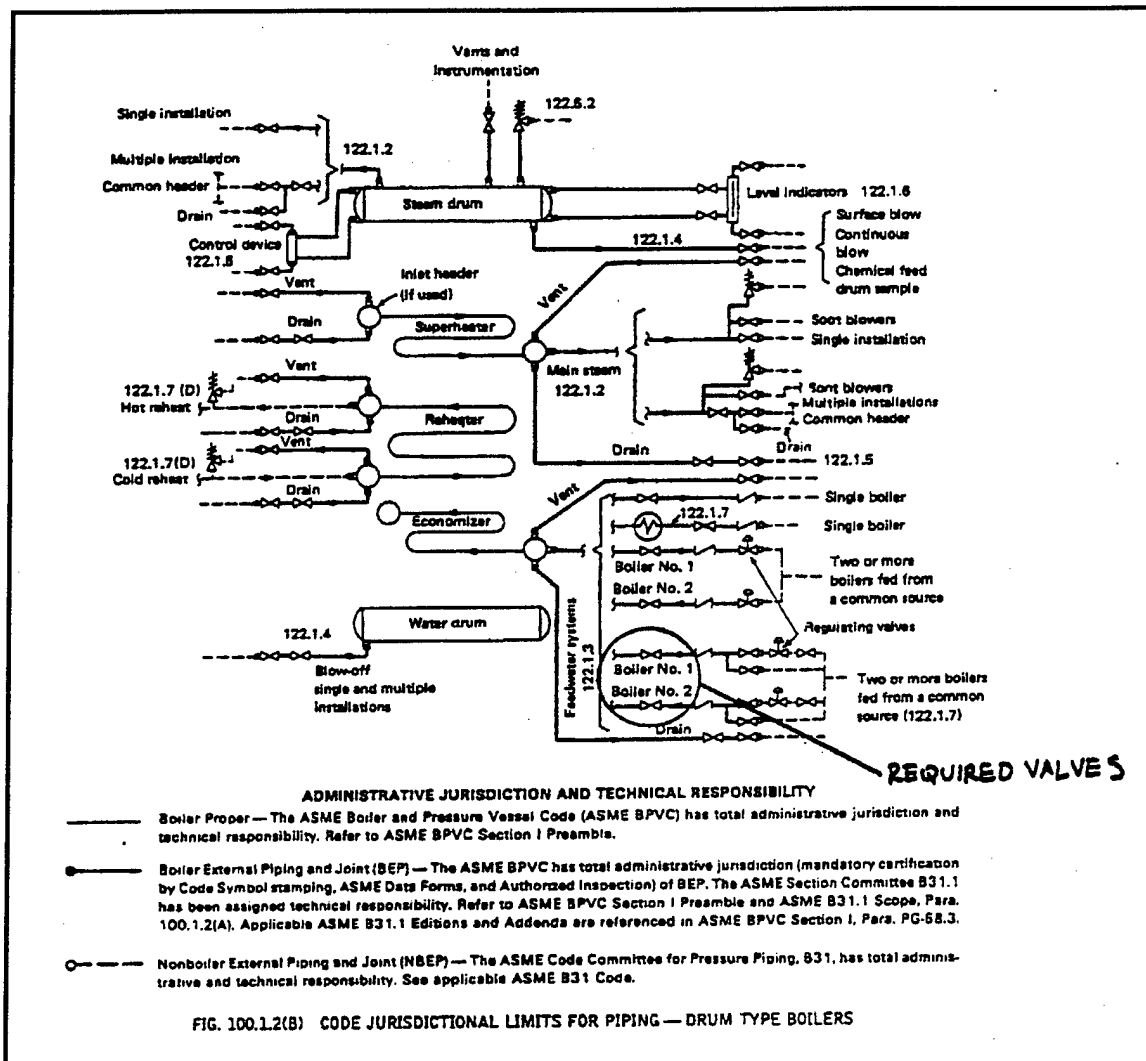
Figure 10. ASME Code B31.1, Fig 100.1.2(B).

- An ASME Boiler and Pressure Vessel required valve is missing in the feedwater piping. Figure 10 shows ASME Code B31.1, Fig 100.1.2(B). There should be a stop valve isolation valve between the check valve downstream of the feedwater regulation station check valve and the economizer.
