# NORTH BASE REHABILITATION STUDY

## EDWARDS A.F.B., CALIFORNIA

SEPTEMBER 1990

**Prepared By U.S. Army Corps Of Engineers**  
**Omaha, Nebraska**

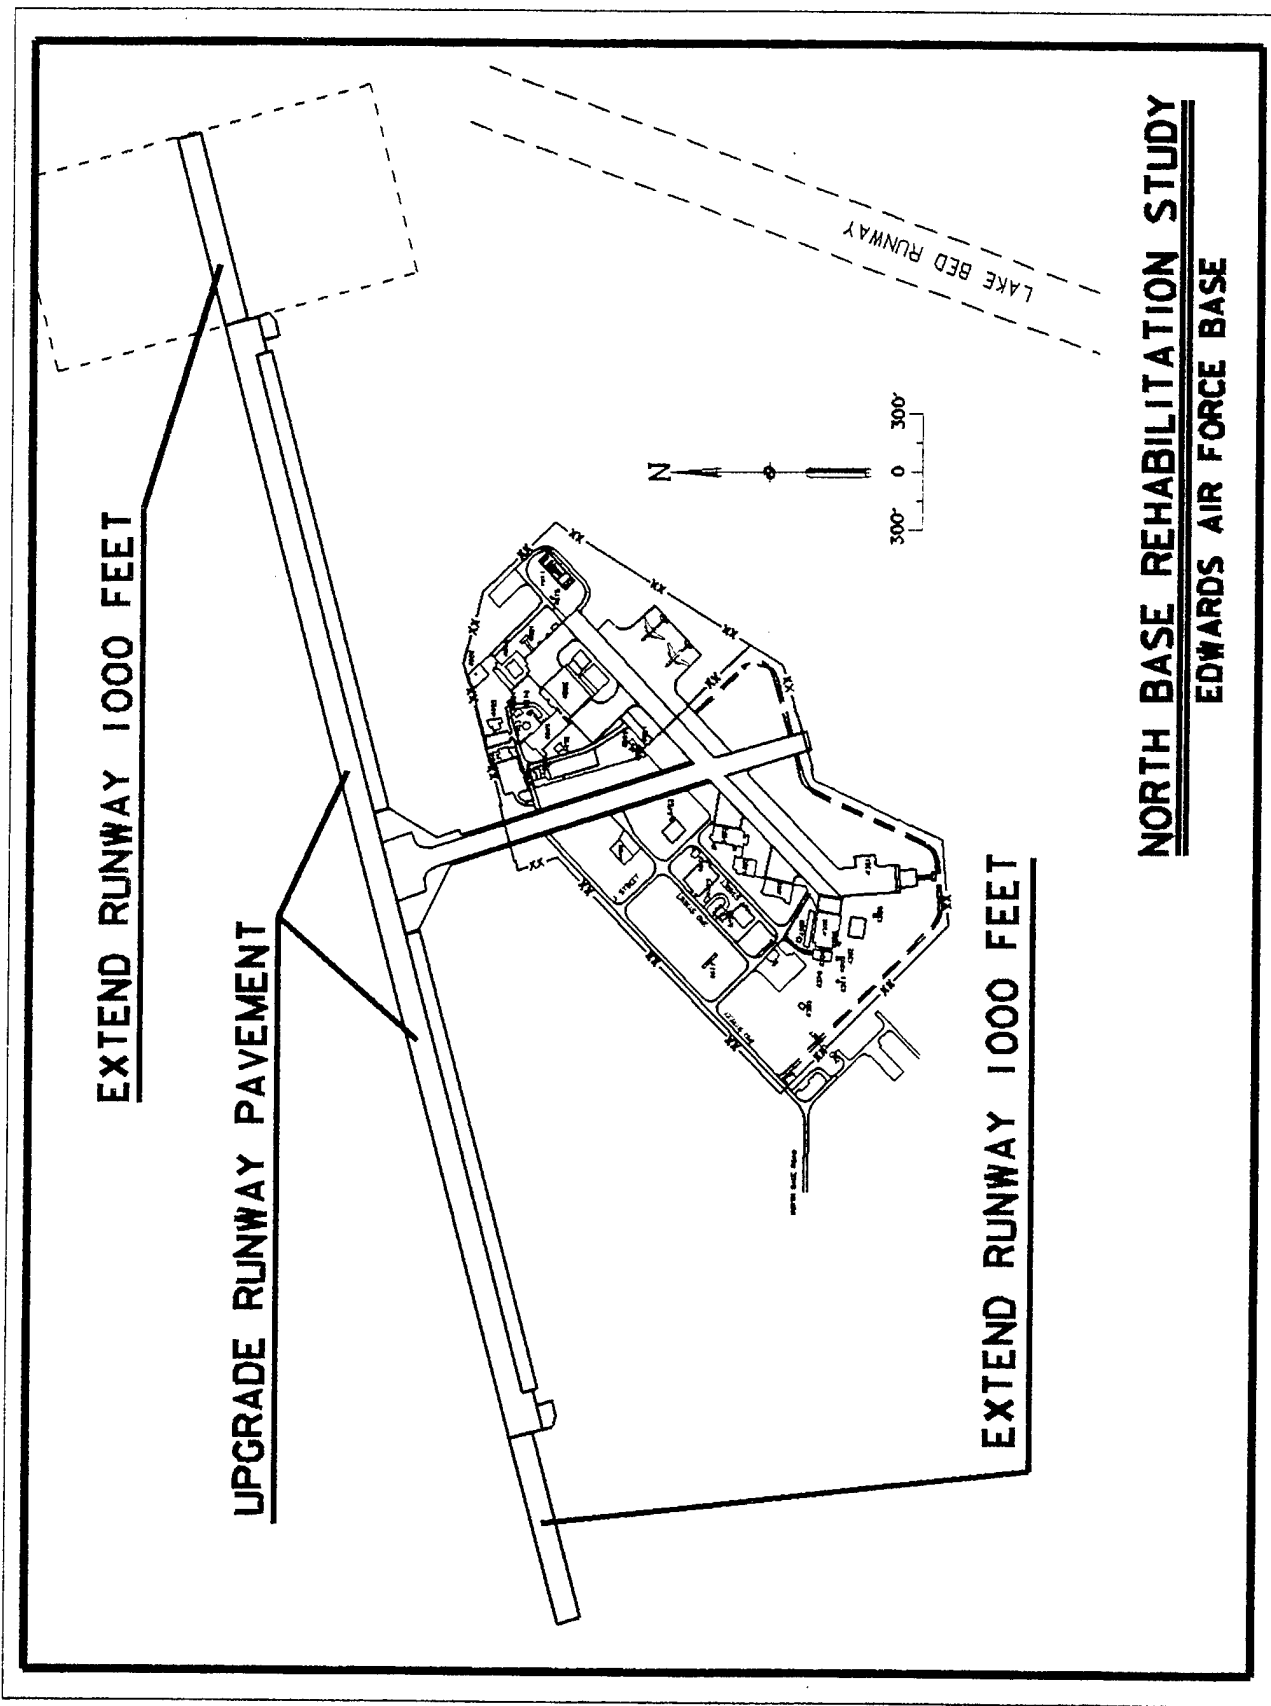
Figure 1 : Location Plan For Extend & Upgrade Runway

- Remove & replace runway lights.
- Remove & replace lighting vault, Building 4452.

- Extend runway 1000 feet on each end.

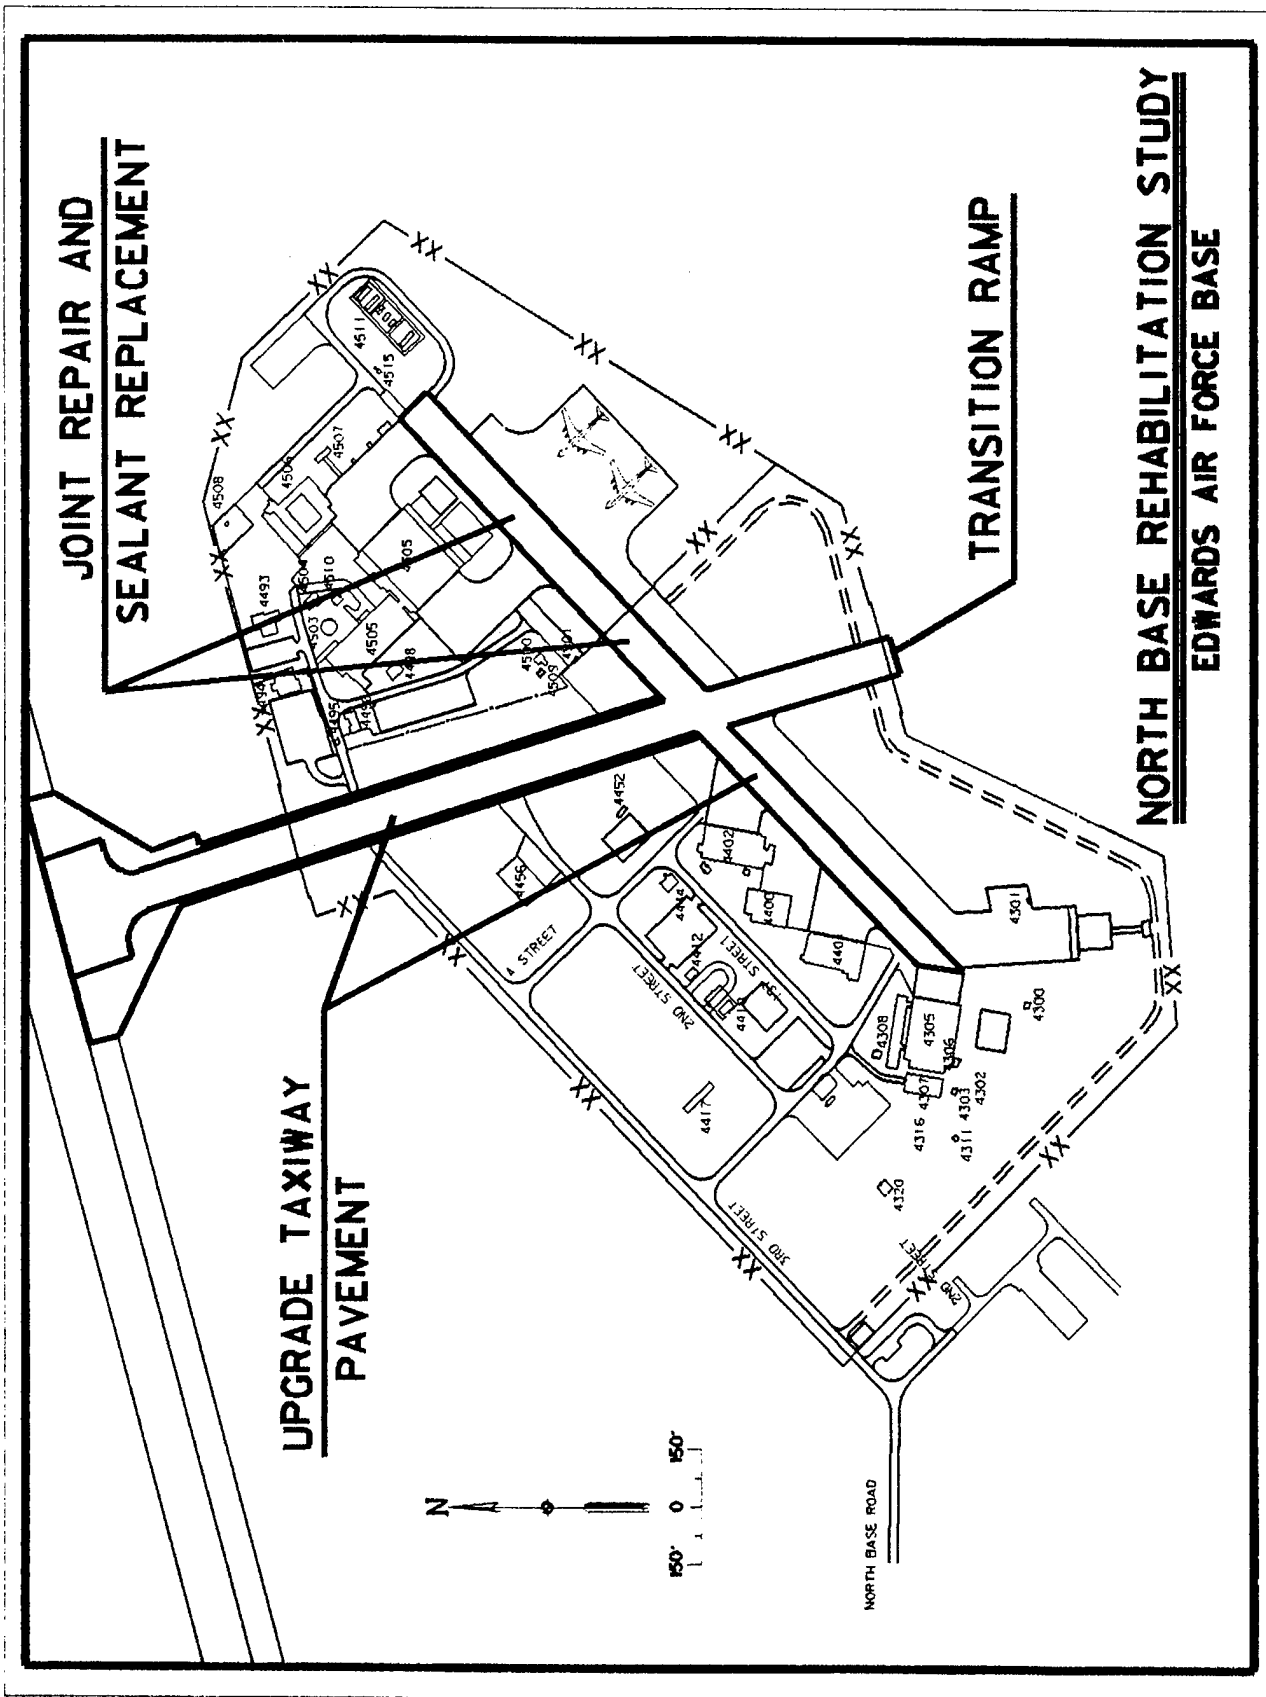
Figure 2 : Location Plan For Upgrade Taxiways

exception of the taxiway leading to and within the compound of Building 4505. This portion of the taxiway has sufficient thickness for the proposed upgrade mission. Replacement of the joint sealant and surface repairs to the transverse joints are recommended. The rigid pavement of the taxiway at the intersection of the runway will be removed and replaced with 11 inches of new Portland cement concrete on grade. The flexible pavement portion of the taxiway has had a surface treatment application applied in recent years and has cracking throughout. As with the runway category the four pavement options were evaluated for their applicability to the taxiways.

- Remove & replace lights on main taxiway.
- Provide taxiway lights in front of Buildings 4305, 4401 & 4402.
- Provide taxiway lights in front of Building 4505.

- Upgrade main taxiway with one of four options:
- Upgrade taxiway in front of Buildings 4305, 4401 & 4402.
- Upgrade taxiway in front of Building 4505.
- Remove & replace drainage structures.

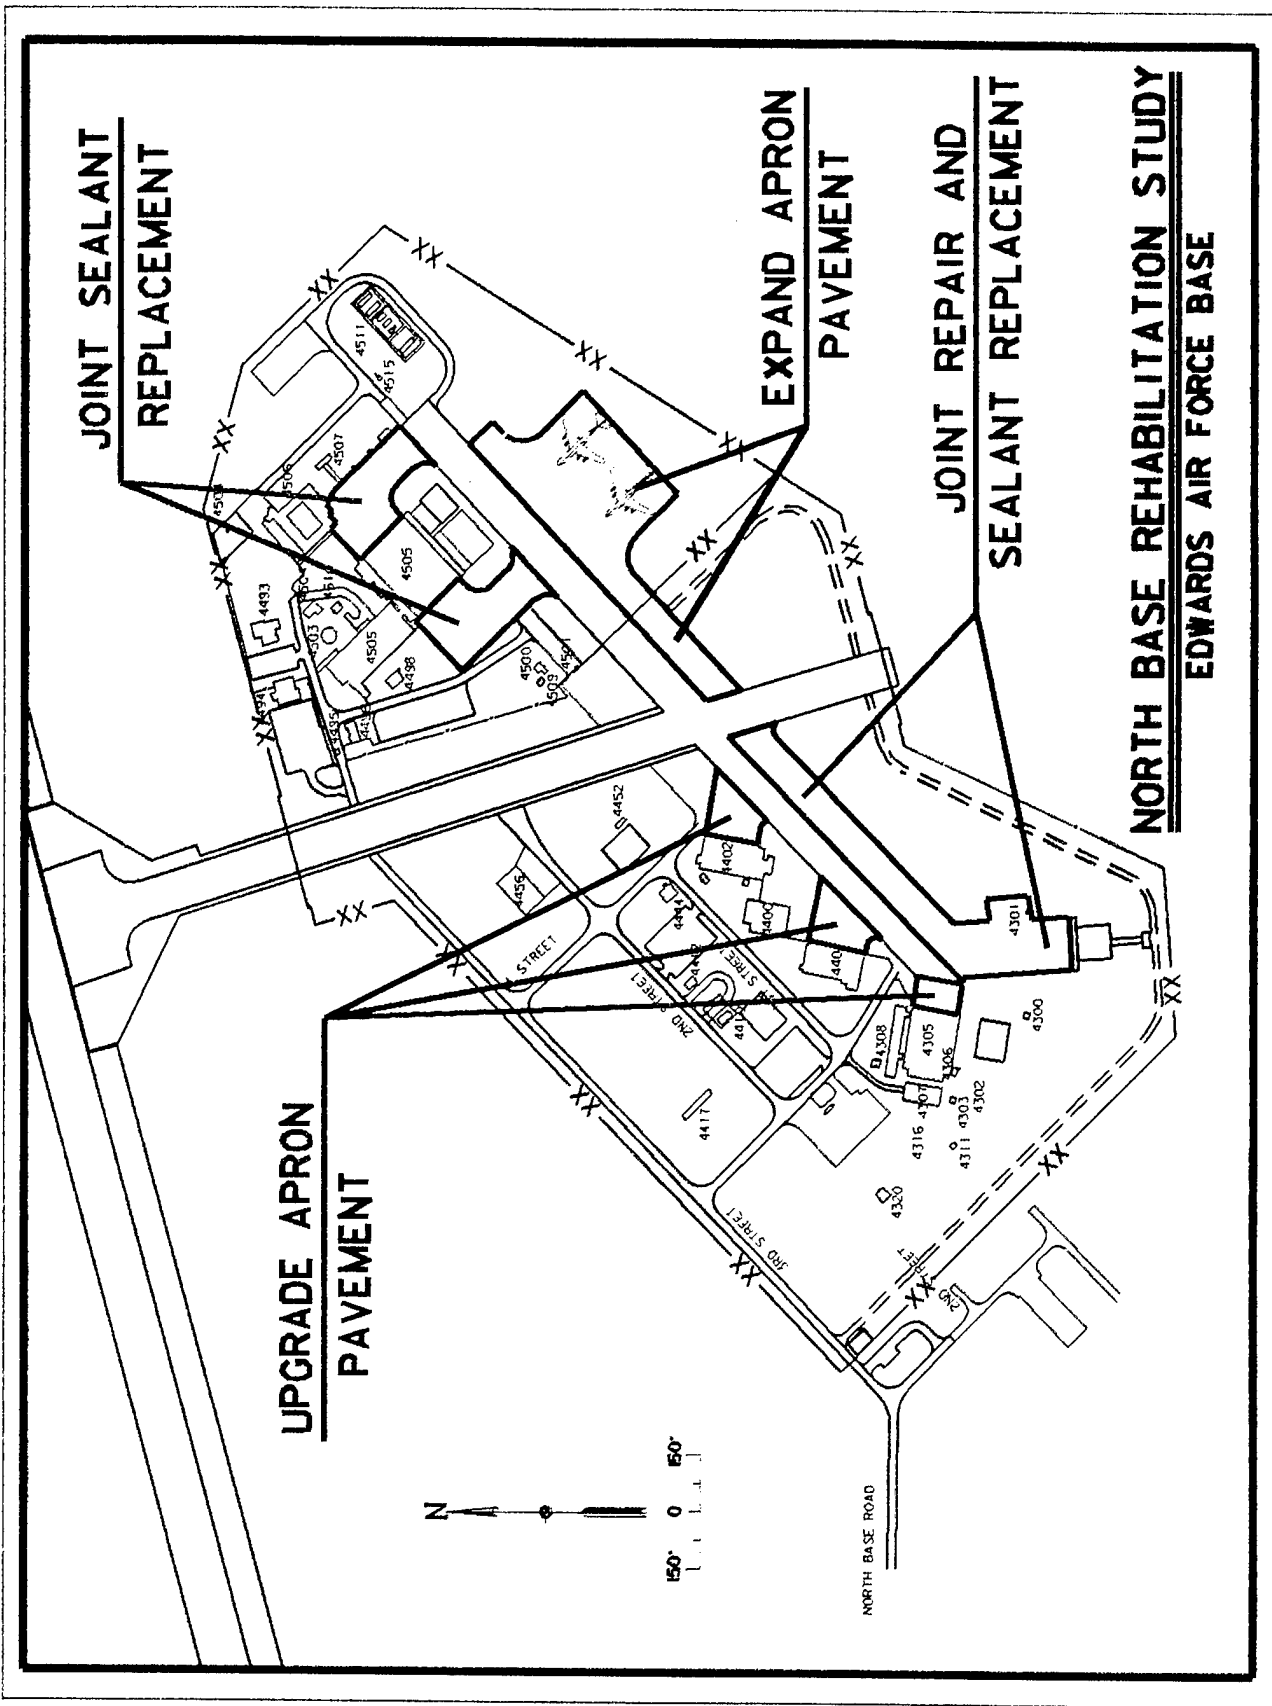
Figure 3 : Location Plan For Expand & Upgrade Apron

All aprons have deficient AGL's for the proposed upgrade mission with the exception of Building 4505. The aprons on each side of Building 4505 have sufficient thickness but will require joint sealant replacement. The apron transition slabs to the entrance of each side of the hangar will require removal and replacement. The apron running parallel to Buildings 4401, 4402, and 4305 has adequate thickness and will require only minor joint repair and joint sealant replacement. The remainder of the

The expanded apron area is within the compound of and to the south of Building 4505. Presently the apron consists of flexible pavement and has large block cracking and vegetation growing in the cracks throughout the entire area. The apron will be enlarged to accommodate parking for two C-141 aircraft. It is recommended to use 10.5 inches of rigid pavement for Type B traffic on this apron. All evaluations, with the exception of the expanded parking apron were performed in accordance with the referenced AFM's in paragraph: Upgrade Runway.

**3. Upgrade Aprons:** The recommended option for the aprons and apron extension areas is Option 3. This recommendation is based upon the following reasons:

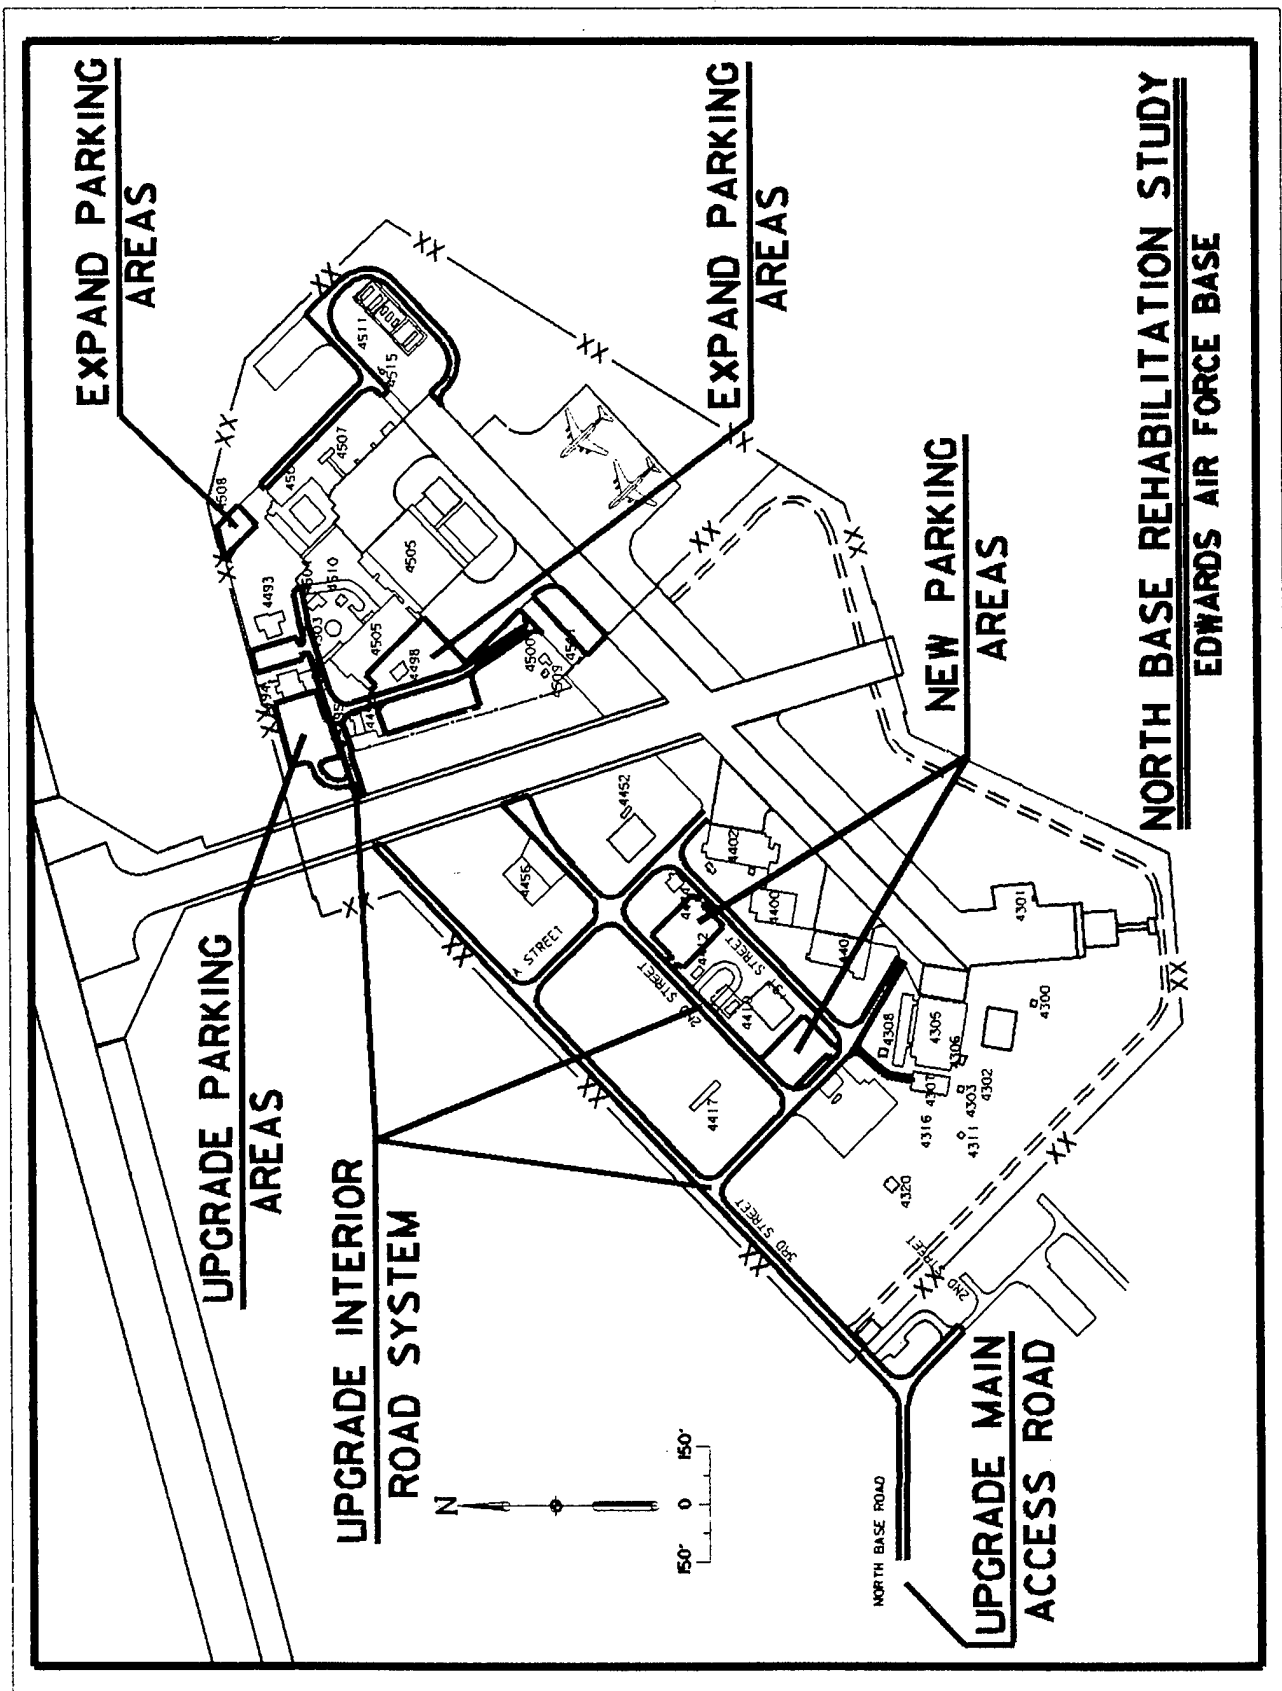
Figure 4 : Location Plan For Roads And Parking

The interior road system is deteriorating due to age and lack of maintenance. Portions of the existing road network are no longer discernible. Most of the roads are not wide enough to accommodate two-way traffic. Removal and replacement of some of these roads will be required for the desired level of service. For the purpose of this evaluation, all roads to be removed and replaced have been assumed to be Class E - two lane roads with an Average Daily Traffic (ADT) of 170 to 1800 vehicles and a Design Hour Volume (DHV) of 21 to 220 vehicles. The proposed

The existing parking area west of Building 4410 is in poor condition. Large areas of subsurface failure were encountered during the field investigation. Removal and replacement will be required for the desired level of service. The removal of the existing pavement section will consist of removing 3 inches of bituminous surface course along with 8 inches of base course material. The replacement pavement section will consist of 1-1/2 inches of bituminous surface course, 1-1/2 inches of bituminous intermediate course, 4 inches crushed aggregate base course, and 4 inches granular filter course. New concrete curb stops will be provided for the perimeter parking stalls and pavement markings will also be provided.

- Rebuild main access road from Rosamond Avenue to existing entry control point, Bldg.4495.
- Remove and replace interior road system.
- Construct new access roads for interior road system.
- Rebuild existing parking area north of existing entry control point, Bldg. 4495.
- Remove and replace parking area west of Bldg. 4410.
- Construct additional parking areas for a total population of 500 people at 70% usage (350 parking stalls).
- Upgrade storm drainage system.
- Removal of existing building foundations, smokestacks and miscellaneous pavements.

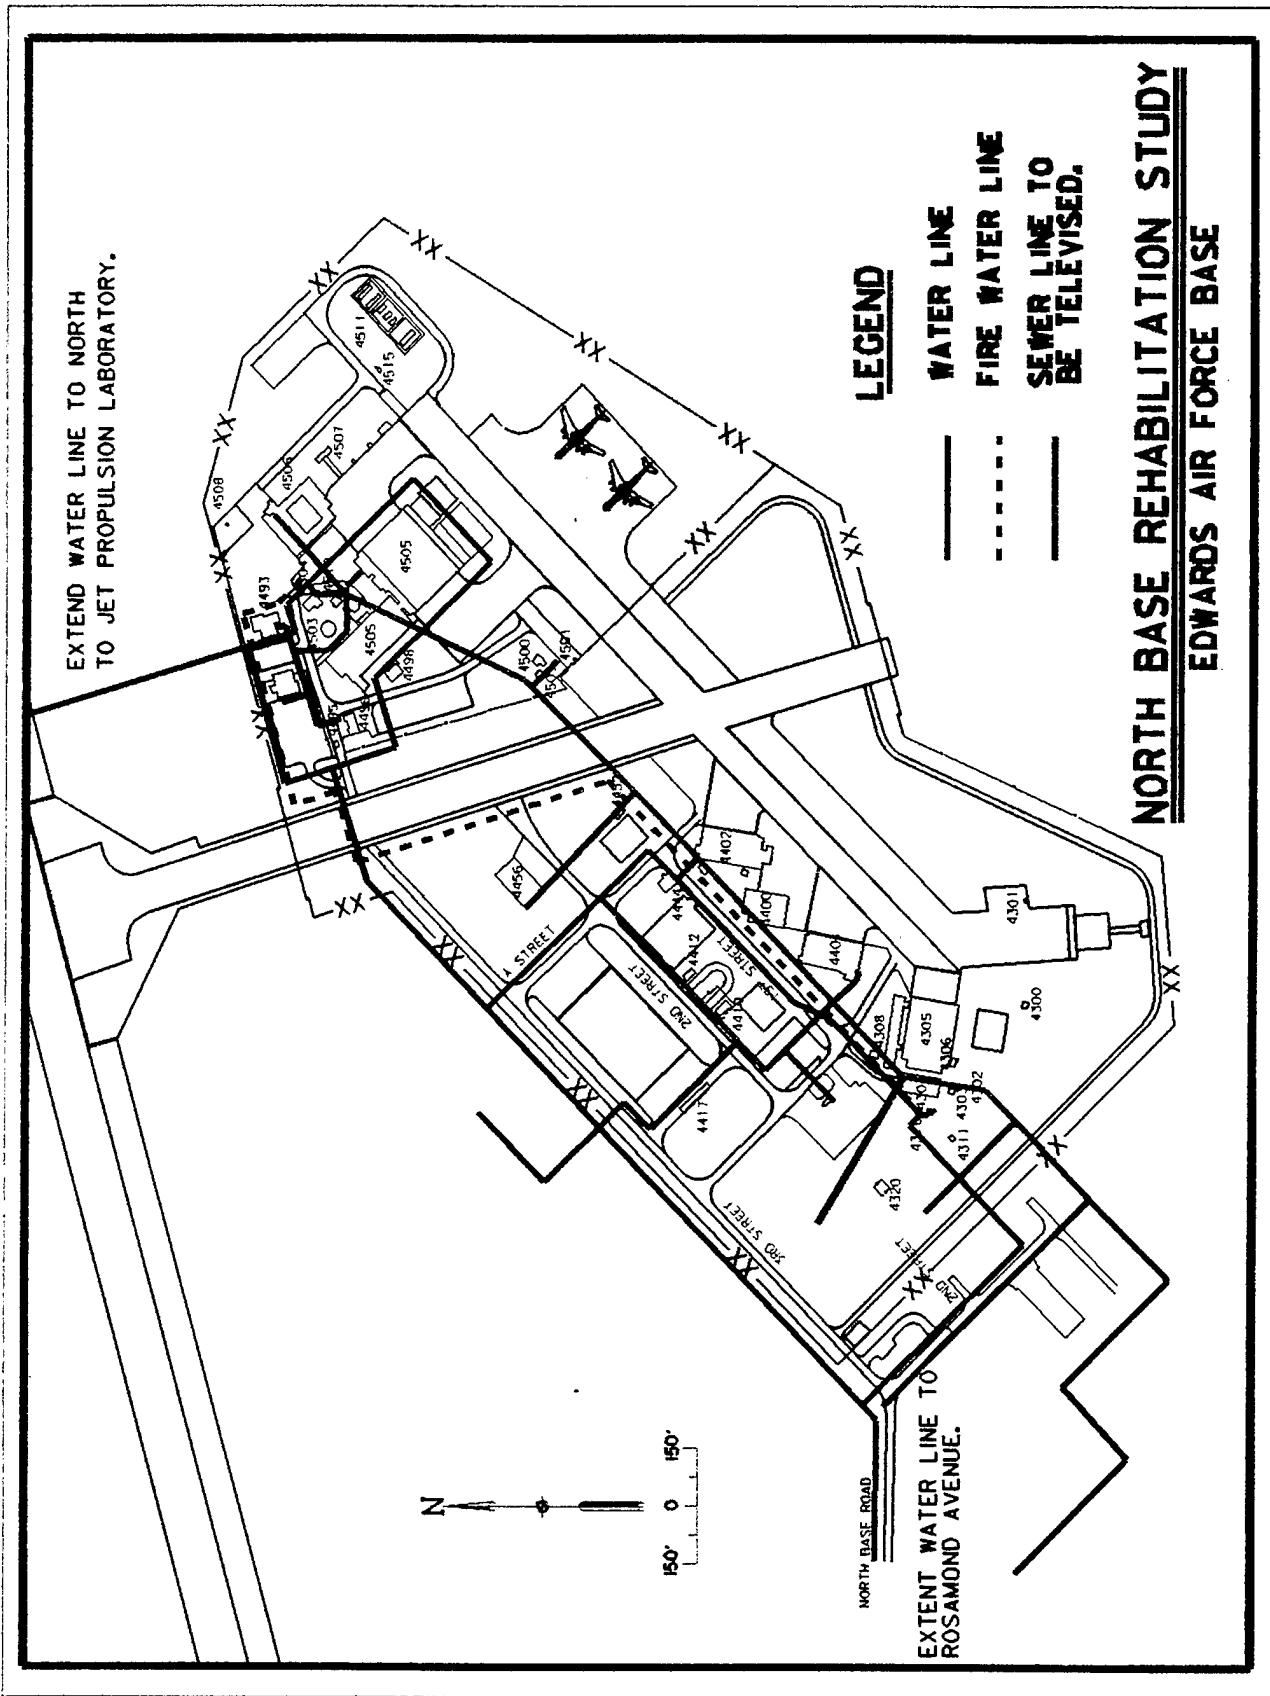
Figure 5 : Location Plan For Utilities ( Water And Sewer )

The existing domestic water system in the North Base is approximately 30 to 40 years old. The majority of the water lines are unprotected steel pipe, that have exceed their useful life expectancy. Numerous leaks and failures have developed in recent years. The system supplies the North Base Area through one six inch supply line located along the North Base Road. The system is capable of providing only 400 gpm @ 20 psi, but has a static pressure of 105 psi. This system does not meet Air Force requirements as listed in Military Handbook 1008 which requires a minimum fire hydrant flow capacity for unsprinklered facilities of 750 gpm at 20 psi.

Currently the existing Imhoff tank and evaporation ponds do not meet the Kern County regulatory requirements. The existing Imhoff tank is proposed to be removed and replaced with a mechanical primary and secondary treatment system. The existing evaporation ponds will be upgraded with concrete rubble, for rip-rap.

- Remove & replace water line serving Buildings 4305, 4401 and 4402.
- Remove Buildings 4316 & 4317.
- Construct 14" fire water main behind Buildings 4305, 4401 and 4402.
- Remove & replace fire water pumps in Building 4504.

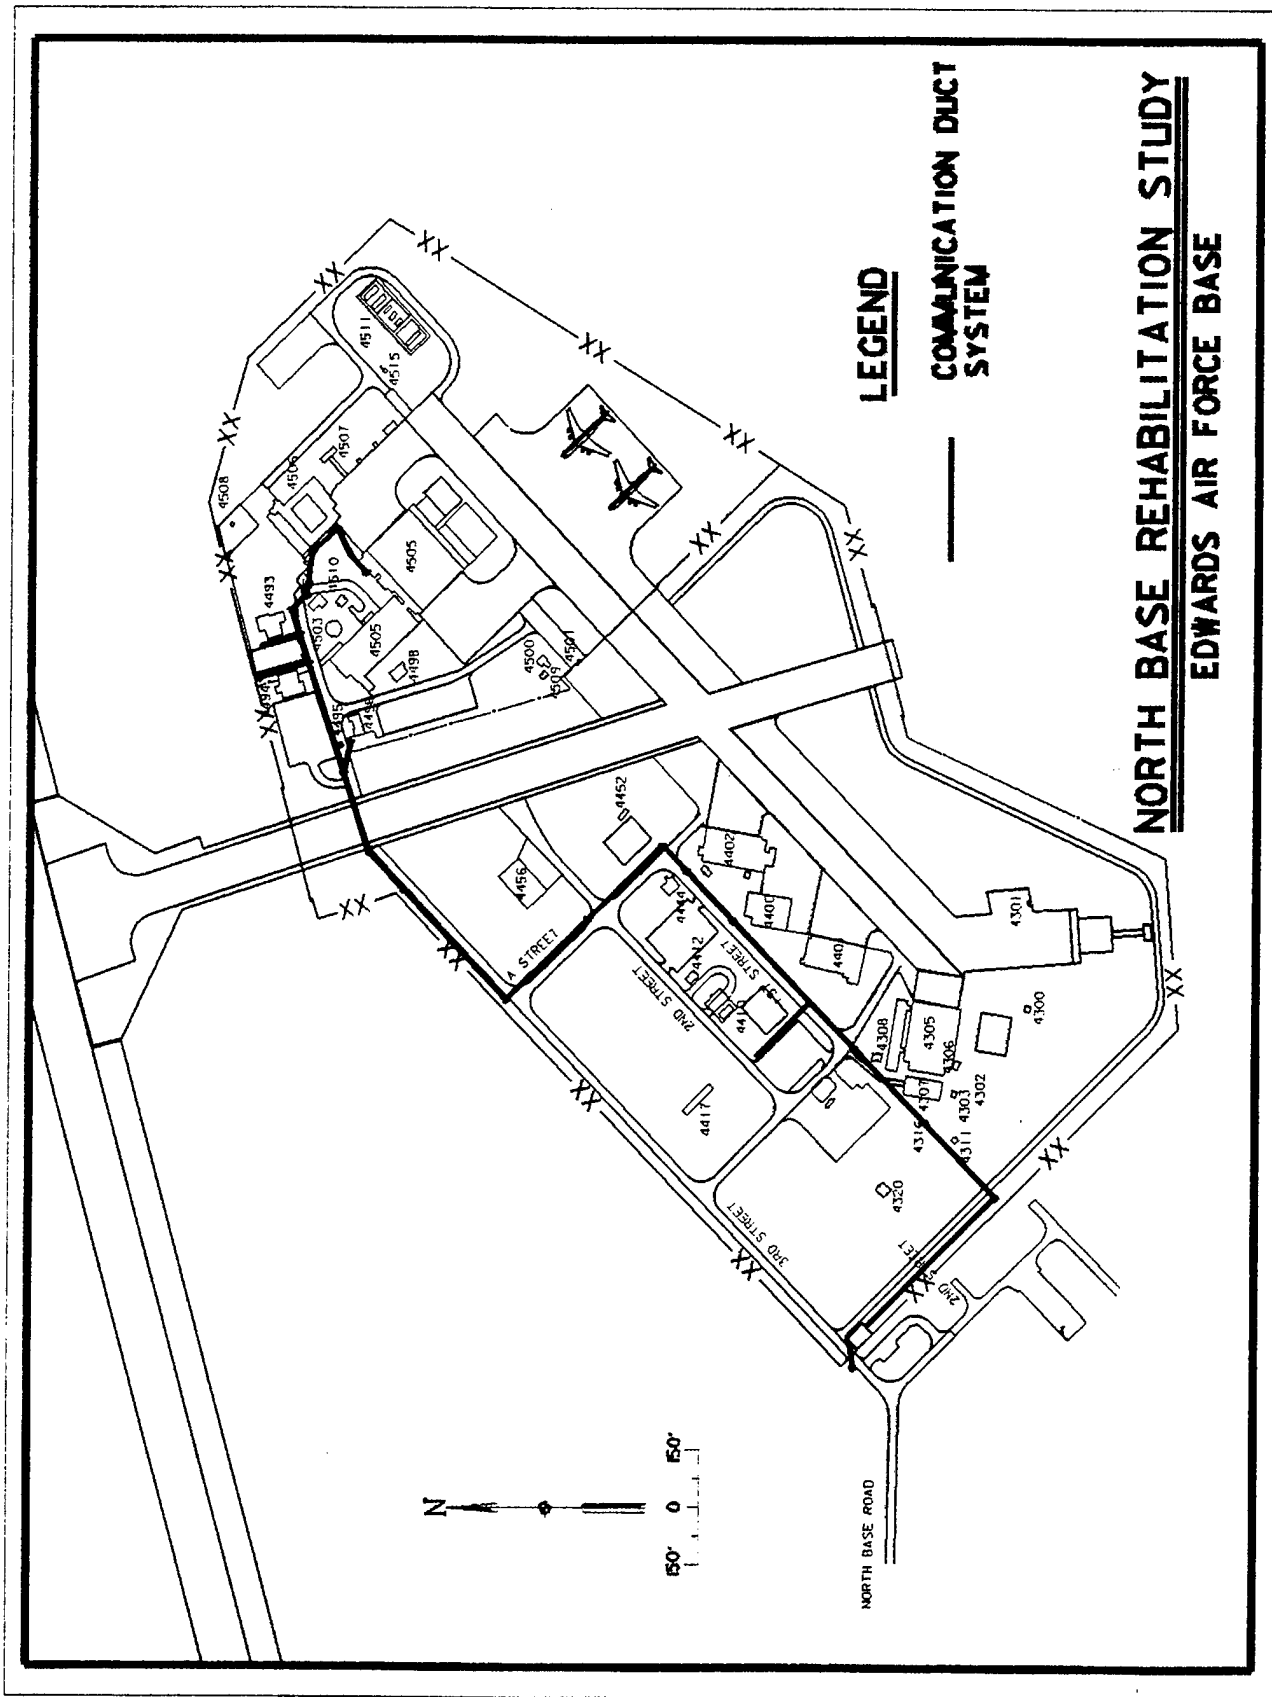
Figure 6 : Location Plan For Utilities  
( Electrical & Communications )

The present communication distribution system is inadequate to support the upgrade to the complex. The present system represents a mixture of additions and minor upgrades, which makes the system difficult to maintain. In addition, the present distribution starts at a facility located in the heart of the complex, which presents an inconvenience to security personnel when maintenance is required. A completely new communication/security distribution system is required in the

complex. Both systems would start from the new entry control point and extend throughout the complex. The new system would consist of manholes and nonconcrete encased duct lines.

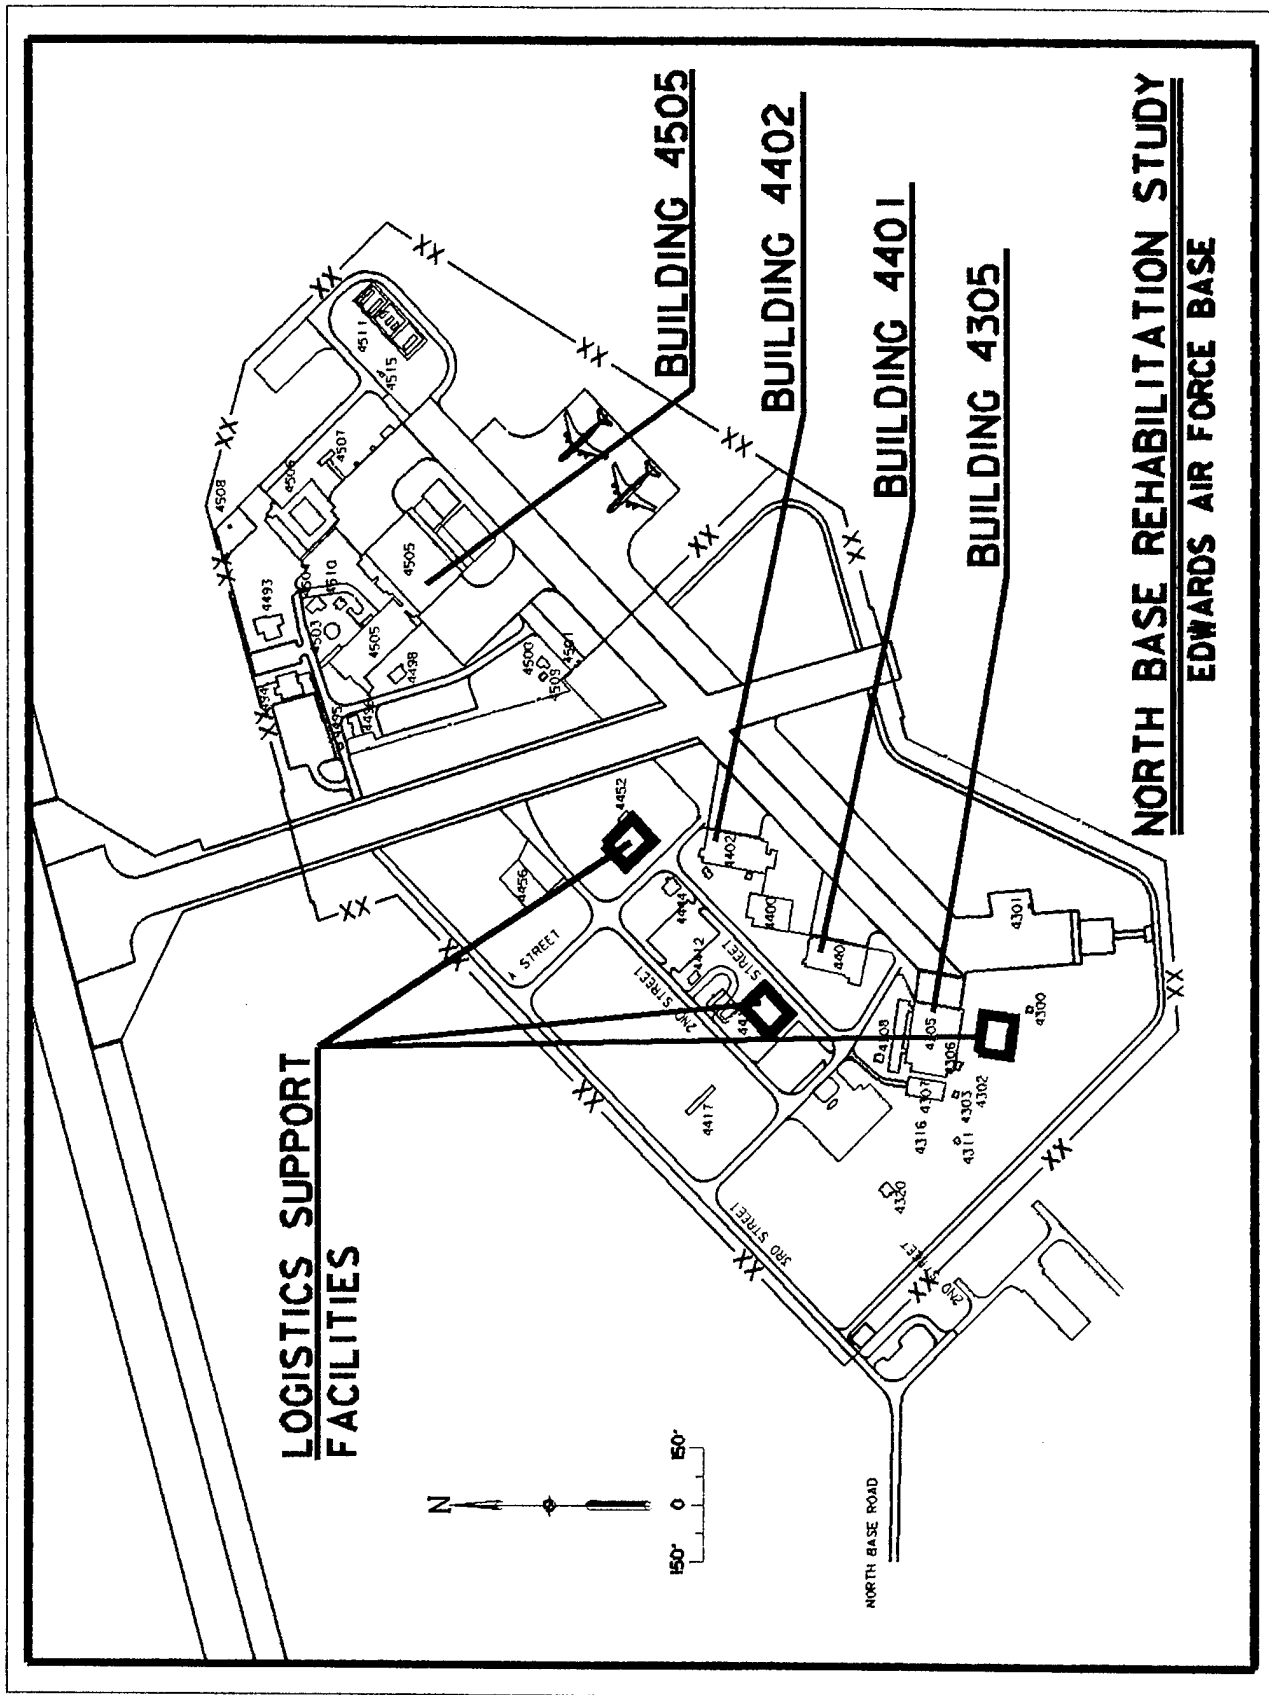
Figure 7 : Location Plan For Upgrade Buildings  
 ( Hangars-Existing)

The hangar does not comply with current Air Force and NFPA regulations/standards regarding lightning protection. A lightning protection system will be provided. The existing static grounding system is inadequate and will be upgraded with additional static ground/tie down points.

The communication/security system will be removed and replaced as necessary in order to be compatible with the communication/ security system upgrade for the entire complex.
