Technical Report REMR-CS-63  
September 1999

## **Repair and Rehabilitation of Dams: Case Studies**

*by James E. McDonald, Nancy F. Curtis*

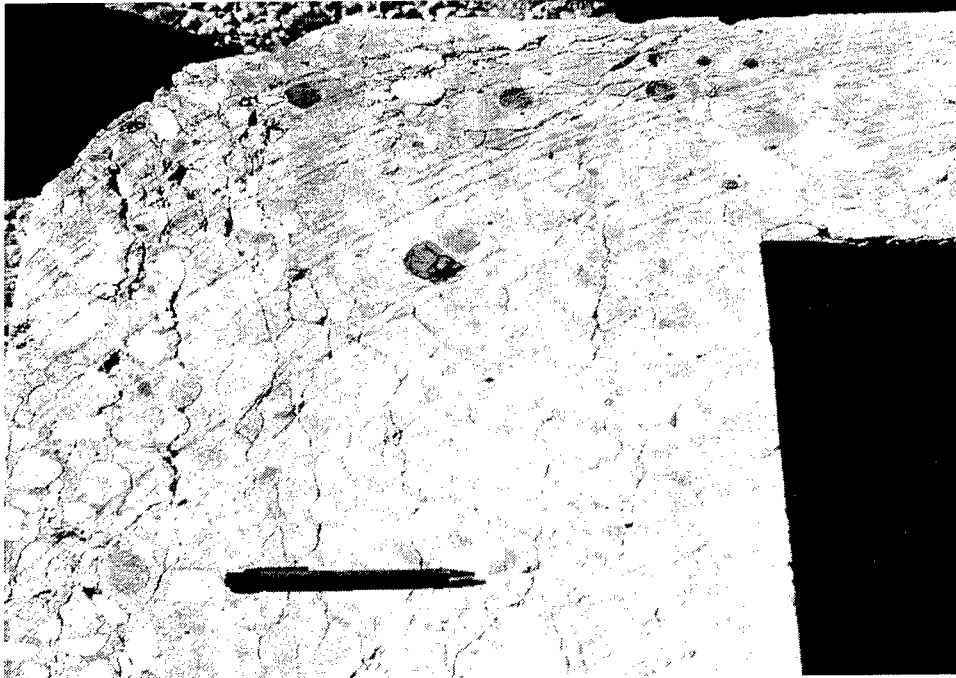
At the time of the Tenth Periodic Inspection (USAED, St. Louis 1997), the removal and replacement of columns on six of the eight bridge piers approved in the 1993 Major Rehabilitation Report were underway. Two of the columns that support the service bridge at Pier 16 had been removed. The periodic inspection team examined them and found excessive cracking, especially toward the top of the columns (Figure 8a). Generally, the concrete in the columns was in poor condition (Figure 8b).

- a. Interior cracking in concrete on Pier 11 removed for replacement, Mississippi Lock and Dam No. 24 (from U.S. Army Engineer District, St. Louis 1997)

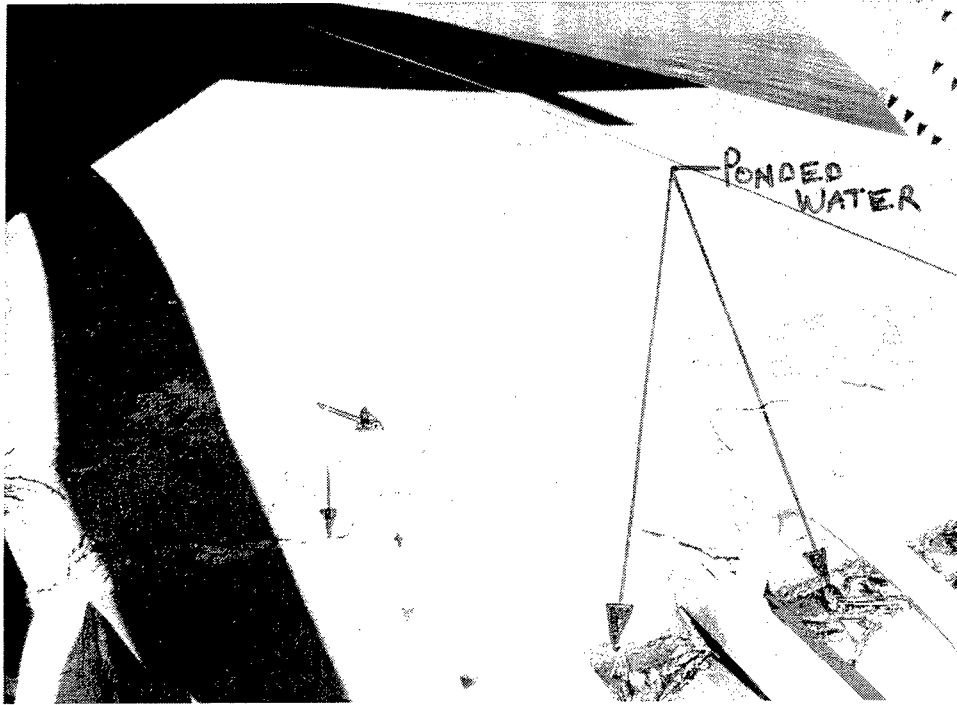
Figure 8c. Lower area of Pier 9 to be capped with floating concrete slab, Lock and Dam No. 24, Mississippi River (from U.S. Army Engineer District, St. Louis 1997)

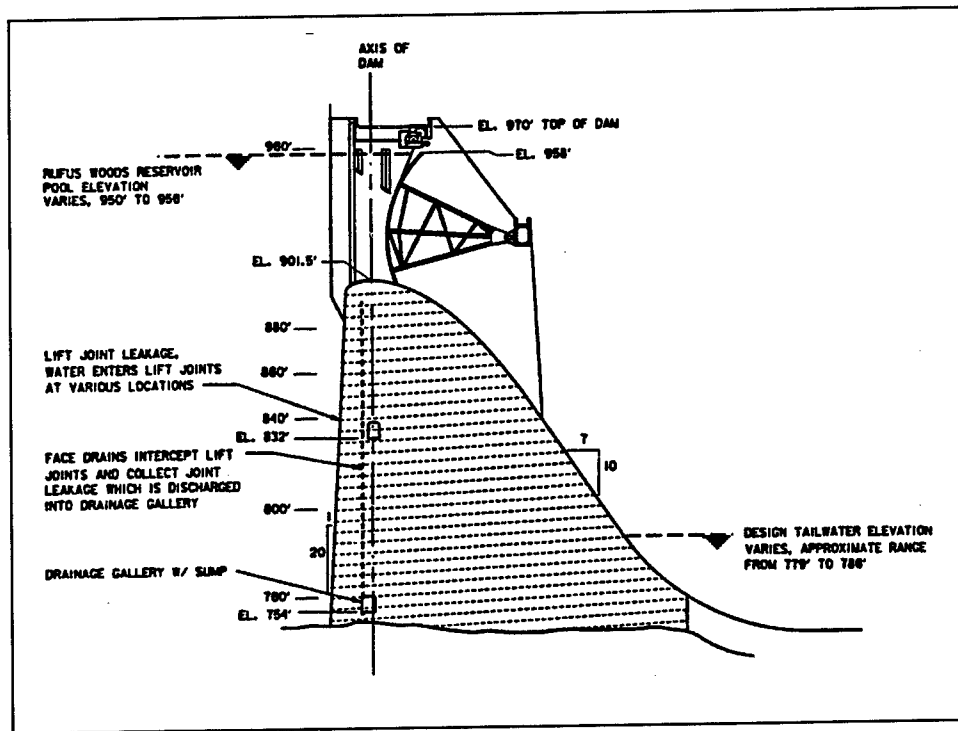
Figure 45. Monolith section showing leakage, Chief Joseph Dam (from Sondergard 1991a) (multiply feet by 0.3048 to obtain meters)

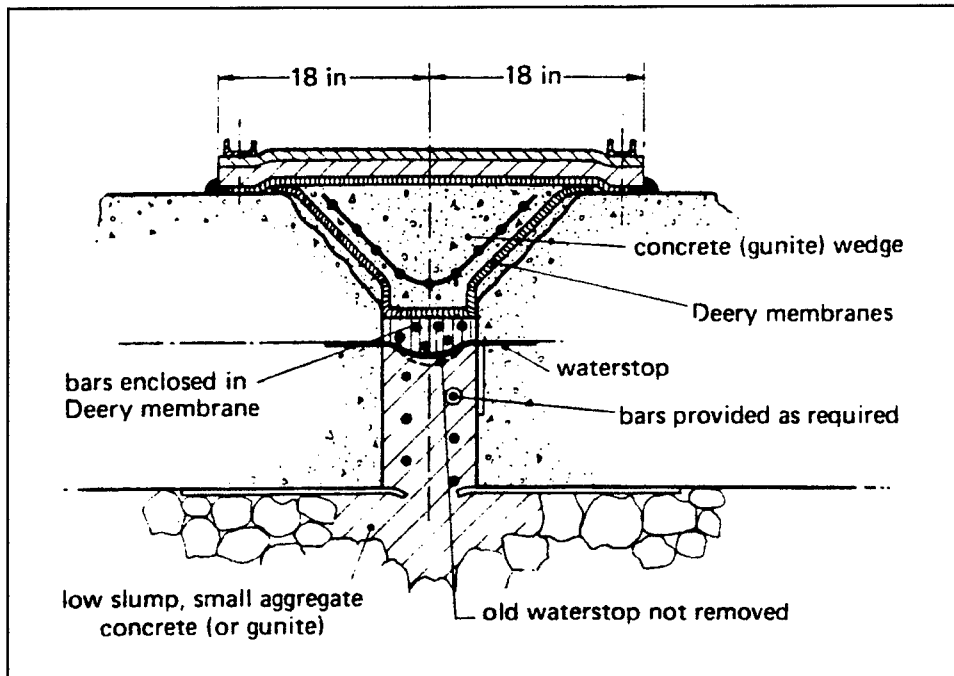
Figure 47. Details of repair for open, leaking joints at New Exchequer Dam (from Brown and Kneitz 1987)

To install the rubber joint covers, workers placed strips of Deery membrane over the shotcrete, then nitrile sheets and steel cover plates. Holes were drilled

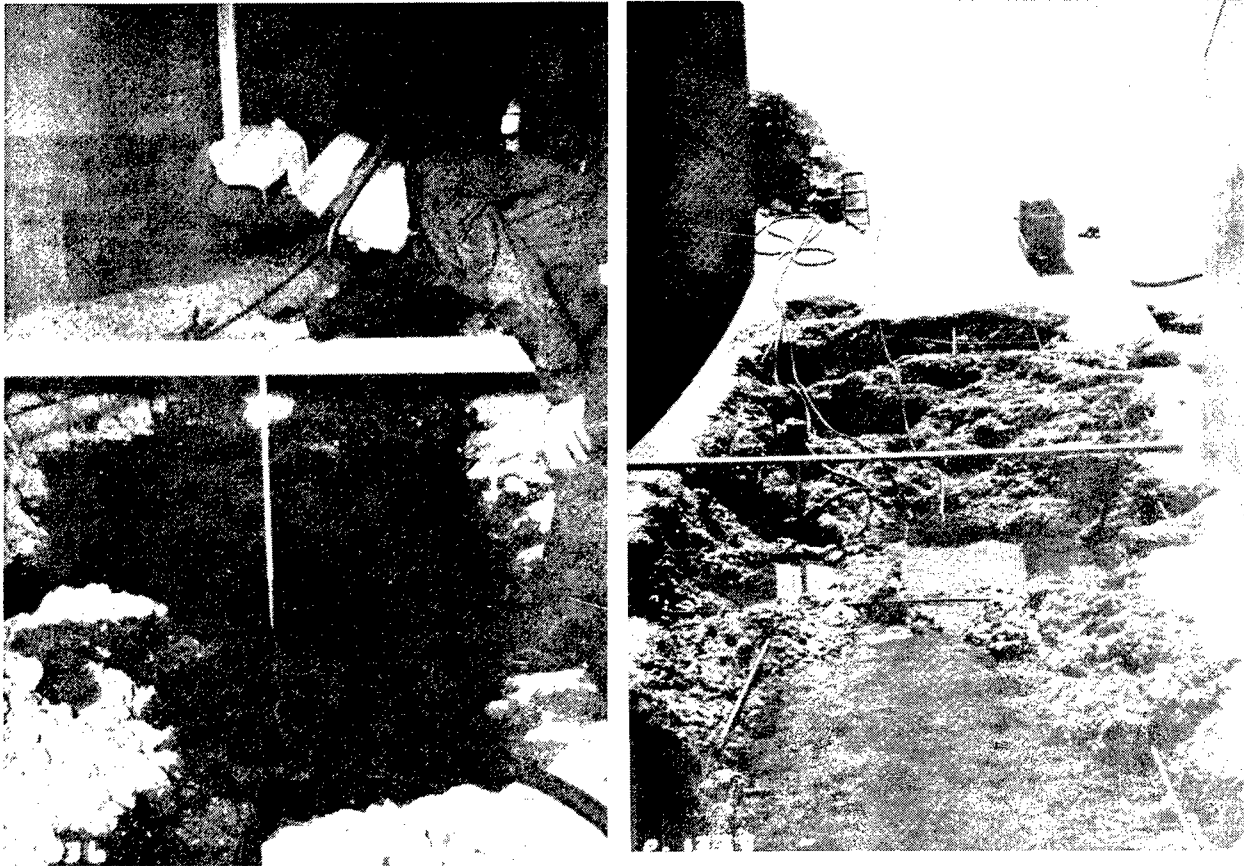
Figure 50. Upstream (left) and downstream views of cavitation in flip-bucket floor in channel no. 1, Luck Peak Dam (from U.S. Army Engineer District, Walla Walla 1983)

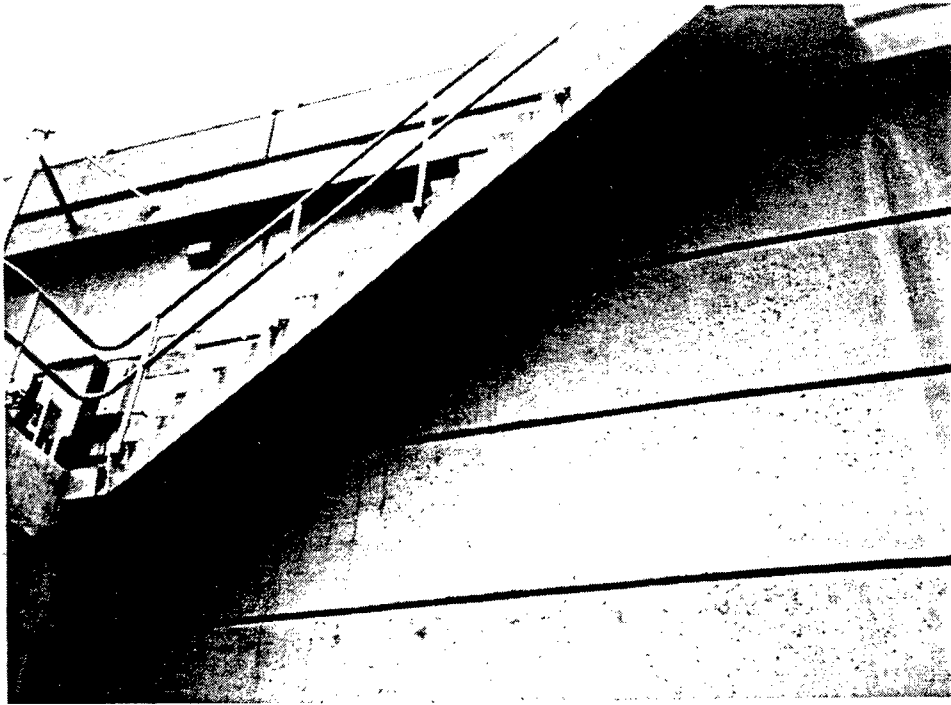
Figure 75. Bug holes on the upstream face of Stonewall Jackson Dam (from U.S. Army Engineer District, Pittsburgh 1989b)

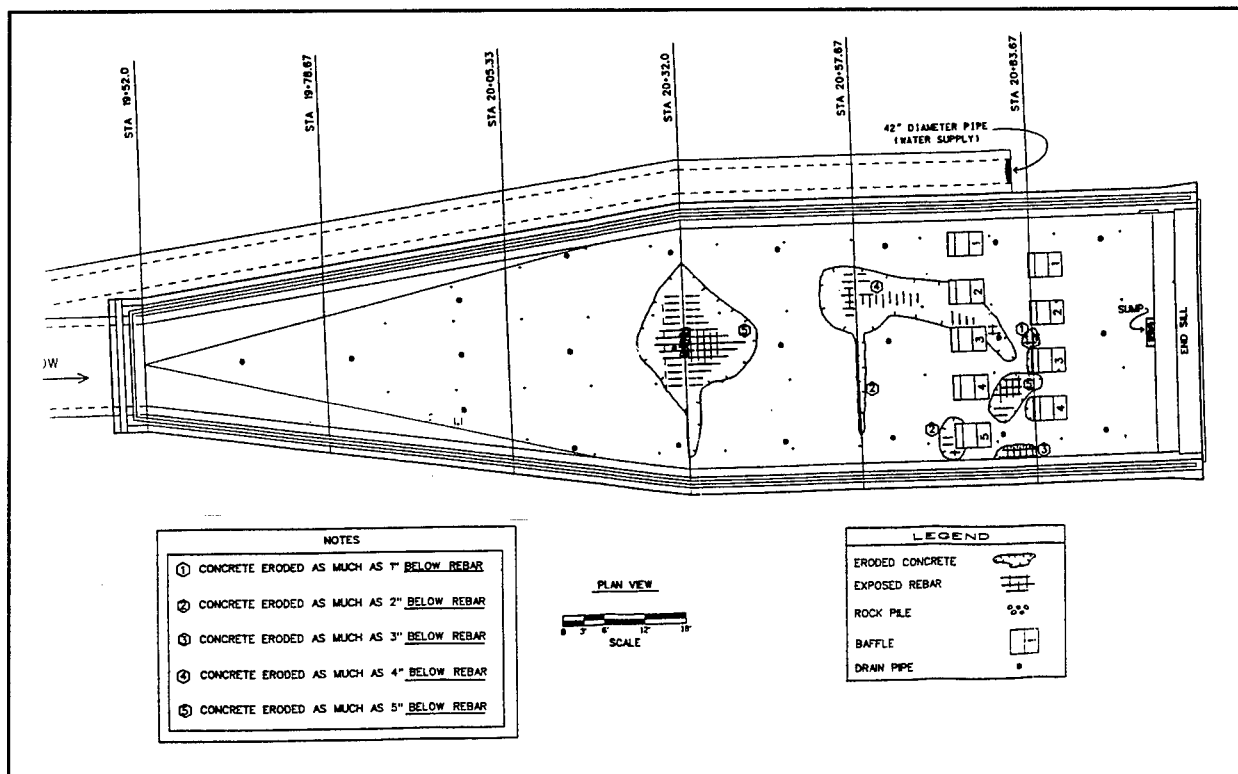
Figure 84. Condition of stilling basin at DeQueen Dam 1993 (from U.S. Army Engineer District, Little Rock 1997a)

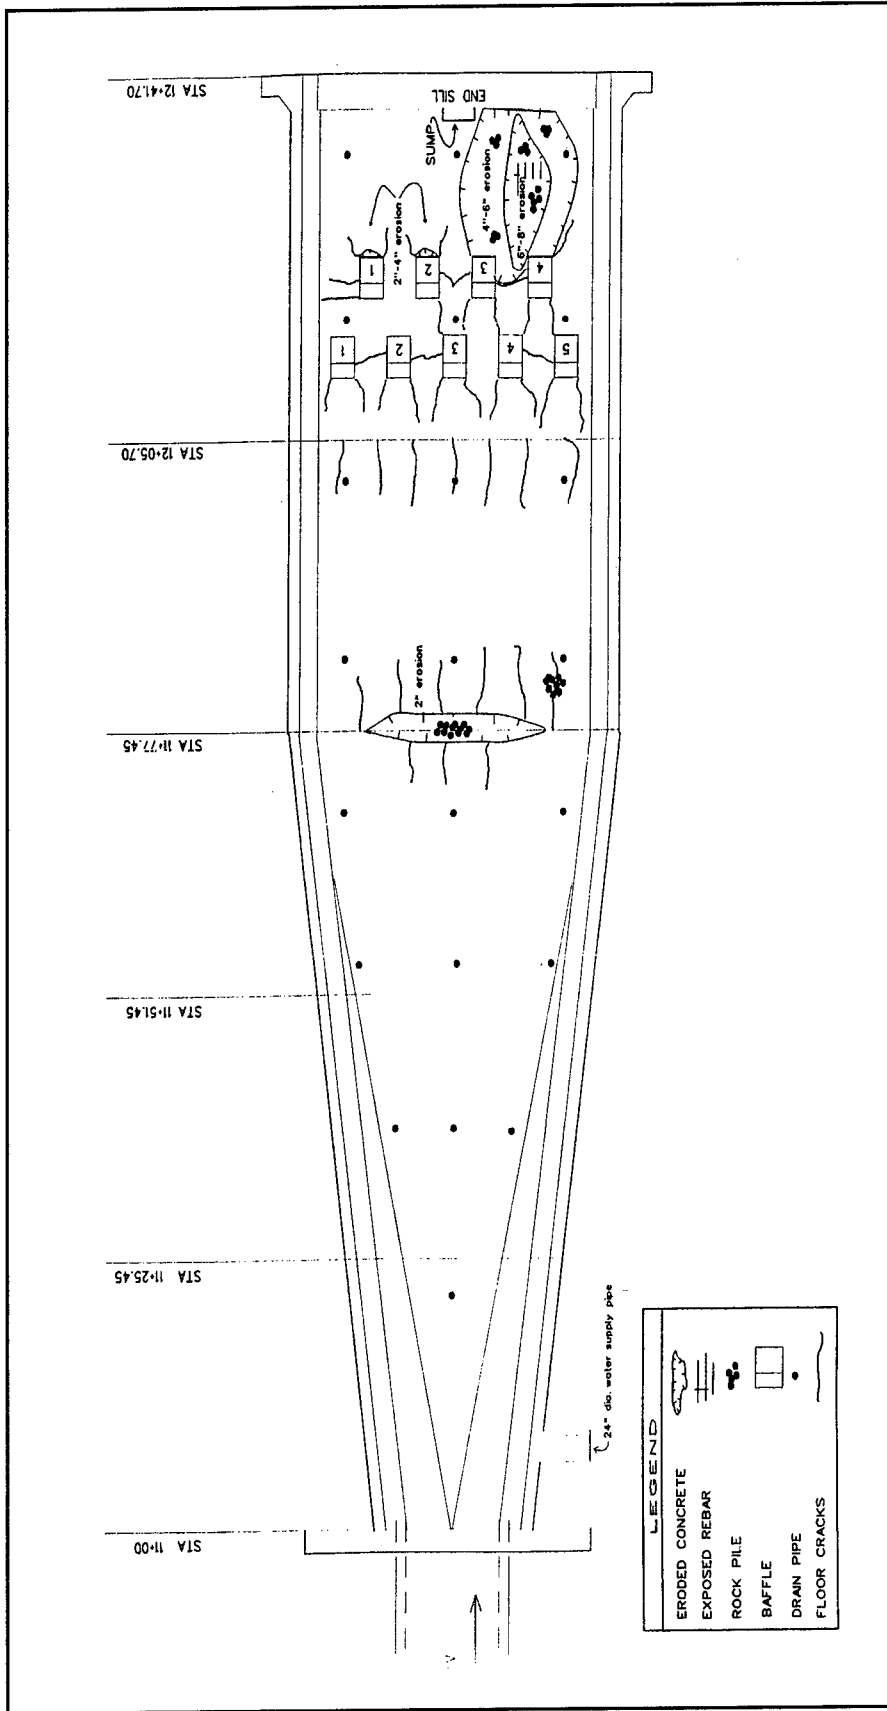
Figure 85. Erosion damage in stilling basin, Gilliam Lake Dam (from U.S. Army Engineer District, Little Rock 1997b)

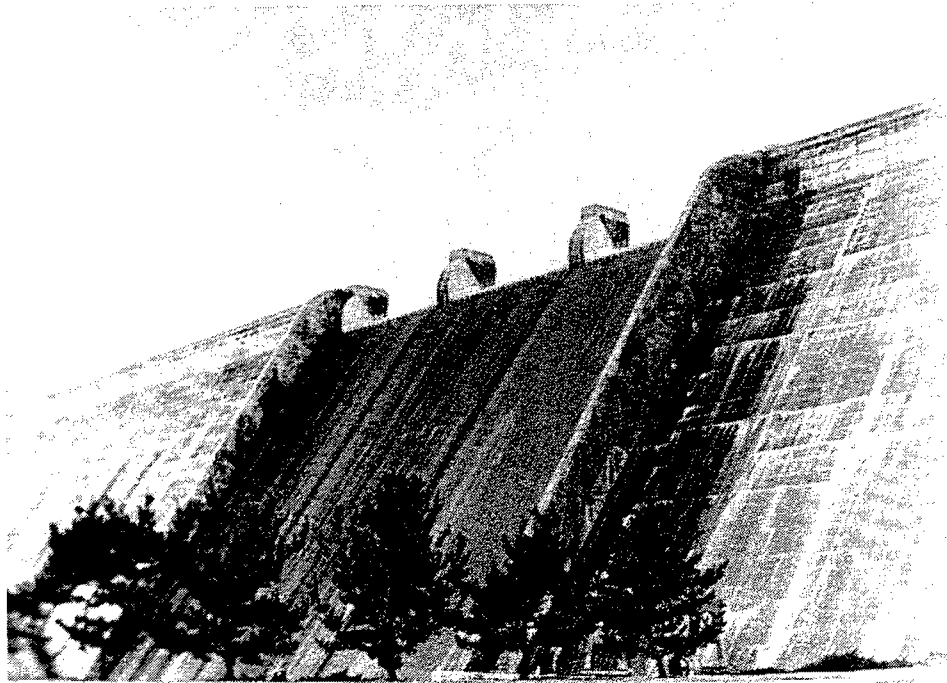
Figure 90. Alkali-aggregate extrusion on the downstream face of Friant Dam  
(from *Hydro Power and Dams* 1997)

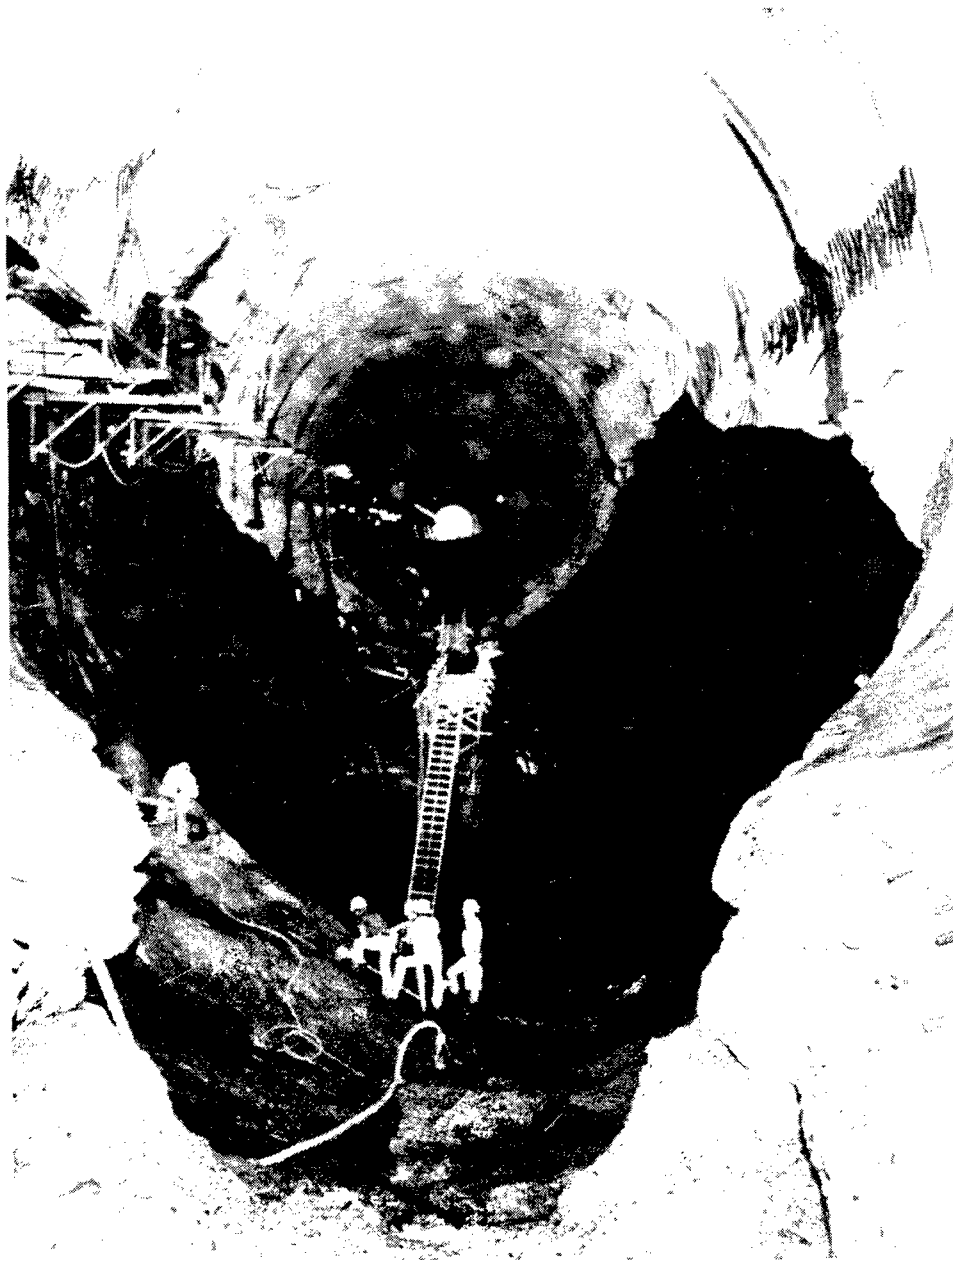
Figure 93. Cavitation damage downstream of the elbow in the left spillway elbow at Glen Canyon (from Burgi and Eckley 1987)

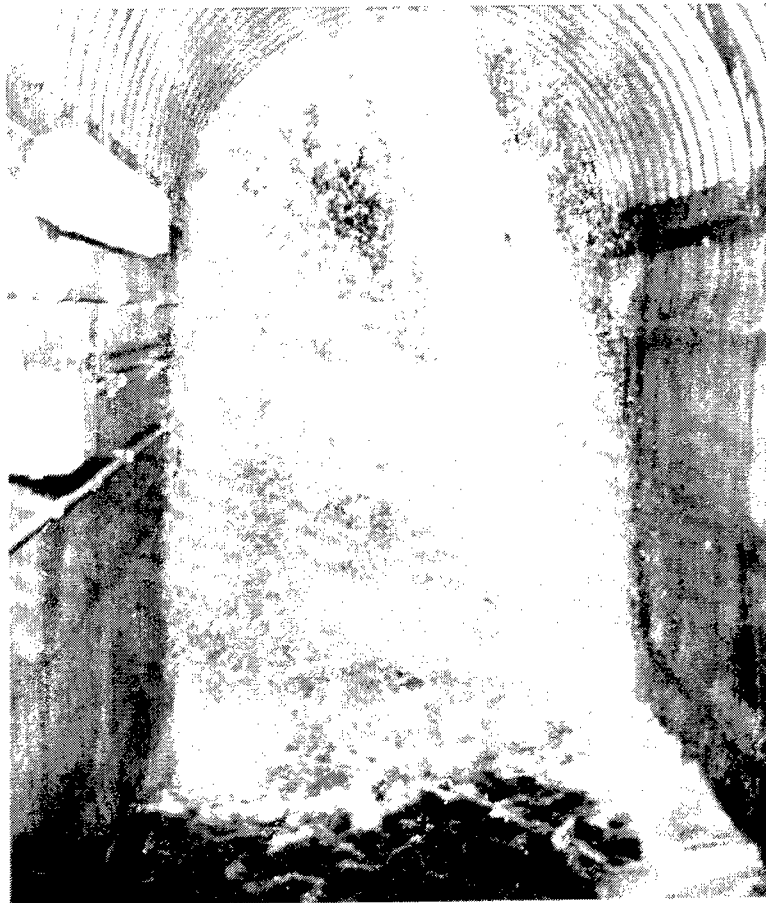
Figure 106. Leakage into the foundation gallery at Upper Stillwater Dam (from Smoak 1991)

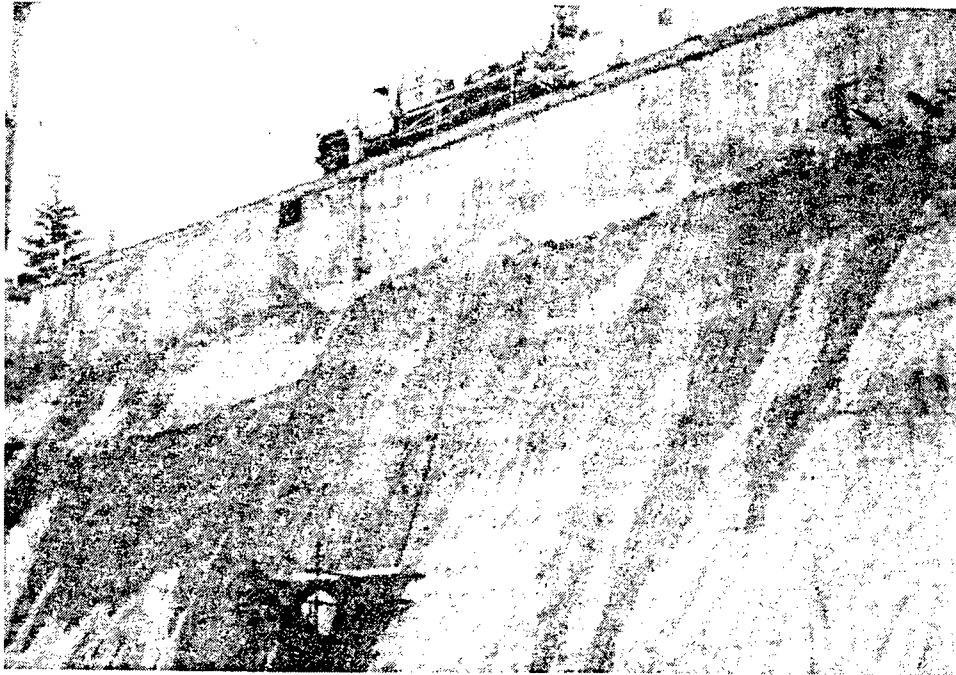
Figure 152. Seepage on downstream face of gravity section of Soda Dam (from Marold, Koniarski, and Bruen 1992)
