Technical Report GL-99-11  
December 1999

# **A Case History of Embankment Failure: Geological and Geotechnical Aspects of the Celotex Levee Failure, New Orleans, Louisiana**

by Joseph B. Dunbar, Victor H. Torrey III, Lillian D. Wakeley

Geotechnical Laboratory  
U.S. Army Engineer Research and Development Center  
3909 Halls Ferry Road  
Vicksburg, MS 39180-6199

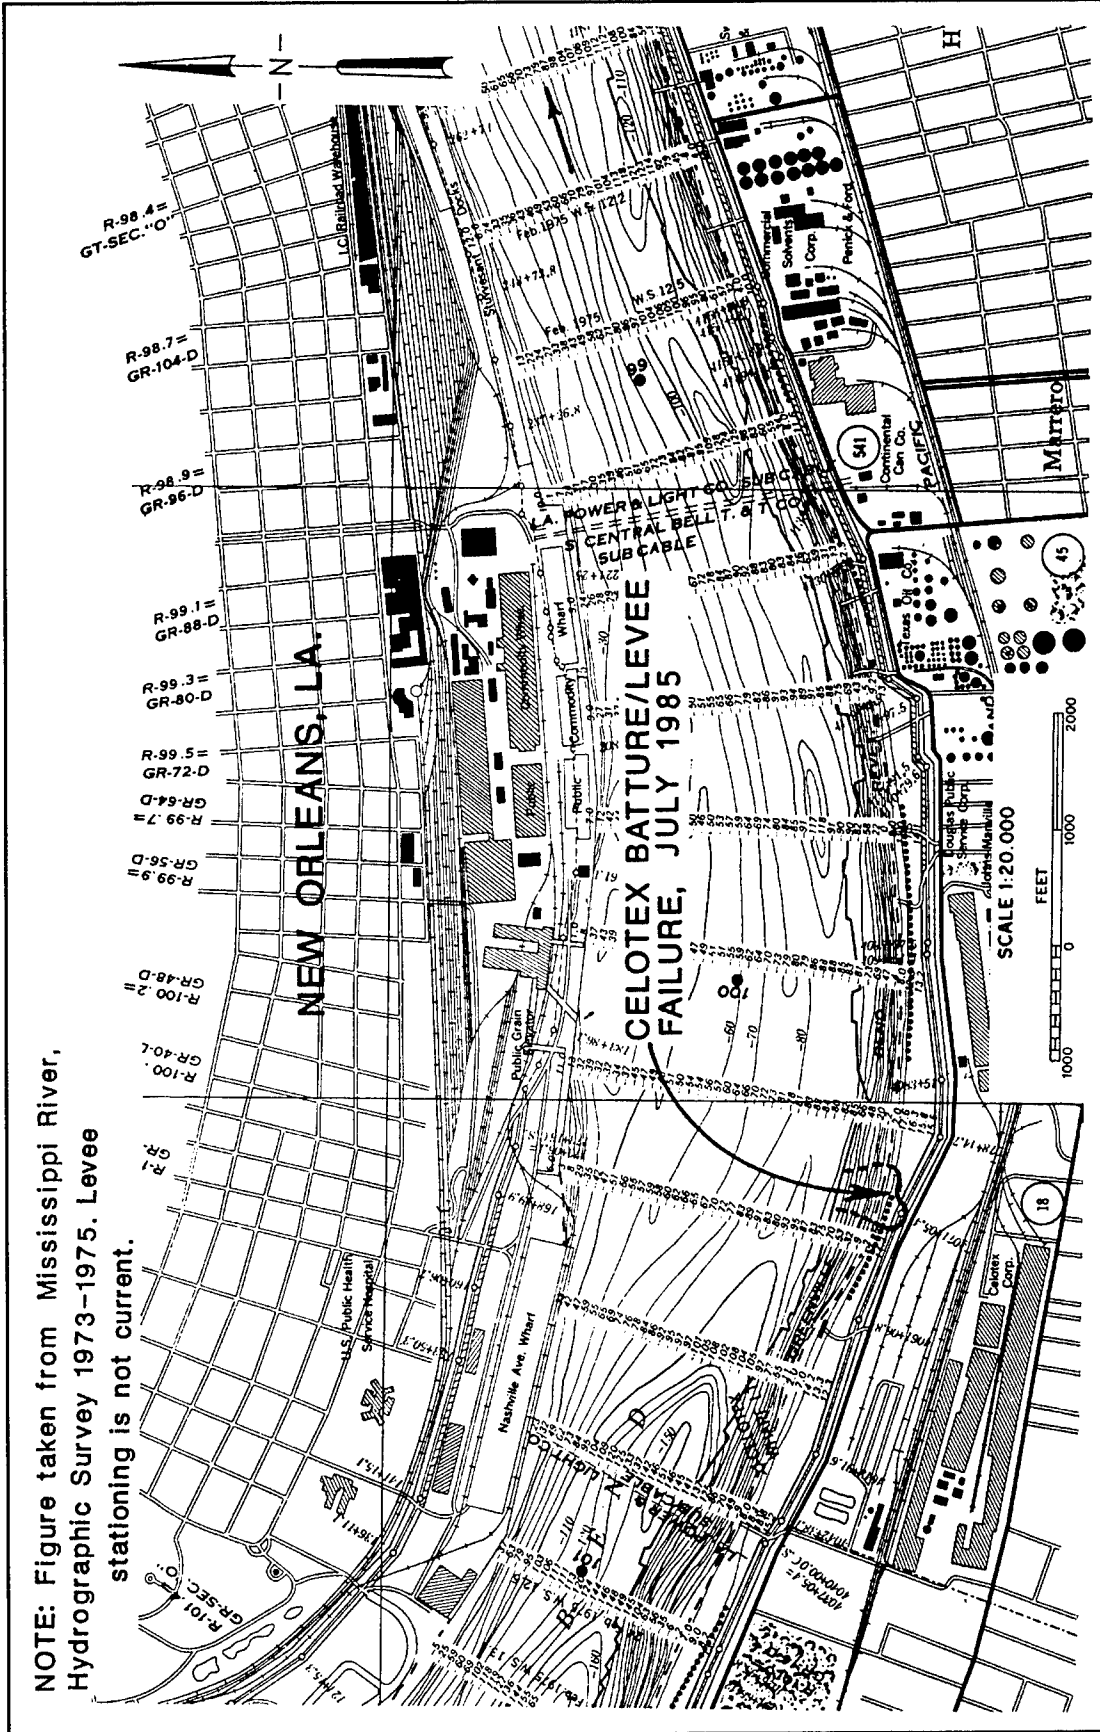
Figure 15. Detailed location map of the Celotex batture and levee failure showing general outline of failure and 1973 hydrographic survey data

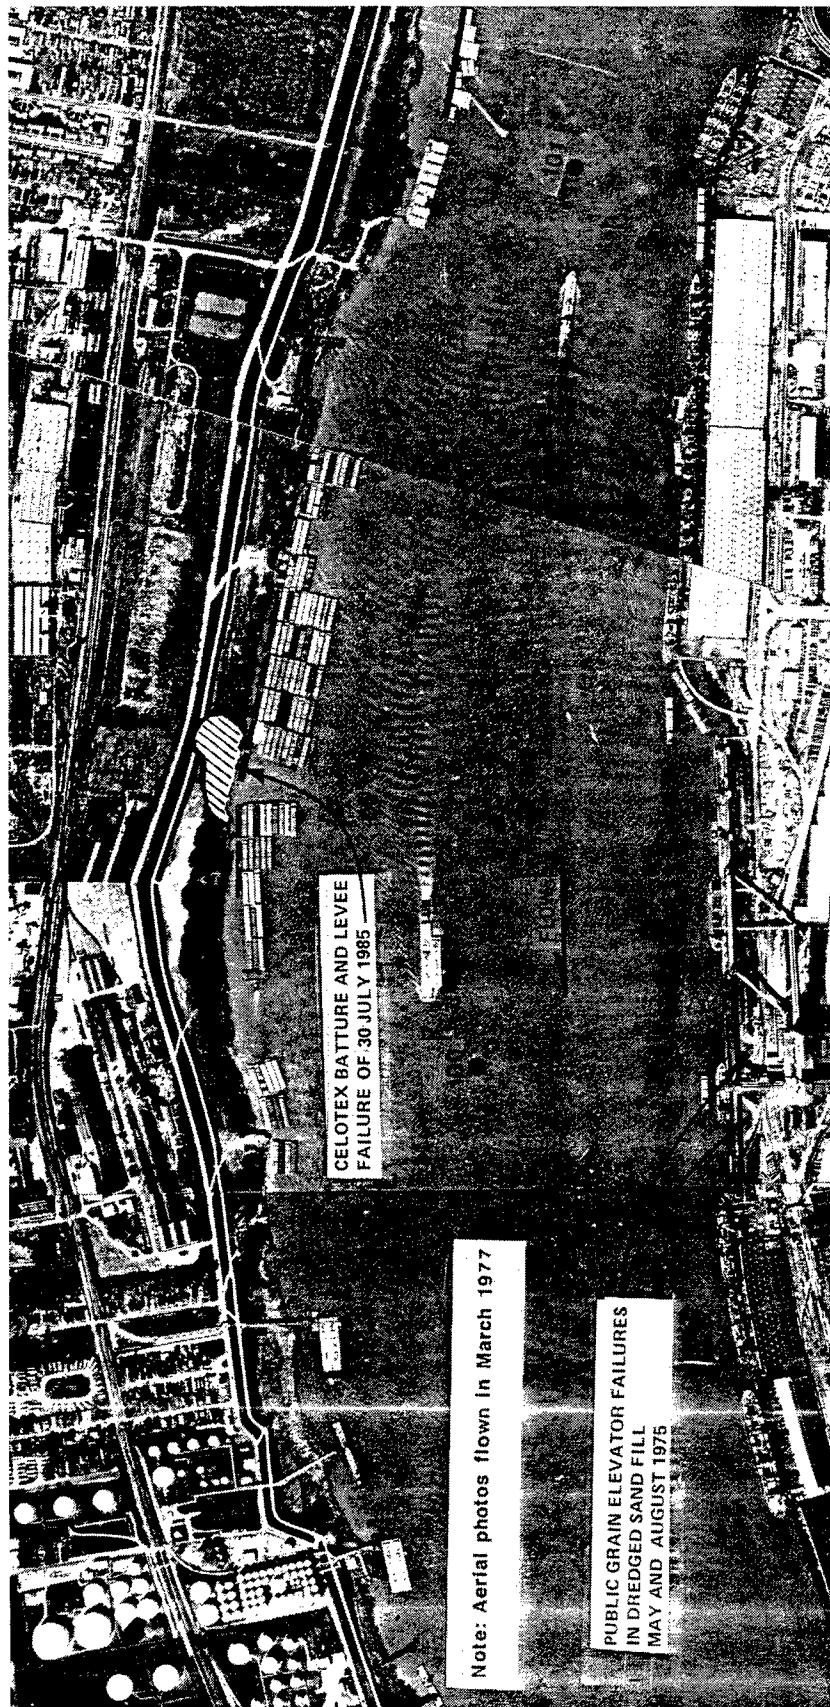
Figure 16. Aerial photo showing location of the Celotex failure

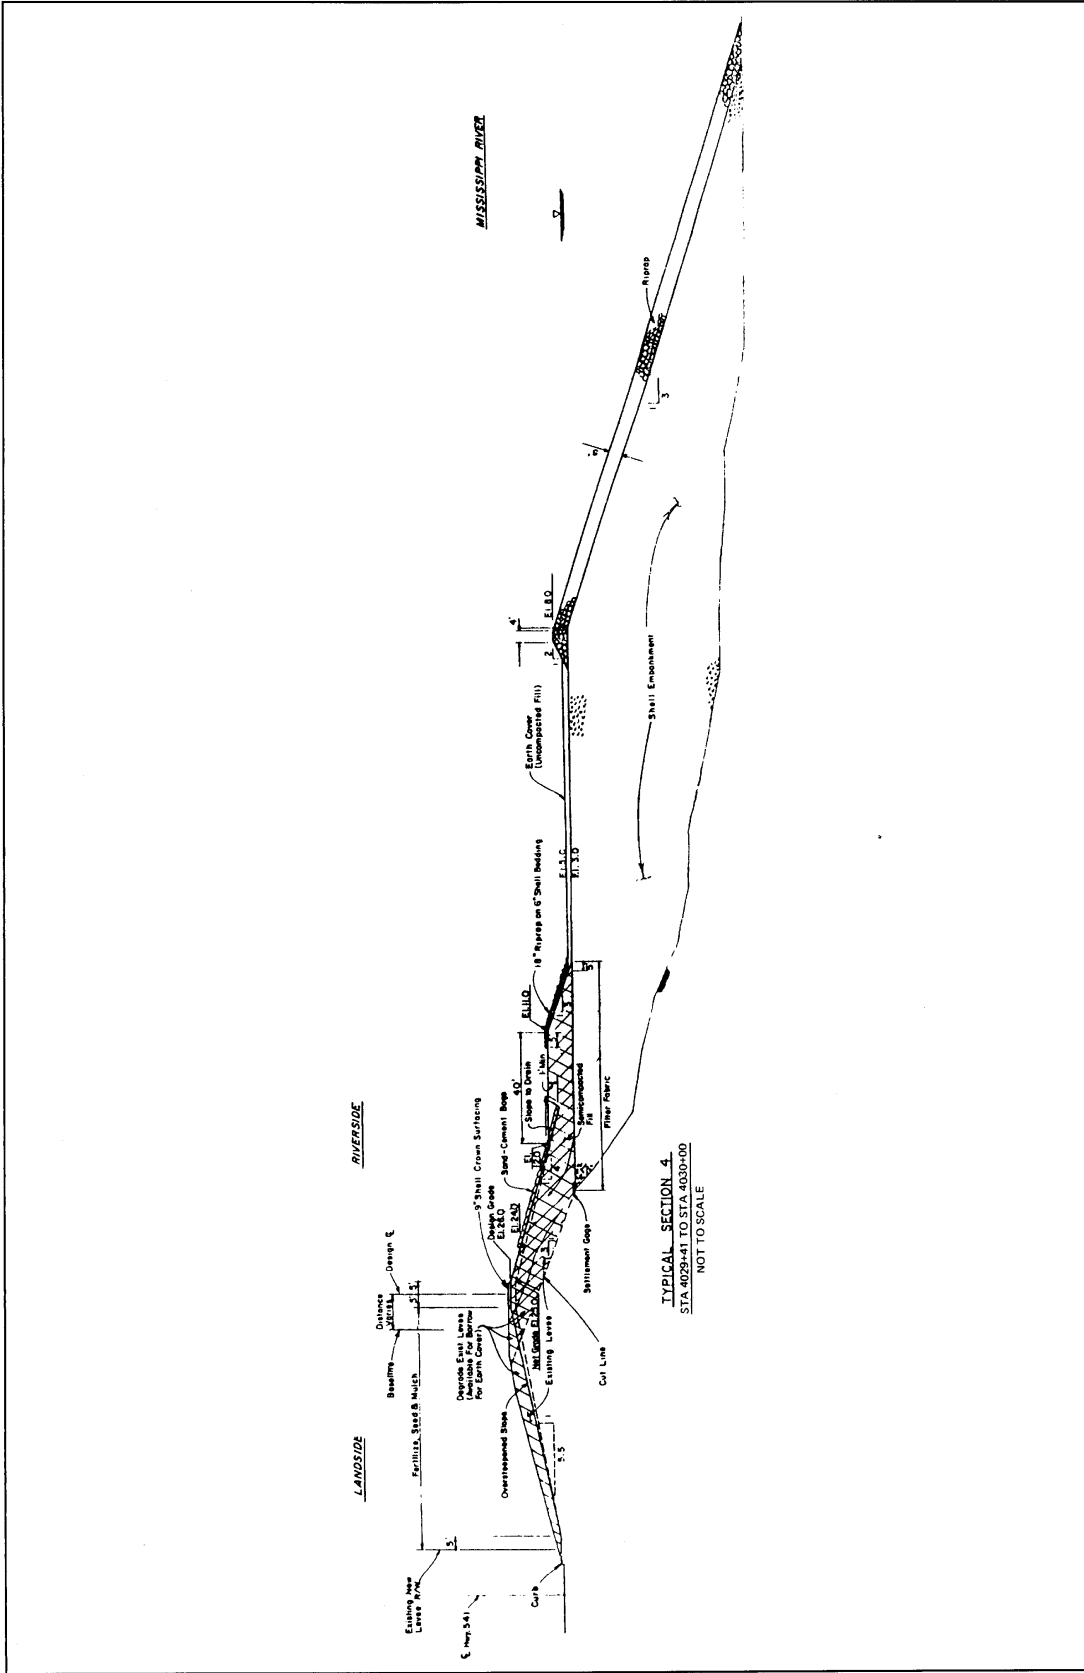
Figure 17. Batture and levee restoration diagram of the Celotex failure

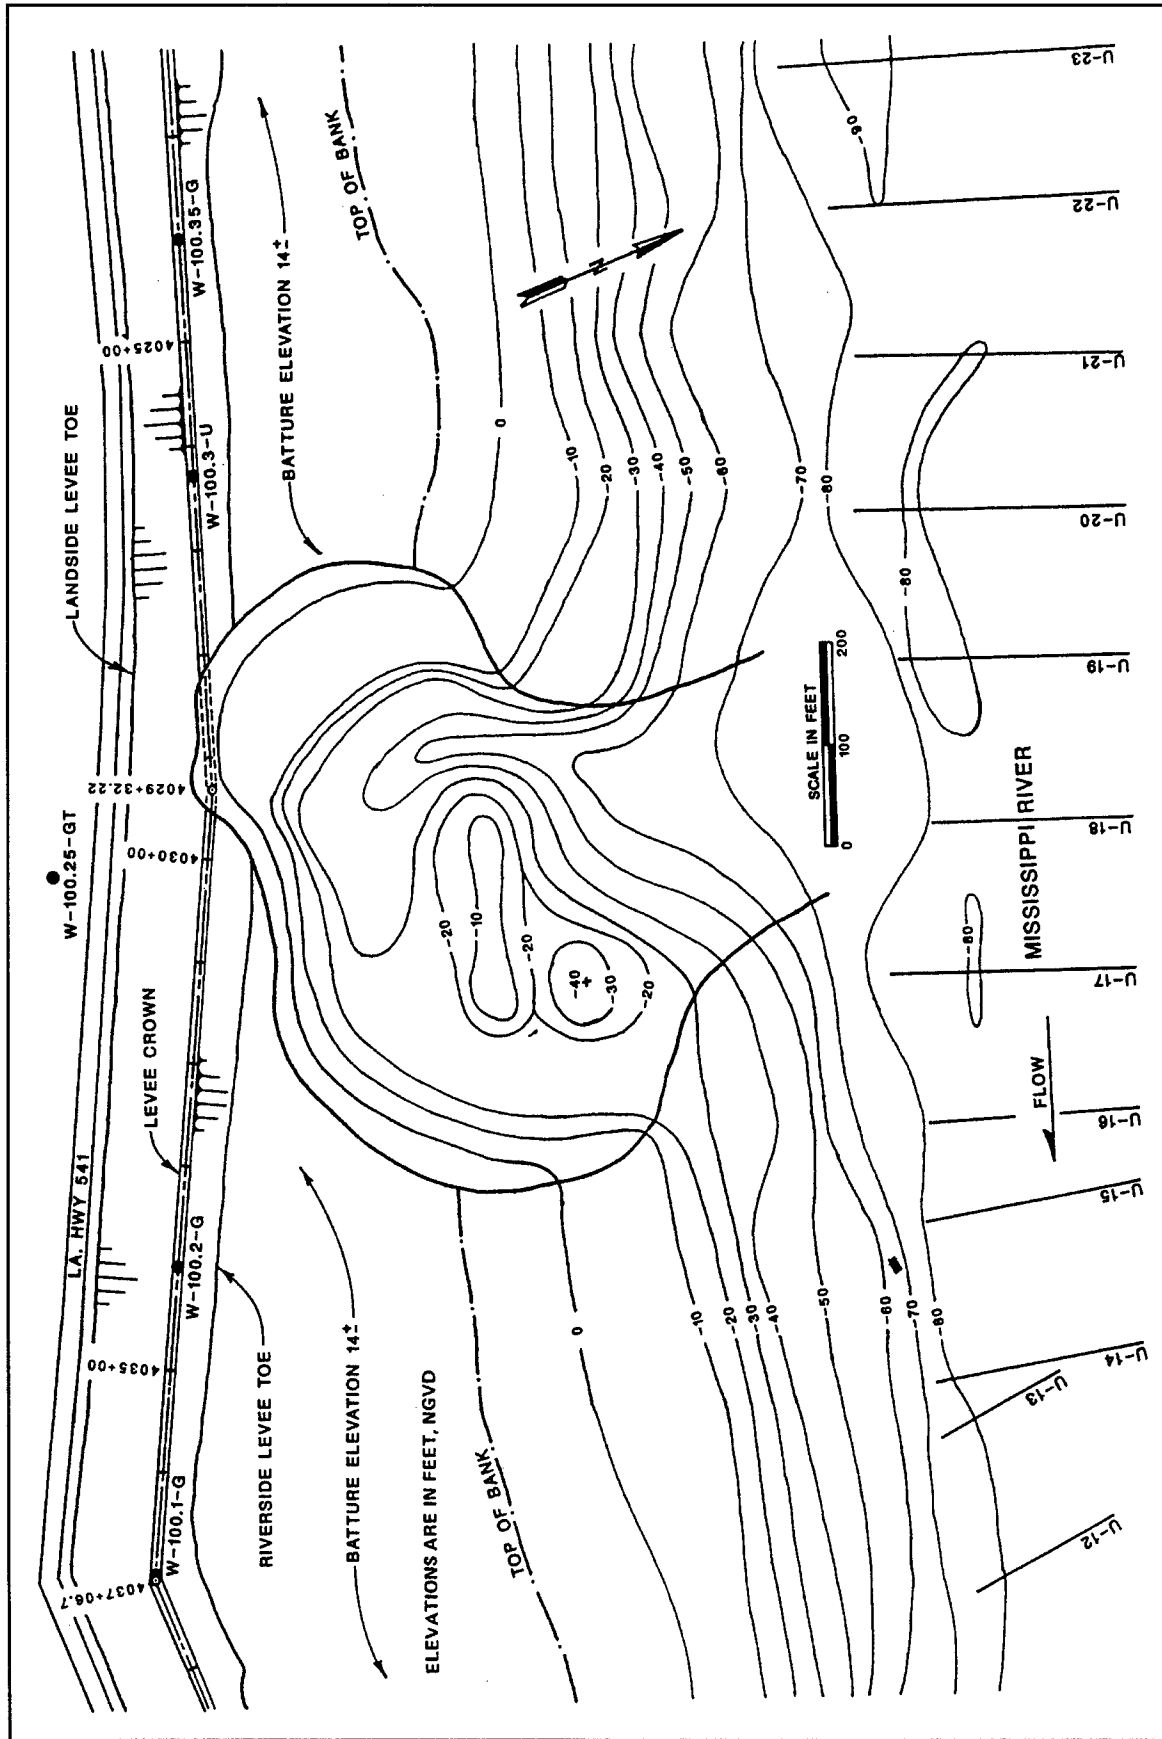
A contour map is presented in Figure 18 showing the general dimensions of the failure area and the locations of the survey range lines referenced in the text that follows. The contour map of the failure area is based on fathometer surveys and borings drilled within and adjacent to the failure reach. A cross section through the failure or flow slide area is presented in Figure 19 showing boring data and fathometer profiles from selected time periods (see Figure 18 for profile locations). In addition, three-dimensional (3-D) computer images of the failure

Figure 18. Topographic map of the Celotex batter and levee failure based on land survey, fathometer, and boring data

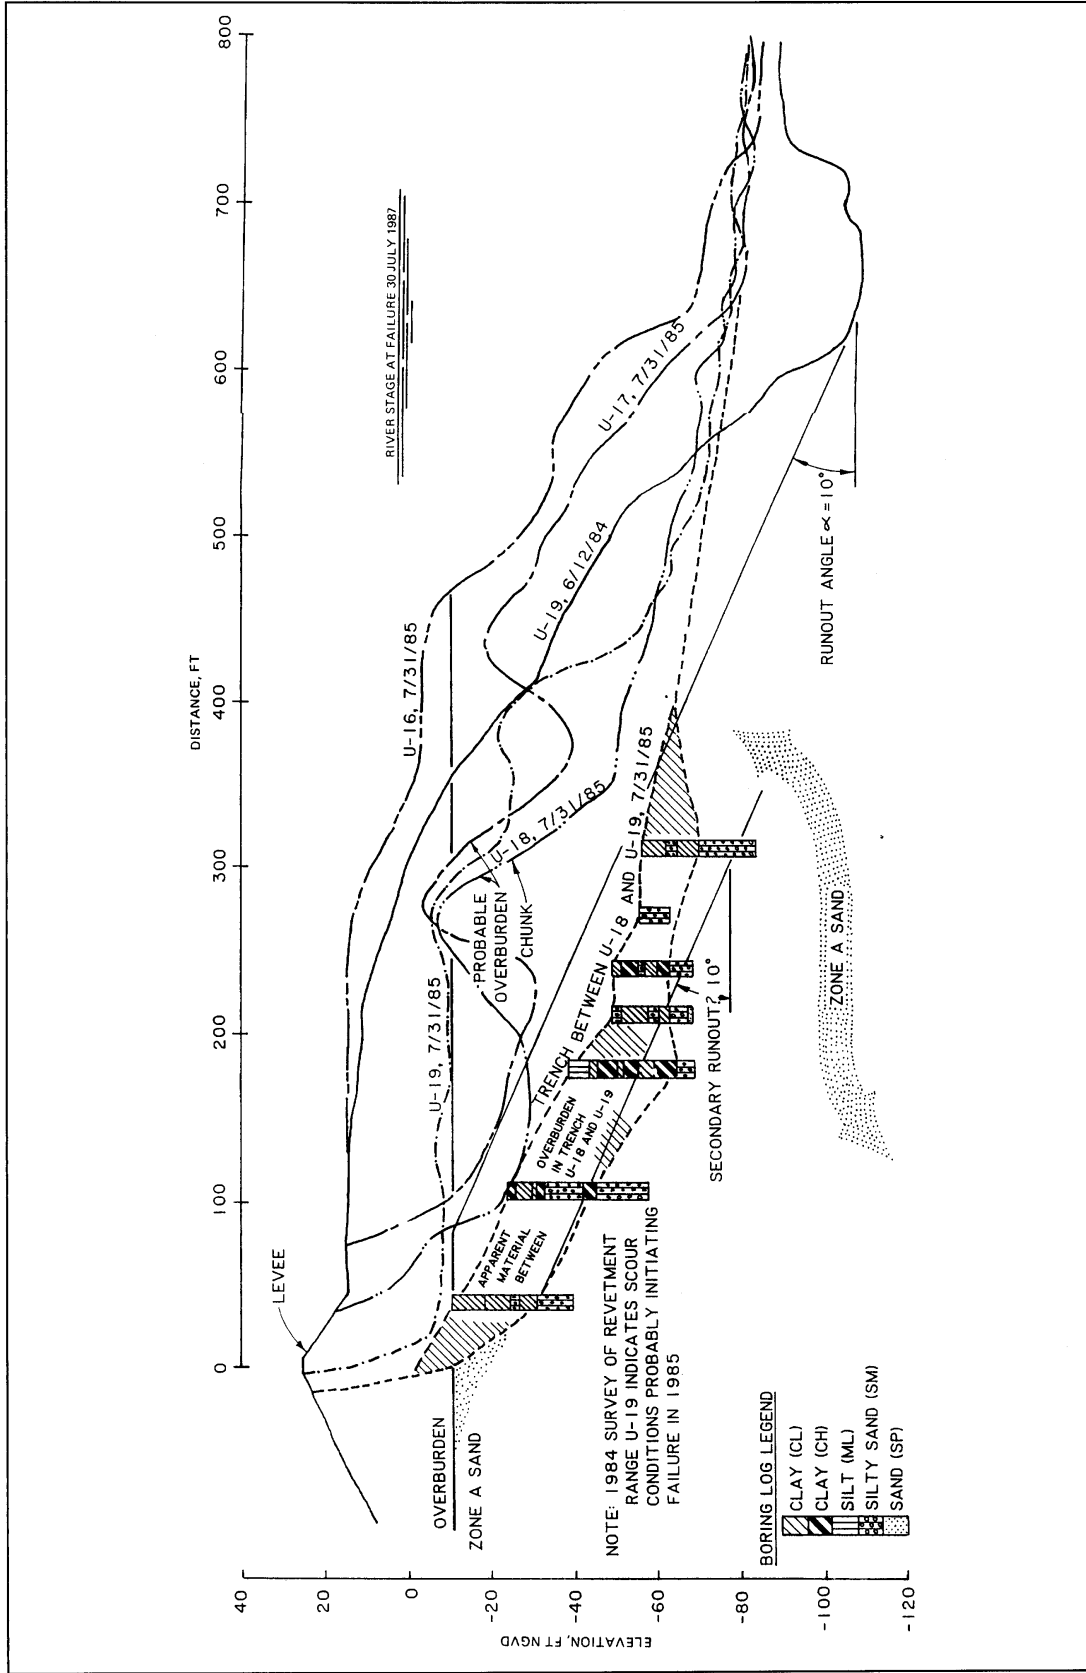
are shown in Figures 20 and 21. The plan view, sections, and 3-D images of the failure reveal the bottleneck shape and relatively flat bottom slopes transverse to the bank line which are typical of a flow slide. At its widest point, the failure is approximately 600 ft (182.9 m) in length and the failure plane extends to approximately -70 ft (-21.3 m) NGVD as shown by Figure 19.

Boring data and geological mapping indicate that the failure area exhibits the particularly dangerous soil stratigraphy of thin overburden (i.e., topstratum) over a thick deposit of fine sands and silty sands (i.e., substratum) as shown by Figure 22 (also see Figure 5c). Geological mapping in Figure 22 (and 5c) shows the failure is situated in point bar deposits associated with an early St. Bernard

Figure 19. Cross sections of the Celotex failure showing boring and profile data from selected time periods

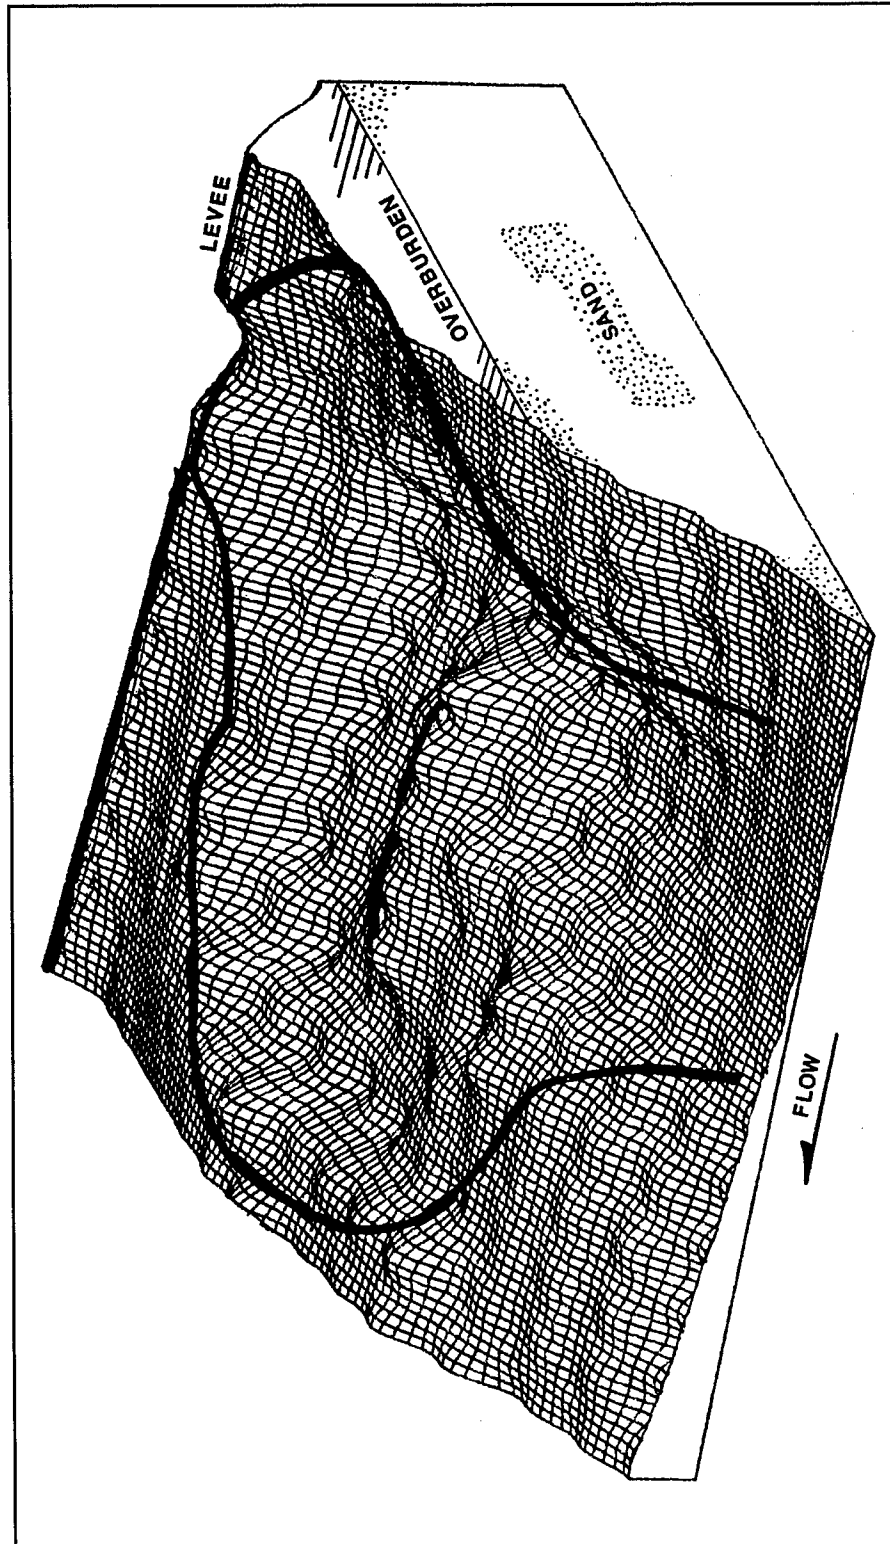
Figure 20. Computer image of the Celotex failure viewed from a position upstream; view is to the south

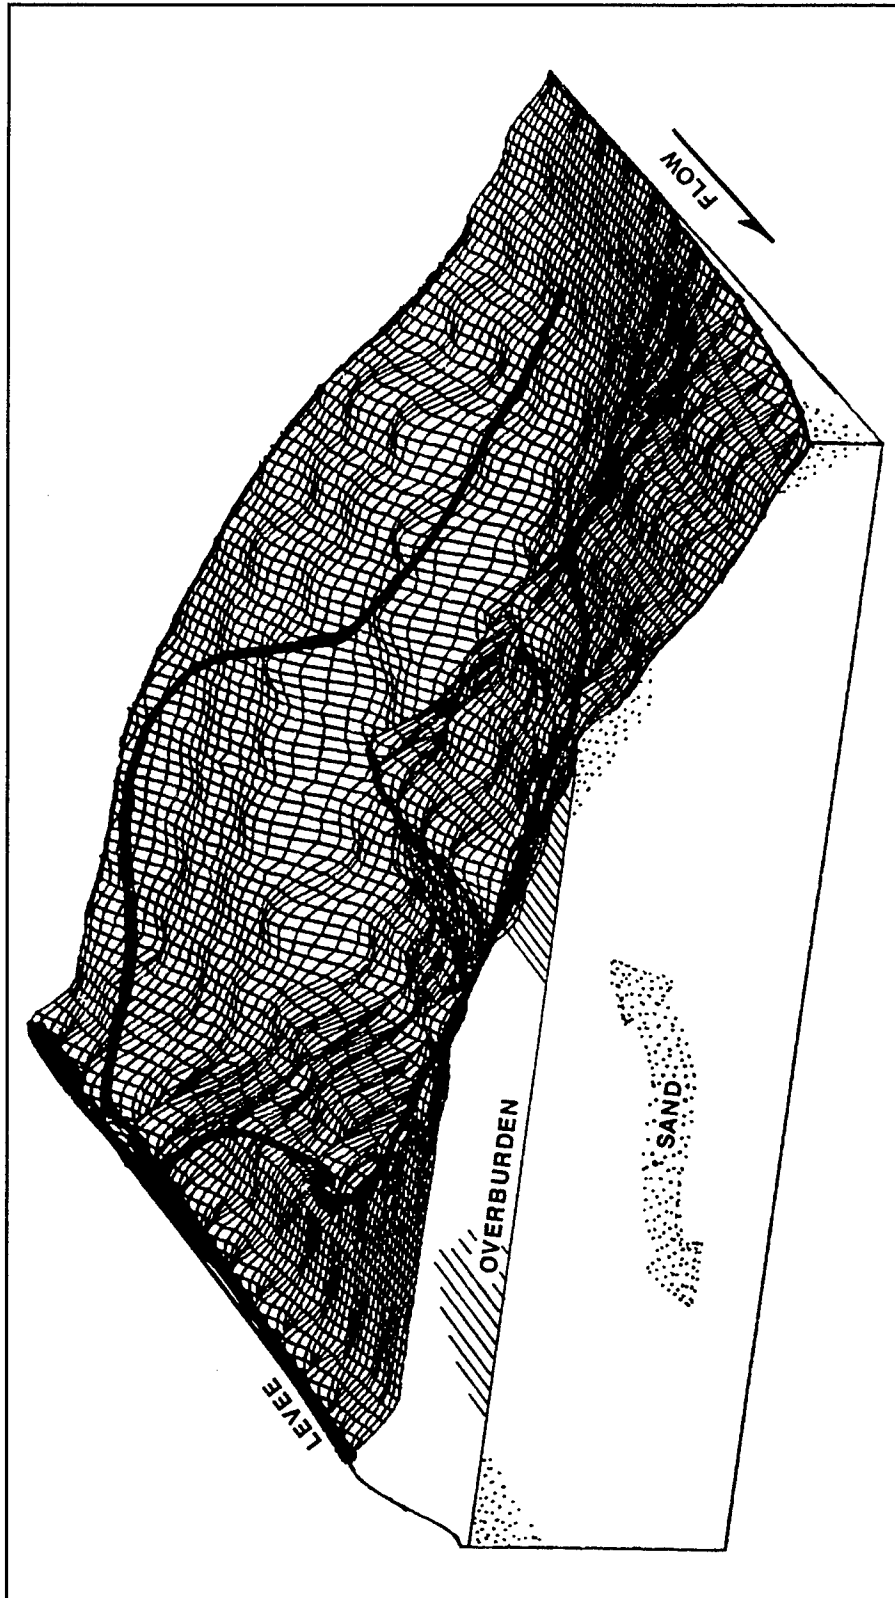
Figure 21. Computer image of the Celotex failure viewed from a position downstream; view is to the west

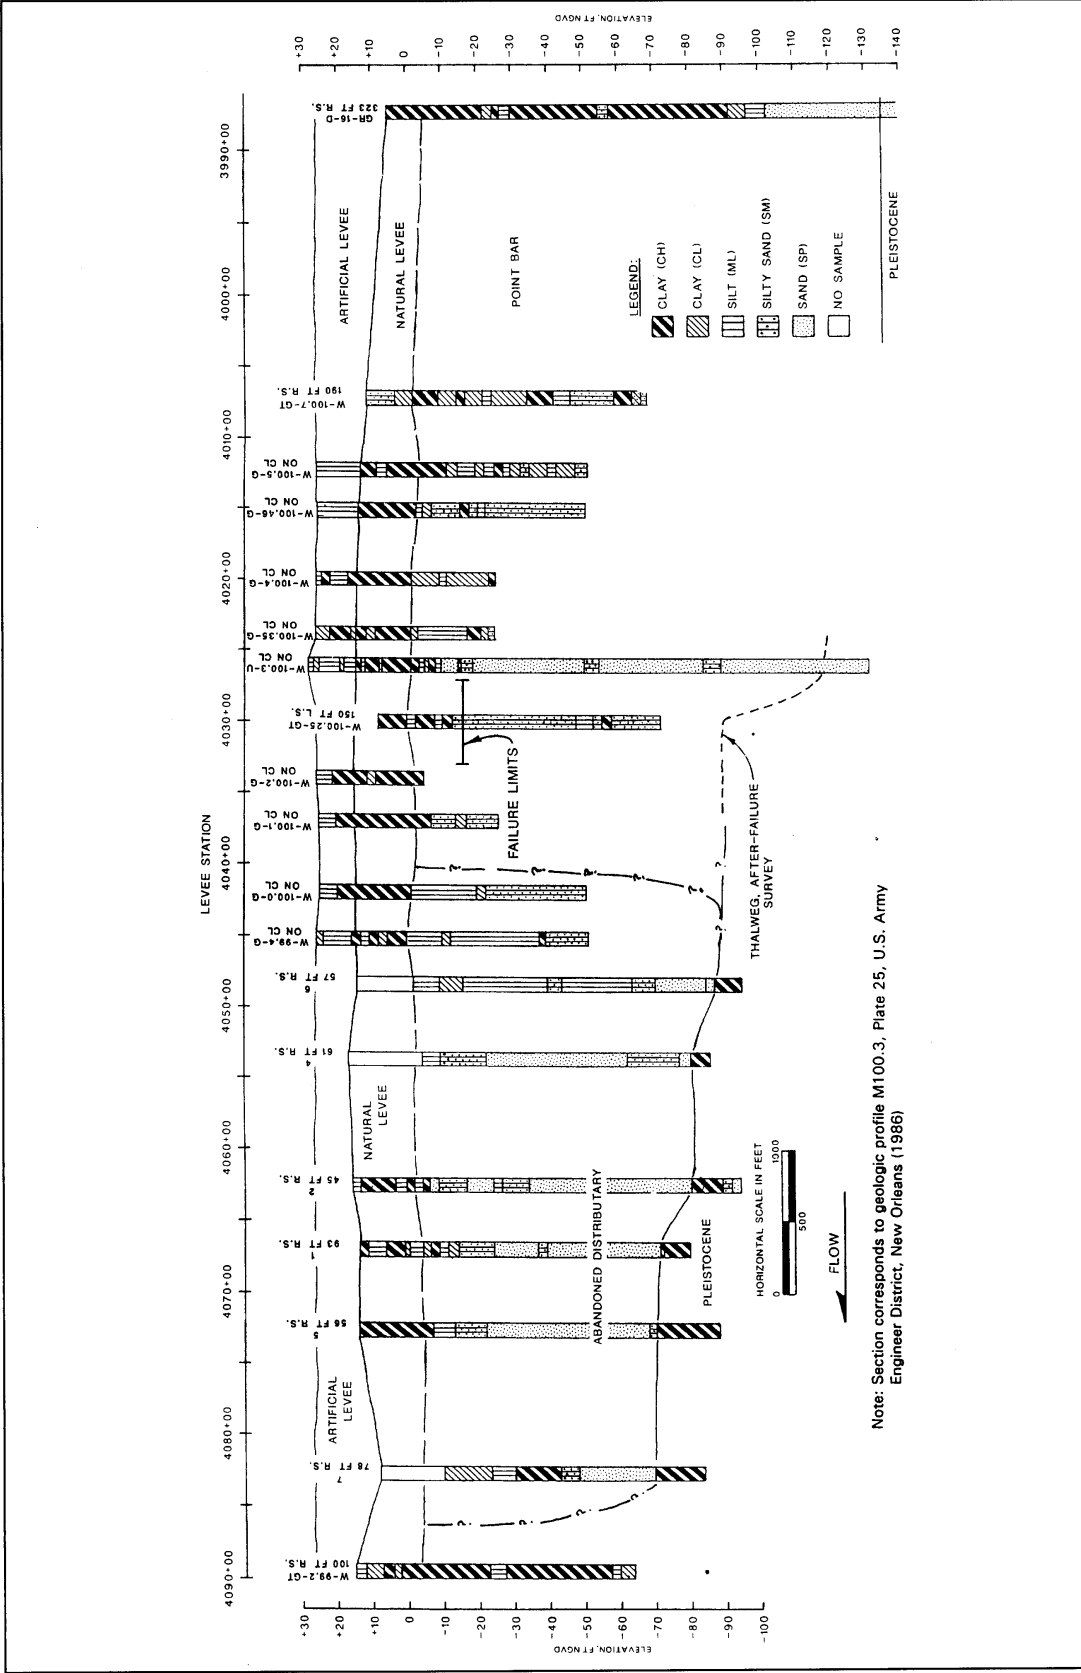
Figure 22. Soil profile along the bank reach containing the Celotex failure

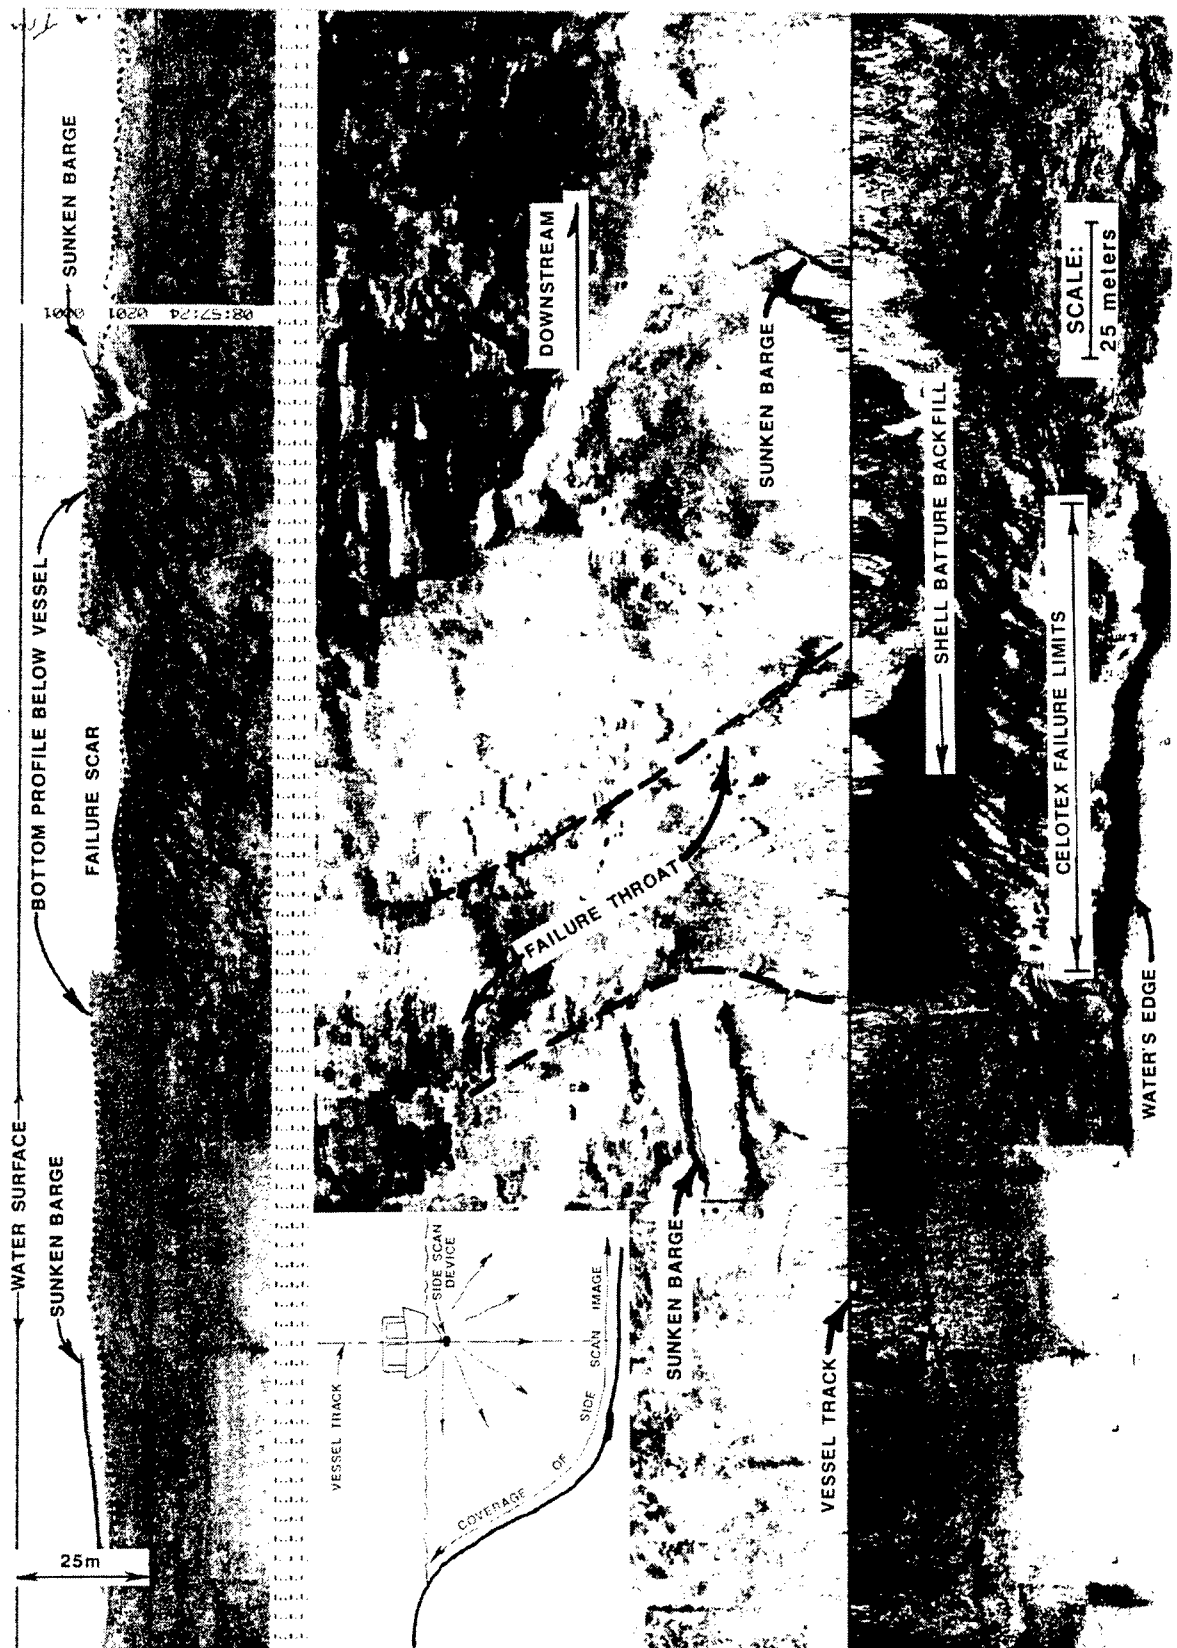
Figure 24. Side-scan sonar image of the Celotex failure reach

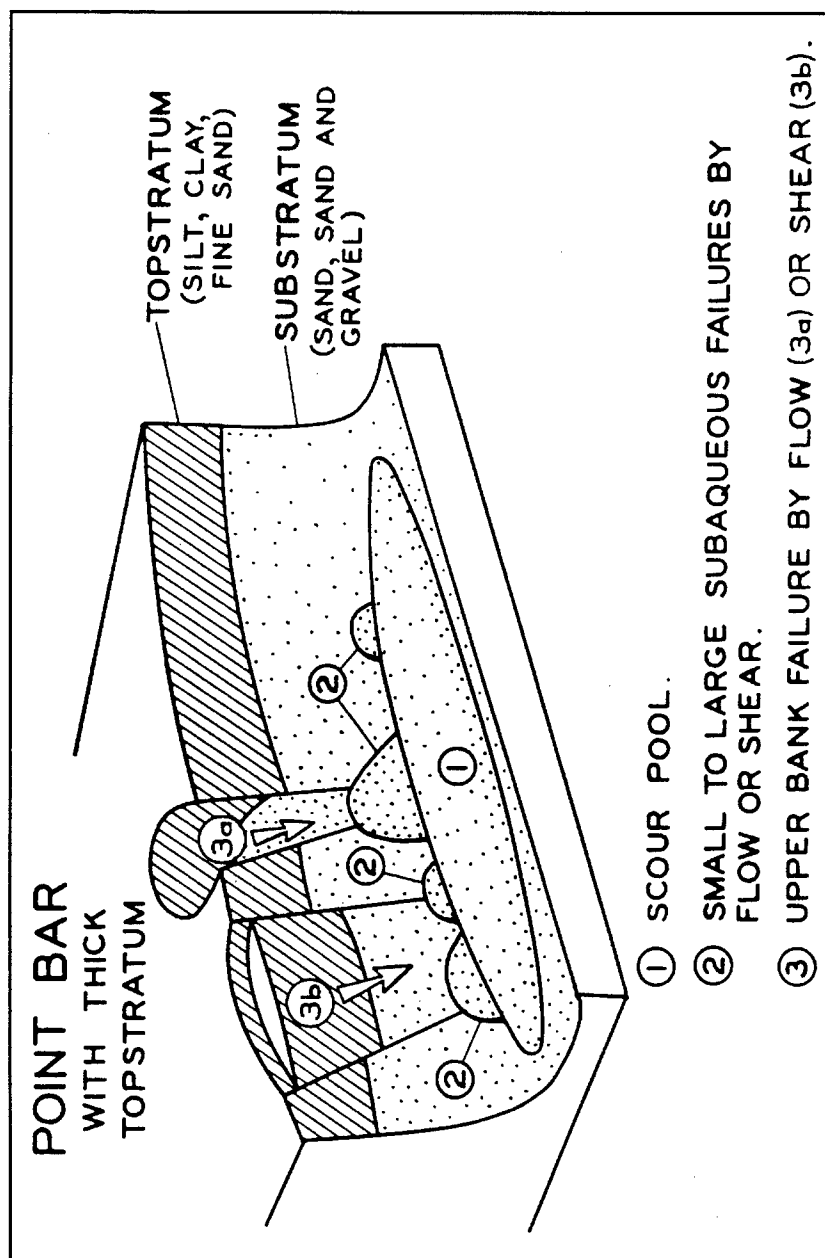
Figure 26. General mechanism leading to bank failures where the river thalweg is in substratum sands

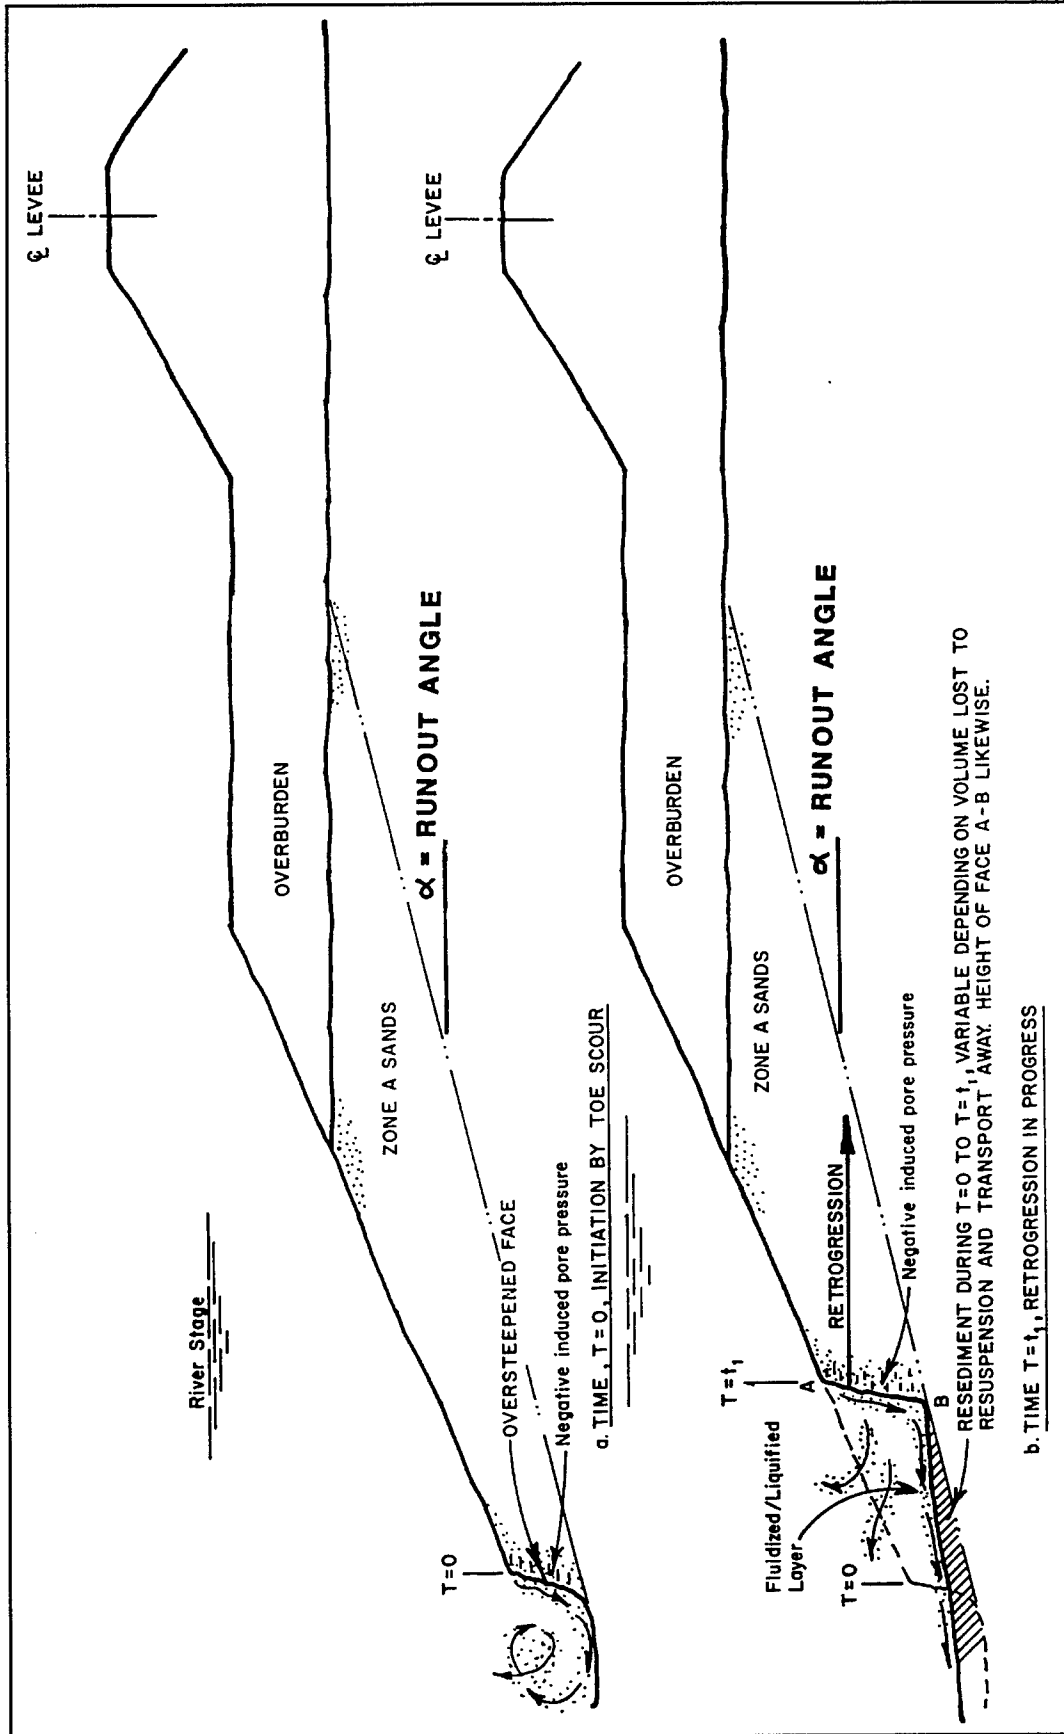
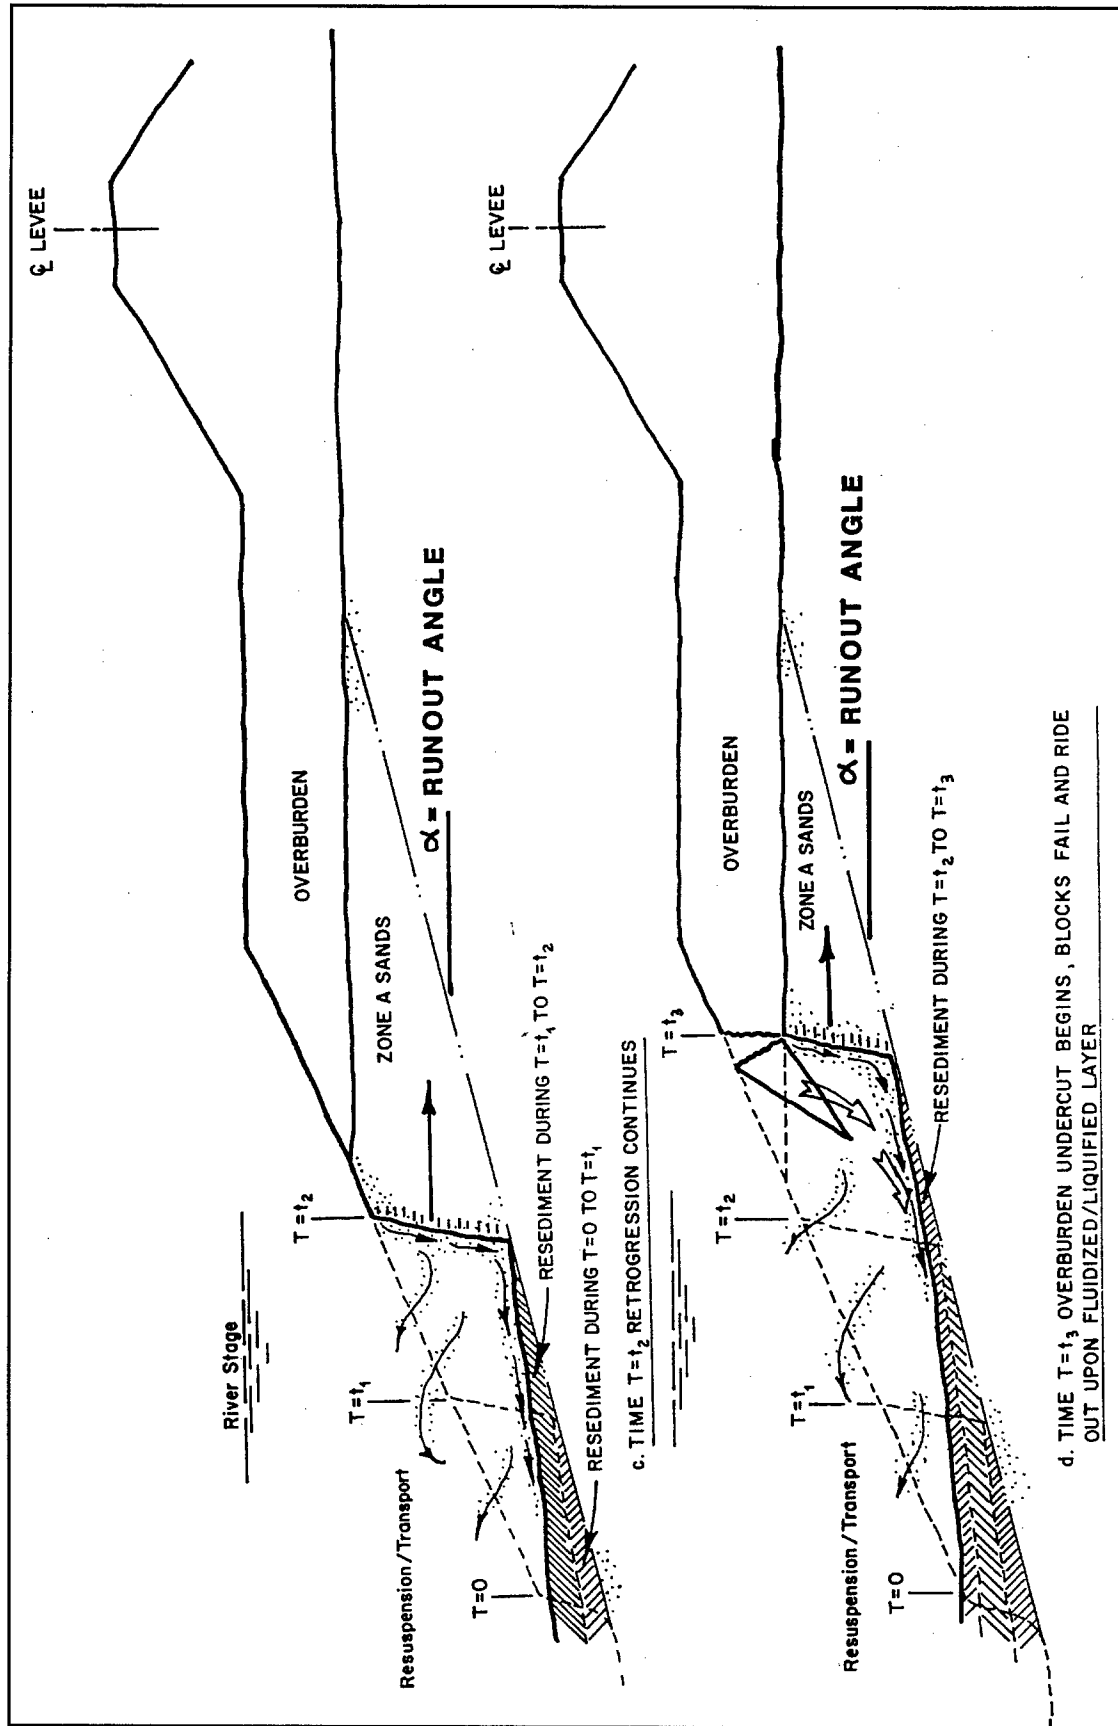
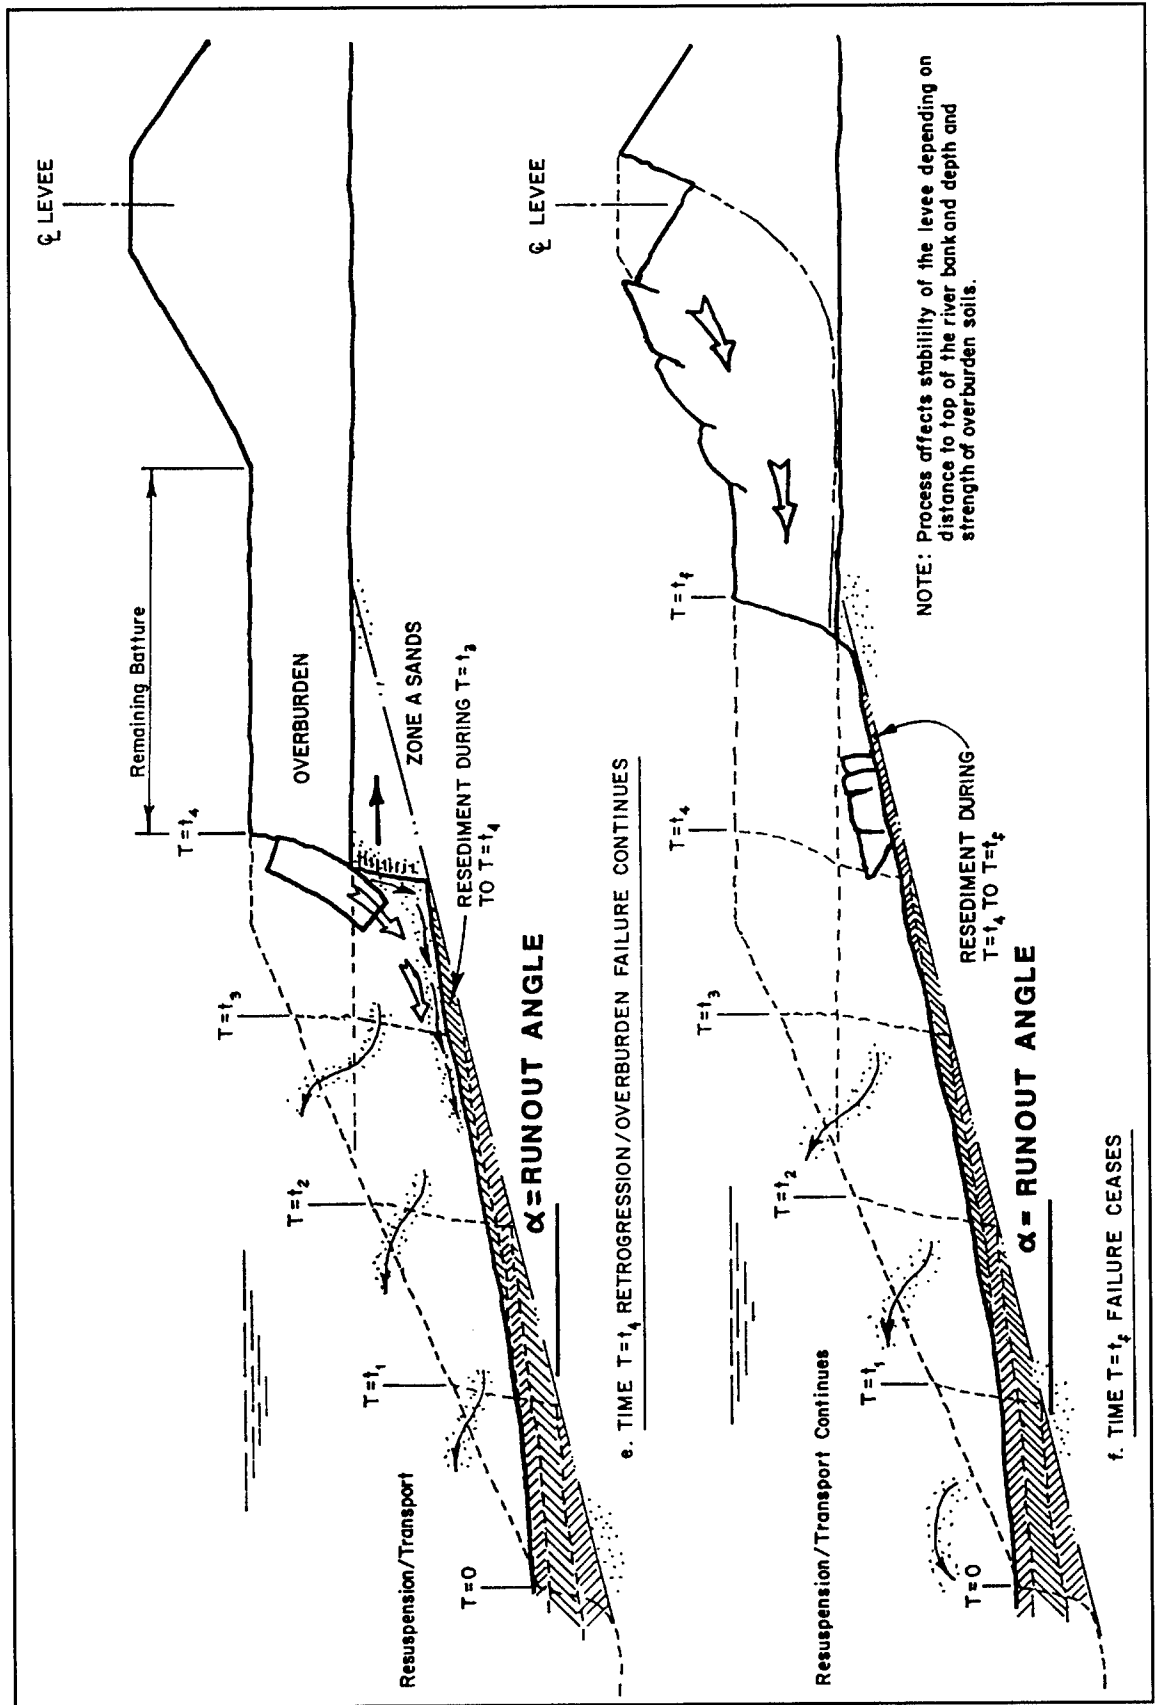
Figure 27. Sequential stages of retrogressive failure in dilatant sand (Sheet 1 of 3)
