September 2000

BORDER PATROL

Procurement of MD
600N Helicopters
Should Be Reassessed

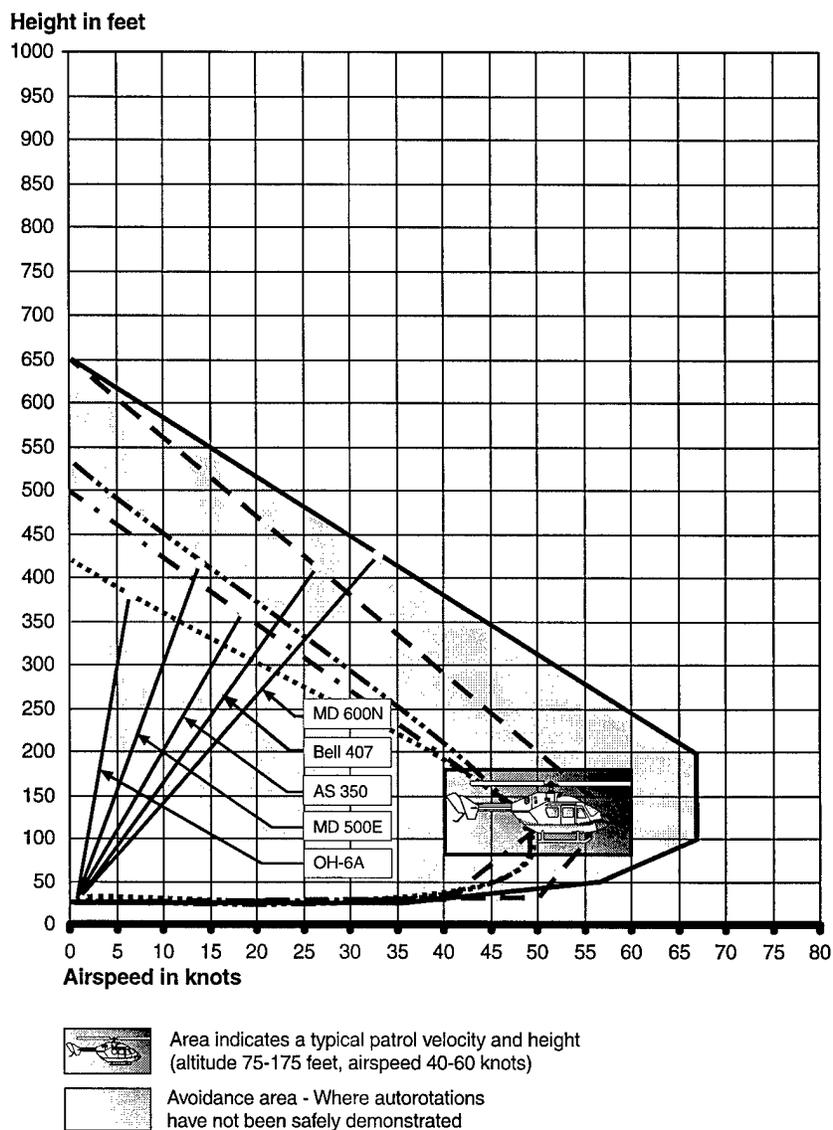
Figure 3: Height/Velocity Curves for MD 500E, MD 600N, Bell 407, American Eurocopter AS 350, and Hughes OH-6A

Most of the pilots we interviewed believed that the autorotation characteristics of the MD 600N are inappropriate for much of the flying performed during Border Patrol air operations missions. Autorotation is a pilot-recovery maneuver performed in the event of an engine failure that keeps the main rotor blades moving so that the aircraft descent can be controlled. Aircraft height and airspeed factors to be avoided during autorotation are depicted as a height/velocity curve.⁸ Pilots are instructed

MDH officials stated that the pilots based their concerns on a misunderstanding of the height/velocity curve rather than on the helicopter's operational characteristics. According to MDH, the MD 600N's height/velocity curve appears to cover more area because of more stringent testing conditions used for establishing the curve.⁹ However, we examined the height/velocity curves for several helicopters that were tested at or estimated for sea level. The MD 600N height/velocity curve had a larger area to avoid (see fig. 3). A senior FAA certification official said that this is a valid means for showing how different aircraft height/velocity curves relate to the height and airspeed of a typical Border Patrol mission.

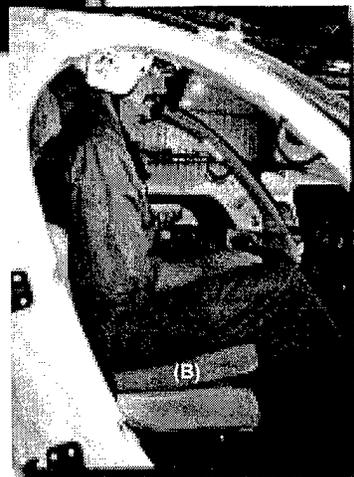
(B) Some pilots reported using seat cushions provided by Air Operations headquarters or their own cushions to relieve some of the discomfort caused by the seats in the MD 600N.

Air Operations officials agreed that the seats in the MD 600N are uncomfortable. Pilots had said they wanted padded seats, so the officials said they asked for high-quality seats during the procurement.¹⁷ Air Operations officials recently took action to replace the seats provided under the original procurement. Seats tested by Border Patrol pilots during the flight evaluations for the stability augmentation system have been ordered and are being manufactured, as of September 21, 2000, according to INS.

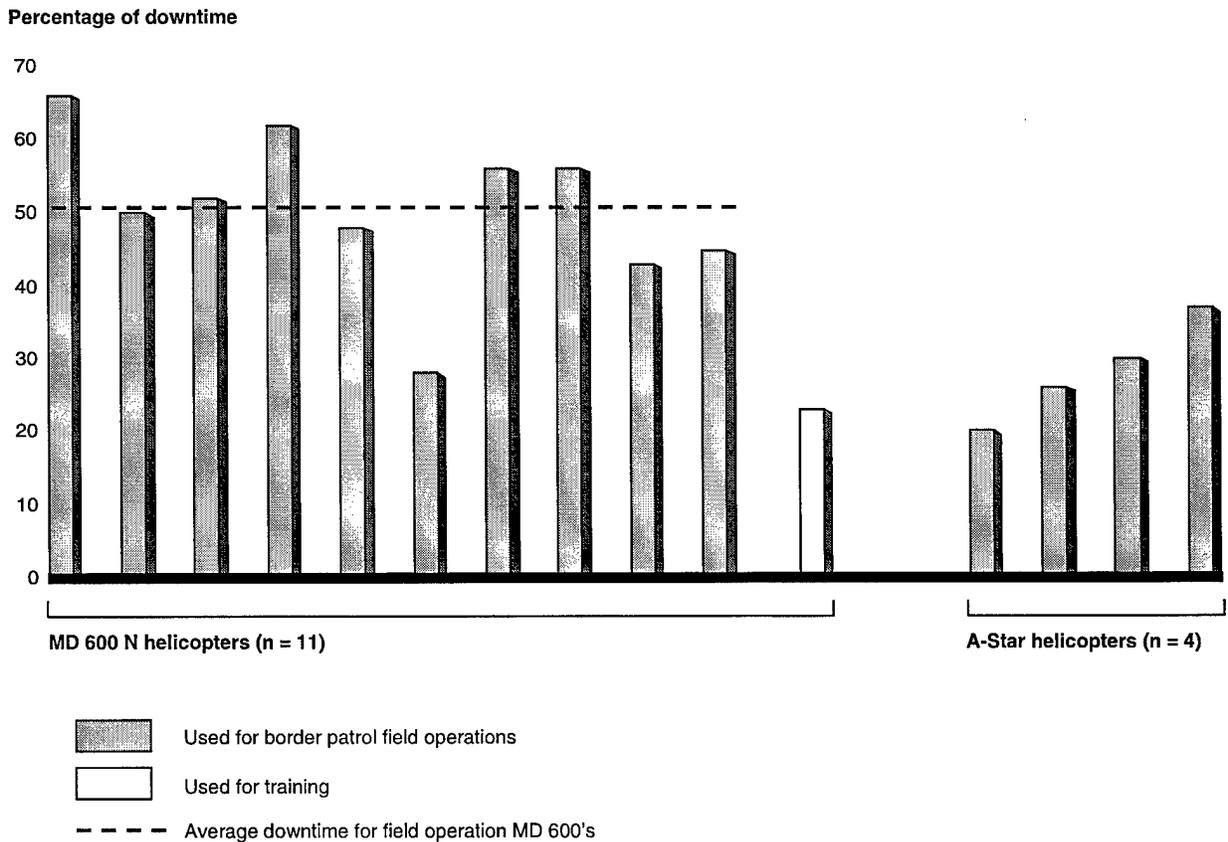
Figure 5: Downtime for Border Patrol 600N Helicopters

A major concern of most sector chiefs and their staffs was the significant amount of time in which the MD 600N helicopters were unavailable for use or "down." Air Operations records for December 1998 to March 2000 show that the 10 MD 600Ns assigned to Border Patrol field operations were unavailable, on average, over 50 percent of the time.¹⁸ This downtime included any time that the helicopters were not operational due to avionics repair, maintenance, or while waiting for parts. In comparison, the four Border Patrol Eurocopter "A-Star" helicopters were down 28 percent of the time during the same period. Reasons for the downtime included delays in obtaining an engine repair contract, slow manufacturer approval for modifications, and parts availability.

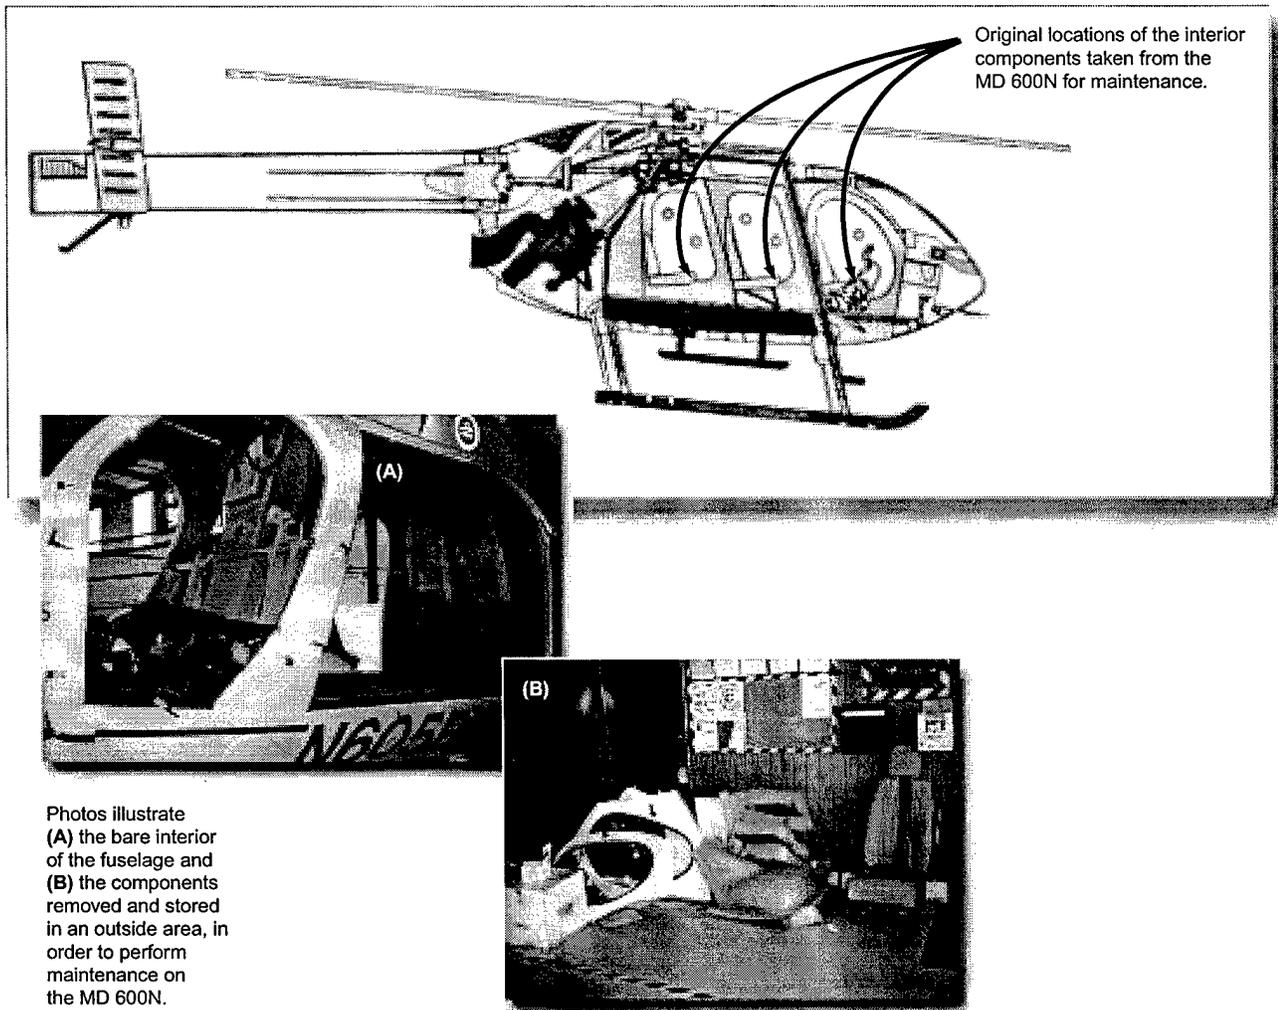
Figure 6: Aircraft Repairs Often Require Interior to Be Removed

Finally, mechanics in two sectors said that the design of the helicopter makes working on it time consuming because many repairs require that the aircraft be taken apart. One mechanic stated, for example, that often carpet must be pulled up, seats removed, and the interior vinyl removed in order for mechanics to access the aircraft's parts for a 100-hour inspection. Helicopters by other manufacturers, such as Bell, have their transmissions and drive trains located externally and would not need to have the interiors removed for a routine inspection, he said. The interiors have also experienced unusually high levels of wear and tear because of the need to remove them, one mechanic said.

Photos illustrate (A) the bare interior of the fuselage and (B) the components removed and stored in an outside area, in order to perform maintenance on the MD 600N.
