# WIRE STRIKE REPORT

**WIRE STRIKE MISHAP ANALYSIS REPORT**

Report No. 71-2

**UNITED STATES ARMY BOARD FOR  
AVIATION ACCIDENT RESEARCH  
Fort Rucker, Alabama**

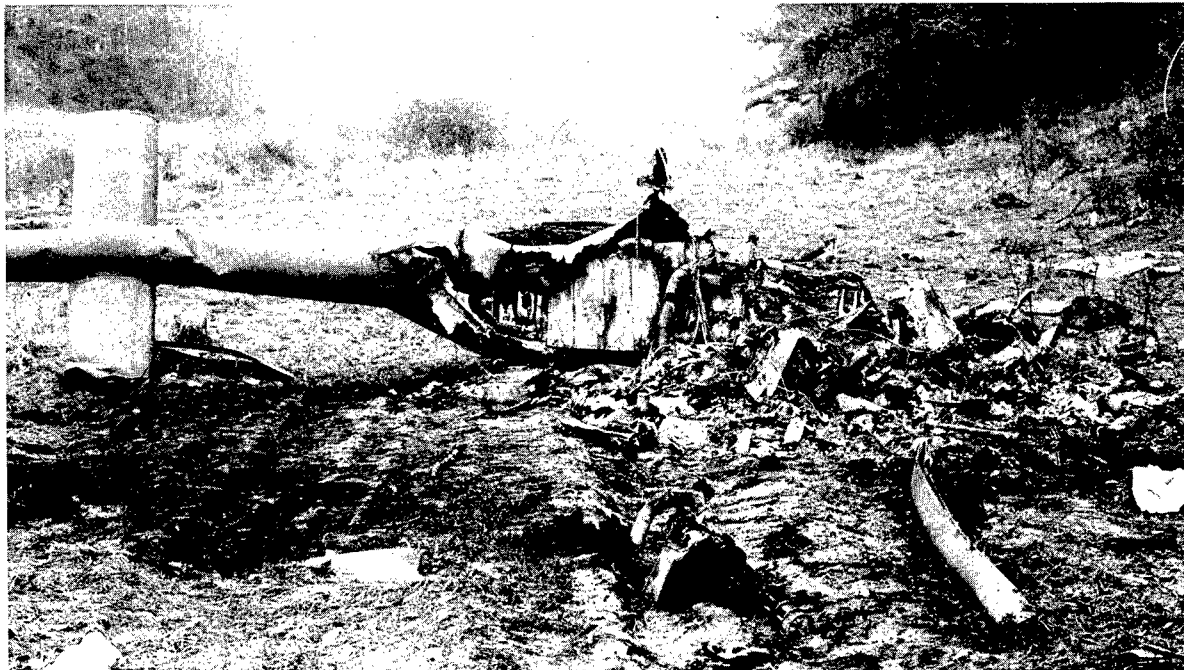
close to the ground. It entered a small valley in which three strands of 1-inch wire cable were strung from power poles on both sides of the valley. The aircraft was flying approximately 30 to 40 feet above the ground with the troop-carrying ship to the left rear and above the lead ship. The pilot of the troop-carrying ship advised the scout ship that the valley contained wires. The pilot of the OH-58 acknowledged and was seen to increase his altitude for a short while and then return to his previous low altitude. After about 1 minute, the troop-carrying ship again advised the OH-58 pilot that there were wires 30 feet to his front. The OH-58 came up momentarily, descended again, and then appeared to climb just prior to hitting the wires. It contacted the wires at 42 feet AGL. Breaking through the wires, the pilot made a left pedal turn approximately 200 degrees and the OH-58 continued to the ground in an apparent controlled attitude. Upon impact with the ground, it exploded into flames and came to rest on its left side. There were two fatalities. The cause of the accident was attributed to the aviator flying at an unnecessary low altitude and high air-speed for mission accomplishment and failure to respond to a warning of imminent wire dangers.

OH-58 pilot flew too low and helicopter struck wires, crashed, and burned.

A probable or suspected cause was listed as improper supervision within the unit of flight planning procedures, disregard of basic safety regulations, and false impression on the part of the pilot that the powerlines ran parallel to the intended route of flight.

1. Proper flight safety rules be established and strictly adhered to prior to initiation of concept testing.
2. Current wire maps be made of all areas that are to be used for training. Dissemination

and input of wire information should be spelled out in SOP's. Individuals should be responsible for carrying currently posted wire maps.

3. Preflight briefings should be comprehensive and include weather, wire location, and heights of any known obstruction to flight.

4. Command emphasis be placed on procurement of Nomex fire retardant flight suits and gloves.

5. All wires in major training areas be marked with reflective devices.

6. The fuel cell of the OH-58 be redesigned or included in the Army aircraft program of construction of self-sealing, high impact strength fuel cells.

7. A high reconnaissance of areas be conducted prior to initiation of any low level flights through the area.

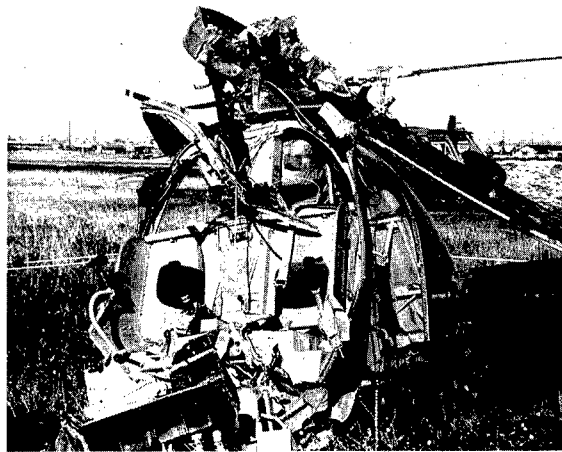
The pilot of an OH-6A was preoccupied by the low level visual recon he was making and failed to see wires stretched between two spans of a river bridge. A wire caught the left skid, ripping it off and sending the helicopter into a left nose low attitude. It hit the water at an estimated 80 knots and sank. The crew of three escaped with one minor injury.

Wire caught left skid of OH-6A during low level recon of river. Helicopter crashed in water and sank.

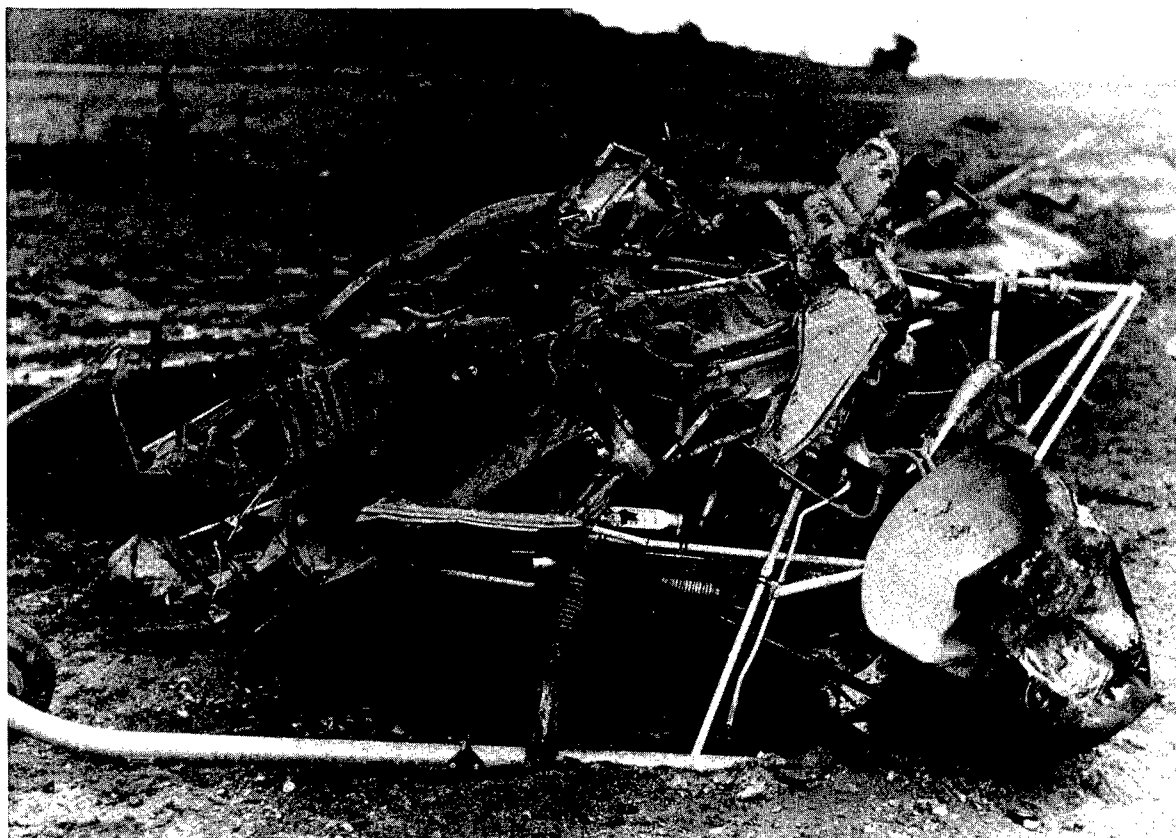
Although restricted visibility is not a significant factor in the overall wire strike problem, this report did reveal cases in which visibility was involved. For example, a TH-55A crashed when the instructor pilot and student were on a cross-country navigation training flight. The instructor pilot was one of two controlling other cross-country aircraft. Shortly after takeoff from the second landing point, the IP transmitted that he was penetrating a squall line. Approximately 1 hour later, the TH-55 struck two high voltage powerlines, resulting in total loss of the helicopter and two fatalities. The cause of this accident was established as operator error, caused by flying in weather that was less than prescribed VFR minimums at an altitude less than 500 feet above ground level which was in violation of written directives.

The probable or suspected cause was listed as supervision due to failure to adequately analyze the forecast weather and the primary controller allowing the TH-55A and his own helicopter to be flown in weather conditions which were less than prescribed VFR minimums. It was recommended that:

IP violated written directives by flying too low and TH-55A struck high voltage powerlines and crashed.

1. Current directives concerning minimum flight altitudes be reviewed with all personnel, with emphasis being placed on strict compliance with all directives.

2. Current directives concerning how to conduct missions in marginal weather conditions be reviewed with all personnel.

3. All personnel receive instruction in the interpretation of current weather forecast terminology.

4. The importance of closely monitoring

weather briefings be emphasized to all flight personnel.
