**OV-1 MISHAP EXPERIENCE REPORT**

FY 1972 through FY 1974

by  
Mr. Paul R. Ewing

Environmental Factors/Fixed Wing Division  
Directorate for Aircraft Accident Analysis and Investigation

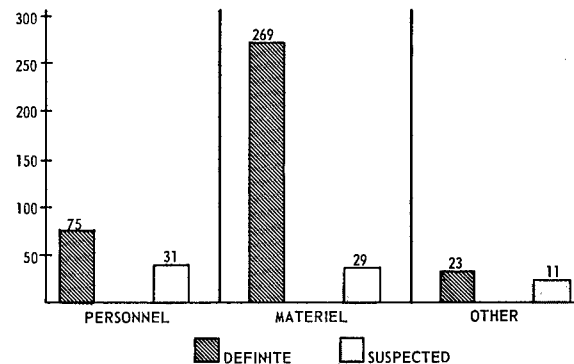
FIGURE 1.—Cause Factors for 376 Mishaps

Three hundred and sixty-seven definite and 71 suspected cause factors were recorded for the 376 mishaps reported. These are shown in figure 1. For the 58 damaging mishaps, 70 definite and 36 suspected cause factors were recorded (figure 2). A brief comparison of figures 1 and 2 reveals that although a majority

of mishaps involved materiel cause factors, personnel cause factors were predominant in the damaging mishaps.

Although materiel dominated the definite cause factors recorded for all mishaps (72%), personnel was recorded as the leading definite cause factor in damaging mishaps (53%). Twelve (21%) of the damaging mishaps accounted for \$13,436,402 (99%) of the damage and all of the injuries and fatalities. Materiel factors referenced in this report include failure of parts and components from all causes, i.e., prior over-stress, improper maintenance, etc.

More exacting standardization, especially in the area of emergency procedures, and increased command emphasis on the use of checklists, will serve to reduce the number and severity of mishaps resulting from personnel cause factors.

Immediate reporting of all materiel deficiencies through the Equipment Improvement Recommendation (EIR) program in accordance with TM 38-750 is the best method we have of reporting unsatisfactory equipment and influencing improvements and/or modifications when necessary. With improved materiel and components, materiel-related mishaps will decline.

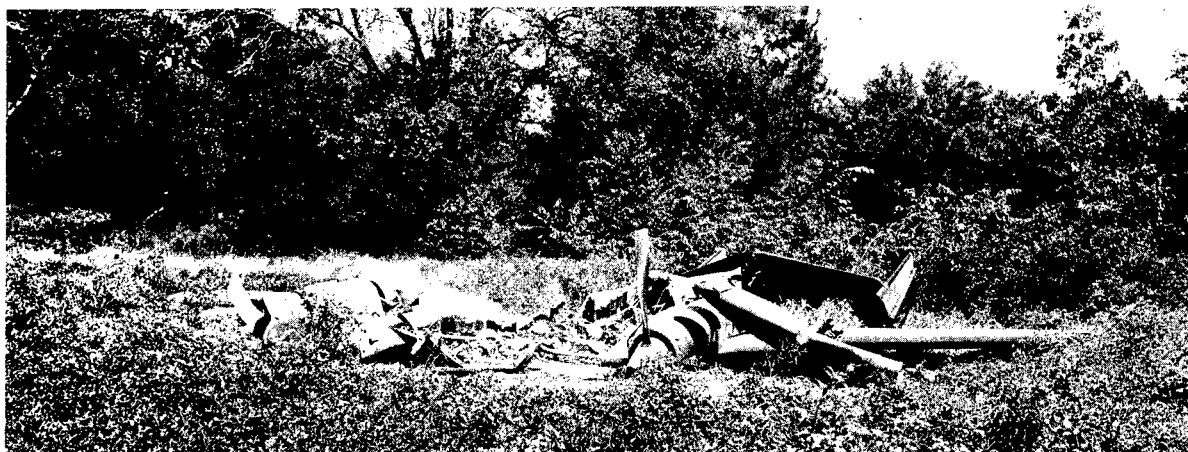
ACCIDENT NO. 1

ACCIDENT NO. 1-IP and pilot took off for a checkride and climbed to 7,500 feet. After entering the upper airwork area, IP had pilot do some unusual attitudes, including recovery from near vertical flight and inverted flight. Pilot went into series of power-on stalls in cruise configuration (clean), then with gear and flaps

extended (dirty) at approximately 10,000 feet msl. IP took control of aircraft and placed it in power-on "dirty" stall while pilot diverted his attention out the left window. Before relinquishing control of aircraft, IP pulled No. 1 engine fire handle, thus shutting the fuel off to No. 1 engine to practice an actual engine failure.

Since the fuel is shut off at the wing root, approximately 4 to 5 seconds are required before the engine actually quits. As pilot lowered nose, engine quit. Pilot then moved power lever of No. 2 engine to what he thought would produce 60 pounds of torque. Both aviators later commented that approximately 80 pounds of torque was developed by No. 2 engine. At that time, the aircraft rolled into a 30° left bank with a slight nose-down attitude. Pilot applied full right rudder and aileron, reducing the left bank to approximately 10°. IP took control and moved No. 2 engine power lever to flight idle while still applying right rudder and aileron. At this point, aircraft suddenly snapped to left, pitched down, and entered spin. IP then feathered propeller of No. 1 engine, retracted landing gear and speed brakes, and reduced flap setting from 45° to 15°. Noticing the extreme nose-down attitude, IP retracted remaining flaps while still maintaining right rudder and aileron. Aircraft then pitched up and continued spinning rapidly to left in near level attitude. The altimeter was indicating approximately 9,500 feet msl when the aircraft banked to the left approximately 45°. Aircraft then returned to level attitude. IP tried various control inputs during descent and, at approximately 7,500 feet, he told pilot to eject at 5,000 feet. At 5,000 feet the IP ejected and at approximately 4,500 feet the pilot ejected. Both ejections were successful.

This accident was caused by the IP placing the aircraft in a dangerous situation in that he induced an actual engine-out condition with the aircraft in a stall attitude with landing gear, flaps, and speed brakes extended. IP was not

knowledgeable of the proper spin recovery techniques for the OV-1 as outlined in TM 55-1510-204-10/4.

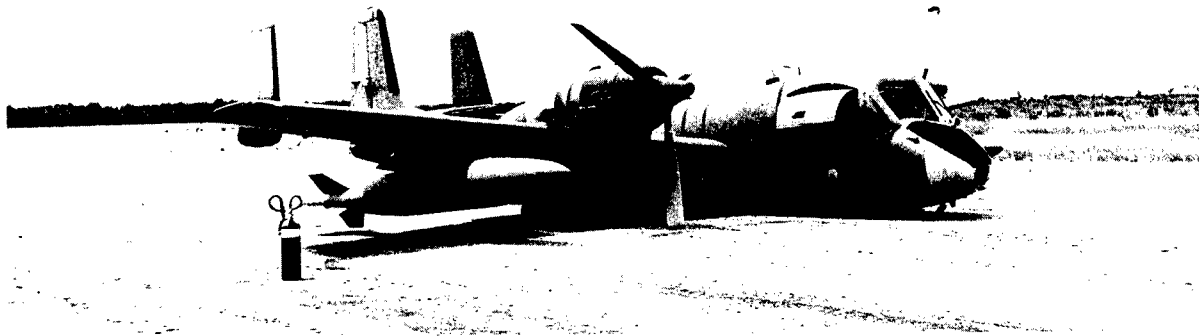
#### ACCIDENT NO. 4

ACCIDENT NO. 4—During training flight, IP gave pilot simulated single engine on takeoff. Pilot established single engine flight, flew the pattern, and landed without difficulty. During

the next traffic pattern, IP initiated simulated single engine as pilot was turning base leg. Landing gear was retracted and single engine flight was established. When landing was assured pilot extended gear and made prelanding check. Pilot turned final and aircraft was landed gear up. Aircraft slid to stop on runway and IP and pilot exited.

The suspected cause of this accident is that the rated student pilot initiated gear retraction during the final moments before touchdown, and the IP failed to recognize this soon enough. A suspected contributing factor is that the student pilot had a significant marital problem which was unresolved at time of accident. This could have served as a distracting influence.

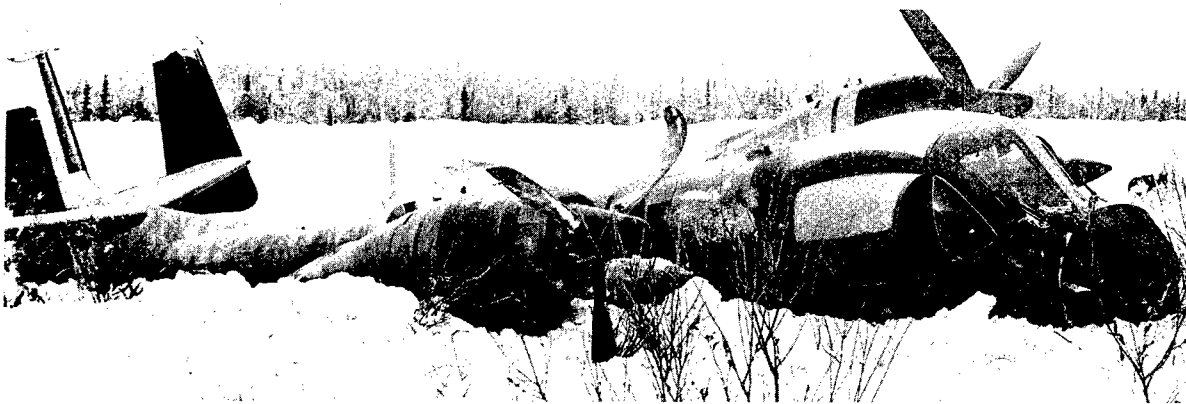
ACCIDENT NO. 6

ACCIDENT NO. 6—Pilot started aircraft and allowed temperatures to rise to normal. He then moved aircraft to runup area and performed normal runup, including cycling the propellers three times from low to high pitch. After approximately 20 minutes, pilot called for airport advisory and was given runway, winds, altimeter setting, and temperature. The runway surface condition was not included in the advisory. Pilot then taxied down runway 19 to avail himself of winds which favored runway 01. After he had taxied approximately 1,870 feet and attained a speed of 25 to 30 knots, he initiated the reverse check. At this time the No. 2 propeller failed to reverse. As rpm increased in both engines with No. 1 propeller in reverse and No. 2 at or near low pitch, aircraft began to turn to left. Pilot recognized the situation and began corrective action to realign aircraft on runway, applying right brake and rudder and moving

engine condition levers from reverse to ground idle position. This action had little effect on aircraft's ground track and pilot applied power to No. 1 engine in an attempt to check this movement, while continuing to apply right brake and rudder. At this point, aircraft had turned approximately 50° to 60° to left and pilot attempted to reverse propellers again. Realizing he had little or no control of aircraft at this point pilot began to prepare for impact. Both propellers were placed in feather position and aircraft departed runway 430 feet after initial application of reverse thrust and right main landing gear braking. Aircraft passed through an area of loose snow, crossed parallel access road, and skidded into large hard-packed snowbank.

The speed at which the aircraft was taxied before application of reverse thrust was excessive. The reason for the excessive speed was attributed to poor judgment on the part of the pilot and the lack of adequate ground reference points due to the snow-covered terrain. The application of differential power and the subsequent attempt to reverse only aggravated the already deteriorating situation.

A break in a wire leading to the No. 2 propeller reversing switch located on the No. 2 engine condition lever rendered the system inoperative. It is suspected that extreme cold temperatures and continued flexing of the wire during previous normal operations caused it to break.
