OH-6A

MISHAP EXPERIENCE REPORT

OH-6 MISHAP EXPERIENCE REPORT

1 July 1967 through 30 June 1971

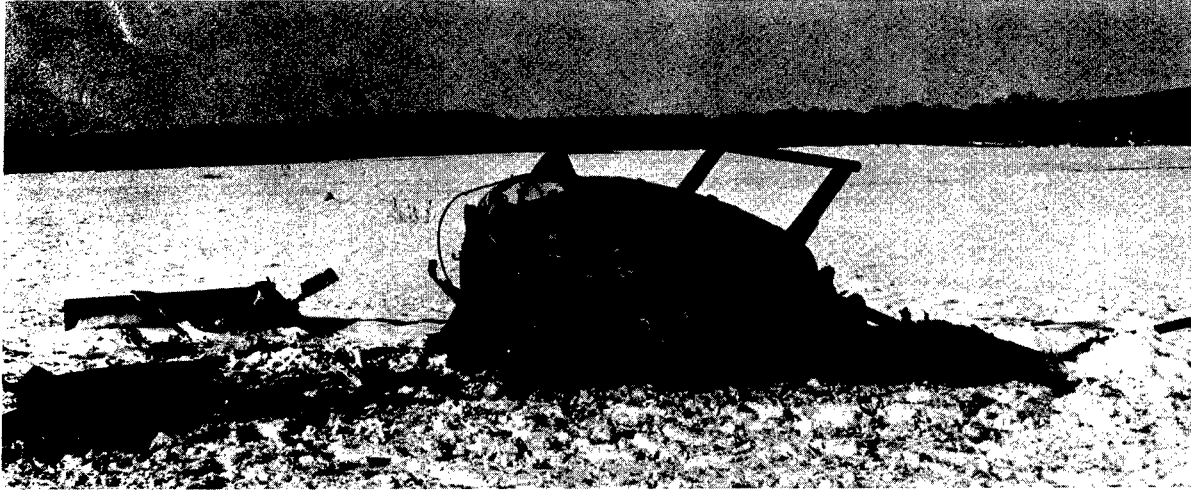
ACCIDENT NO. 1—Both pilots experienced vertigo in blowing snow.

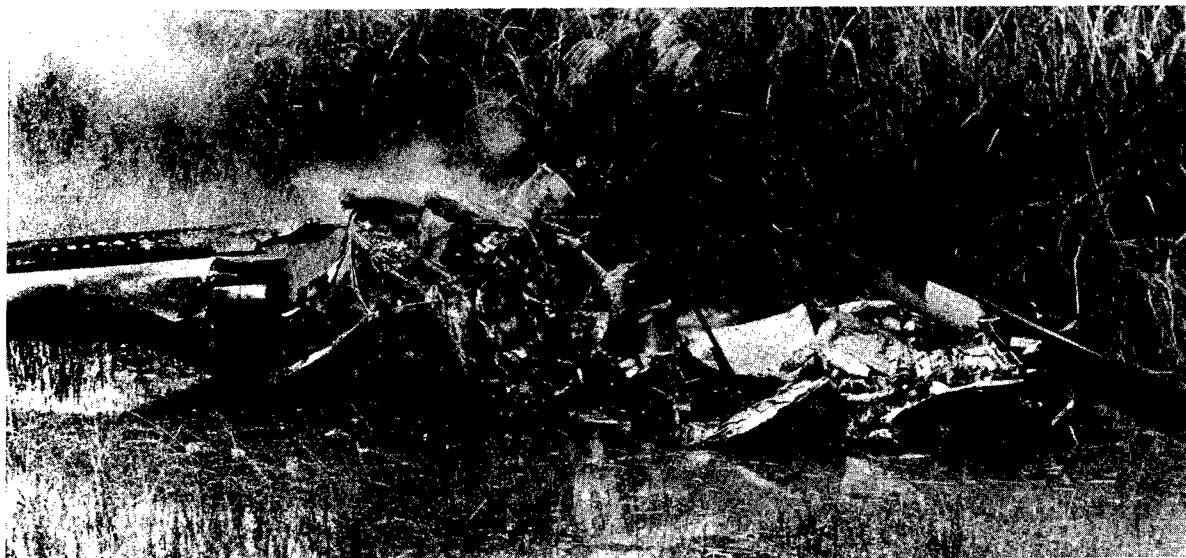
ACCIDENT NO. 6—Gunner was dropping fragmentation grenades from aircraft in attempt to destroy footbridge. Explosion occurred in passenger compartment and compartment was engulfed in flames. Explosive force knocked pilot's feet off pedals and broke out chin bubble. Emergency landing was made and pilot and observer escaped. Aircraft was consumed by fire with the gunner still in his seat. There was one fatality and one major injury. Aircraft was destroyed. Caused by gunner dropping live grenade on passenger compartment floor.

ACCIDENT NO. 6—Gunner dropped live grenade on passenger compartment floor.

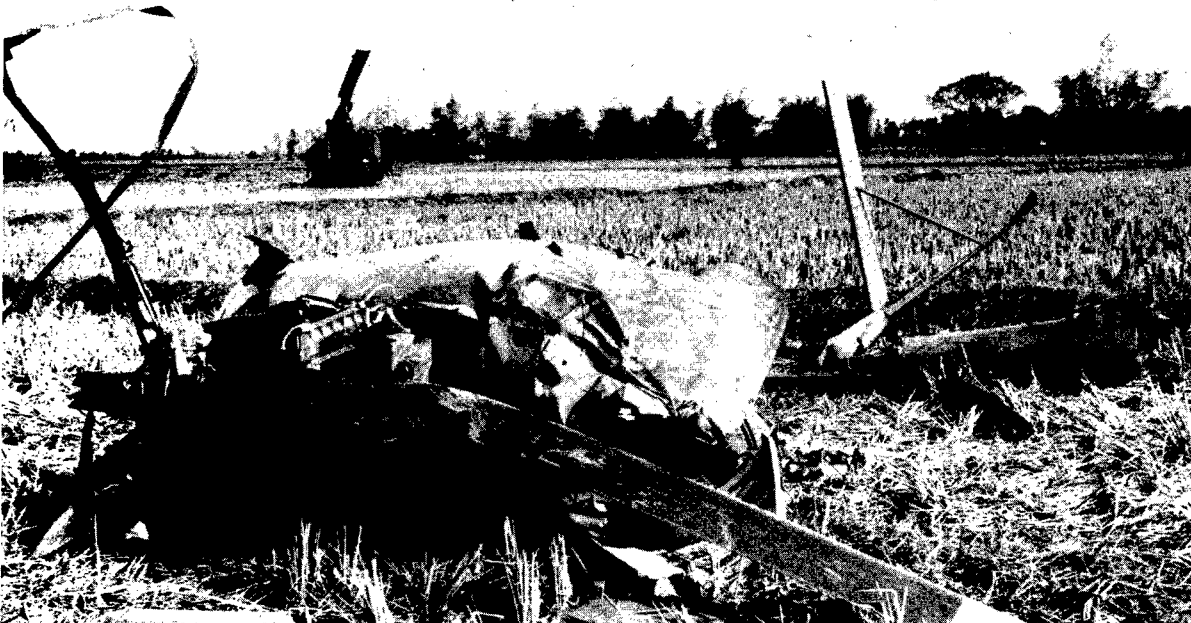
ACCIDENT NO. 9—Result of improper preflight, low fuel, and unnecessary and erratic low level flight.
