NATIONAL TRANSPORTATION SAFETY BOARD

SAFETY STUDY

Emergency Evacuation of Commercial Airplanes

**NTSB/SS-00/01
PB2000-917002
Notation 7266
Adopted June 27, 2000**

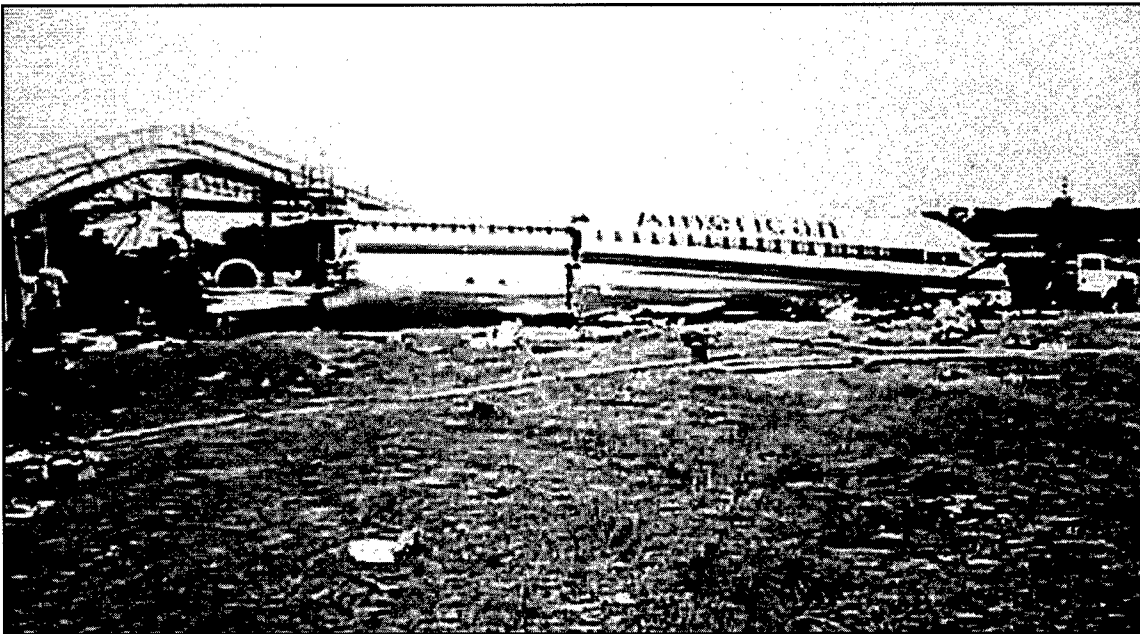
In the MD-82 accident in Little Rock, Arkansas (case 45), the crash forces caused seats to break free from their seat tracks and block aisles. In the forward portion of the cabin, passengers had to navigate around fallen overhead bins and across a severely deformed floor. Fortunately, the crash caused several gaps in the fuselage that passengers were able to use for egress. As seen in figure 5–3, the crash forces split the cabin in two separate sections divided at the wing.

Figure 5–3. View of the McDonnell Douglas MD-82 accident scene that involved evacuation on June 1, 1999, Little Rock, Arkansas (case 45).

Based on the circumstances of the evacuation in this accident, the Safety Board recommended that the FAA

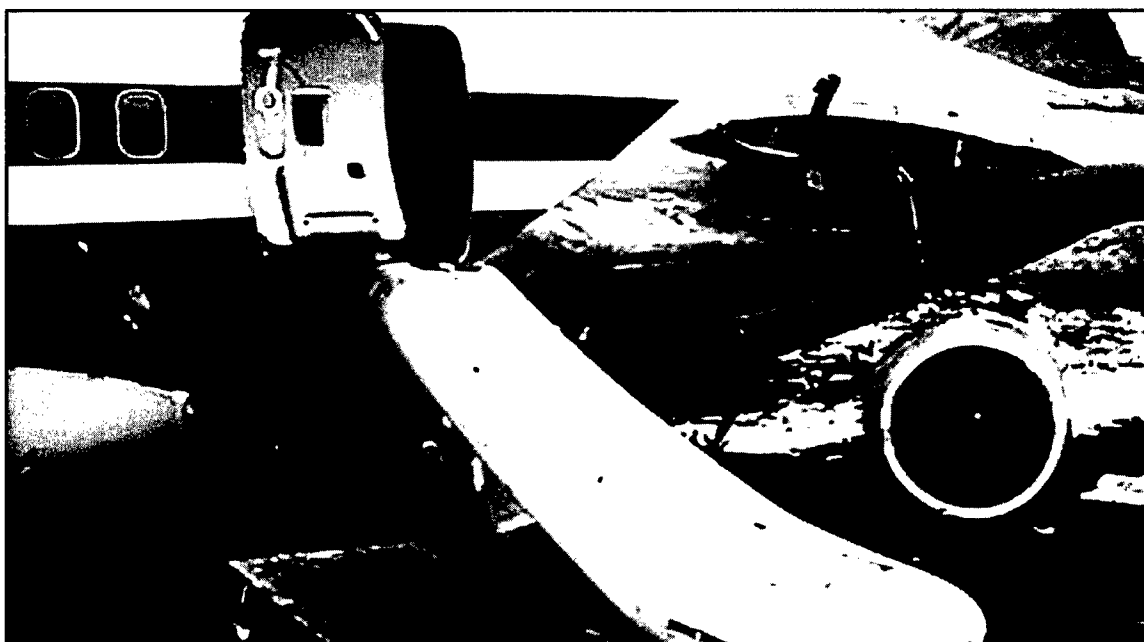
In the 727 accident in Chicago (case 9), the aircraft landed short of the runway, striking a light structure and the runway threshold. A liferaft ceiling panel door⁵³ fell open, blocking the main aisle to the L1 exit.⁵⁴ The flight attendant assigned to the L1 exit decided not to use the exit because the ceiling panel blocked access to the exit. Passengers evacuated through the R1, overwing, and L2 exits (figure 5–4).

Figure 5-4. View of a slide used in the Boeing 727 evacuation on February 9, 1998, Chicago, Illinois (case 9).

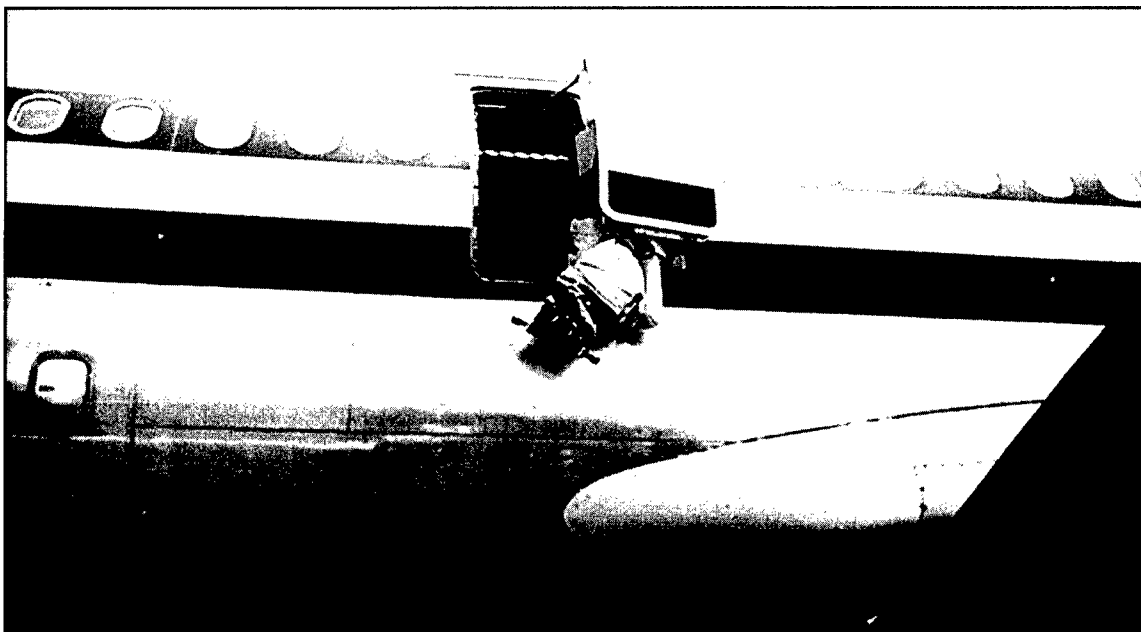
Seven passengers reported that they had difficulty attempting to open an airplane floor level exit door during their evacuation: five were involved in the evacuation of the MD-82 in Little Rock, Arkansas (case 45); one was involved in the evacuation of an A300 in San Juan, Puerto Rico (case 24); and the last was in the evacuation of a 727 in Chicago, Illinois (case 16). Three Little Rock passengers attempted to open a floor level exit door leading to the tailcone; the door exit could not be opened because of a deformation in the floor of the airplane. The two other Little Rock passengers attempted to open inoperable forward floor level exit doors. The 727 passenger reported opening the L2 door 10 inches before it “jammed.” Finally, the A300 passenger attempted to open the R3 door that had not opened as intended after a flight attendant first tried to open the door (figure 5-5).

Figure 5-5. View of the R3 door that failed to operate as intended following the Airbus 300 accident on July 9, 1998, in San Juan, Puerto Rico (case 24).

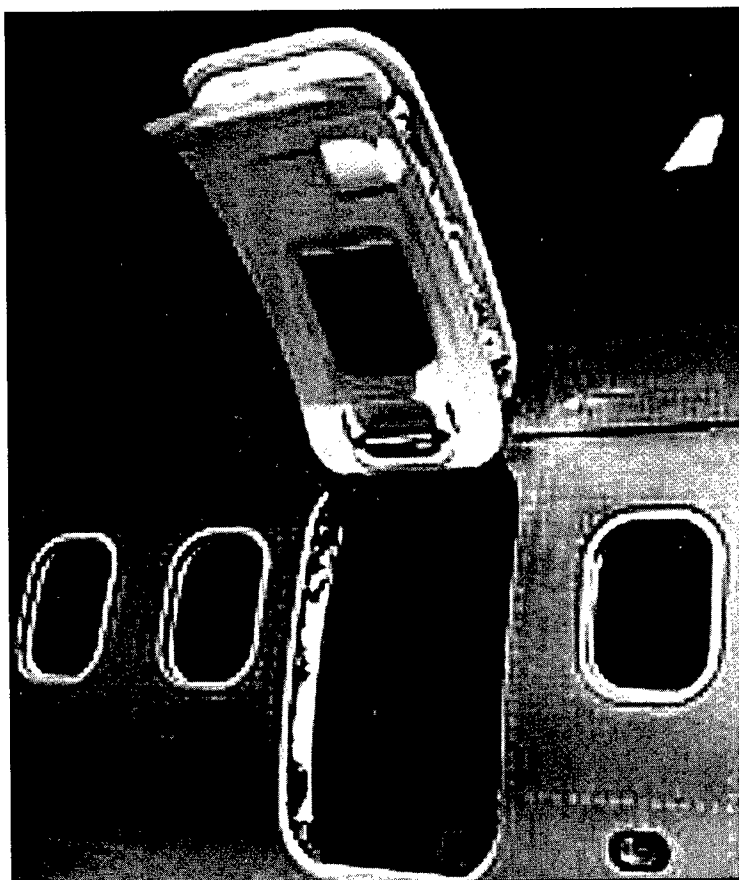
⁶¹ This issue relates to Boeing's intent to increase the passenger count on the 737-600/700/800 series aircraft. The European Joint Aviation Authorities (JAA) determined that they would only agree to an increased passenger count if there was a significant change to the cabin configuration. Boeing developed the new Type III hatch in order to meet the JAA position.

Figure 5-6. View of the newly designed Type III exit for the Boeing 737-600, -700, -800, -900.
