Damage mechanisms and non-destructive testing in the case of water ingress in CF-18 flight control surfaces

Technical Memorandum

DCIEM TM 2000-098

August 2000

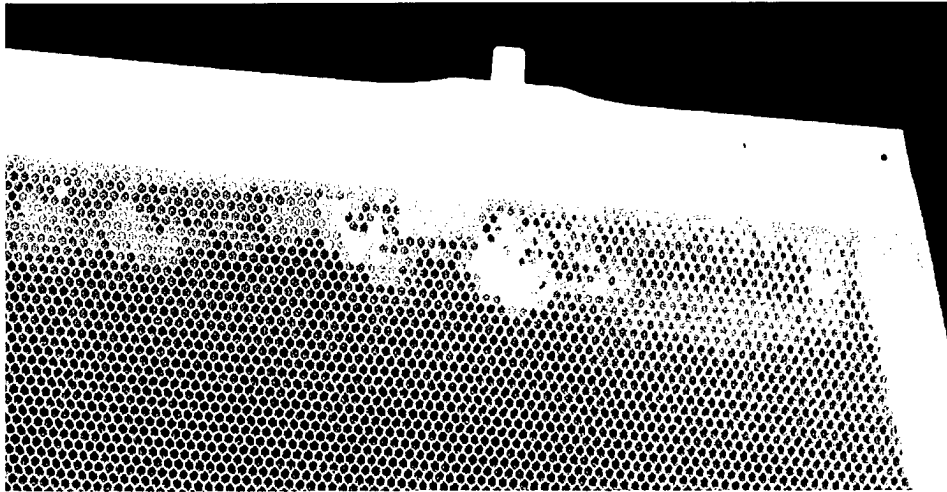
X-rays are routinely used in the field for core damage (including corrosion) and the procedure is available for the inspection of CF-18 flight controls [29]. Of all applicable NDT techniques, radiography is considered the most effective for detecting core damage [1]. X-ray also has the potential to detect disbands under some circumstances and provided that technicians have proper training and experience.

Figure 8. X-Ray inspection results showing water along the leading edge of the rudder.
