AIRCRAFT ACCIDENT REPORT

In-flight Breakup Over the Atlantic Ocean
Trans World Airlines Flight 800
Boeing 747-131, N93119
Near East Moriches, New York
July 17, 1996

**NTSB/AAR-00/03
DCA96MA070
PB2000-910403
Notation 6788G
Adopted August 23, 2000**

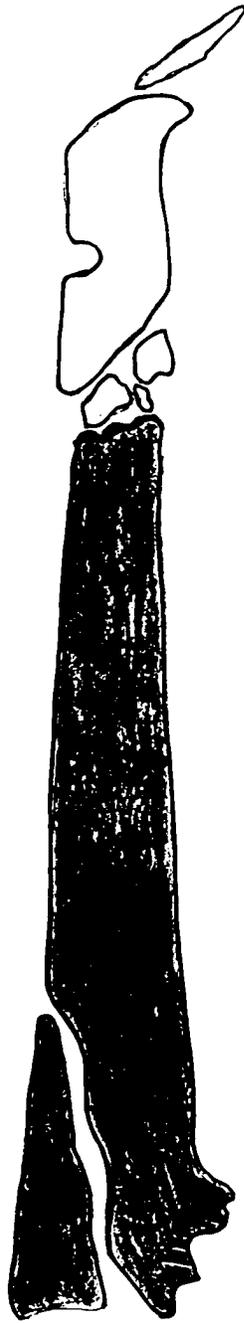
RIGHT WING SOOTING PATTERN DIAGRAM

UPPER SKIN - EXTERNAL SURFACE

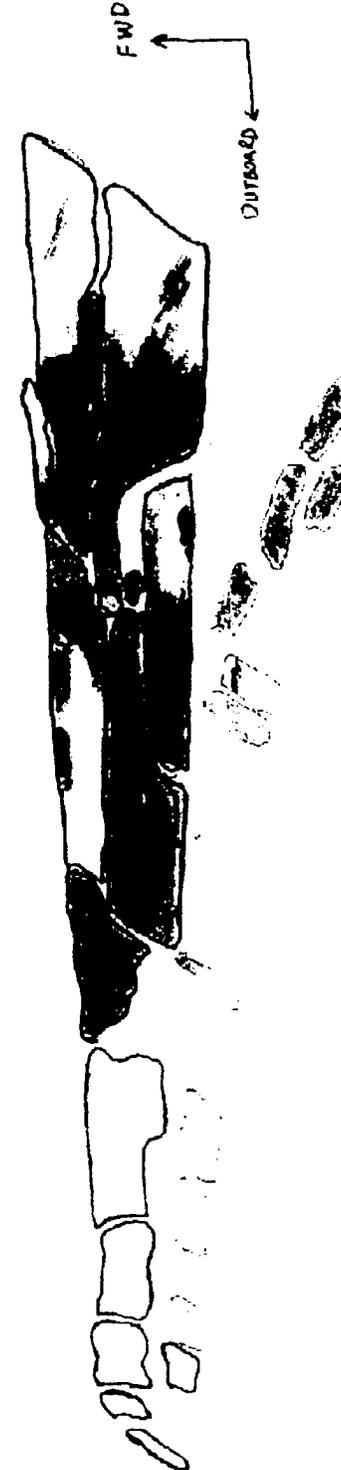
LOWER SKIN - EXTERNAL SURFACE

NOTE: With the exception of the piece noted, of the external surface of the upper skin is clean. The control surfaces do show sooting and fire damage to the composite parts.

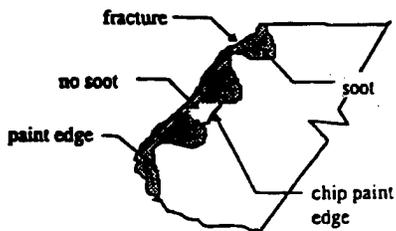
Aft of STA 1600, no sooting is evident internally. On the exterior, there is light to moderate sooting extending aft along the entire length of the fuselage from approximately the main deck window belt on the RHS to approximately S-8 on the LHS

Determination primarily made by examining external paint failures near the fracture edge. Soot deposits remain on underlying paint when the top layer peels near fracture.
