ok
**(OPERATION OF A FORCED CIRCULATION,
HAYNES ALLOY NO. 25, MERCURY LOOP
TO STUDY CORROSION PRODUCT
SEPARATION TECHNIQUES)**

by David B. Cooper

Prepared under Contract No. NAS 5-462 by
THOMPSON RAMO WOOLDRIDGE, INC.
Cleveland, Ohio

NATIONAL AERONAUTICS AND SPACE ADMINISTRATION • WASHINGTON, D. C. • JULY 1965

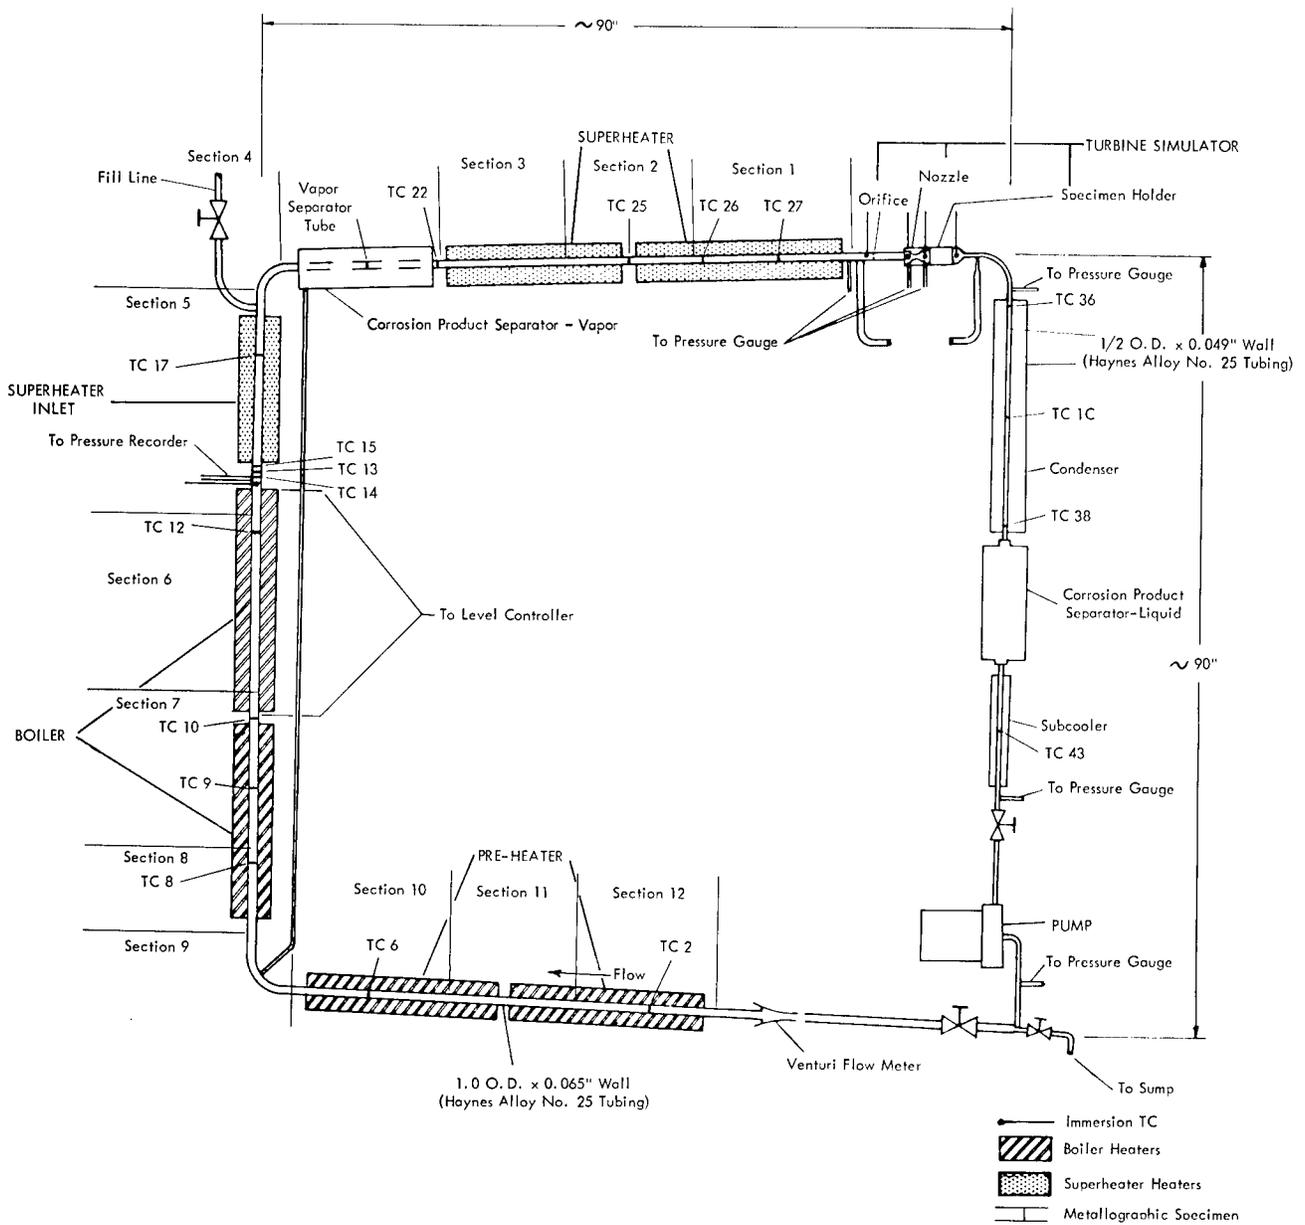
FIGURE 10. SCHEMATIC OF LOOP SHOWING SECTIONING LOCATIONS AND LOCATION OF METALLOGRAPHIC SPECIMENS

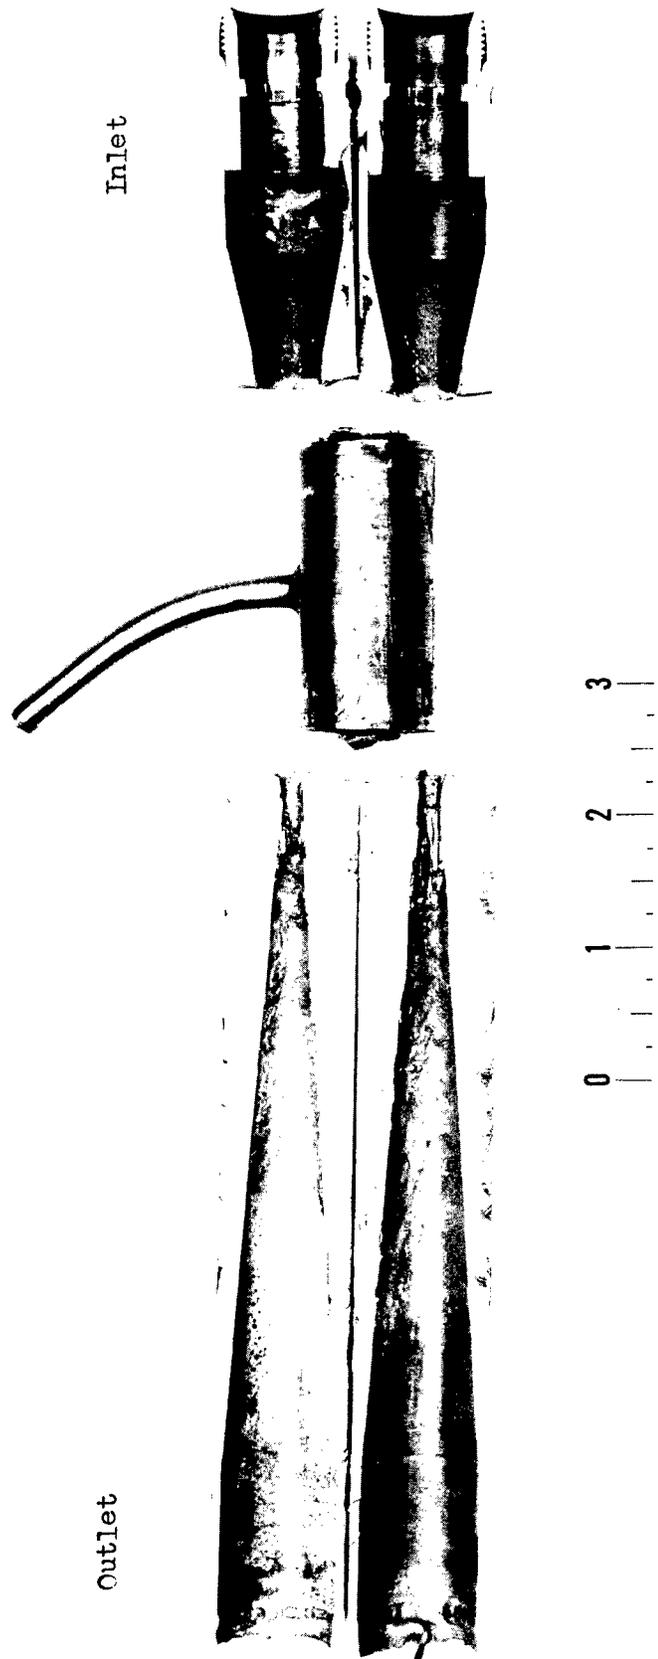
As shown in Figures 11 and 12, the Venturi was found to contain an amalgam which was located on the outlet side in the vicinity of the orifice. The pre-heater (Sections 10, 11, and 12) also contained an amalgam, as shown in Figure 13. Photographs of the boiler are shown in Figure 14. As seen here, the boiler inlet contained a small quantity of a dark deposit while the mid-section and outlet again contained an amalgam. The amalgam extended into the superheater inlet, as shown in Figure 15. From this point on, as the mercury was dried and superheated, the quantity of deposit decreased until the superheater outlet was reached, where an amalgam was again present. The vapor corrosion product separator outlet tube and the superheater mid-section were essentially free of deposit, Figure 15.

Figure 11. Deposition in Venturi.

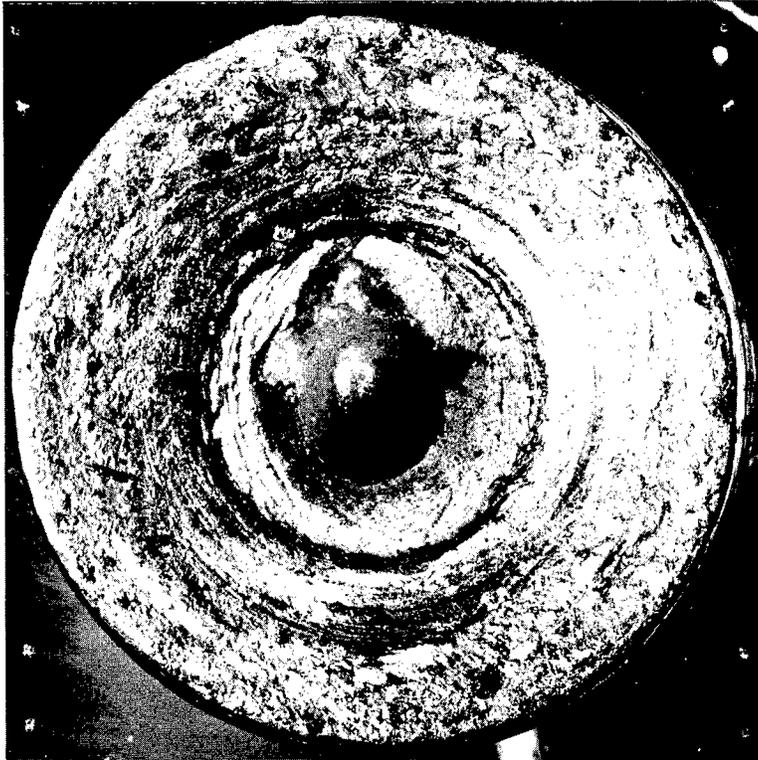
Figure 12. Outlet Side of Venturi Orifice Showing Amalgam Deposit.

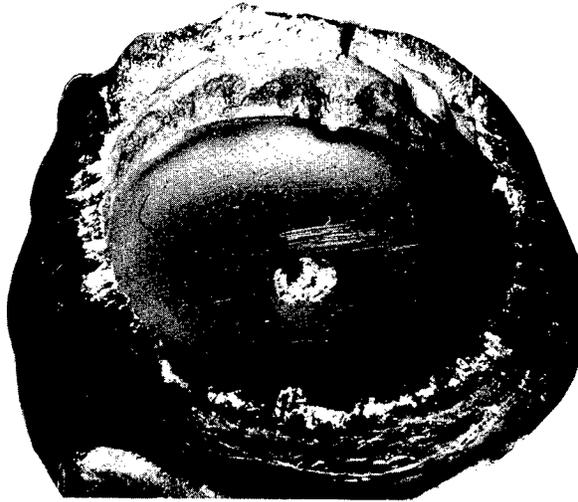
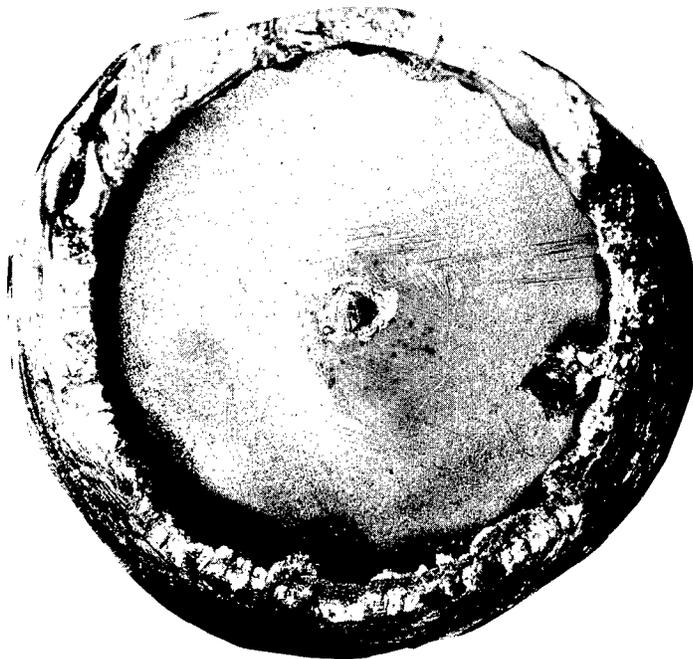
A hard deposit was found in the orifice and is shown in Figure 16. The deposit contained essentially no mercury and was blocking approximately 99.2 percent of the flow passage. The presence of this deposit accounts for the decrease in flow rate in the system during the final hours of operation. However, it is believed that the majority of this deposit was formed during the shut-down operation, since the change in flow rate did not reflect essentially complete blockage.

Figure 16. Deposit Found in Loop Orifice.

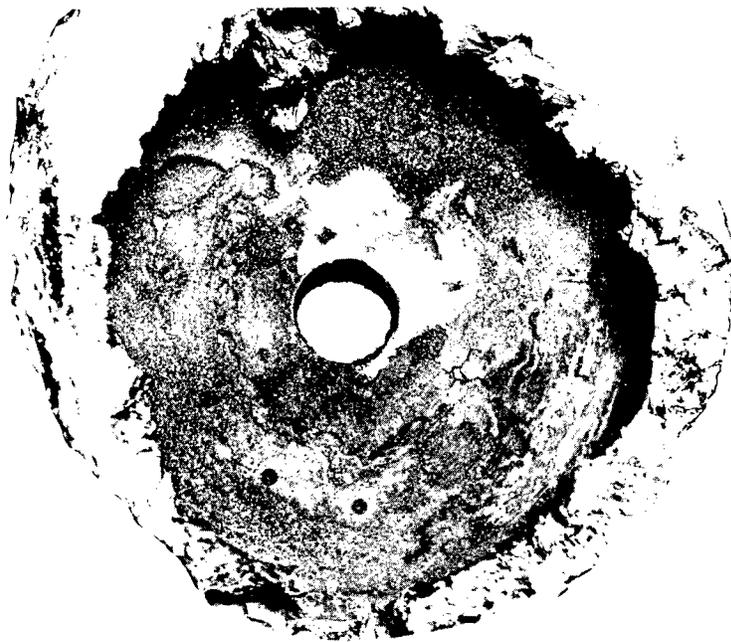
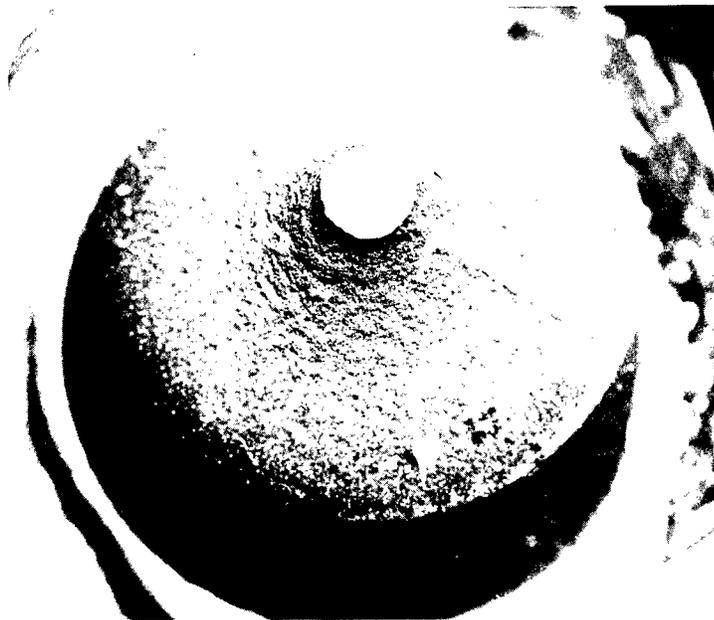
The nozzle was also observed to contain a deposit, as shown in Figure 17. Although there was a small amount of deposition on the inlet side, the majority of the deposit was found on the outlet.

Figure 17. Deposit Found in Loop Nozzle.

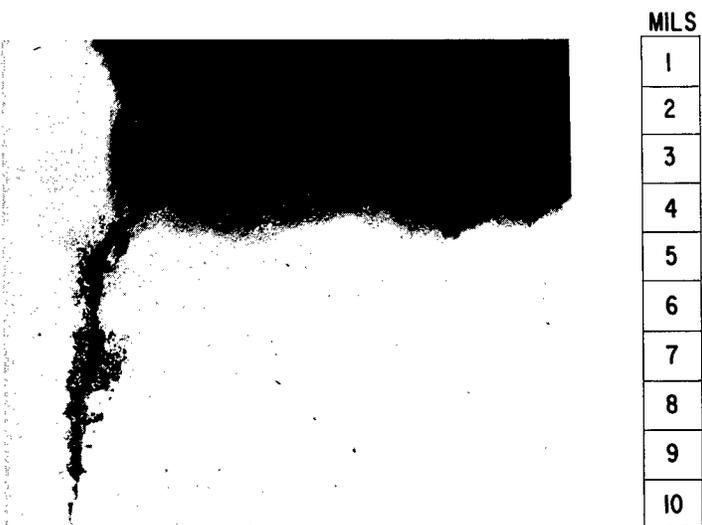
a) Section 5, TC 14
Weld; Superheater Inlet
(Layer Attack)

Haynes alloy No. 25 fusion welds appeared to be unattacked in all cases except in the vapor section (No. 5) of the boiler. Corrosion was present at the weld and in the crack, Figure 21a. Corrosion was manifested as a depleted layer.

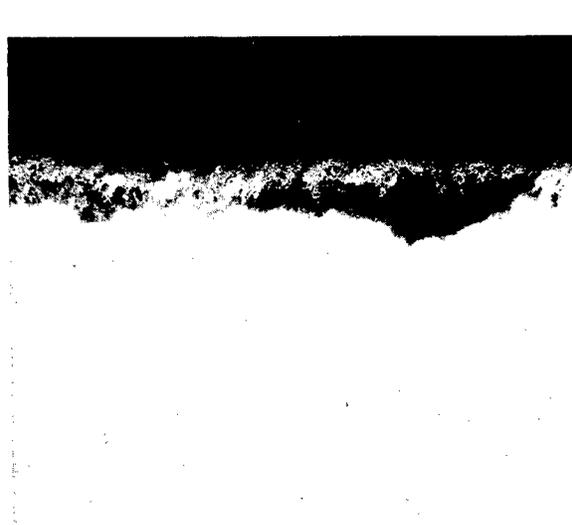
b) Section 5, TC 14
Superheater Inlet
(Layer Attack)

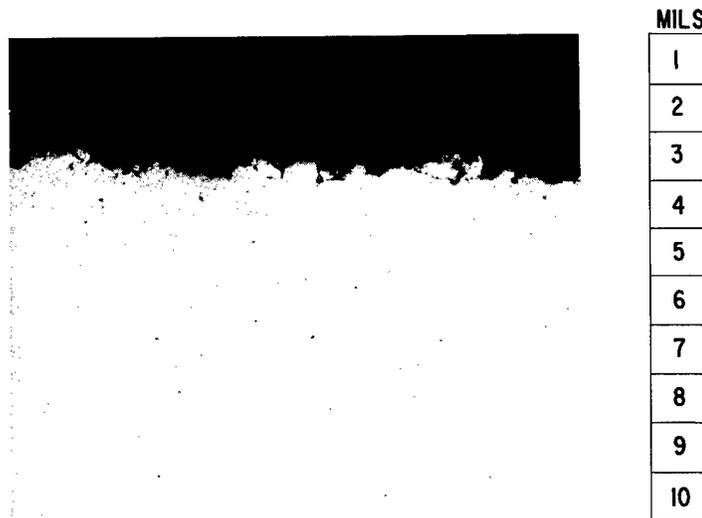
c) Section 5, TC 17
Superheater Inlet
(Crevice Attack)

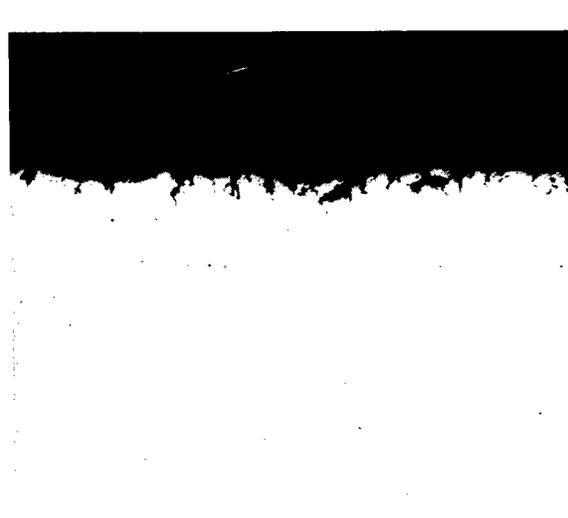
d) Vapor Corrosion Product
Separator Filter Tube
(Crevice and Intergranular Attack)

The vapor corrosion product separator was attacked to a depth of 1.9 mils in the 1130°F temperature zone. Corrosion was manifested as both intergranular and leached layer attack (see Figure 21d). Attack diminished to 1.1 mils penetration in the superheater mid-section as vapor quality improved, Figure 22a. Corrosion was of the crevice type. In the last quarter of the superheater (outlet), a substantial deposit was observed, Figure 22b. The maximum thickness of this deposit was seven mils. Swirl wire attack in the vapor portion of the loop generally was of the intergranular type and varied between 0.3 and 1.35 mils, Figures 23e and 24b and Table 3. Only the Haynes alloy No. 25 swirl wire in the vapor region contained cracks as contrasted to the lack of cracking in the liquid-contacted sections, Figure 24. The swirl wire was cold-worked as a result of swirl forming.

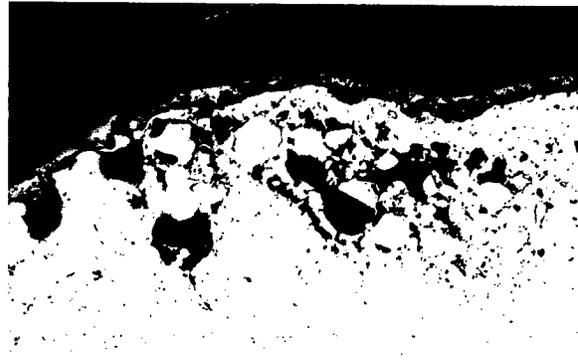
a) Section 2, TC 25
Superheater Mid-Section
(Crevice Attack)

b) Section 1, TC 27
Superheater Outlet
(Deposition)

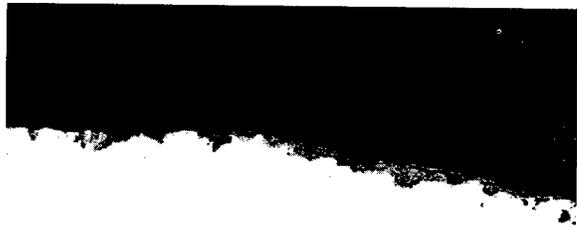
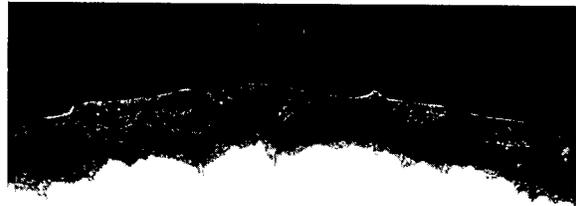
a) Section 12
Pre-Heater Inlet
(Crevice and Layer Attack)

b) Section 11
Pre-Heater Mid-Section
(Layer Attack)

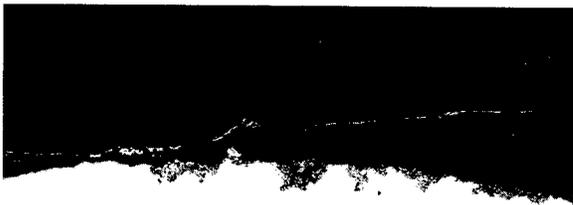
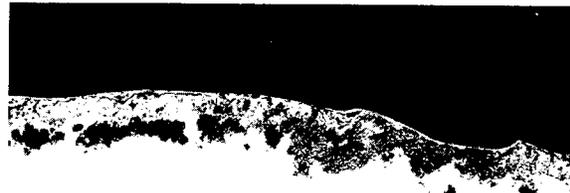
c) Section 8
Boiler Inlet
(Layer Attack)

d) Section 7
Boiler Mid-Section
(Layer and Intergranular Attack)

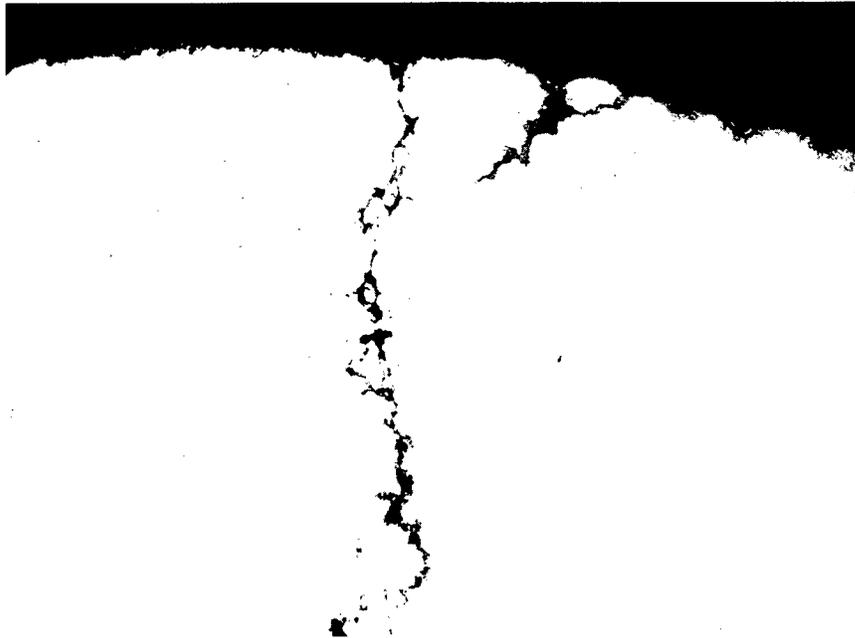
a) Section 6
Boiler Outlet
(Cracking and Layer
and Crevice Attack)

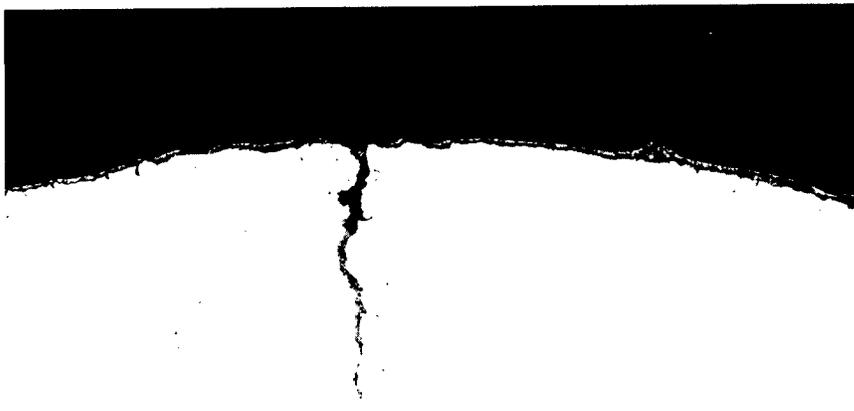
b) Section 2
Superheater Mid-Section
(Cracking and Intergranular Attack)

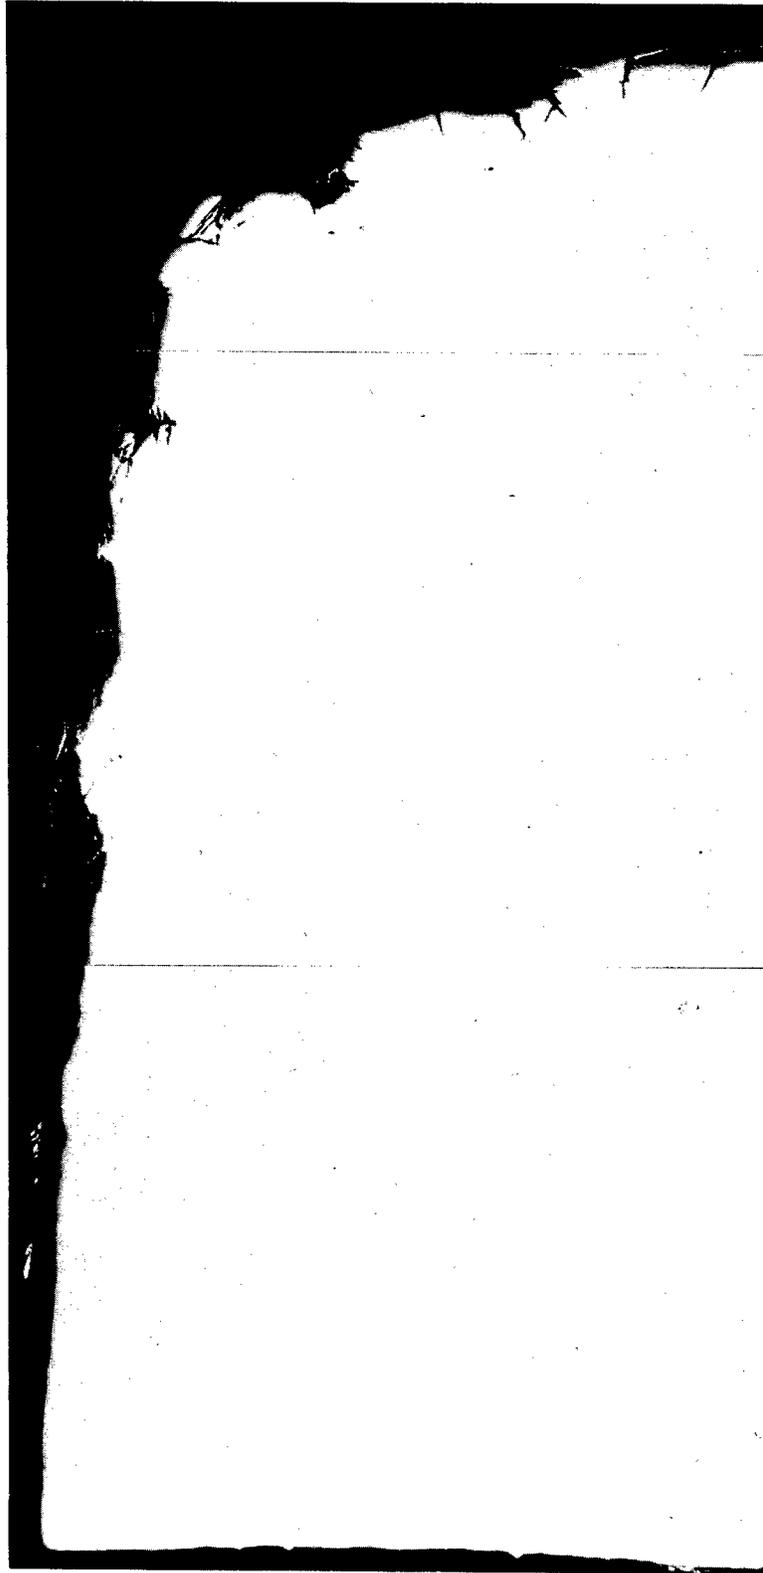
Orifice Opening

Outlet Side

Orifice corrosion was greatest on the inlet side near the wall and measured 7.3 mils in depth, Figure 25. Cracking was also observed at the orifice plate-tube wall junction, Figure 26b. Corrosion up to 1.1 mils in depth was also present on the orifice opening, Figure 26a. The corrosion was manifested as both layer and intergranular attack. The outlet side of the orifice contained deposits which adhered to the orifice wall. The attack was undoubtedly a result of mercury vapor condensation on the orifice plate, since immersion thermocouples recorded 796 and 867°F as the respective inlet and outlet temperatures. The severity of the attack could also be a result of erosive action by the condensing mercury vapor, which is not readily separable from corrosive attack.

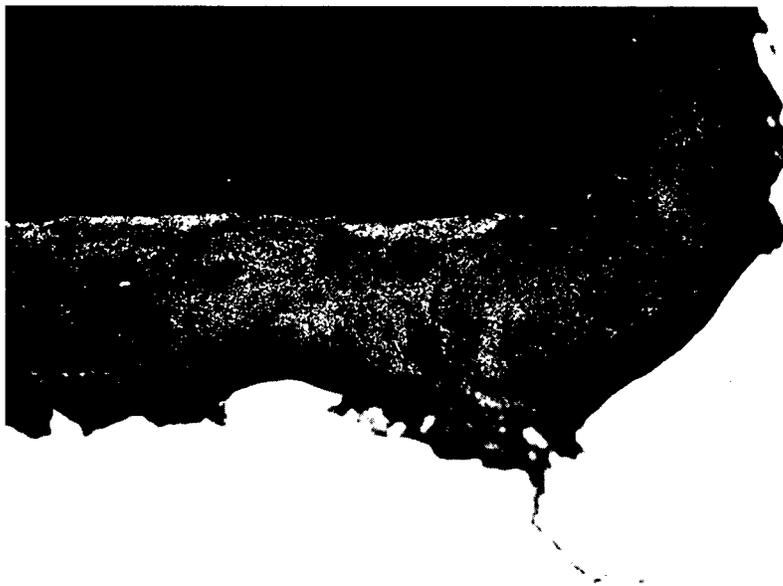
b) At Tube-Orifice Plate Junction

Figure 26. Cross-Section of Orifice on Inlet Side Showing Intergranular Attack Near Orifice Opening and a Leached Layer and Cracking at the Orifice Plate-Tube Junction. Magnification: 250X, Unetched.

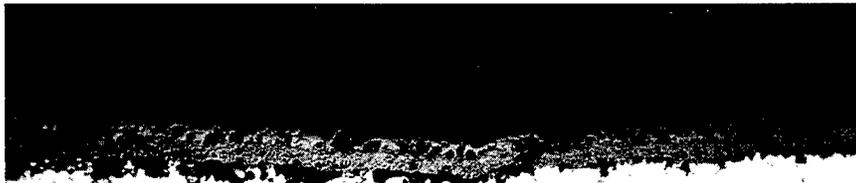
a) Inlet Side Oxidation

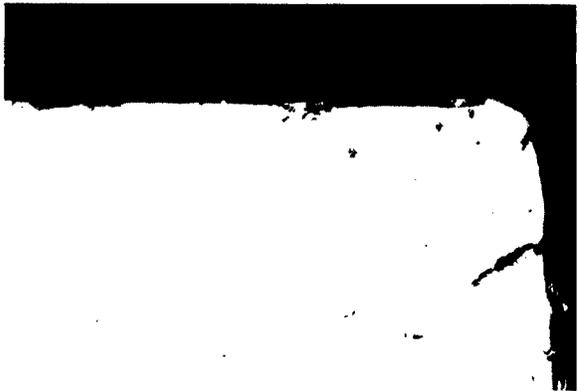
c) No. 3 Nivco 10
(Erosion and
Intergranular Attack)

d) No. 3 Nivco 10
(Deposition and
Intergranular Attack)

Corrosion was also evident in the eroded area. Erosion damage on PH15-7Mo in condition RH 950 (specimen No. 4) was less severe, 1.85 mils, Figure 28e. The increased resistance to erosion of specimen No. 4 over specimen No. 2 was probably the result of the greater hardness of specimen No. 4 (about 3 Rockwell C hardness units). Nivco 10 specimen No. 1 showed no signs of erosion. However, specimen No. 3 showed erosion up to 1.85 mils, Figure 28c.

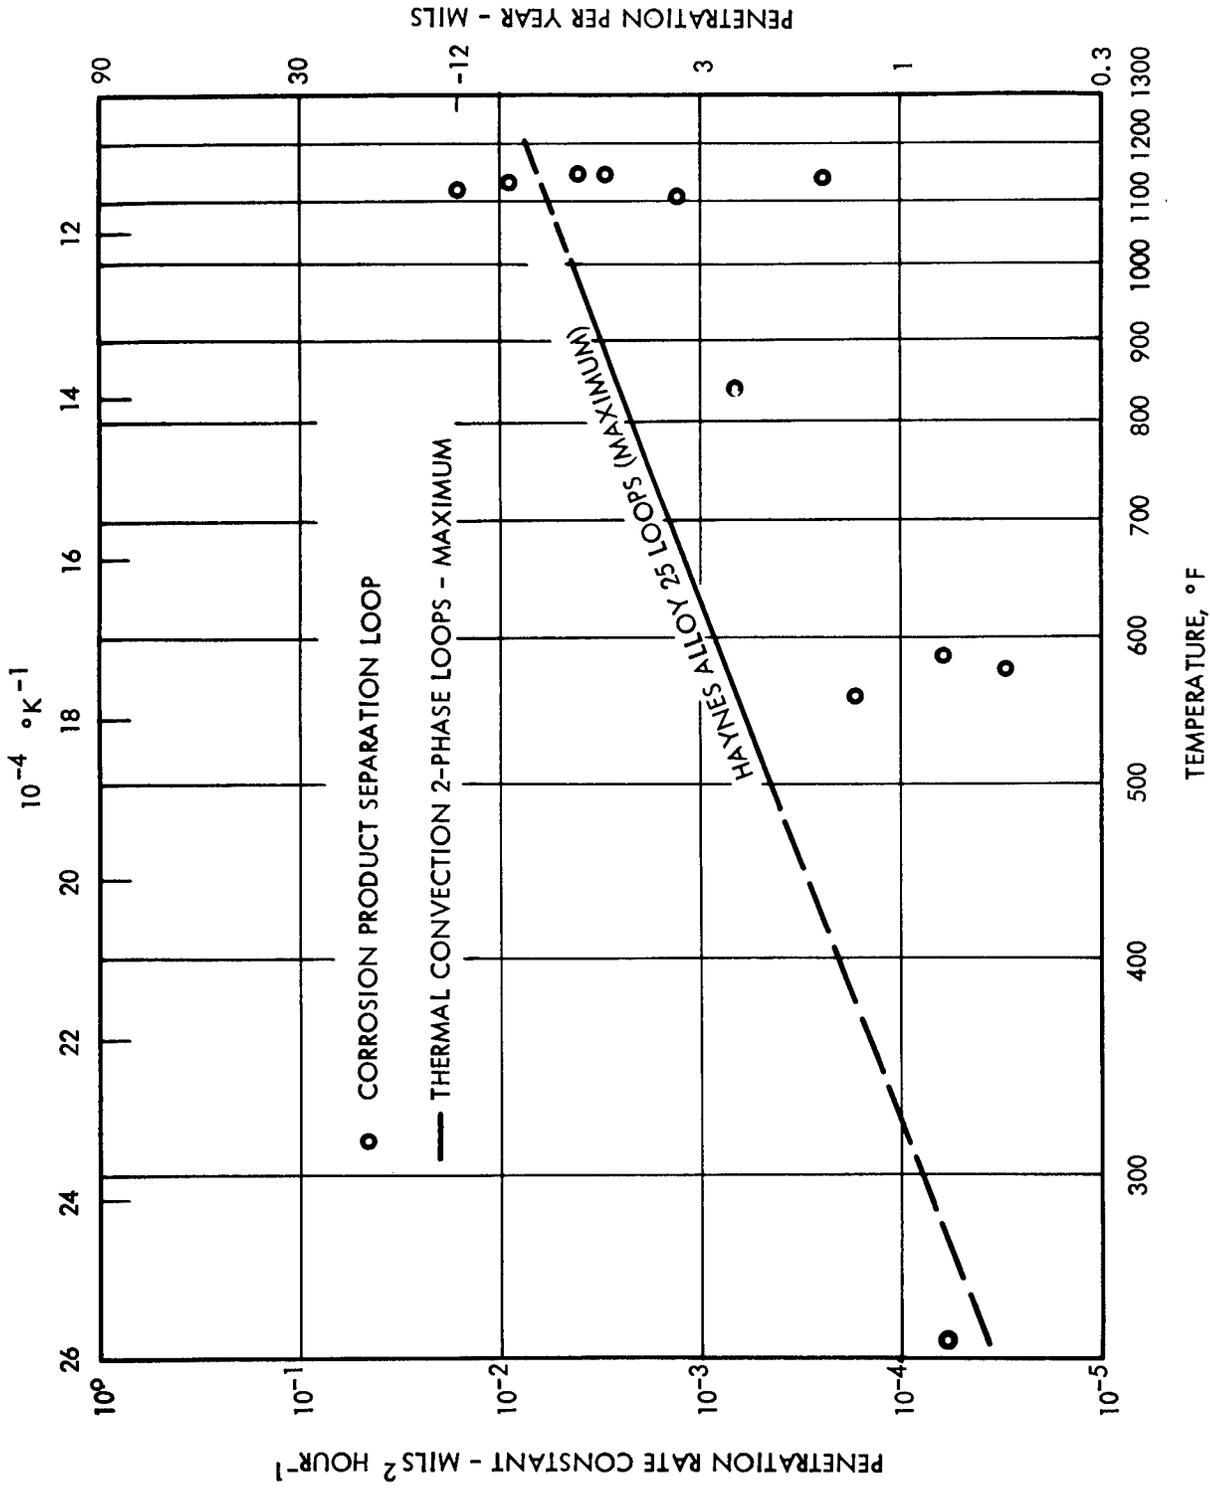
FIGURE 30. COMPARISON OF HAYNES ALLOY NO. 25 MERCURY PENETRATION FROM CORROSION PRODUCT SEPARATION LOOP WITH THERMAL CONVECTION, TWO-PHASE LOOPS (4).

In general, the results indicate that the greatest attack occurred in the low vapor quality regions of the boiling section of the loop and that the attack decreased as the vapor quality increased. Near the outlet of the superheater, where condensation was beginning to take place, deposition was observed. This continued into the region of the orifice and nozzle as the vapor quality continued to decrease. As a result of the increase in liquid content of the vapor, corrosion of the orifice (up to 7.3 mils) and of the nozzle (up to 5.0 mils) occurred. The Nivco 10 and PH15-7Mo erosion specimens also suffered some attack and erosion damage, but this was not severe. Minor attack was observed in the condenser and subcooler.
