Archaeological Site and Reservoir Shoreline Stabilization Using Wetland Plants and Bioengineering, Rice Reservoir, Wisconsin

by Cathy J. Wendt and Hollis H. Allen

PURPOSE. This technical note describes a case study in which wetland plants and bioengineering treatments were used to protect an archeological site on an eroded reservoir shoreline and to stabilize the shoreline from further erosion. The site is called the Robinson Site and is located on Rice Reservoir in northern Wisconsin, about 26 km (16 miles) southeast of Rhinelander.

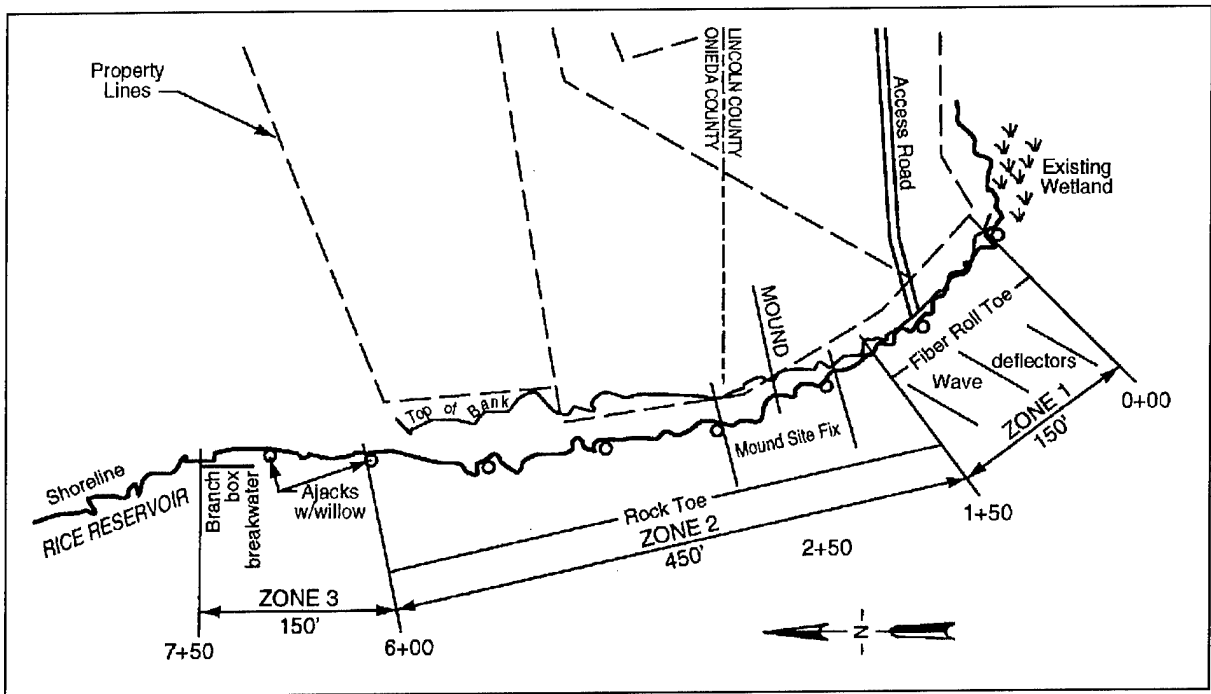
Figure 2. Zones of eroded shoreline and installed measures

- **Zone 1** - The southern 45-m (150-ft) section varied in bank height from 0 to 4 m (0 to 12 ft). A natural wetland exists around the point at the south end. This zone had vertical, lower banks that required less protection.

- **Zone 2** - The middle 14-m (450- ft) section was the most severely eroded. Bank heights varied from 4 m to more than 9 m (12 to 30 ft) with an average slope of 1.5(h):1(v). This zone required installation of a hard toe and stabilization of the face of the bank.

- **Zone 3** - The northern 45-m (150-ft) section had the least amount of active erosion. The face of the bank in this area was fully vegetated with red and white pine, white birch, oak, aspen, shrubs, and herbaceous plants. Bank height varied from 0 to 6 m (0 to 20 ft) and the only erosion evident was an undercut lip at the toe of the bank. This zone required methods where no disturbance of the bank would occur. Protection was added at the toe to attenuate wave action that threatened the semi-stable area.

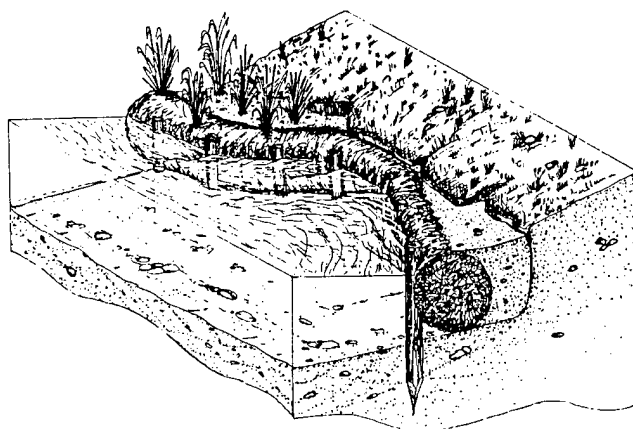
Fiber Roll Installation. Four 30-cm- (12-in.-) diameter and three 40-cm- (16-in.-) diameter fiber rolls were installed. Their configuration varied with the shape and height of the bank. A single 30-cm- (12-in.-) diameter roll was used where the bank was lowest and was positioned to "fit" under the lip of the existing undercut bank (Figure 3). As the height of the bank increased, fiber rolls were placed two and three high, resulting in a tiered structure. The fiber rolls were anchored in place with 1- to 1.2-m - (3- to 4-ft-) long wooden construction stakes made of 2 by 4's cut diagonally to form a longitudinal taper.

Figure 3. Fiber roll toe

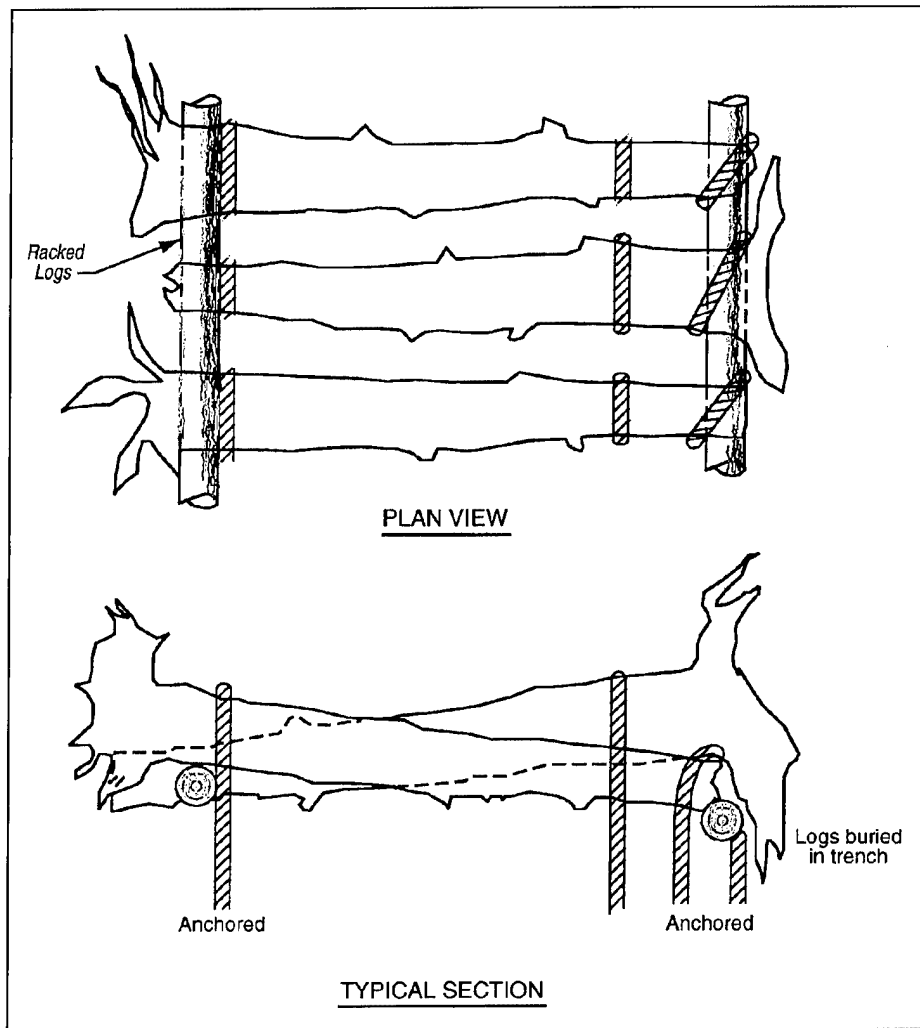
Figure 4. Anchored log wave deflector

Zone 1 Wave Deflector Performance. The wave deflectors failed within 5 months of installation. The precise cause of the failure was not documented or observed, but it appears that at a partial drawdown level, the wave action undermined the bottom crosspieces. When the water level again rose, it apparently floated the loosened crosspieces away, allowing the large trees they supported to buoy up and down with the waves, thereby loosening the anchoring system. The wave deflectors were removed entirely after the anchoring system failed.

- Wave deflectors must be installed differently in a reservoir with fluctuating water levels. Possibly if the crosspieces were eliminated from the design, the larger trees could be anchored more securely.
- Fiber rolls can be easily vegetated using willow cuttings. There does not appear to be any advantage to using rooted stock instead of dormant, unrooted cuttings. Inserting herbaceous plants into the fiber roll is difficult and was not very successful at this particular site.

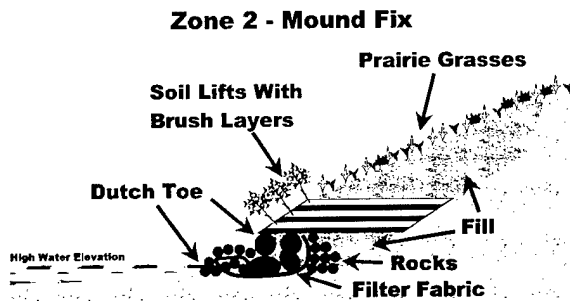
Figure 5. Mound site fix

Top Bank Treatment. Two variations were utilized. The critical area near the mound was filled above the vegetated geogrid to the top of the bank (Figure 5). The area was then hydroseeded with prairie grasses (*Elymus canadensis*, *Andropogon gerardi*, *Schizachyrium scoparium*, *Bouteloua curtipendula*, and *Sorghastrum nutans*) and covered with an Excelsior®

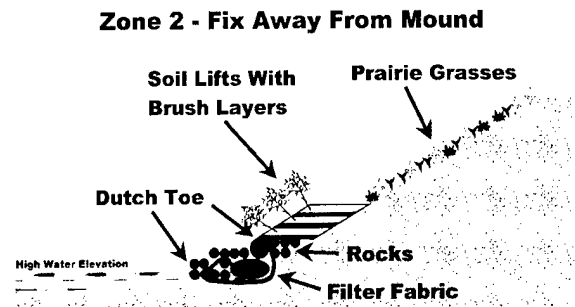
Figure 6. Fix away from mound area

erosion control blanket. The amount of fill was gradually reduced as the distance from the mound increased, thereby blending it into the previously existing bank configuration as illustrated in Figure 6. Where it was not already vegetated, the bank away from the mound area was hydroseeded with the same species of prairie grasses as listed above.

- It is much more cost-effective to limit erosion control at high eroding banks to the toe without filling to the top (see cost comparisons above of “Rock Toe – Fix Away from Mound” vs “Rock Toe – Mound Fix”).

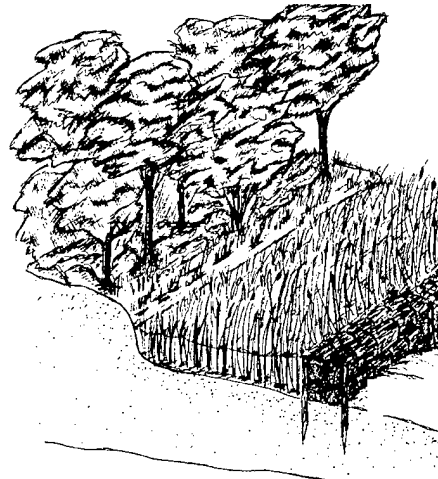
Figure 7. Branchbox breakwater lakeward of protected wetland plants

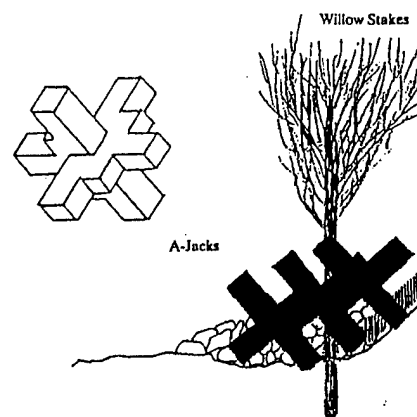
A-Jacks® Installation. The A-Jacks® were installed during the April workshop. They were placed in rows so that each A-Jacks® unit interlocked within each row and with the units in adjacent rows (Figure 8). Each A-Jacks® unit, when installed, has three 60-cm (24-in.) axes forming six 30-cm (12-in.) legs. The lowest rows of A-Jacks® were trenched in close to the base of the bank. Fibredam® was placed between the rows and in the crevices to reduce soil movement and encourage root growth through the A-Jacks®. Live native willow and dogwood cuttings were jetted into the structures in April. Pre-rooted willows (USFS stock) were planted between the A-Jacks® and the toe of the bank in mid-August. The A-Jacks® were backfilled in September with a soil/rock mixture.

Figure 8. A-Jacks® toe

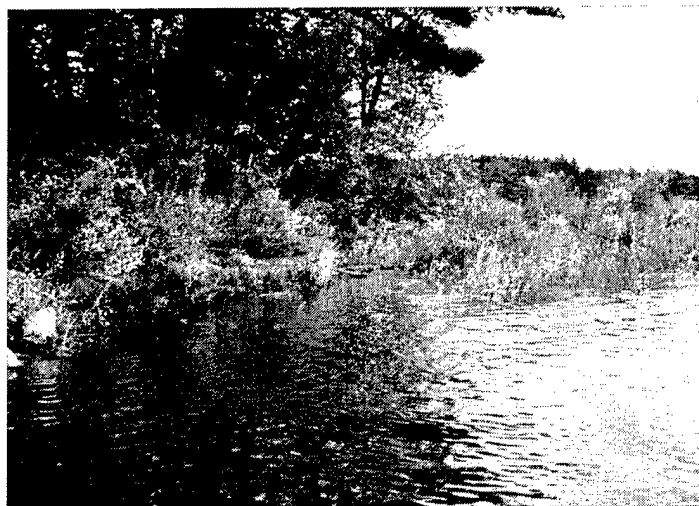
In Zone 1, the fiber rolls have remained intact (Figure 9) with an added benefit of providing wildlife habitat. Burrowing animals, primarily rabbits, excavated and inhabited small

Figure 9. Zone 1, July 7, 2000

openings behind the fiber rolls. These openings do not seem to be compromising the integrity of the structure. The rabbits browsed much of the willow over winter that had been planted as cuttings behind and between the fiber rolls. Despite the browsing, the willow resprouted. Of the 20 rooted willows (USFS stock) that were planted, 10 have survived.

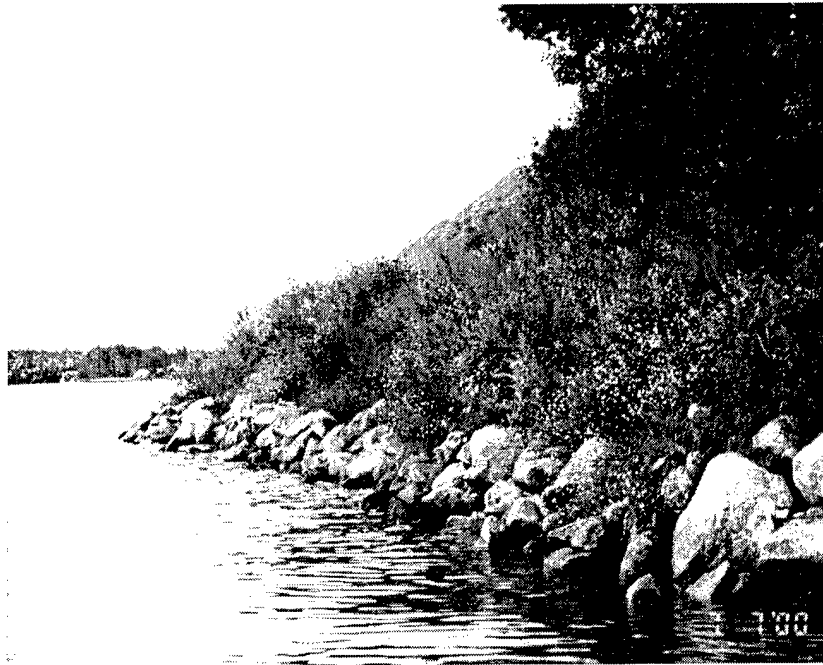
Zone 2 Rock Toe Performance. The rock toe has performed as expected for the majority of the zone (Figure 10). Soon after completion, however, the reservoir level rose and a void was created behind the large rocks, causing 1.5 lin m (5 lin ft) of soil lifts to collapse. Filling this area with small rock repaired the void and no further erosion has occurred in this area.

Additional smaller areas (1-2 m³ or 11-22 ft² each) have also washed out, but no major problems seem to have been created by these voids. As a preventative measure, these new voids could be filled, but the voids seem to have limited themselves and our intent is to monitor them to see if they will be "self-healing." All of the voids are located away from the mound. It appears that the reduced level of armoring in the fix away from the mound may be contributing to these minor failures. No failures have occurred in the mound fix area.

Figure 10. Zone 2, July 7, 2000

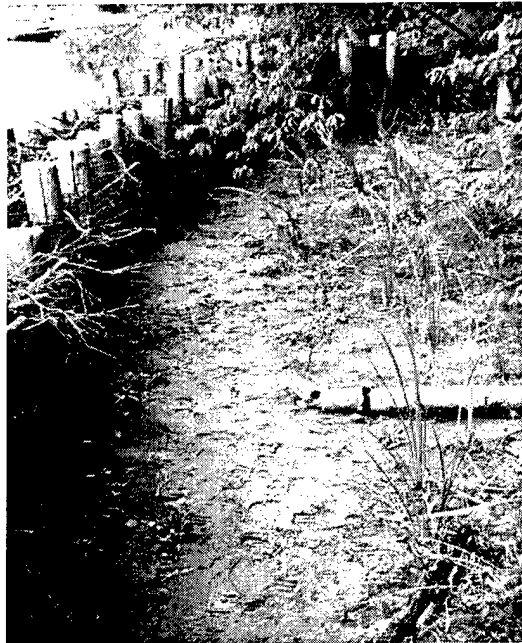
Zone 3 Branchbox Performance. The branchbox breakwater is providing limited habitat for emergent plants (Figure 14). The habitat is limited because Wisconsin laws prohibit most structures from being more than a few feet away from the shore. The Wisconsin Department of Natural Resources did, however, allow this structure for demonstration purposes, but only allowed it to extend 4.5 m (15 ft) from the shore. This is still short of the more typical placements of 10 m (33 ft) or more.

Figure 14. Area behind branchbox breakwater

It appears that the area between the branchbox and shore may have suffered from either or both of two effects created by the branchbox's proximity to the bank. First, the protected area is shaded by existing trees on the steep bank for half of the day, then is shaded by the branchbox breakwater for much of the remainder of the day. This lack of sunlight may be responsible for an observed 0.76-m- (2-1/2-ft-) wide area directly behind the branchbox that is unvegetated (Figure 14). Second, sand has deposited behind the branchbox to a height approximately 6 in. higher than directly in front of the branchbox. This sand appeared to be enough to cover small plants as they began to grow. Between this 0.76-m- (2-1/2-ft-) wide void and the original bank, however, there is vegetation. Quadrats were used twice to assess the vegetation of the entire area behind the branchbox breakwater, once on May 17, 2000 and again on July 7, 2000. The entire area was covered with 28 quadrats or partial quadrats. Numbers of *Juncus effusus*, *Scirpus spp.*,

Although the branchbox breakwater had limited success in this project, the structure could be well-utilized under different circumstances. In states other than Wisconsin, the breakwater would be located farther from the shoreline as designed. This would protect a much larger area for vegetation establishment.

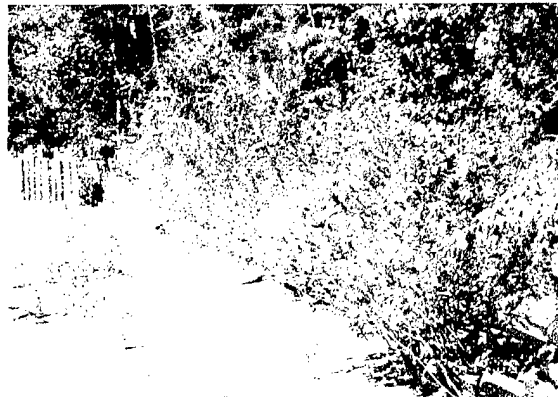
Zone 3 A-Jacks® Performance. Due to the heavy vegetation, the A-Jacks® are barely visible from the water. Although the total stem count has decreased (359 stems on July 7, 2000 down from 391 stems on May 16, 2000), the percent area covered is increasing based on visual comparison of photos (Figures 16 and 17). The stem count may have decreased for several possible reasons. First, the water level of the reservoir was within 3 ft of full by the middle of April, which provided the plants with adequate moisture producing the initial surge of growth indicated by the high stem count for May. Second, from the end of June through early August the water level was within 1 ft of full and some of the individuals may have succumbed to drowning and/or wave action causing abrasion from the A-Jacks®, lowering the overall stem count. Third, competition for light and nutrients between individual plants may have been a source of mortality.

Figure 16. A-Jacks® willow coverage, May 2000

Figure 17. A-Jacks® willow coverage, July 2000
