NASA TM X-1119

INVESTIGATION OF ATLAS SOLID
FUEL RETARDING ROCKET DURING
ATLAS-CENTAUR SEPARATION TESTS

*Lewis Research Center
Cleveland, Ohio*

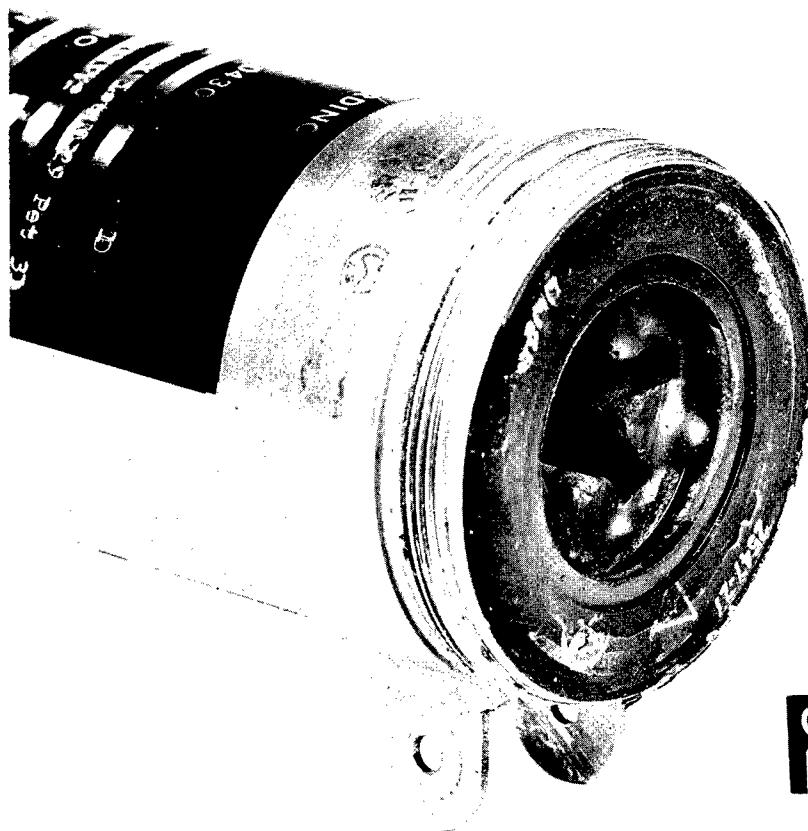
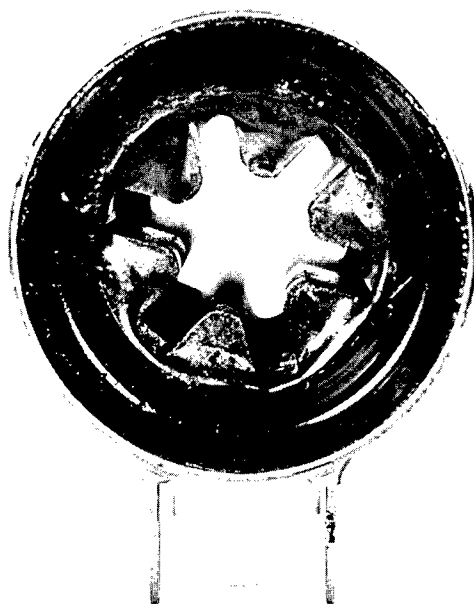
Of the 67 units fired, 6 misfires were encountered when Ordnance Associates igniters were used. Examination of the misfired units revealed that the grain was intact, the nozzle diaphragm (which was in accordance with the flight configuration) when used was ruptured and partly extruded into the nozzle, and the igniter was fired with no part of its "propellant" to be found in the rocket (figs. 4 and 5). The characteristic pressure record from a misfired motor is an abrupt pressure rise to approximately 250 to 450 pounds per square inch, after which a rapid decay ensues (fig. 6).

Figure 4. - Grain of misfired rocket.

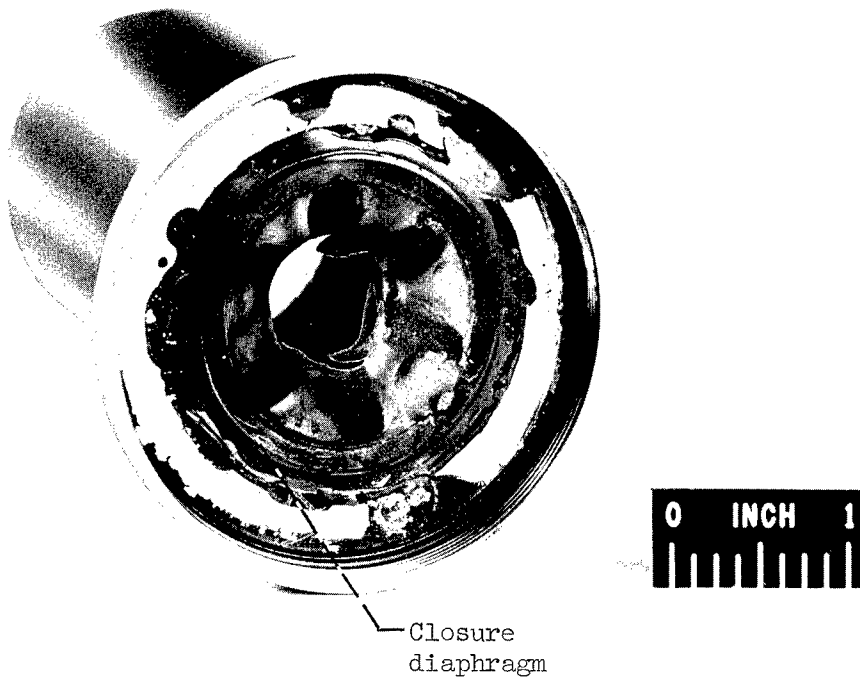
(a) Nozzle showing ruptured diaphragm.

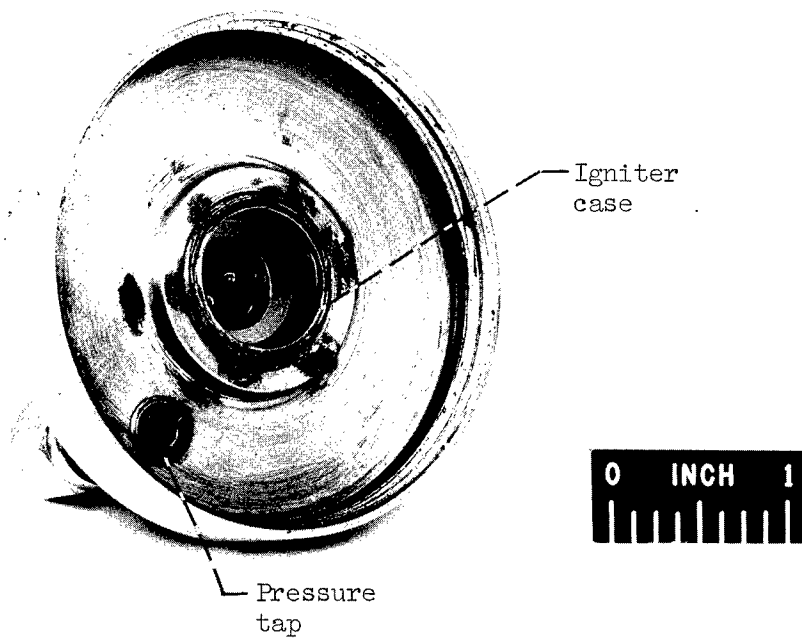
(b) End cap showing expended igniter.

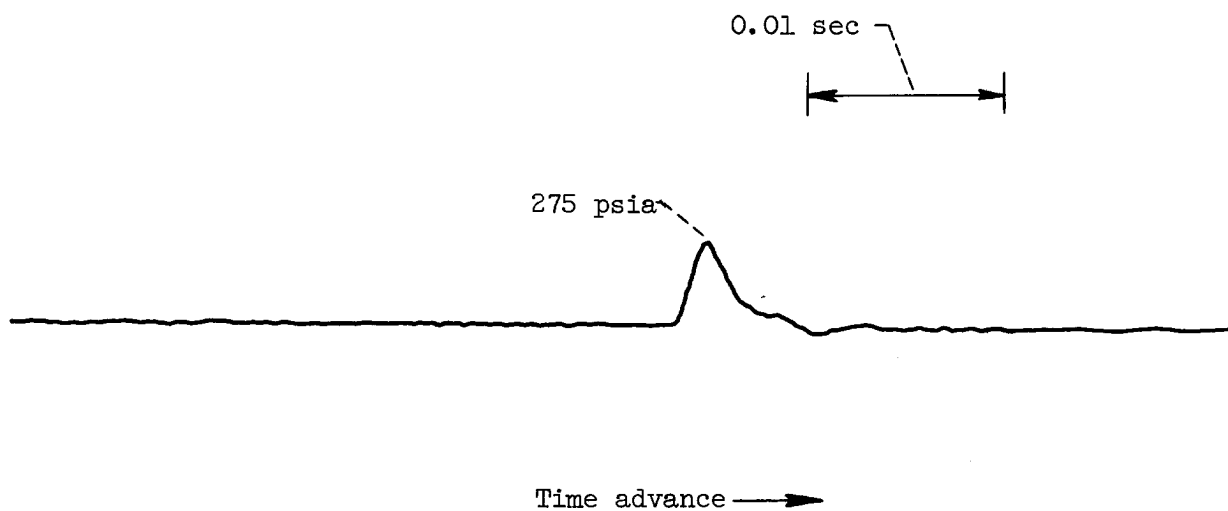
Figure 6. - Typical pressure trace of misfired rocket.

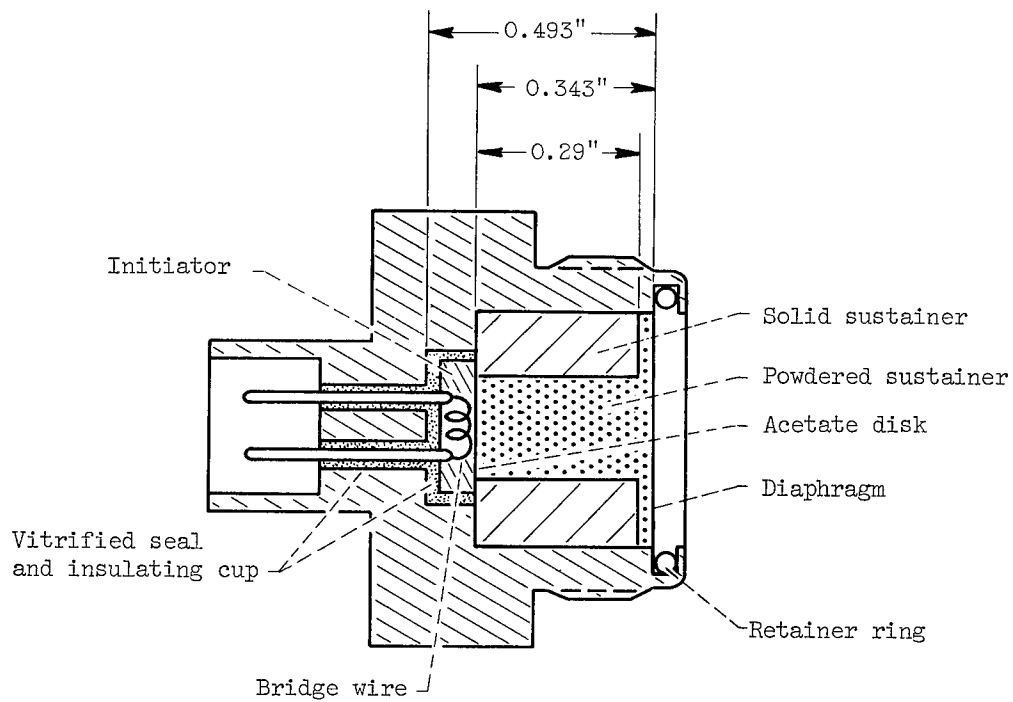
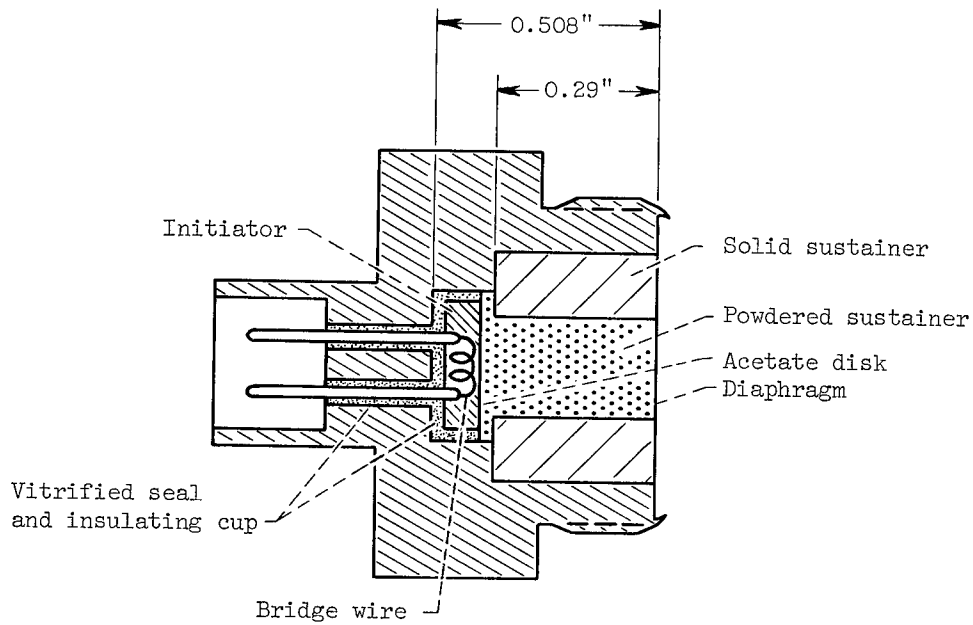
Figure 7. - Igniter configuration; P/N OA-A8, Ordnance Associates, Inc.

It was noted initially, and supported by subsequent firings, that the igniters in all misfired rocket engines using Ordnance Associates igniters (except for one special test) were from production lot 3-2 (table I). Investigation revealed that the configuration of the igniter (P/N OA-A8) had not been maintained constant; several internal configurations had been used in the igniter with changes made from one lot to the next (fig. 7). The changes from lot 2-1 to 3-2 include (1) the omission of the retaining ring at the igniter exit, (2) a decrease in the depth of the initiator cavity and elimination of a cavity at the exit of the unit, and (3) a repositioning of an acetate disk below the solid sustainer, which created a new cavity containing powdered sustainer.

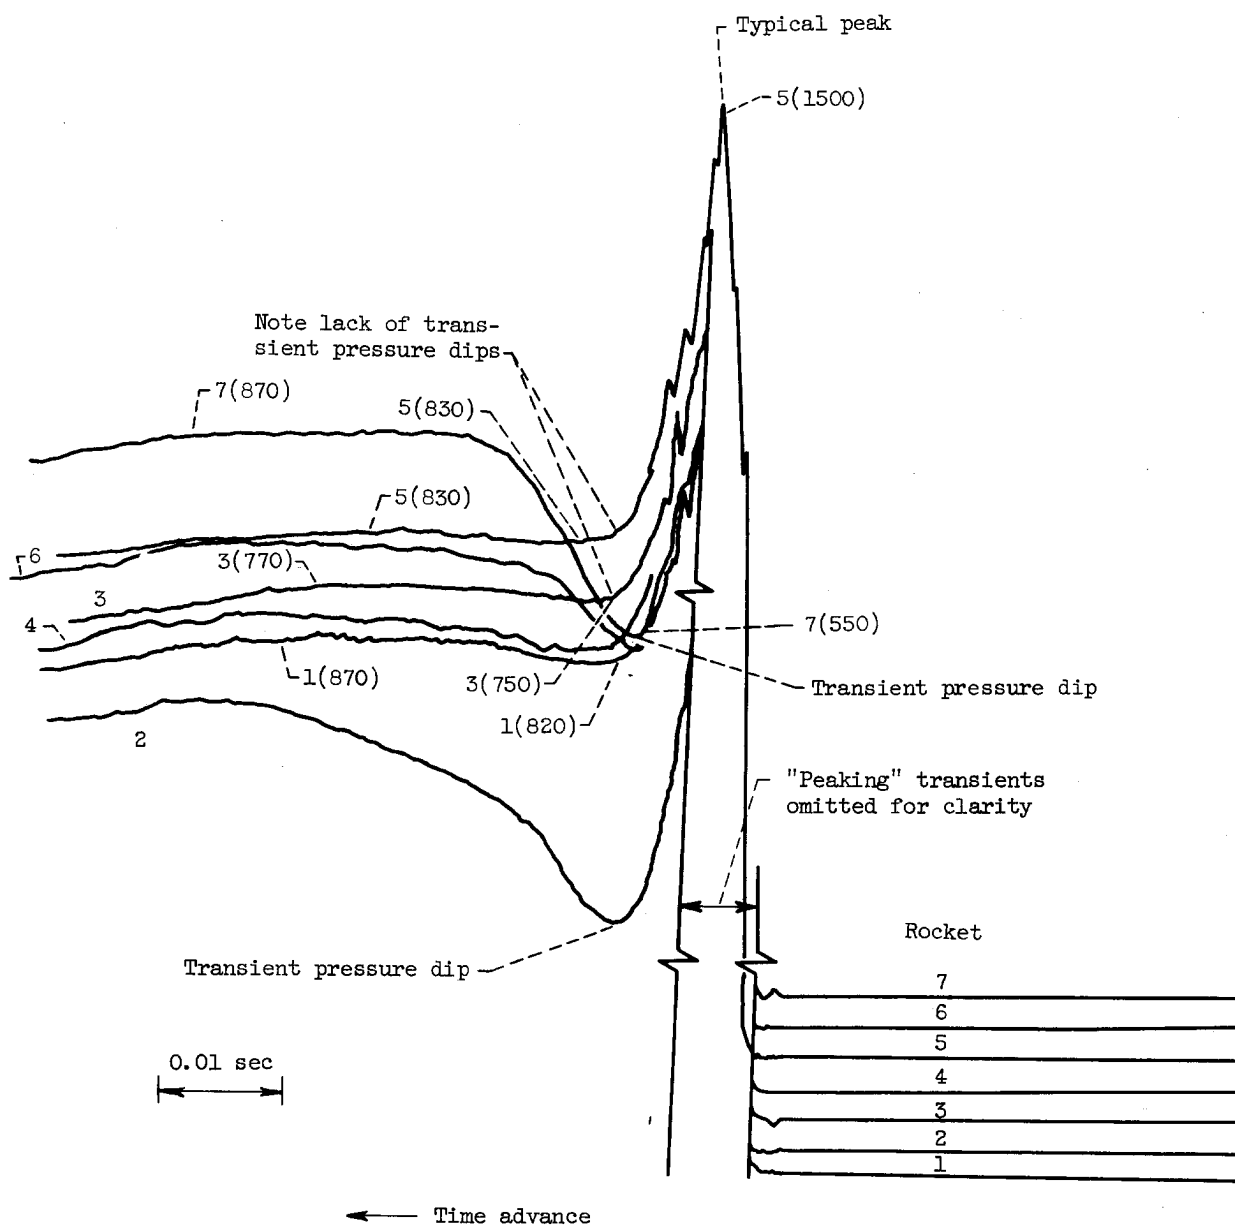
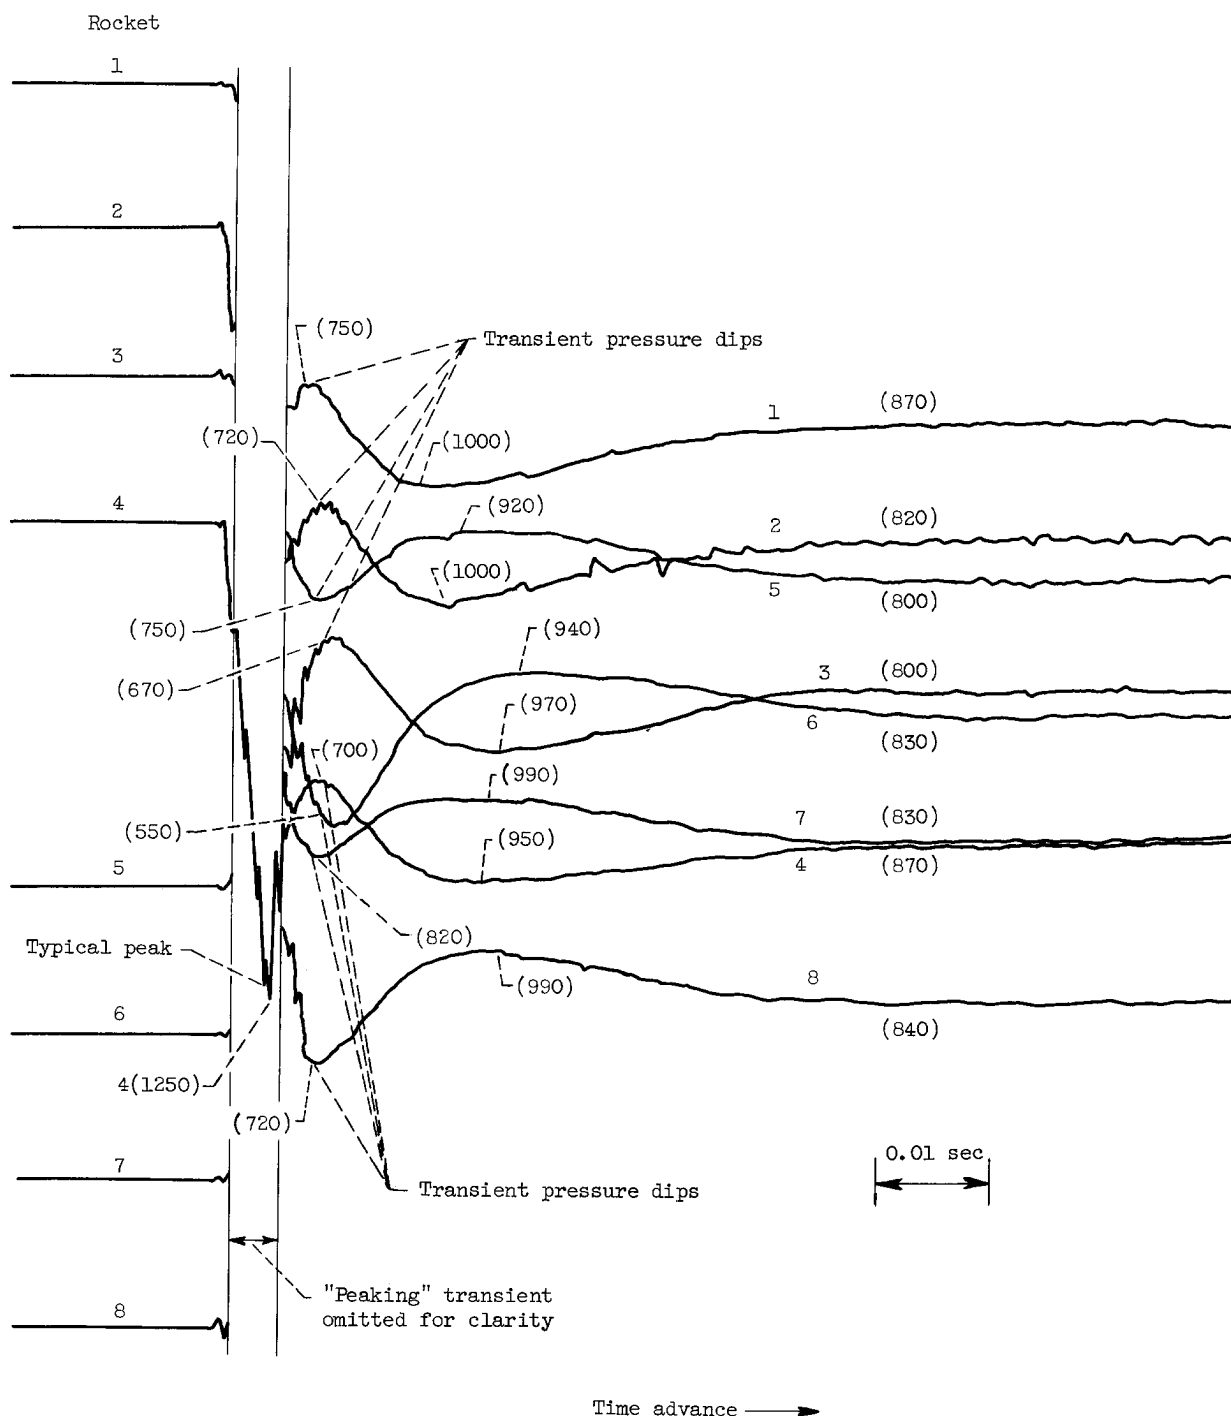
Figure 8. - Pressure records of incipient rocket failures. Numbers in parentheses are peak pressures and pressure dips in psia.

Pressure traces obtained in the test firings were scrutinized in an effort to discover any apparent inadequacies in the ignition cycle which could be related to the igniter changes. In several instances an abnormally low chamber pressure occurred between the ignition peak of approximately 1500 to 2000 pounds per square inch and the steady-state burning pressure (fig. 8(a)). In order to understand this occurrence, eight rockets having lot 2-1 igniters were fired with a 1/8-inch hole drilled through the nozzle closures so that the chambers were at a near vacuum condition prior to firing. The pressure traces from this test firing, which are shown in figure 8(b), revealed that each engine experienced a pressure falloff similar to that mentioned earlier although not quite as severe. The generation of the falloff, or saddle, in each instance is felt to demonstrate a susceptibility of the igniter to an initial low-pressure condition in the combustion chamber and to give an indication of inadequate performance margin. The pressure falloff probably results from the propellant grain not being sufficiently ignited at the time of igniter burnout and could probably be eliminated with the use of a longer burning igniter. While these tests did serve to uncover a marginal performance characteristic, they did not explain why lot 3-2 igniters produced misfires and lot 2-1 igniters did not under normal conditions.

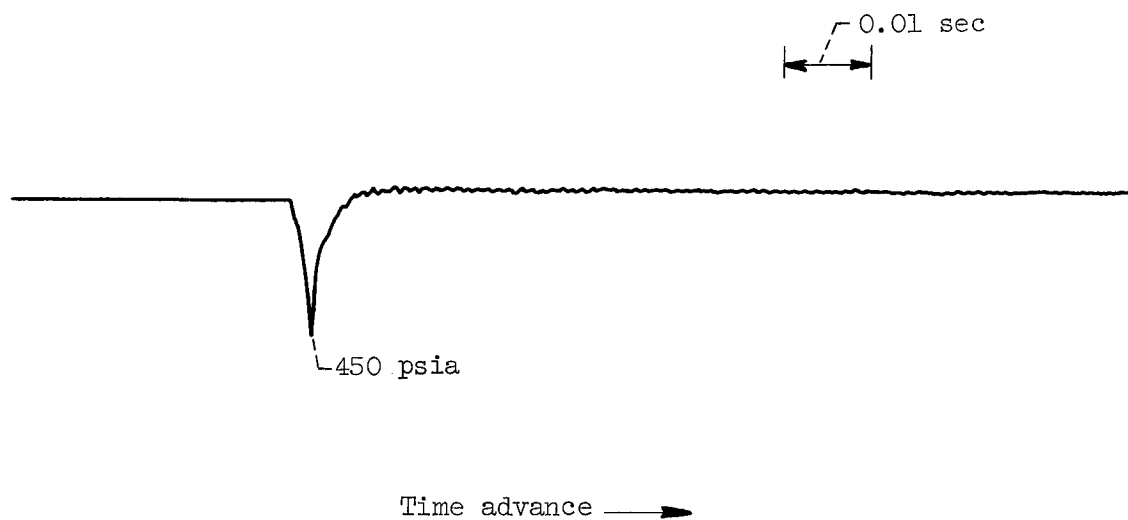
In an effort to determine how much the margin of performance could be reduced before the engine refused to fire, two rockets were tested with no nozzle closures, one with a lot 3-2 igniter (fig. 9) and one with a 2-1 igniter. Both failed to ignite the rockets at the altitude condition, which confirmed that the limits of reliable operation had been exceeded. Although the ability to ignite the propellant grain successfully under vacuum conditions and with no nozzle closure is a more severe requirement than encountered during flight, it is felt that this test further illustrates the lack of adequate margin in the combination of the Ordnance Associates, Inc., igniter and the Rocket Power, Inc., rocket.

Figure 9. - Pressure record of lot 3-2 igniter fired into live rocket with no closure diaphragm.

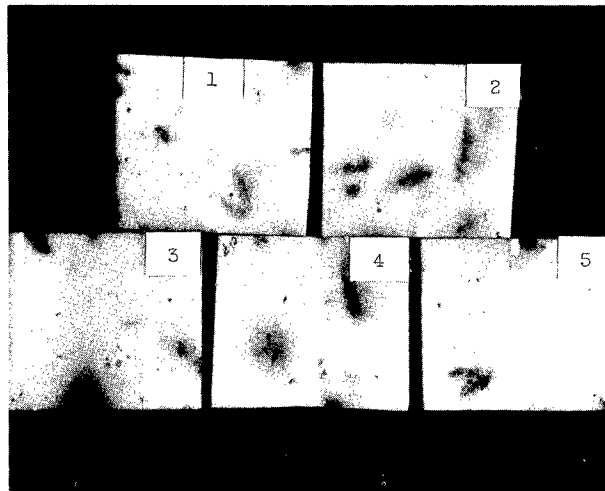
Some tests were conducted by Beckman and Whitley Laboratories to determine what had caused the 3-2 igniters to lose all their margin of performance. Both the lot 3-2 igniters and the lot 2-1 igniters, which had no record of misfires, were fired into Styrofoam blocks to make a record of flame-impingement patterns. Their findings, noted in references 1 and 2, reveal that the lot 2-1 igniters consistently displayed a widely dispersed flame pattern, while the lot 3-2 igniters were inconsistent. The 3-2 units occasionally fired an extremely narrow and concentrated flame front (fig. 10). This characteristic leads to the theory that the lot 3-2 igniters when their discharge pattern is concentrated do not impinge on the grain surface sufficiently and, therefore, may not impart enough heat into the grain to cause ignition. This inconsistency in performance may be inferred to result from the previously described changes in the igniter's geometry. The combination of an initial low performance margin and an inconsistent flame discharge pattern is apparently sufficient to cause occasional ignition failures. Supporting this conclusion are data obtained at Lewis from the firing of two igniters manufactured by Librascope (fig. 11) whose constituents were described earlier. The first igniter firing at sea-level ambient pressure was made into a Styrofoam block, and a narrow impingement pattern was observed (fig. 12). The second firing, at a 98 000-foot-altitude ambient pressure, involved the installation of a Librascope igniter in a Rocket Power, Inc., rocket from which the nozzle closure had been removed. The igniter failed to ignite the rocket propellant, as would be anticipated from the flame pattern.

(a) Lot 2-1 igniters. Note widely dispersed patterns.

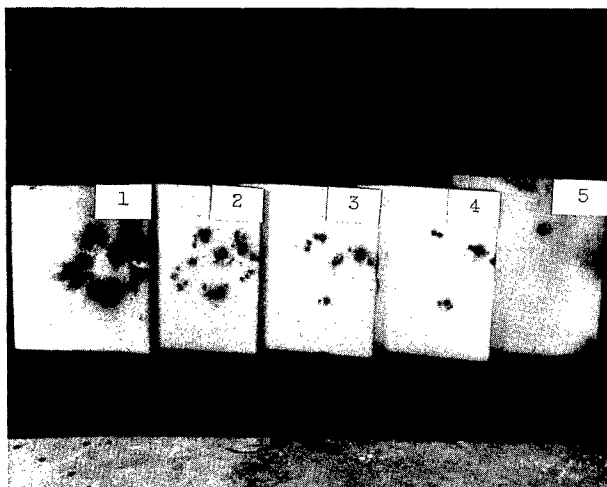
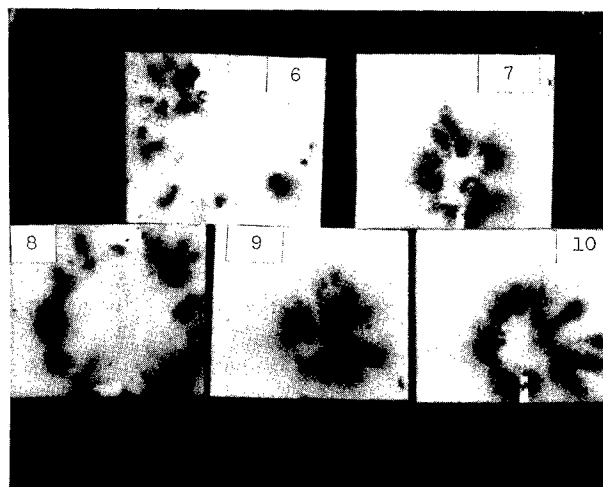
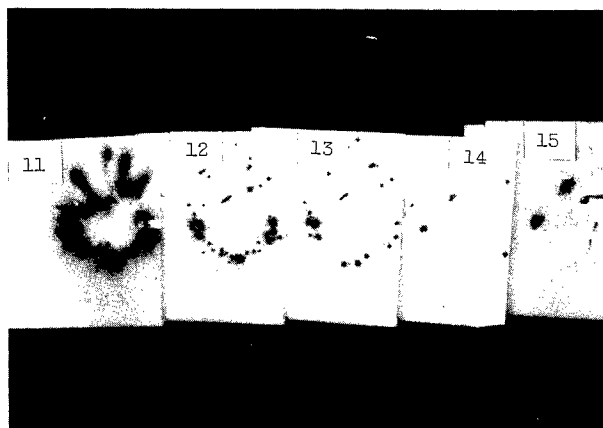
(b) Lot 3-2 igniters. Note narrowly dispersed patterns in 1, 7, 9, and 11 and widely dispersed patterns in 4, 5, 6, 8, and 14.

The specific causes for the marginal performance appear to be (1) an inadequate igniter burning time aggravated by (2) inconsistent igniter discharge patterns, which occasionally did not impinge on the rocket propellant grain. Therefore, it is desirable to substitute an igniter which (1) burns till the rocket grain is sufficiently ignited, and (2) directs its flame pattern positively towards the grain surface. *— end*

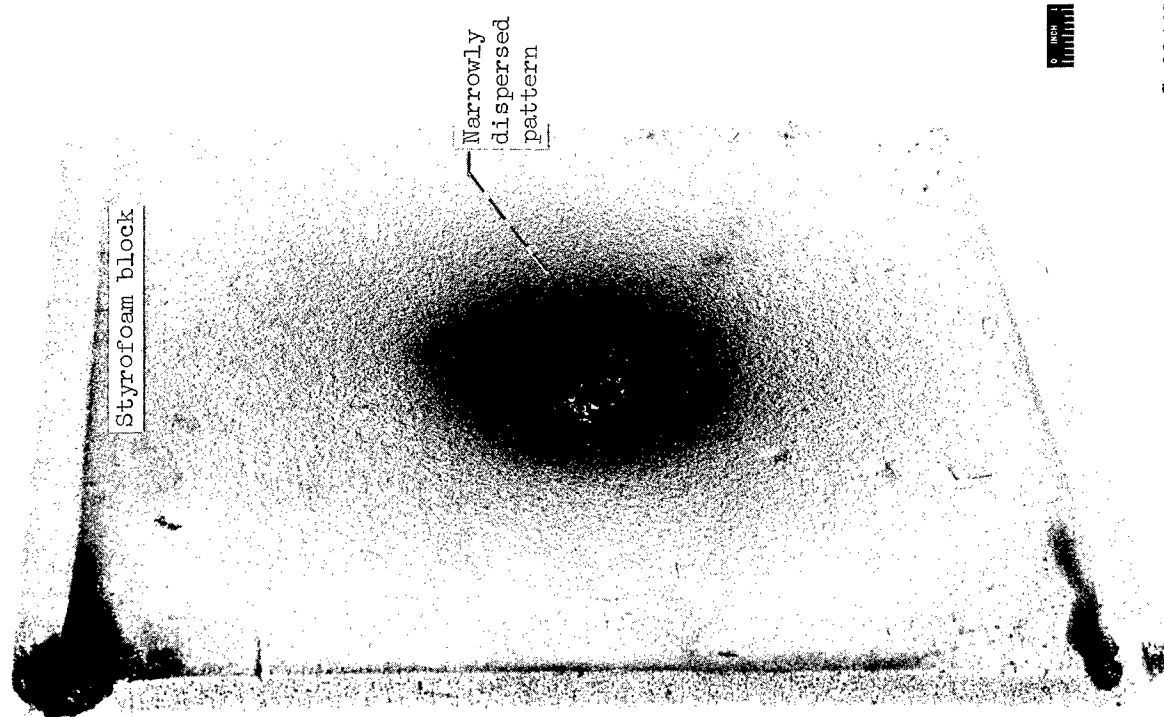
Figure 12. - Flame impingement pattern of Librascope igniter.

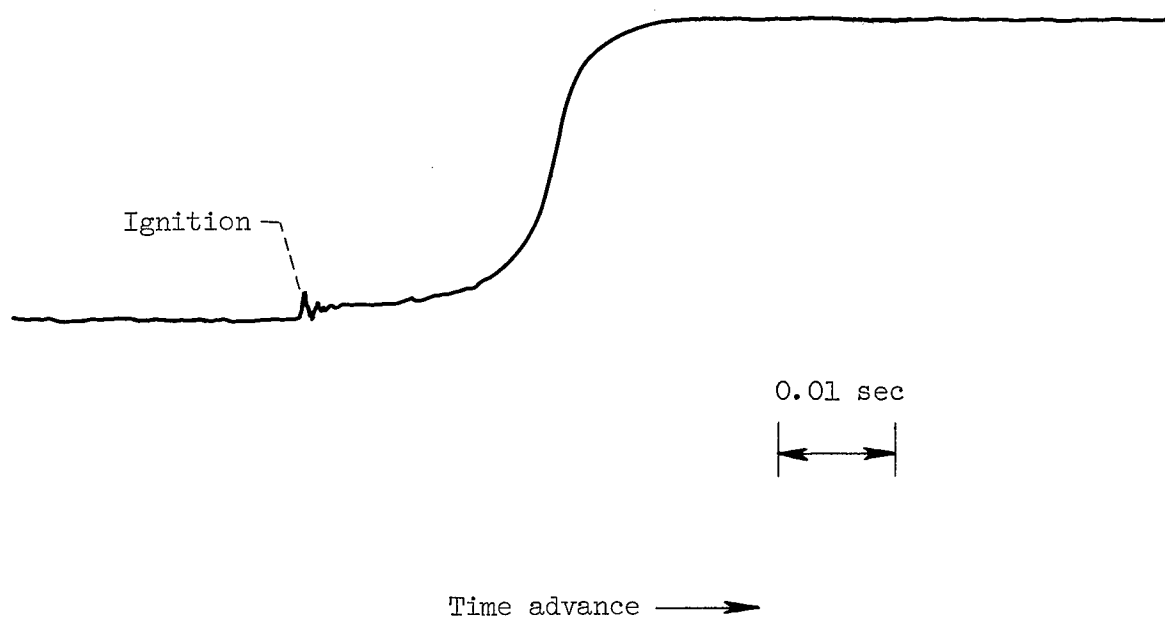
In order to further substantiate the theories concerning flame direction and igniter burning time outlined, a test was made at a pressure altitude of 98 000 feet with a Thiokol Chemical Corp. igniter (fig. 13), installed in Rocket Power, Inc., rocket having no nozzle closure. This igniter burns for a longer period of time (0.25 sec compared with 0.004 sec for the Ordnance Associates igniter) and directs the flame pattern at the rocket grain. The longer burning time is effected primarily by an increase in the igniter's constituent mass. The increase in the mass, with its resultant increase in heat content and burn time, coupled with the directed flame pattern tended to ensure that the rocket grain would receive sufficient heat to ignite. Successful ignition of the rocket propellant occurred (fig. 14).

Figure 14. - Internal pressure record of Rocket Power, Inc., rocket ignited by Thiokol Chemical Corp. Pyrogen igniter.
