# Flightfax

ARMY AVIATION  
RISK-MANAGEMENT  
INFORMATION

SEPTEMBER 2001 VOL 21 NO 3

## IN BAD WEATHER IS HIGH RISK

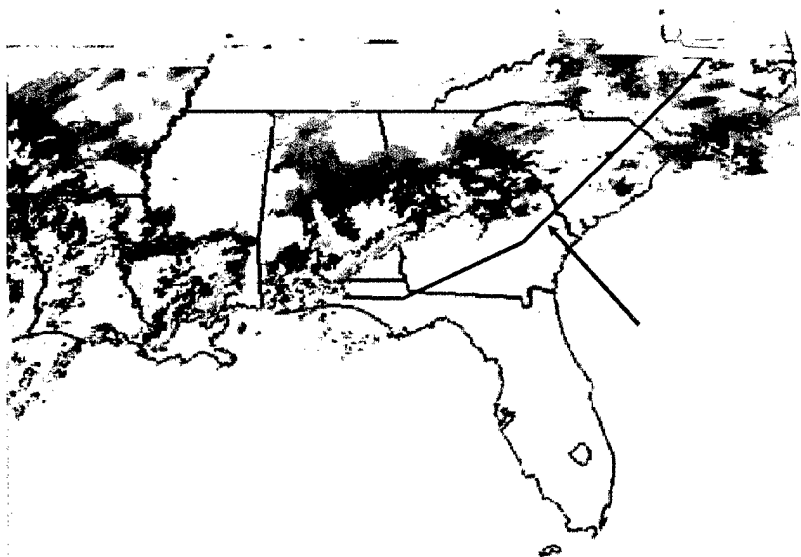
**Figure 1. Fly as far east as possible**

The flight crew arrived at base operations approximately 1 hour before the scheduled takeoff time on the day of the mission. About 40 minutes before takeoff, the crew received a weather briefing. The forecaster identified an area of thunderstorms along the crew's filed route of flight, with 16 to 45 percent coverage, and maximum tops at 50,000 feet. He told the crew to fly as far east as possible before turning north to avoid the weather (See Figure 1). There were no questions of the forecaster by the crew.
