Little Goose Dam Radial Gate Inspection and Testing

US Army Corps of Engineers, Walla Walla District

13. ABSTRACT (Maximum 200 words) This report is an evaluation of the overall condition of the spillway tainter gates at Little Goose Lock and Dam, Snake River Washington.

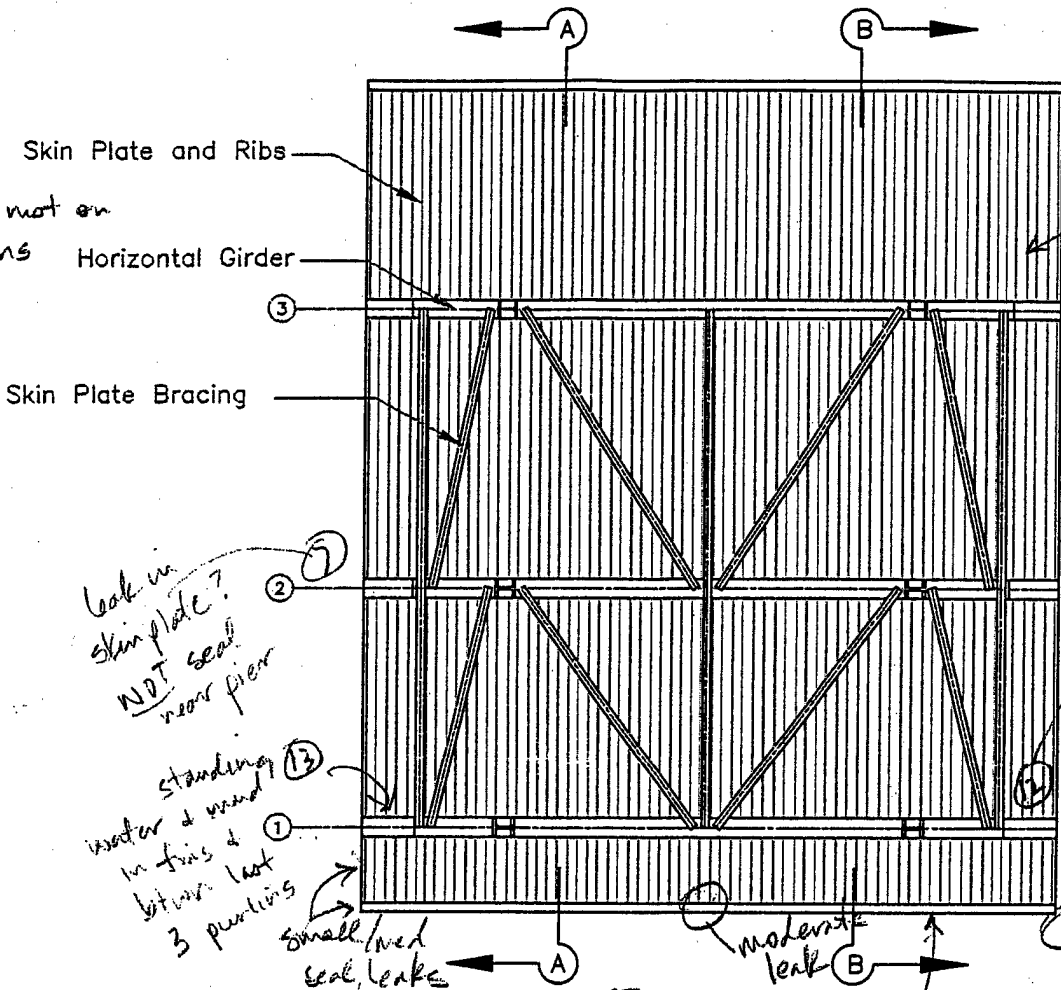
Gate No. 2 Downstream Elevation

light surface mat on stem of purlins most near flange

small med seal, leaks

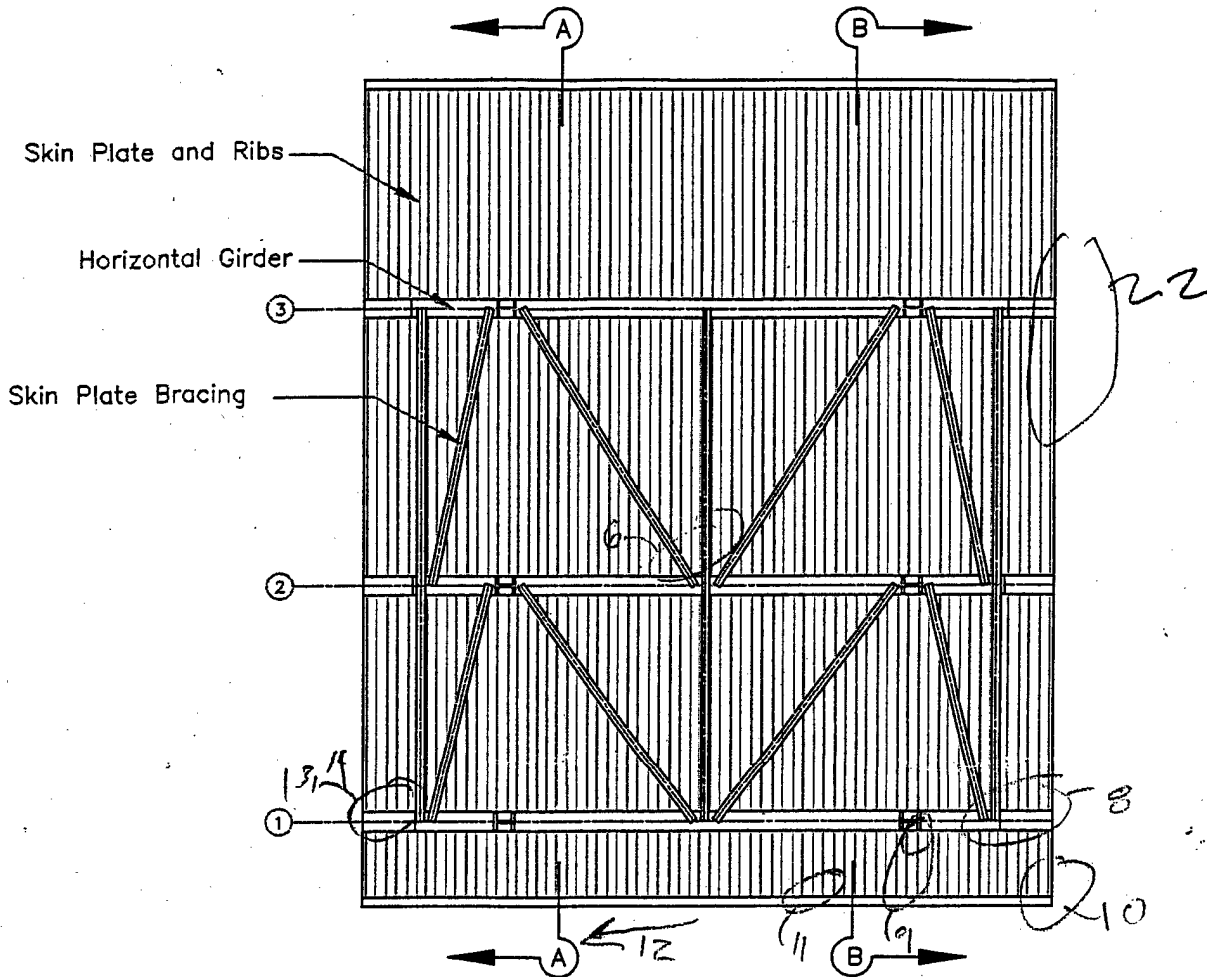
Gate No. 3 Downstream Elevation

- 2. LEFT Purlin light rust w/ min deposits
- 6. Light rust on Bracing top.
- 8. Standing H₂O on bot. Girder NOTE light rust
- 9. Drain hole w/ continuous flow from above
- 10. Side Seal leak. (LEFT)
- 11. Standing H₂O and muck @ Bot. Pt.
- 12. looking RT. Along bottom seal
- 13, 14. Moderate to heavy rust @ Bot Girder @ Brace Pts

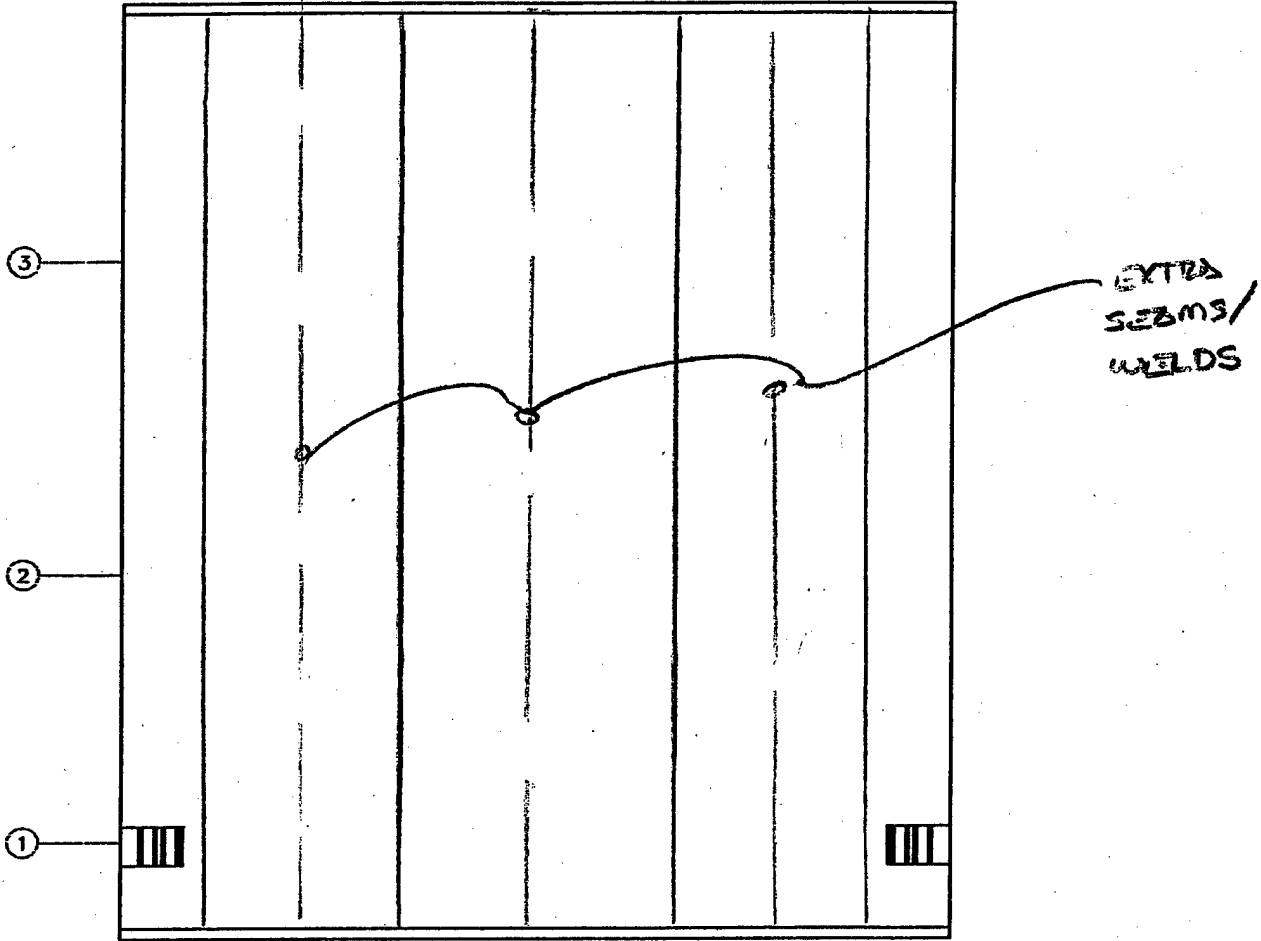
Gate No. 3 Upstream Elevation

- VERY LITTLE COR.

- NOT PITS TOP 20'

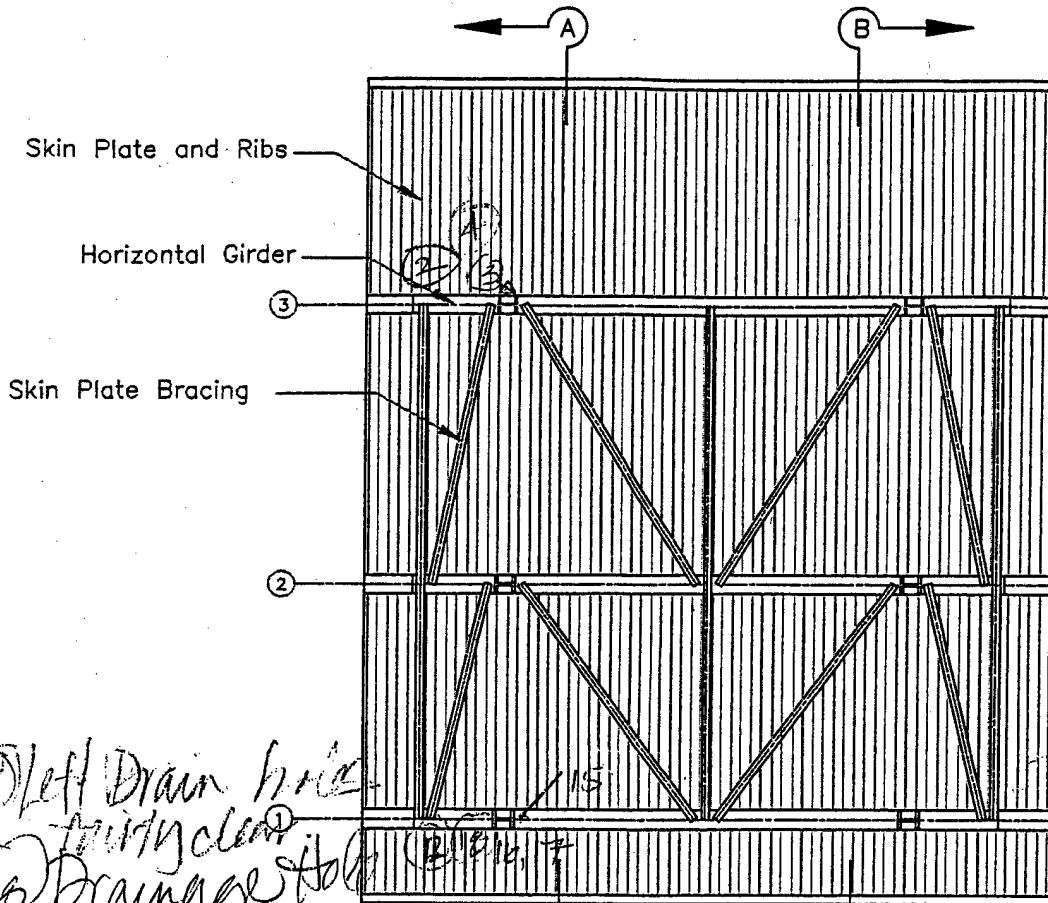
Gate No. 4 Downstream Elevation

(10) Left Drain hole
 (11) Drainage hole
 (12) Ponding water
 (13) Bottom seal

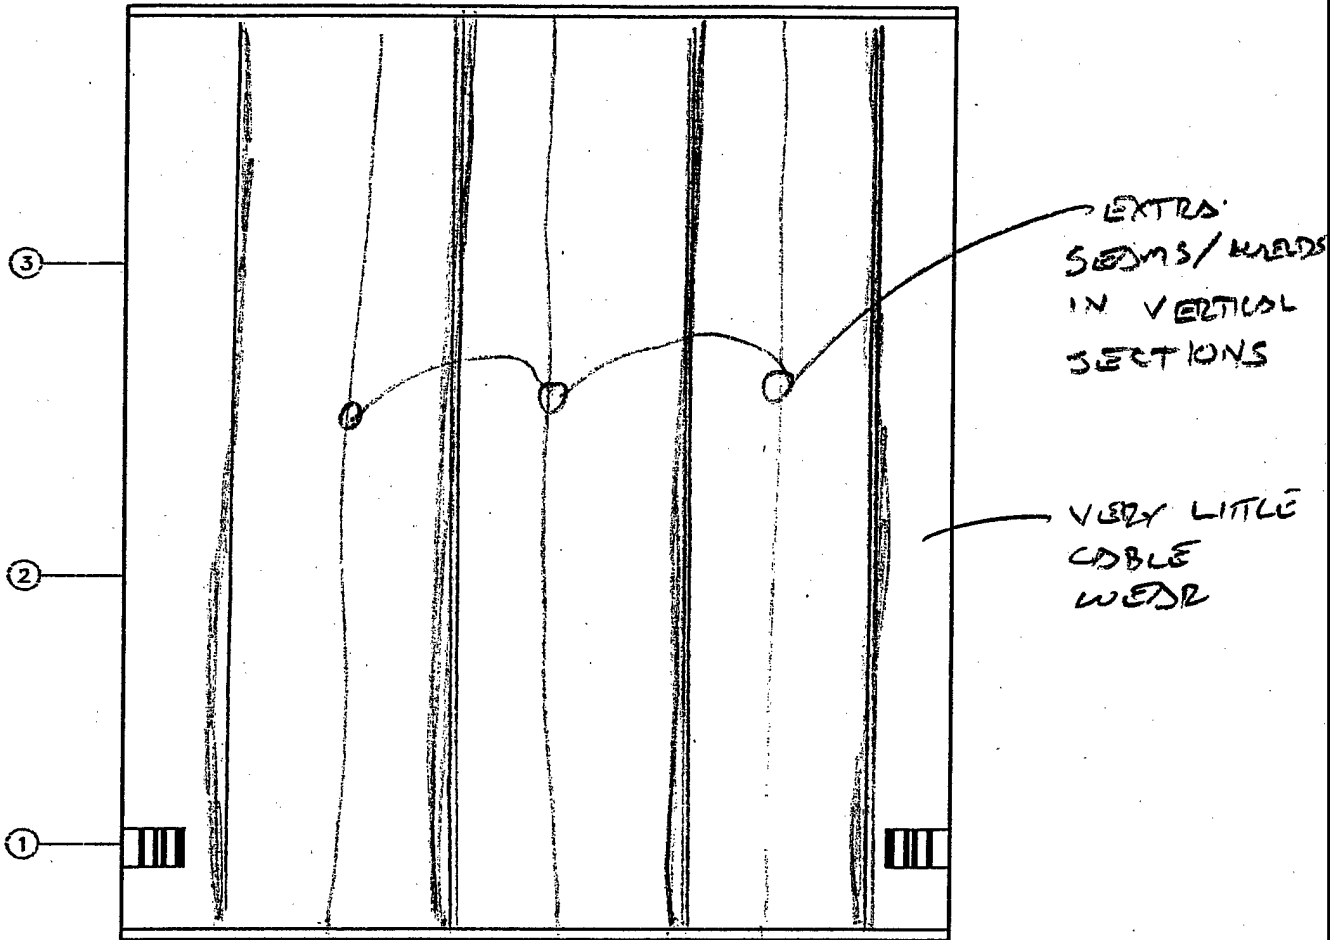
Gate No. 4 Upstream Elevation

- TYPICAL PITTING, LIGHTER THAN USUAL

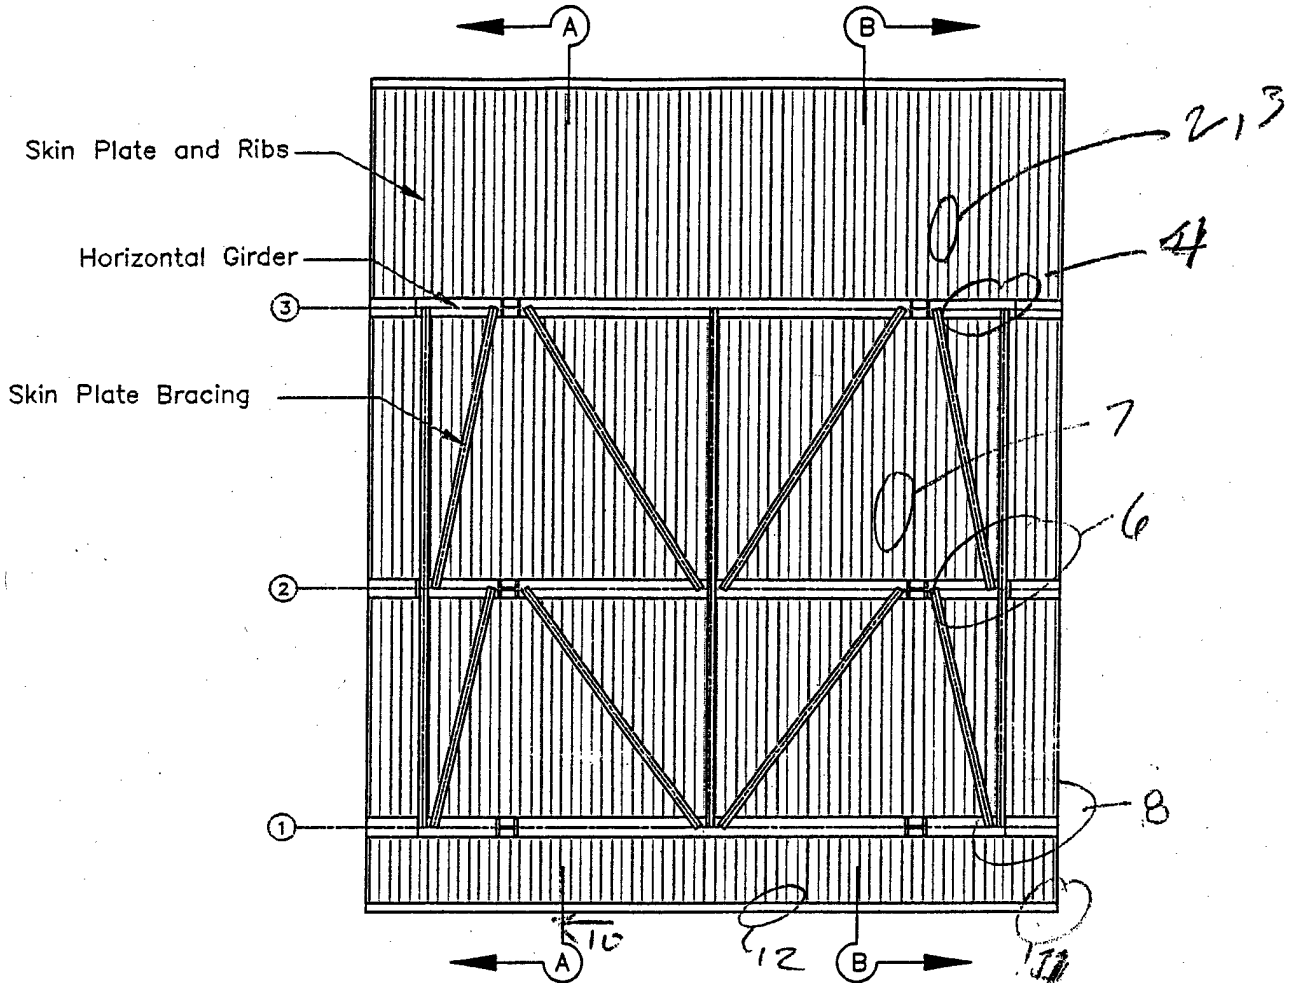
Gate No. 5 Downstream Elevation

- 2, 3. Delaminated Plat and light rust ON GATE FACE
- 4. Light Rust TOP GIRDER
- 6. Light Rust ON GIRDERS AND BRACES NOTE Delam ON GATE FACE
- 7. Delam. ON GATE FACE w/ light Rust. These Delam spots ARE TYP ACROSS ENTIRE GATE FACE.
- 8. SIDE SEAL LEAK @ Bot GIRDER NOTE Light Rust & MINORAL Dep.
- 10. Bottom Seal looking Right
- 11. LEFT CORNER leak
- 12. Bottom Plate w/ STANDING H₂O

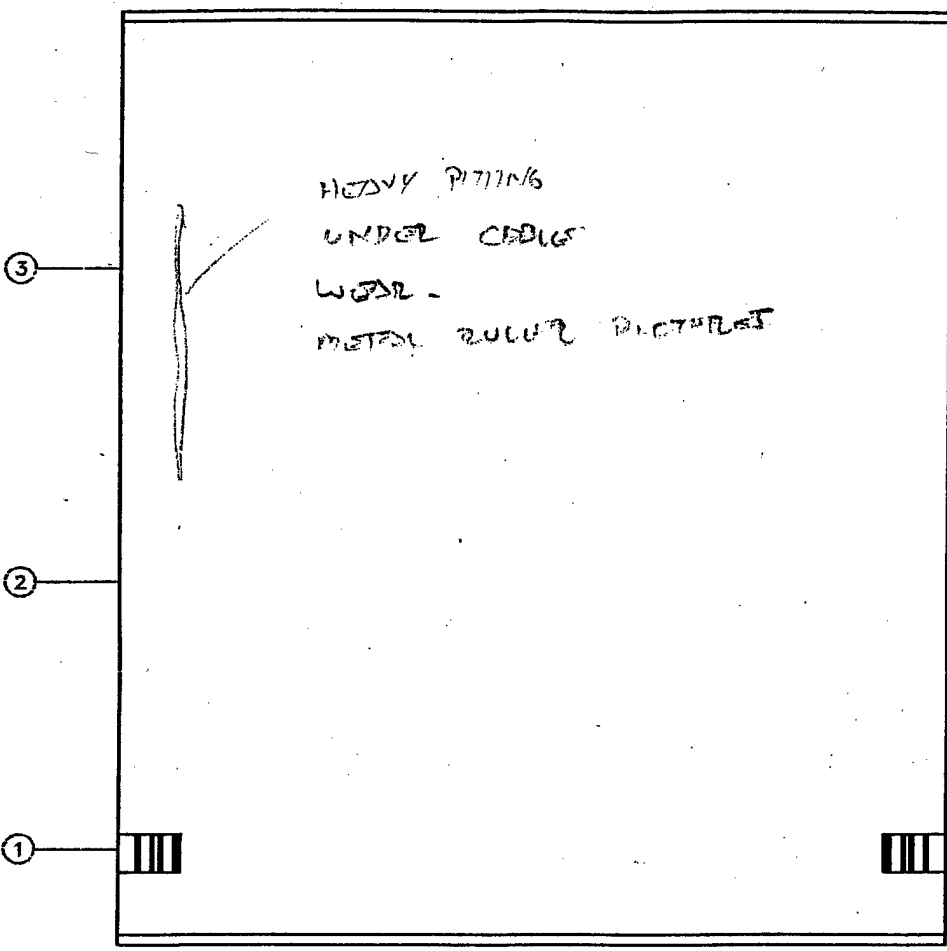
Gate No. 5 Upstream Elevation

- BEST CONDITION OF ANY GATES SEEN
- MINIMAL PITTING
- EXCESSIVE STOP LOS WEAR, COULD NOT GO UNDER SILL DO TO FALLING WATER -

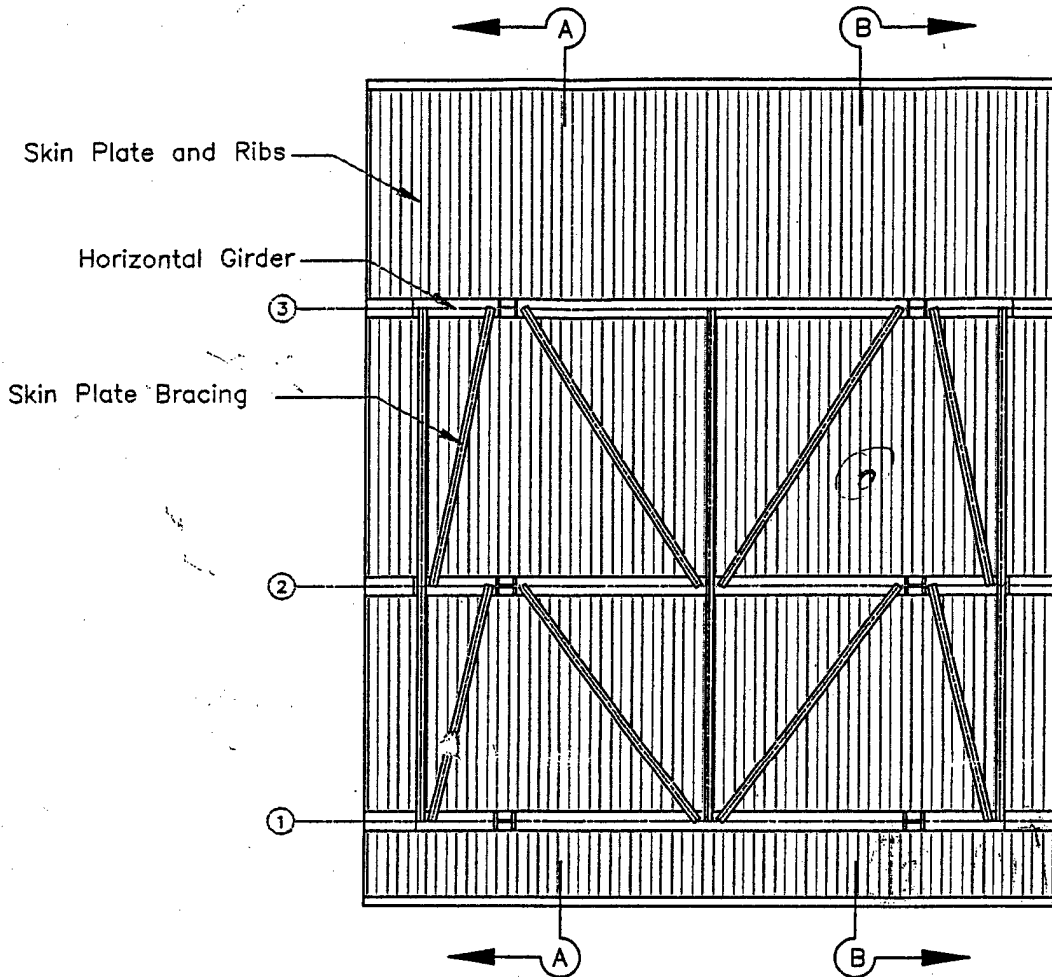
Gate No. U Downstream Elevation

(19) (20) Leak in middle, water coming through hole

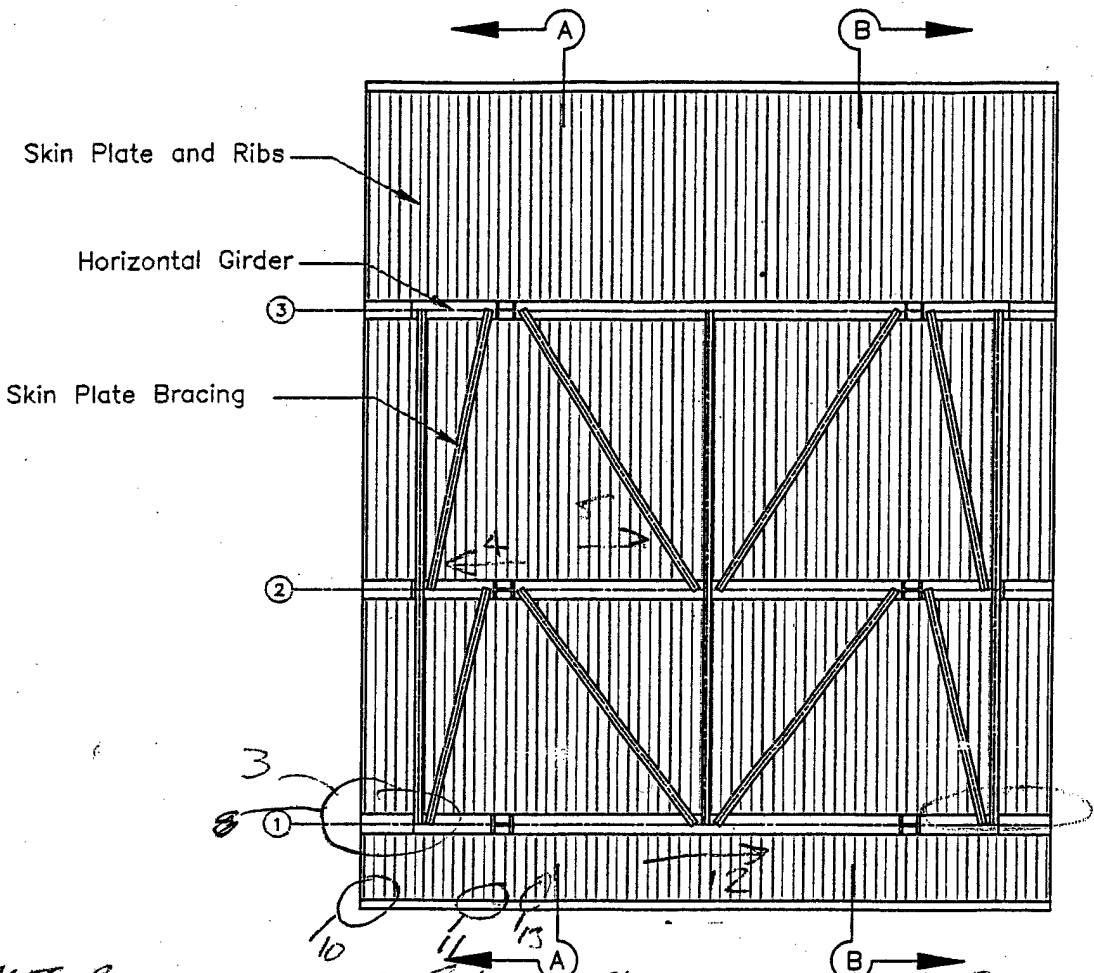
Gate No. 7 Downstream Elevation

NOTE. PAINT ON GATE FAILING. FLAKY W/ LIGHT RUST

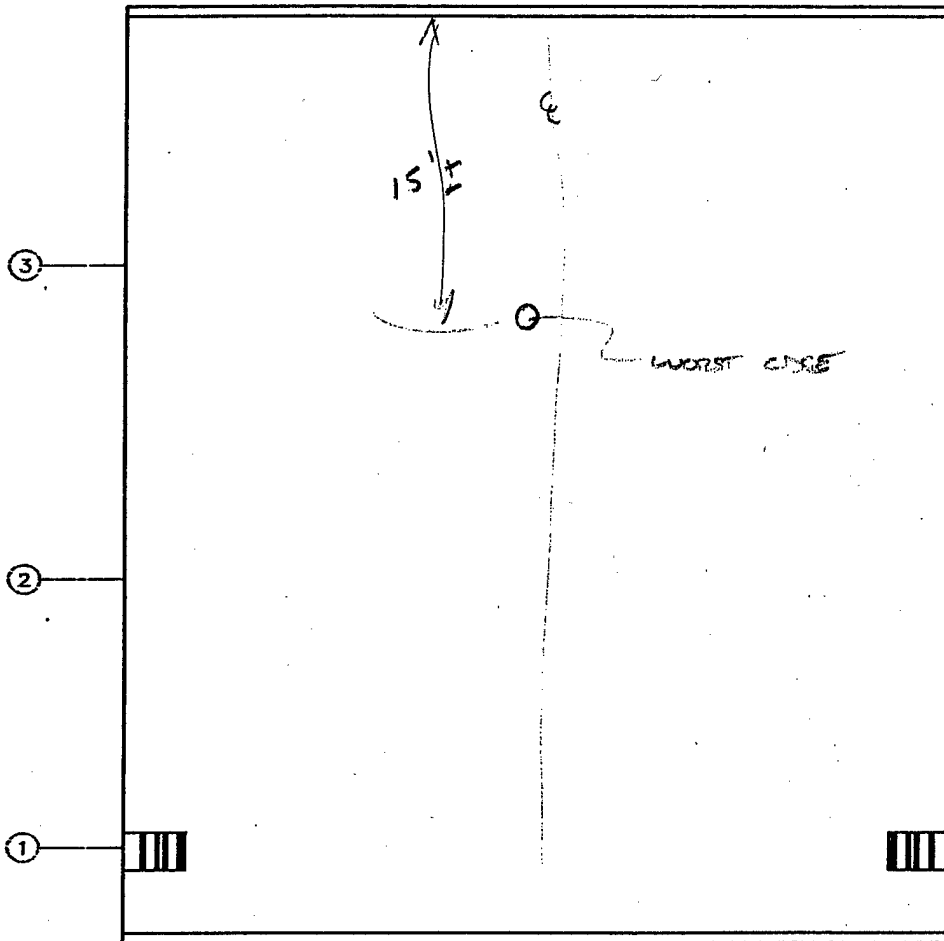
Gate No. 7 Upstream Elevation _____

MUCH BETTER CONDITION THAN GRANITE

EVIDENCE OF PAST WEAR & GRIND

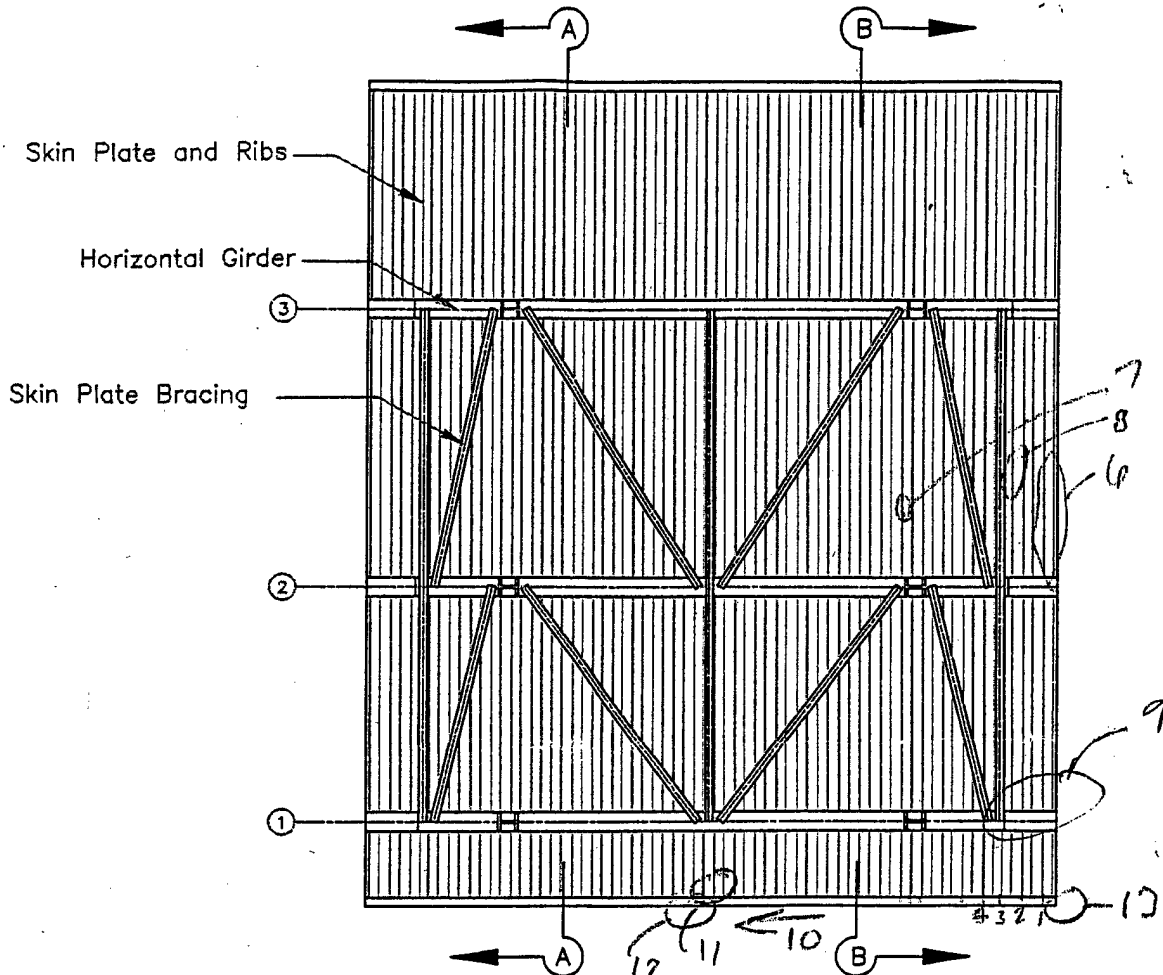
Gate No. 8 Downstream Elevation

NOTE. ENTIRE GATE is peeling w/ light RUST. there is evidence of NEW PAINT @ V. GATE FACE PL.

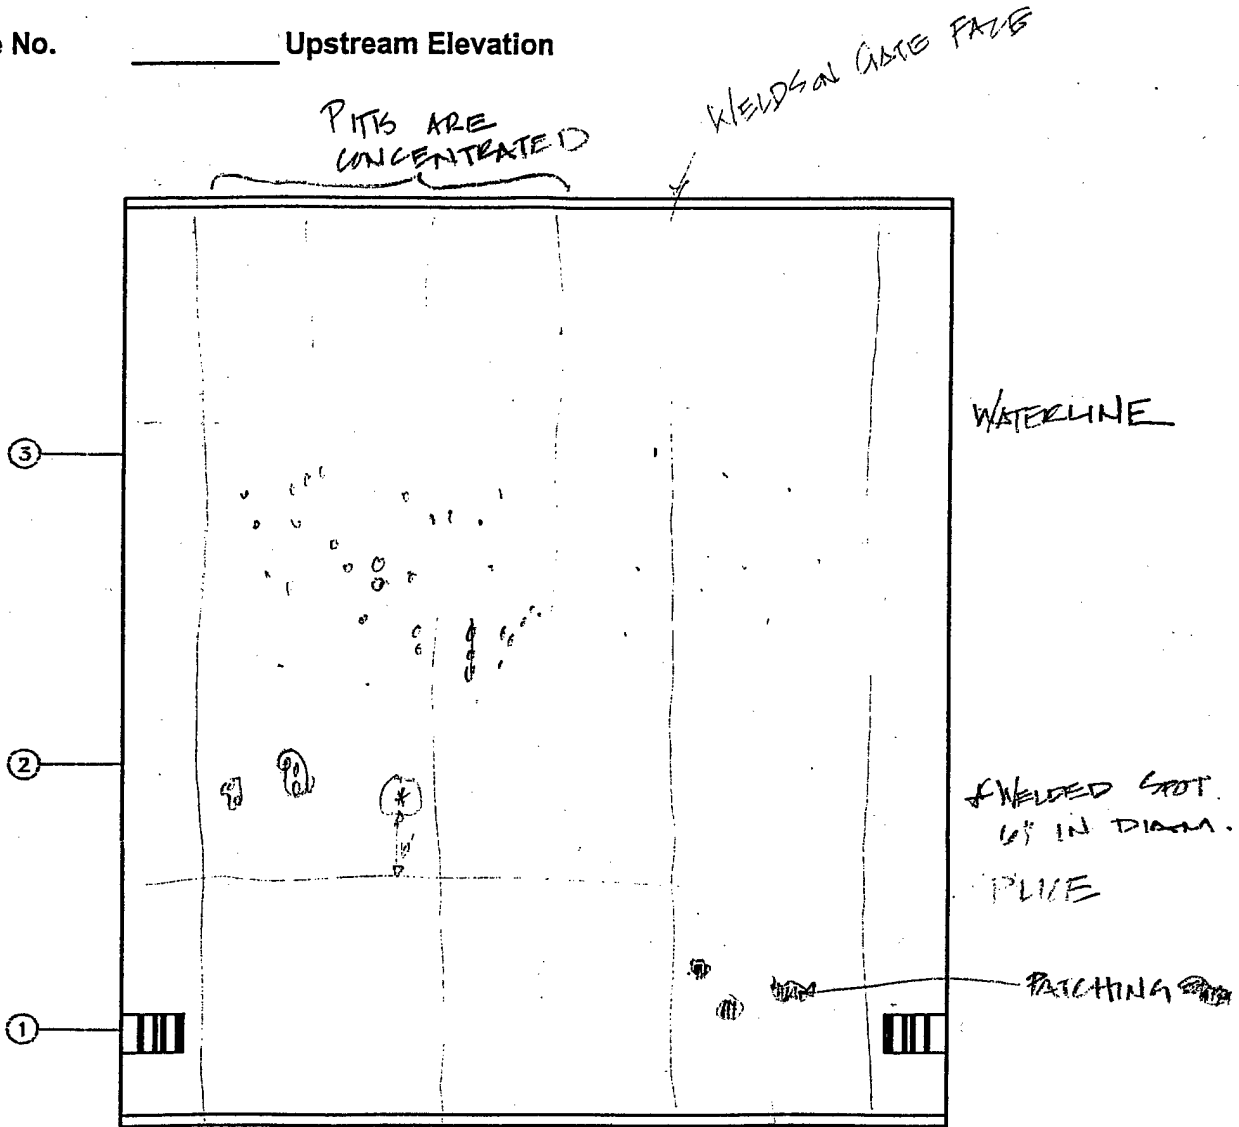
Gate No. _____ Upstream Elevation _____

- SOME PITS HAVE BEEN FILLED W/ WELD MATERIAL
- RECORDS SHOULD BE REFERENCED
- OTHER PITS ARE EXISTING
- SMALL PITS
- WEAR PLATES LOOK CLEAN

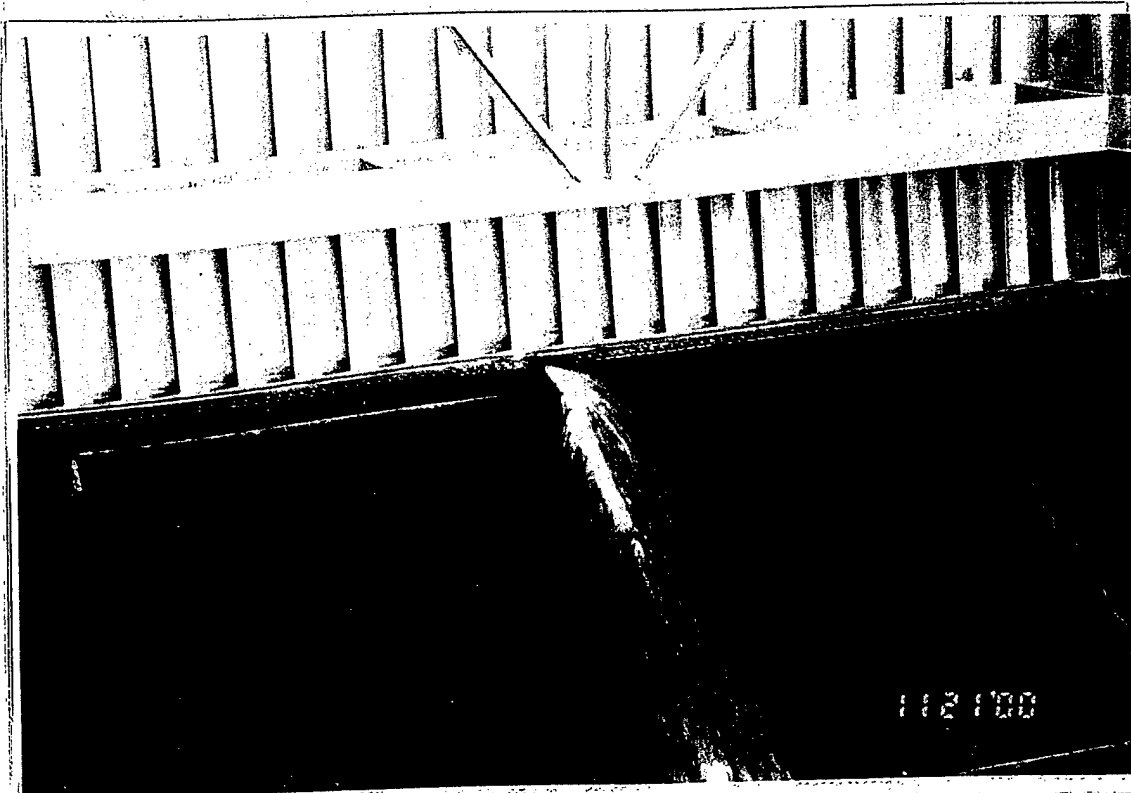
1-23

Gate 1
Leak at center construction joint in
spillway monolith.

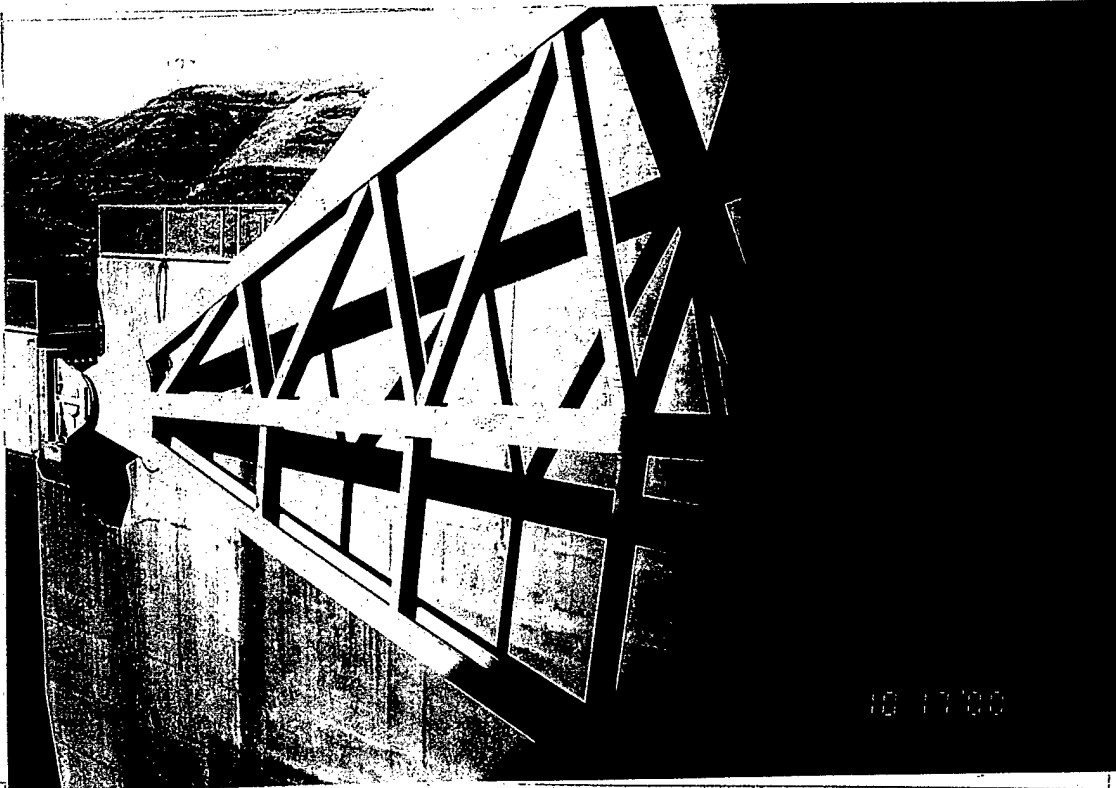
Gate 2
Right frame, typical.

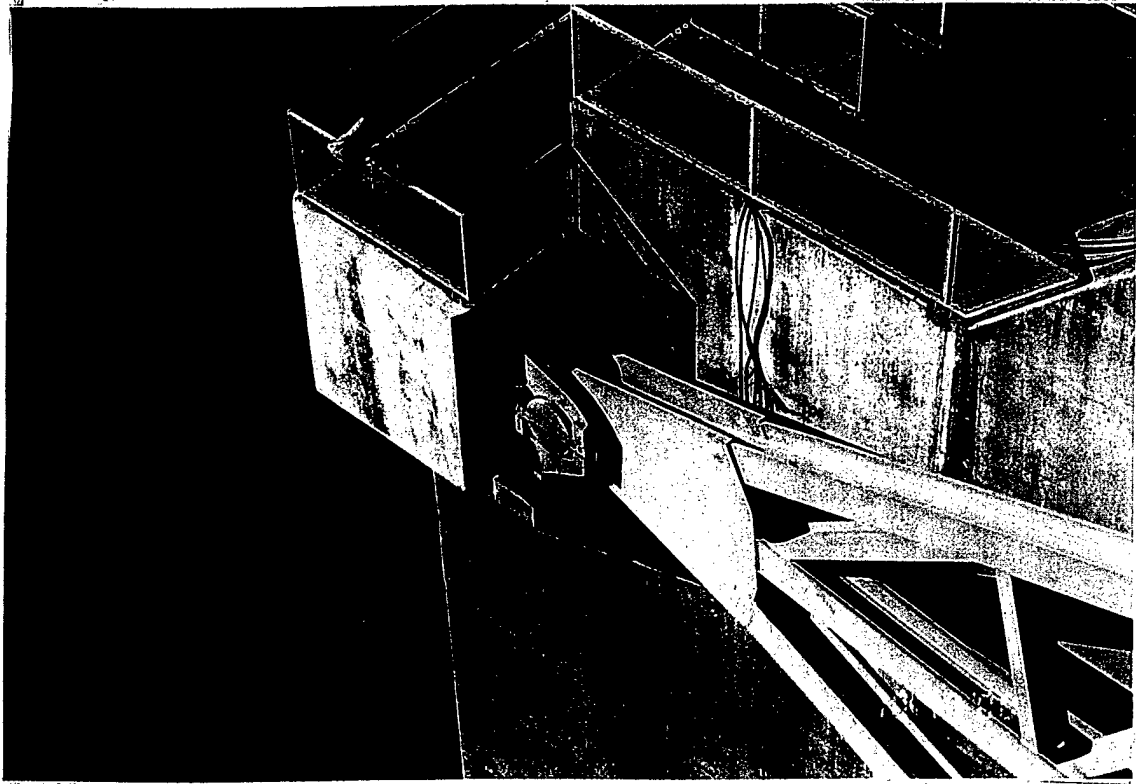
Gate 2
Right trunnion block, typical.

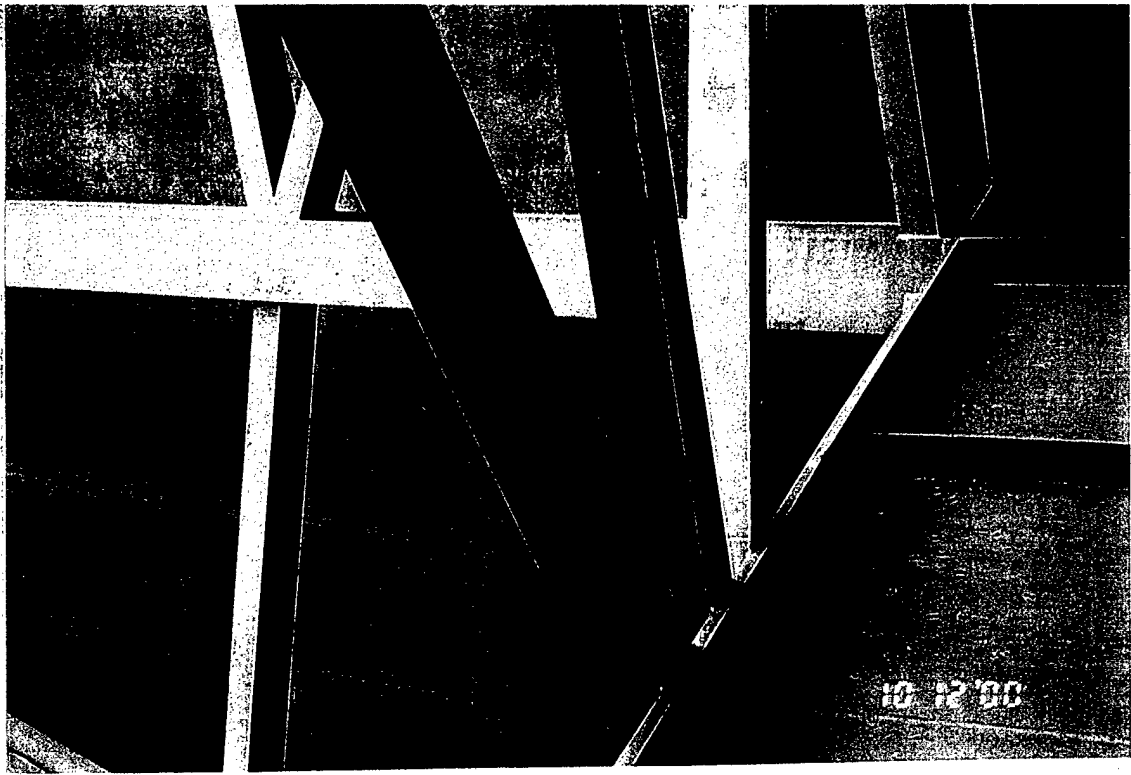
3-4

Gate 3
Middle horizontal girder bracing.
Light corrosion on braces.

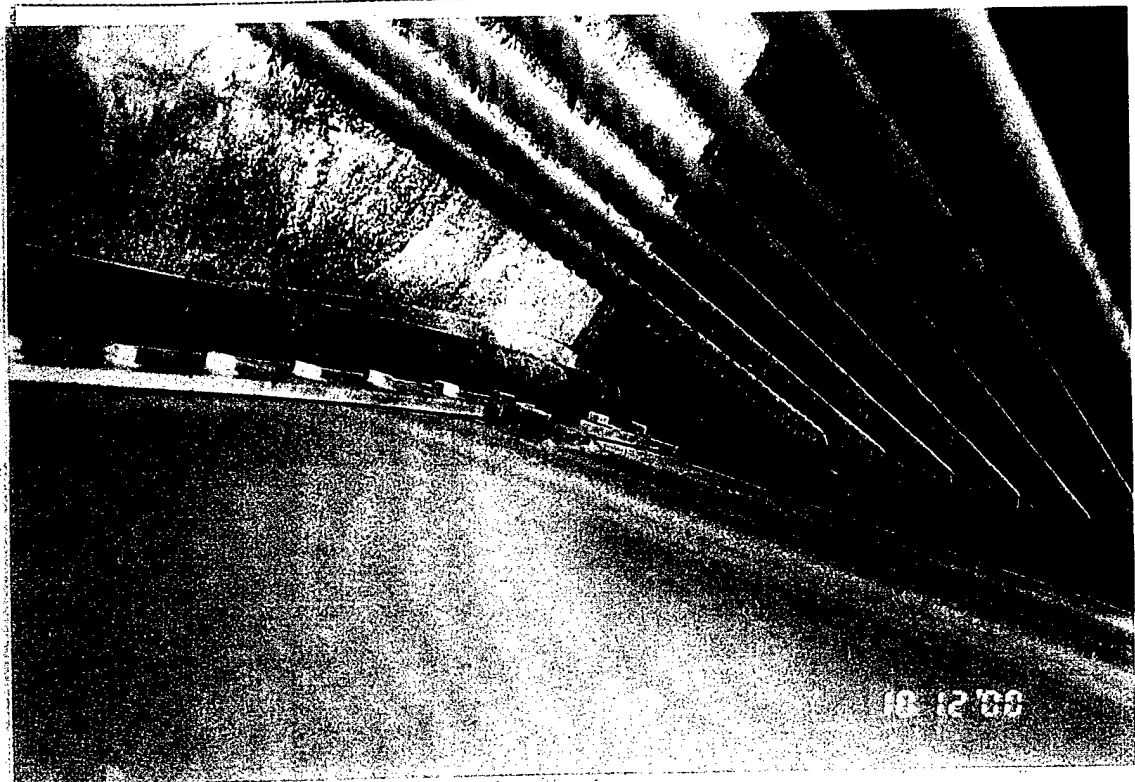
3-15

Gate 3
Top upstream skinplate at hoist
cables. Moderate corrosion on
unidentified metal.

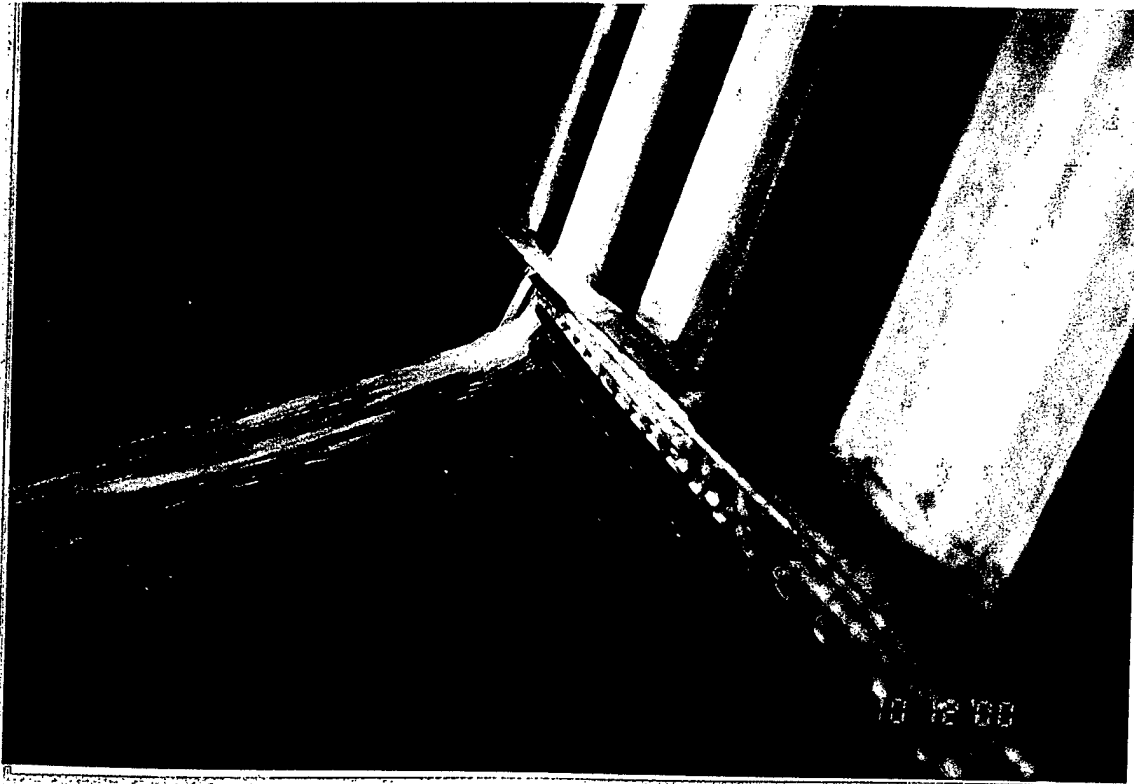
Little
Goose
Dam
10/12/00
4-11

Gate 4
Standing water between closure plate,
purlin webs and skinplate, typical.
Bottom right corner seal leak.

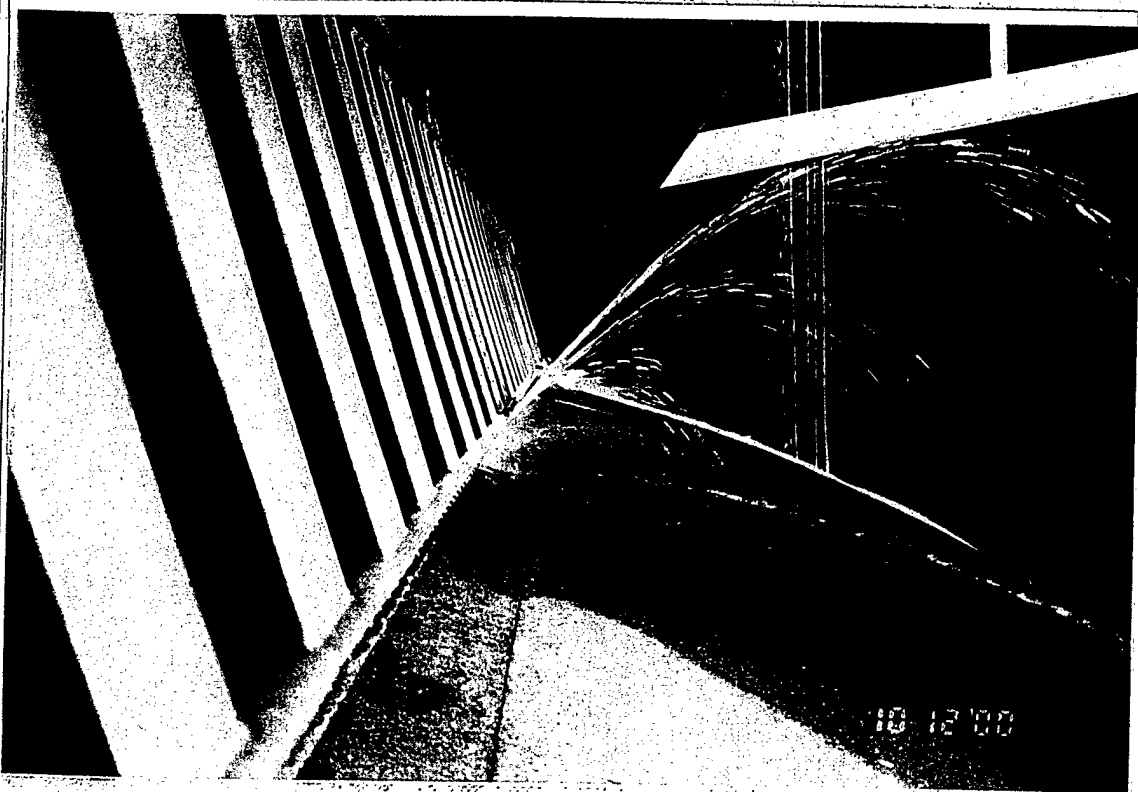
Little
Goose
Dam
10/12/00
4-12

Gate 4
Leak at center construction joint in
spillway monolith.

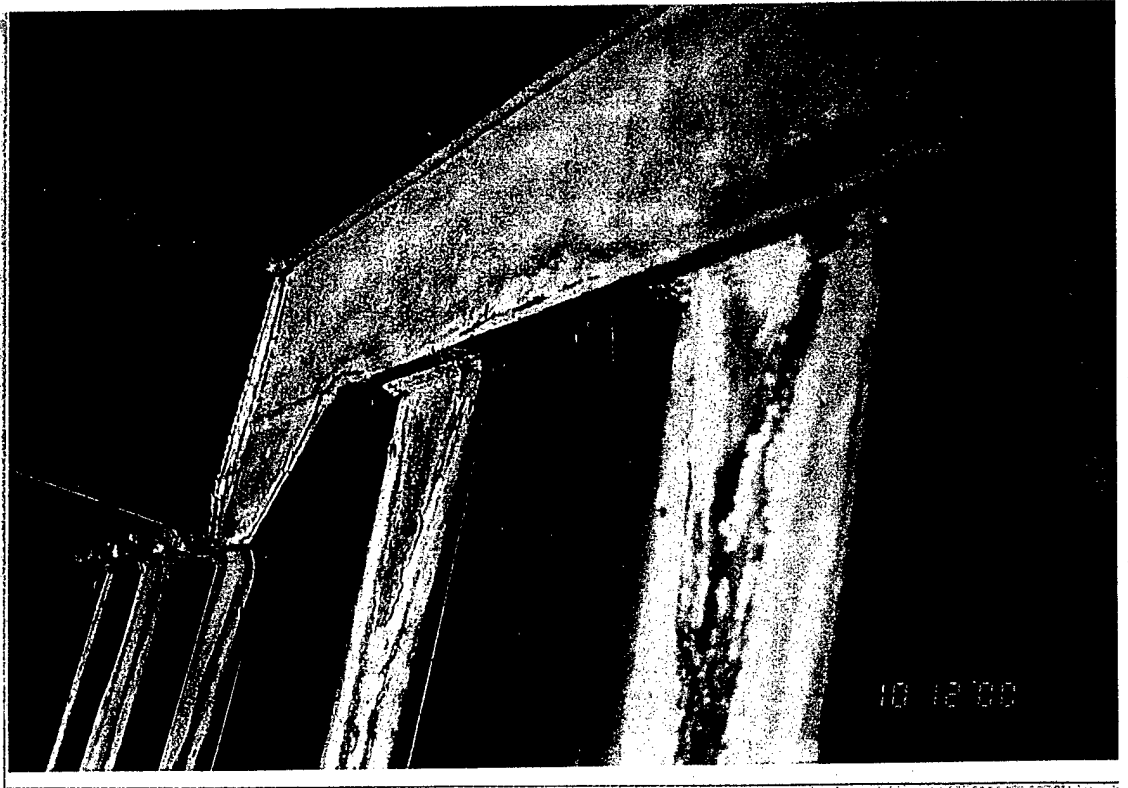
Little
Goose
Dam
10/12/00
4-17

Gate 4
Bottom of bottom horizontal girder,
light corrosion on girder, stiffeners
and purlins.

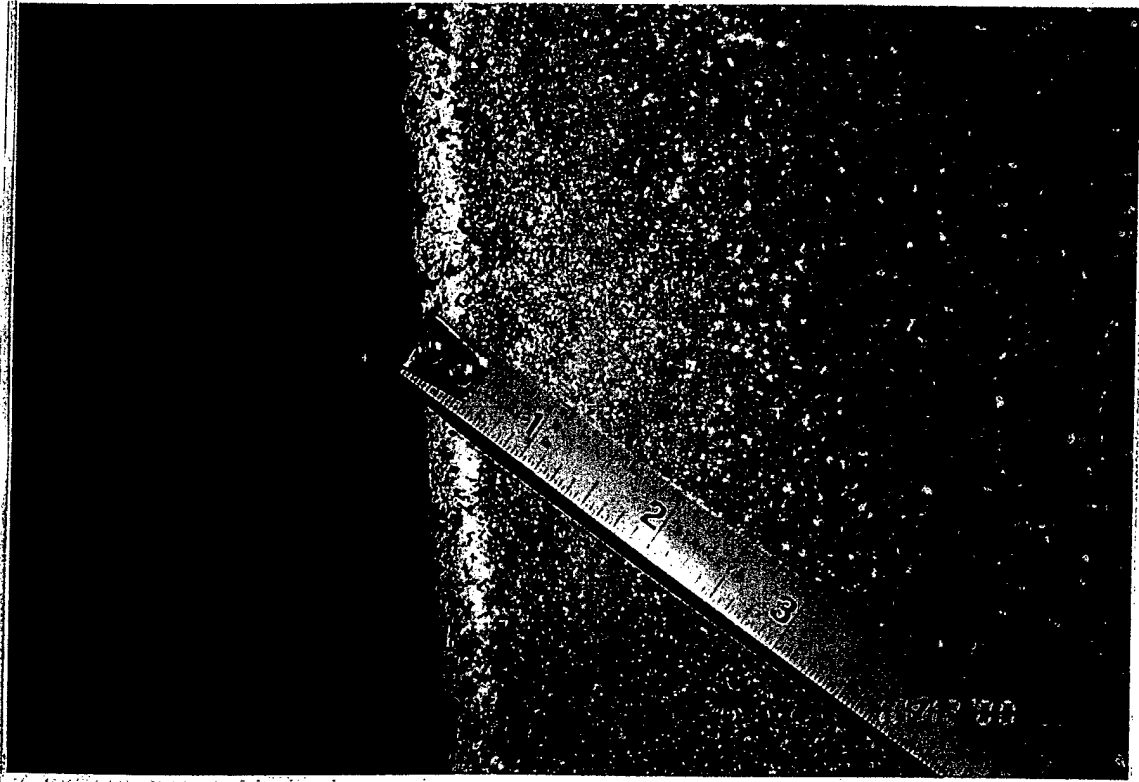
Little Goose Dam	Gate 4 Brace N, left frame. Light corrosion on brace web and flanges.
10/12/00	
4-19

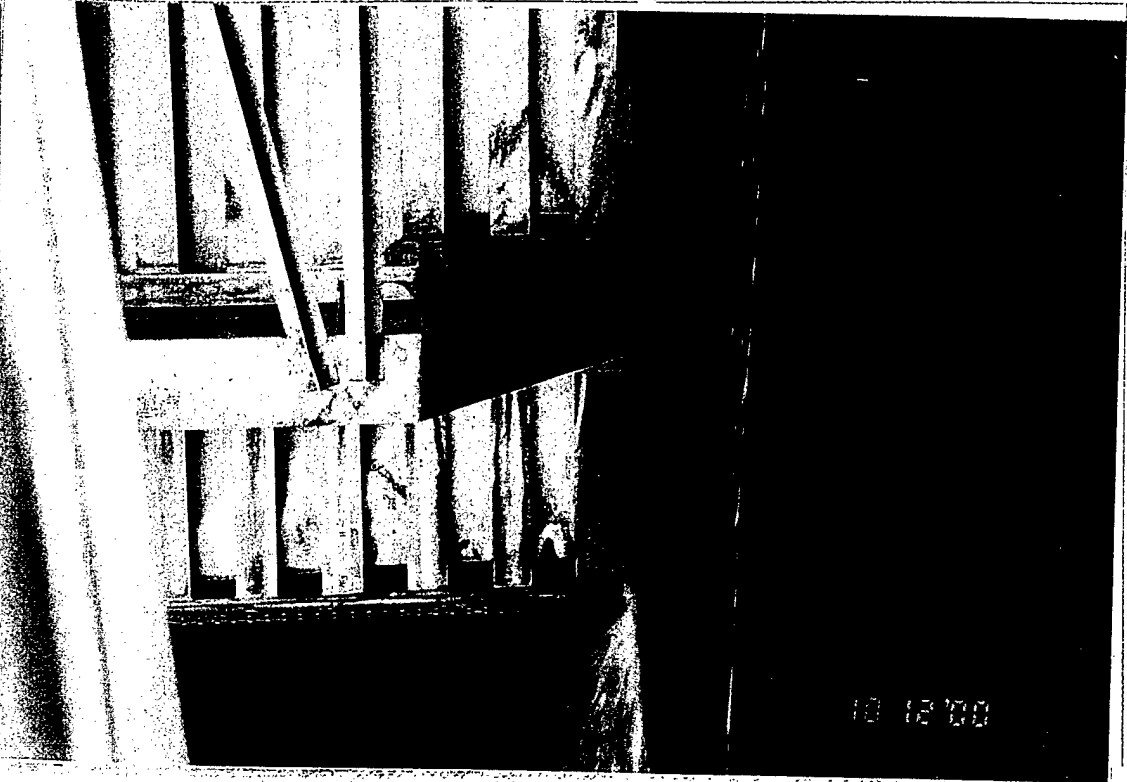
Little Goose Dam	Gate 4 Bottom horizontal girder, left side. Standing water, no drainage between multiple stiffeners, typical. Side seal leak.
10/12/00	
4-20
