Little Goose Dam Radial Gate Inspection and Testing

US Army Corps of Engineers, Walla Walla District

13. ABSTRACT (Maximum 200 words) This report is an evaluation of the overall condition of the spillway tainter gates at Little Goose Lock and Dam, Snake River Washington.

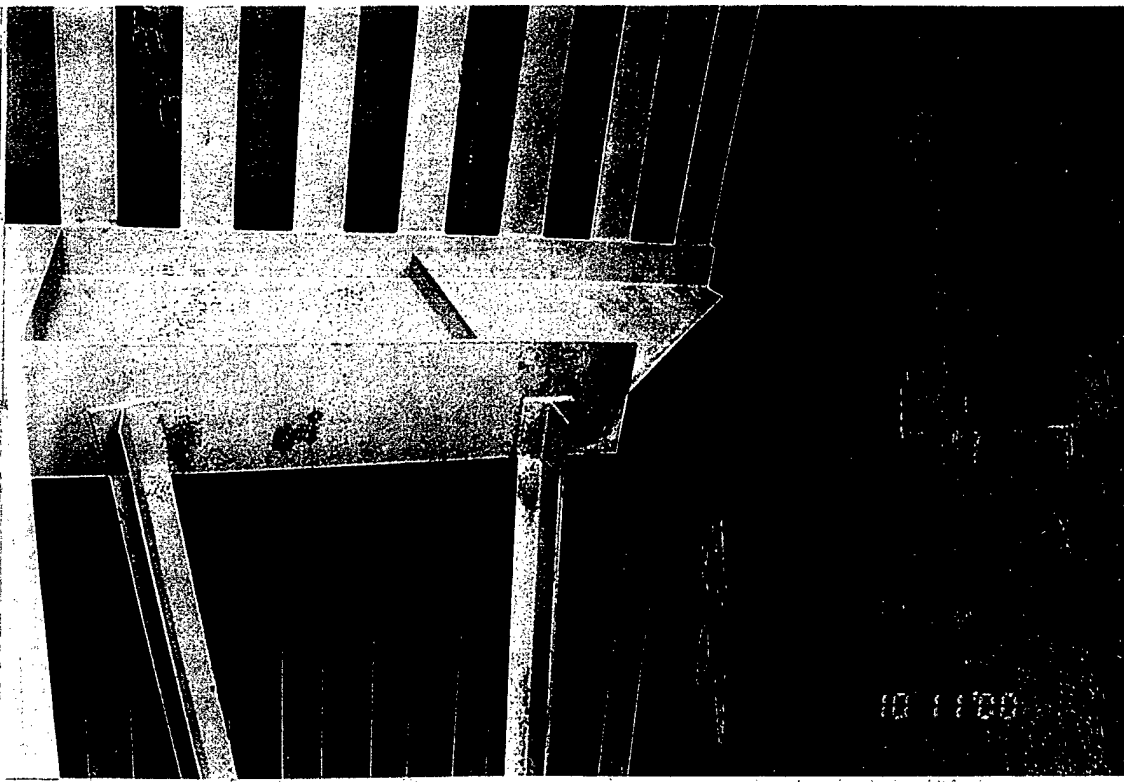
Little
Goose
Dam
10/11/00
5-3

Gate 5
Top horizontal girder, left side of
gate. Light corrosion on girder web,
purlins, braces.

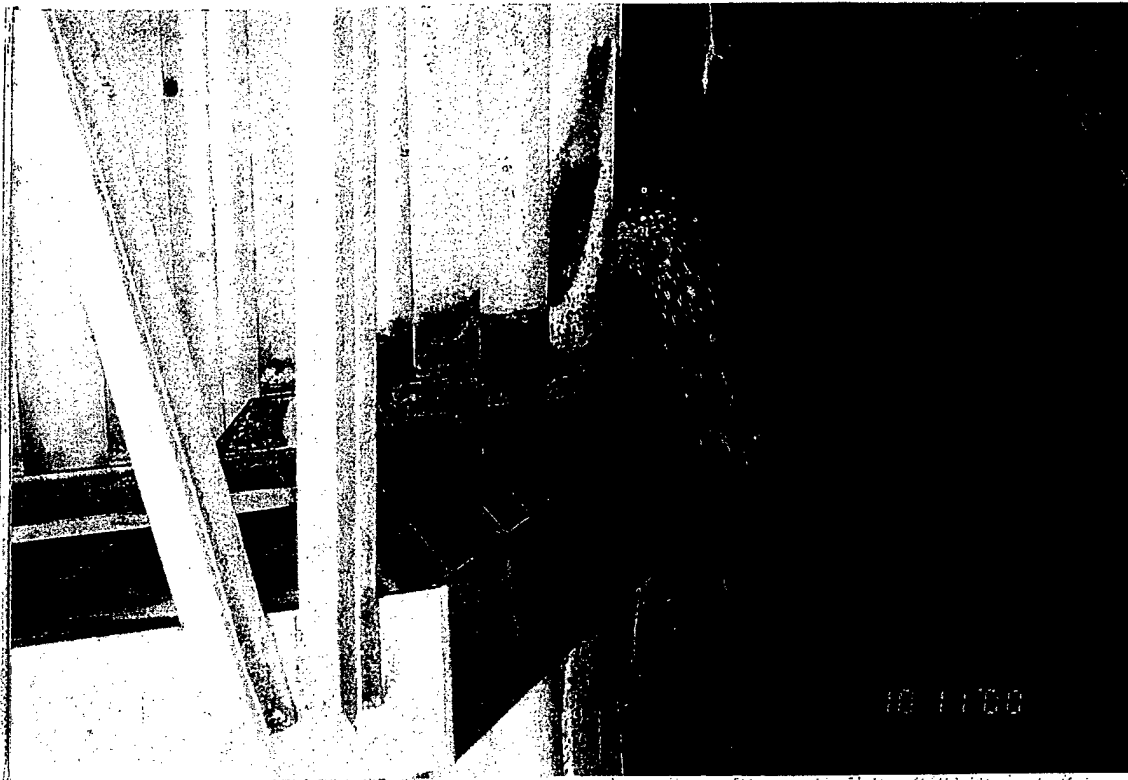
Downstream side of skin plate, left
side of gate, above middle horiz.
girder. Peeling pain, light corrosion.
Appears to be possible paint blister
due to upstream skin plate welding.

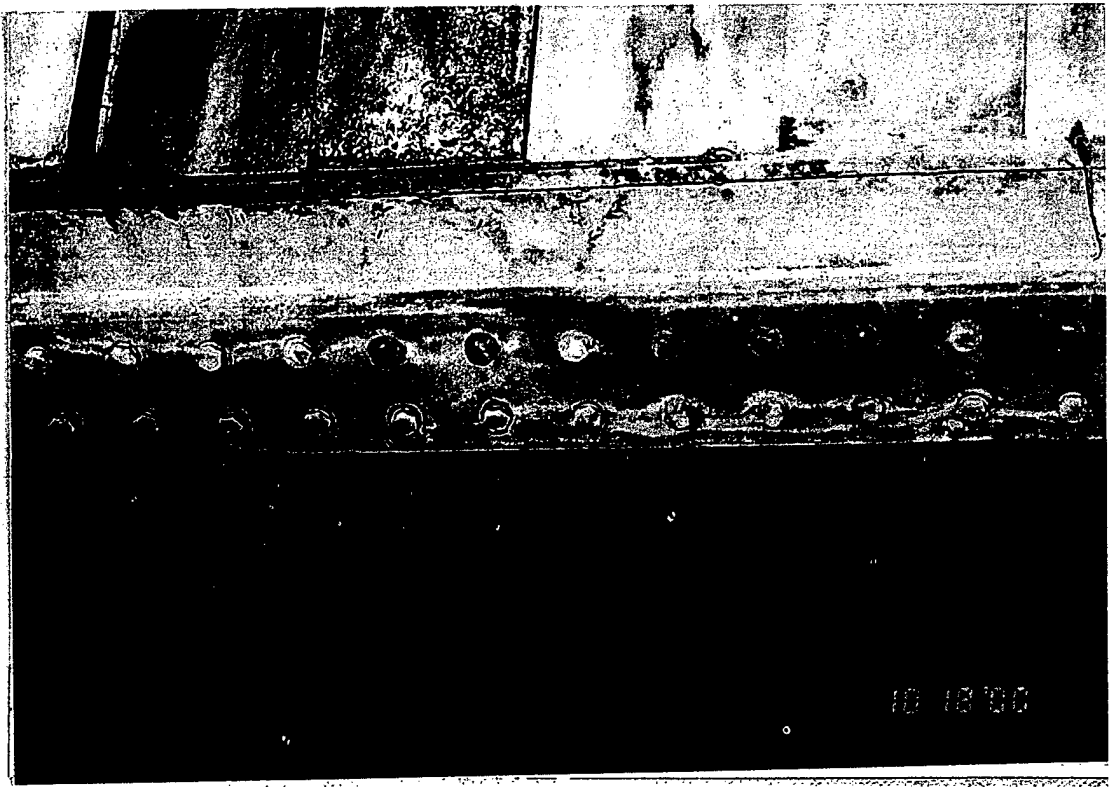
Top of right hoist connection. Light corrosion on lifting lugs and plates.

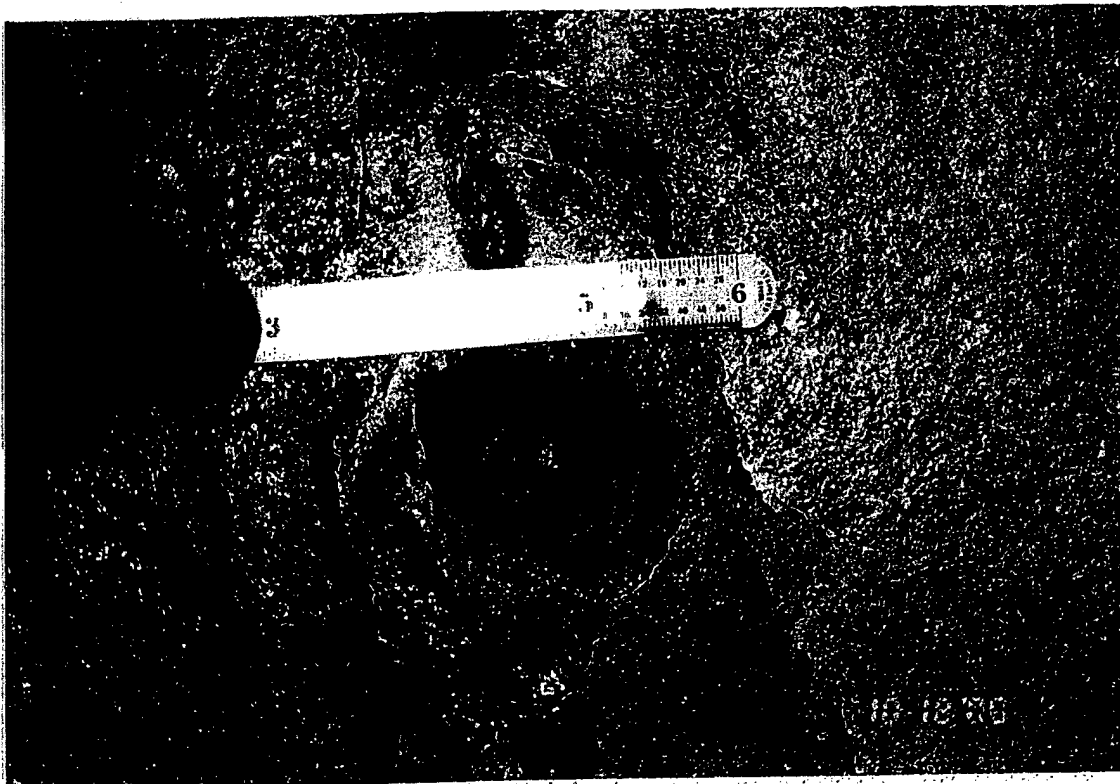
Little
Goose
Dam
10/18/00
5-23

Gate 5
Heavy pitting on wear plate, typical.

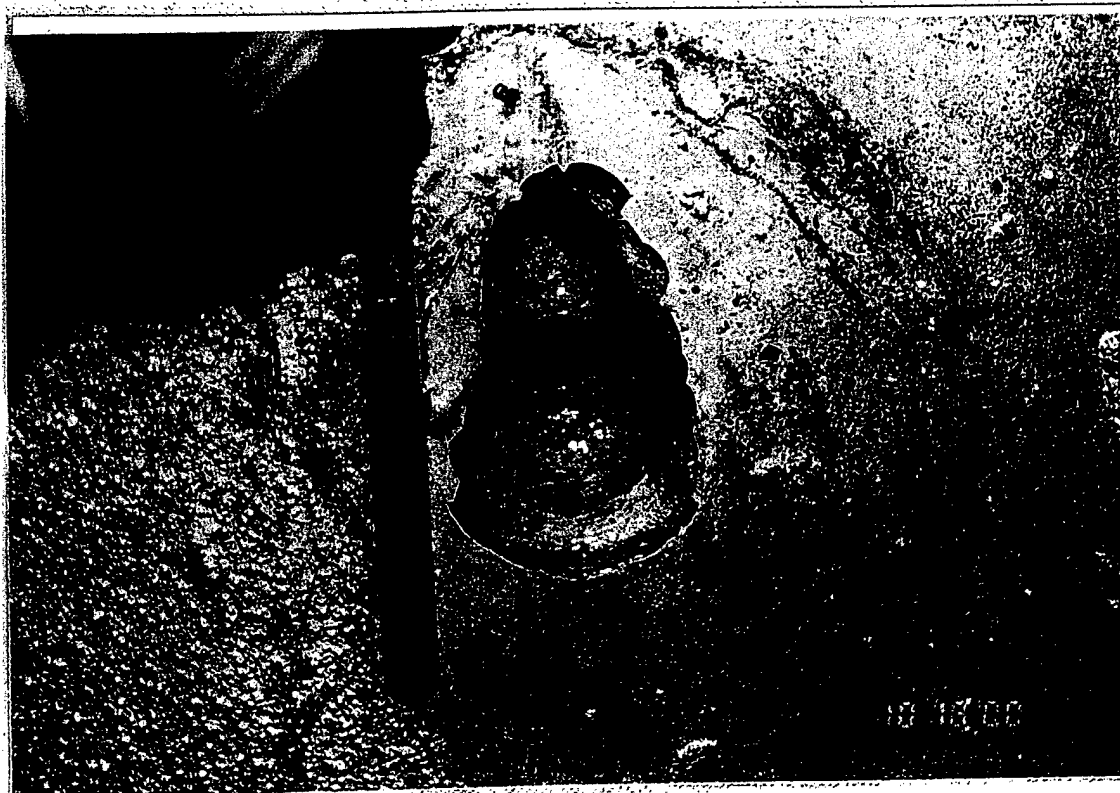
Little
Goose
Dam
10/18/00
5-24

Gate 5
Heavy pitting on wear plate, typical.

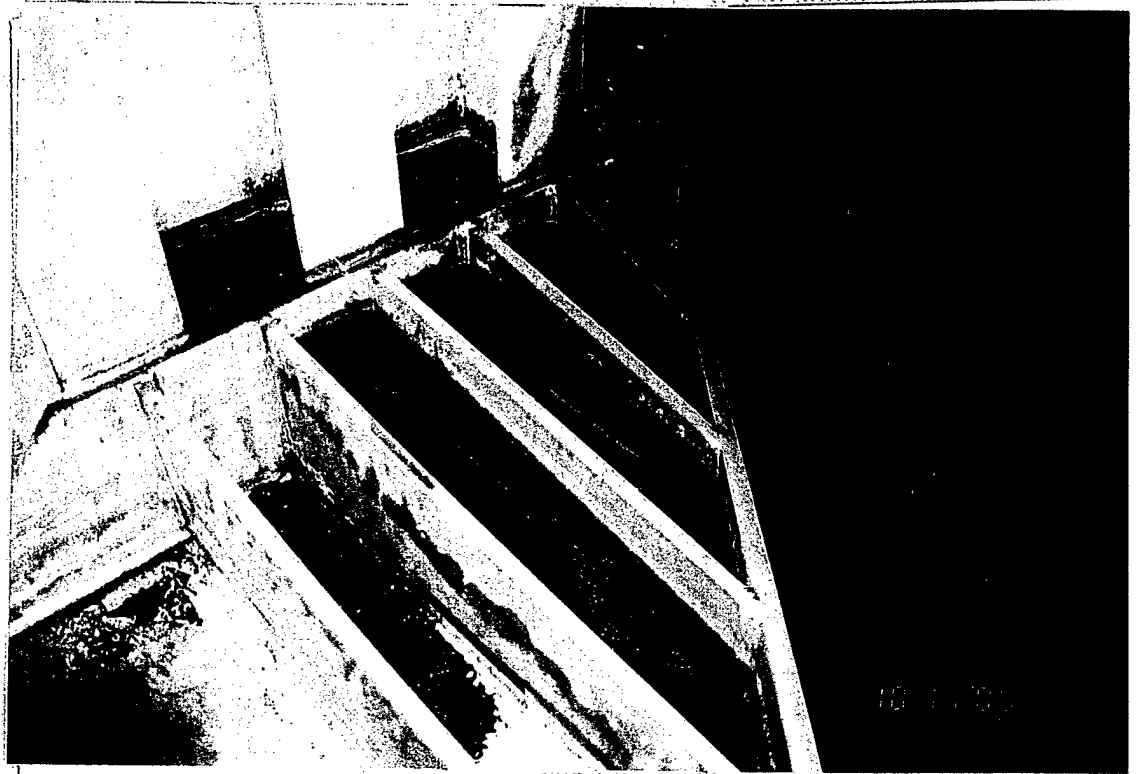
Gate 6
Gate face and spillway, typical. Leak
at center construction joint in spillway
monolith.

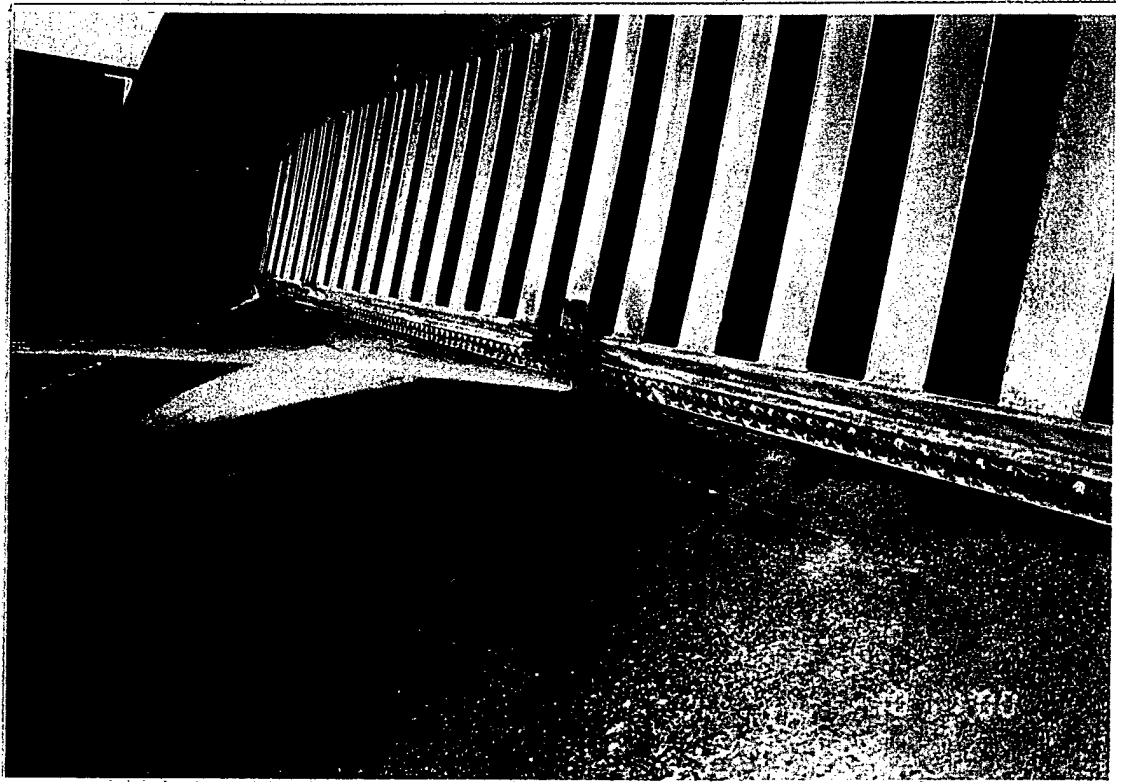
Little
Goose
Dam
10/11/00
6-14

Gate 6
Leak at center construction joint in
spillway monolith.

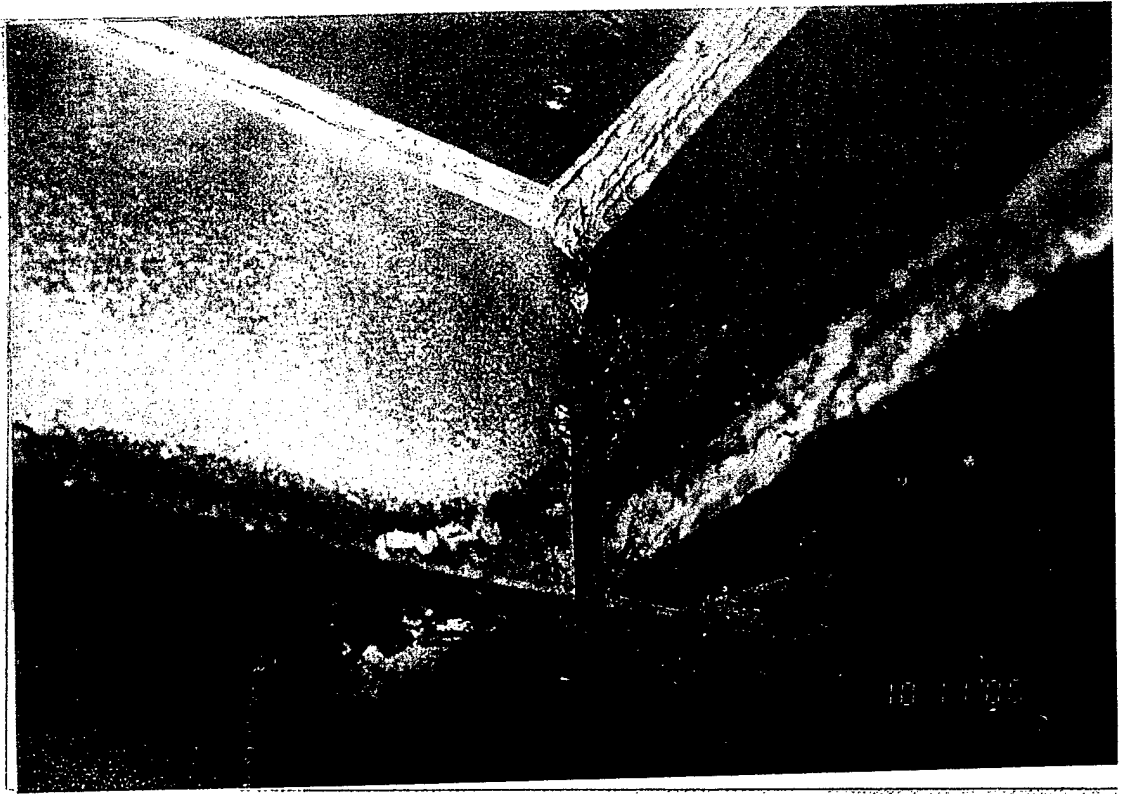
Bottom of bottom horizontal girder
at radial strut connection and girder
drain hole. Light corrosion on girder
web and stiffeners.

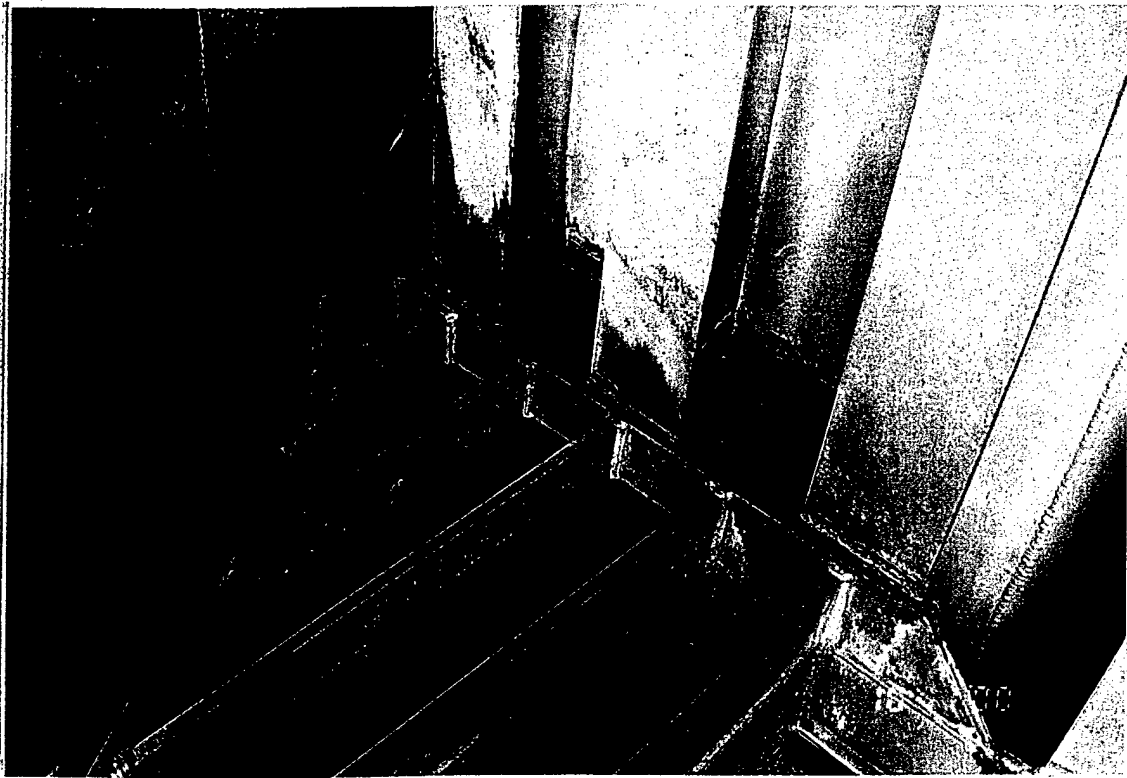
Gate 6
Side seal leak, bottom right side of
gate. Light corrosion on purlin,
horizontal girder and girder
stiffeners.

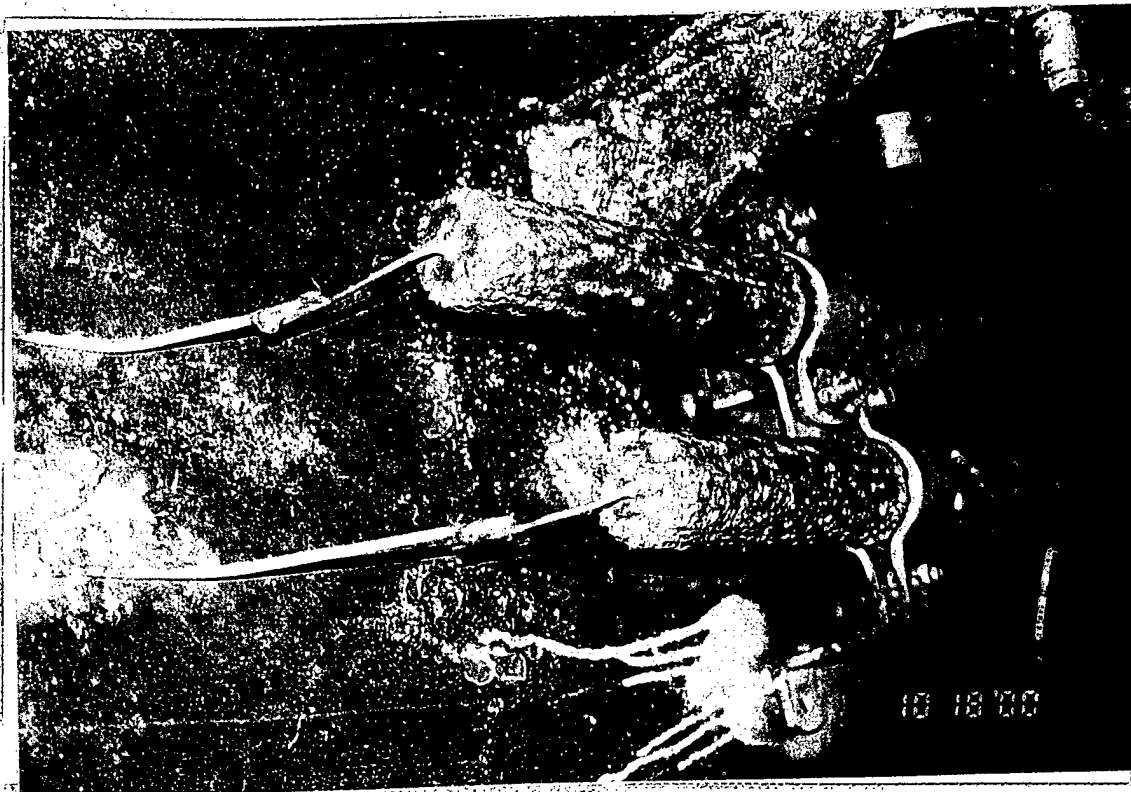
Little Goose Dam	Gate 6 Hoist connection anodes, typical.
10/18/00	
6-28

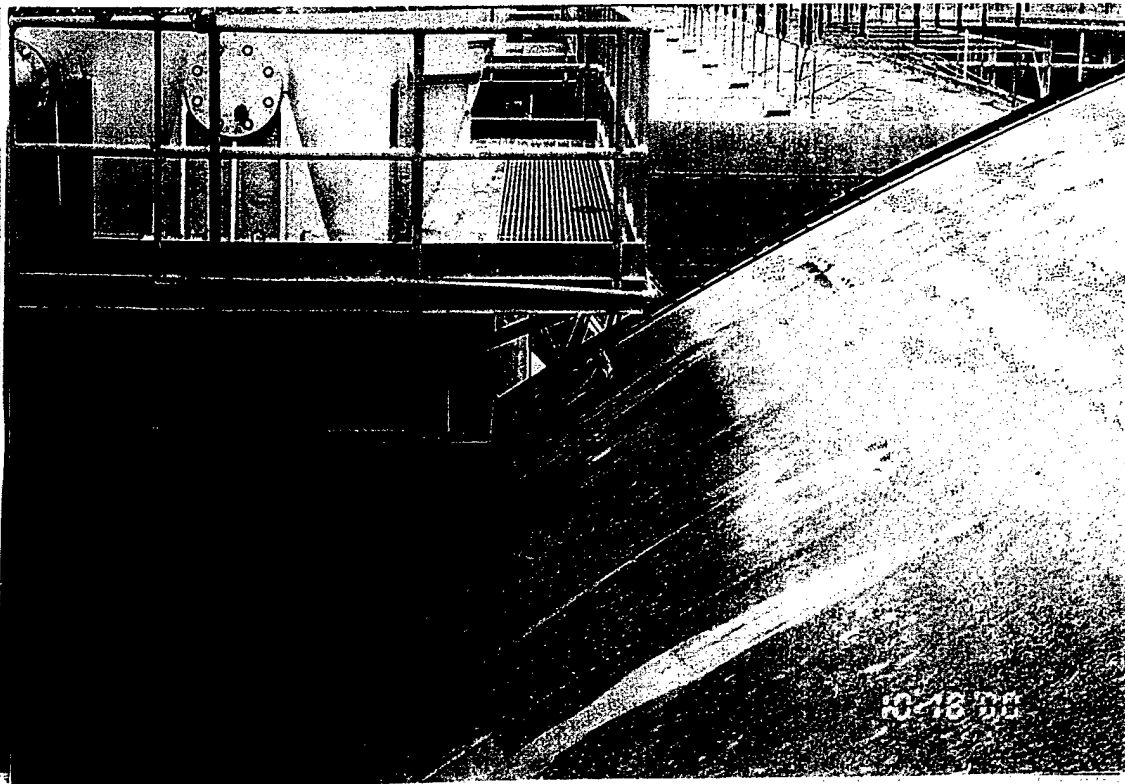
Gate 6
.Skin plate pitting, typical.

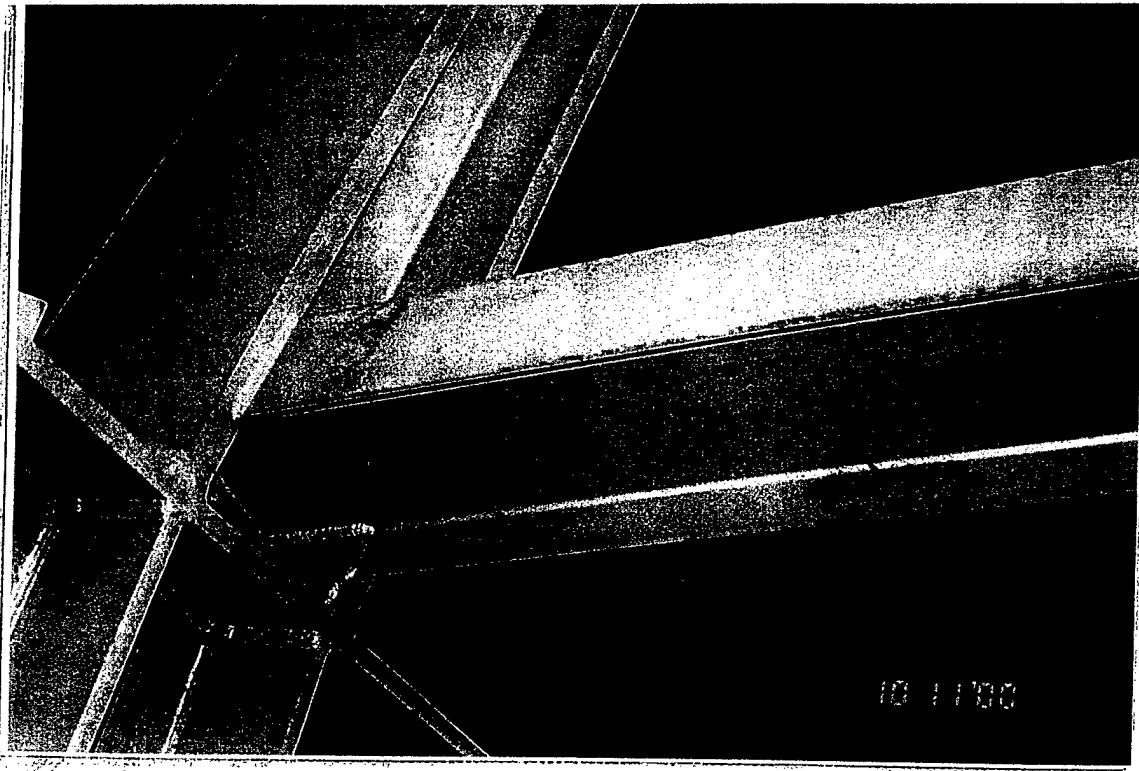
Little
Goose
Dam
10/11/00
7-3

Gate 7
Bottom horizontal girder, right end.
Standing water, no drainage between
multiple stiffeners, typical.

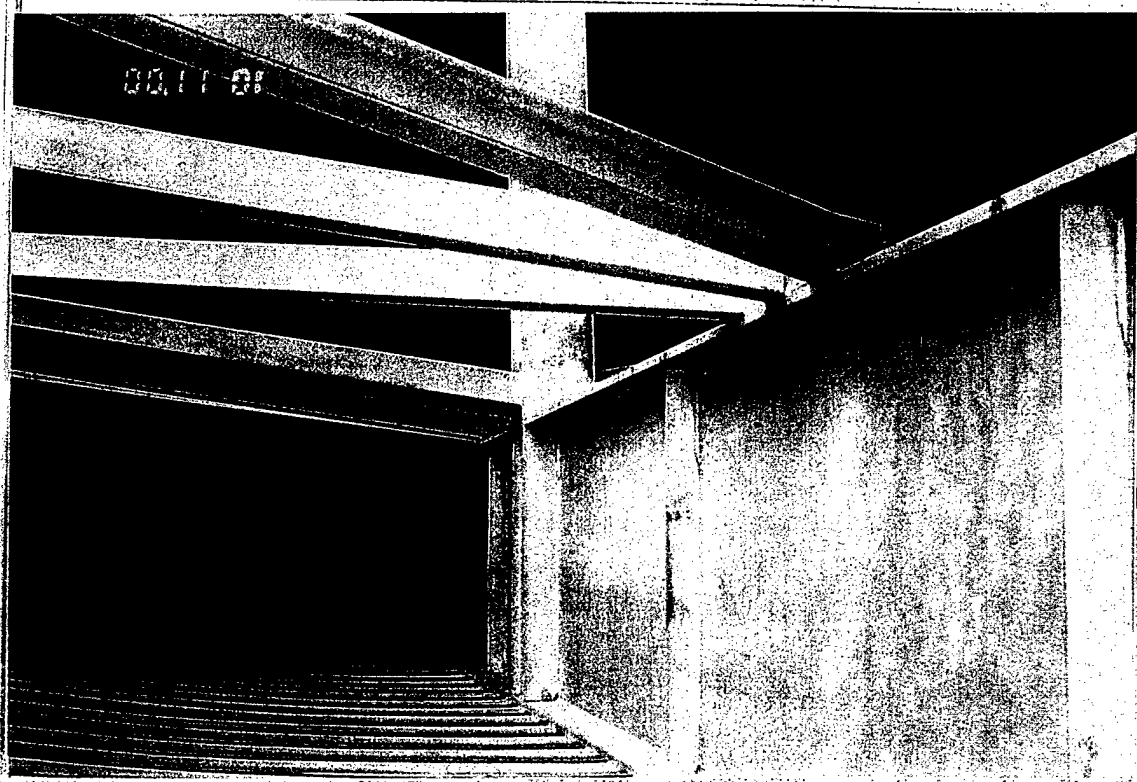
Little
Goose
Dam
10/11/00
7-4

Gate 7
Left frame, Brace A. Light corrosion
on brace, radial strut and horizontal
girder.

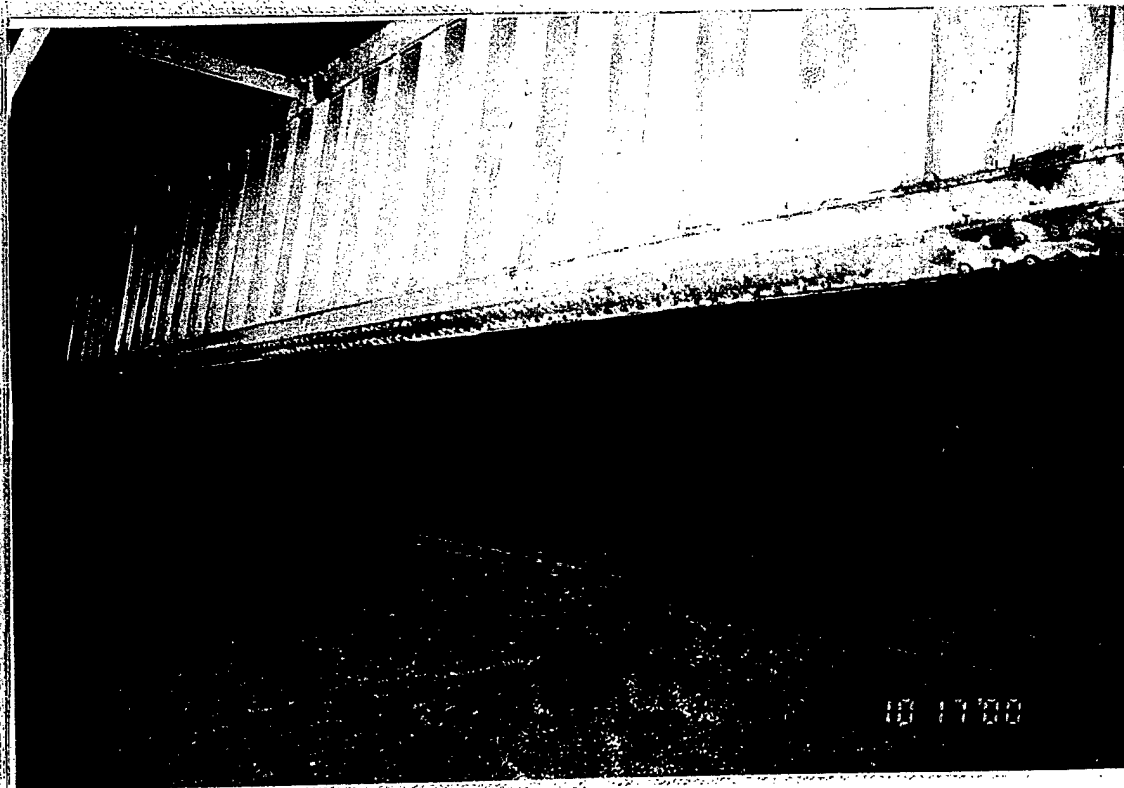
Stop log leakage precluding
inspection of hoist connections from
bottom.

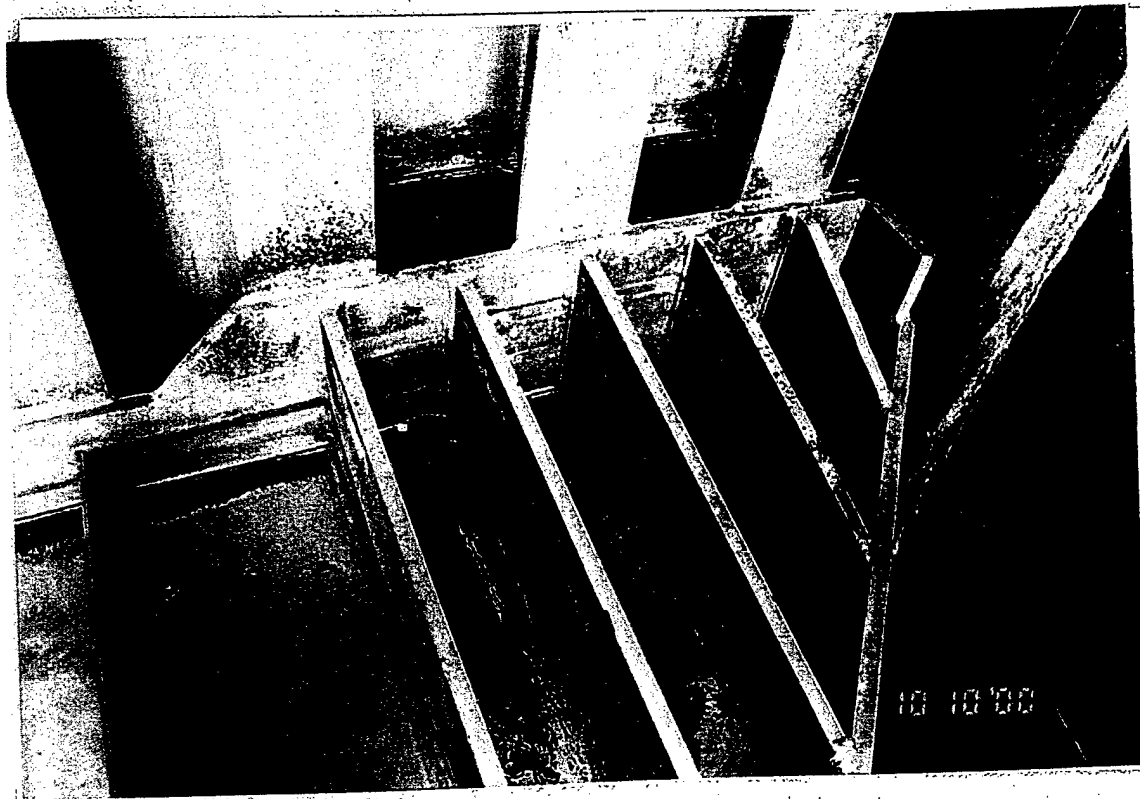
Gate 8
Downstream surface of skin plate, left
side of gate above middle horizontal
girder. Apparent grind marks from
weld repair.
