<b>13. ABSTRACT (Maximum 200 words)</b> This report is an evaluation of the overall condition of the spillway tainter gates at Lower Granite Lock and Dam, Snake River Washington.				
<b>14. SUBJECT TERMS</b> Spillway tainter gates inspection testing			<b>15. NUMBER OF PAGES</b> 250	
			<b>16. PRICE CODE</b>	
<b>17. SECURITY CLASSIFICATION OF REPORT</b> Unclassified	<b>18. SECURITY CLASSIFICATION OF THIS PAGE</b> Unclassified	<b>19. SECURITY CLASSIFICATION OF ABSTRACT</b> Unclassified	<b>20. LIMITATION OF ABSTRACT</b> UL

February 2001

# Lower Granite Dam Radial Gate Inspection and Testing

US Army Corps of Engineers, Walla Walla District

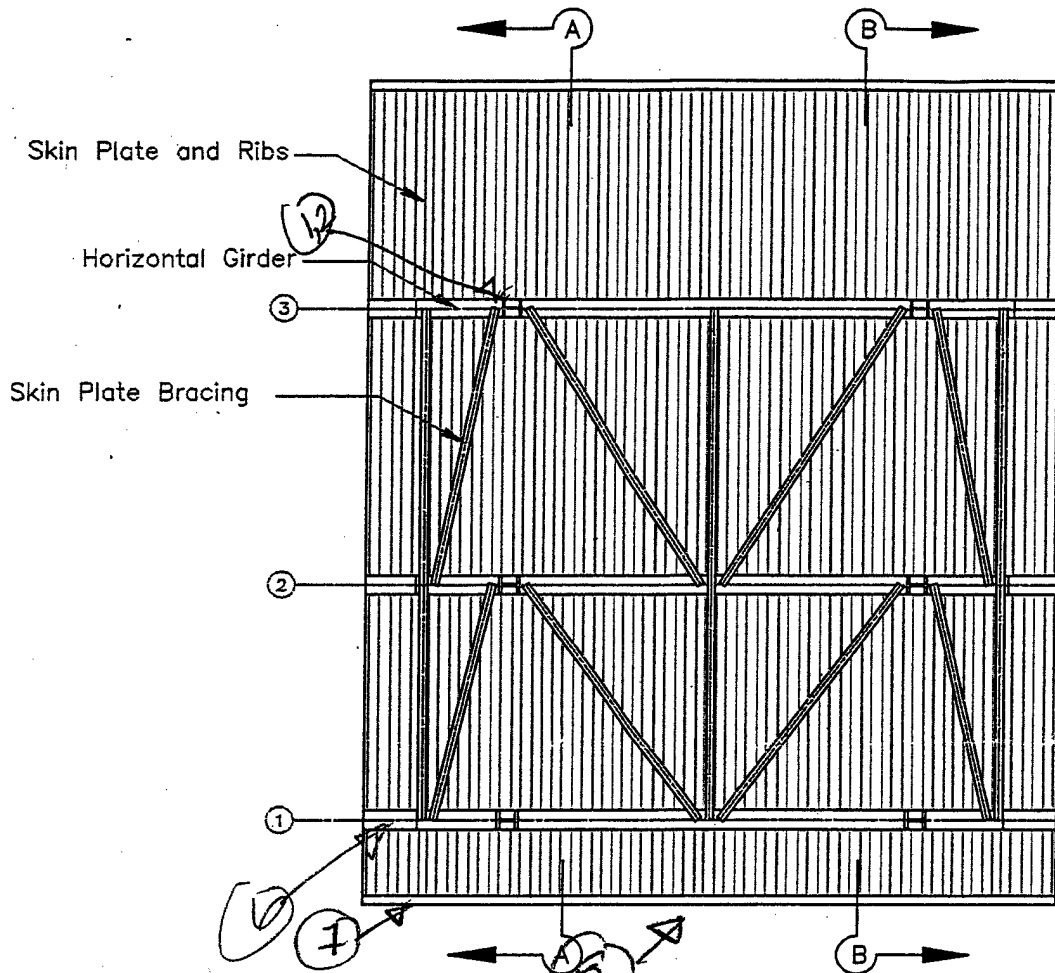
Gate No. 1 Downstream Elevation

① leaking Gate @ Bottom ②

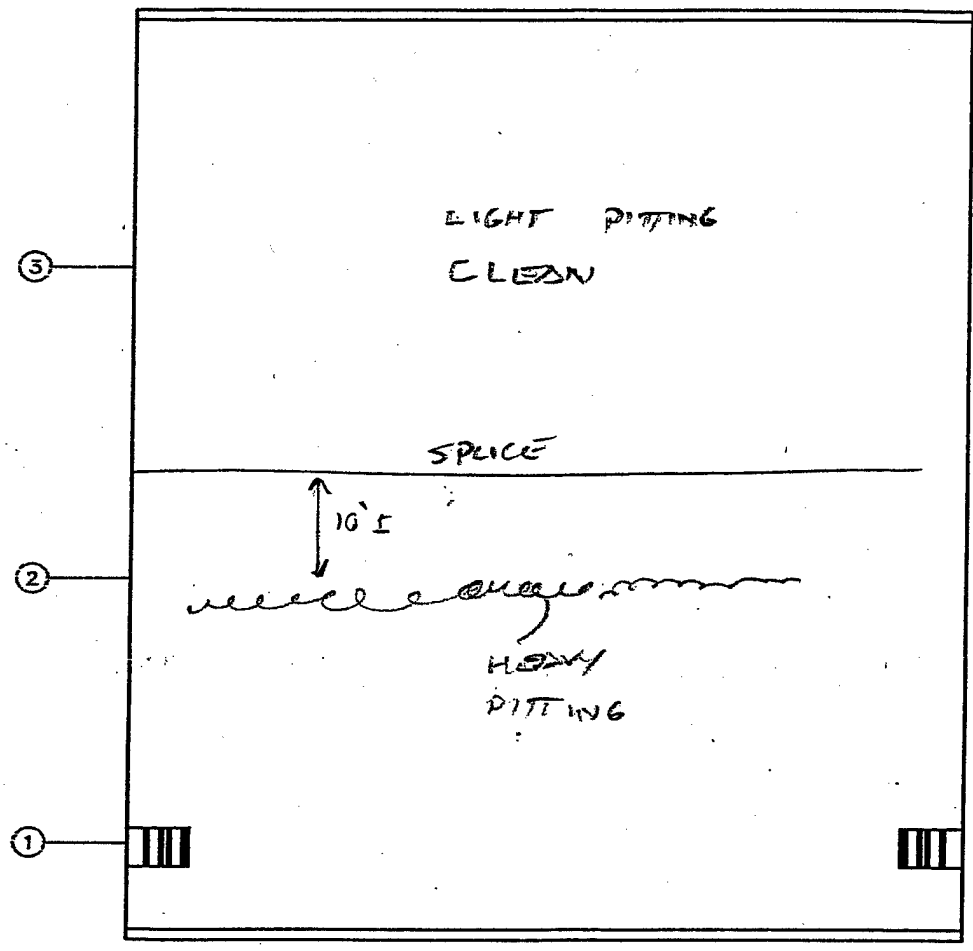
Gate No. 1 Upstream Elevation

HEAVY PITTING @ 10' BELOW SPICE / TOP OF OTHER GATES

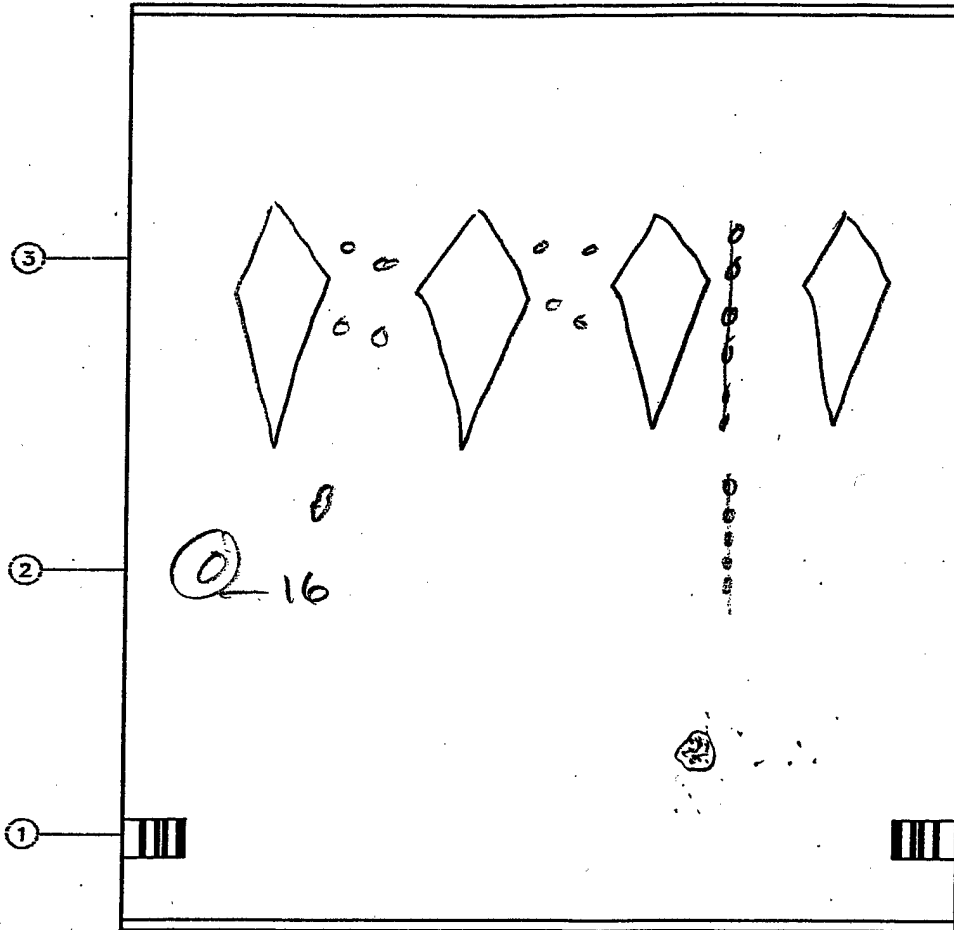
Gate No. 2 Upstream Elevation

- Paint Flaking off due to pressure wash ( $\frac{15}{14}$  pic)  
16: Top Potting hole  $\approx \frac{1}{8}$ " to  $\frac{1}{4}$ " depth

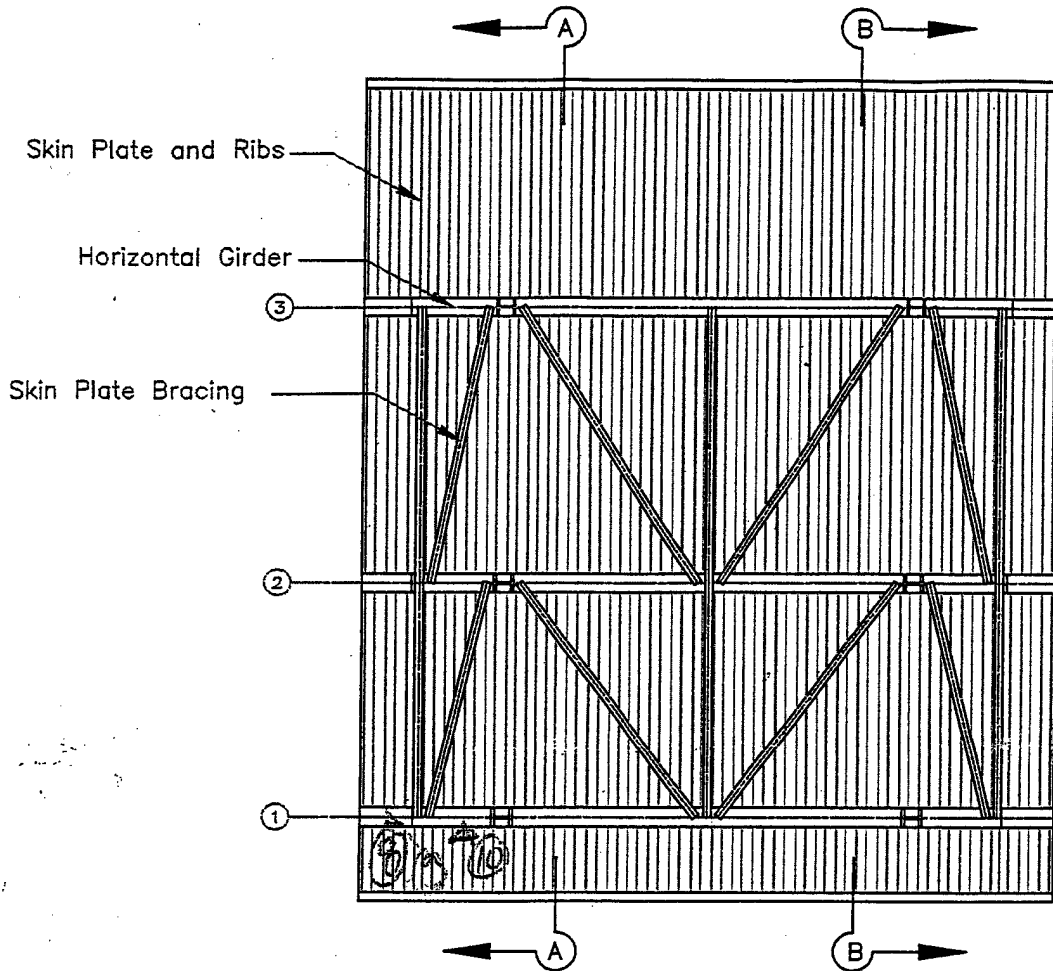
Gate No. 5 Downstream Elevation

(1) Leak in side seal on top girder  
 (2) ponding water @ middle  
 (3) ponding water overall  
 (4) ponding water in bottom girder  
 (1) side seal, rivet  
 (2) bottom seal ✓ from R → L  
 (3) (4) ponding in purlins & bottom gate

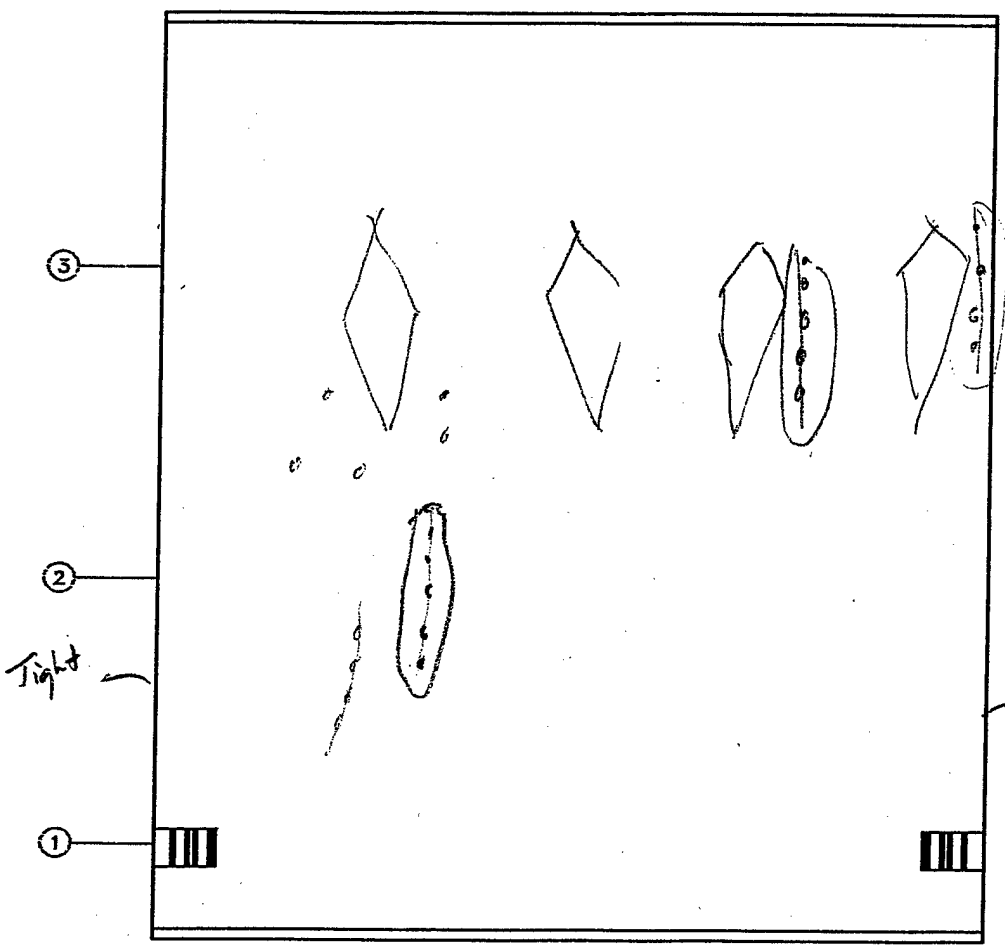
Gate No. 6 Upstream Elevation

NOTE: THERE appears to be  
 Scratches along Corrosion  
 lines.  
 CORR. Varies from 1/8" to 1/4"

- ① Gate Div. ID.
- ② Ponding @ Bottom of Gate
- ③ Bottom Seal
- ④ Bottom Seal Gate L → R
- ⑤ Water up of ponding.

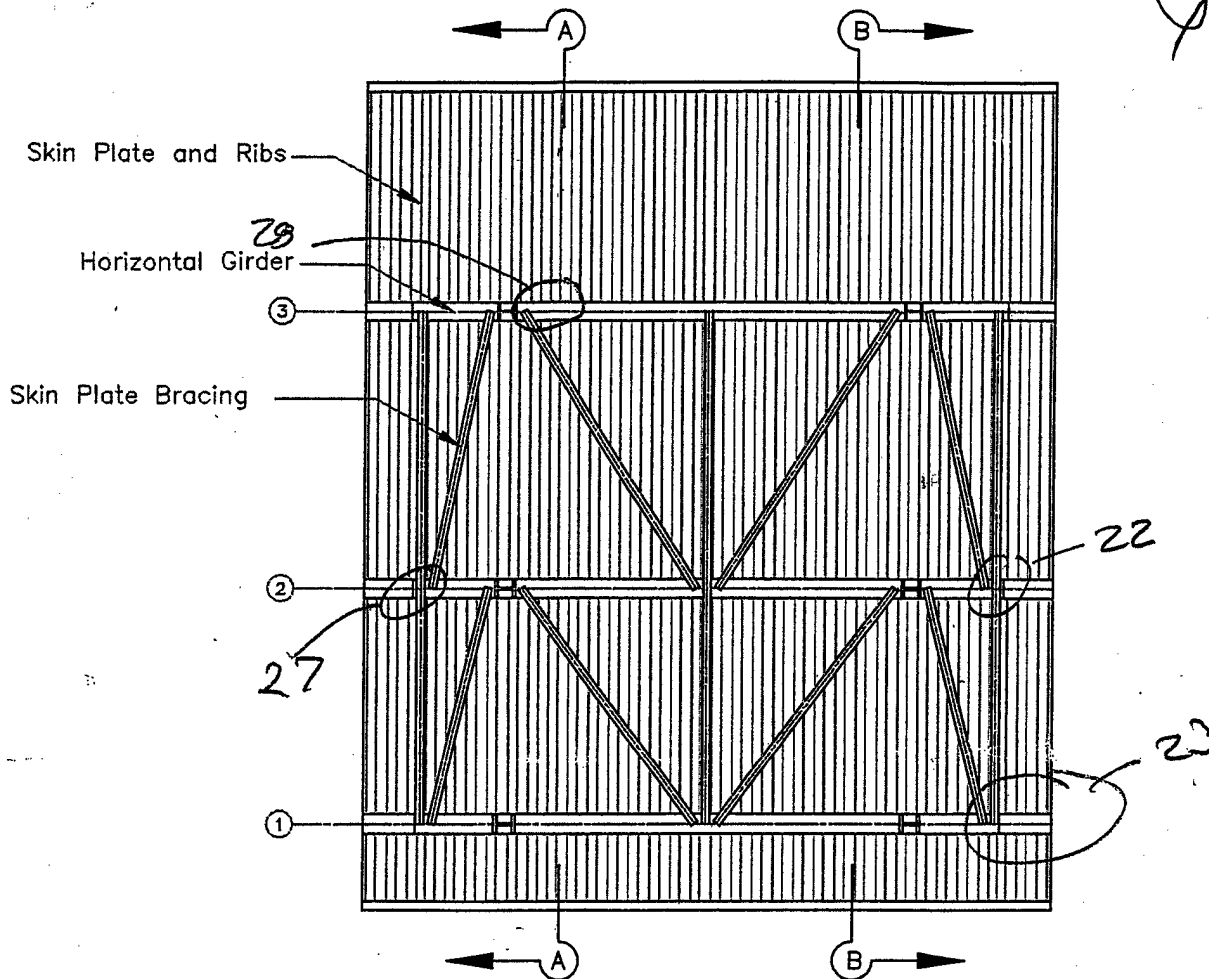
Gate No. 7 Downstream Elevation

- 22. Brace plates @ 2nd strut to girder. NOT WELDED @ back of GIRDER (Typ.)
- 23. Evidence of standing H<sub>2</sub>O w/ Debris
- 24. Standing H<sub>2</sub>O AND Muck in Bot. SEAL Plt.
- 25. LEAKS ALONG Bot. SEAL
- 26. Bot. LEFT STRUT @ Bot Girder Light Rust
- 27. BENT WEB OF T beam
- 28. Light Rust & Delam Pmt.

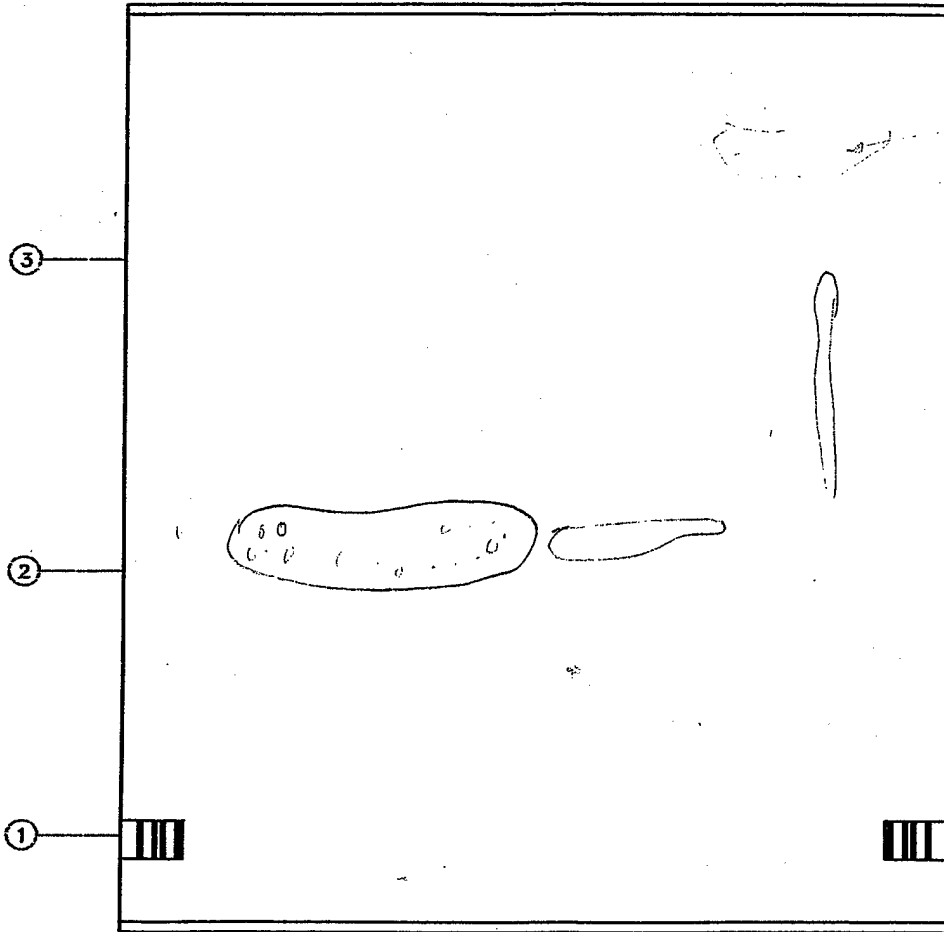
Gate No. 7 Upstream Elevation \_\_\_\_\_

- EROSION PITS ARE IN GROUPS. 1/2 - 1/4" DEEP
- Cables on LEFT SIDE: High Vibrations
- BOTTOM 3rd PITS ARE EVERY 1 1/2 - 2' ON AVE.

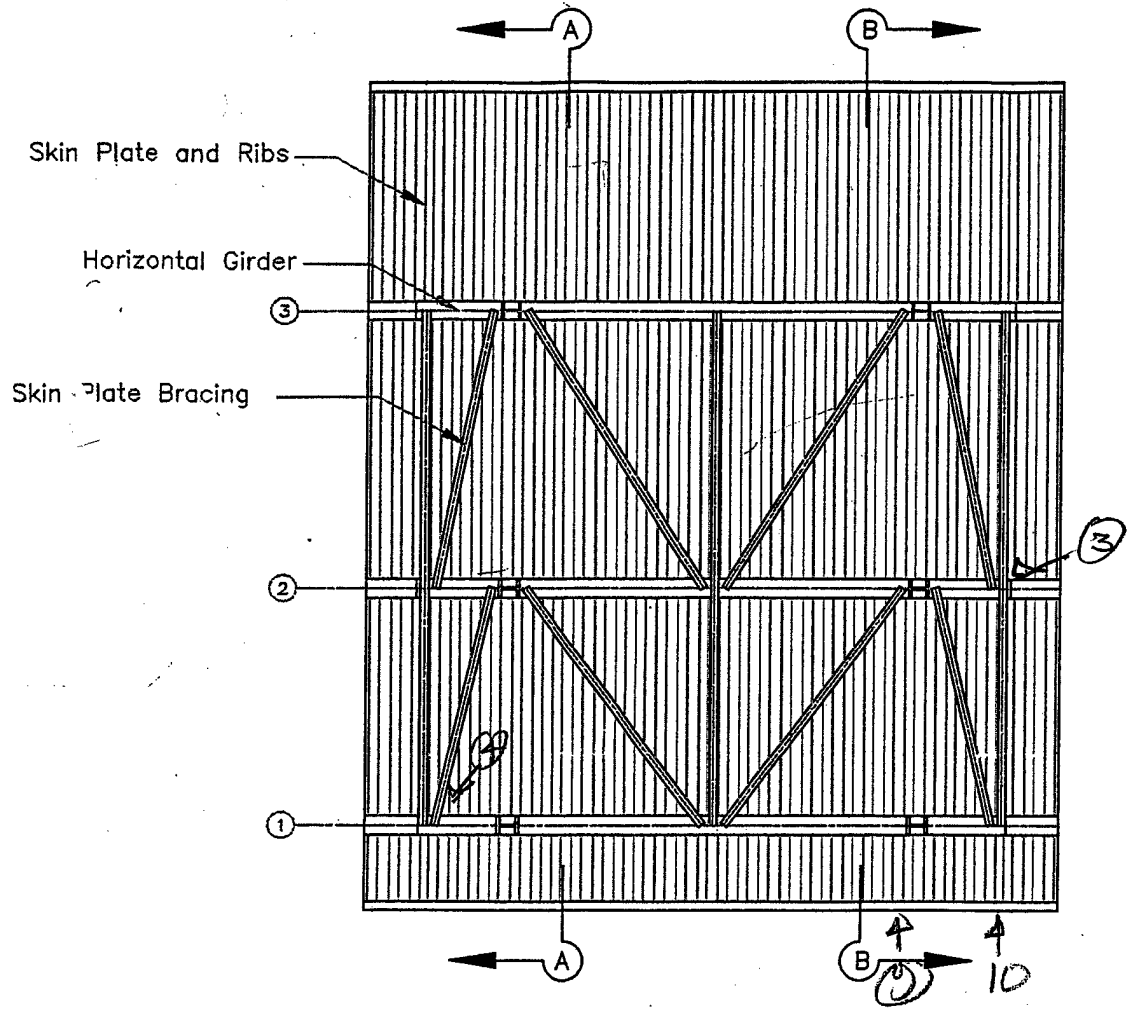
Gate No. 3 Downstream Elevation

- ③ ponding in second girder, no corrosion
- ④ leak on left
- ⑤ side seals, right, look good
- ⑥ leaking bottom seal, left
- ⑦ ponding water in bottom seal
- ⑧ ponding water, right, bottom girder, cable slots
- ⑨ leaking bottom seal
- ⑩ leak in bottom seal, by pier
- ⑪ middle leak
- ⑫ leak in bottom seal, - left

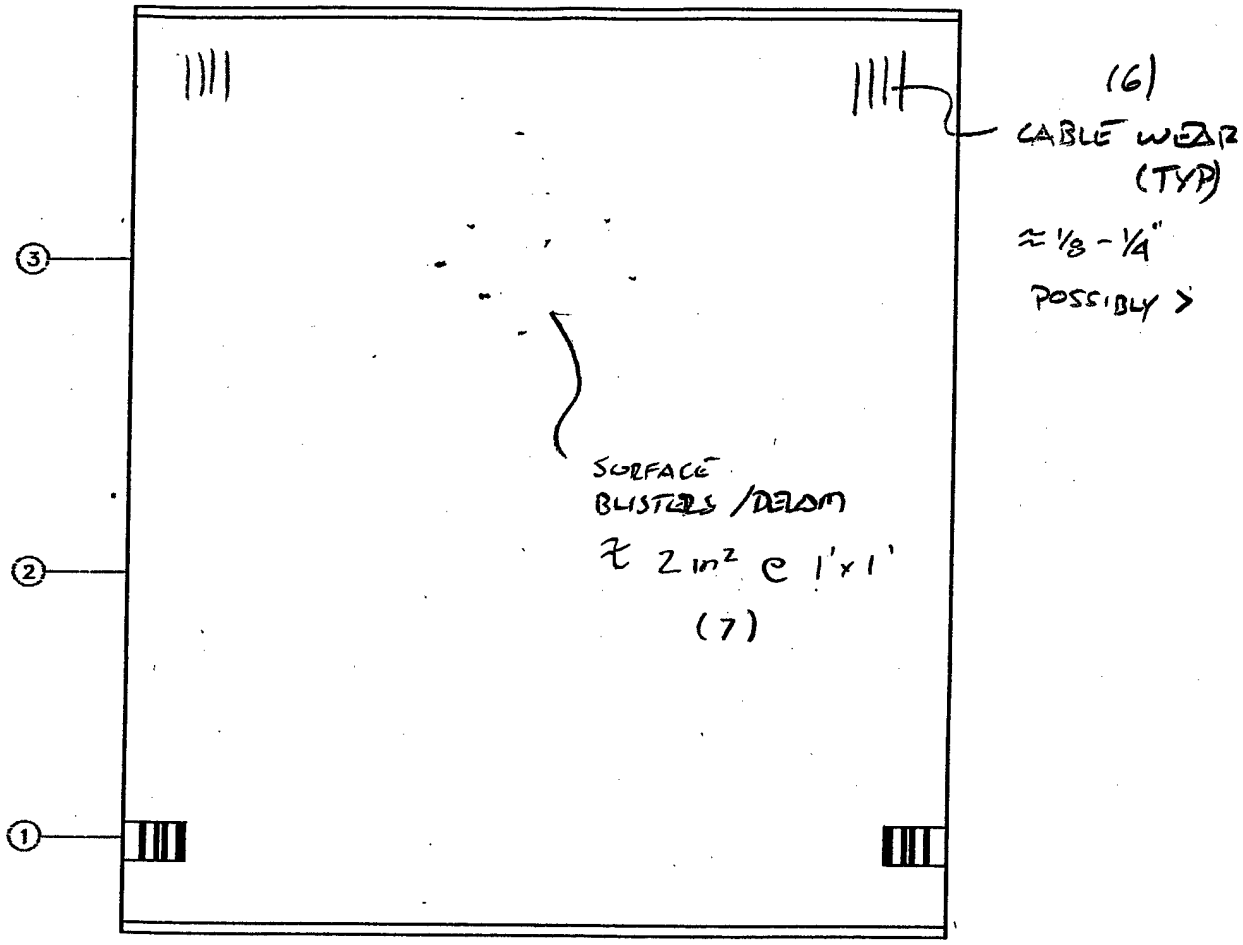
Gate No. 8 Upstream Elevation

DEEP PITTING UP TO 1/4" AT TOP

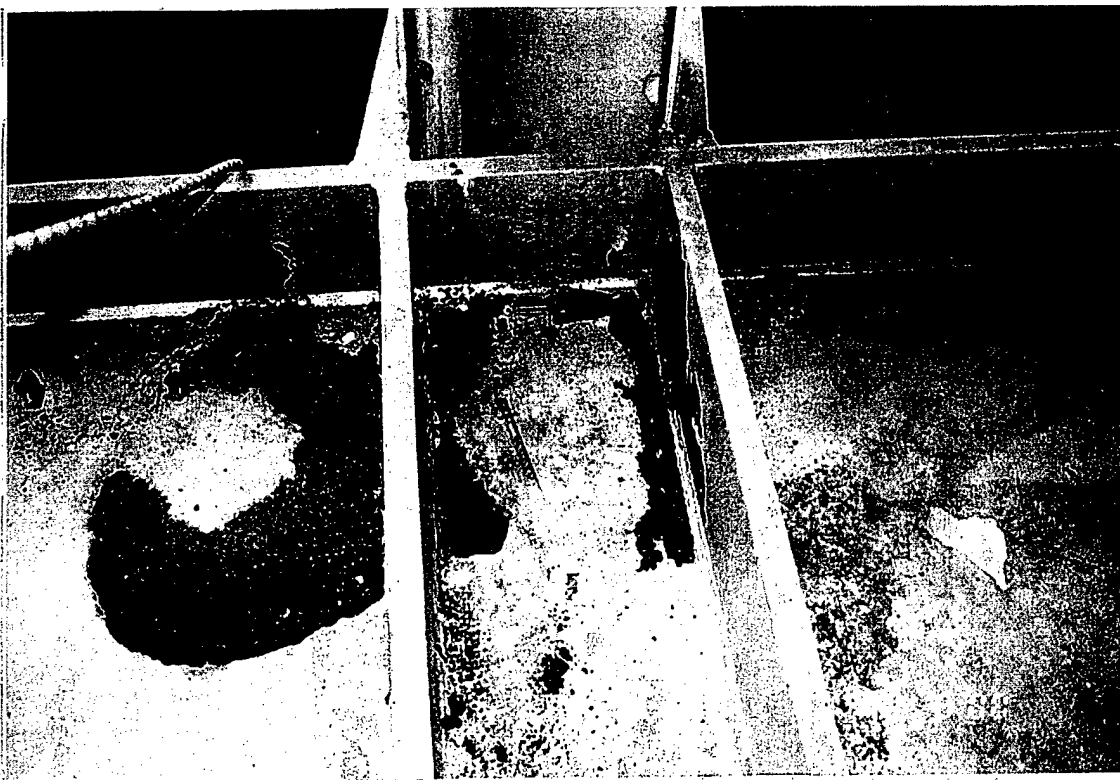
Lower Granite Dam  
10/06/00  
1-11

**Gate 1**  
Top horizontal girder, right side, between stiffeners at radial strut connection. Delaminated paint and light corrosion due to poor drainage.

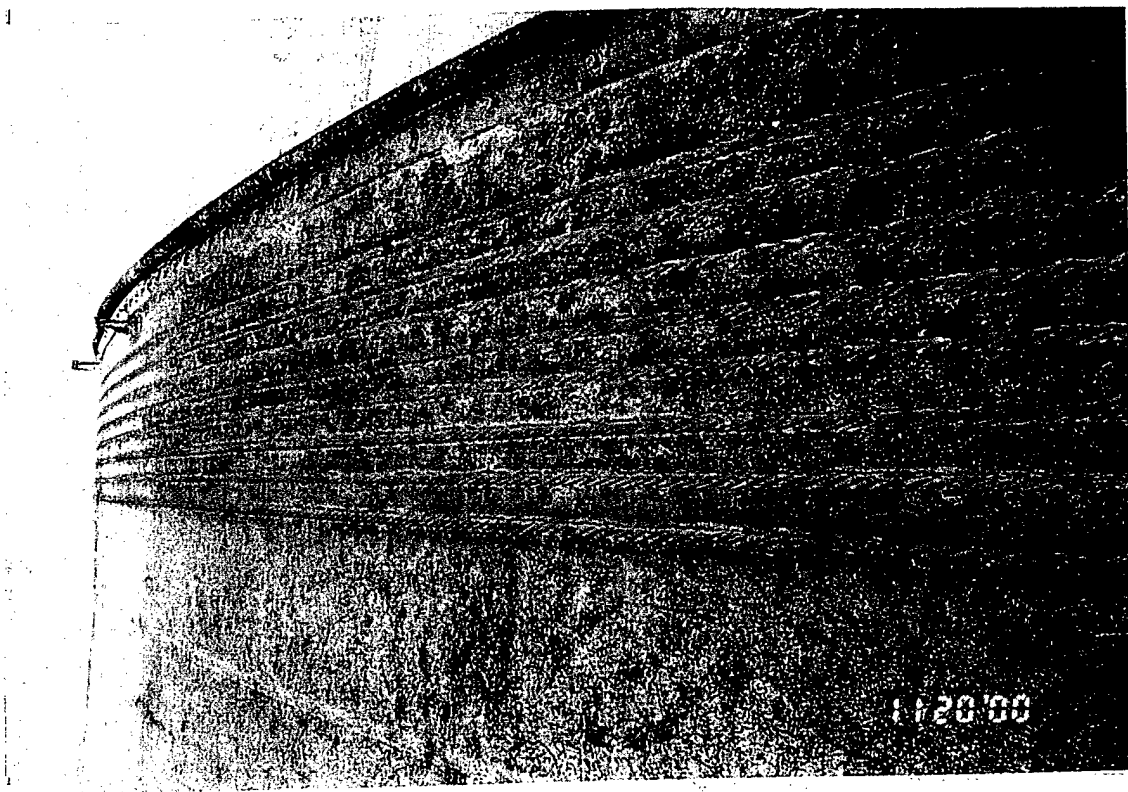
Lower  
Granite  
Dam  
11/20/00  
1-19

**Gate 1**  
Typical wear plate condition. Light grooves due to cable wear, light to moderate corrosion.

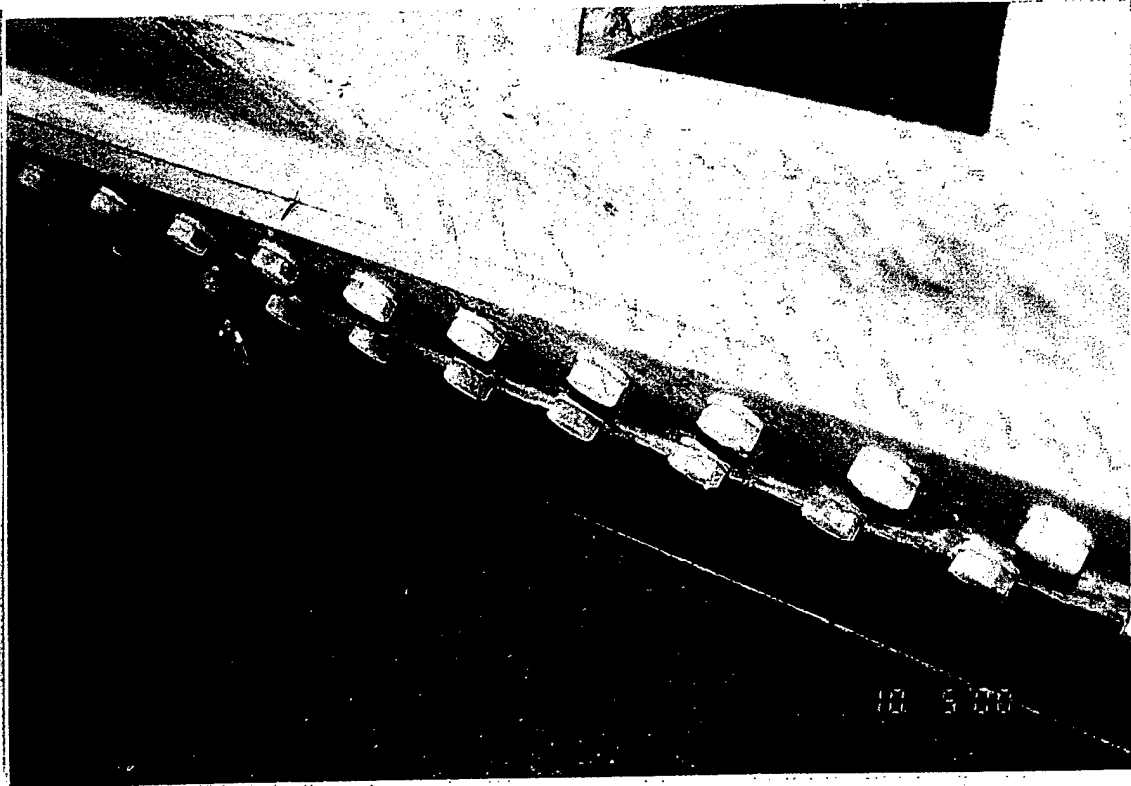
Lower Granite Dam Gate 2 Bottom seal keeper bar and closure plate, typical.

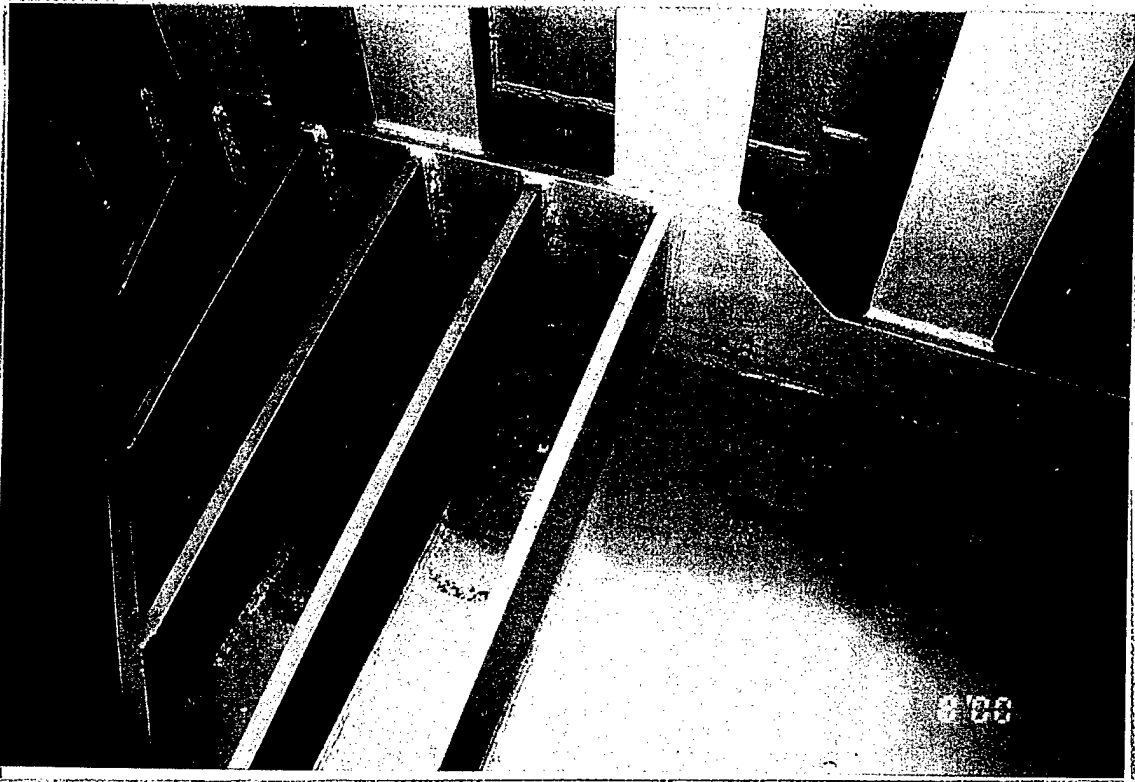
**Gate 4**  
Skin plate leak after removal of paint  
blister.

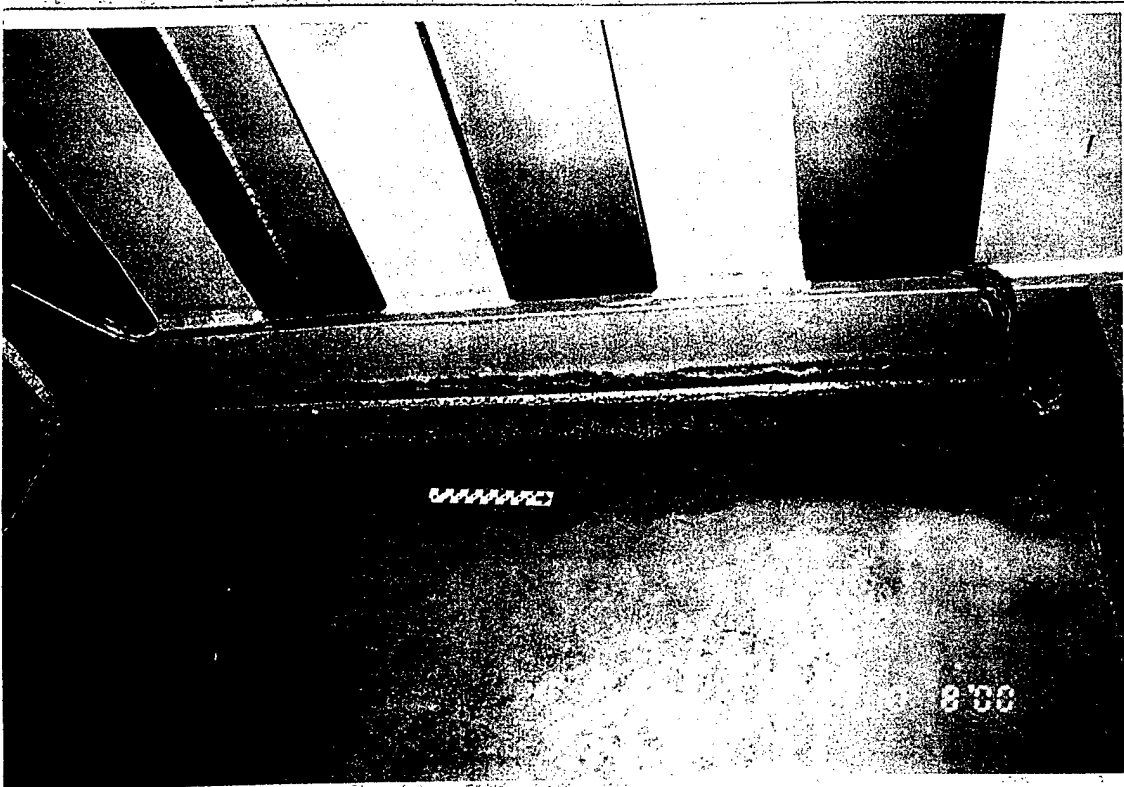
Lower  
Granite  
Dam  
10/08/00  
5-8

**Gate 5**  
Right end of bottom horizontal girder.  
Standing water, no drainage between  
multiple stiffeners. Horizontal girder  
to skin plate stiffeners, standing  
water, debris and no drainage

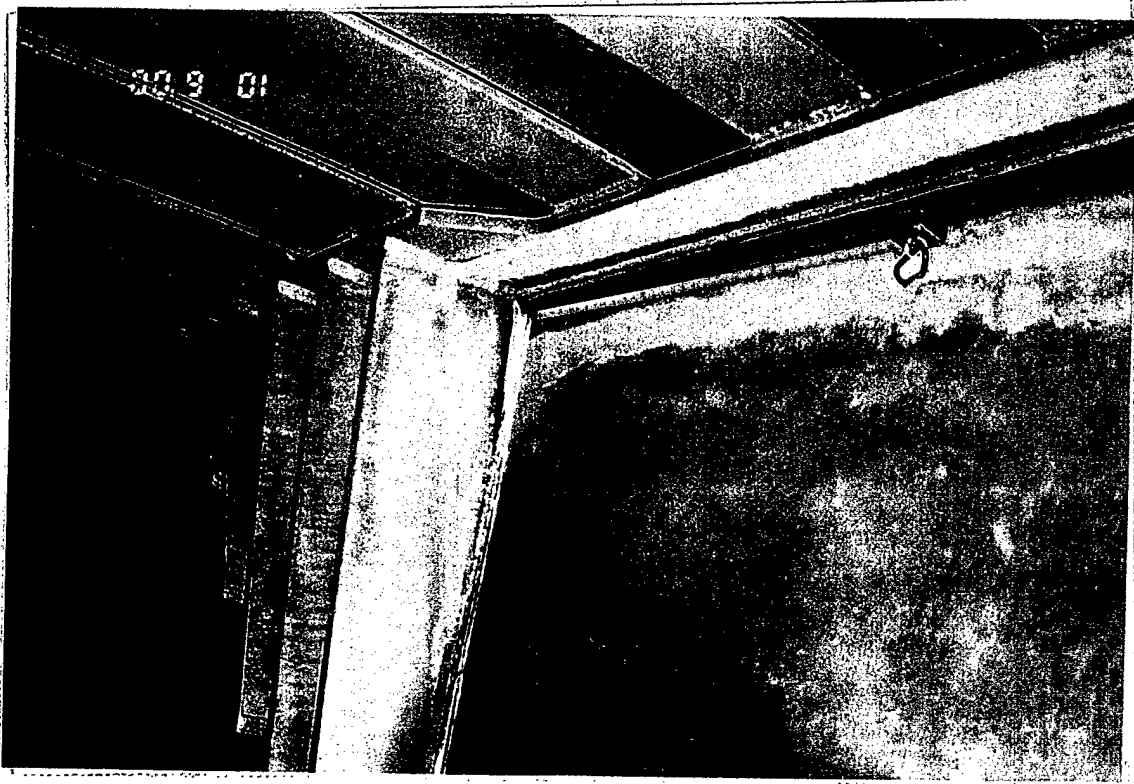
Lower  
Granite  
Dam  
10/06/00  
6-10

**Gate 6**  
Right frame, bottom radial strut.  
Standing water at upstream end of  
strut due to inadequate drainage.

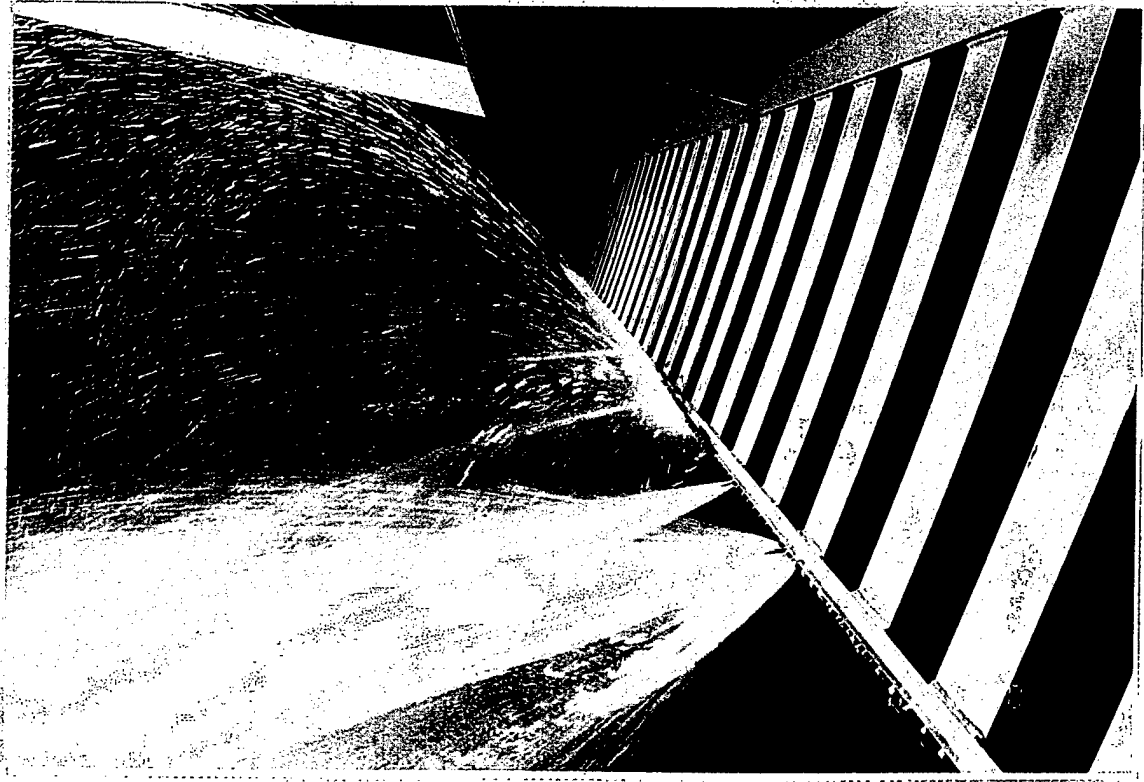
Lower  
Granite  
Dam  
10/06/00  
6-14

**Gate 6**  
Bottom seal closure plate looking upstream. Standing water between closure plate, purlin webs and skinplate, typical.

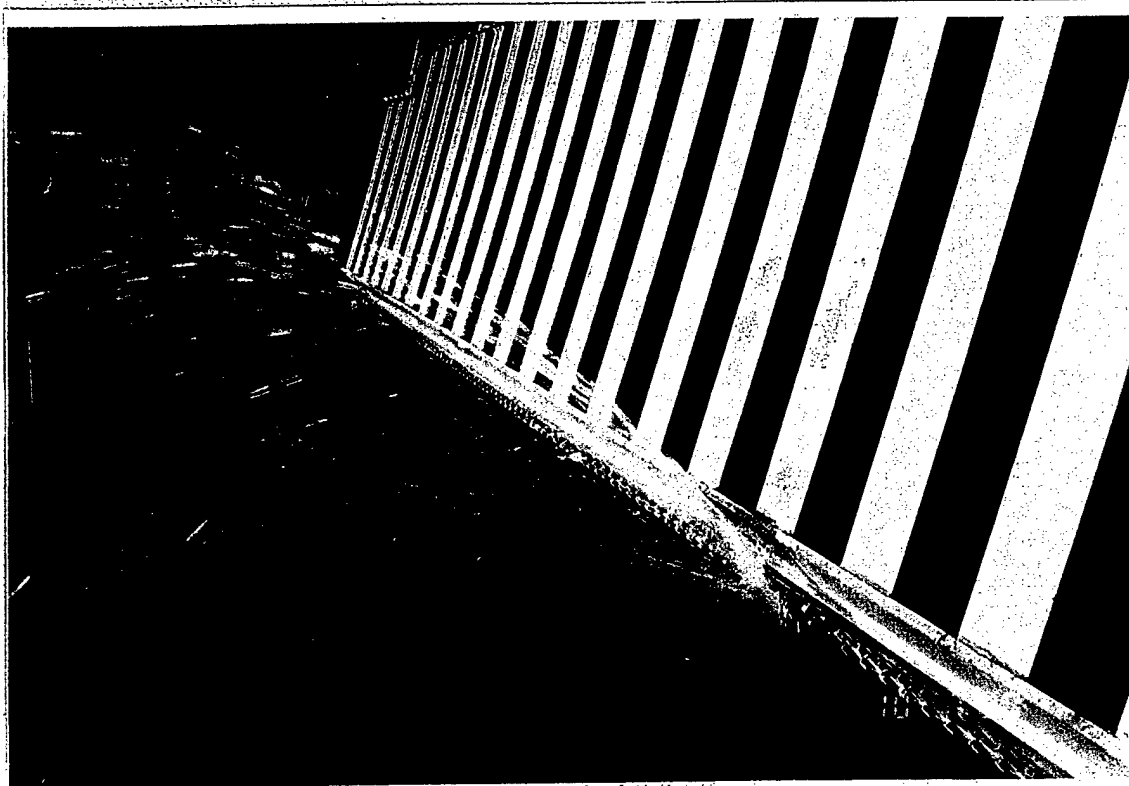
Lower  
Granite  
Dam  
10/07/00  
7-4

**Gate 7**  
Bottom seal closure plate looking  
upstream. Standing water between  
closure plate, purlin webs and  
skinplate. Typical.

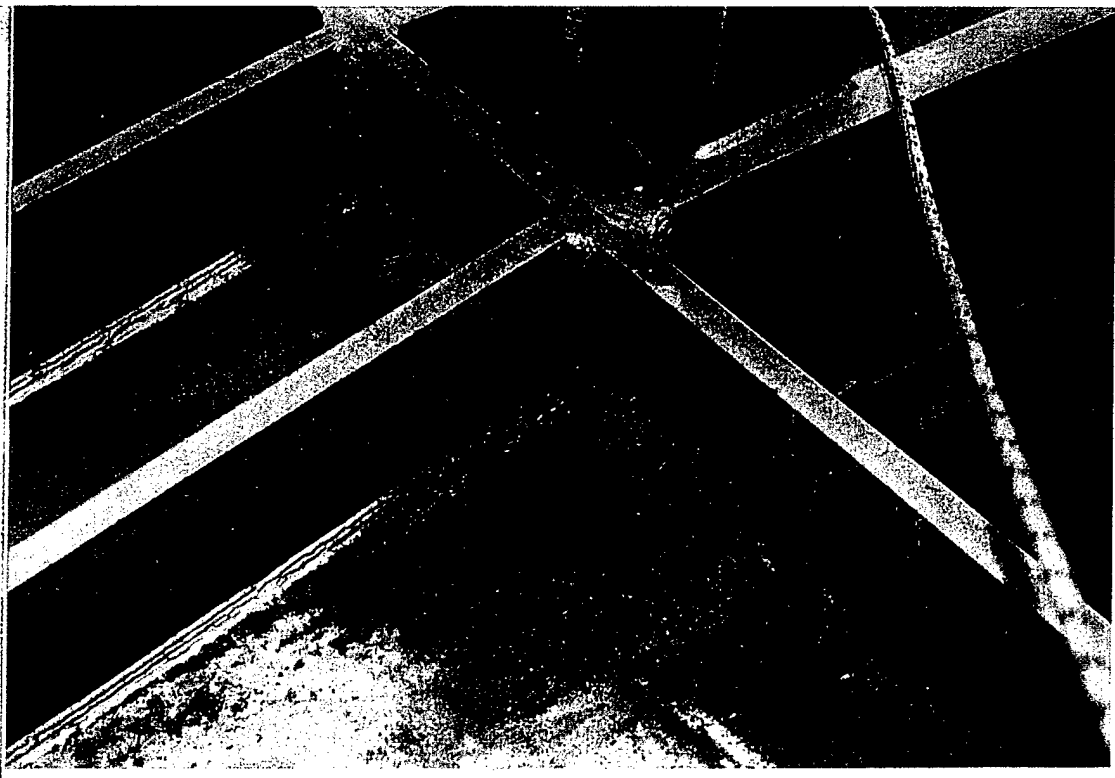
Lower Granite Dam	Gate 7 Typical wear plate condition. Light grooves due to cable wear, light to moderate corrosion.
10/04/00	
7-16

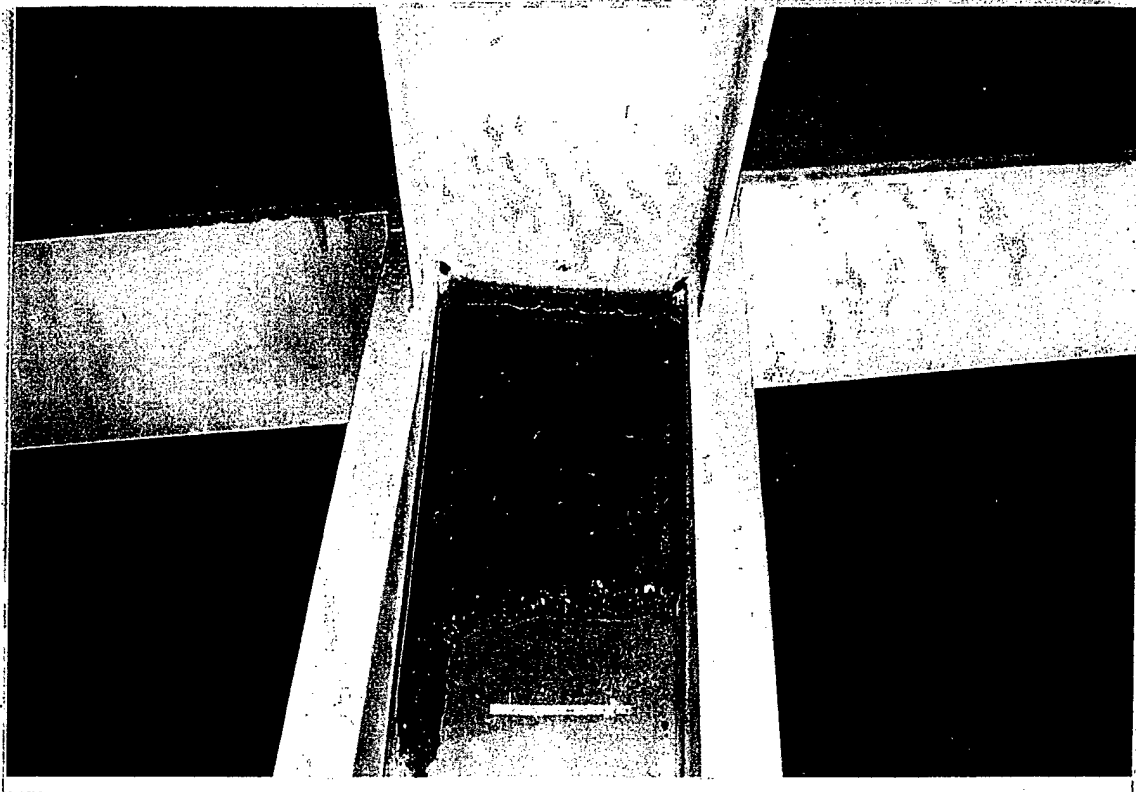
Gate 8  
Bottom right corner seal leak.

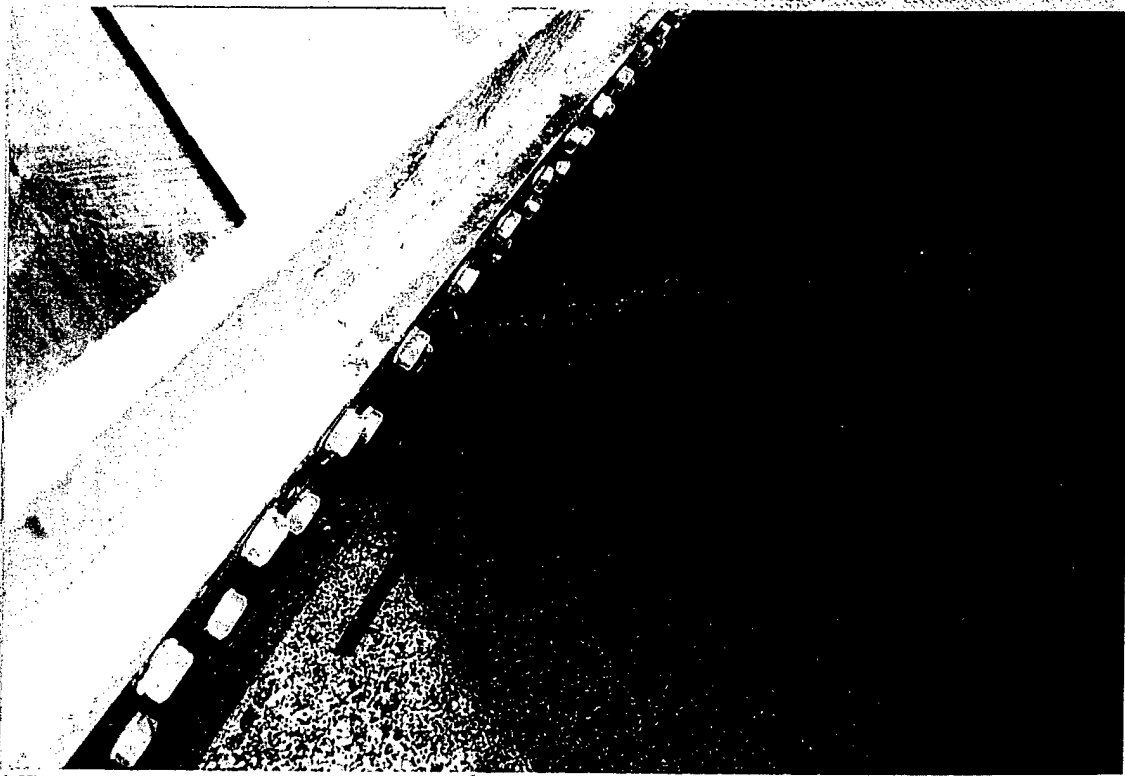
Lower  
Granite  
Dam  
10/07/00  
8-10

**Gate 8**  
Bottom seal closure plate looking  
upstream. Standing water between  
closure plate, purlin webs and  
skinplate. Typical.
