**Southwest Research Institute (SwRI) Project  
18.03562  
"Evaluation of Tungsten Alloy Rods"  
Final Report**

*Kathryn Dannemann and James Walker*

May 2000

IAT.R 0301

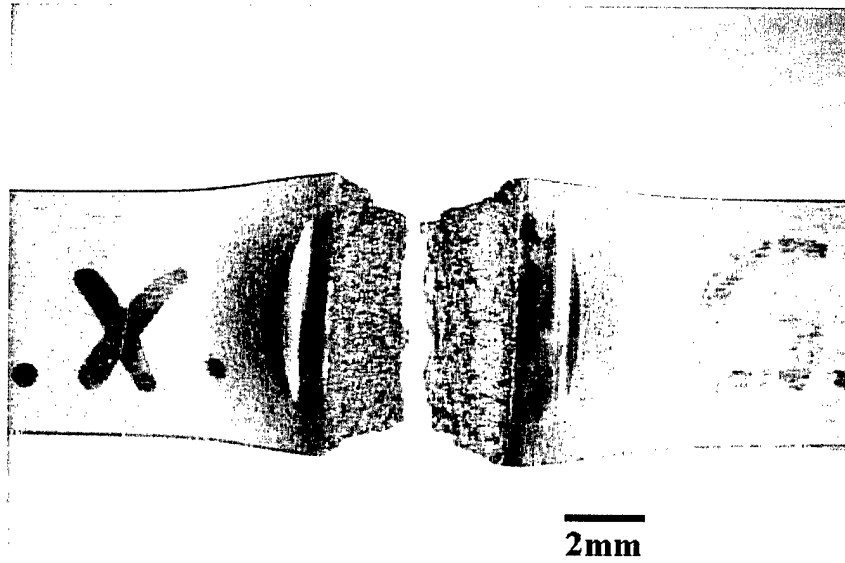
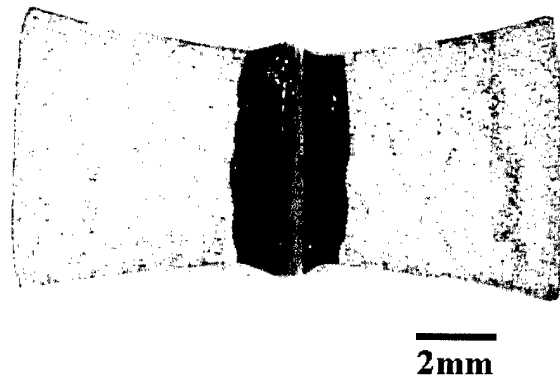
The cross sections of the fractured bend samples were trapezoidal, as shown in Figure 1 for sample A. Both tensile and compressive fracture modes were operative, though the samples ultimately failed in tension. The compression component is due to bending. Several tensile cracks were detected in the mounted cross-sections on the opposite side of the sample from the bend (i.e., tensile side). The cracks were most prevalent in the vicinity of the fracture surface, as shown in Figure 2a. The longest tensile cracks measured approximately 0.15 to 0.17 mm long.

Figure 1. Condition of Sample A following dynamic bend testing. The bottom photo illustrates the fracture cross-section.

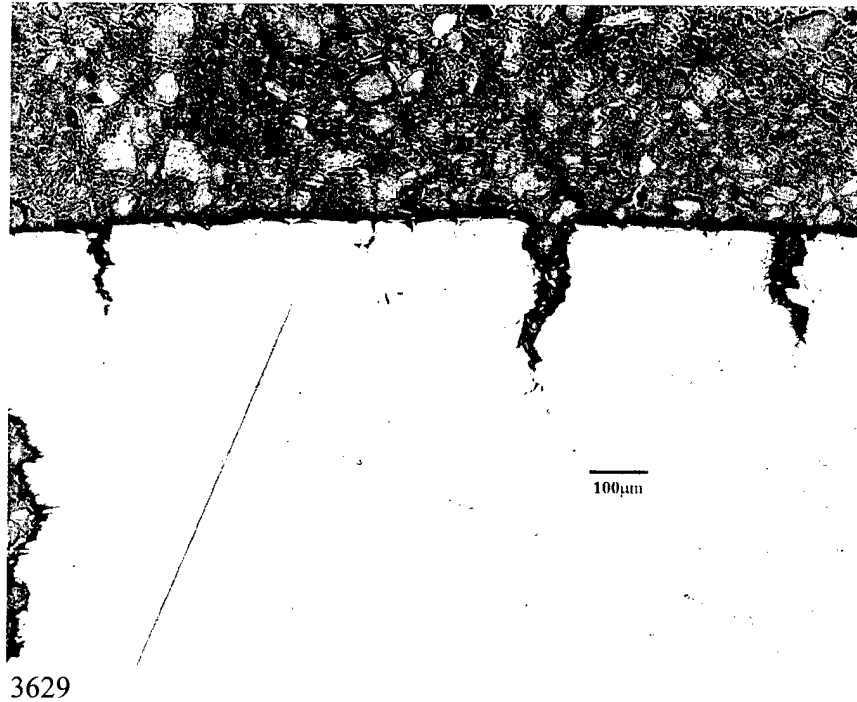
(a) Several tensile cracks in the vicinity of the fracture surface for Sample A

The cracks initiated at the tensile surface and progressed towards the compressive side of the sample in a direction approximately parallel to the fracture surface. Ultimate failure of the sample occurred in tension when the load capacity of the sample was exceeded due to competitive, crack growth processes from opposite sides of the sample diameter.

Figure 2. Tensile cracks on the tensile surface (side opposite the bend surface) of the dynamic bend test samples.

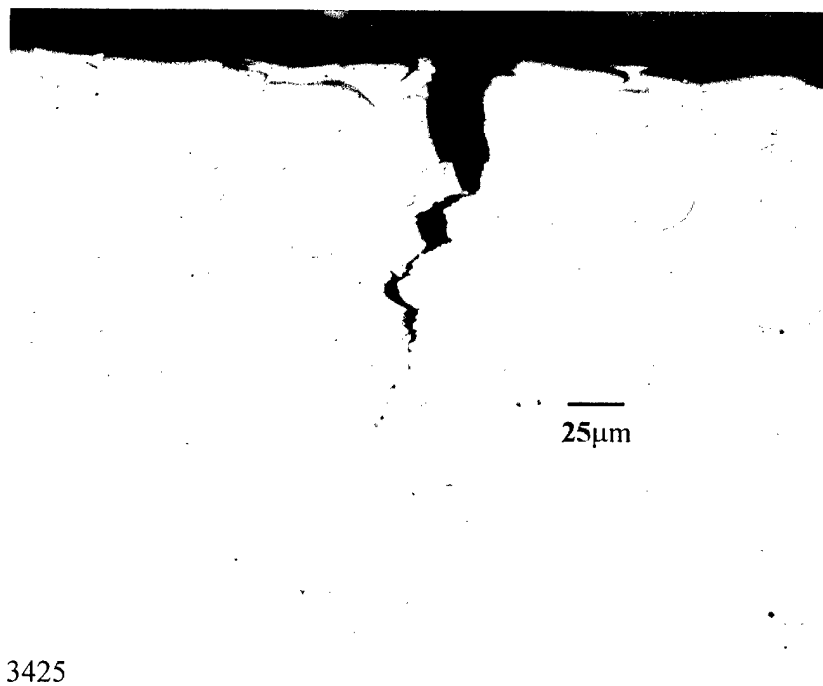
(c) Enlargement of tensile crack for Sample B showing particle fracture

Higher magnification microscopy of the mounted cross-sections revealed the tensile cracks progressed through some of the W particles, resulting in cleavage of the particles. Fracture of the W particles is evident in representative photos of the tensile cracks, illustrated in Figure 2. The cracks also progressed along W particle/matrix interfaces. Some W particle fractures were observed on the compressive side of the samples near the initial bend region. A limited number of isolated W particle fractures and W particle/matrix fractures were detected towards the center of the sample cross section. Some fractured W particles were observed along the fracture surface on both the tensile and compressive sides of the samples evaluated. Particle fractures were more prevalent on the tensile fracture surface. Some W particle-particle decohesion was detected for W particles just beneath the fracture surface. Depending on the microstructure, damage progressed from the debonded regions along adjacent particles or particle/matrix interfaces.

Figure 2. Tensile cracks on the tensile surface (side opposite the bend surface) of the dynamic bend test samples (continued).

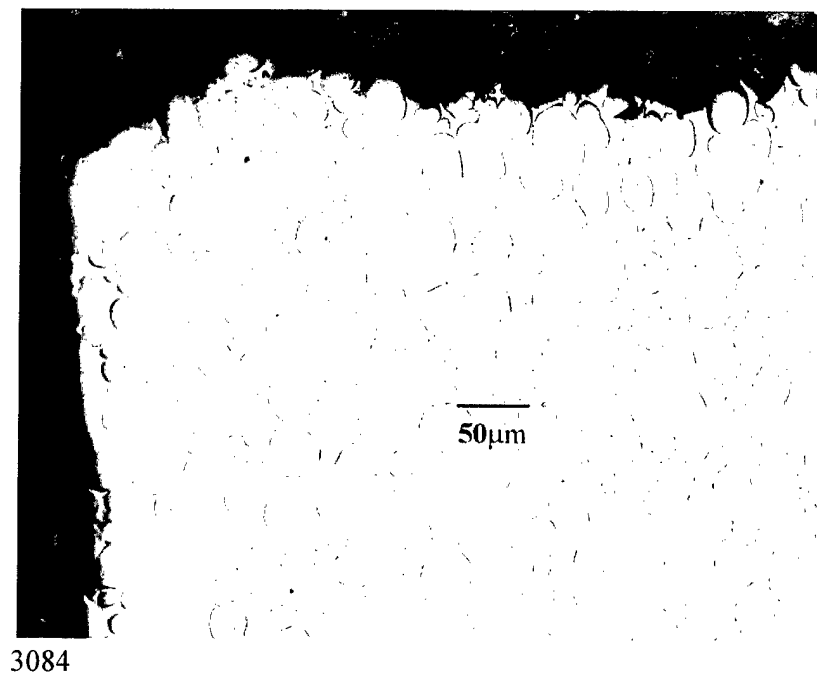
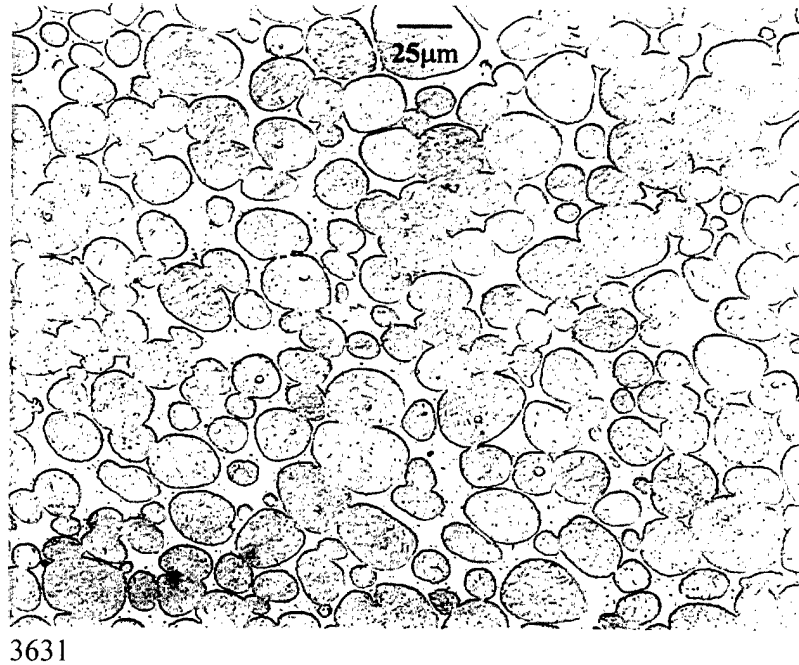
The W particles were somewhat elongated on the tensile side of the samples relative to the compressive side, central fracture region, and regions away from the fracture. The difference in aspect ratio of the W particles is evident upon comparison of Figures 2 and 3. Strains up to 150 % were calculated for the dynamic bend samples based on the extent of elongation of the tungsten particles on the tensile vs. compressive sides of the samples. Particle fracture likely initiated in the most highly strained particles.

Figure 3. Microstructure on the compressive side of the dynamic bend test samples.

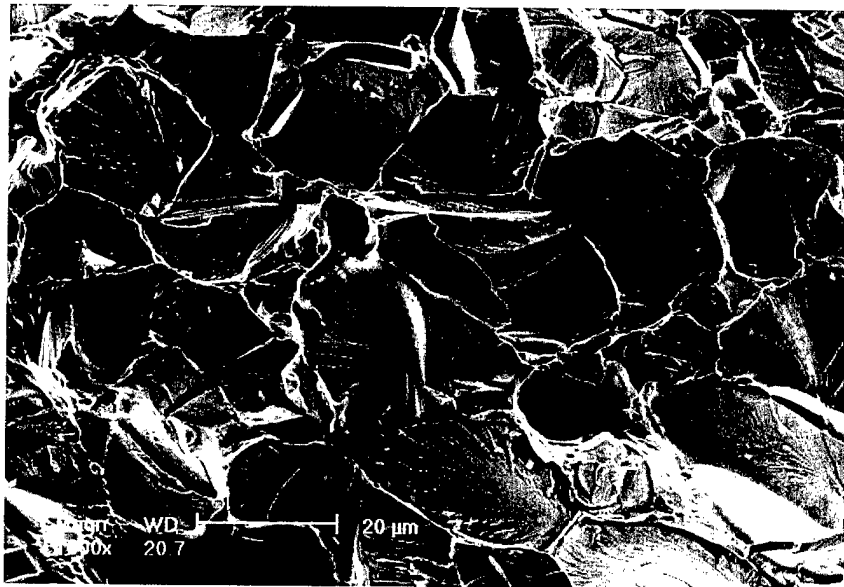
(a) Tensile region

SEM evaluation of the fracture surface confirmed the optical results. Cleavage fracture of the W particles occurred on the tensile side of the fracture, as shown in Fig. 4a. The fracture mode was more ductile towards the central region of the sample. The central region consists of failed intergranular matrix zones, composed of W facets and ductile dimples in the matrix regions. Some cleaved W particles were also detected, along with decohesion between adjacent W particles, and between the W particles and the matrix. Fig. 4b is representative of the central region of the fracture for Sample B. More matrix dimples and W facets were evident in the bend region on the compressive side of the fracture surface. However, W particle cleavage was still observed in the compressive region of the fracture. Compare the compressive region, shown in Fig. 4c, with the other locations on the fracture. Some precipitates are evident in the dimpled matrix regions (Fig. 4d).

Figure 4. SEM micrographs of the fracture surface of Dynamic Bend Sample B.

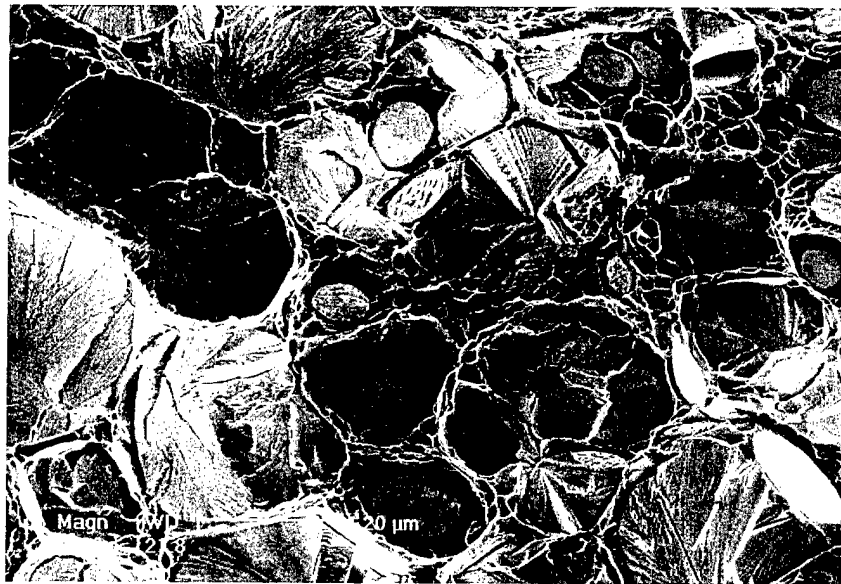
(c) Compressive region

Figure 4. SEM micrographs of the fracture surface of Dynamic

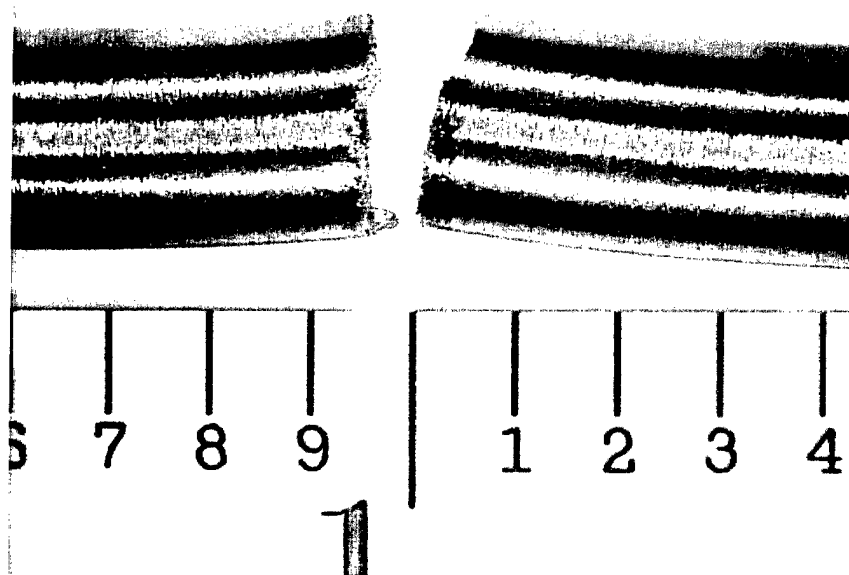
(a) As-received condition

Figure 5. Fracture of the WHA rod (Shot 74) following dynamic transverse impact

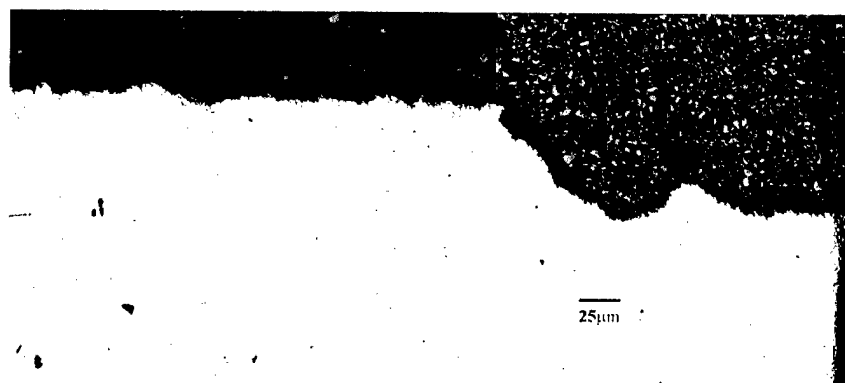
(b) Cross-section through the fracture

Fractographic and metallographic evaluation of the fractured sample revealed the operation of competitive tensile and compressive fracture modes. The micrograph in Fig. 5b illustrates distinct tensile and compressive regions on the fracture surface. The Al impactor imparted a compressive load. Tensile loading occurred on the surface opposite the impact. Comparison of the microstructures in the tensile and compressive regions of the mounted cross section showed that elongation of the W particles was not as significant for this sample relative to the dynamic bend samples. Maximum strain levels approaching 20 to 40 % were calculated based on particle elongations.

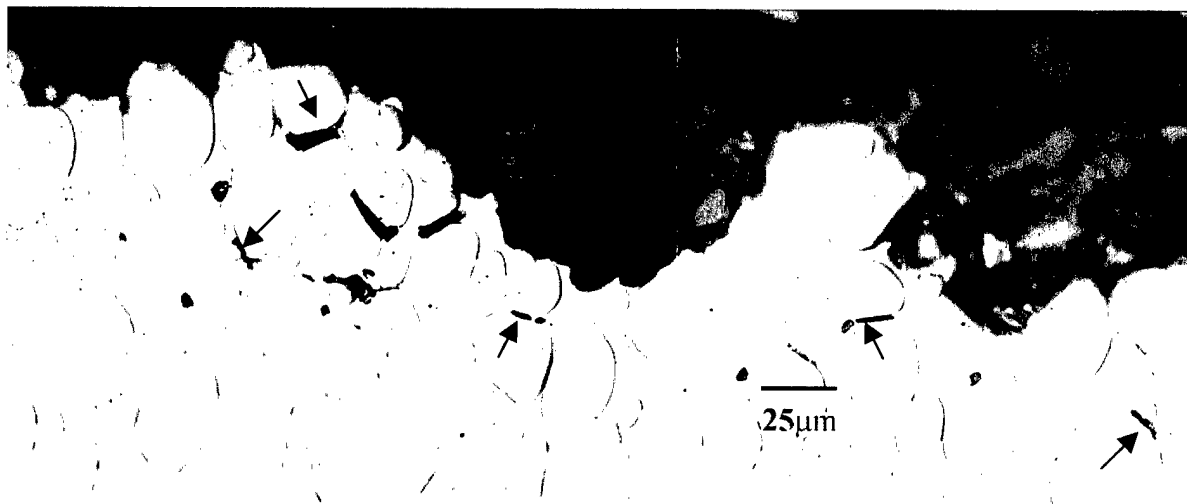
Although a few fractured W particles were observed in the vicinity of the impact region, generally, W particle cleavage was not observed. The W particles remained intact along the fracture surface path as illustrated in Fig. 6. Note the intergranular nature of the fracture path. A limited number of cleaved W particles were evident at the transition region between the tensile and compressive fracture regions. Some W particle fractures were observed on the tensile surface. Although the number of particle fractures observed on the tensile surface was greater for this sample relative to the dynamic bend samples, the fractures only extended through the top two particle surface layers. These had not progressed to form tensile cracks as shown for the dynamic bend test samples in Fig. 2a.

Figure 6. Optical micrograph of a cross section through the fracture surface of Shot 74. Damage development by decohesion between contiguous tungsten particles and between the tungsten particle-matrix interface is highlighted by the arrows.

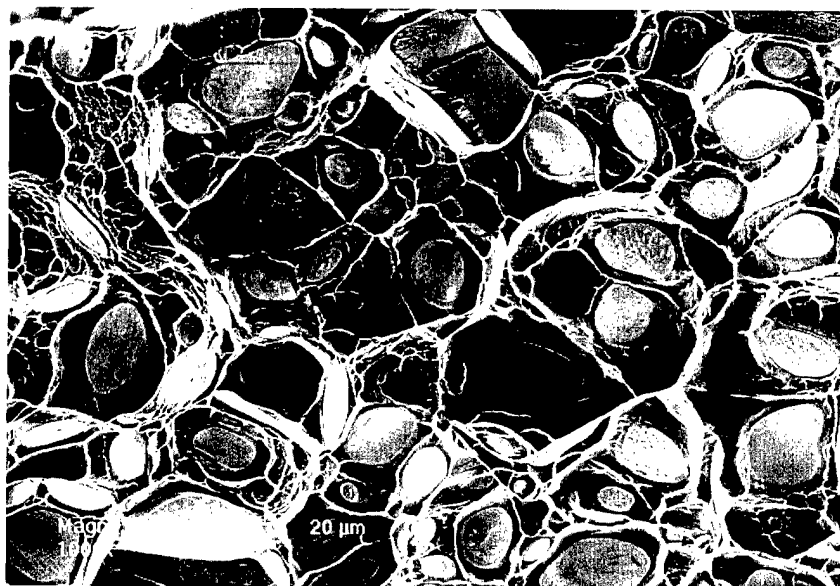
(a) Tensile region

The fractographic features detected in SEM evaluations of Shot 74 support the optical microscopy results. The features are similar to those reported previously by Lankford, et al. [3-5] for WHA materials following dynamic fracture at strain rates up to  $1000 \text{ s}^{-1}$ . Intergranular fracture is apparent in the SEM micrographs in Fig. 7. The photos show representative areas from the tensile, compressive and central regions of the fracture and confirm that dynamic fracture occurred along tungsten particle and tungsten-matrix interfaces. Macroscopic dimples surrounding individual W grain facets were evident in each of the three regions. Some W particle cleavage was evident for the compressive region (Fig. 7d) near the impact location. Except for some pores surrounding the W facets (see Fig. 7b), there is little evidence of any plastic flow. Dimples in the matrix regions are not as apparent in the W-Ni-Fe dynamic transverse impact sample relative to the W-Ni-Co dynamic bend samples discussed in the previous section. Note the differences in matrix plastic flow upon comparison of Figs. 4 and 7 for the dynamic bend and dynamic transverse fracture test samples. This difference can be attributed to material differences and strain rate differences.

Figure 7. SEM micrographs of the fracture surface region of Shot 74, following dynamic transverse impact.

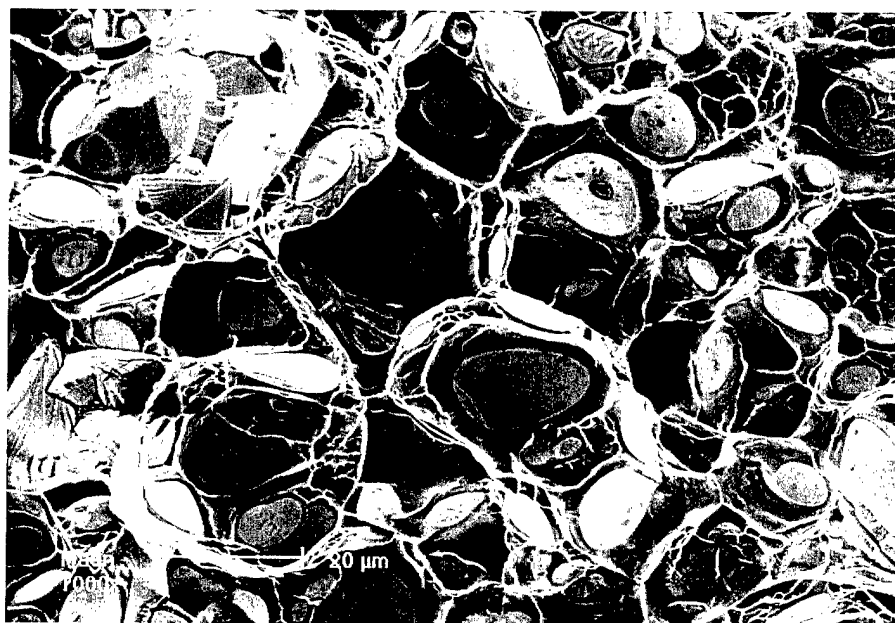
(c) Central region of fracture

Figure 7 SEM micrographs of the fracture surface region of Shot 74, following dynamic transverse impact (continued).

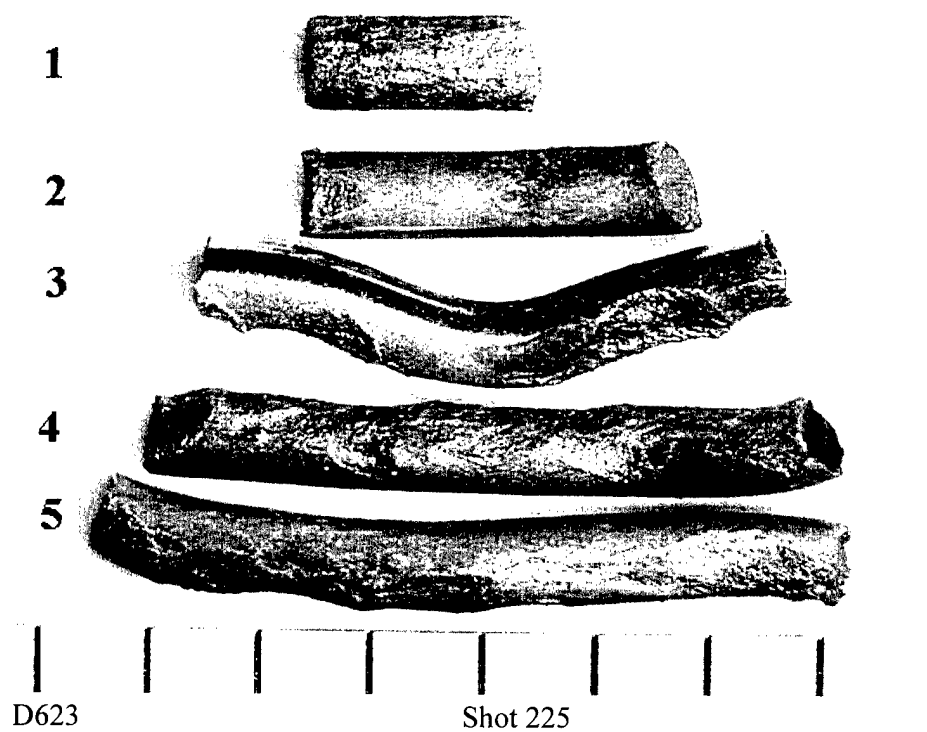
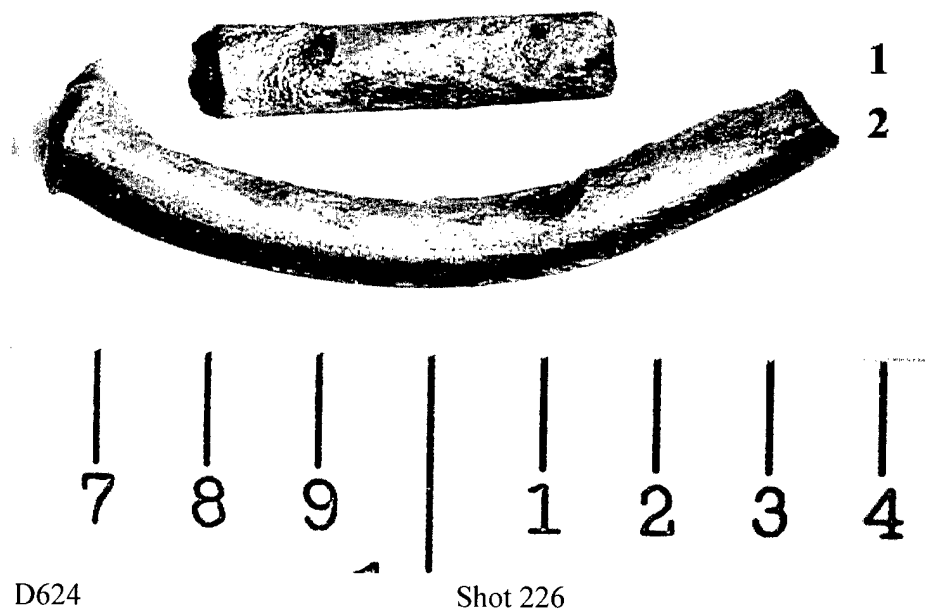
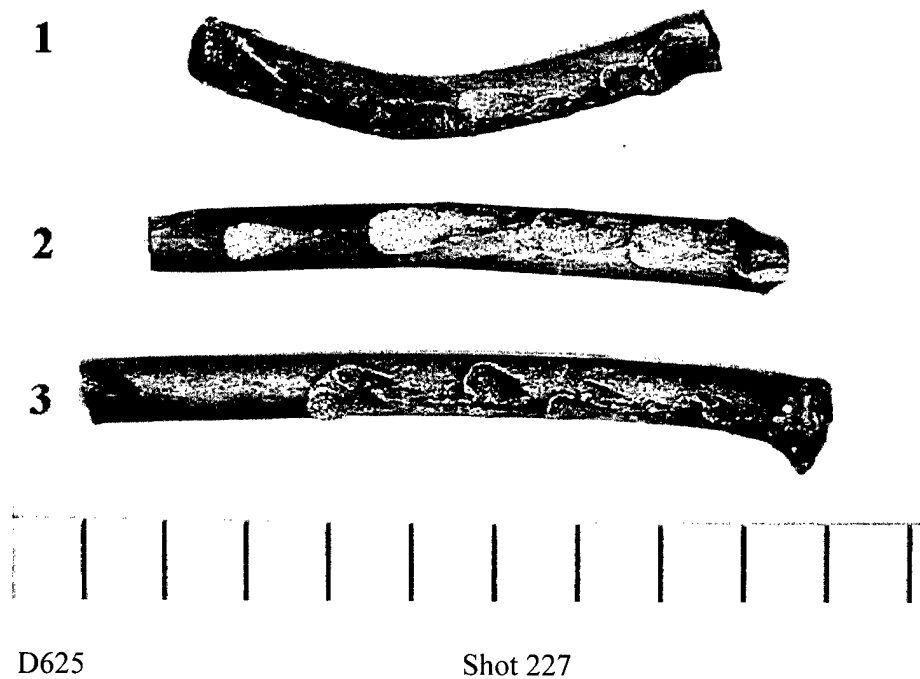
The as-received condition of the remnants from each shot (Shot 225, 226 and 227) is shown in Fig. 8. Impact damage from the target occurred along the surface where the yawed target impacted the W rod. Mushrooming of the impact surface was observed for Shots 226 (Remnant 2, Fig. 8b) and 227 (Remnant 3, Fig. 8c). The extent of mushrooming and surface impact damage is shown in the enlarged view of Shot 227, Fig. 9. The mushrooming phenomenon is characteristic of penetration and is further described for WHA in Ref. [6]. Shear localization occurs after the development of the mushroomed head (i.e., shear localization occurs at a high strain).

Figure 8. Overall view of fragments supplied from each of the reverse ballistic tests (Shot 225, 226 and 227).

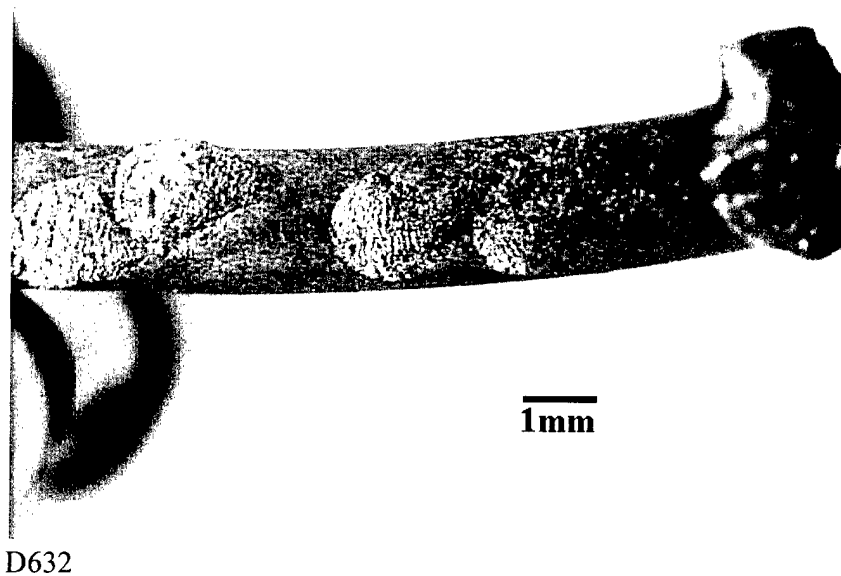
Figure 9. Mushroomed fracture surface and impacted regions for Shot 226.

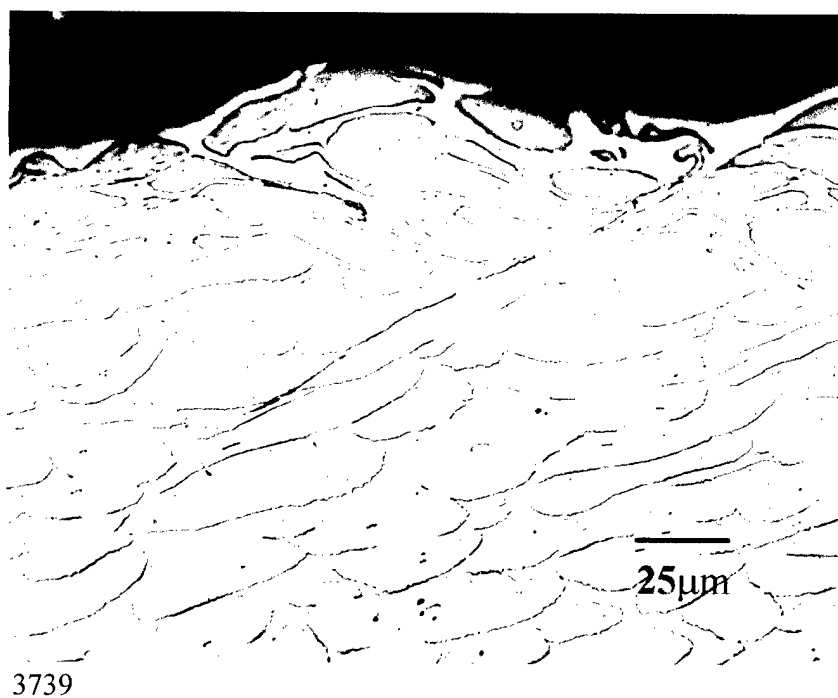
mushroomed ends. The W grains in the mushroomed region were transformed from spherical grains to "pancake"-like grains with extremely high aspect ratios. Elongation of W particles also occurred in the shear band regions. Figure 10 is representative of the shear banding observed, and is consistent with the shear banding reported by Lankford, et al. [3-5] for similar alloys. The extremely high aspect ratio of the W grains within the shear bands indicates that the local shear strains exceeded several hundred percent. Matrix fracture and/or melted matrix areas were detected in some of the shear bands investigated and are further evidence of shear instability.

Figure 10. Elongated particles and matrix fracture in a shear band at the impacted surface of Shot 225 following reverse ballistic testing.

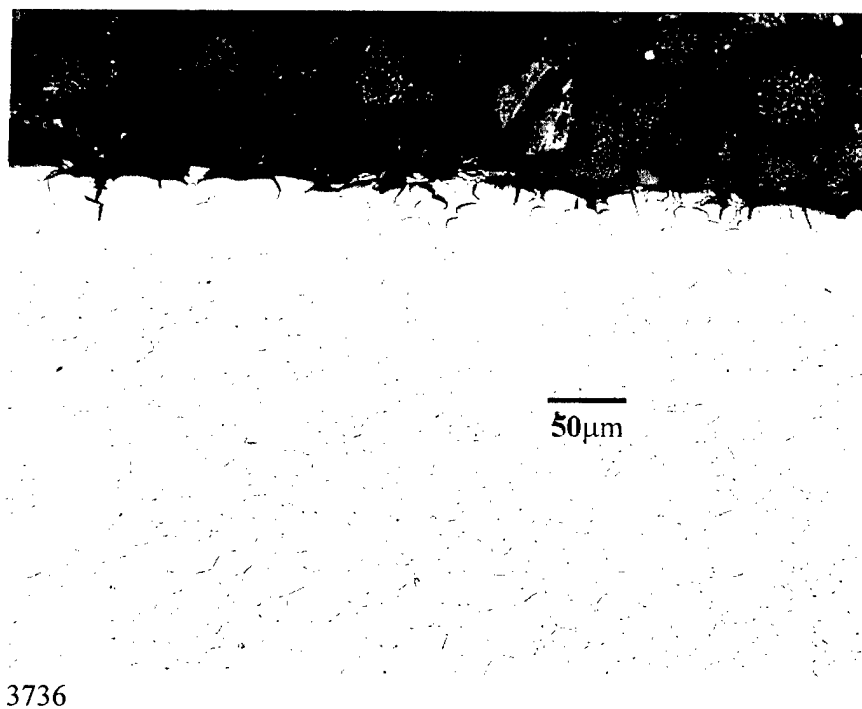
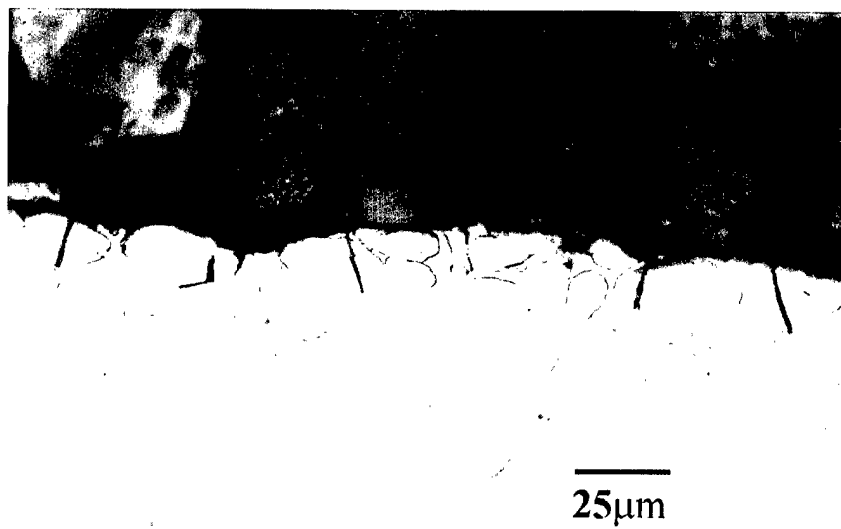
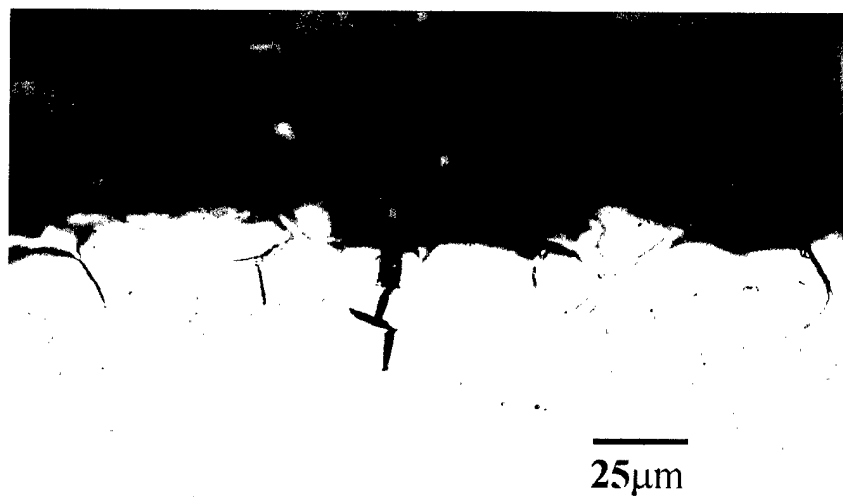
Although shear localization was the predominant form of damage, W particle fracture was observed in some cases on the non-impacted surface (opposite the shear-banded surface) of the remnant. Fracture proceeded through the W particles and appeared to be associated with decohesion of contiguous W particles. Fracture progression through more than three adjacent particles was not detected. The fractured W particles observed at the surface of Shot 227 were concentrated in several regions, and were spaced approximately 30  $\mu\text{m}$  (i.e., a particle spacing) apart. These are illustrated in Fig. 11, taken from the center of the Shot 227 specimen, half-way between two fractured ends (i.e., away from locations where a crack progressed all the way through the rod). These small particle-scale cracks could possibly be examples of widespread initiation sites. However, such fractures are not seen extensively near the fracture surface, and on only one end of the rod are such fractures seen near the actual fracture surface (see Fig. 12). Thus, it is unlikely that many small cracks were uniformly initiated and that the fracture was then dominated by a growth process – i.e., that we should focus on the growth of these small cracks. Rather, understanding initiation is critical.

Figure 11. Low and high magnification views of W particle fractures on the side surface of Shot 227 following reverse ballistic testing. The surface containing the cracks is located opposite the surface containing the shear-banded regions.

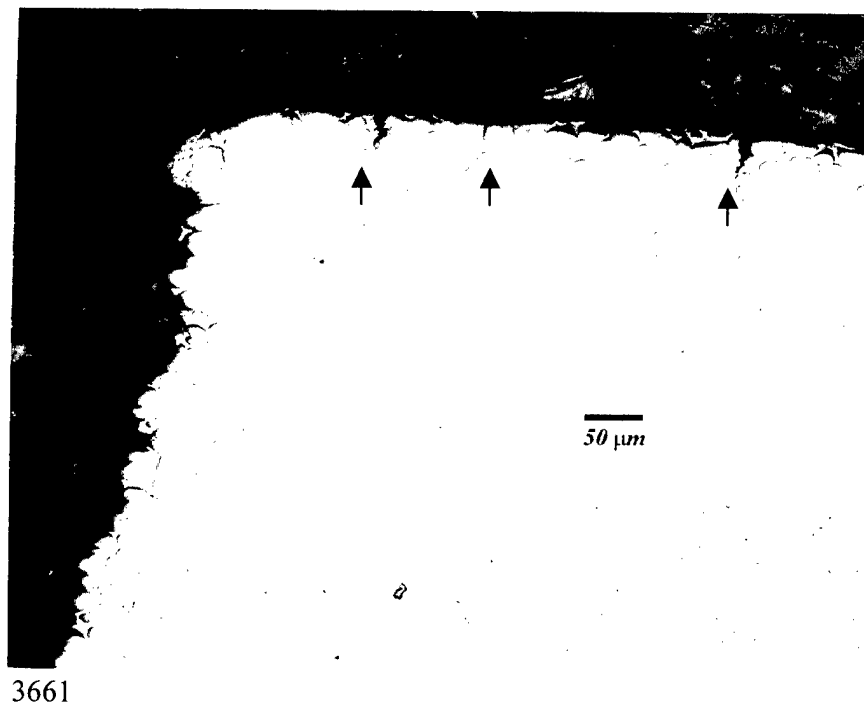
Figure 12. View of one corner of the fracture surface of Shot 227, showing small cracks at the nearby exterior surface.

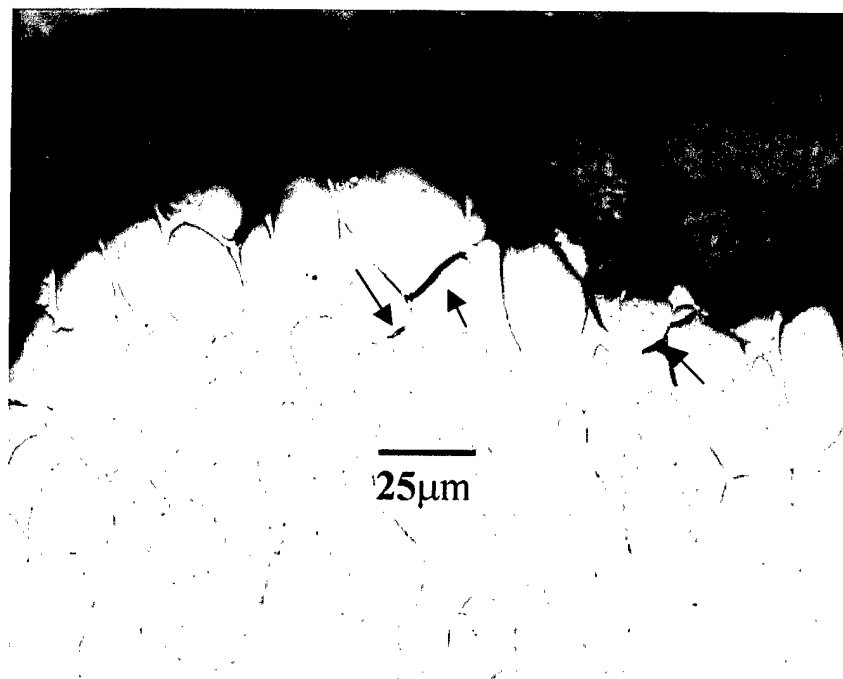
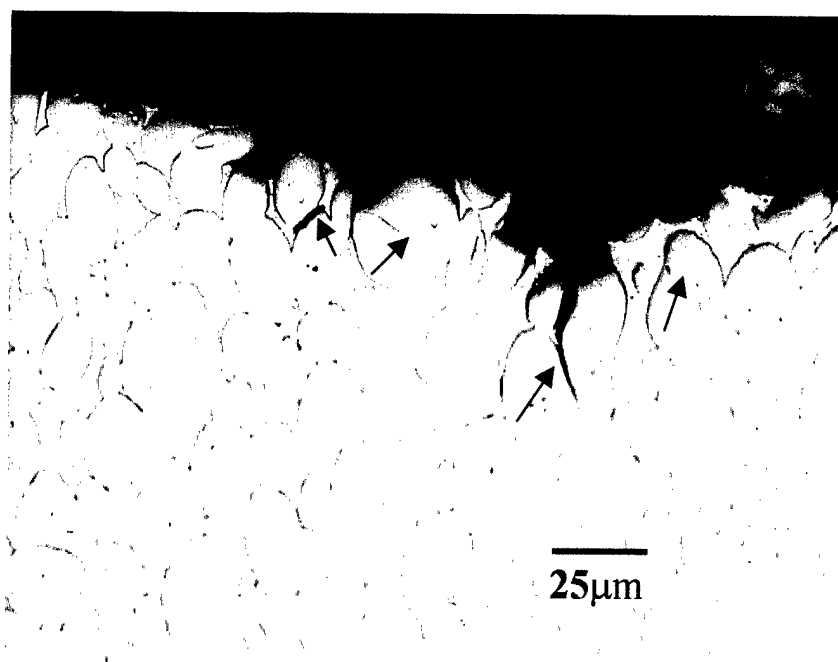
Optical microscopy evaluations of mounted fracture cross-sections revealed decohesion of adjacent W particles and W particle matrix debonds in the vicinity of "non-mushroomed" fracture surfaces. Fractured W-particles appeared to be associated with these debonds. W-particle fracture was also observed along the fracture path and just beneath the fracture surface as shown in Fig. 13 for Shot 227. The fracture surface features for the reverse ballistic samples are similar to those reported above for the dynamic bend test samples.

Figure 13. Enlarged view of the fracture surface of Shot 227 showing particle-particle debonding, particle-matrix debonding and fractured particles.

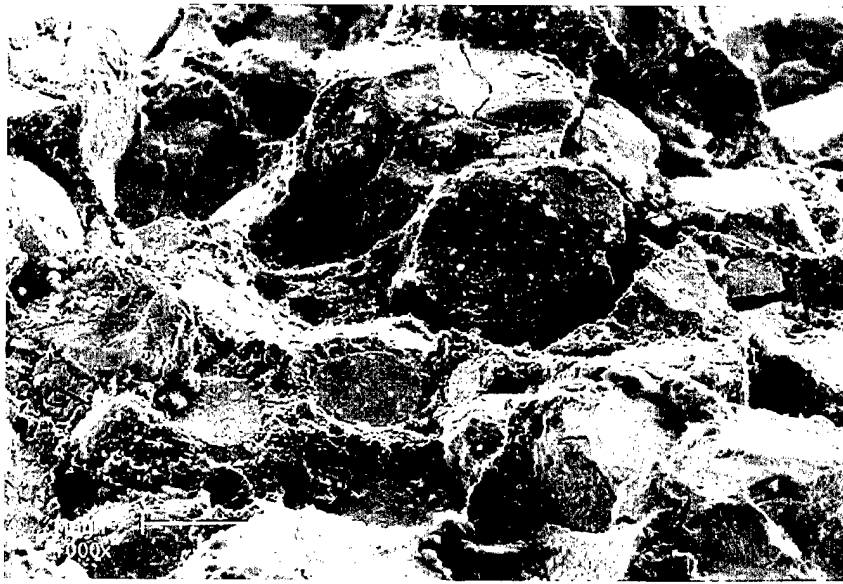
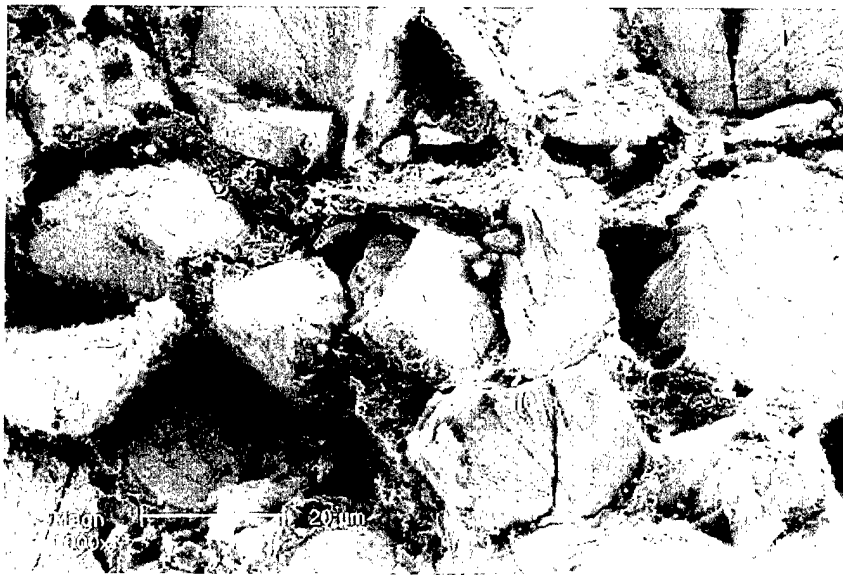
Cleavage of W-particles was more apparent upon SEM evaluation of the "non-mushroomed" fracture surfaces. Evidence of intergranular fracture was observed. Dimpled matrix regions were not as prevalent as for the dynamic bend test samples already discussed (*Dynamic Bend* section) for this alloy. Decohesion of W particles from the matrix was detected in isolated locations. Cleavage of numerous W particles was observed parallel to the rod axis. Representative photos of these features are illustrated in Fig. 14. The fracture mode is more brittle than the other test samples evaluated owing to the high loading rate and yawed projectile.

Figure 14. SEM micrographs of the fracture surface of Shot 227 showing W particle-matrix decohesion, cleaved and faceted W particles.
