Aircraft Accident Report

**In-Flight Electrical System Failure
and Loss of Control
Jet Express Services
Raytheon (Beechcraft) Super King Air 200,
N81PF
Near Strasburg, Colorado
January 27, 2001**

**NTSB/AAR-03/01
PB2003-910401
Notation 7358A
Adopted January 15, 2003**

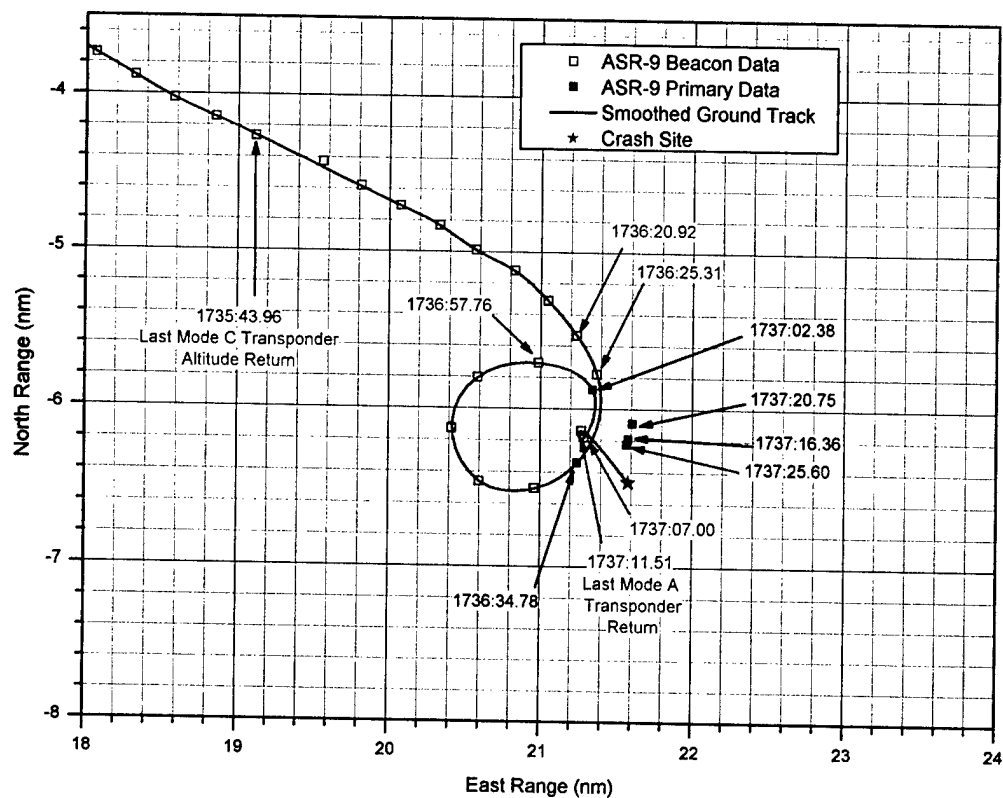
Figure 1. Radar data for the last 2 minutes of the accident flight.

Note: Airport surveillance radar-9 (ASR-9) primary data are reflected radio signals. ASR-9 primary data returns were received until about 1737:26, about 14 seconds after the last mode A (beacon data) return. The distances shown are relative to the ASR-9 radar site at Denver International Airport.
