Technical Report ARFSD-TR-03002

PREDICTING THE CAUSE OF FAILURE IN 120-mm MORTAR FINs

July 2003

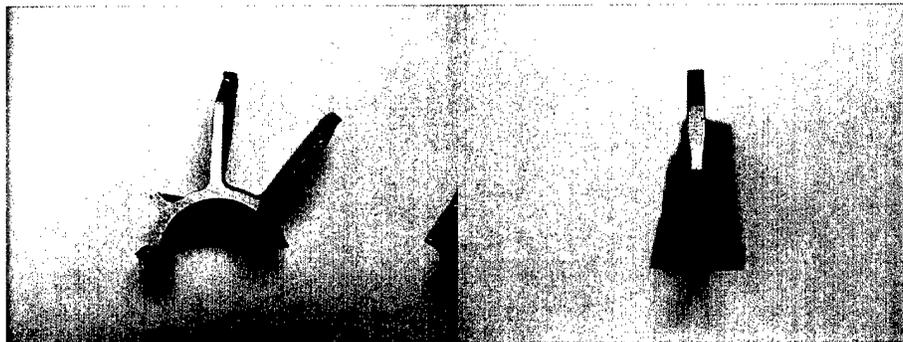
Figure 2
Two broken fin parts, flat fin plus cylindrical part

cause of failure between fins (fig. 2) is a defect at a high-hoop stress region that results in fracture failure. The fracture failure occurs from an internal pressure in the fin cylinder. Yielding is probably not visible.

crack size was estimated at 0.23 mm (0.009 in.). As shown in figure 2, several of the broken fins had failure modes consistent with fracture failure. The failure surface was rough and without discernable yielding of the fins or fin cylinder.

The analysis indicated that a fracture could occur with large internal pressures at critical defects. The smallest crack size was predicted with longitudinal cracks on the inside of the fin cylinder. This type of defect is consistent with scoring due to assembly at the press fit. Evidence of scoring was found in some broken parts, but it was not clear that scoring had caused a specific failure. However, the broken parts shown in figure 2 are consistent with the high stress regions in figure 6b.

Six-sigma techniques are being used to assess the manufacturing and assembly process. The goal is to reduce the size and number of scoring defects on the inside of the fin cylinder.

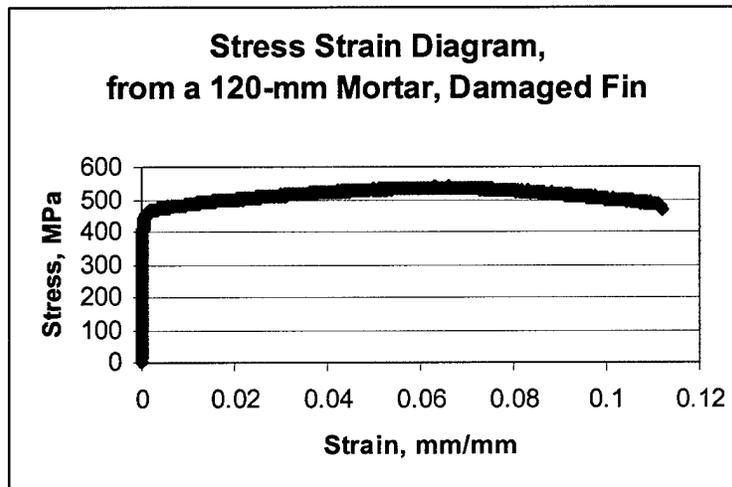
Figure 5
Stress/strain diagram from damaged fin

Both parts of the tail assembly were extruded from aluminum. Young's Modulus was 73,023 MPa, Poisson's ratio was 0.3, and the mass density was 2.3-gm/cm³. The perforated section was modeled as a linear-elastic material. The fin section was modeled as an elastic-plastic material. Points from a tensile test of a fin were used to model the fin part (fig. 5). The engineering yield and ultimate strength were 464 and 502 MPa. ABAQUS uses the true stress and strain, 466 MPa for yield and 538 MPa for ultimate tensile strength.

A fracture analysis was done on the fin section following analysis. The fracture toughness for the fin-section is estimated to be 17.9 MPa√m.

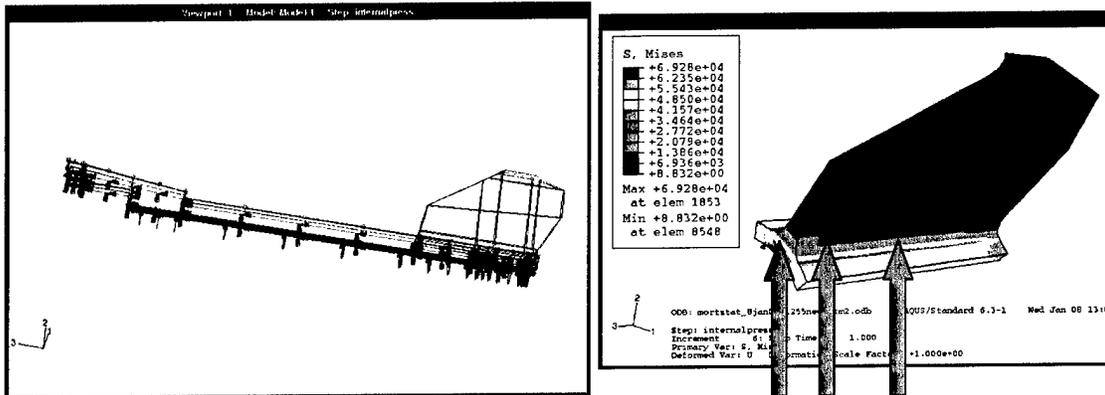
Figure 6
Internal pressure on fin assembly, 98 MPa

The internal pressure of 98 MPa, load case 2 from table 1, resulted in three, high-stress regions (fig. 6b). There are high von Mises stresses directly under the fin and at the inner diameter of the cylinder, at the fin fillet on the outside of the fin cylinder, and midway between the fins on the inside of the fin tube. Yielding was predicted directly under the fin on the inside of the cylinder. The plastic region did not go through the thickness of the cylinder and the von Mises stress was below the ultimate tensile strength of the aluminum.

Critical crack sizes were predicted for the three high-stress regions shown in figure 6b. The smallest critical cracks resulted from the longitudinal cracks opened by the hoop stresses. For load, the 98-MPa internal pressure, the smallest critical flaw on the inside of the cylinder, was estimated at 0.18 mm (0.007 in.). Along the outside of the cylinder, the smallest critical

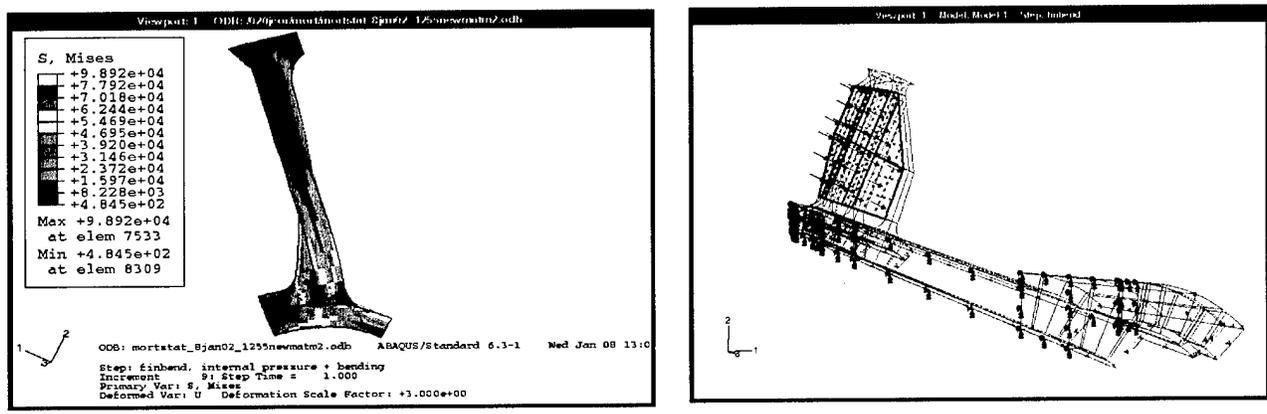
Figure 7
Load case 4: pressure on one side of fin

Figure 7a shows load case 4, an unequal pressure on one side of the fin. A pressure of 1.4 MPa resulted in yielding of the fin near the root. A pressure of 2.1 MPa resulted in von Mises stresses exceeding the ultimate tensile strength of the aluminum (figure 7b in units psi). At the 2.1-MPa pressure, the plastic zone extended through the fin thickness, indicating probable tearing of the fin at this location. Numerous examples of broken and twisted fins were consistent with the deformation and stresses shown in figure 7b.

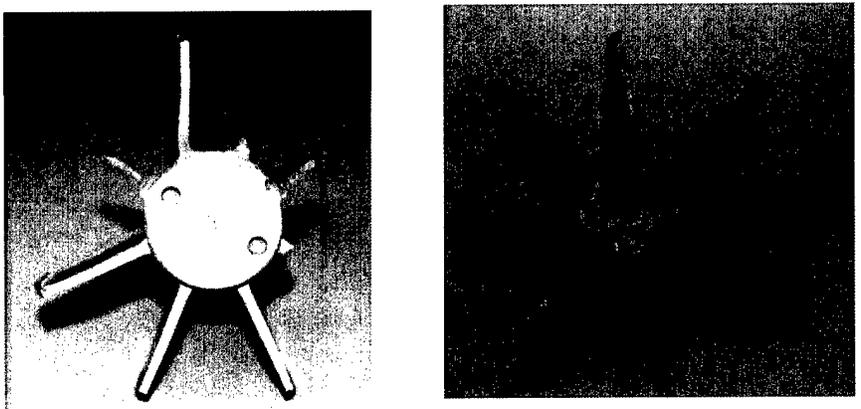
Figure 8
Evidence of high unequal pressure between two fins

Additional evidence of unequal pressure as a proximal cause of failure occurred in recent short-rounds. In the broken short-rounds in figure 8, two adjacent damaged fins appear to be twisting away from the same spot, indicating high pressure between two fins. In figure 8a, note the fins at 10:00 and 12:00 seem to be twisting in opposite directions. Similarly the damaged fins in figure 8b seem to be twisting away from one another. Note the fins at 4:00 and 6:00 in figure 8b.

A test program was initiated to determine if unequal pressure is occurring on one side of the fins. Instrumentation of rounds is in progress. Results should provide a dozen pressure time curves over different fins for different charge distributions. The input will be used to determine dynamic reaction of the fins and to verify that unequal pressure is occurring in some cases.
