**Metallurgical Examination of a Failed AH-64D Pilot  
Cyclic Stick (Part Number 7-511512001-3)**

**by Victor Champagne and Scott Grendahl**

**ARL-TR-3272**

**August 2004**

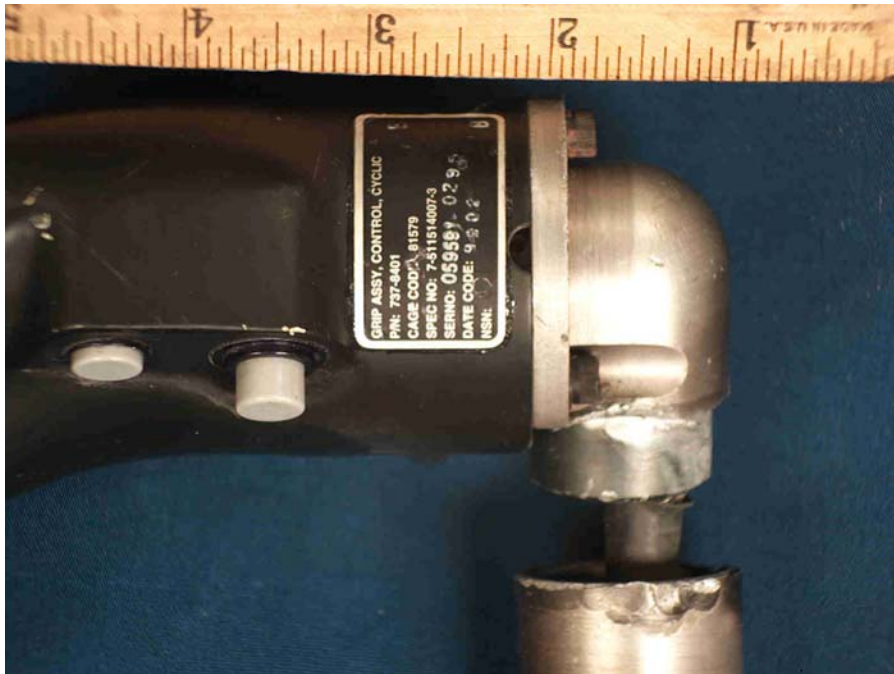
Figure 2. Enlargement of the fracture area on the pilot stick.

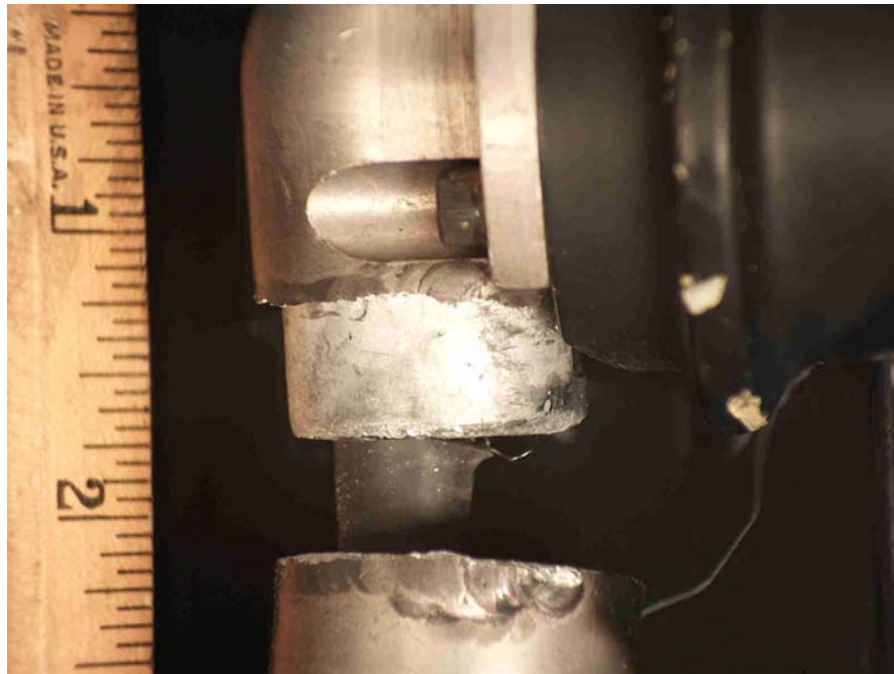
Figure 3. Detail of the pilot stick fractured area.

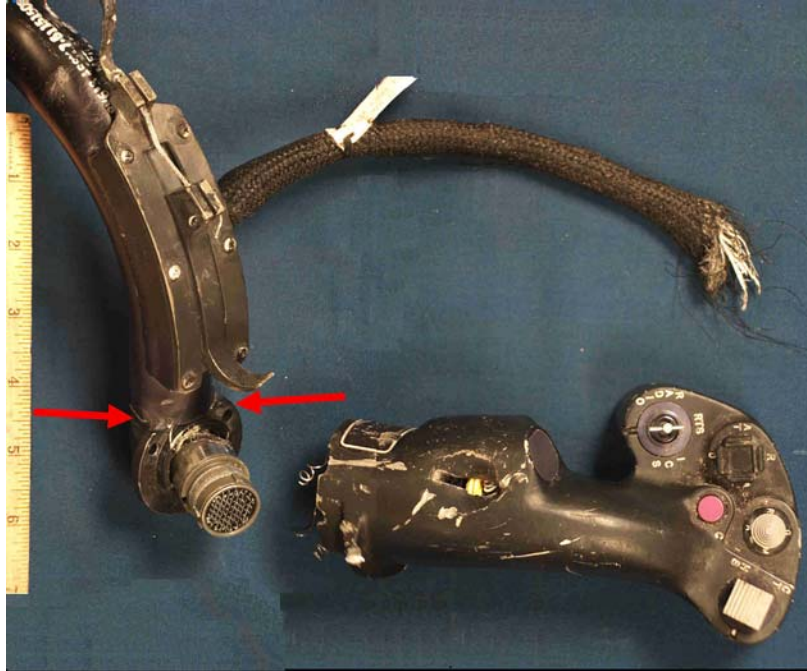
The copilot cyclic stick was cracked in the same area but did not break into two pieces (figure 4). The bolts that mount the grip to the stick were removed prior to the photograph being taken. Arrows indicate the area of concern in figure 4. Both sticks sustained mishap damage. The copilot stick contained considerably more damage, such that areas of the aluminum tube as well the section containing the control buttons, were dented, gouged, and/or bent, indicative of severe impact loading. However, the copilot cyclic stick, although cracked, was still intact and would most likely require a mechanical testing machine to properly separate the two fracture halves for subsequent examination (figure 5). The important point was that the fractured copilot stick could not easily be broken the rest of the way. Subsequently, the wiring assembly, which ran through the tubular section, was removed, separating the “tube” fracture half from that of the “elbow” fracture half.

Figure 4. The fractured AH-64D copilot cyclic stick as received by ARL.

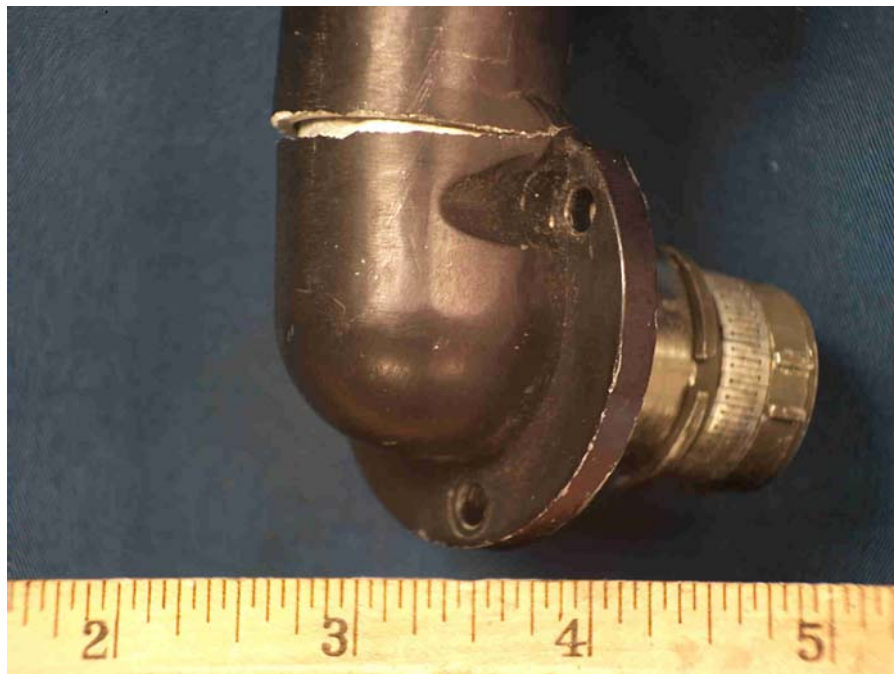
Figure 5. Detail of the copilot stick crack at the elbow to tube weld.

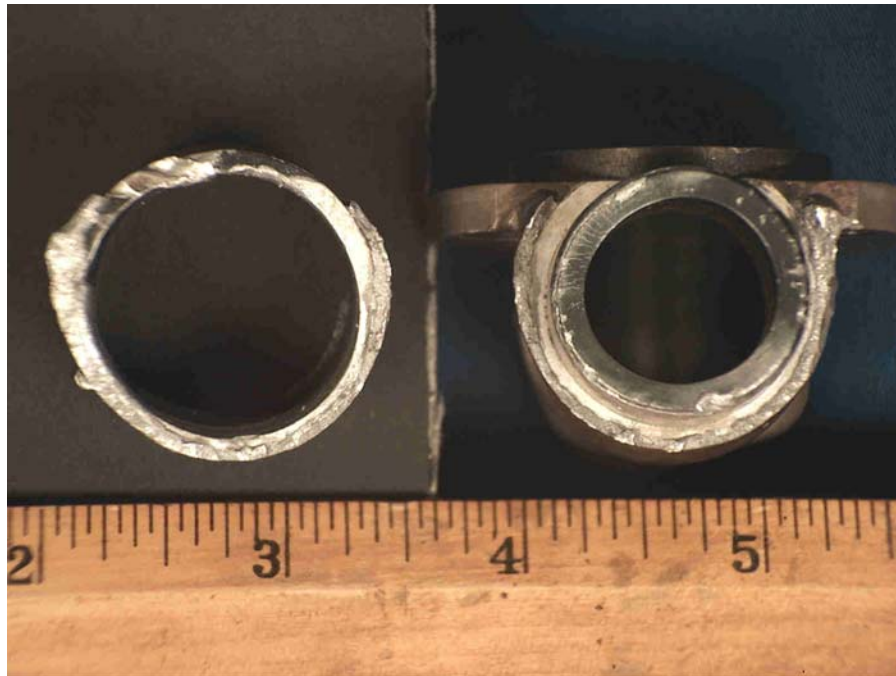
Figure 6 shows the tube fracture and the elbow fracture halves, respectively. The lack of penetration appeared as areas without fracture topography, where the as-formed/machined surfaces of the tube and the elbow were clearly discernible. Significant portions of the joint interface also sustained damage and appeared as bright patches without reconcilable topography. Figures 7–9 are enlargements of the weld fracture, showing the lack of penetration and large gas voids. The tube wall thickness was  $\sim 0.095$  in and was used along with the surface morphology characteristics of the fracture to determine weld penetration.

Figure 6. The fracture halves of the pilot cyclic stick.

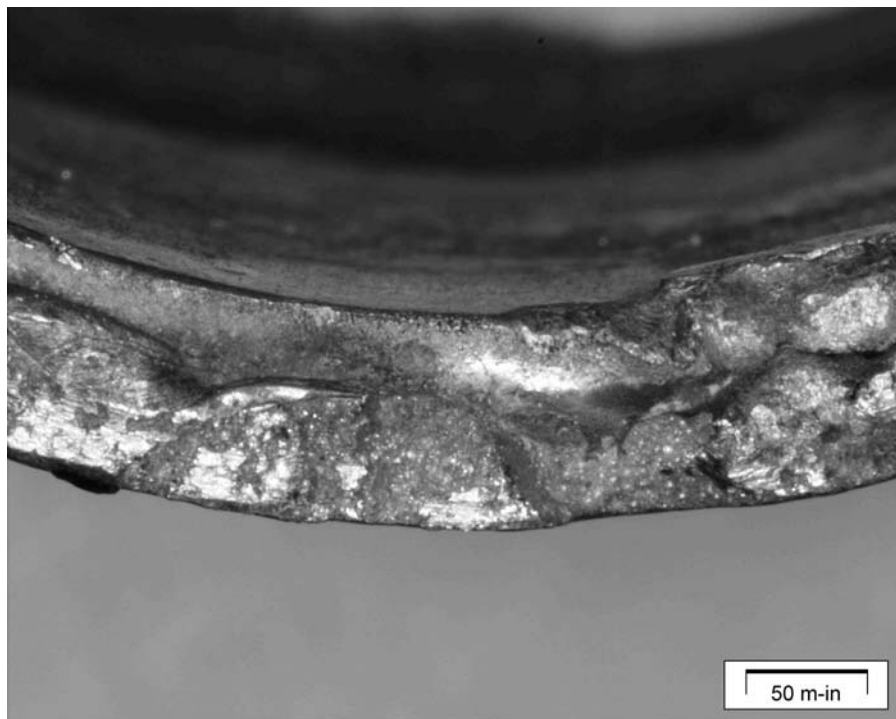
Figure 7. Lack of penetration observed on the tube side fracture half.

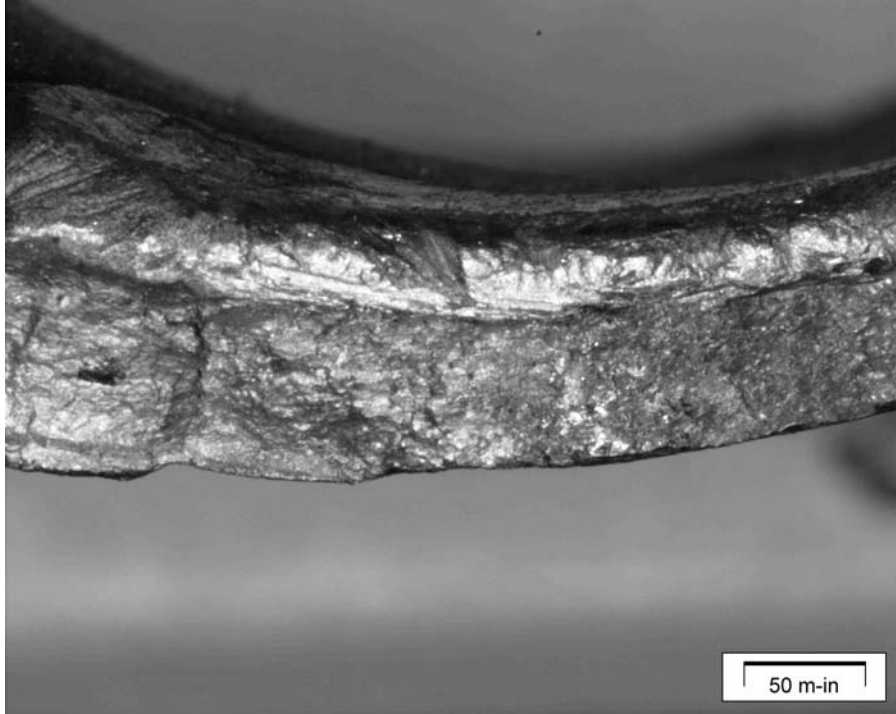
Figure 8. Lack of penetration on the tube side at location G on the drawing.

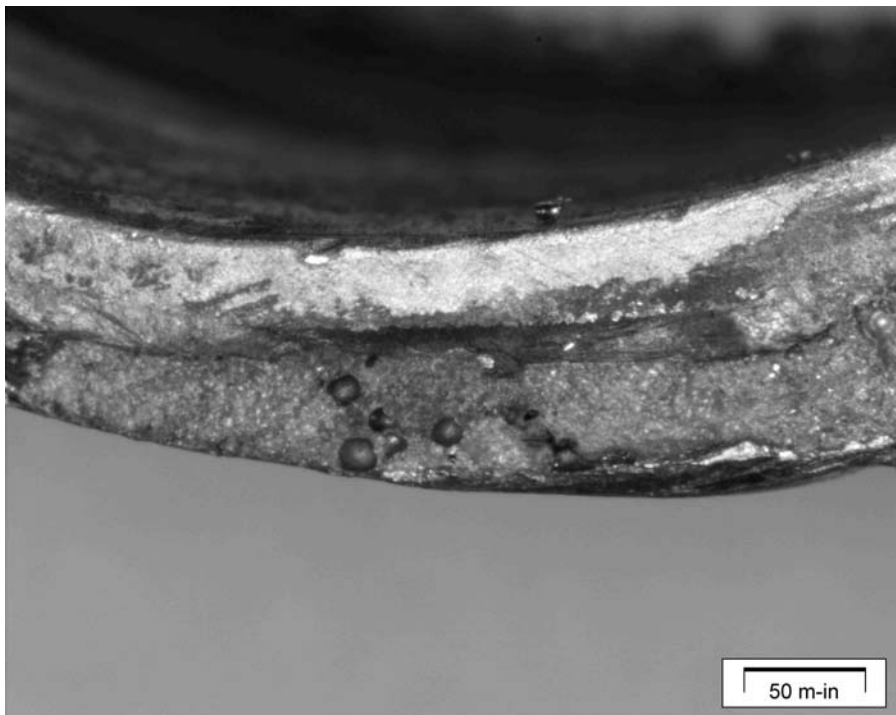
Figure 9. Lack of penetration on the tube side at location F on the drawing.

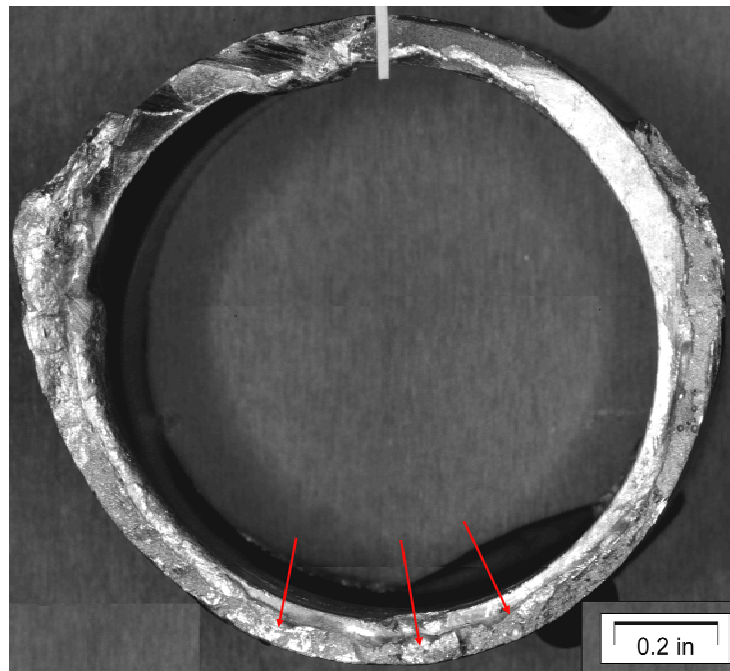
Figure 10 is a montage of the entire tube weld fracture from which penetration calculations were determined. The cross-sectional area of the welded region was ~40%, as determined by quantitative image analysis. This value was obtained by taking the ratio of the calculated areas between the welded fracture surface and what should have been welded according to the manufacturer's engineering drawing. The area coincides with the tube thickness mating with the elbow below the top of the flange. Figure 11 shows the portion of the tube that should have been welded, while figure 12 depicts the areas left unwelded. The calculated percentage of welded material can be used with the tube thickness to estimate the loading required to fracture the assembly.

Figure 10. Montage of the fracture surface of the pilot cyclic stick.

The failure originated at the root of the weld where there existed incomplete penetration coupled with localized flaws. Arrows in figures 10–12 depict these areas. Figures 13–16 show all three areas in greater detail on the elbow fracture half.

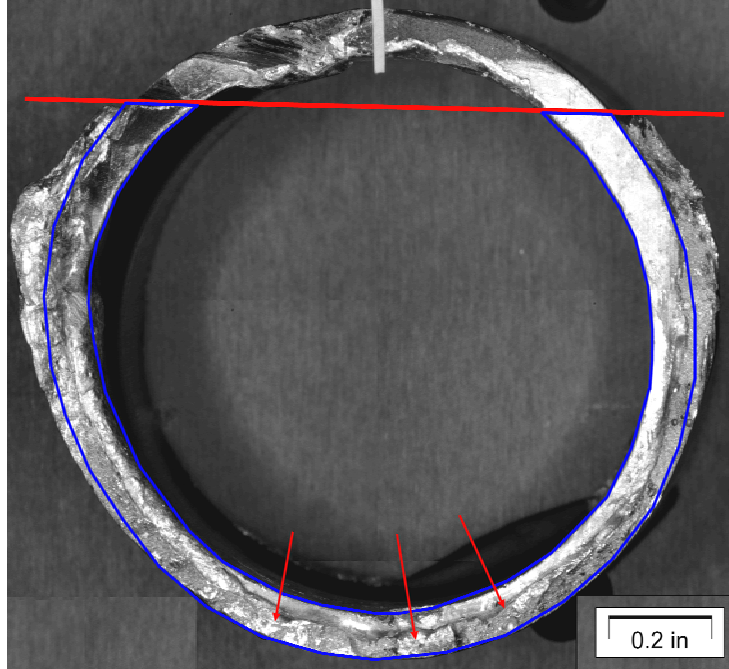
Figure 11. Montage from figure 10 depicting the area that should be welded.

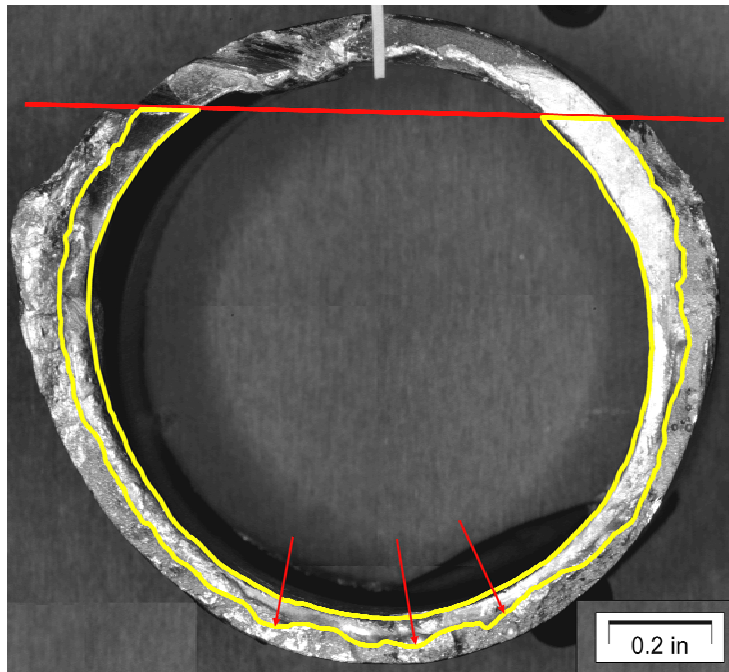
Figure 12. Montage from figure 10 depicting the area that was not welded.

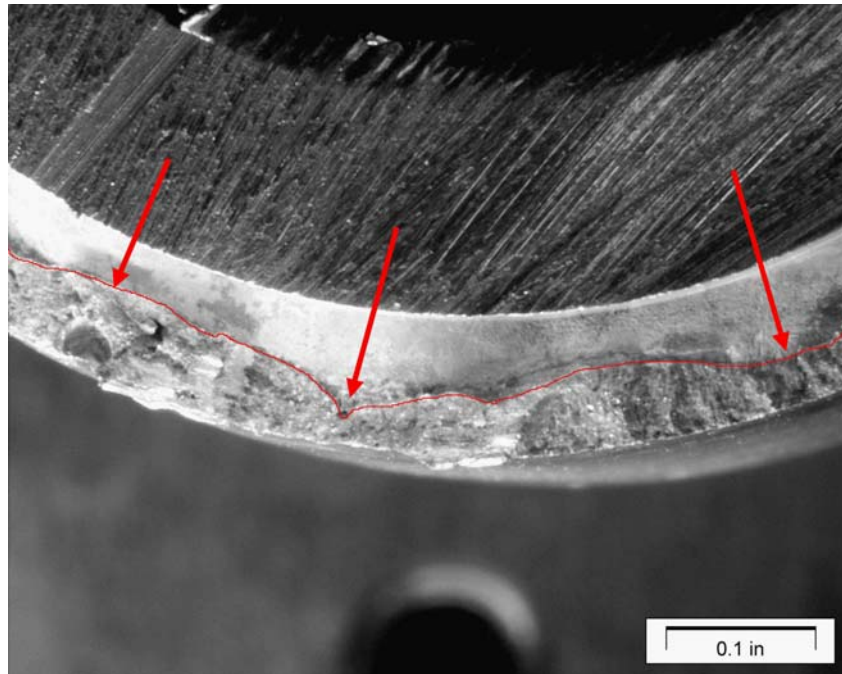
Figure 13. Elbow side fracture half depicting failure origins.

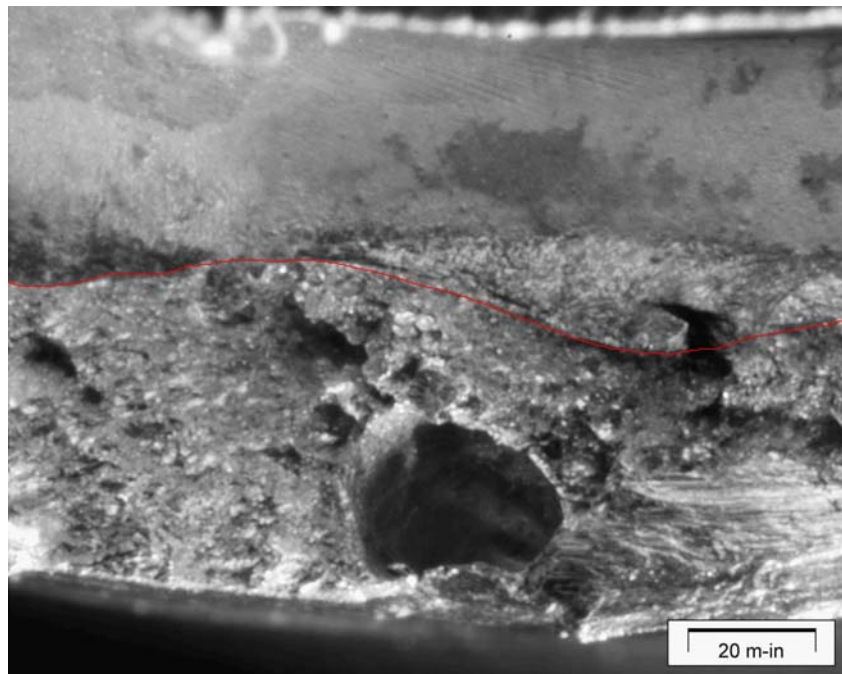
Figure 14. Elbow side fracture half depicting large gas void failure origin, from left side of figure 13.

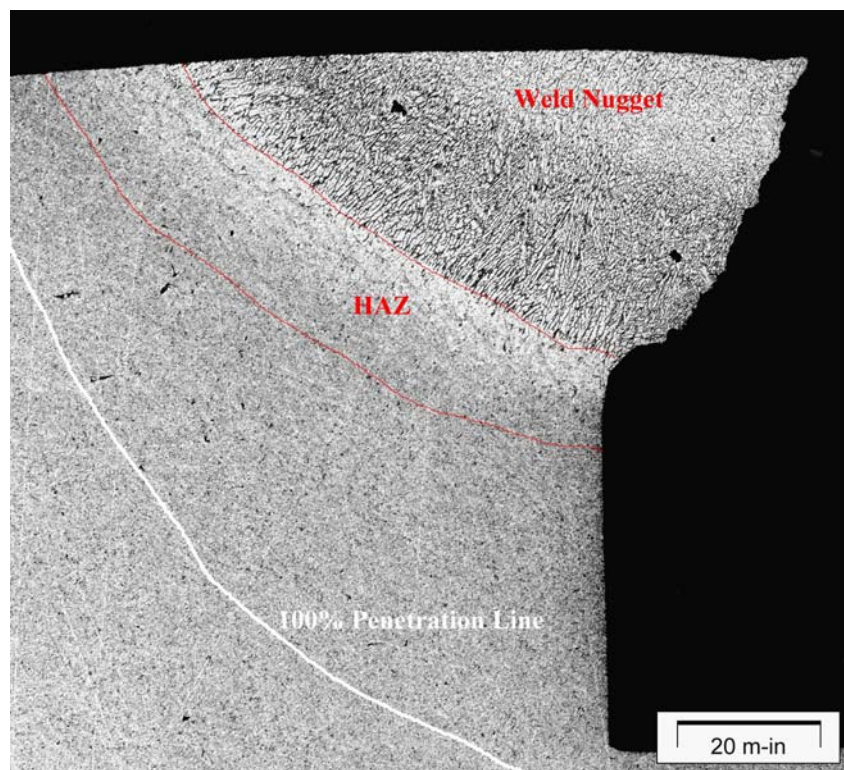
A cross section of material was taken through the fractured weld on the “tube side” of the fracture as well as on the “elbow side” of the fracture. Both samples were mounted and metallographically prepared for examination. Keller’s reagent was used for etching. Figure 17 is an optical micrograph of the elbow fracture showing the lack of penetration of the weld. To illustrate a weld with 100% penetration, an outline of such a weld (drawn in white) was added to figure 17. The weld bead contained an interdendritic network of aluminum-silicon eutectic (black) and dark etching, Al-Mg<sub>2</sub>Si eutectic between the grains in the heat-affected zone. Figure 18 is an optical micrograph of a cross-section of the tube side of the fractured weld, which did not contain any of the elbow material, also indicating a lack of penetration. Porosity was observed within the weld. Figure 19 represents a micrograph of the tube base material showing a matrix of aluminum solid solution containing particles of Mg<sub>2</sub>Si (black).

Figure 17. Elbow side cross section through the weld; the white line depicts what would be a 100% penetration weld.

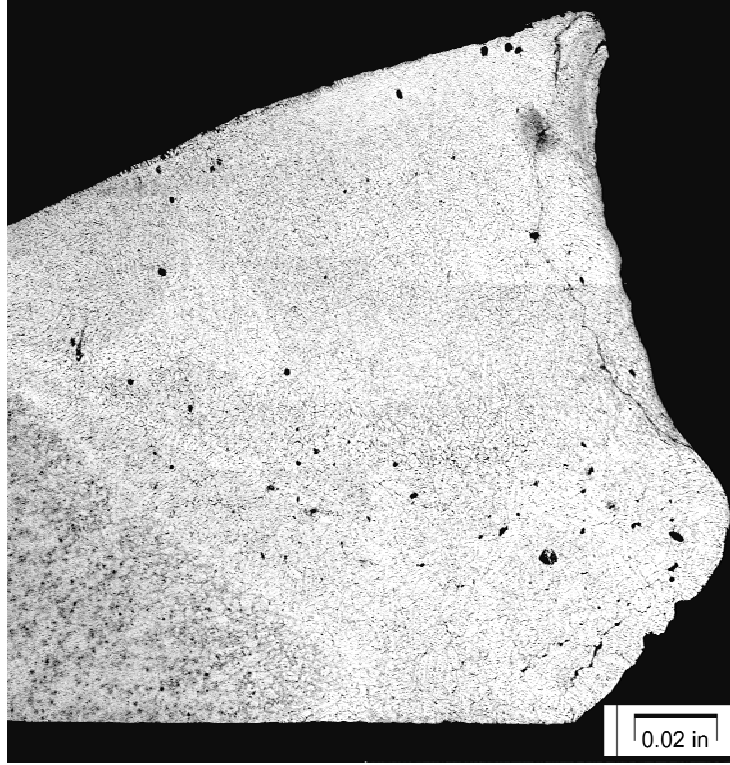
Figure 18. Tube side cross section through the weld.

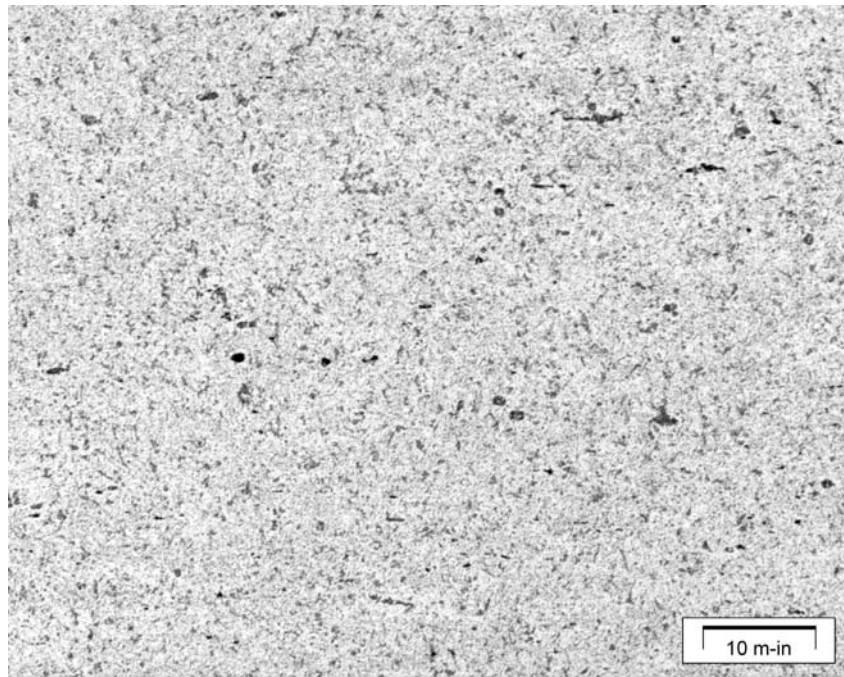
Figure 19. Tube side cross section of base material.

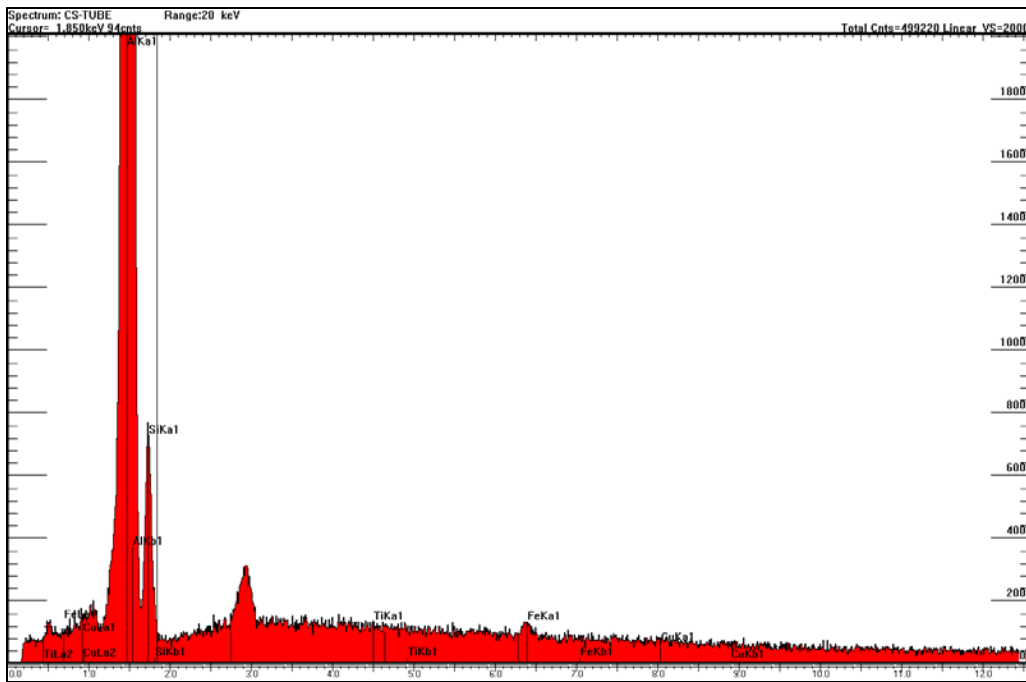
The chemical composition of the weld bead was initially determined by quantitative energy dispersing spectroscopy (EDS), within the scanning electron microscope. This method was chosen to obtain relative chemical composition quickly in lieu of wet chemistry techniques to verify the weld rod material. It was not meant to provide absolute values of chemical composition. The differences in the silicon and copper content between the two welding rods were the distinguishing elements used as a basis for comparison. The small concentrations of manganese, magnesium, and zinc did not yield an appreciable peak and therefore did not factor into the overall weight-percentage calculation. Samples of the two possible weld rod materials, AMS 4190 (ER4043) and AMS 4189 (ER4643), were obtained and analyzed to calibrate the EDS system. The spectra obtained are shown in figures 20 and 21. A section of the weld bead on the elbow fitting was polished with 15- $\mu\text{m}$  diamond paste, to remove surface contamination, in preparation for EDS analysis. The spectrum of the weld bead compared favorably to that of ER4643, as figure 22 reveals. Table 5 lists the corresponding numerical values of these EDS analyses.

Figure 22. EDS spectrum for the filler metal on the welded pilot stick.

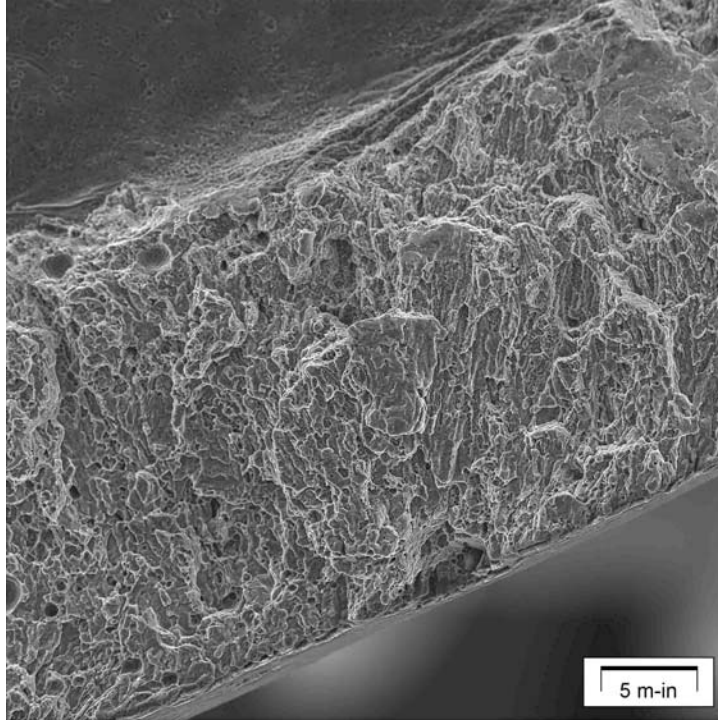
SEM examination of the fracture surfaces did not reveal any evidence of fatigue, such as beach marks, fatigue striations or a region consistent with an “older” fracture surface. No type of crack arrest marks were found anywhere on the fracture, suggesting that the entire fracture occurred all at once. Additional information substantiating this position was the predominately dimpled fracture morphology, which is indicative of overload conditions (figure 23). At times, these dimples demonstrated directionality, as in figure 24, but only in the late stages of fracture typical of sheared material. There also existed some areas where quasi-cleavage fracture was present (figure 25).

Figure 23. SEM fractograph showing the morphology predominant on the cyclic stick.

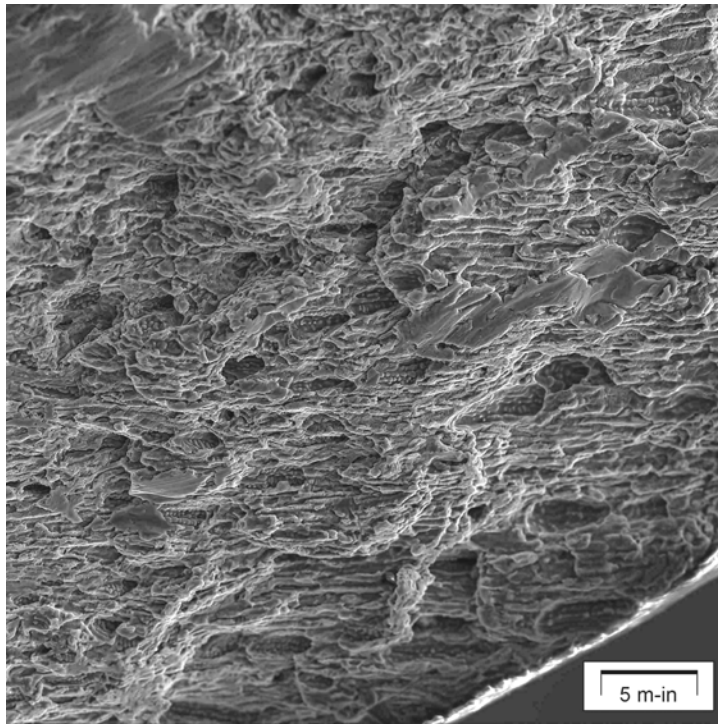
Figure 24. SEM fractograph showing dimpled morphology with directionality.

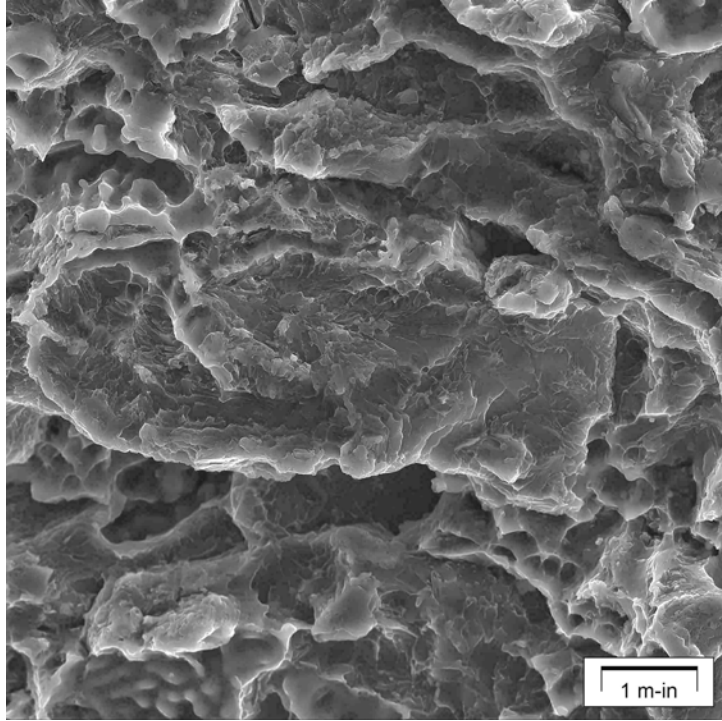
Figure 25. SEM fractograph showing quasi-cleavage morphology.

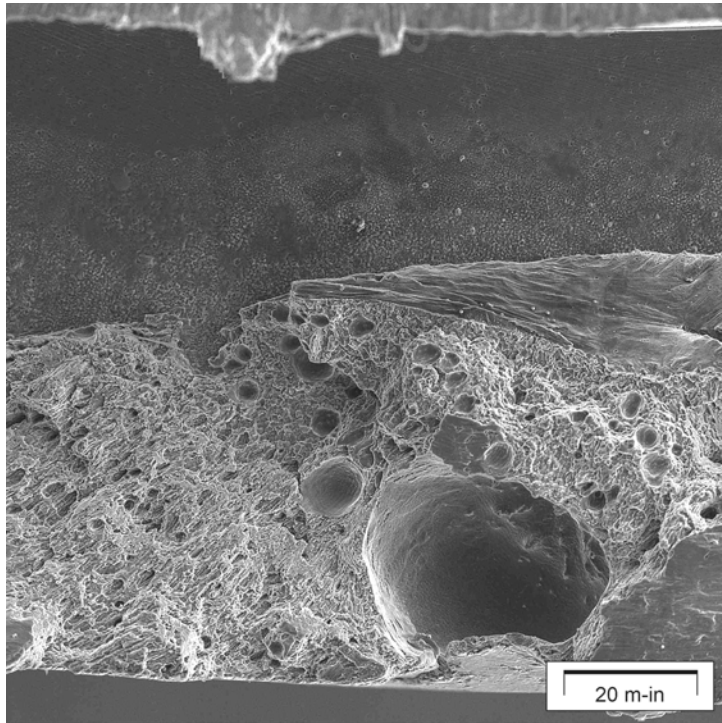
Scanning electron micrographs of the three fracture origins discussed earlier can be observed in figures 26–28 and at higher magnification in figures 29–31. Figure 29 presents the large gas void in greater detail. Due to the inherent gap between the tube and the elbow prior to welding, and the lack of full penetration, there existed areas where the tube material was melted but not

Figure 26. SEM fractograph showing fracture origin from figure 14.

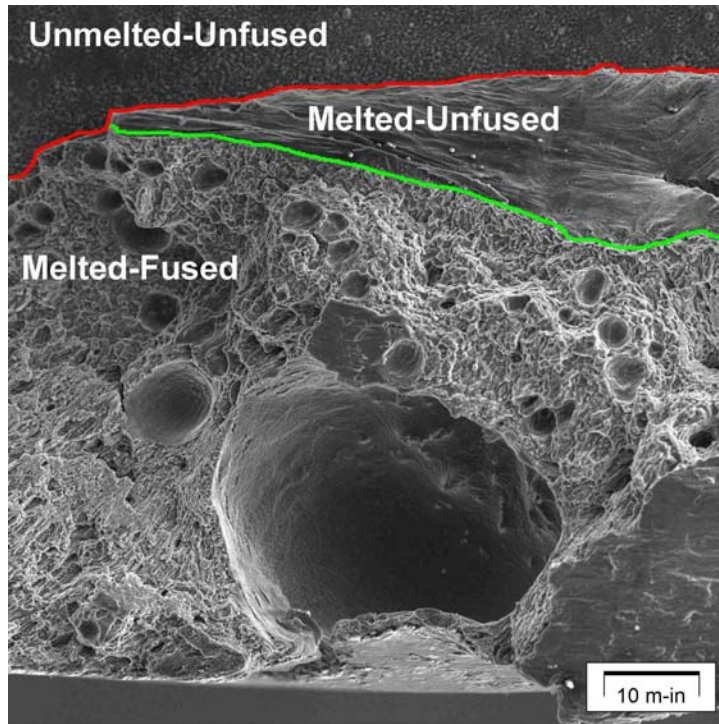
Figure 29. SEM fractograph showing unfused material from figure 26.

fused to the elbow. The melted and fused material left a discernible fracture surface where the parts were separated. This phenomenon can be observed in figure 29. Numerous large gas voids were observed at various locations on the fracture surfaces (figure 32 and 33).

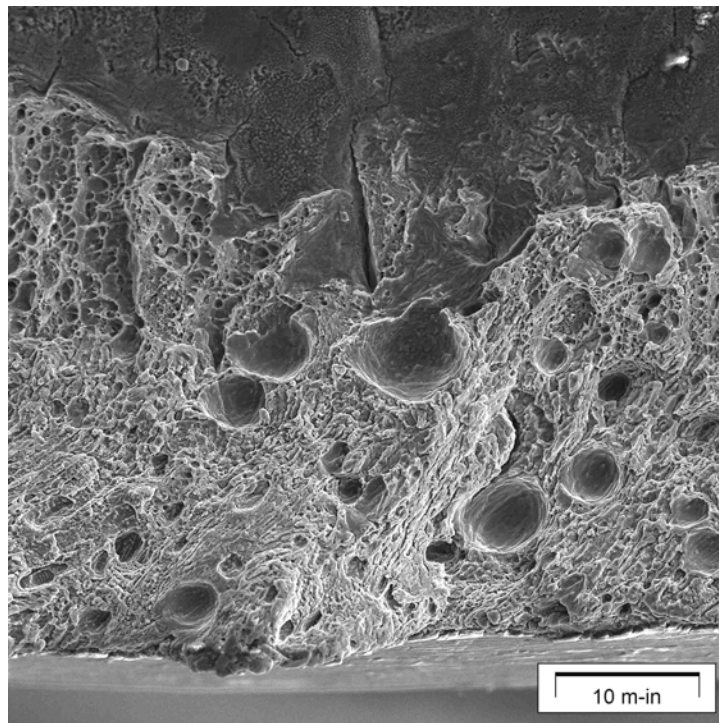
Figure 30. SEM fractograph showing enlargement of figure 27.

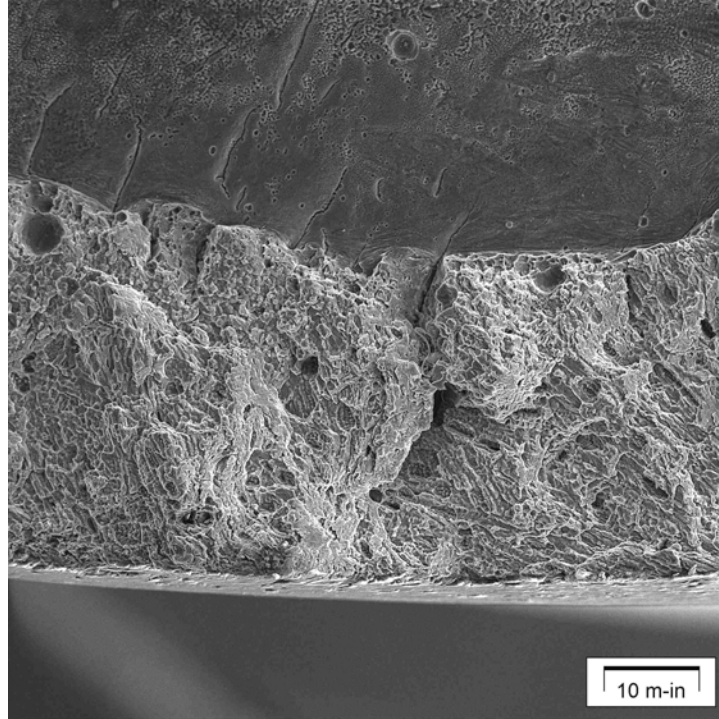
Figure 31. SEM fractograph showing enlargement of figure 28.

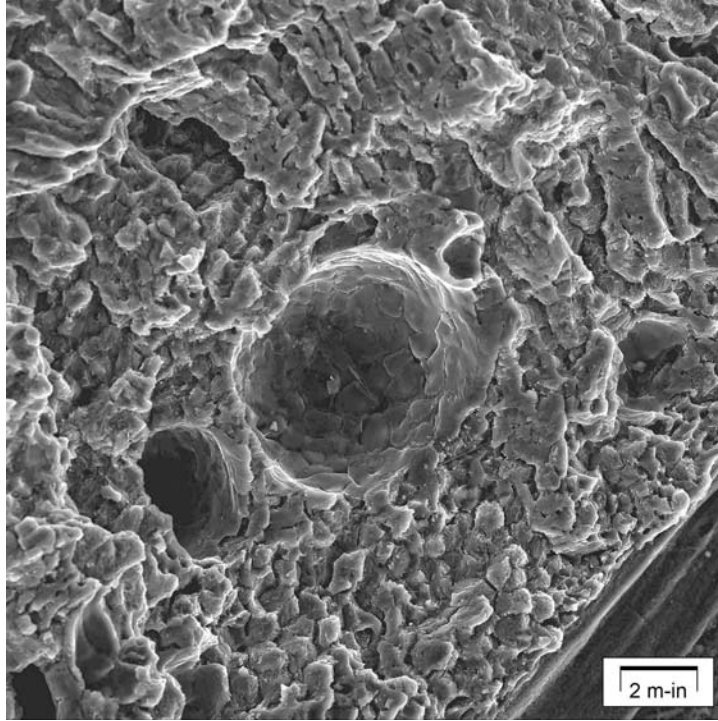
Figure 32. SEM fractograph showing typical gas voids on the surface.

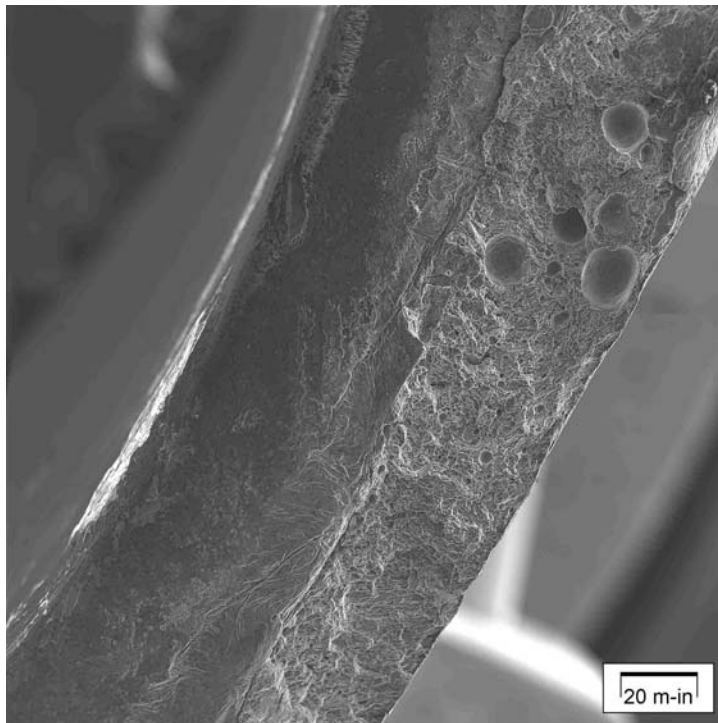
Figure 33. SEM fractograph showing additional typical gas voids on the surface.
