Australian Government
Department of Defence
Defence Science and
Technology Organisation

A Review of Australian and New Zealand Investigations on Aeronautical Fatigue During the Period April 2003 to March 2005

DSTO-TN-0624

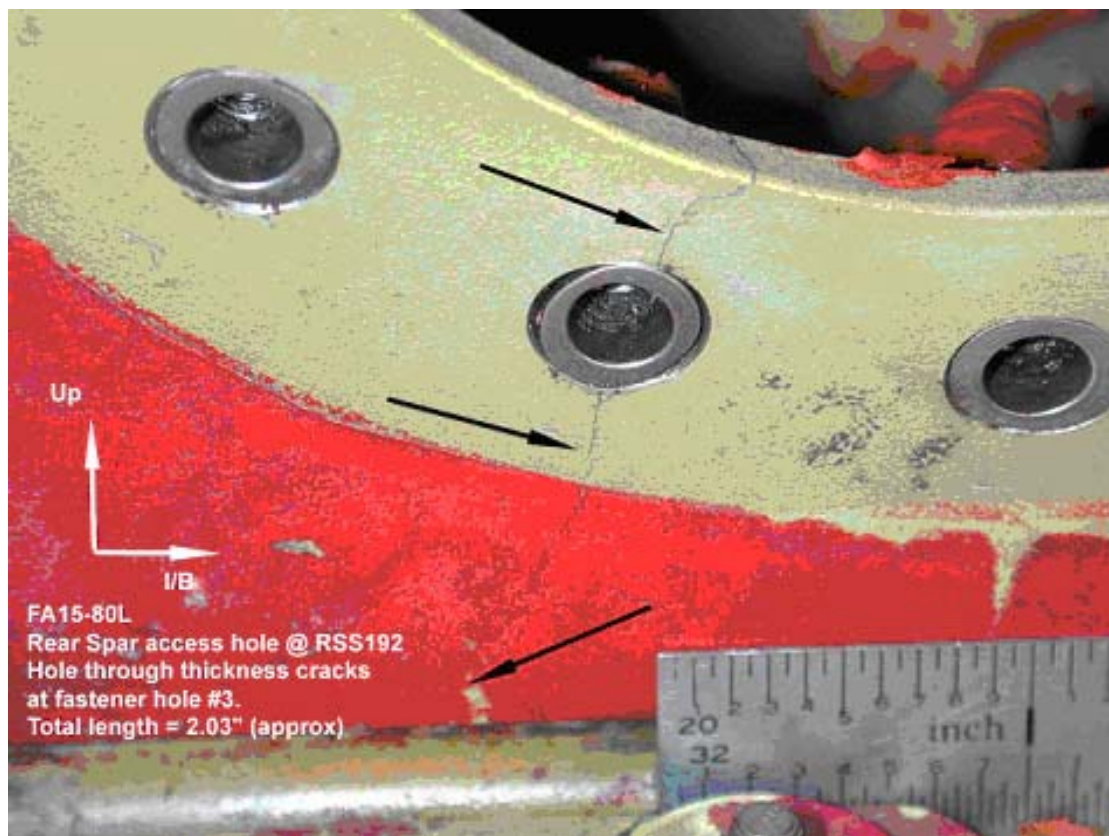
From the starting point of 4,500 Cannon AFB hours the test has progressed in a satisfactory manner although not without incident. During inspection of the test article at 5,500 flying hours a crack was detected at an inspection opening in the rear spar at a location known as Durability and Damage Tolerance (DADTA) item 73; this is a location known to crack in service. The crack had grown from an anchor nut hole (See Figure 4) across the spar web and the low spar cap. Stainless steel doublers were used to restore the spar web and to reinforce the lower wing skin to prevent further cracking of the lower spar cap as shown in Figure 5. To date this repair has performed satisfactorily with no further crack growth being evident.

Figure 4: Rear Spar Crack at DADTA Item 73

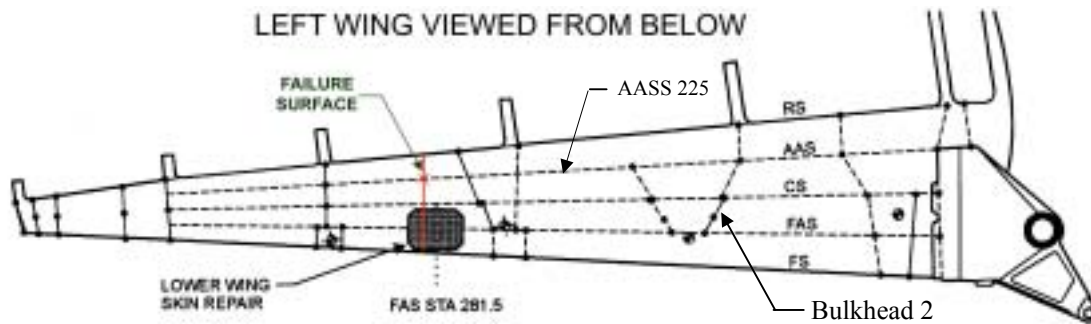
Figure 1. RAAF F-111C fatigue test wing showing failure location at Aft Auxiliary Spar Station (AASS) 277.3. The other spars are the Rear Spar (RS), Centre Spar (CS), Forward Auxiliary Spar (FAS) and the Front Spar (FS). Another significant crack location is at AASS 225.

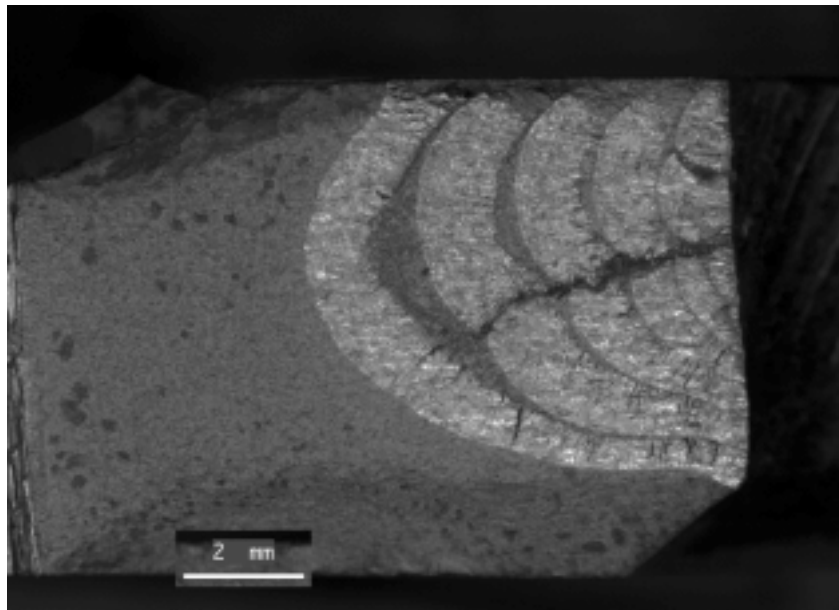
Figure 2. Fracture Surface from the forward side of the hole at AASS 225

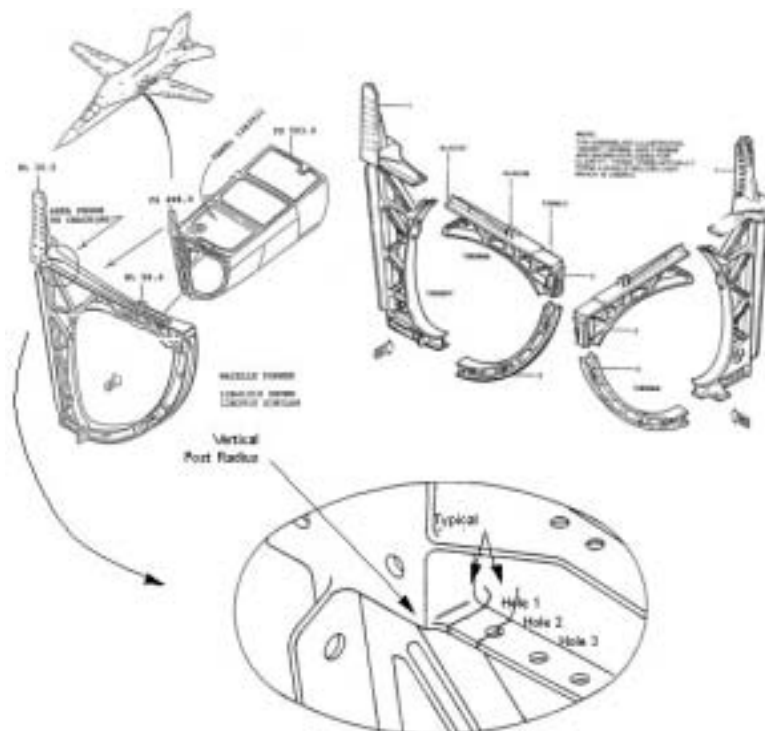
Figure 1: Location of crack prone area on the FS 496 nacelle former

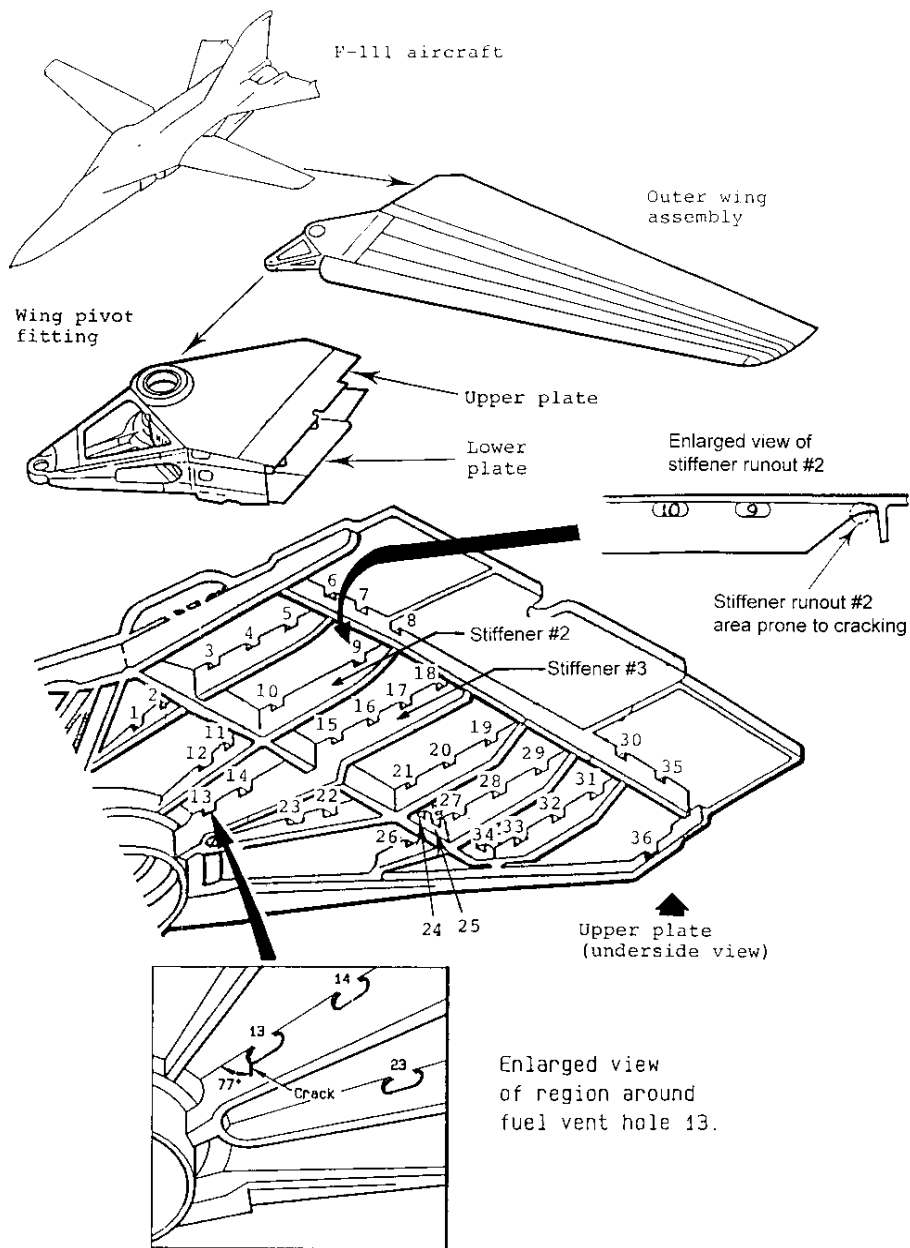
Figure 2: Internal view of the Wing Pivot Fitting (WPF) structure showing Fuel Flow Vent Hole (FFVH) and Stiffener Runout (SRO) features and typical crack locations.

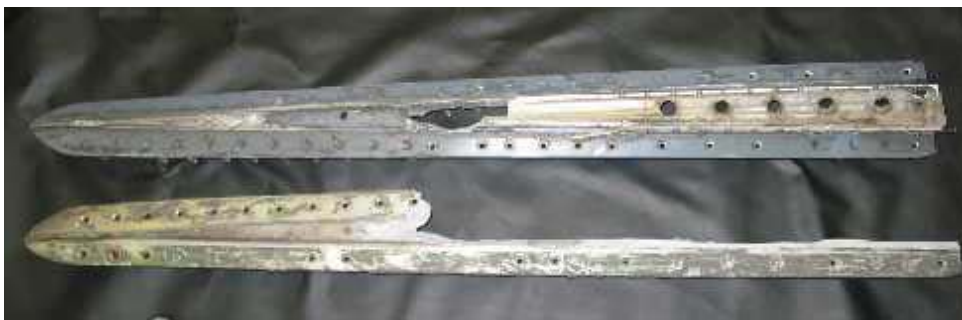
Figure 3: Two failures.

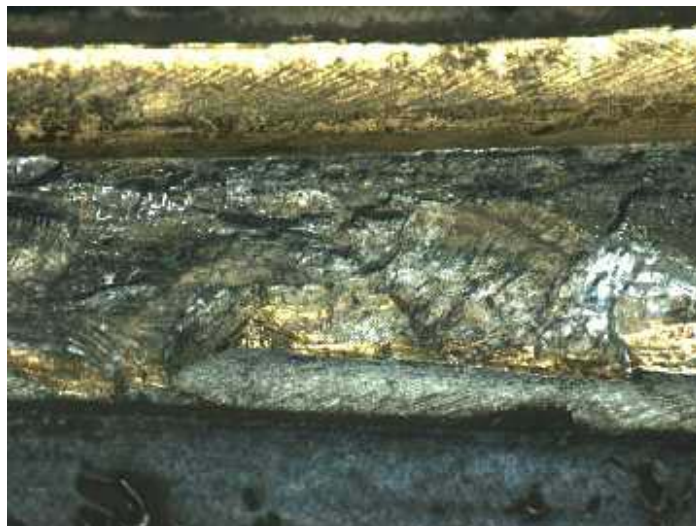
Figure 4: Detail of typical fatigue region.

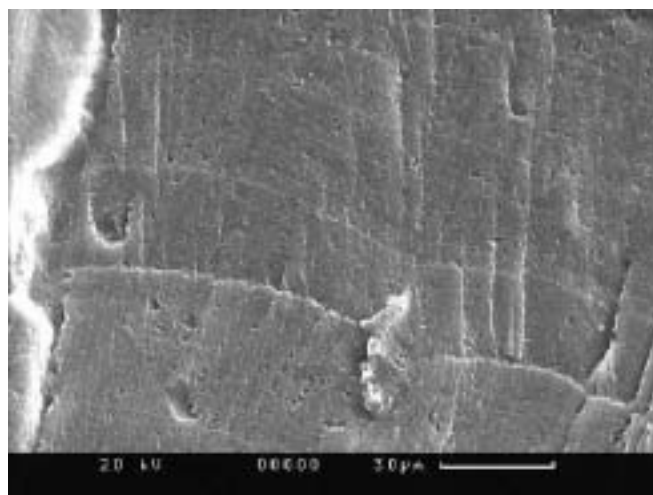
Figure 5: SEM striations on fracture surface.

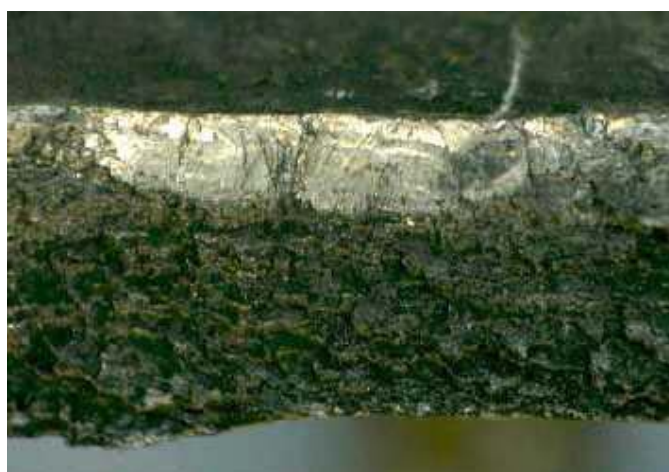
Figure 6: Fatigue crack in "overload" zone.

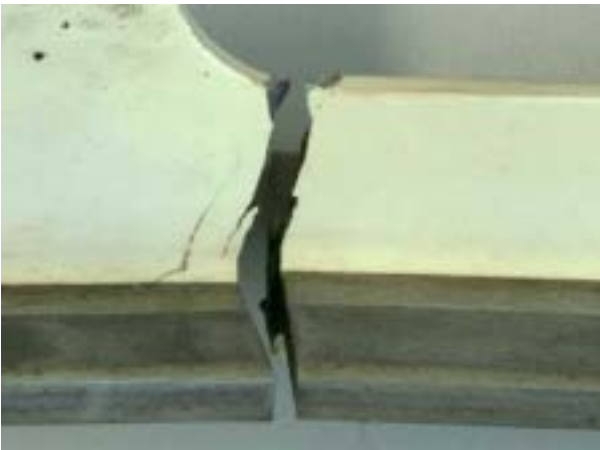
Figure 4: Optical view of fracture

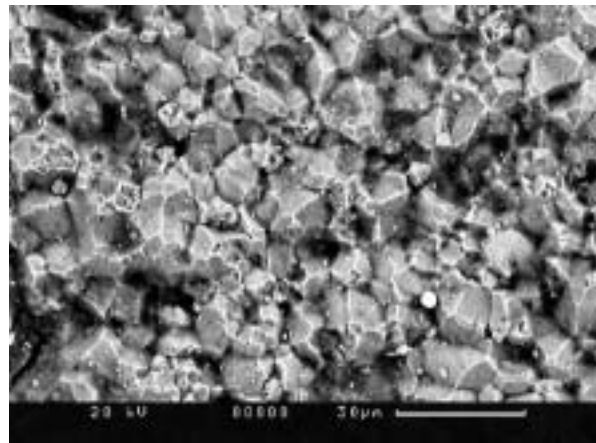
Figure 5: SEM examination of surface

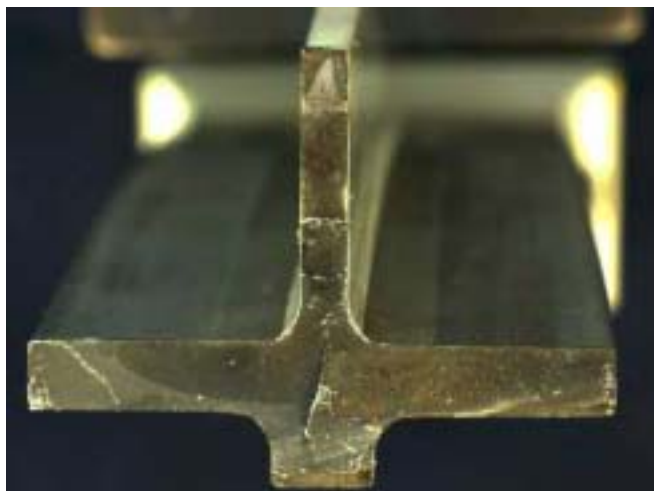
Figure 6: Fracture surface

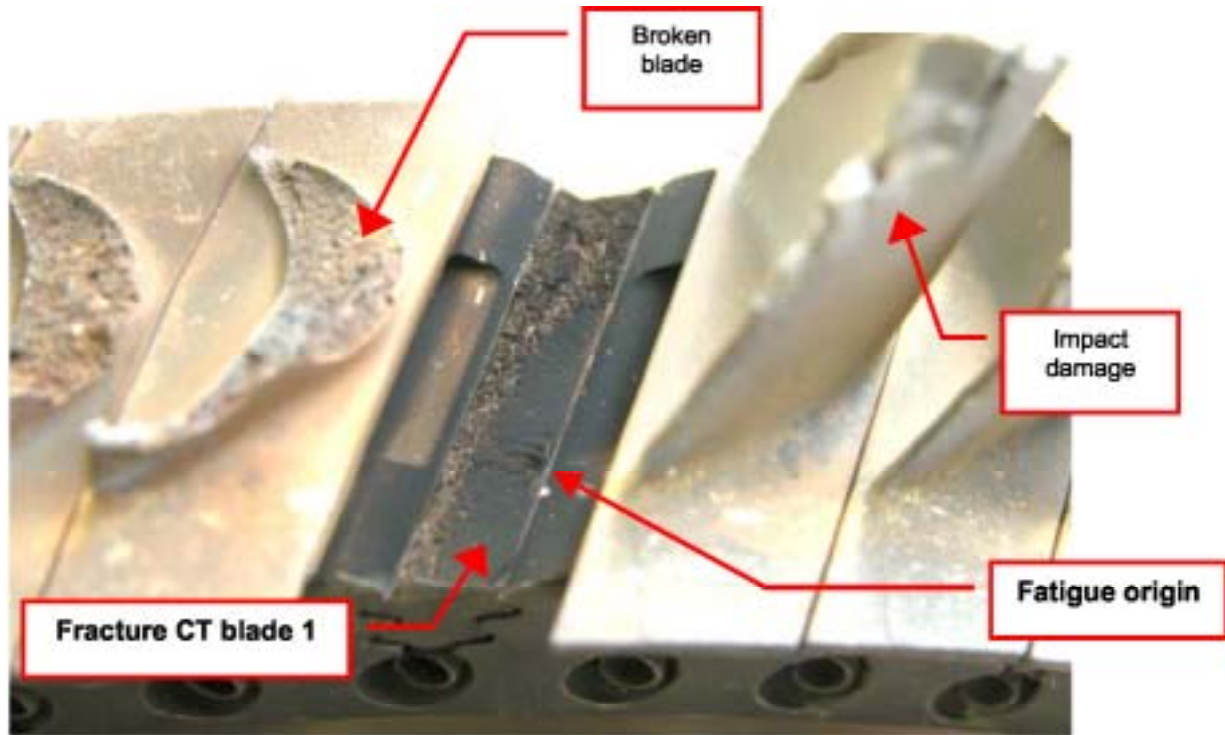
Figure 2. Photograph of the subject CT turbine blade assembly showing the fracture surface and the fatigue crack origin (Labelled) on CT blade 1. Also note that the remnant of the trailing edge of the adjacent CT blade was bent in the direction of impact (labelled).

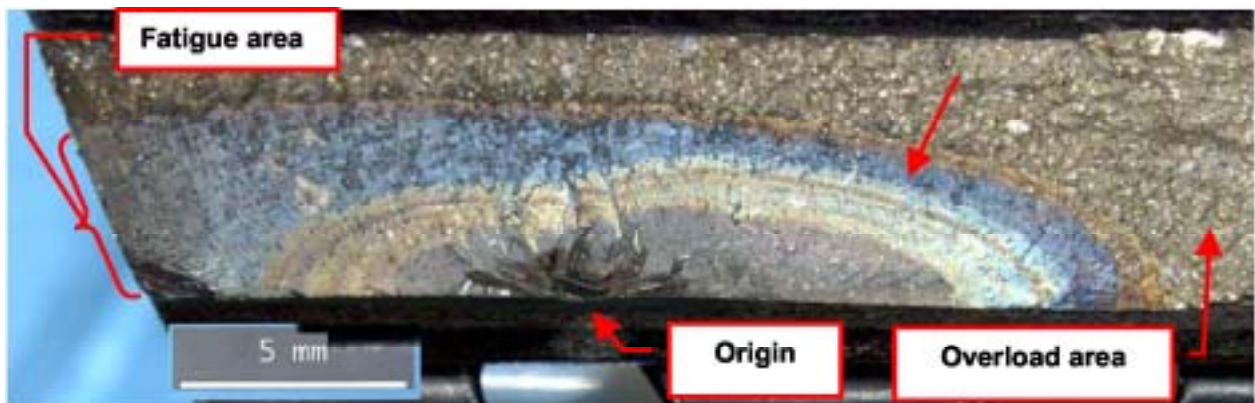
Figure 3. Photograph of the fracture surface of CT blade. Note the concentric rings produced by differing thicknesses of the oxide due to exposure time. The fatigue crack propagation is from bottom to top. Note banding of the fracture surface (example arrowed). The bands are caused by changes in the oxide layer due to variations in the service conditions and/or exposure time; this indicated that the fatigue crack propagated in numerous engine cycles

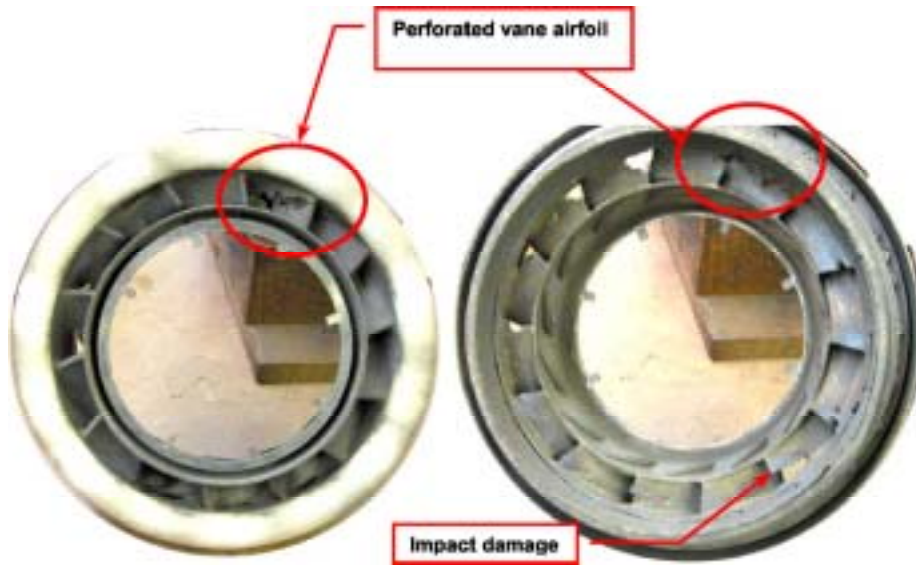
Figure 4. Photographs of the CT stator from both the leading (left) and trailing (right) sides. Severe impact and wear damage is observed at the trailing side (right). Also note the perforation of CT vane (circled). A higher magnification view of the perforated airfoil is shown in Figure 5 and 6.

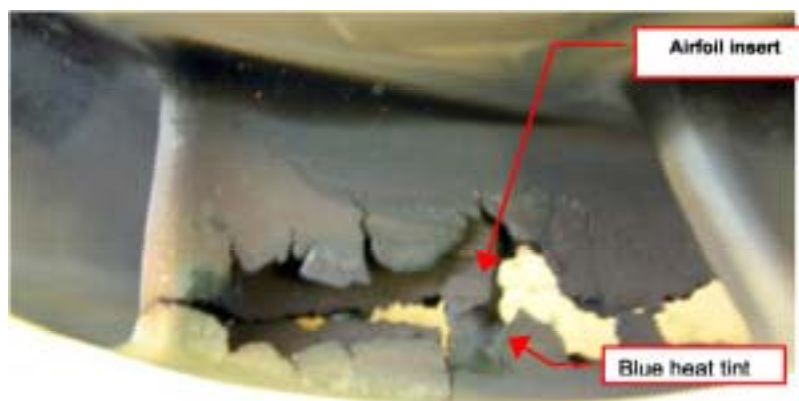
Figure 5. Photograph of the leading side of the perforated airfoil of CT vane 10 (Circled area in Figure 2). Note the rounded edges and the jagged cracking. Heat tinting of the surface is also observed (labelled).

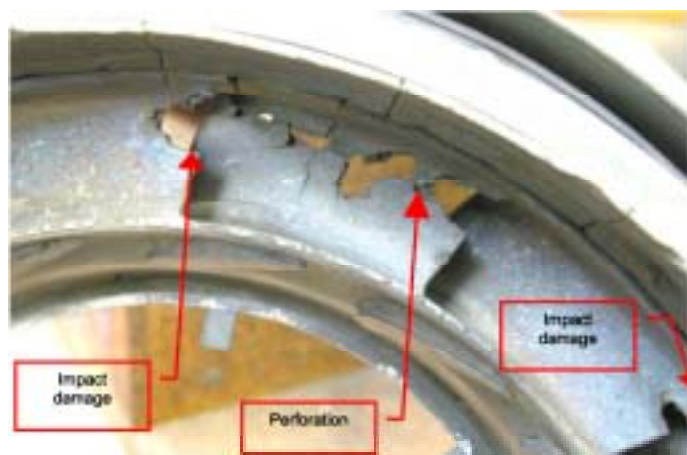
Figure 6. Photograph of the trailing side of the perforated airfoil of CT vane 10 (Circled area in Figure 4). Evident impact damage sustained on the adjacent vanes during the departure of the CT blades is also labelled.

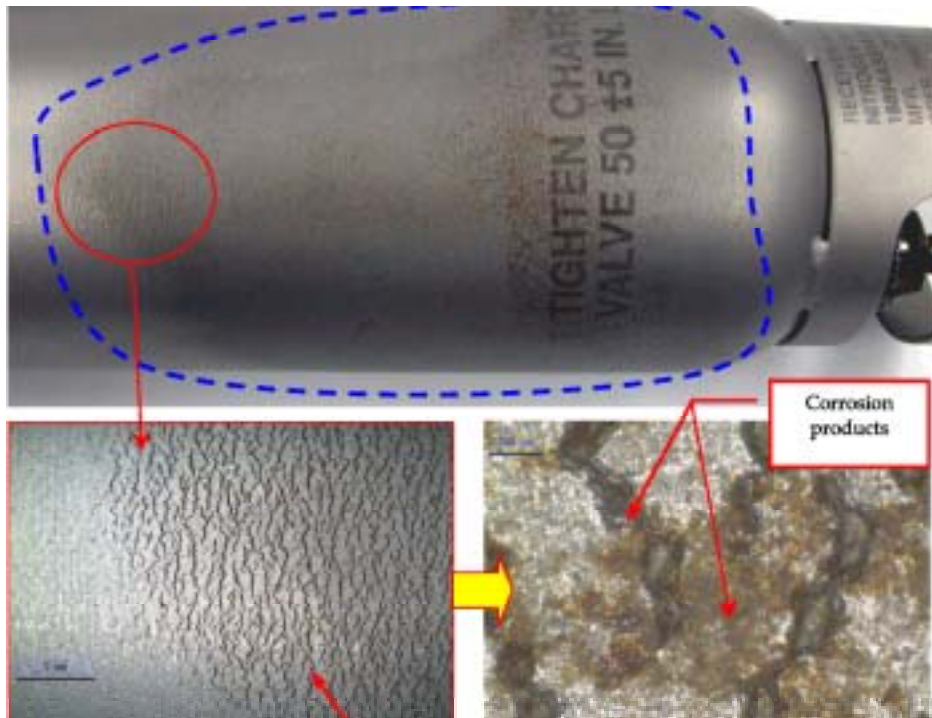
(Top) Photograph of a subject cylinder showing a large area of cracking (circled area). (Bottom left) An enlarged view of the cracking showing a network of circumferential cracks. (Bottom right) Note the corrosion products (i.e. 'rust stain') inside and in the vicinity of the cracks (arrowed).

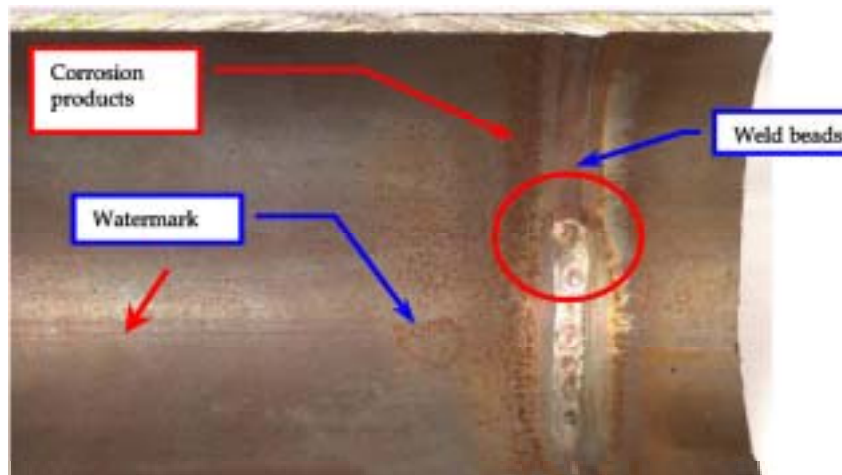
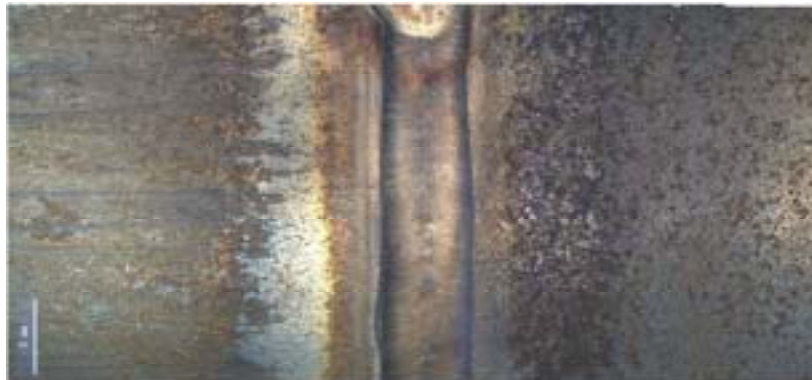
Photograph of a section of the internal surface of a subject cylinder (Top) and a higher magnification view (bottom) of the weld beads (circled). Note the large concentration of brown corrosion deposits and the dark grey colouration of the background surface. Plug scores (i.e. longitudinal score marks) are also noted (examples arrowed). Also note that the amount of surface corrosion observed on the HAZ.

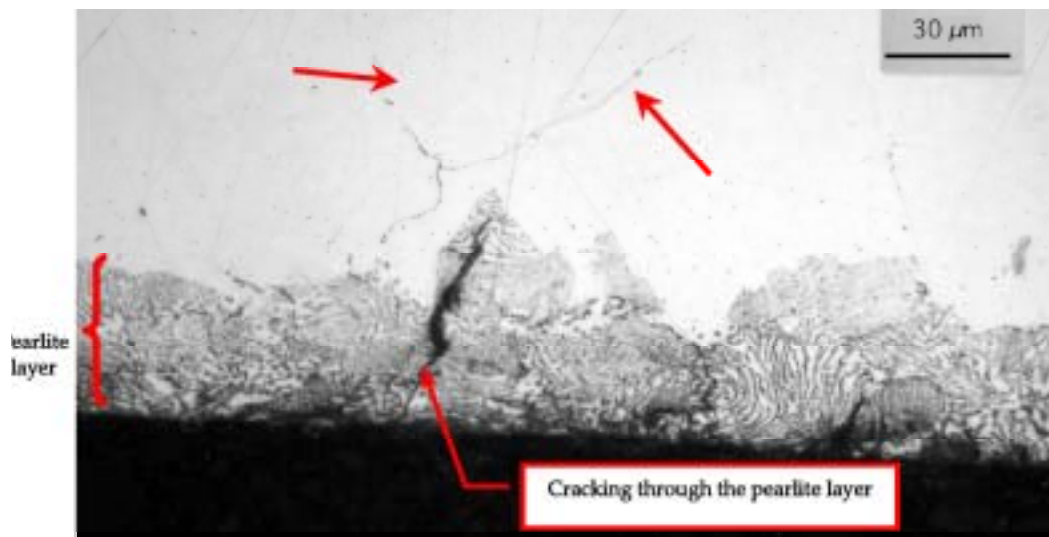
Electrolytic etching of metallographic specimens revealed the presence of a pearlite layer at the areas where corrosion and/or cracking were observed. Cracking through the pearlite layer is evident. Intergranular hairline cracking along the austenitic grains is also observed (examples arrowed).

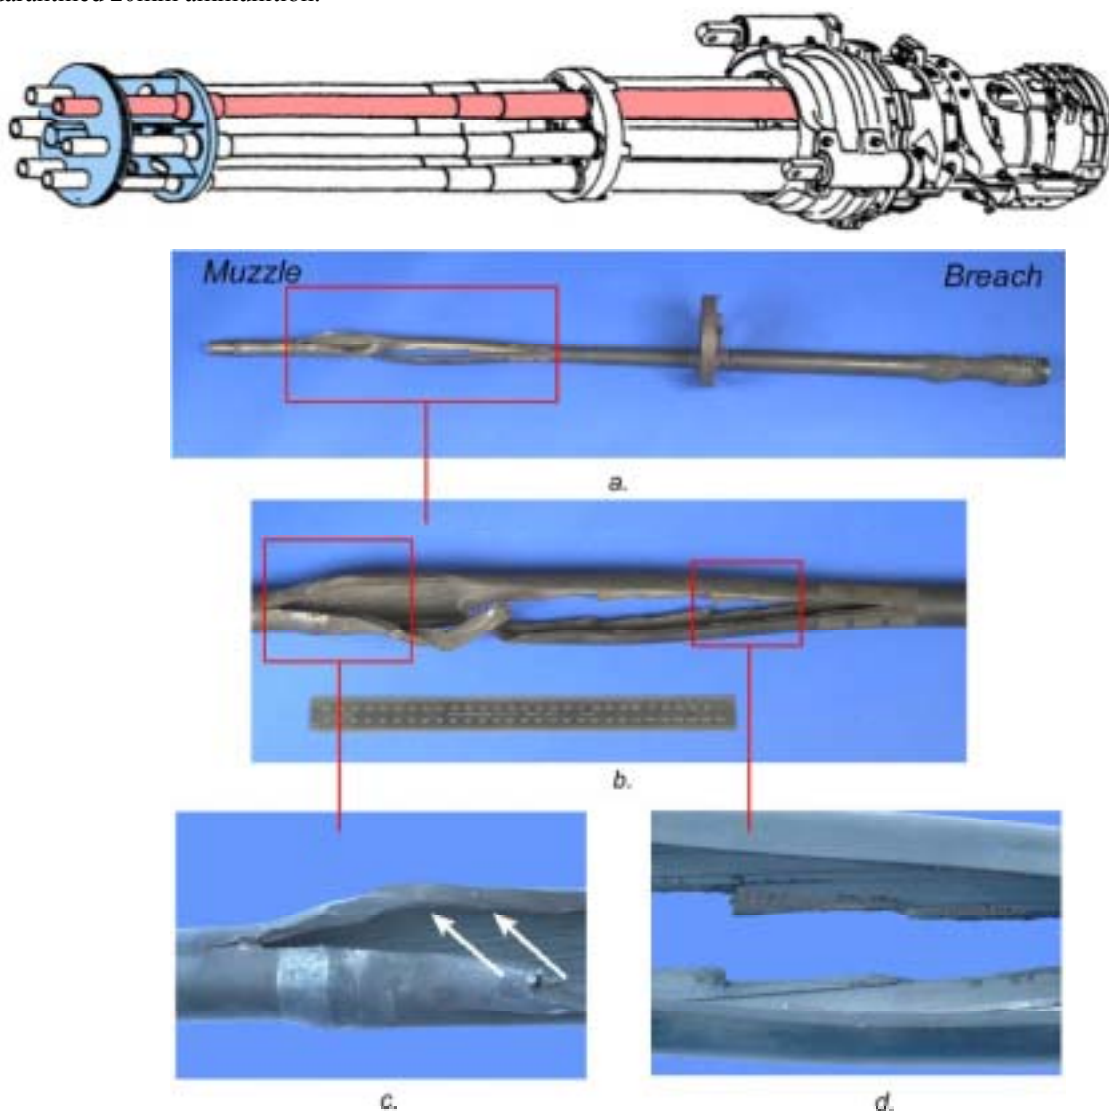
Photograph (a) shows the defective cannon barrel as received by the DSTO. Photographs (b), (c) and (d) show higher magnification images of the damaged region of the barrel and parts of the fracture surfaces. Longitudinal cracks in the barrel were located approximately 200mm aft of the muzzle, and extended for approximately a further

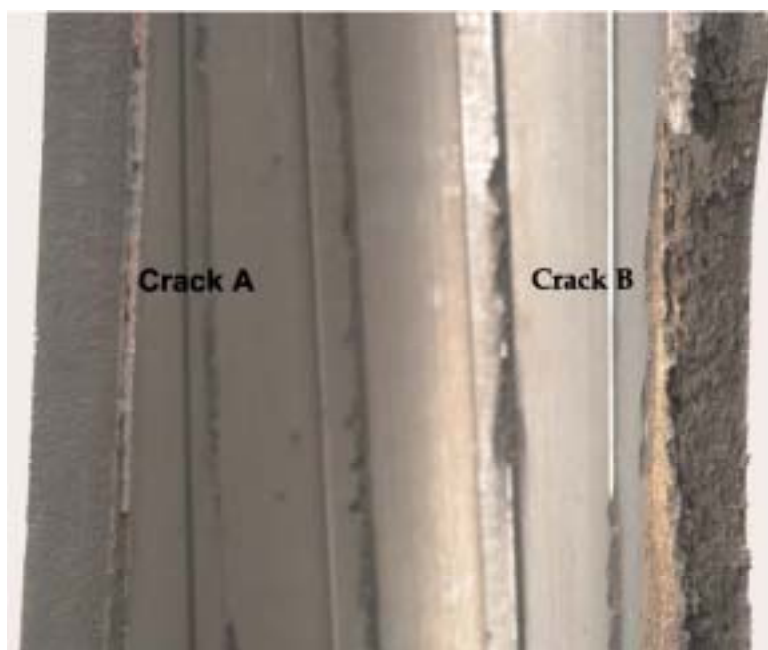
Macro-photograph of part of the fracture surface from the ruptured barrel. Two different regions of fracture associated with the failure are identified and labelled (Crack A) and (Crack B). Crack A is associated with a pre-existing defect within the barrel and Crack B is associated with rapid overload.

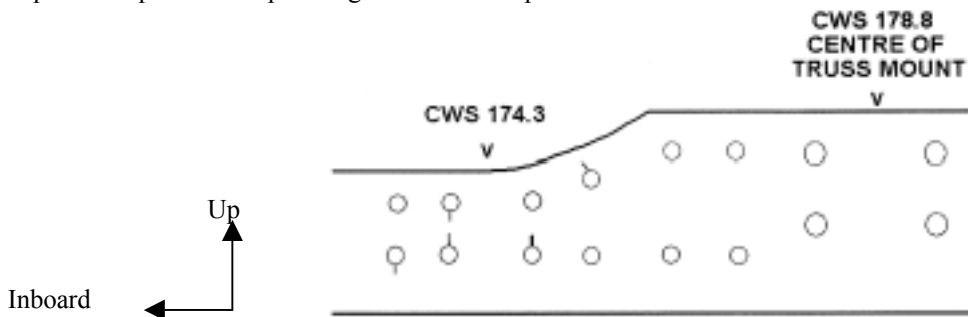
Figure 1(a) Example of cracking from Port wing of Aircraft 1

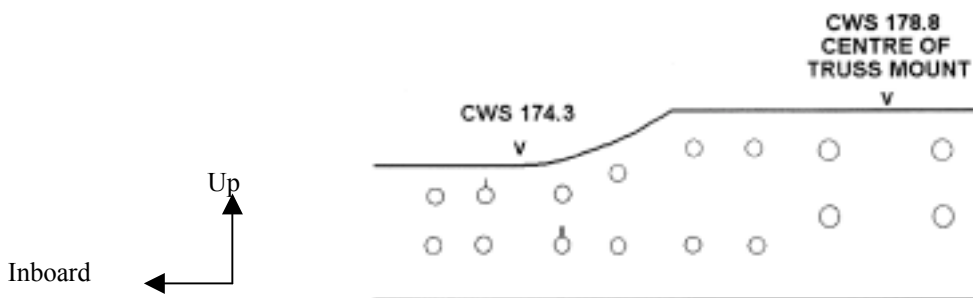
Figure 1(b) Example of cracking from Port wing of Aircraft 2

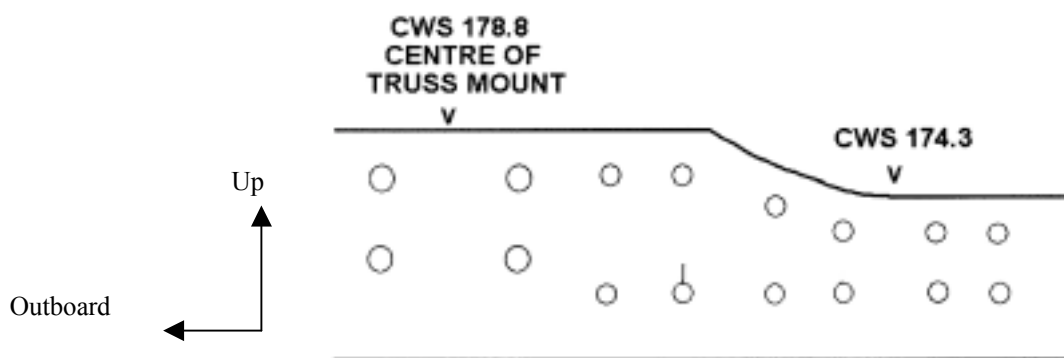
Figure 1(c) Example of cracking from Starboard wing of Aircraft 1

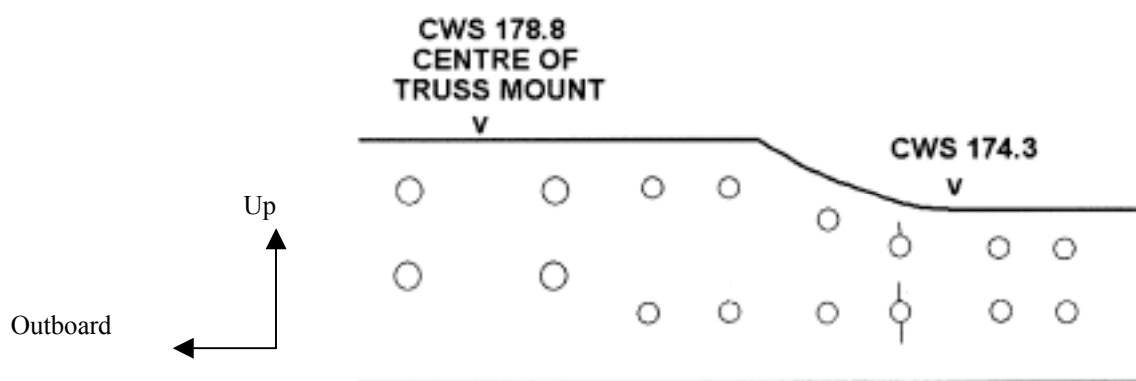
Figure 1(d) Example of cracking from Starboard wing of Aircraft 2

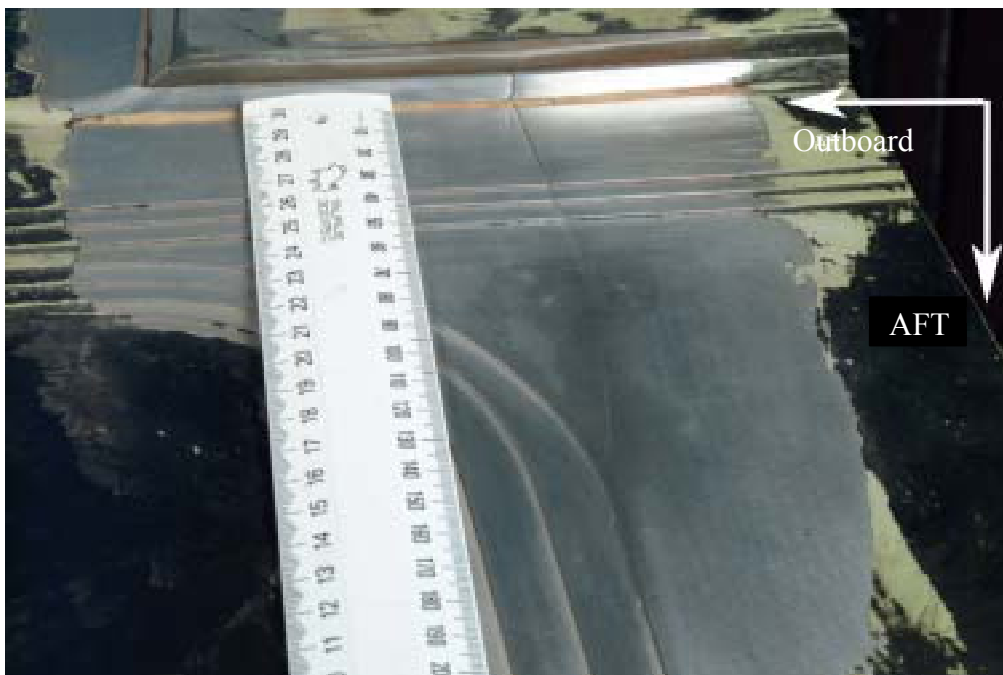
Figure 2. *View of the crack propagating beyond the doubler.*

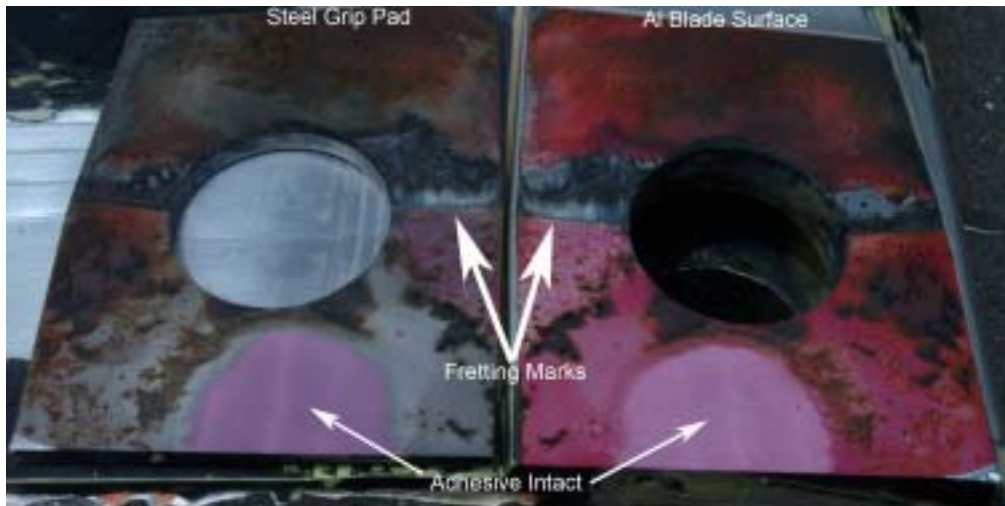
Figure 3. Adhesive surfaces after removal of the grip pad (left). The fretting marks indicate the crack opening displacement experienced in flight.

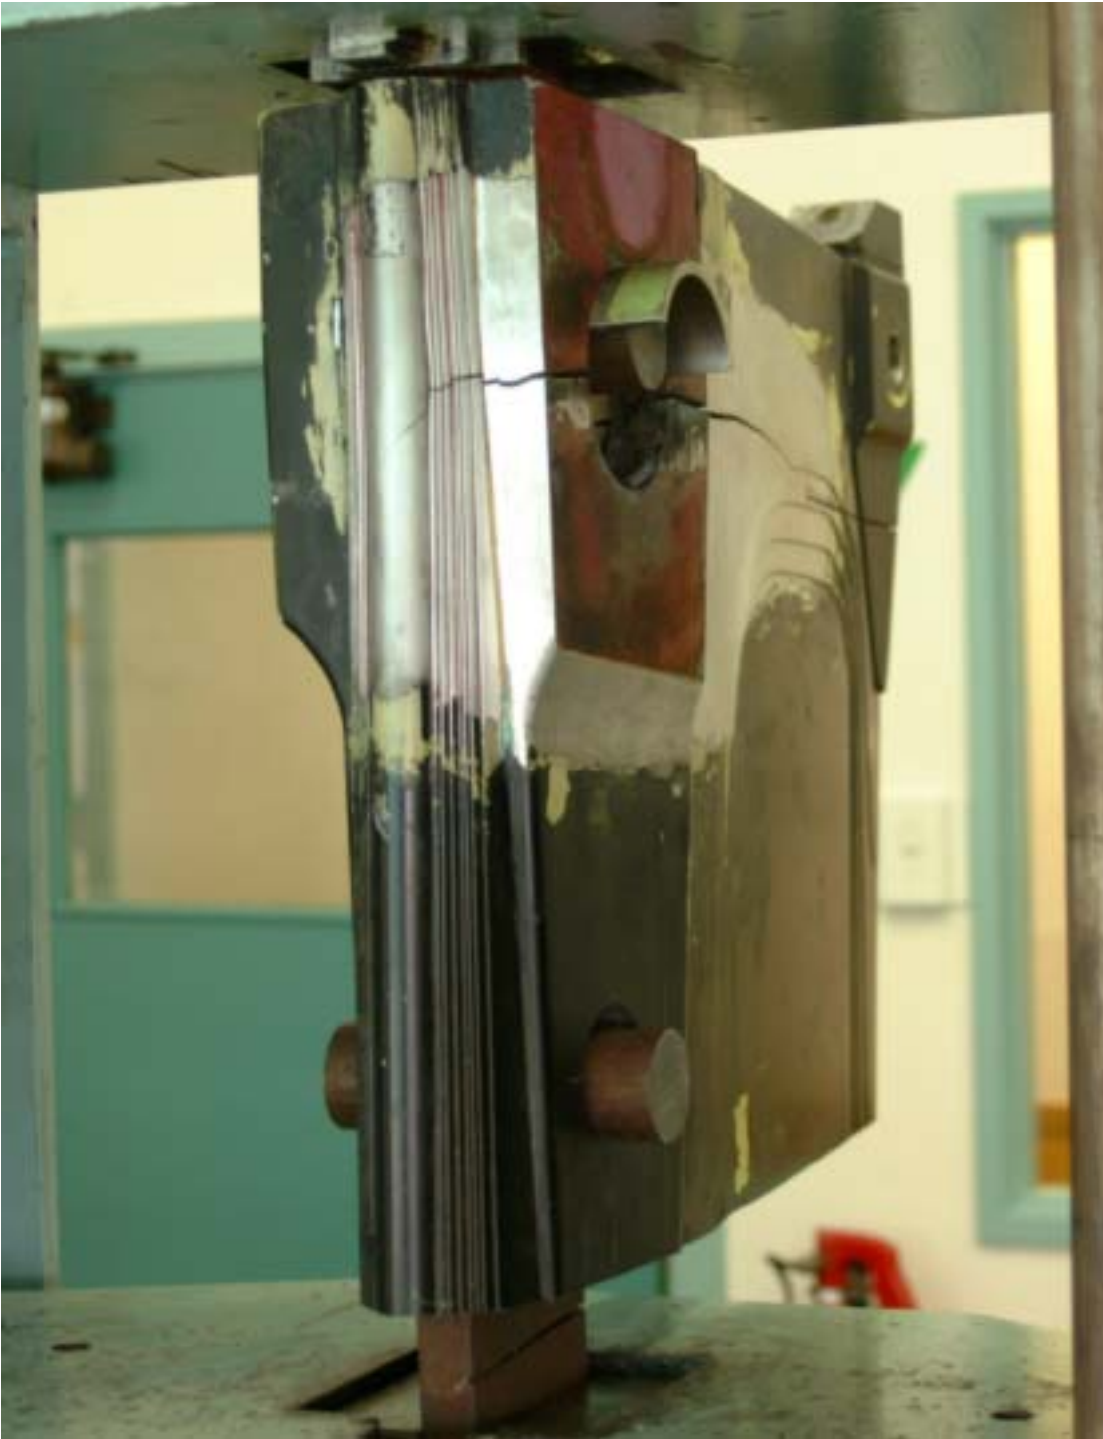
Figure 4. Application of a tensile load to simulate the crack opening displacement indicated by witness marks on the doubler. The aircraft was likely to have been flying with the crack in this configuration.
